# Heritage Impact Assessment

Proposed rebuild of damaged gate pillar (north pillar of east gates – Love Lane)  
at Ayscoughfee Hall Gardens, Love Lane, Spalding, Lincolnshire

On behalf of South Holland District Council

A1572EG – HIA rev P1

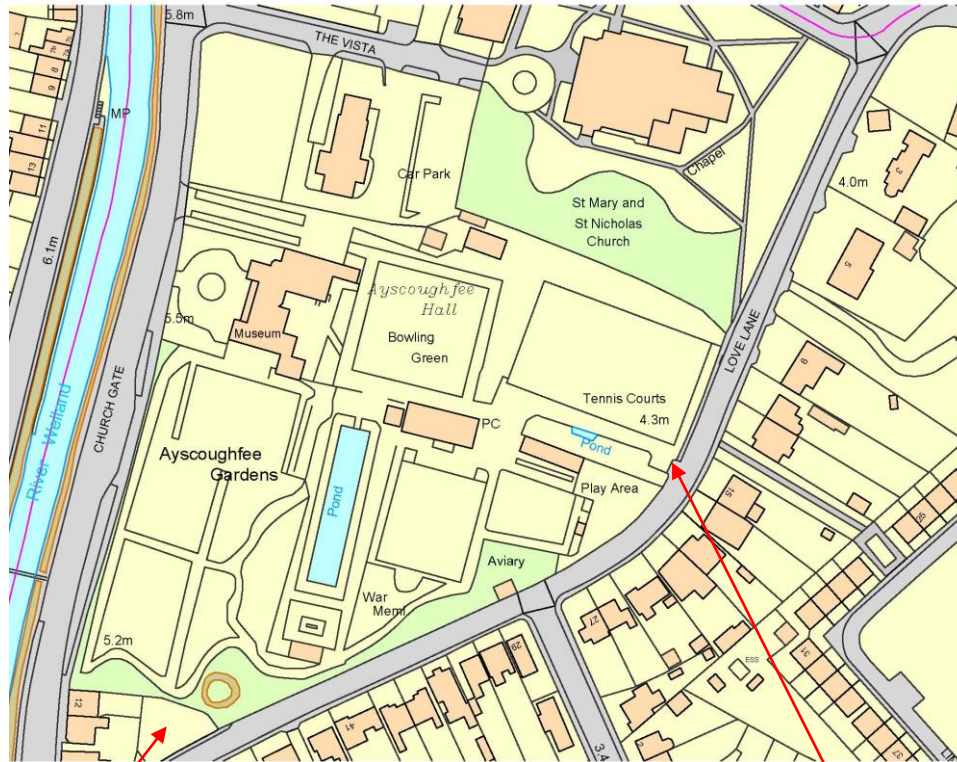
Fig.1 Gates to the Tennis Courts showing their position in Love Lane to the East of Ayscoughfee Hall

Area referred to in Section 4 (3.3.8)

Gates to the Tennis Courts

- 1.8 The relative positions of elements mentioned in this document are shown in Fig 1 below

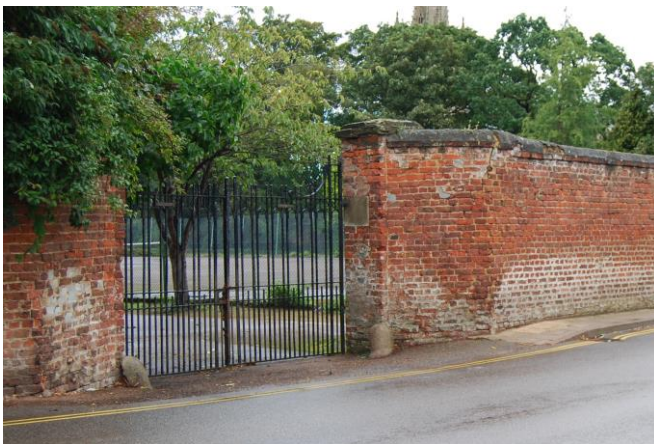
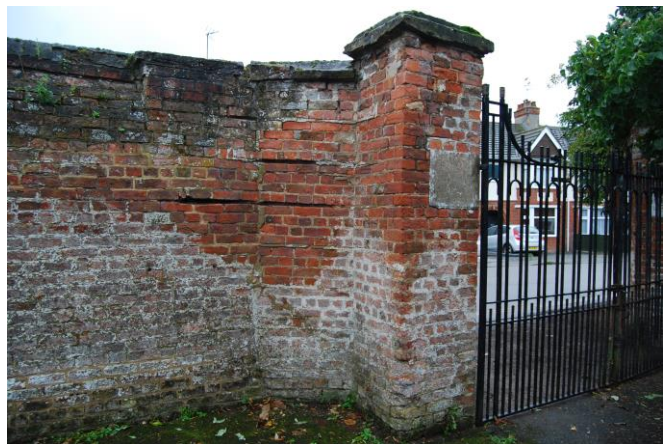
Fig.2 The Love Lane Entrance showing a view from the road and an internal view of the gates and supporting pillar prior to the damage

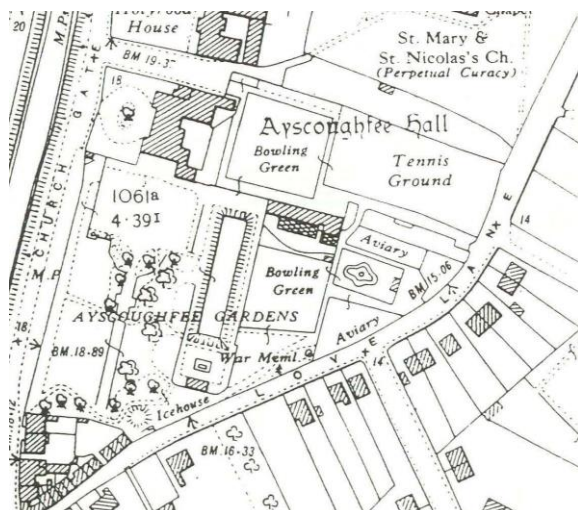
**Fig 4. OS map of 1929**

The OS map of 1929 (Fig 4) shows the tennis 'ground' and it appears to show the opening in Love Lane to the left of the tennis courts. This map was revised in 1950 and in 1952 but the layout does not change. In the OS map of 1974 shows the Tennis court to have been widened.

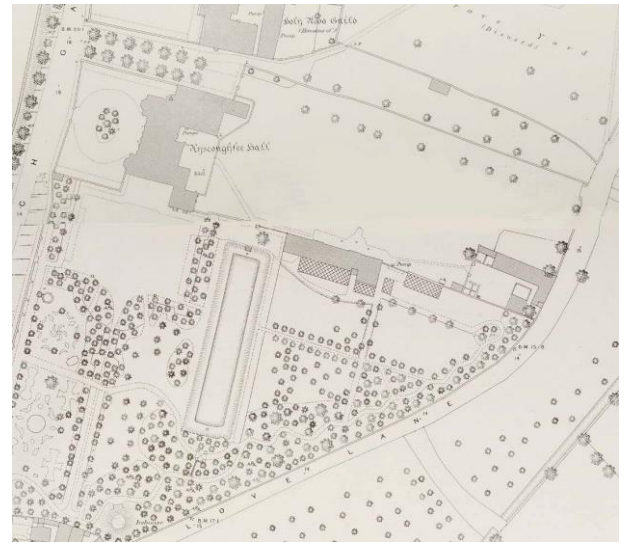
**Fig 5. Extract from the map produced by The Parish Church of St Mary and St Nicholas in conjunction with Ayscoughfee Hall**

This map appears to show openings in the wall close to the site of the gate.

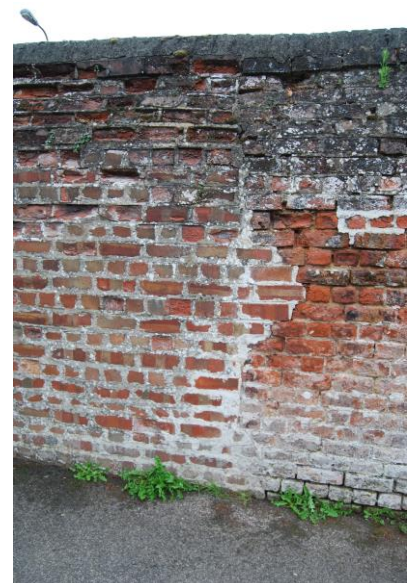
The wall shows areas with the pointing being missing and of damage caused by the use of inappropriate mortars and poor workmanship.

**Fig 7. General Photograph showing the condition of the internal face of the boundary wall to the left of the gates where the battered face changes from four to five courses**

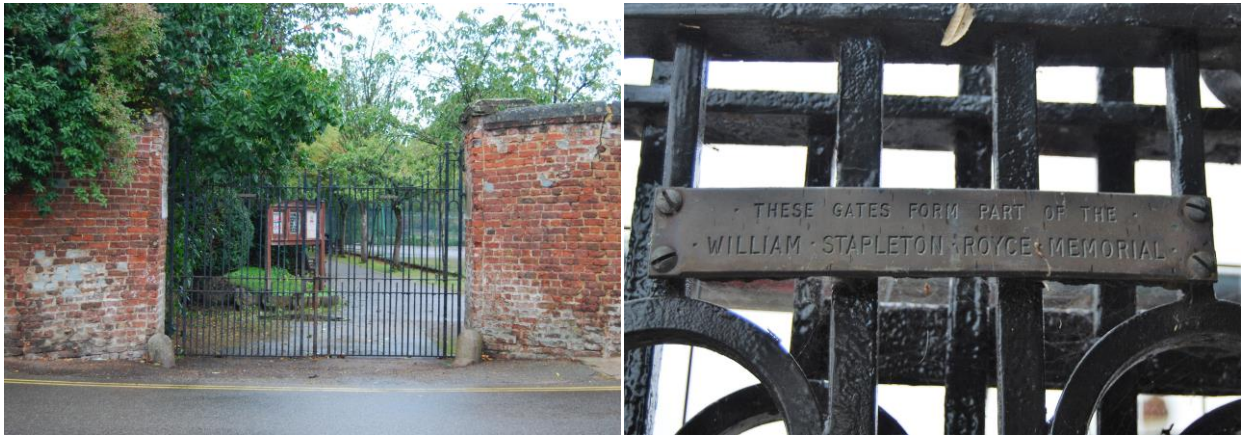
**Fig 8. Photographs of the existing opening and gates with memorial plaque before being damaged**

- 5.2.1 It is not known when the entrance was made, the map of 1929 mentioned in 4.4 above shows the opening and may have been made to serve the tennis courts which had been re-sited in 1925 (see 4.3 above).
- 5.2.2 The opening is set back from the line of the main wall with short angled walls and 690mm square piers topped with lime stone cappings.
- 5.2.3 The gates are of wrought iron and are hinged on stone blocks set in the brickwork.
- 5.2.4 It is not known exactly when the gates were installed but they form part of the William Stapleton Royce Memorial along with the main gates at the front of the Hall. (see Fig 8 above)  
William Royce died on 23<sup>rd</sup> June 1924

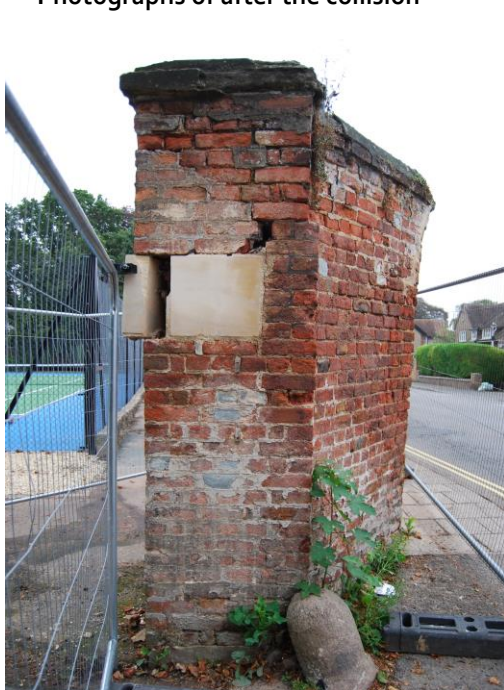
Fig 9: South Elevation view

The existing brick gate pillar to the north of the southern Love Lane opening, suffered impact damage in 2023 when stuck by a vehicle. The hinge stone on the west face of the pillar has cracked and parted vertically, through the line of the hinge plate. This stone has rotated anti-clockwise on plan such that it projects beyond the brickwork beneath by circa 50mm. The brickwork beneath the hinge stone has cracked vertically through at least 3 courses. The brickwork above the hinge stone (again on the west face) has been displaced to the north, such that it overhangs the north face of the pillar by circa 50mm, for a height of 9 courses. On the south face, the west section of the hinge stone has been shifted to the west, and a significant gap has opened up between the two components of the hinge stone. A very significant opening has also resulted above the hinge stone, rising through 2 courses before reducing to a single crack. The impact also appears to have resulted in a number of smaller cracks throughout the pillar and into the adjoining boundary wall.

1. Fracture and displacement of the west hinge stone.
2. Rotation of the upper section of the gate pillar.
3. General cracking throughout the pillar and into the abutting wall.

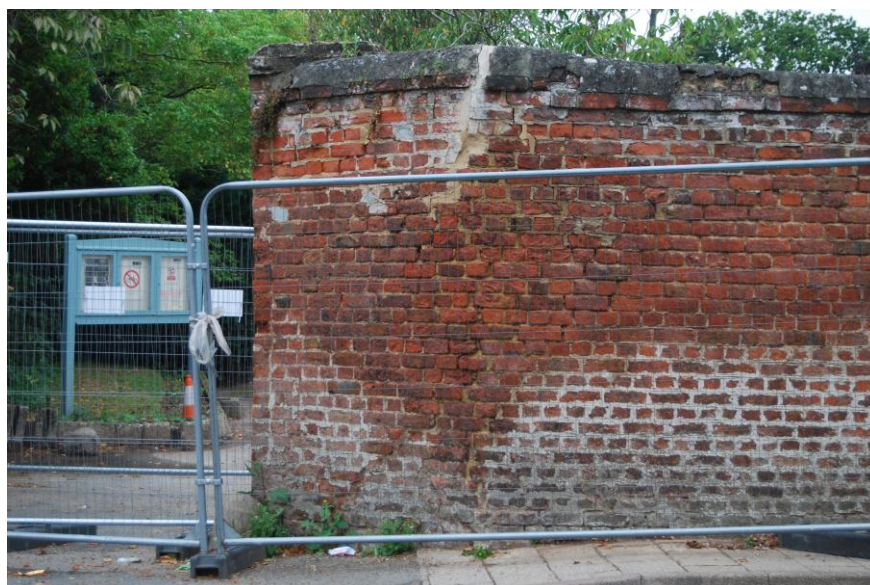
Fig 11: West  
Elevation view

Beyond this, immediately north of the pillar there are a number of iron straps set within the bed-joints of the brickwork, continuing around the wall splay on plan, and set at various heights. This mortar cover on the ironwork has eroded away on the upper 3 straps, exposing the iron to the elements. This has resulted in the iron corroding, expanding significantly in the process.

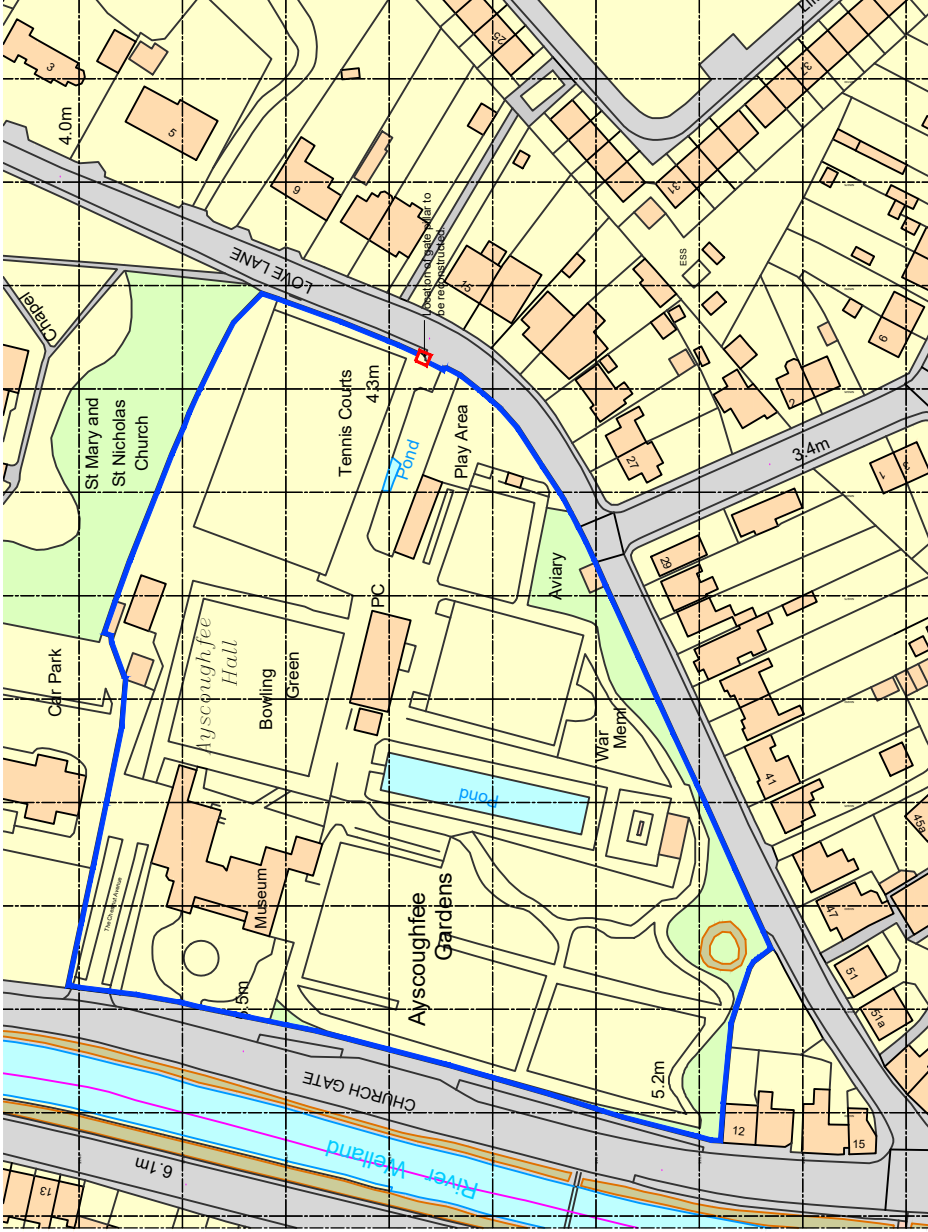
### Site Location Plan

Site of works proposal outlined in red.
