## **Phase II site investigation**

**Client;** Scott Park Developments Ltd

**Site;** 36/38 Holbeach Road

H16-0505-17

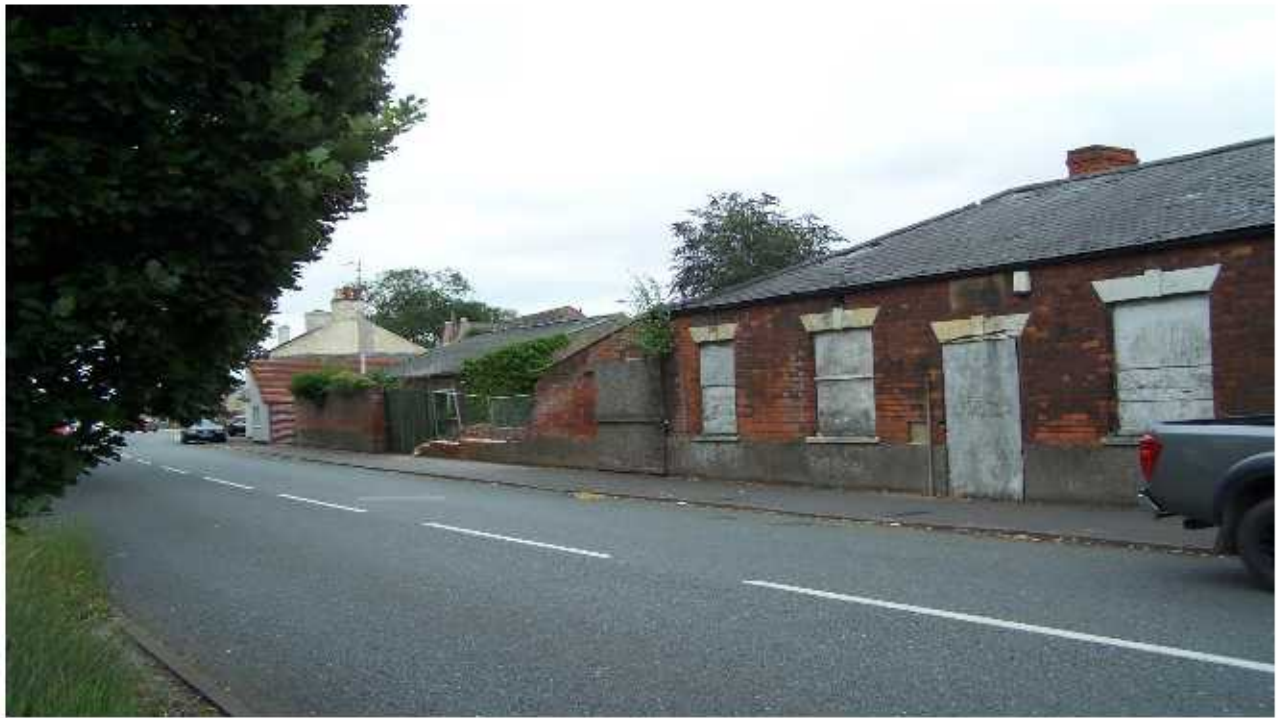
Photograph 1 – Site frontage adjacent to Holbeach Road (Pre demolition)

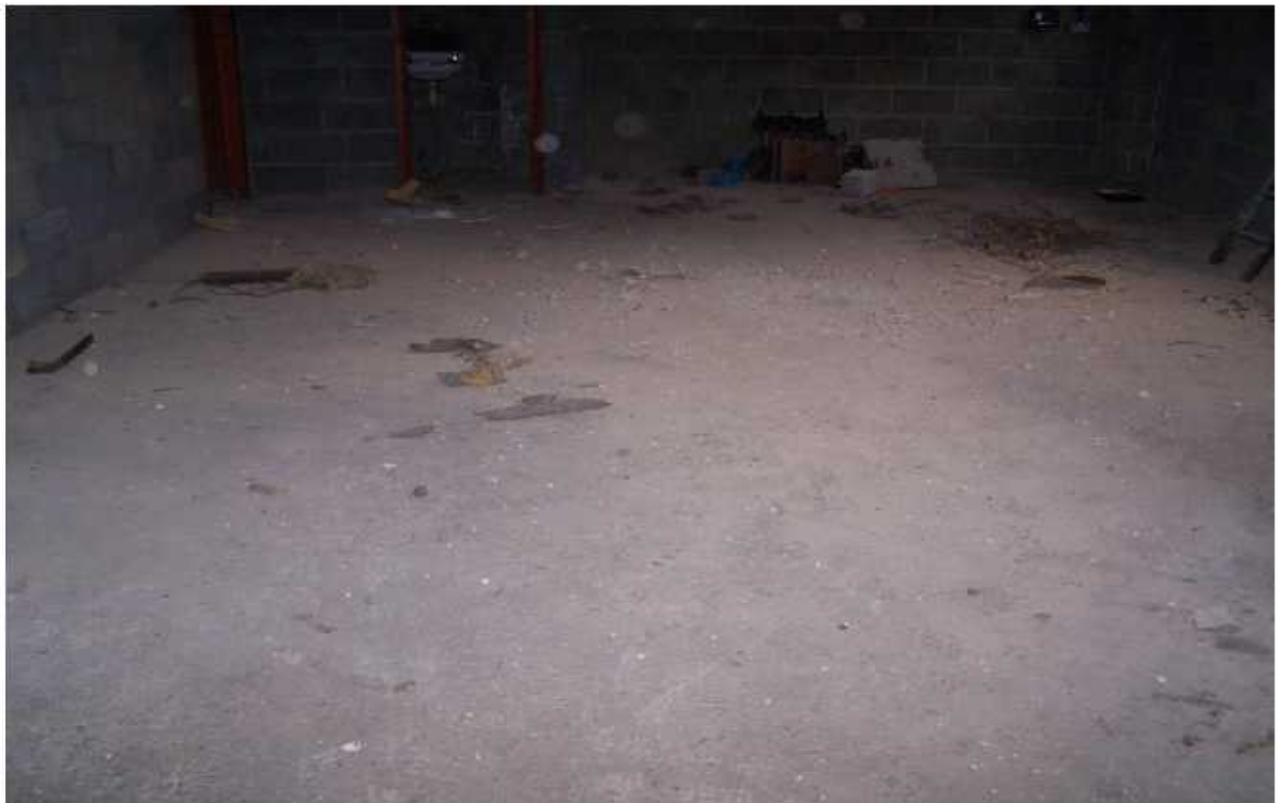
Much of the site is occupied by concrete slabs. Indications suggest that the slabs are around 250mm to 350mm thick with reinforcing mesh.

Photograph 2 – Internal floor slab

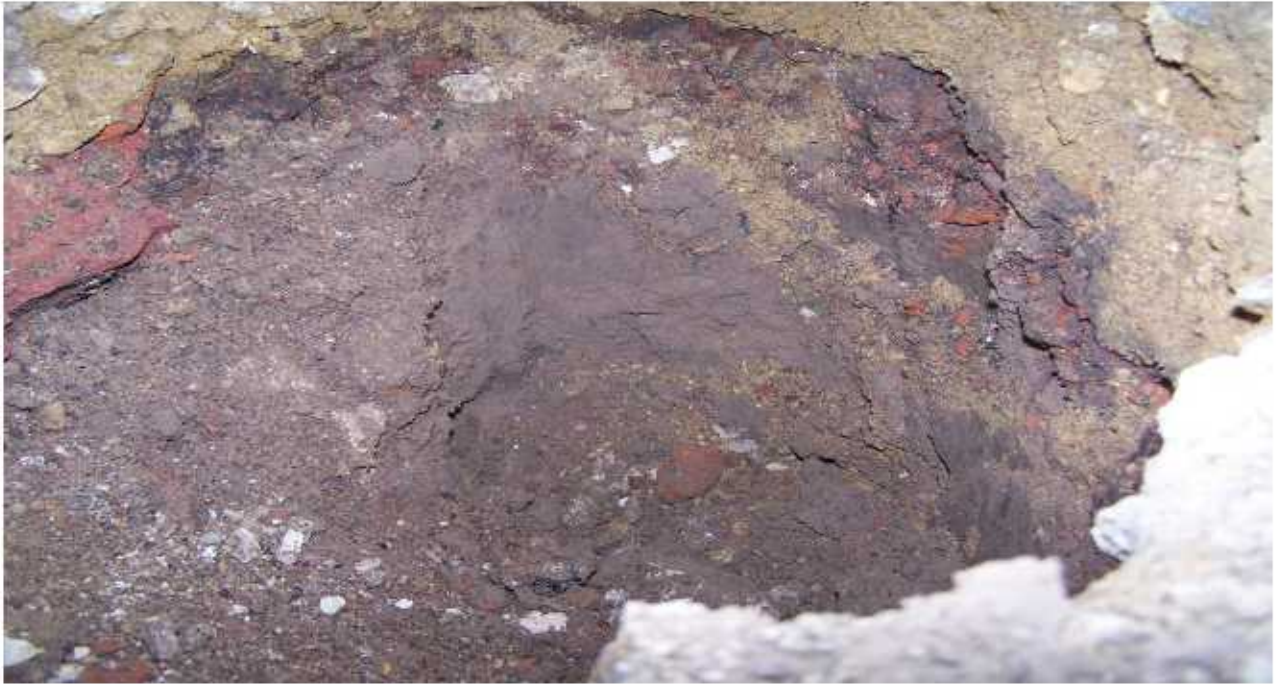
During the site visit, 3 samples were taken. 'Windows' were cut through the slabs with 2 samples taken beneath. The samples included mortar residues, evidence of brick and soil. One sample was taken outside adjacent to the rear wall of the workmen's Institute. This sample resembled clean soil with root material present. (Appendix III – sample locations)

None of the samples were discoloured or emitted an odour both, which if present, could suggest evidence of contamination.

Photograph 3 – Sample point 1

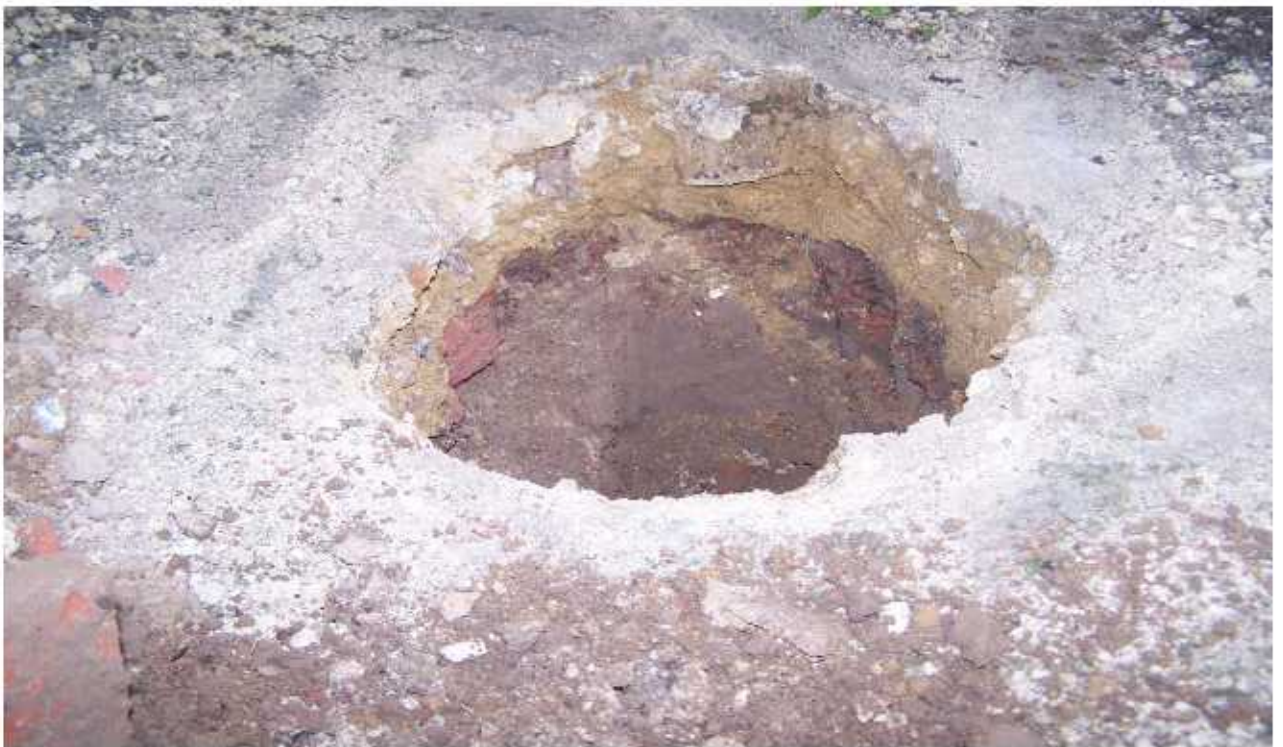
Photograph 4 – Sample point 2

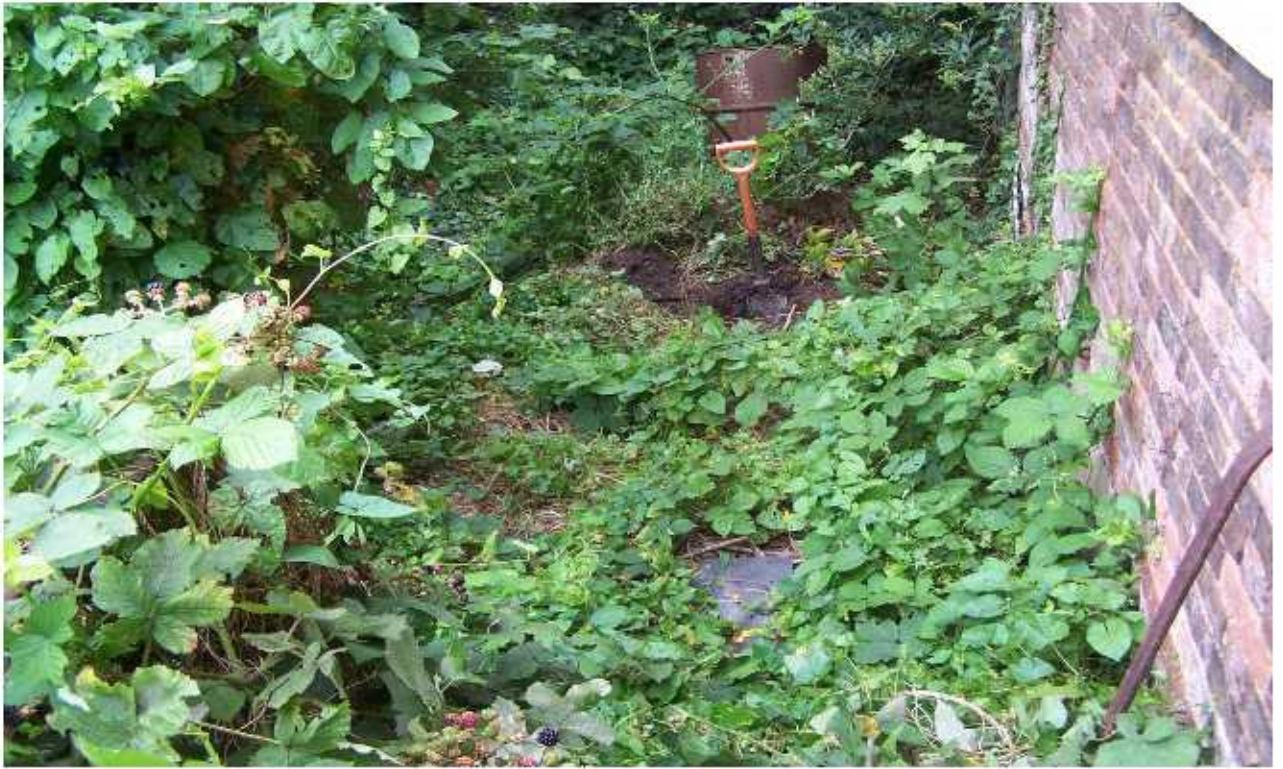
Photograph 5 – Sample point 3

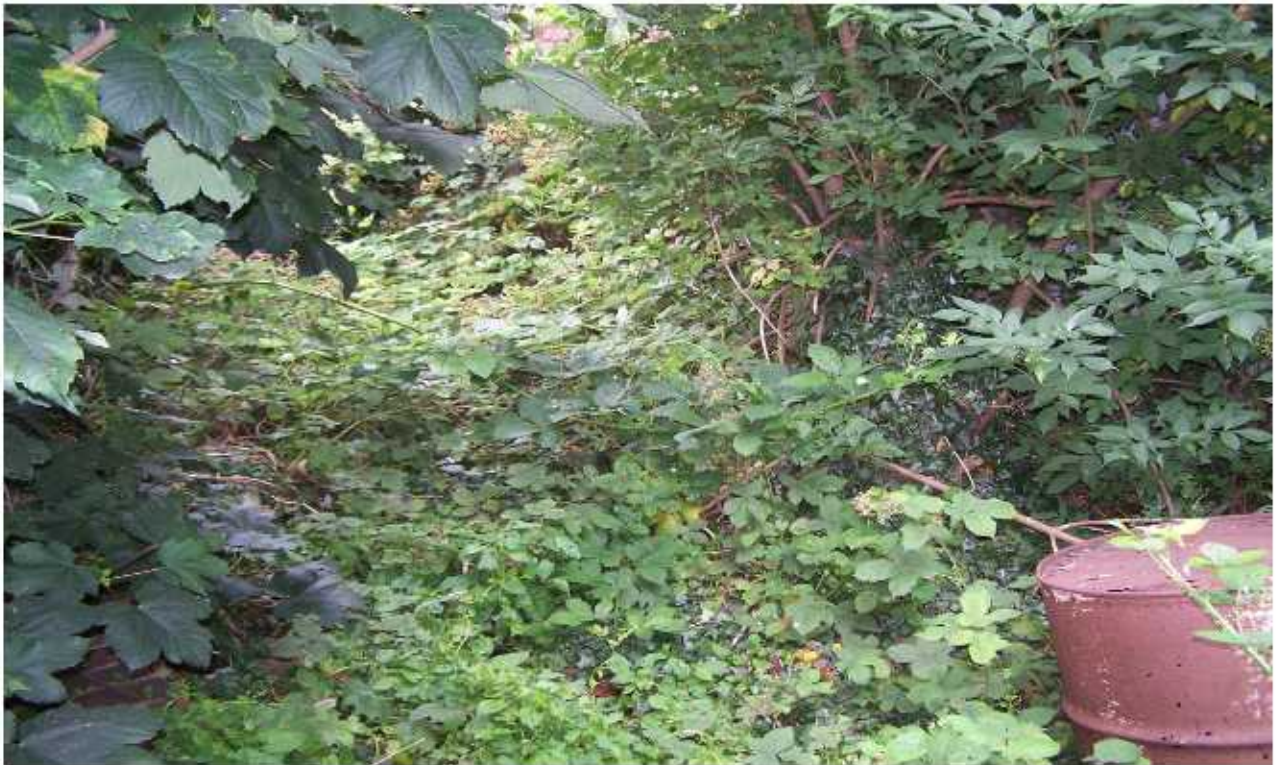
It should be noted the only significant area not occupied by buildings incorporating concrete floors is the rear courtyard area.

On inspection there is undergrowth including self-sown trees, brambles, ivy and docks. There is no evidence that normal weed growth is being restricted due to the presence of potential contaminants.

Photograph 6 – Vegetation in rear courtyard area.
