**FORMER SESSIONS HOUSE  
SHEEP MARKET  
SPALDING  
LINCOLNSHIRE**

**HISTORIC BUILDING APPRAISAL**

APS Report No: **HS/048**

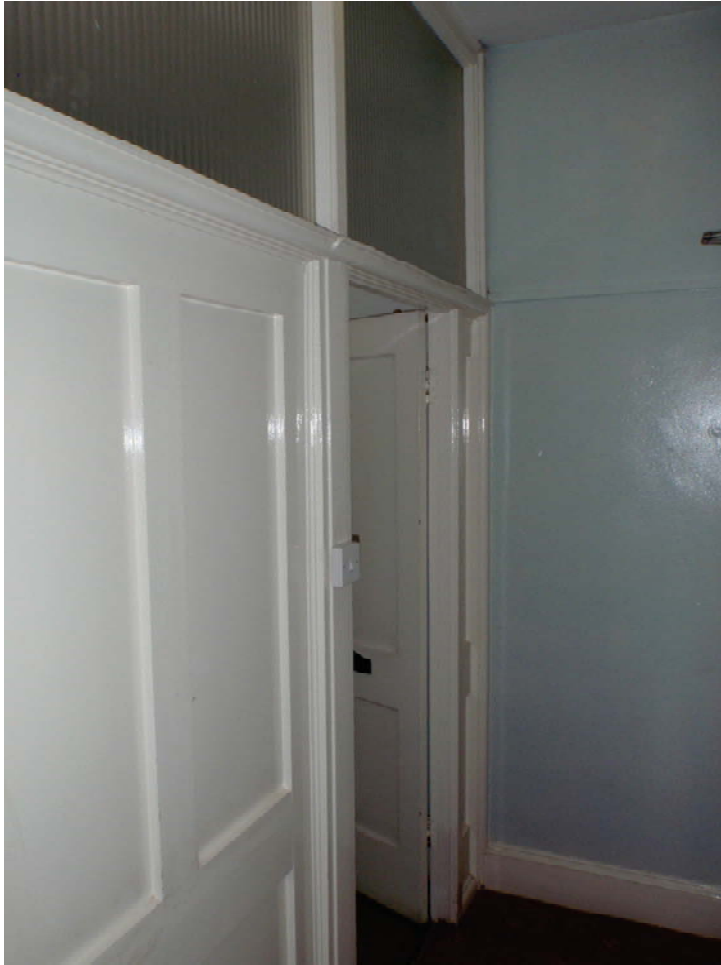
This is comprised of a short corridor which provides access to two small rooms, one containing toilet facilities, the other a wash-hand basin. Panel walling separates the corridor and rooms from each other. The wall panel creating the corridor has a general early 20<sup>th</sup> century appearance, though it is surmounted by borrowed light glazing of probably the 1960s-70s (Plate 1). Parallel to the corridor panel wall, and crossing the two rooms, is a beam-type feature (Plate 2) formed from the upper remnant of a removed wall. This removed wall, when extant, would have defined the original width of the corridor. Dividing the two rooms is a panel wall which, like the corridor wall, has an early 20<sup>th</sup> century appearance. The boxed skirting of the room containing the wash-hand basin is covered with decorative metal panelling, perhaps of early-mid 20<sup>th</sup> century date.

Plate 1 1<sup>st</sup> Floor WC, from corridor,  
panel wall with borrowed light  
glazing

The remnants of the cut-through wall indicate that the present panel divisions are not original to the structure but are part of probable early-mid 20<sup>th</sup> century alterations. It is considered that the alteration or removal of the existing panel walls would be of minor significance and negligible impact on the historic fabric and integrity of the Sessions House.

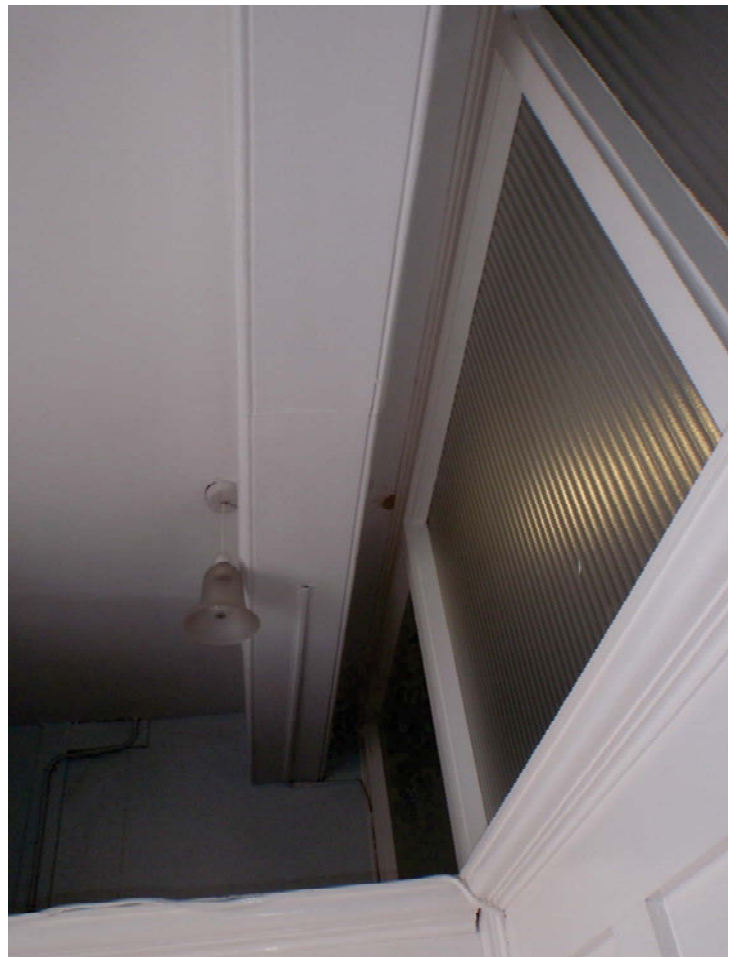
Plate 2 1<sup>st</sup> Floor WC, panel wall with  
borrowed light glazing and 'beam' of  
cut-through wall

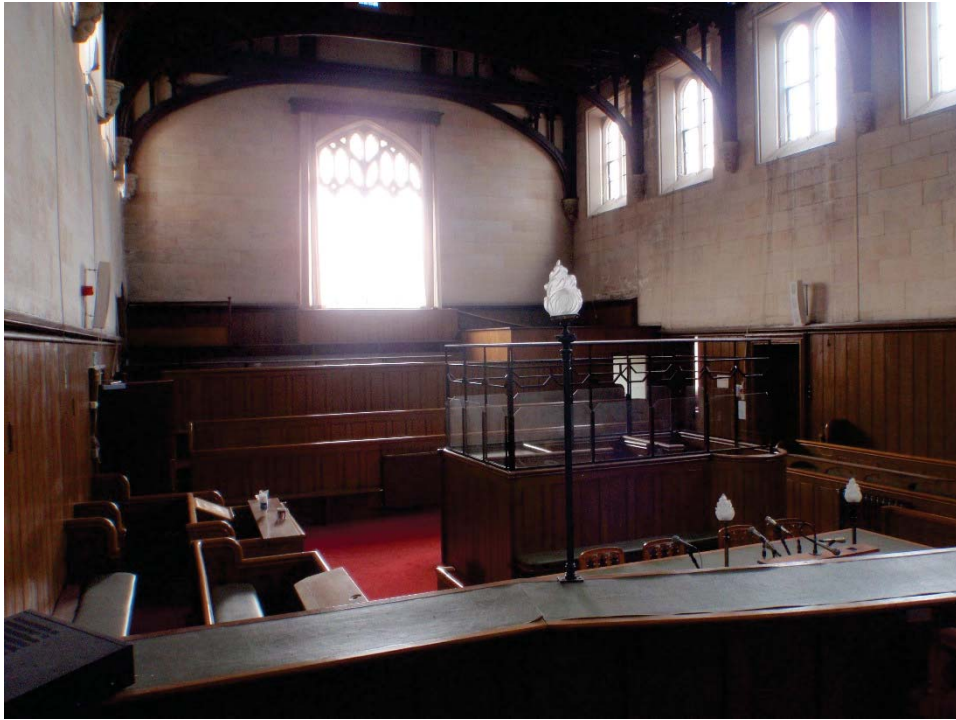
The courtroom contains all the fixtures and fittings appropriate to its function (Plates 3 and 4). It is a large high room with arched beams above, supporting the ceiling. Original wooden panelling clads the lower third of the walls, rising a little higher at the back of the room (Plate 3), behind the public galleries (Plate 5). The lower stages of public seating is original but above these the seating is provided by several tiers of simple wooden benches supported on iron bars that are set into the concrete steps that rise to the back of the courtroom (Plate 6). These upper benches are a later insertion, perhaps from the 1960s. They stand on a stepped concrete platform that is supported on raked cast-iron beams.

Plate 3 Courtroom, general view from magistrates' dais

The fixtures and fittings are specific to the function of the room as the courtroom and their removal (the fixtures in particular) will have a major impact on its original use, nature and appearance. However, retention of the fixtures would largely prevent any other use of this room beyond that originally designed for. The intended retention of the wall panelling and perhaps some of the perimeter benches will, however, preserve a veneer of the historic style of the courtroom. Removal of the modern radiators will improve the retained appearance of the courtroom.

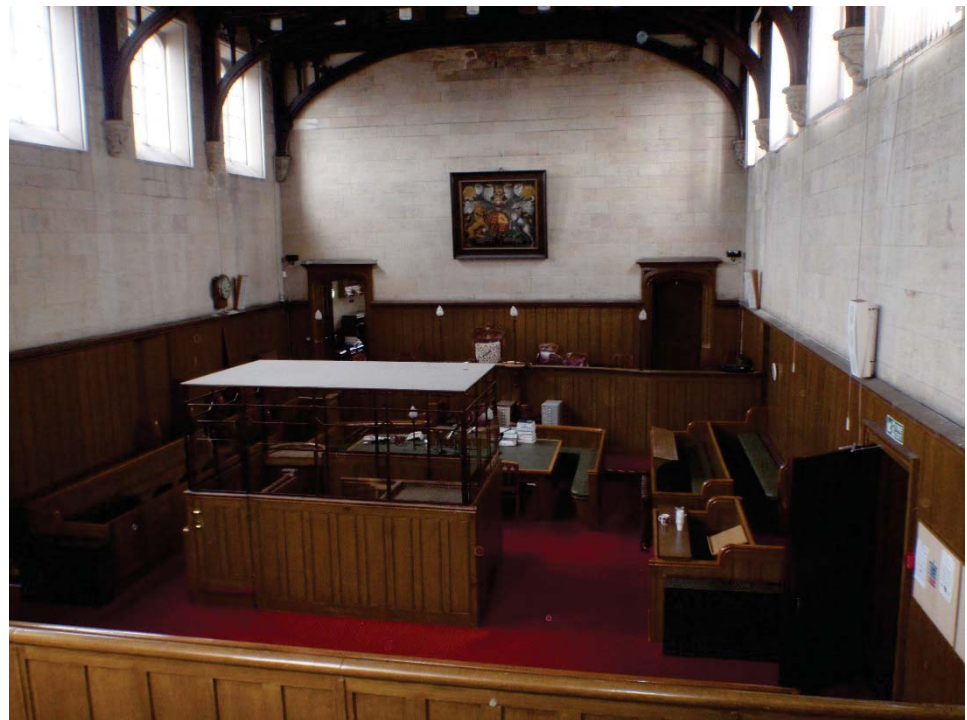
Plate 4 Courtroom, general view from public gallery towards magistrates' dais

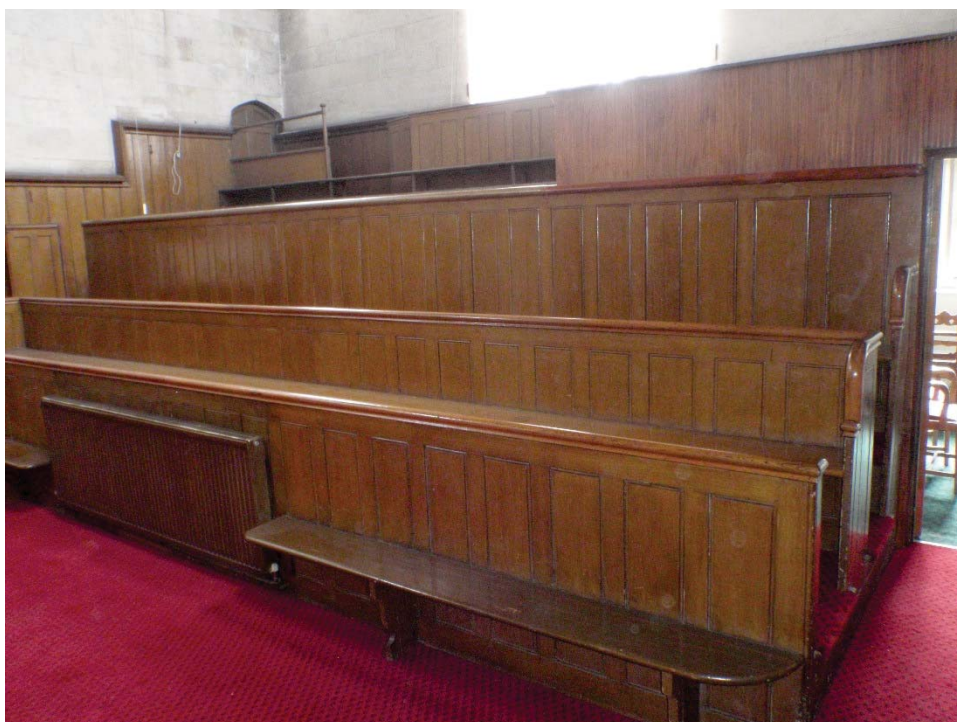
Plate 5 Public seating area at rear of courtroom

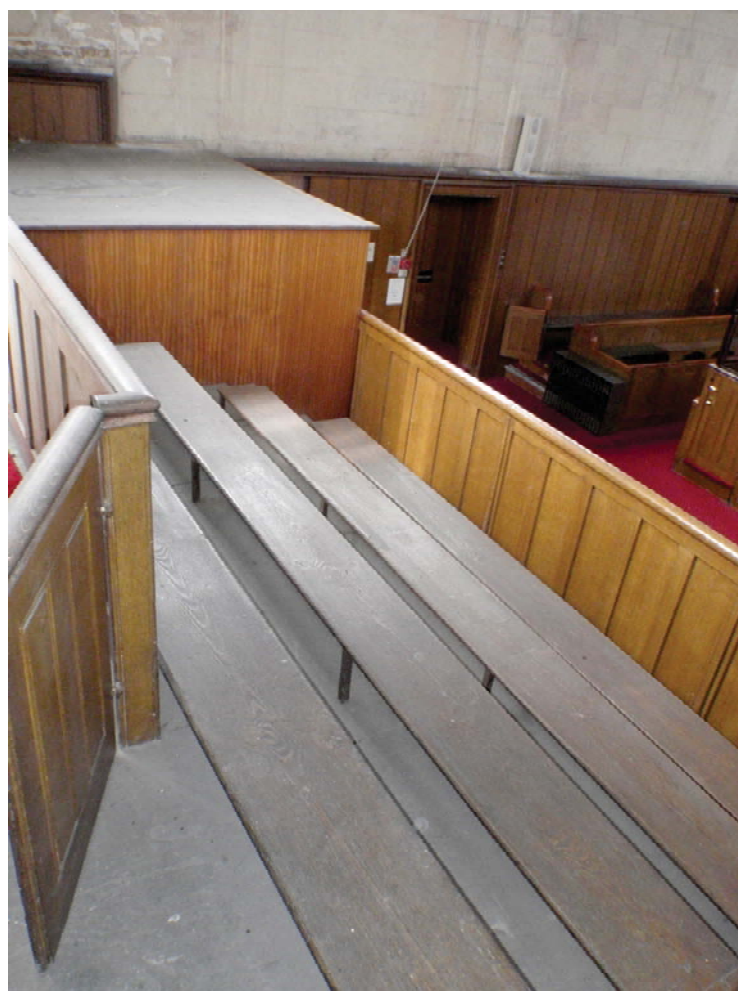
Plate 6 Public seating area,  
inserted modern benches

The area of the upper, modern, benches in the public gallery appears to have been altered to allow their insertion. Any proposed removal of these plain benches would have a neutral or minor positive effect on the appearance of the courtroom.

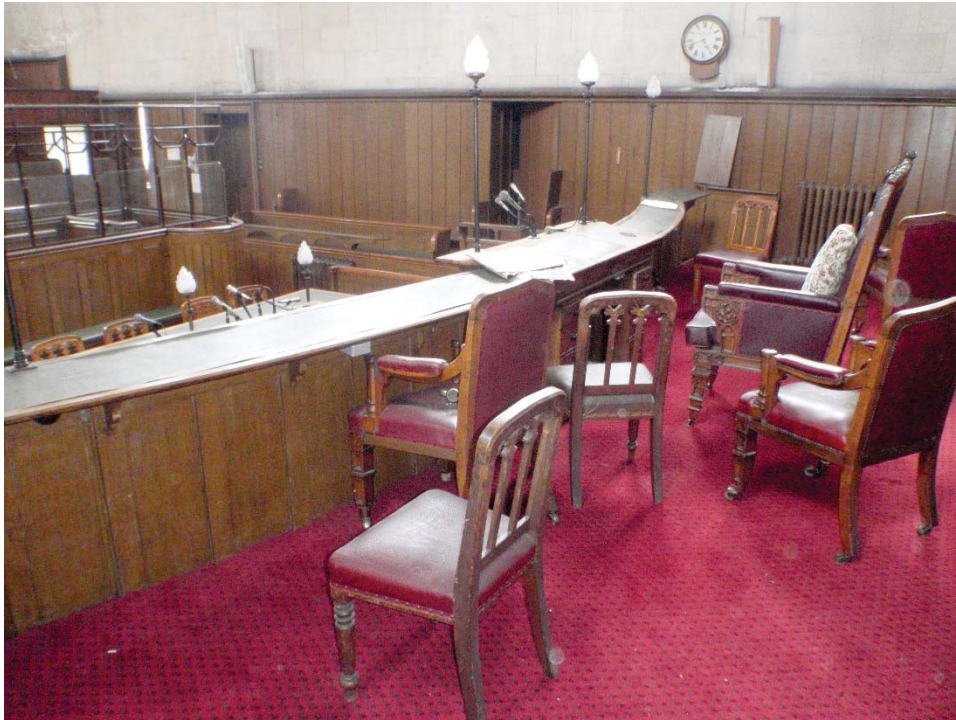
At the opposite, top, end of the courtroom is the raised dais that accommodates the fixed judge's/magistrates' desk (Plate 7). Immediately below the magistrates' desk are the clerks' benches, also fitted, and a large moveable table (Plate 8). In front of the clerks' table is the dock, which has internal access from the cells on the floor below (Plate 9). The dock also has original panelling and upper level cage-work, though the latter has modern, probably 1980s or

Around the courtroom are several sets of radiators. There are four sets of decorative cast iron radiators of probable late 19<sup>th</sup>-early 20<sup>th</sup> century (c. 1890-1910), two on the raised dais and one each on the fronts of the benches flanking the dock (Plates 7 and 11). In addition, there are sets of plain 'functional' radiators of probable 1960s-70s date along the wall behind the magistrates' bench (Plate 12) and immediately in front of the public galleries (Plate 5). There are also two modern radiators, probably of 1990s date, at the ends of the benches flanking the dock (Plate 10).

Plate 7 Magistrates' dais, with desk

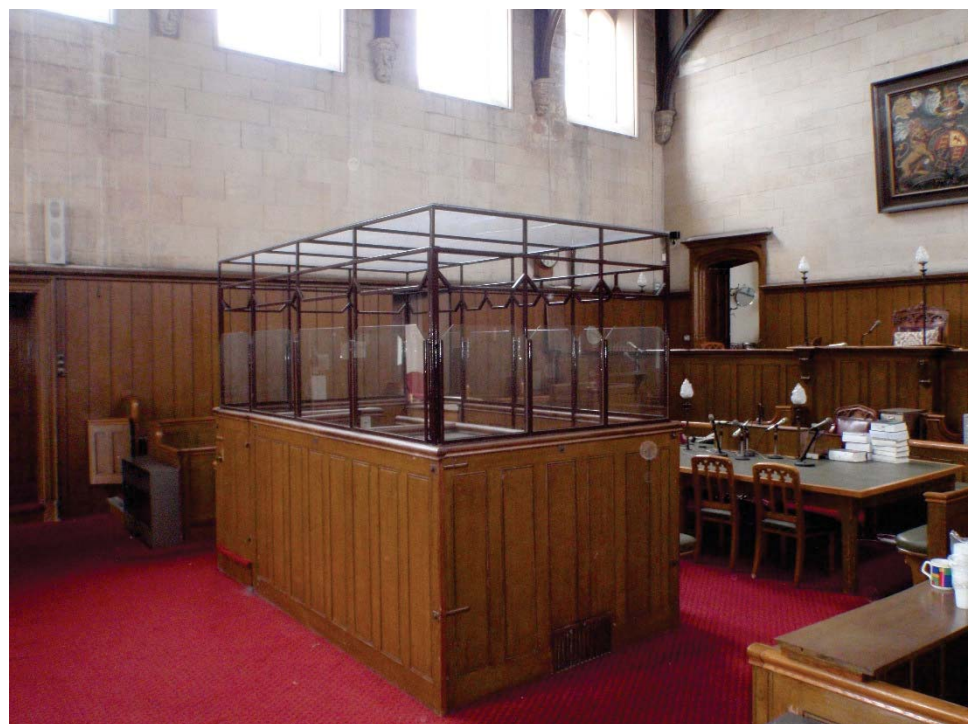
Plate 8 Dock, with clerks' table immediately to right, and magistrates' dais above

Removal of the moveable fittings will have less impact on the appearance and setting of the courtroom. However, the large clerks' table, which was probably custom-made, and the coat of arms painting, are intimately associated with the function and appearance of the courtroom and their removal will have a minor-moderate impact on the visual integrity of the room.

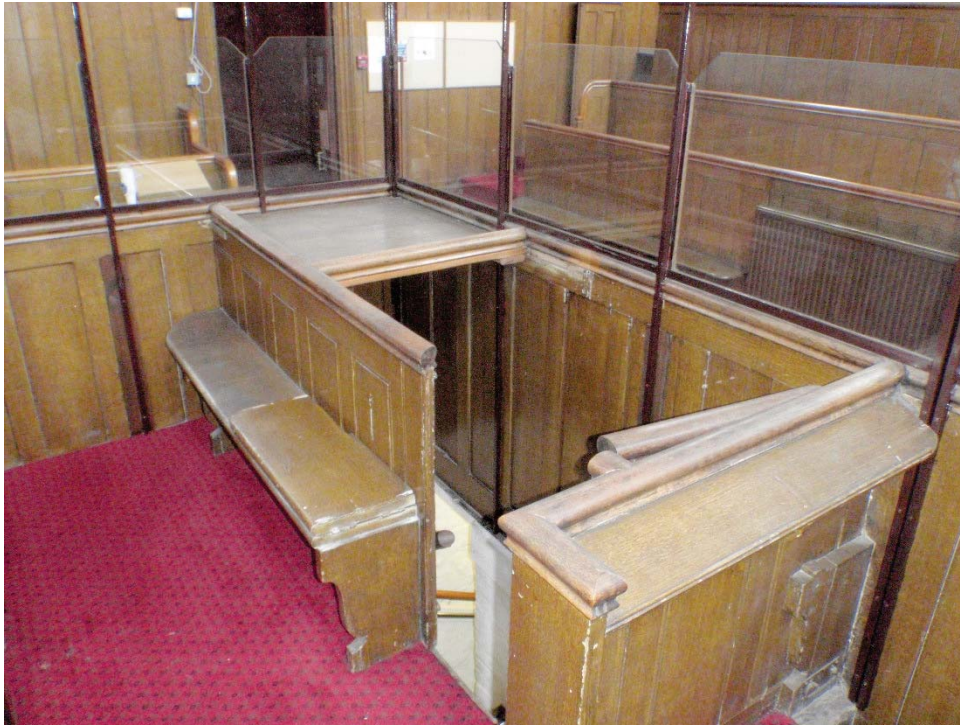
Plate 9 View into dock, showing access from cells below

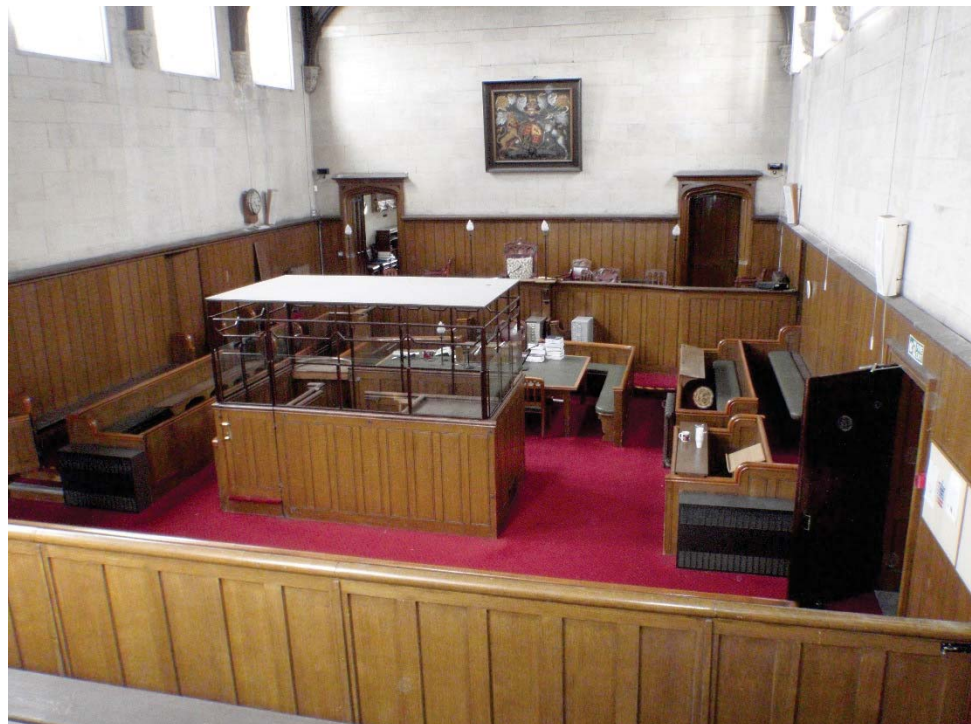
later, glazing. To either side of the dock are tiers of original fitted benches (Plate 10), probably separate sets for witnesses and, perhaps, jury.

On the wall above the magistrates' bench is a large painting showing the Royal Coat of Arms of Queen Victoria (Plate 10).

Plate 10 Courtroom from public gallery, showing benches either side of dock (note modern radiators at ends of benches)

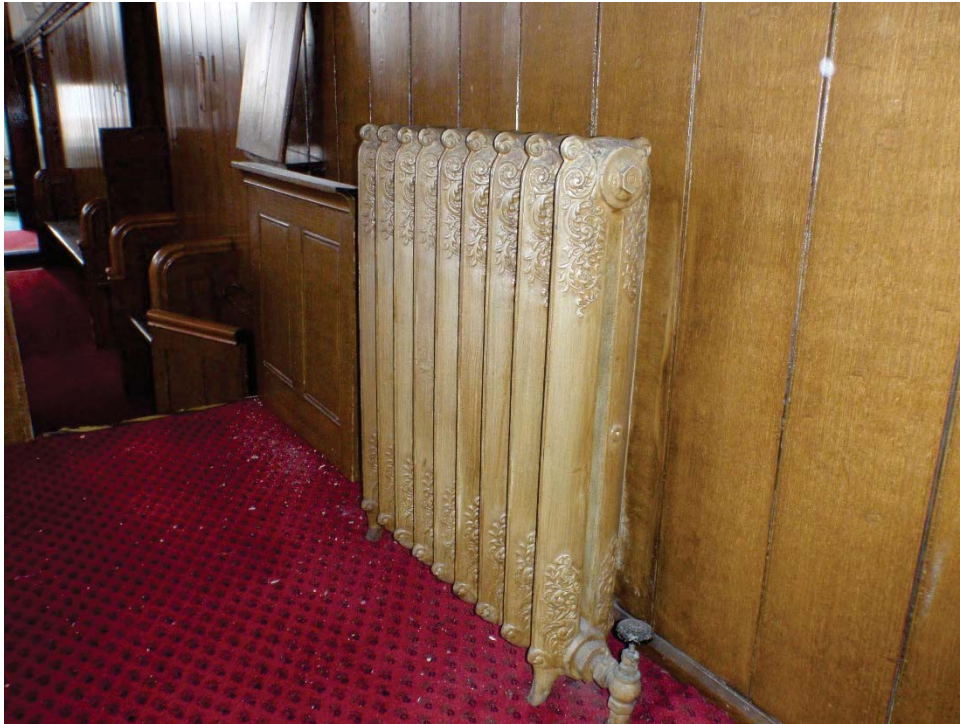
Plate 11 Decorative radiator

Removal of the early modern radiators (Plate 12) will improve the appearance of the room. Retention of the decorative early radiators (Plate 11), although they are probably not original to the building, will help maintain the style and historic appearance of the courtroom.

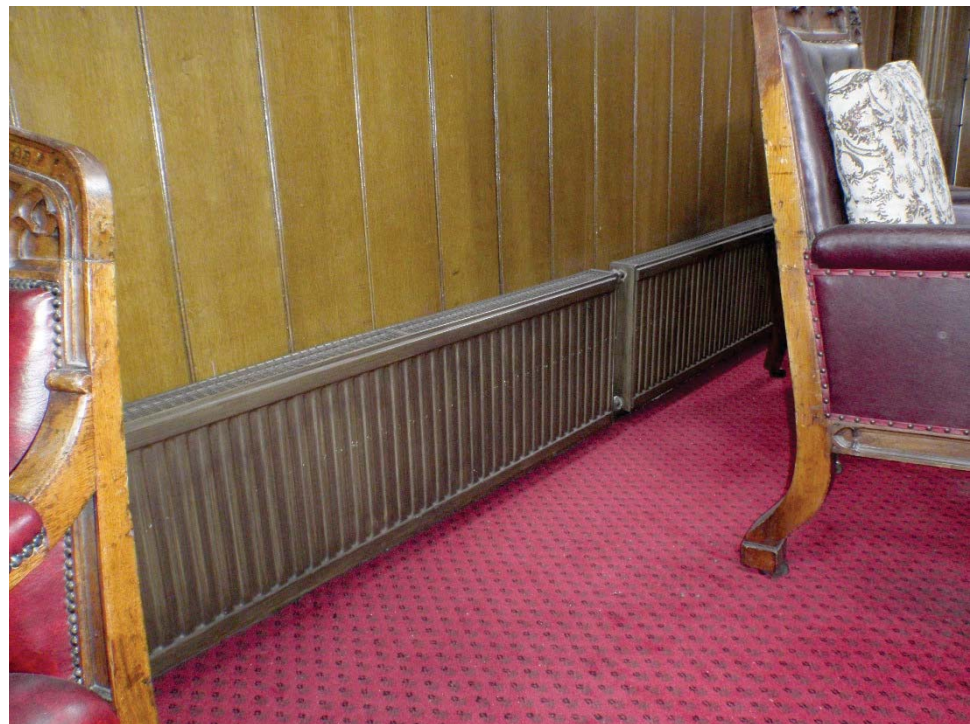
Plate 12 Modern radiator

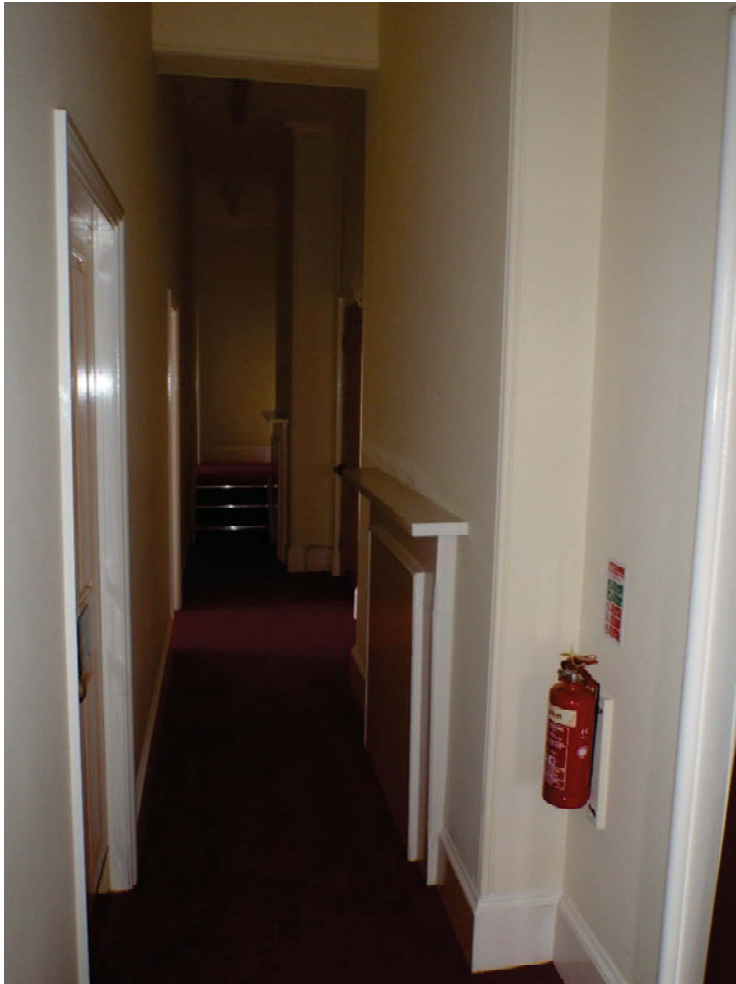
Blank partition walls provide the divisions between the interview rooms (including the CPS and advocates rooms), and this range of rooms and the corridor. These walls are plain and lack any architectural style. However, within the corridor is a series of blocked fireplaces (Plate 13).

In addition, crossing the corridor (Plate 13) and the adjacent interview room (Plate 14) are the remnants of a cut-through wall. Along the northeastern side of this cut-through wall stub is a surviving ceiling edge moulding (Plate 15) which shows that the two northeasterly interview rooms, and part of the next to the southwest, were, together with the adjacent section of corridor (Plate 16), once one large room. The ceiling edge moulding, wall remnant and blocked fireplaces indicate that the range of four interview rooms and flanking corridor were, originally, just two large rooms accessed directly from the Courtroom, and the corridor did not exist. The inserted panel walling is not clearly datable but is plain and functional and probably dates after World War 2, perhaps from the 1960s.

Plate 13 Corridor with interview rooms on left. Note blocked fireplaces and 'beam' of cut-through wall (top of picture)

Due to them representing probable mid-20<sup>th</sup> century alterations to the original rooms, the partition walls are of negligible significance and their removal would have no-negligible impact on the historic integrity of the building.

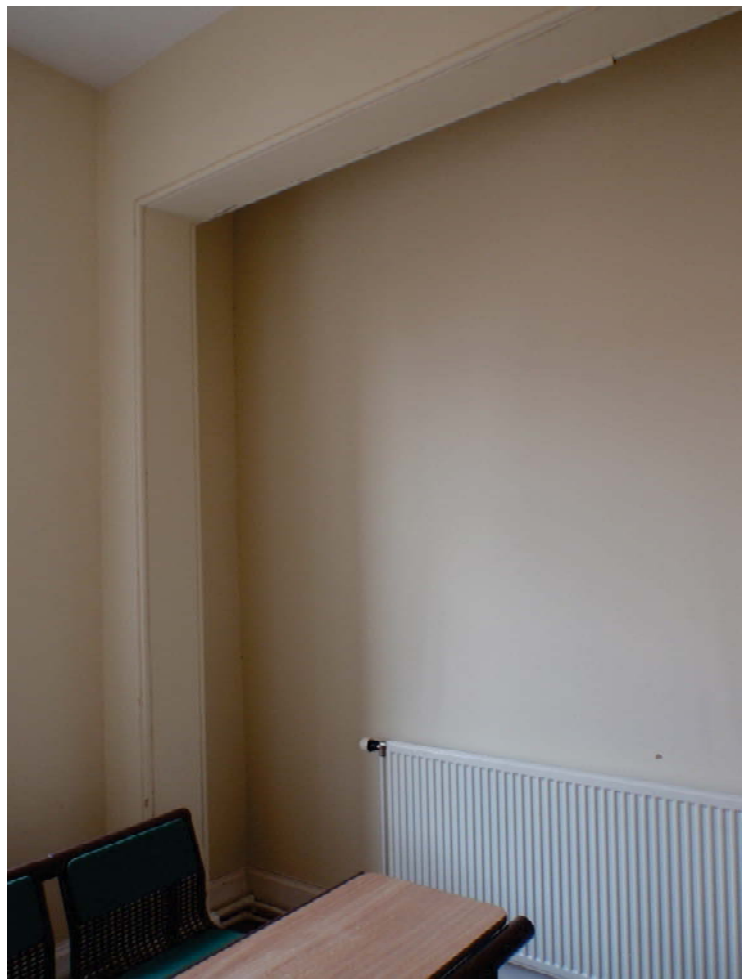
Plate 14 Interview room 2, showing cut-through wall

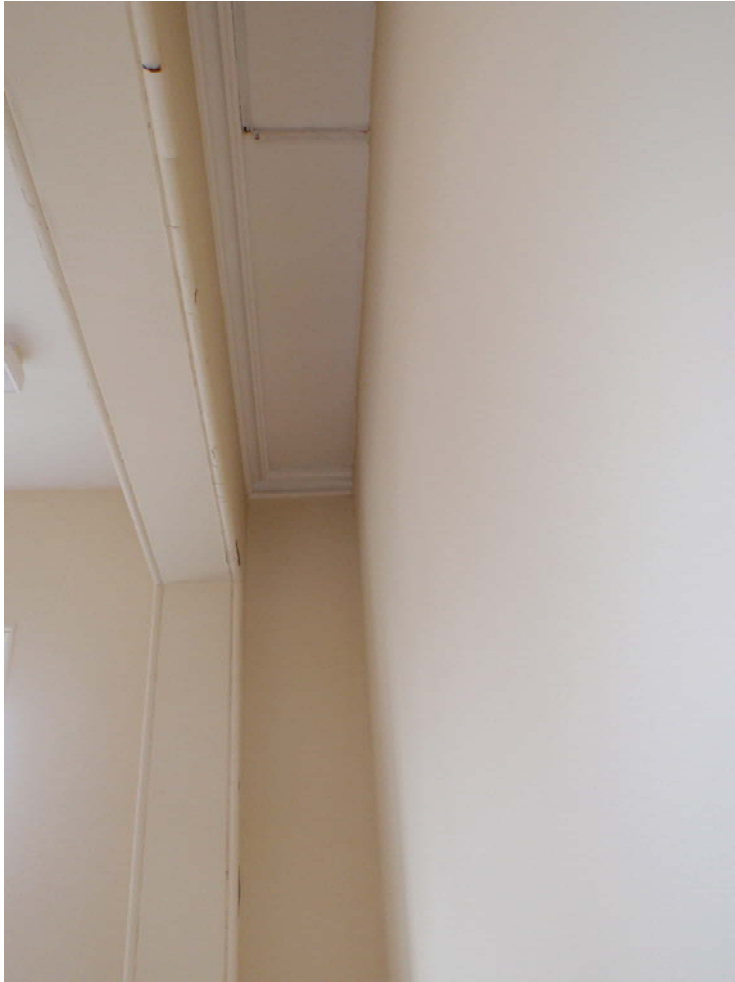
Plate 15 Interview room 2, cut-through wall and ceiling edge moulding crossed by inserted modern partition wall

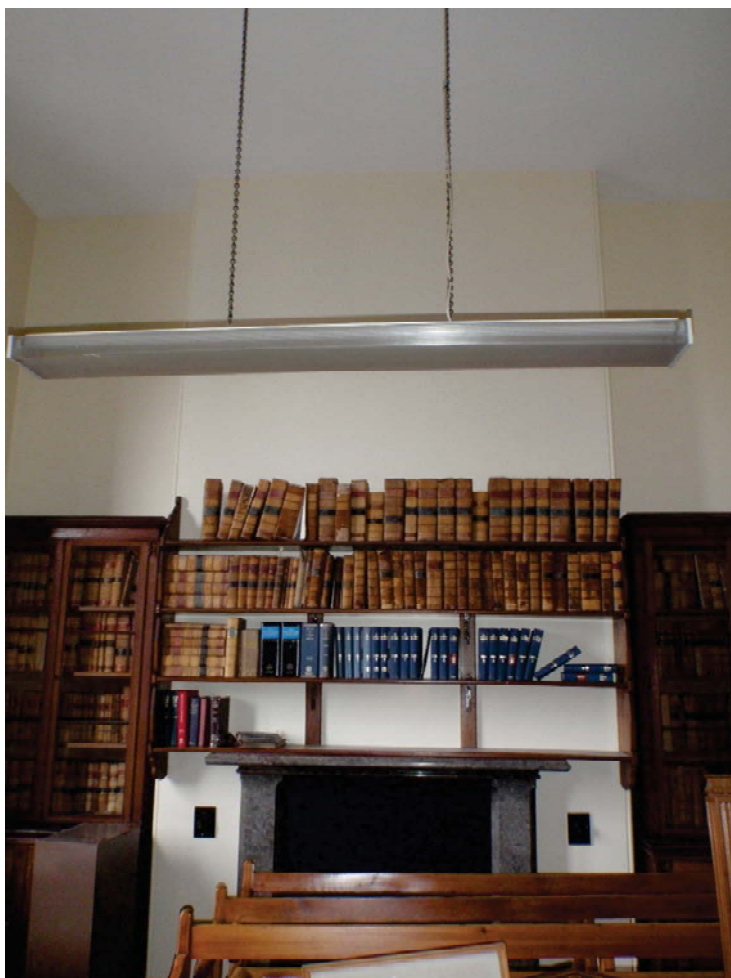
The fireplace blocking, light fitting and heater are all early modern (Plate 17), probably dating from the 1970s or later. They are of no to negligible significance and their removal would have a beneficial effect on the visual integrity of the room and its fireplace.

Plate 17 Library (Courts Clerks room), showing original fireplace with modern blocking, and modern light

The possible future installation of a wood burner in the fireplace might have a minor negative impact of the visual integrity of the fireplace, but this would be temporary and reversible.

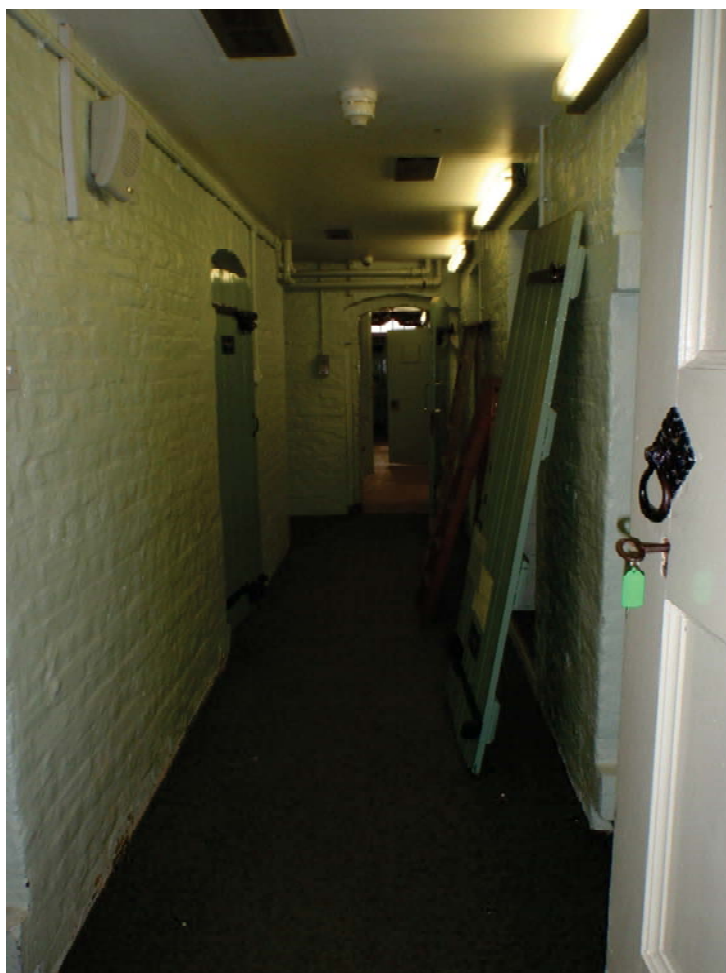
It is likely that the walls and ceilings of the range of cells, and probably the adjacent access corridor (Plate 18), were originally exposed brick or, perhaps more probably, whitewashed. The stripping of paint to reveal the bricks would, therefore, revert the cells to their original appearance and provide a minor beneficial effect on their visual integrity.

Plate 18 Corridor to cells, general view

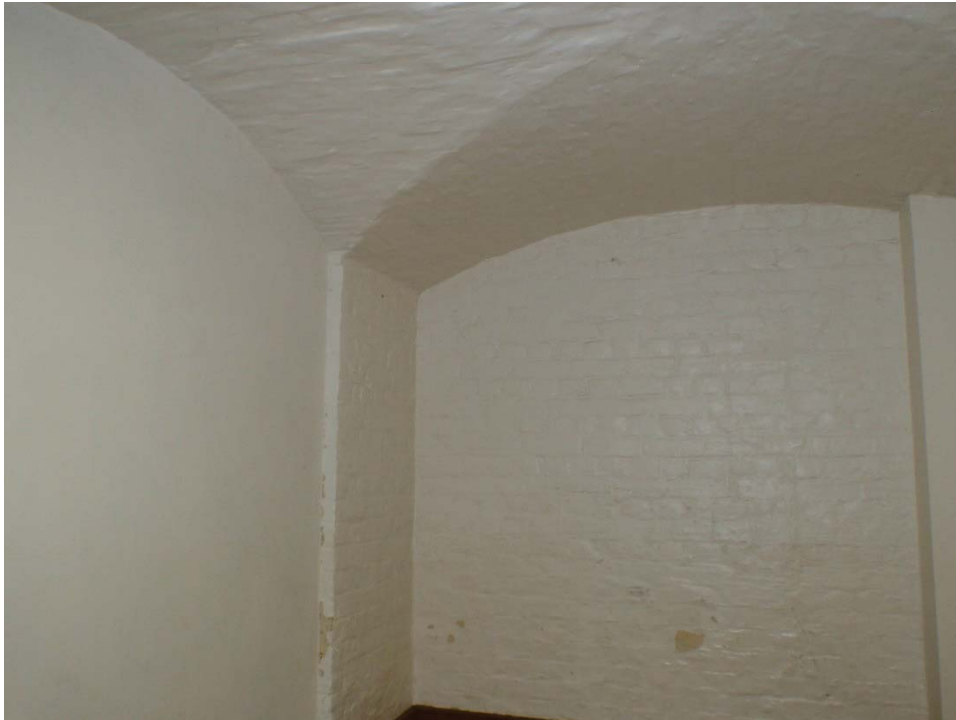
The divisions between at least some of the cells are rendered with a smooth finish while adjacent walls are of unsmoothed brick beneath the whitewash/paint (Plates 19 and 20). It therefore seems possible that these dividing walls are inserted blocking, perhaps to create smaller, more numerous cells. They may, alternatively, have replaced divisions such as bars.

Plate 19 Cells. Note difference of painted brick in alcove to right and smooth rendered finish in alcove to left

On the likelihood that some, if not all, of the cell dividing walls are inserted, their removal would return the cells to their former dimensions and be a beneficial alteration to their setting.

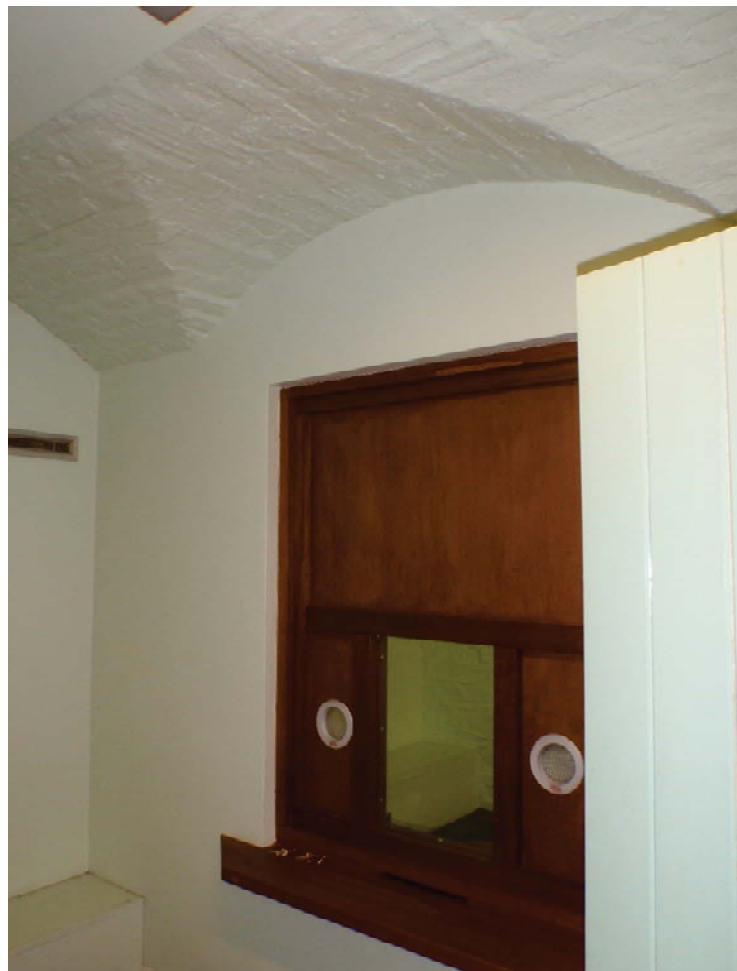
Plate 20 Cells 'interview room'.  
Note smooth rendered finish of  
wall around communication  
panel
