**REPORT:** REMEDIAL METHOD STATEMENT FOR SITE  
OFF GOSBERTON ROAD, SURFLEET

**CLIENT:** SEAGATE HOMES (UK) LTD

Project No: E21106  
Ref No: E21106/3/1

## REMEDIAL METHOD STATEMENT: SITE OFF GOSBERTON ROAD, SURFLEET

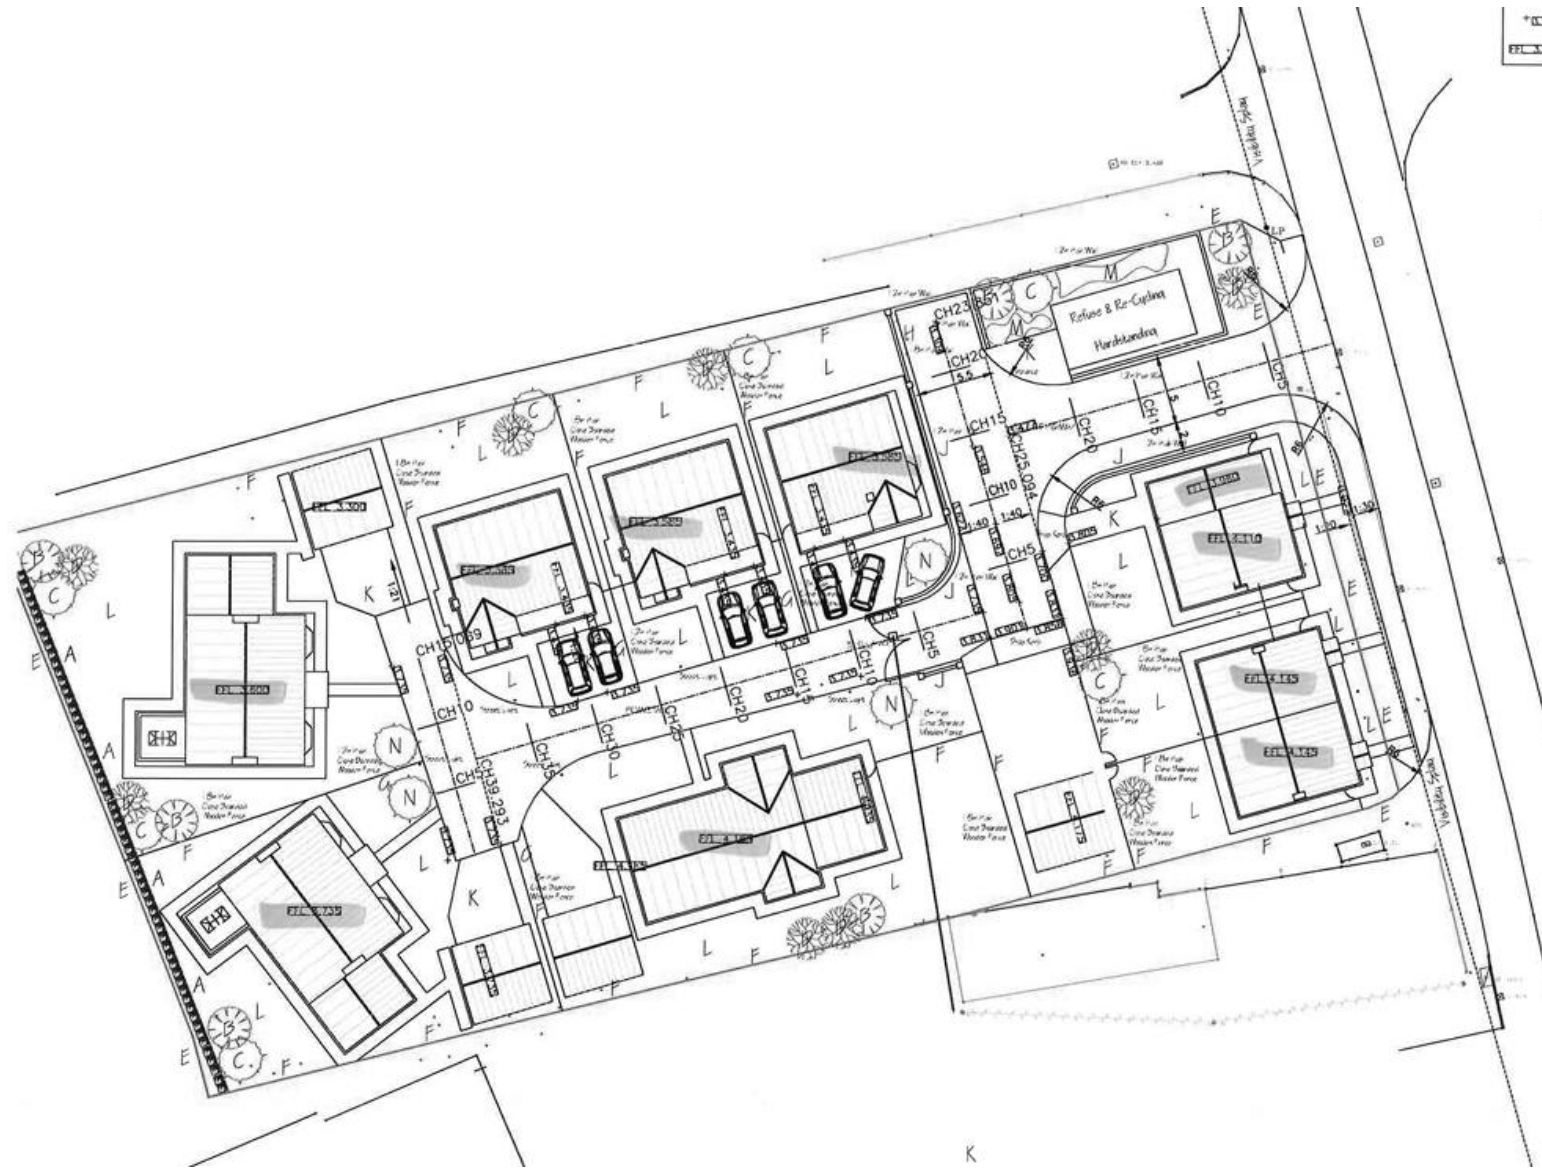
This report has been prepared on the understanding that the site is to redevelopment to support residential housing. We have been supplied with a copy of the proposed layout, and extracts of this plan are presented in the Proposed Site Layout Plan (Drawing 001) in Appendix I.

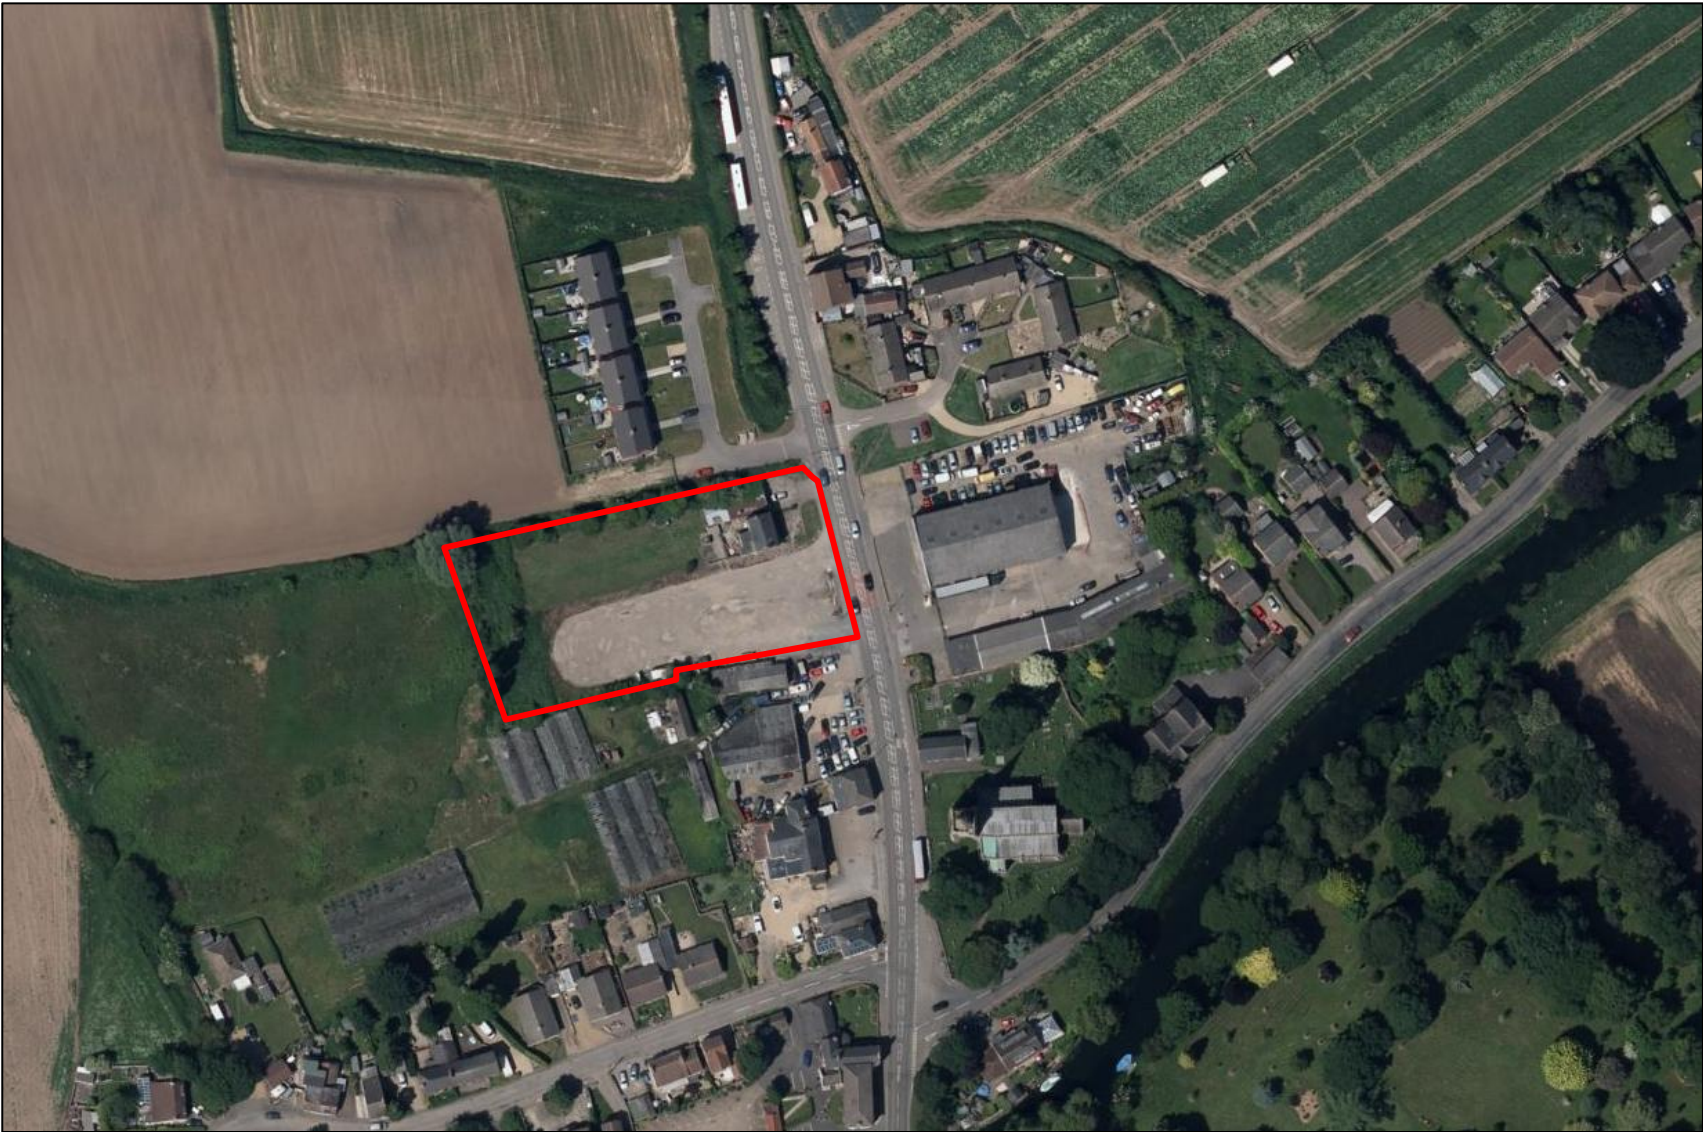
An Exploratory Hole Layout Plan (Drawing 002) and a General Photographic Record (Drawing 003) are included in Appendix I.

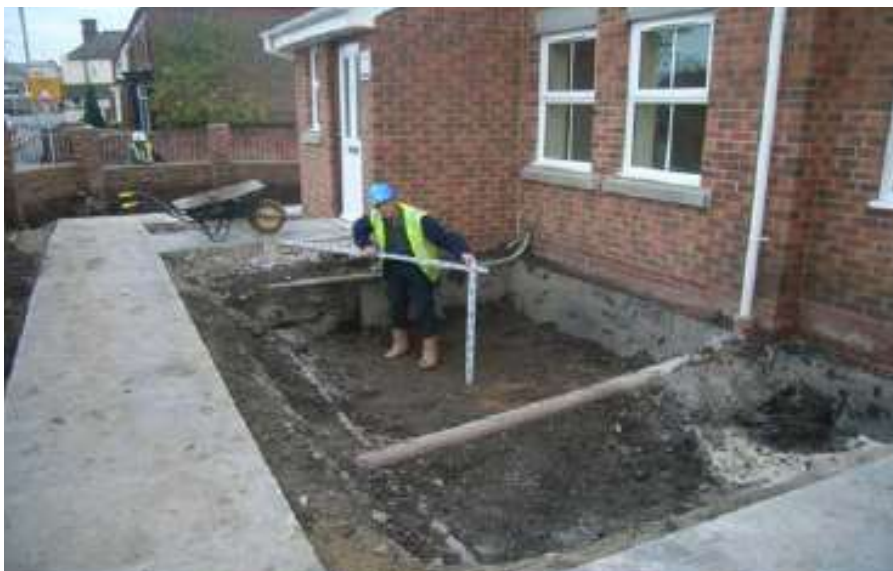
Photograph 4:  
Depth check of inert cover within areas of front gardens.

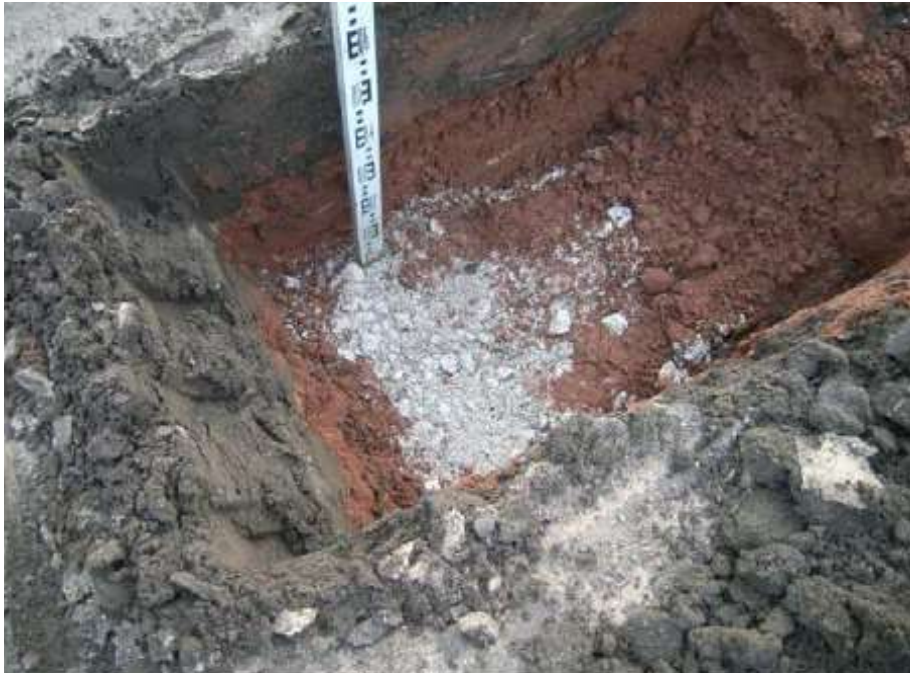
Photograph 8:  
Excavation within public open space and verification pit showing the presence of a remediation break layer at the base, a crushed sandstone inert fill overlain by topsoil.

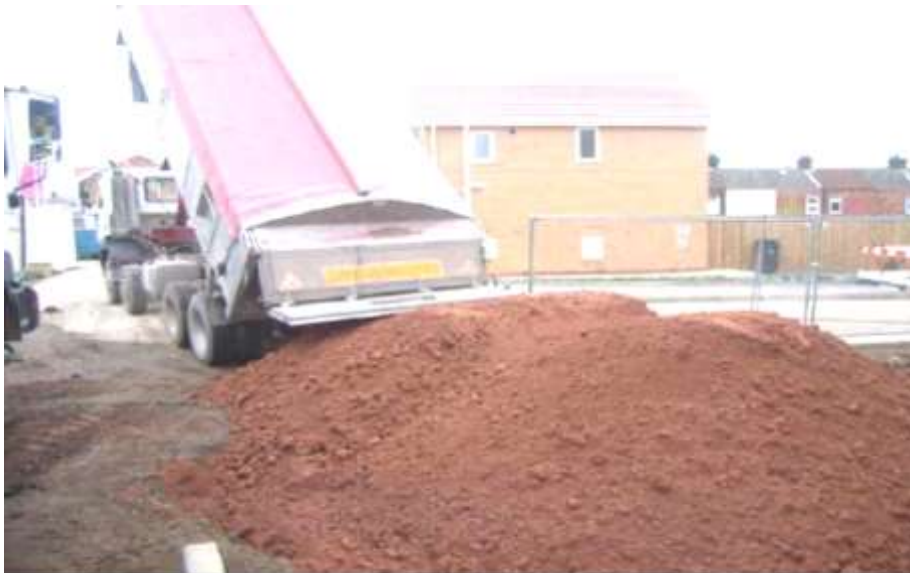
Photograph 9:  
Inert crushed sandstone being delivered. The spatial area of the remediation can be observed from these photographs (old terrace housing).

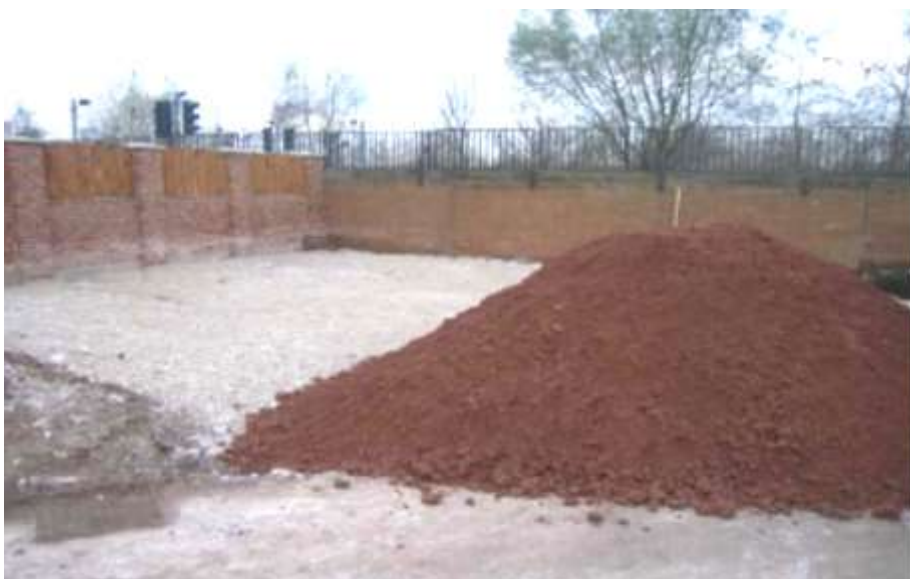
Photograph 10: Inert crushed sandstone being delivered with visible remediation break layer. The spatial area of the remediation can be observed from these photographs (traffic lights).
