**A PHASE II CONTAMINATION REPORT TO SUPPORT A PLANNING APPLICATION FOR A  
RESIDENTIAL DEVELOPMENT AT:**

**LAND ADJACENT TO 72 STATION ROAD, SURFLEET**

**REFERENCE:** MSH/17.041/Phase II

**DATE:** 12 May 2017

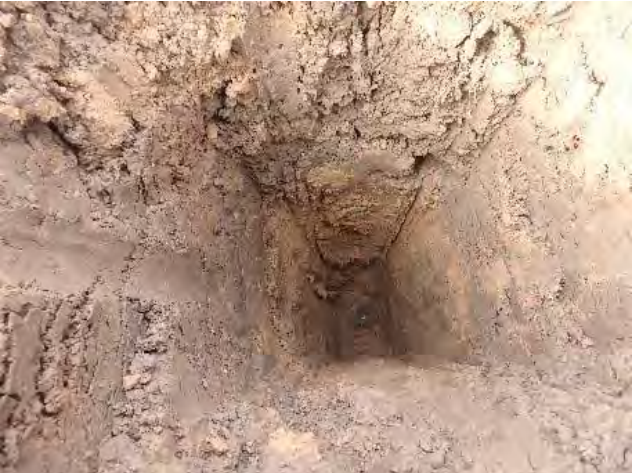
| | <b>Remarks</b><br><br>1. Location CAT scanned prior to excavation.<br>2. No groundwater encountered<br>3. Pit remained open and sidewalls stable during excavation<br>4. Backfilled with arisings upon completion | | |

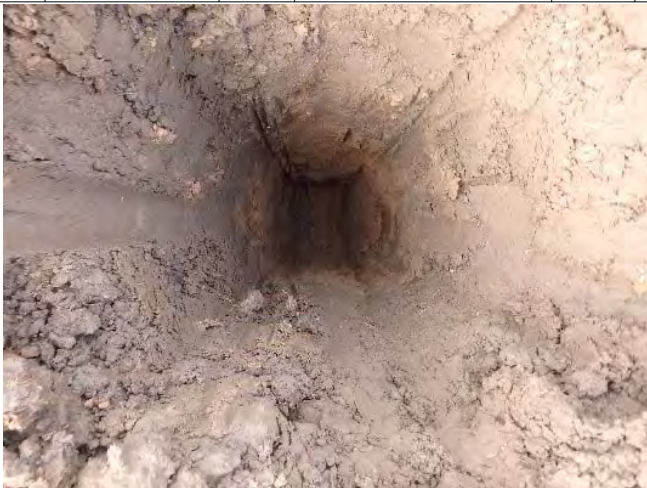
| | | | | | 1. Location CAT scanned prior to excavation.<br>2. No groundwater encountered<br>3. Pit remained open and sidewalls stable during excavation<br>4. Backfilled with arisings upon completion | | | | |

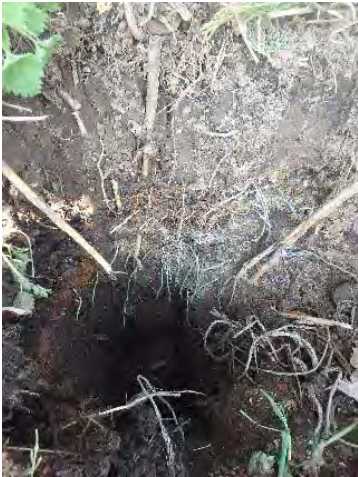
| | | | | | | <b>Remarks</b><br>1. Location CAT scanned prior to excavation.<br>2. No groundwater encountered<br>3. Pit remained open and sidewalls stable during excavation<br>4. Backfilled with arisings upon completion | | |

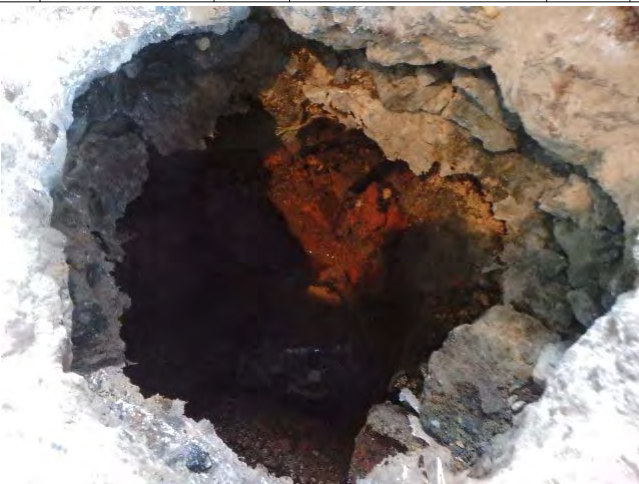
| | | | | | (0.55) | MADE GROUND (Red brick rubble in a dark brown sandy subangular fine to coarse brick, concrete and glass gravel matrix) | | | |
| | | | | | 1. Location CAT scanned prior to excavation.<br>2. Groundwater struck at 0.58 m<br>3. Pit remained open and sidewalls stable during excavation<br>4. Backfilled with arisings upon completion and reinstated with post-crete | | | | |

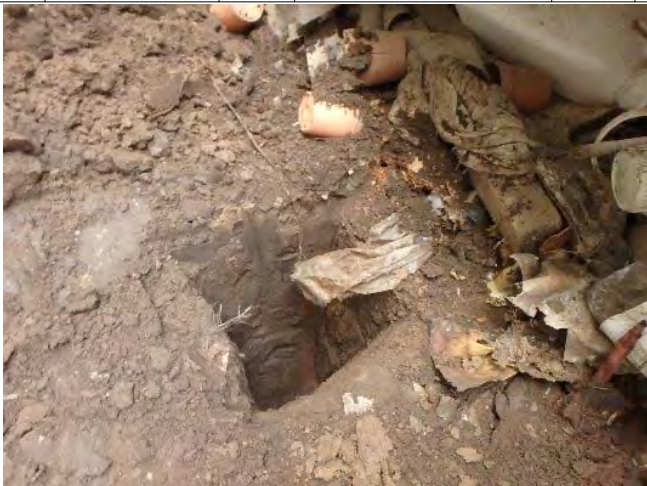
| | | | | | <b>Remarks</b><br><br>1. Location CAT scanned prior to excavation.<br>2. No groundwater encountered<br>3. Pit remained open and sidewalls stable during excavation<br>4. Backfilled with arisings upon completion | | | | |

In the area of the **TPH** hot spot, around TP10, further sampling and testing is recommended following decommission of the diesel-powered greenhouse fan heater to determine the extent of the contamination. Once this is known, the most practical solution is likely to be the removal off-site of the diesel impacted soils. Existing diesel storage tanks are also present on site. Following decommissioning and removal of these tanks, further soil sampling and testing should be carried out within these areas to confirm the soil is free of hydrocarbon contamination.

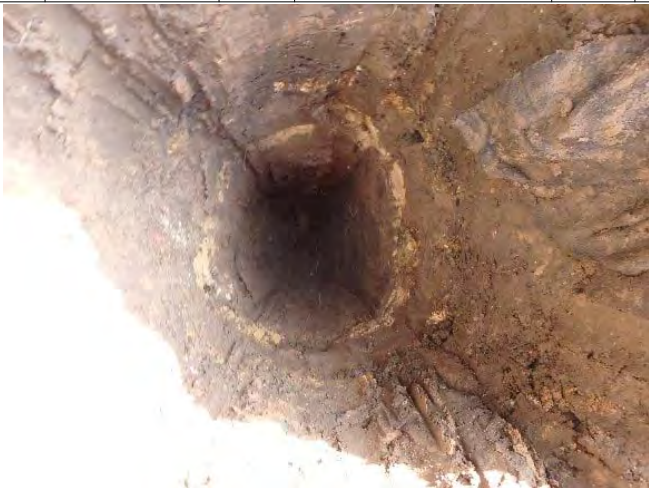
| | | | | | (0.60) | MADE GROUND (Brown mottled dark brown in places clayey slightly gravelly silt with clay pockets. Gravel is subangular fine to medium brick and sandstone) | | | |
| | | | | | 1. Location CAT scanned prior to excavation.<br>2. No groundwater encountered<br>3. Pit remained open and sidewalls stable during excavation<br>4. Backfilled with arisings upon completion | | | | |

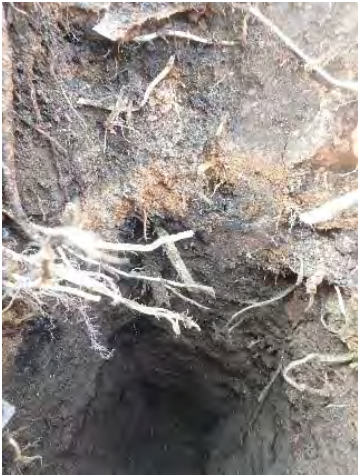
| 0.70<br>0.70 | D2<br>ES2 | | | 3.51 | 0.55<br>(0.45) | MADE GROUND (Dark brown clayey sand with ash pockets) | | | | |

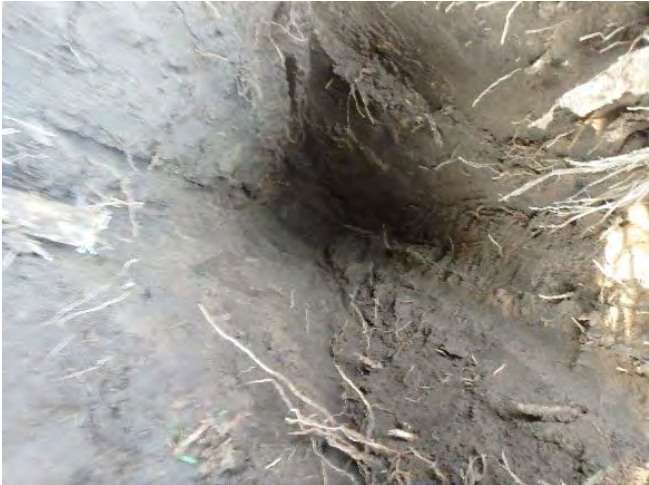
| | | | | | <b>Remarks</b><br><br>1. Location CAT scanned prior to excavation.<br>2. No groundwater encountered<br>3. Pit remained open and sidewalls stable during excavation<br>4. Backfilled with arisings upon completion | | | | | |

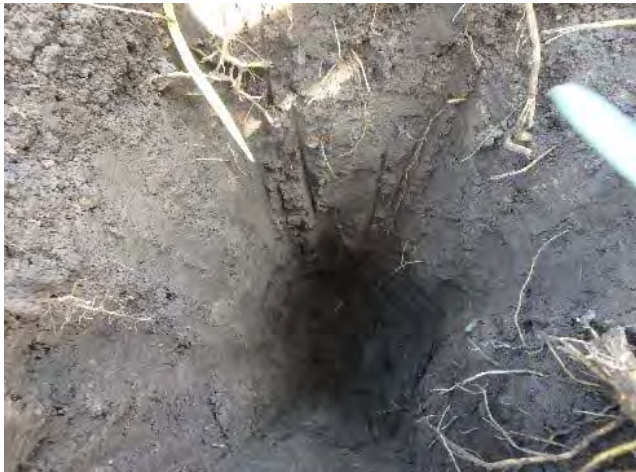
| | | | | | (0.70) | Brown very clayey silty fine to medium SAND | | | | |
| | | | | | 1. Location CAT scanned prior to excavation.<br>2. No groundwater encountered<br>3. Pit remained open and sidewalls stable during excavation<br>4. Backfilled with arisings upon completion | | | | | |

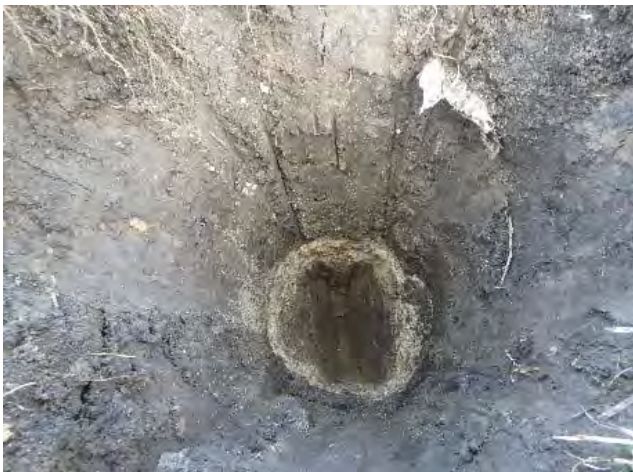
| | | | | | (0.40) | Light brown slightly clayey sandy SILT | | | |
| | | | | | | <b>Remarks</b><br>1. Location CAT scanned prior to excavation.<br>2. No groundwater encountered<br>3. Pit remained open and sidewalls stable during excavation<br>4. Backfilled with arisings upon completion | | | |
