**A1816-2**  
**Geo-Environmental Report**

**Land Adj to Chestnut Terrace,  
Sutton Bridge, Lincolnshire.**

**October 2018**  
**Report Number: A1816-2**

| Document Title | Phase 2 Geo-Environmental Report |

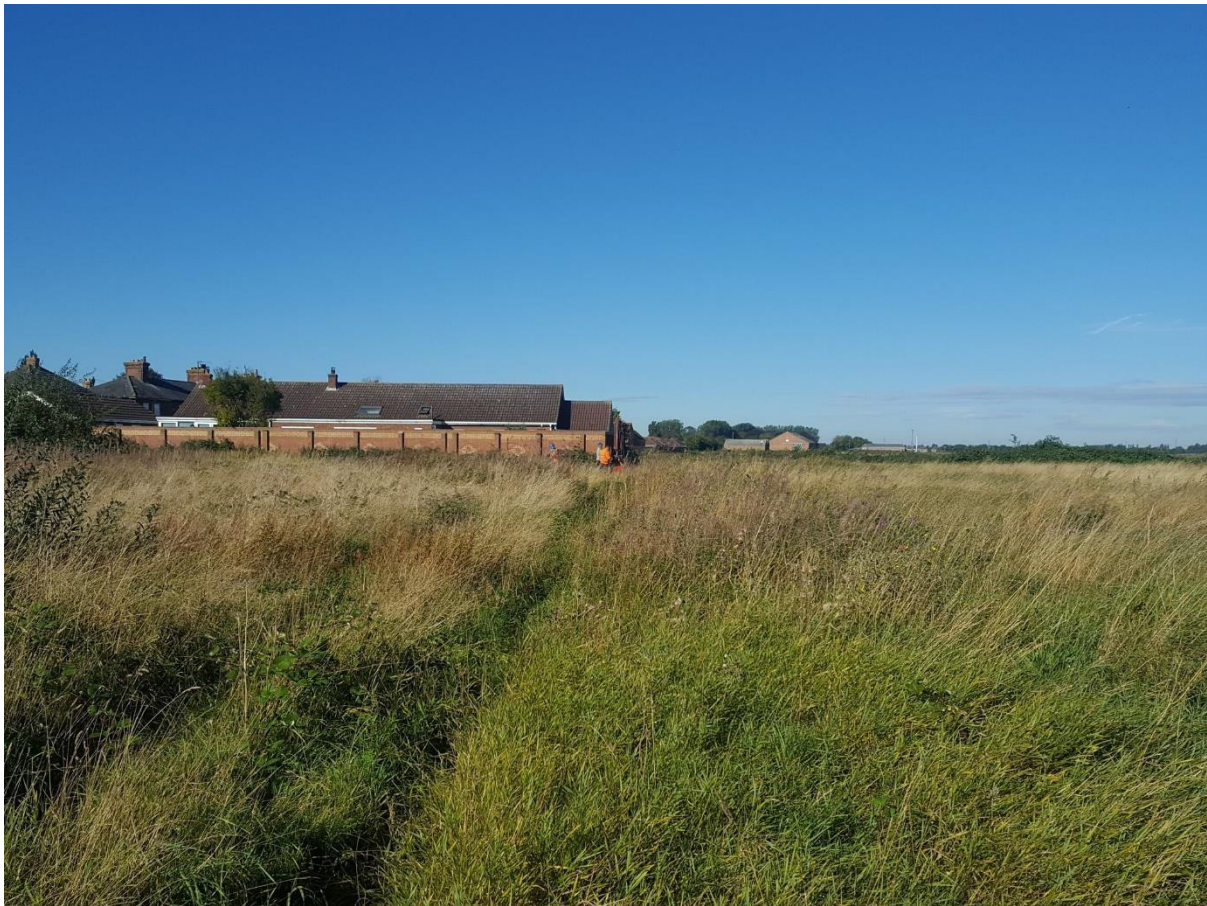
Photograph 1: General view of site, facing west, showing the northern end of Area A, and the western end of Area C. The drill rig is set up on window sample hole WS1.

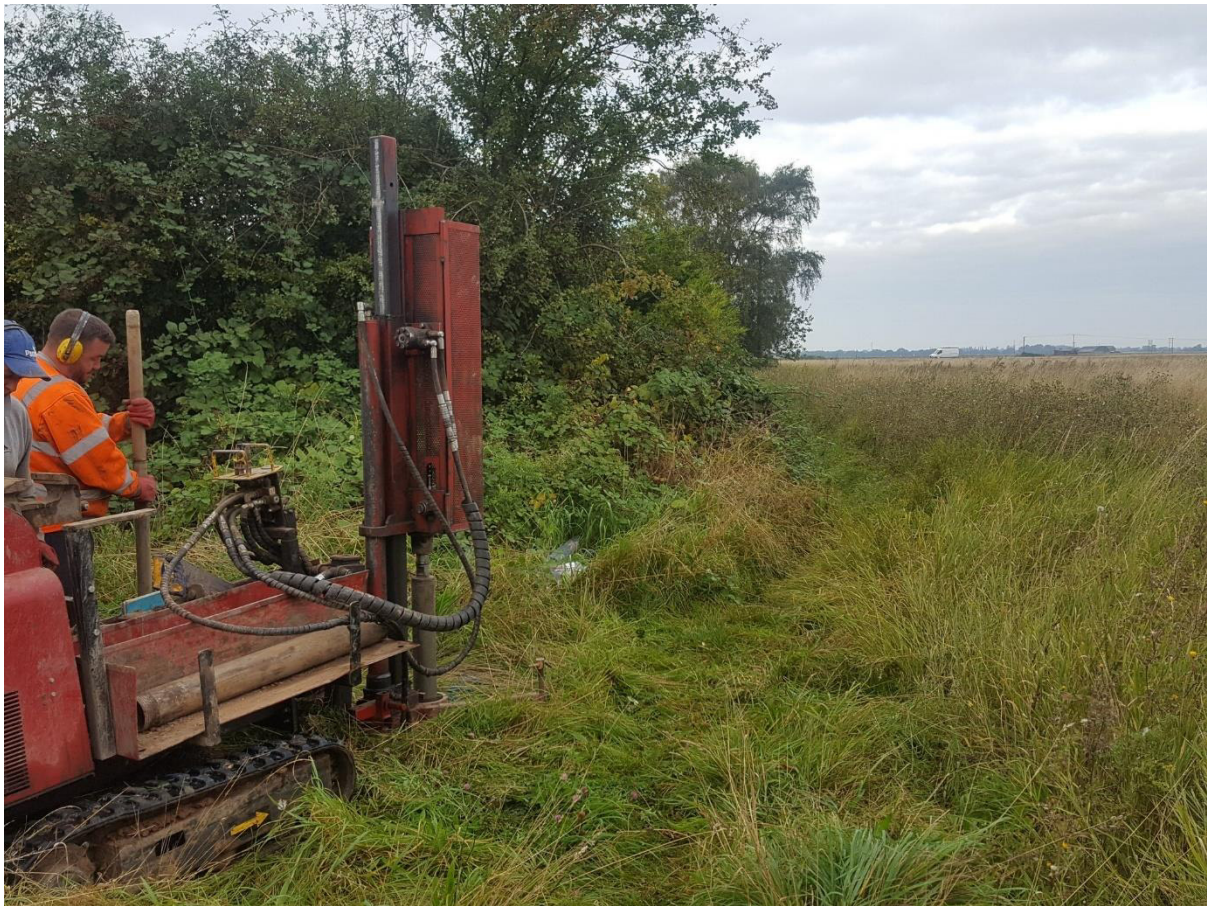
Photograph 2: Location of window sample hole WS5, facing north west. The white van is parked at the western end of Area C. The drill rig is positioned within Area B.

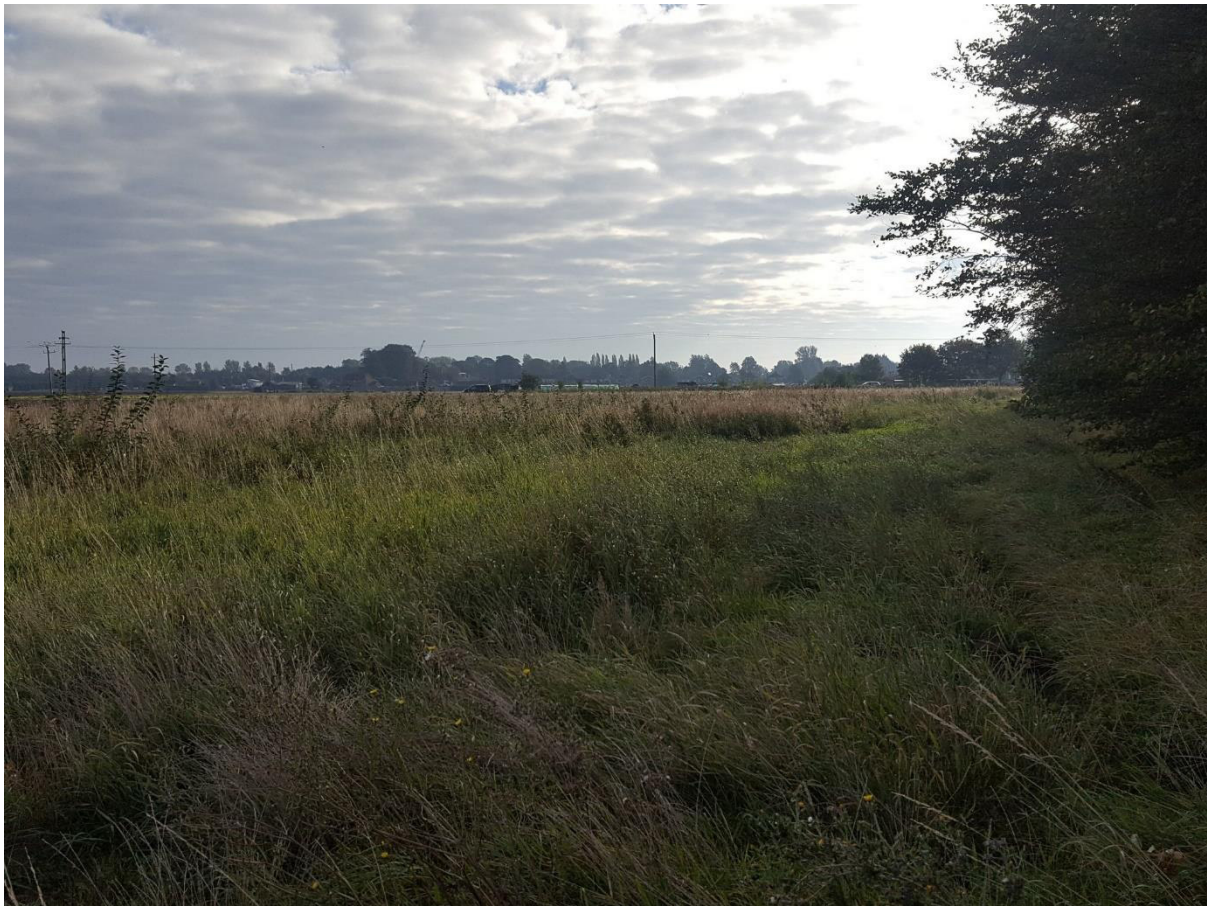
Photograph 3: View from Area B, looking east, showing the eastern end of Area C. The vehicles parked denote the end of Area C.

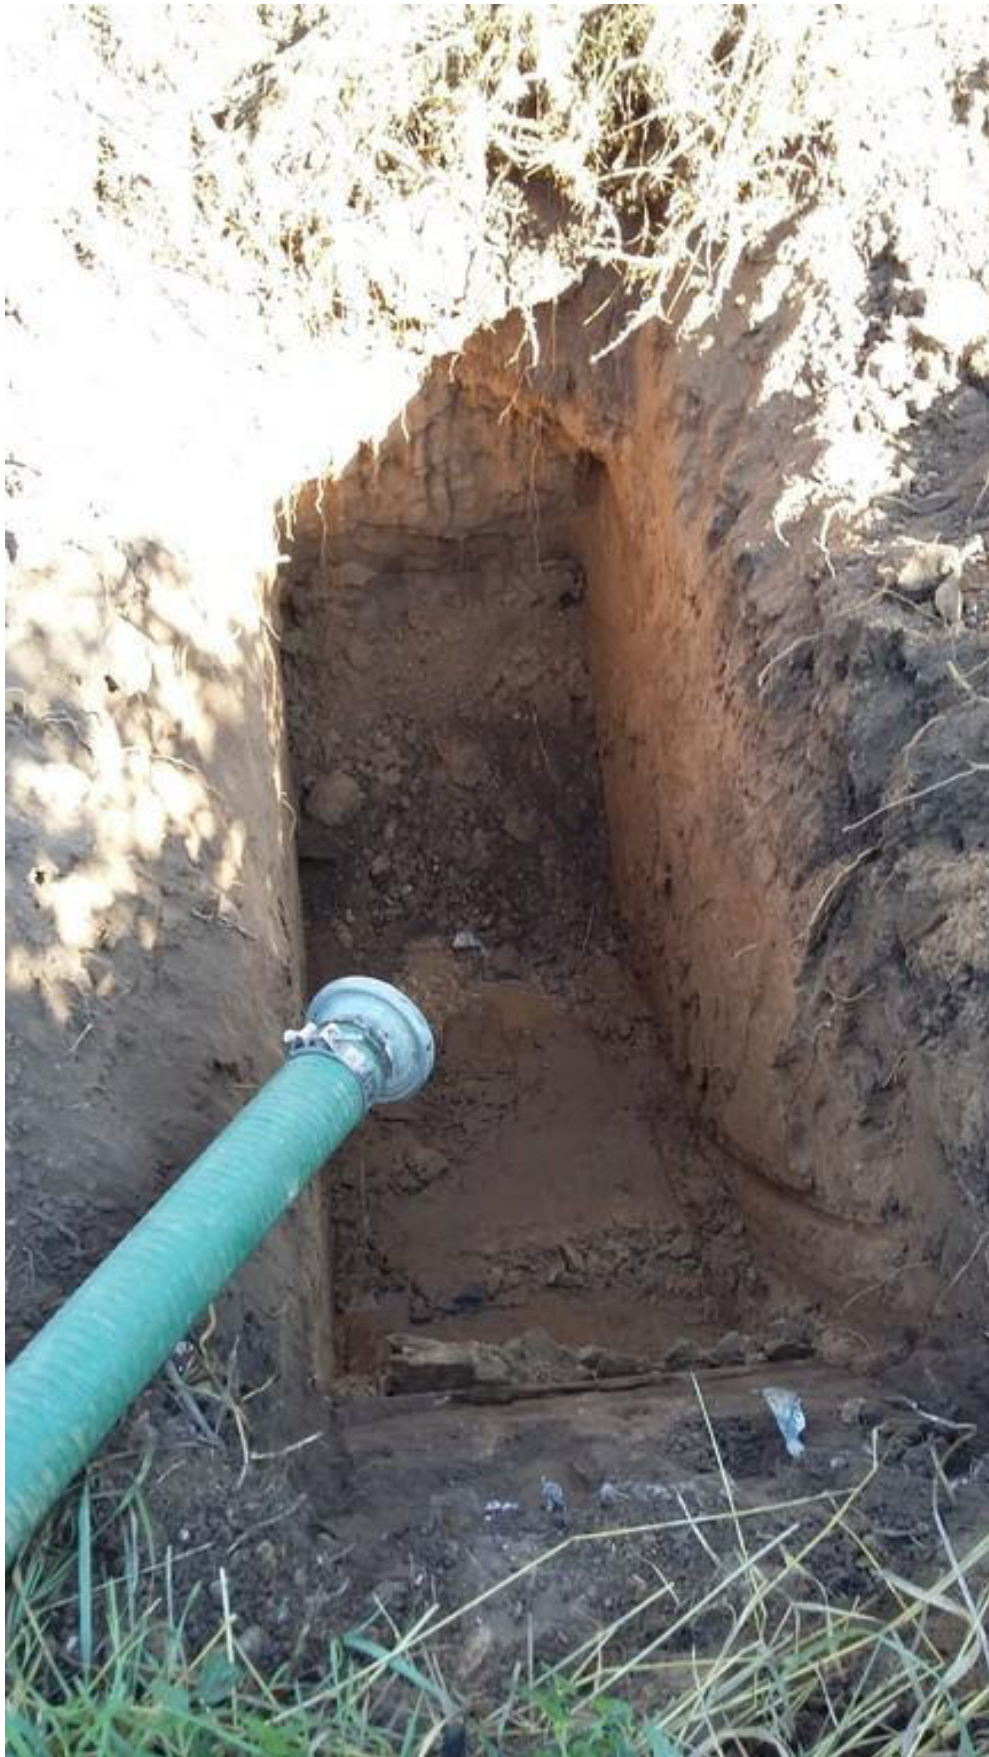
Photograph 4: Trial pit TP1 immediately prior to filling.

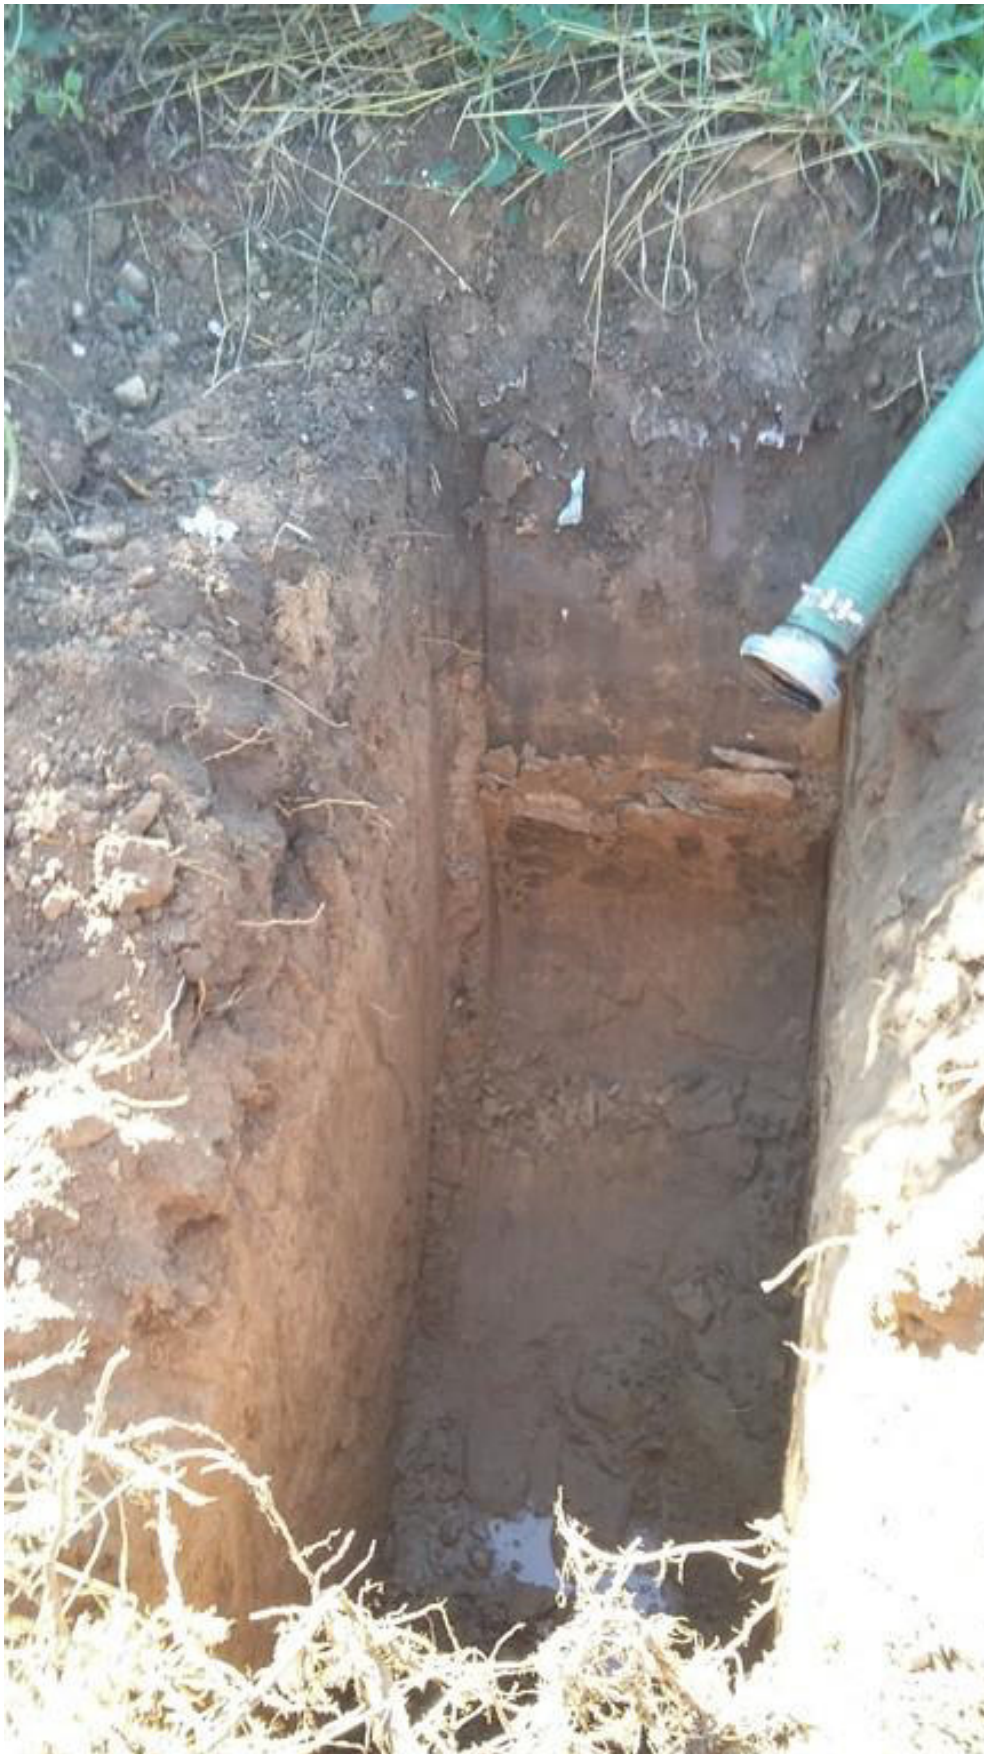
Photograph 5: Trial pit TP2, immediately prior to filling.

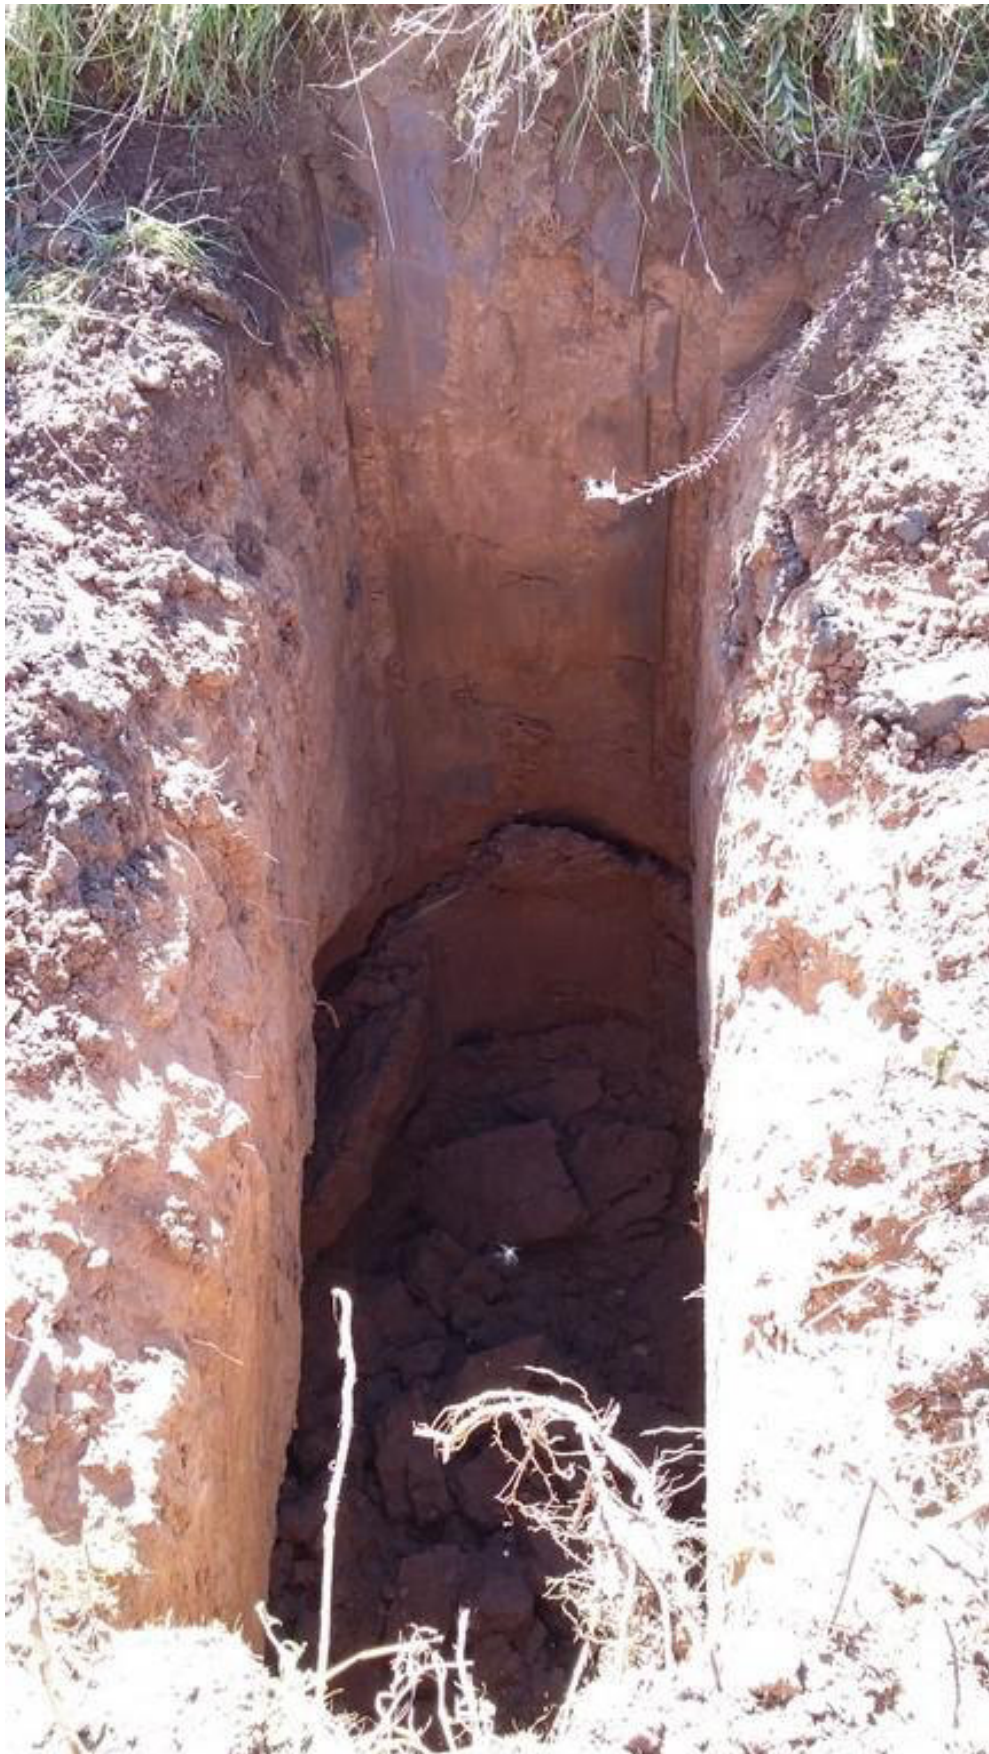
| TP3 | 2.30 | 2.30 | 20 | Soils noted as saturated |

In addition, the high groundwater combined with the geology of the site will create conditions where running sands are possible, making deep excavations difficult on the site. This was observed in the trial pitting exercise. Specialist excavation techniques, including temporary piling and dewatering are likely to be required for any deep excavations on the site. This will result in a longer construction time and significant additional expense.

Photograph 6: Trial pit TP3, showing collapsing of saturated soil.

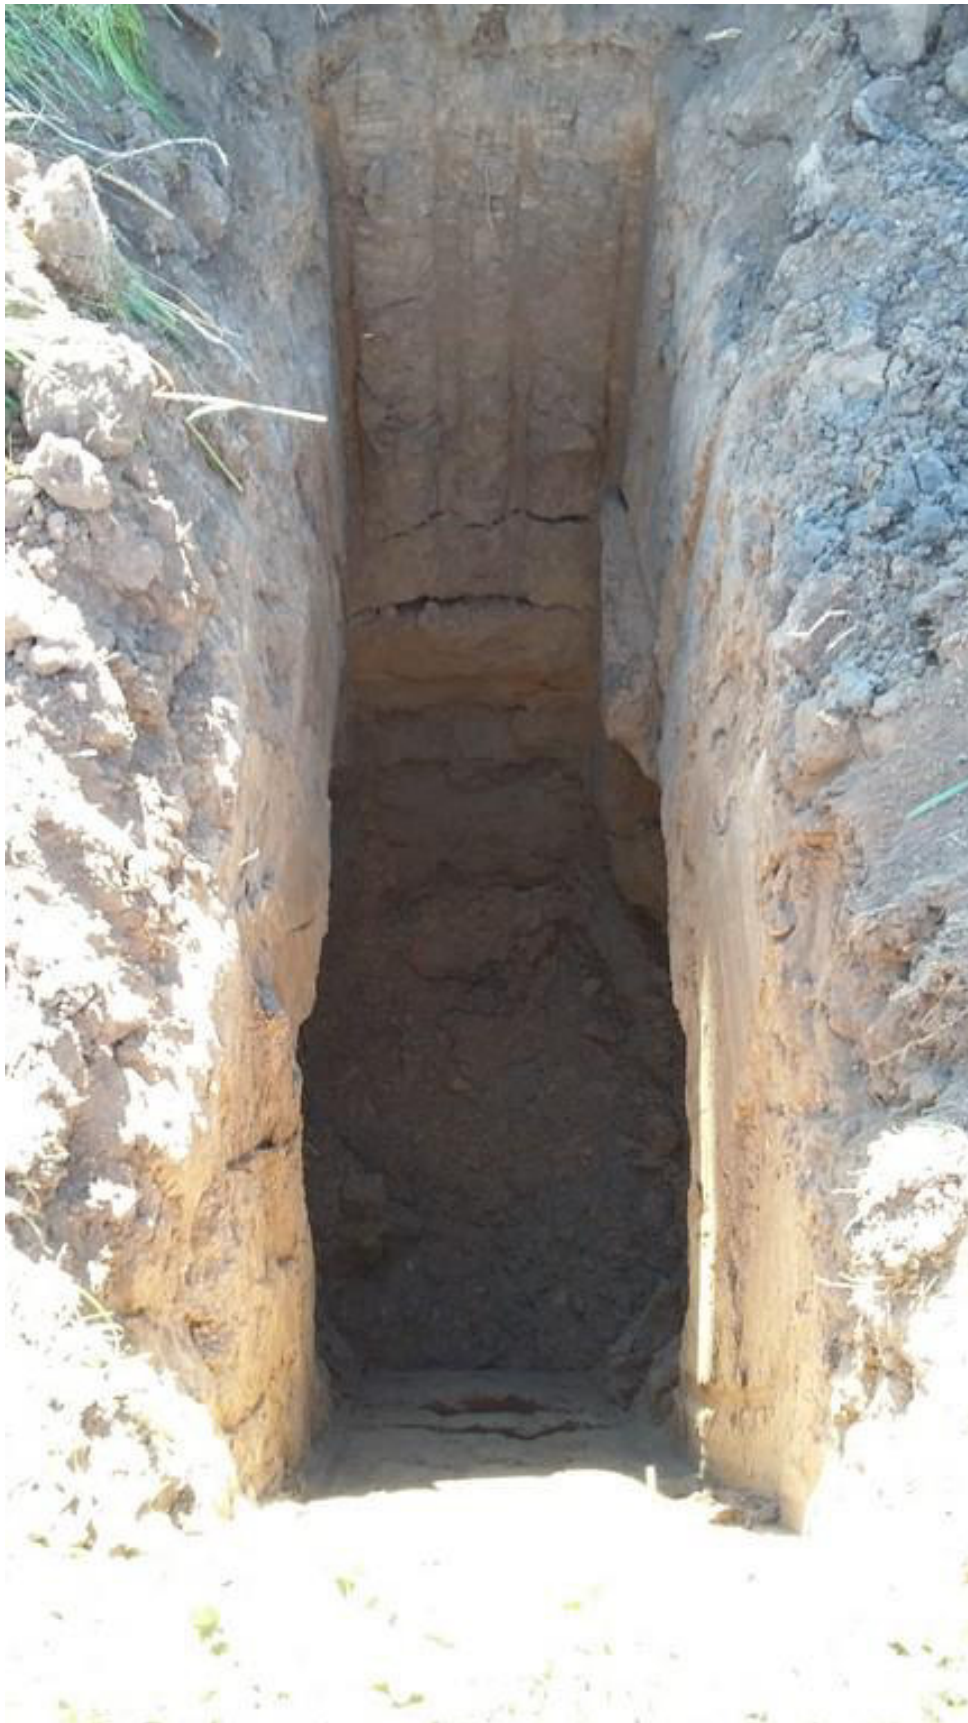
| TP4 | 2.50 | 2.50 | 20 | Soils noted as saturated |

Photograph 7: Trial Pit TP4, showing the collapsing of trial pit sides due to saturated soil.
