# OUTBUILDING TO REAR OF NO. 68, BRIDGE ROAD, SUTTON BRIDGE, LINCOLNSHIRE

## HISTORIC BUILDING SURVEY

Report prepared for G. R. Merchant Ltd.

December 2023

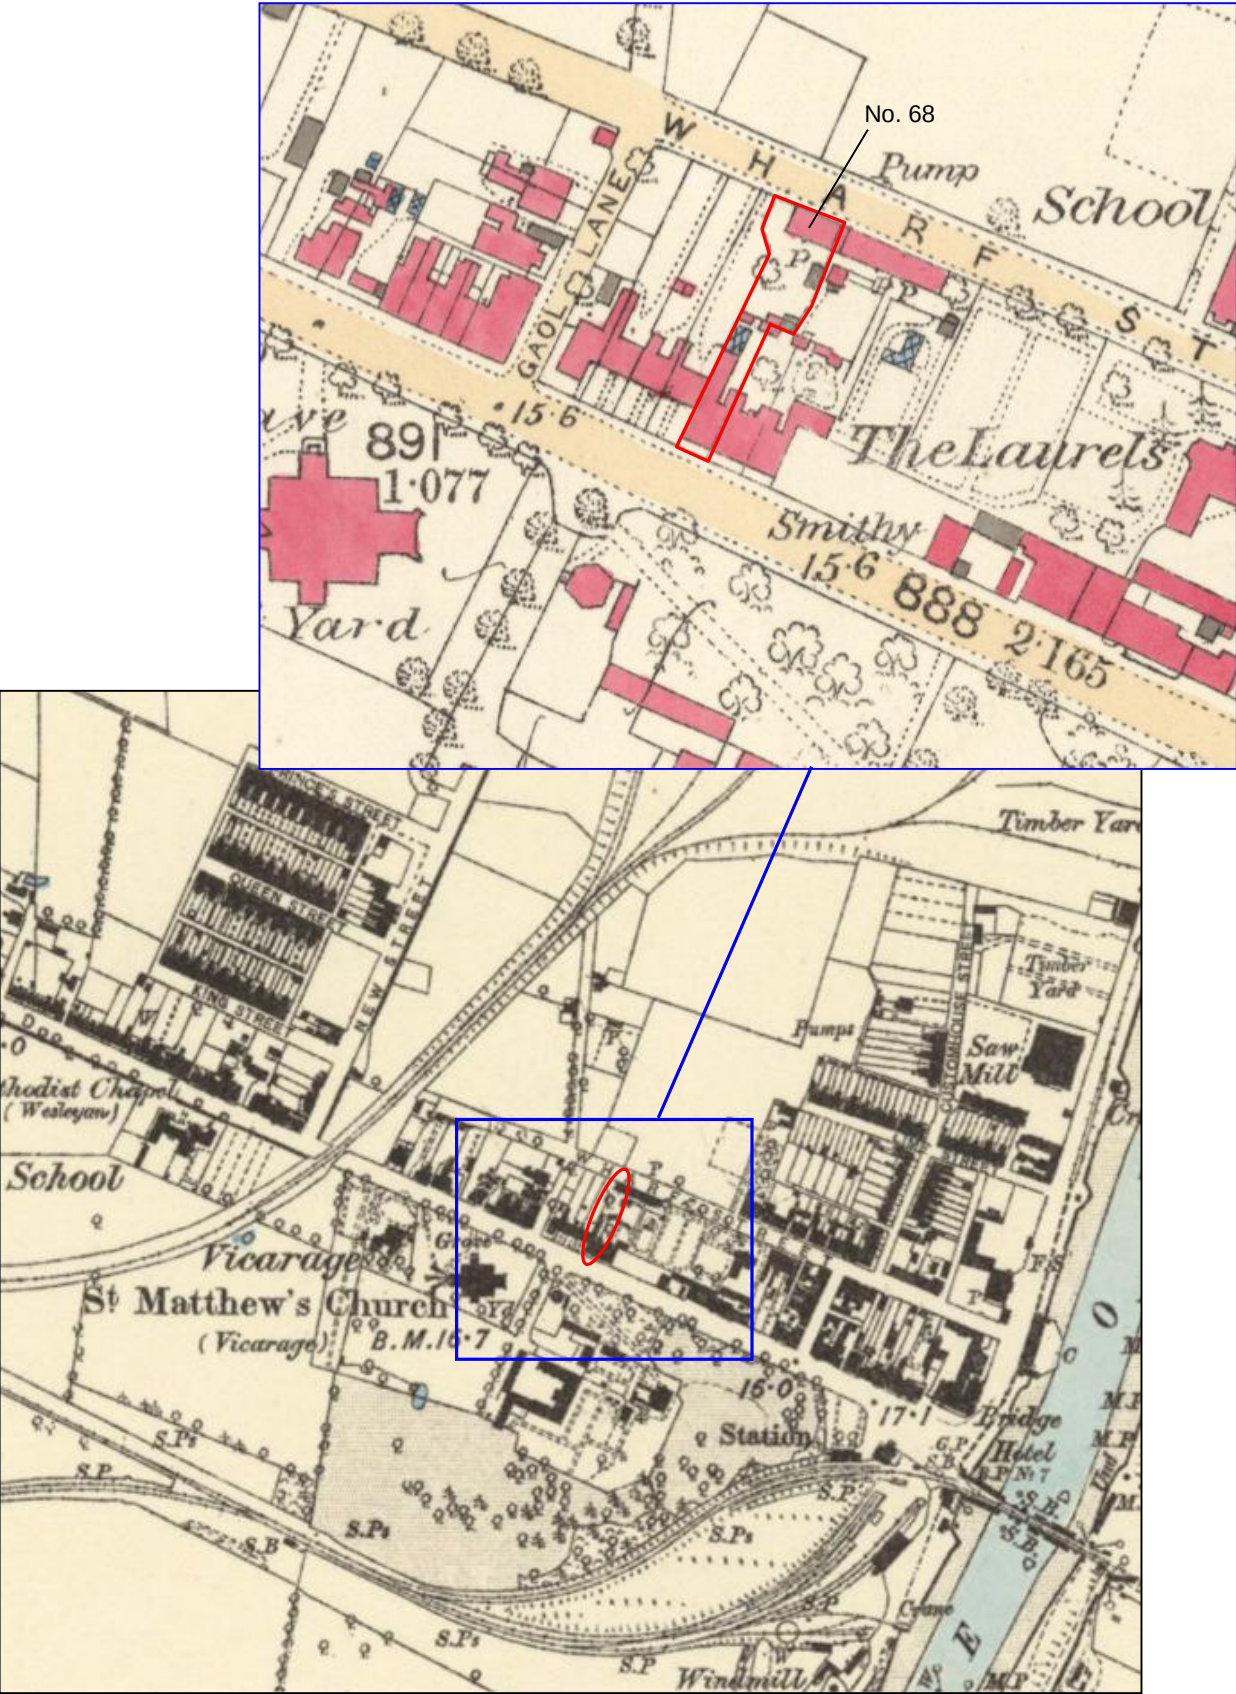
Once the Nene channel had been deepened, the trade both to the port of Wisbech and the wharves beside Sutton Bridge increased, and continuing land reclamation brought a greater acreage under the plough: the Guy's Hospital Estate gained land. The hospital estate's steward began to make improvements to its drainage and roads, connecting the outlying farms to the village, building new streets to the north of the turnpike road, and constructing warehouses near the riverbank. Inns profited from the increase in trade, which in turn encouraged shopkeepers and other tradesmen to settle along the Bridge Road. While the new settlement of Sutton Bridge was considered to be a suburb of Long Sutton, and was within the remit of Long Sutton's local administrative officers, the community was dependent on the governors of the Guy's Hospital Estate for all developments such as roads and housing. As traffic across the Nene estuary increased, new streets – Wharf Street and Lime Street – were laid out to the north of the Bridge Hotel; the name Lime Street refers to the local industry of lime-burning. Many houses were built by the Hospital governors along the north side of Bridge Road; after 1852, houses were also built in Customs House Street and shops in the High Street, with a National School for boys in Wharf Street and one for girls in Church Street. The parish church, St. Matthew's, with an associated vicarage, was built by the Hospital governors in 1841-2: it is a flint building with a square tower, a style more typical of Norfolk than of Lincolnshire. Sutton Bridge became an ecclesiastical parish in 1843. The greatest period of activity for waterborne trade was between 1831 and 1856: as local towns became connected by railways, fewer farmers moved their produce by river. During the 1850s and 1860s, three railway lines incorporated branches to Sutton Bridge, and two railway stations were opened (Markillie, 1994; Wright, 1980). The new streets, largely laid out in a grid pattern across the recently reclaimed land, and new buildings and industries are shown on the 1<sup>st</sup> edition Ordnance Survey mapping produced in the late 1880s (fig. 3).

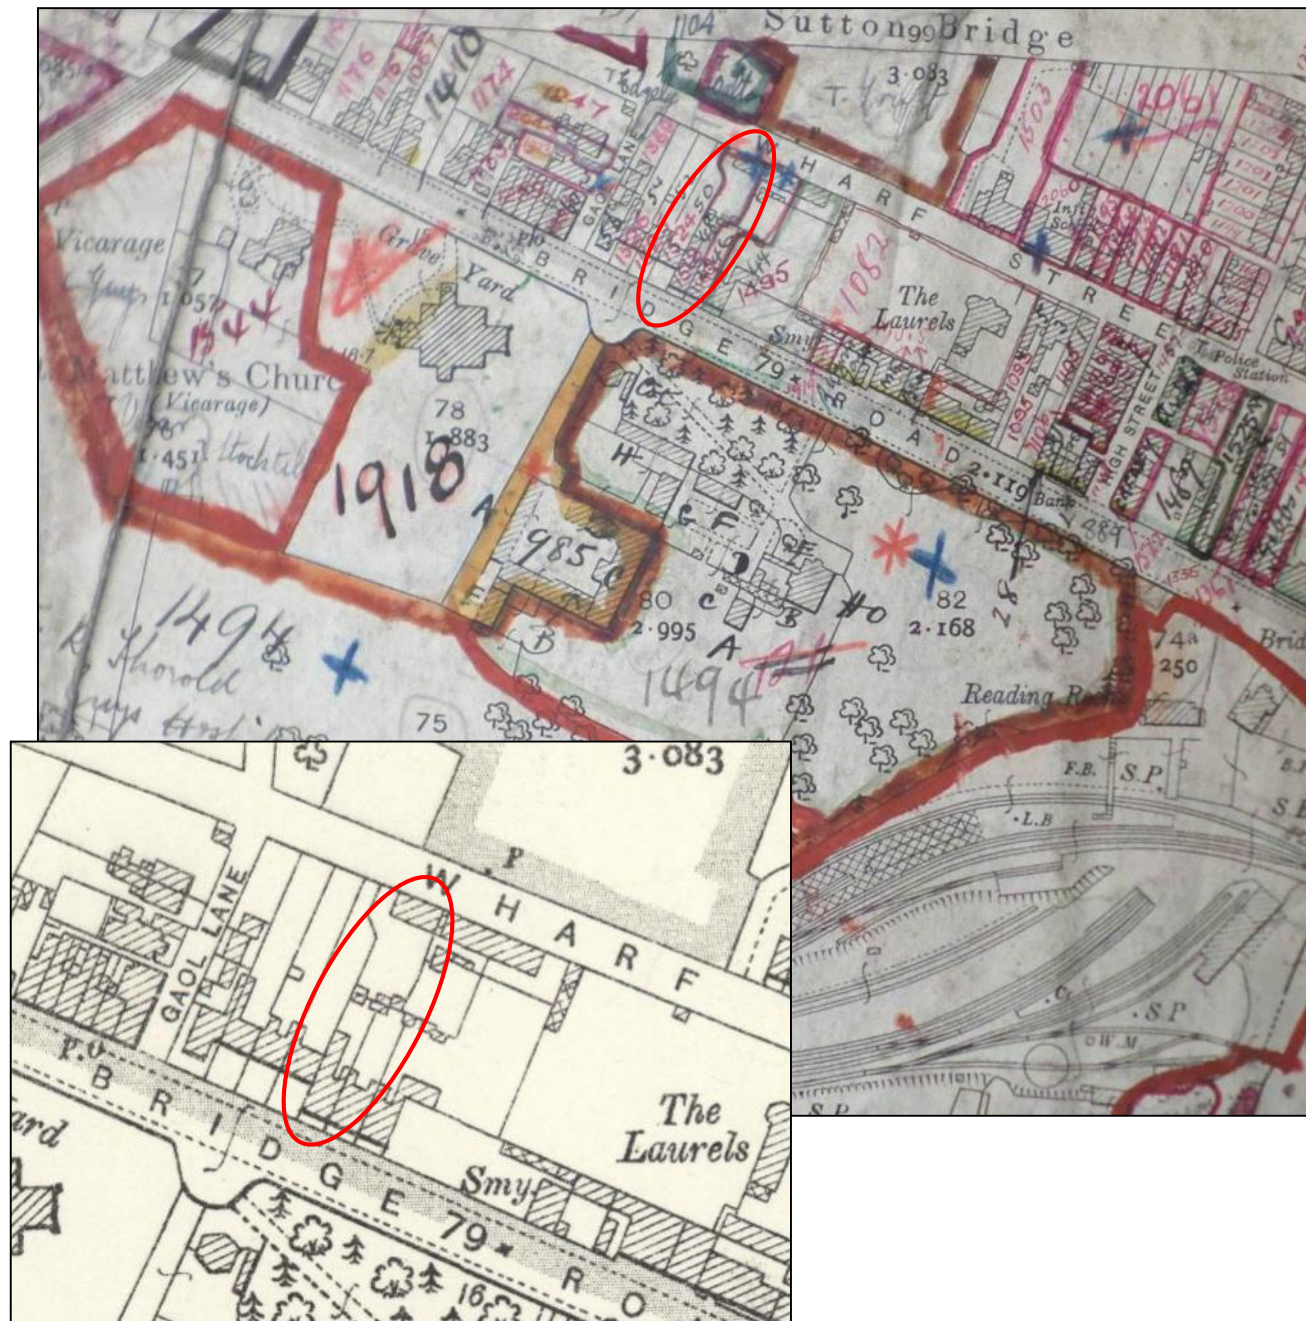
The 1910 Land Tax assessment map records the current no. 68 as plot 1518, owned by Guy's Hospital and occupied by John Walton; the accompanying map, using the 1904 2<sup>nd</sup> edition 1:2500 scale Ordnance Survey map as a base plan, shows the layout of the main buildings within the plot as unchanged from the 1<sup>st</sup> edition mapping, although a number of the smaller garden buildings, including the glasshouse, have been removed (fig. 5). Although private residences are not as easy to trace through county directories as farms and commercial properties are, John Walton is listed as a private resident in Sutton Bridge in the 1913 edition of Kelly's Directory (p. 584): the address given is no. 48, Bridge Road, but the List Entry for this building notes that the street was renumbered in the mid-20<sup>th</sup> century and this block of houses was previously numbered 44, 46 and 48. No other reference could be found to John Walton in earlier or later editions.

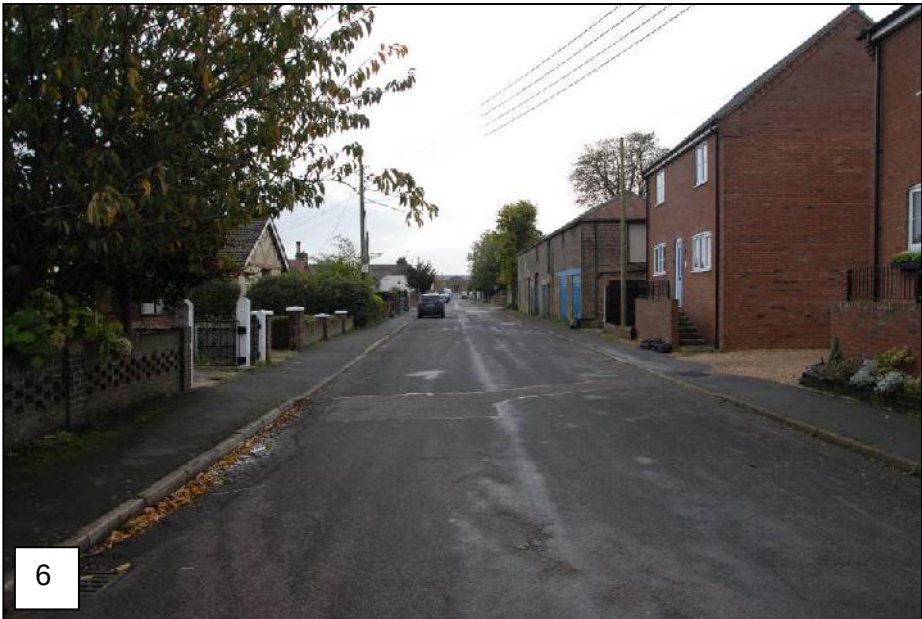
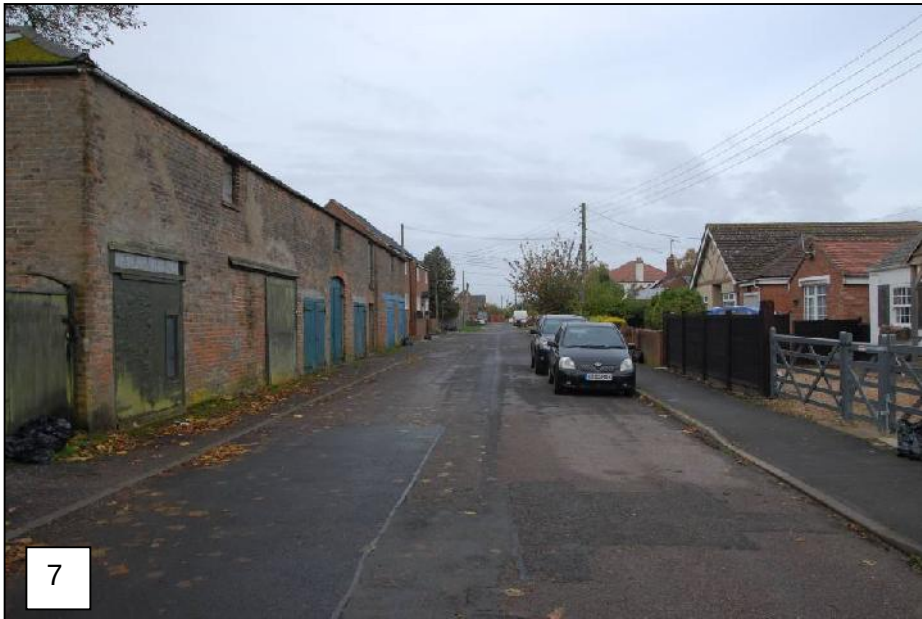
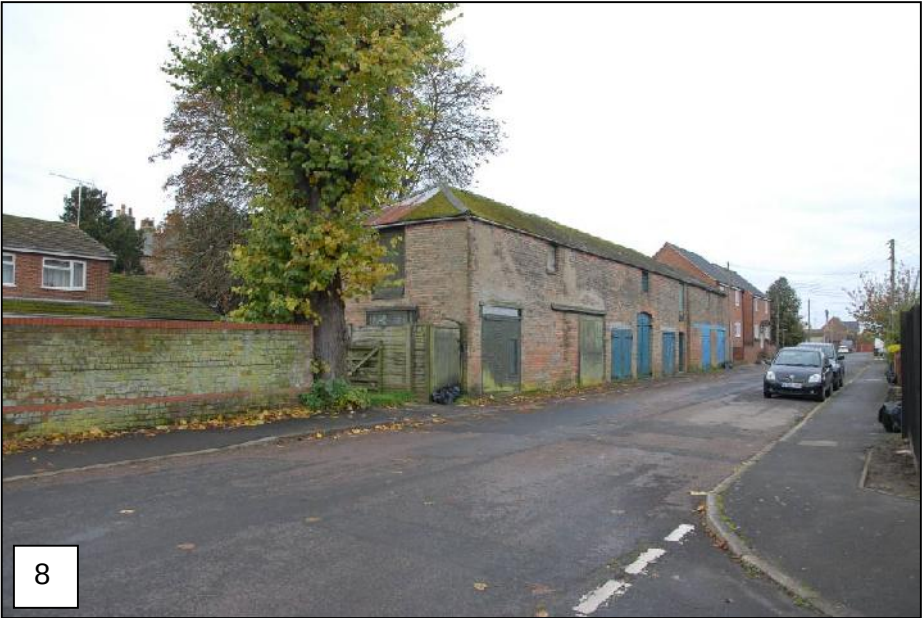
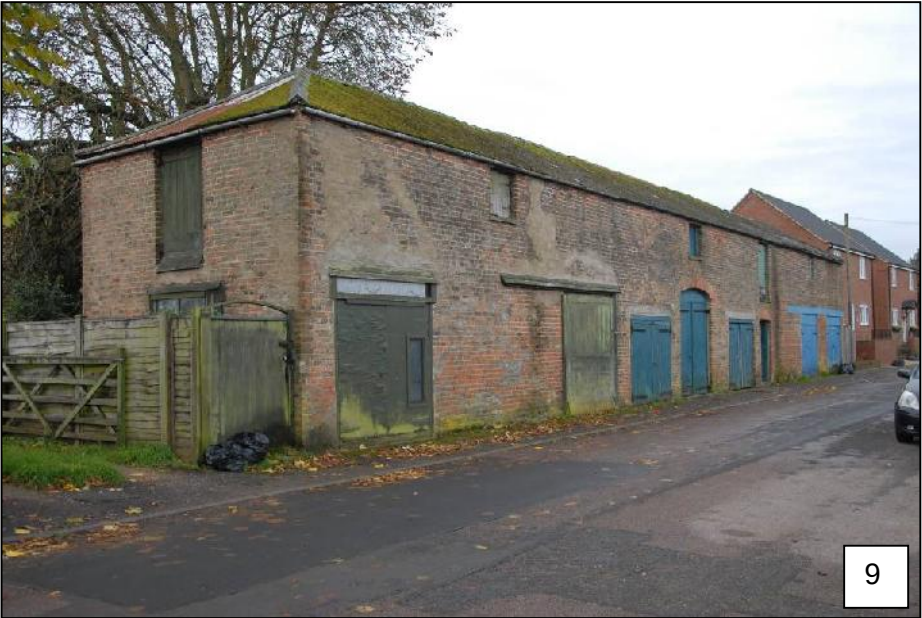
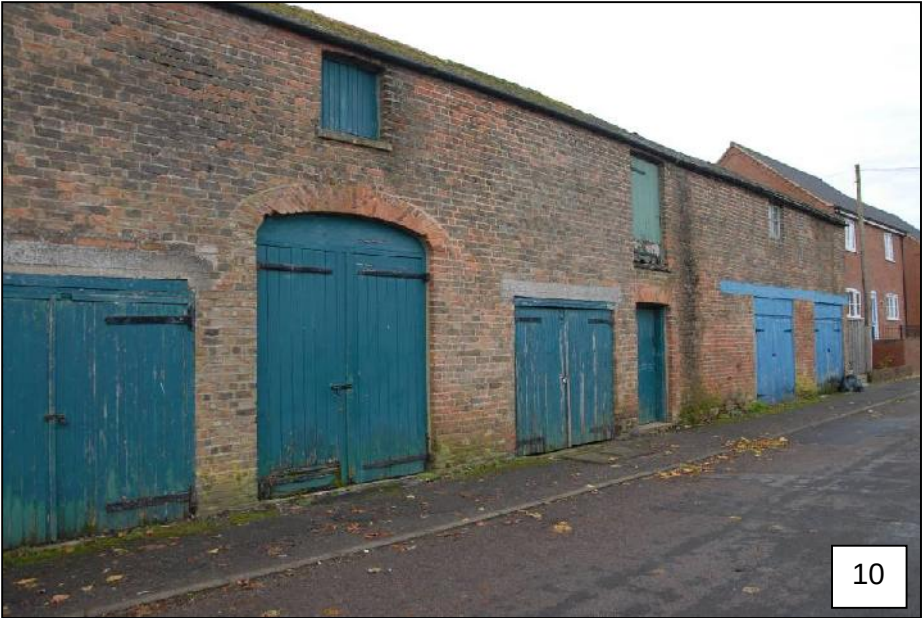
The outbuilding group is situated directly on the property boundary to the south side of Wharf Street. These are clearly the oldest buildings in the vicinity, with mid-20<sup>th</sup>-century bungalows opposite and more recent development to east and west.

The building which is under investigation is the western of three similar structures, each of which has had ground floor openings inserted into the Wharf Street frontage.

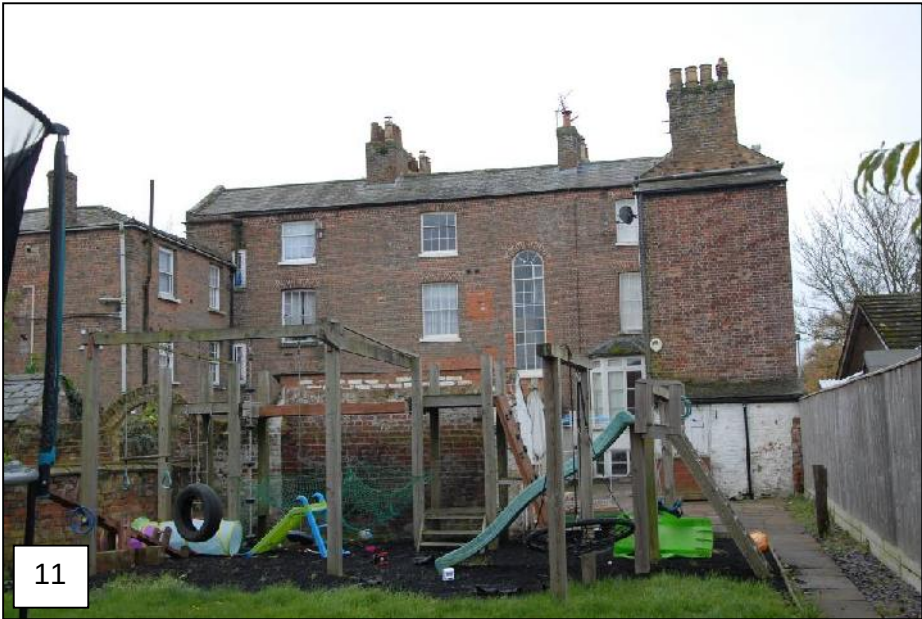
The outbuilding faces into what was probably a courtyard (now garden), partially separated by a former outhouse from the paved area at the rear of 68 Bridge Road.

The western boundary of the property is a 6ft modern timber panel fence.

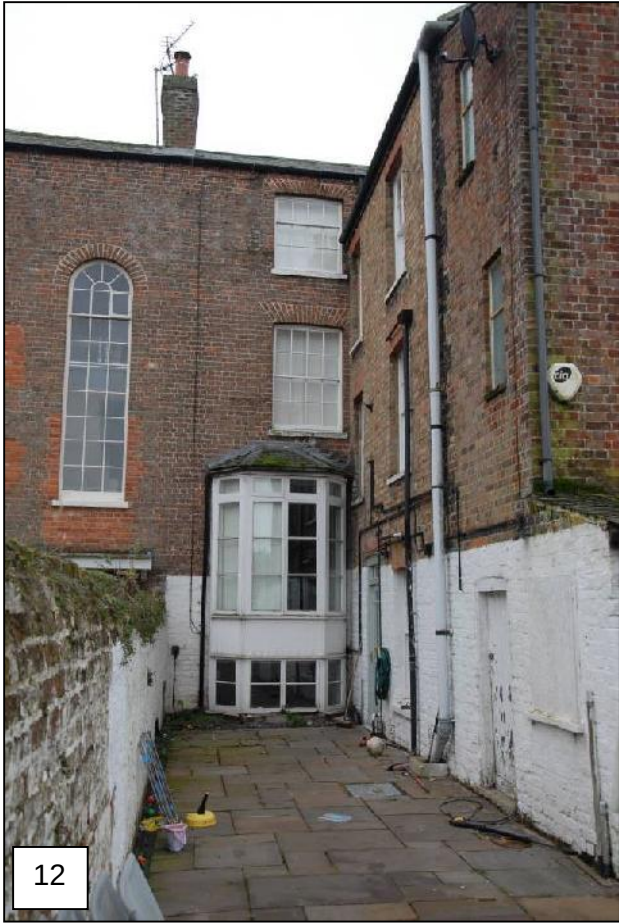
**Rear of 68 Bridge Road**

The rear of the house appears to have been extended twice to the north; first in 3" brick, later in modern red commons. All brickwork to west & north is carried out in English Bond (alternating courses of headers and stretchers).

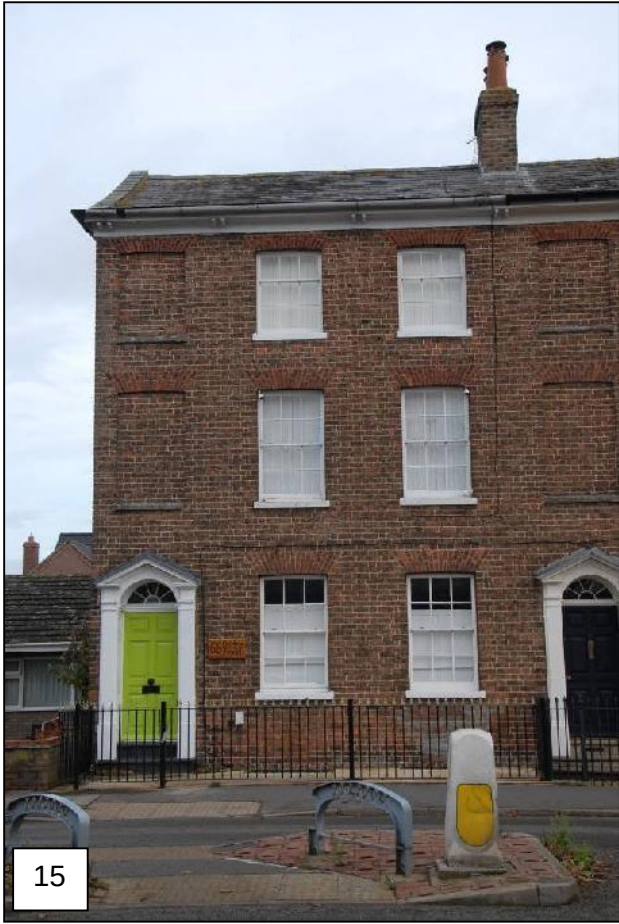
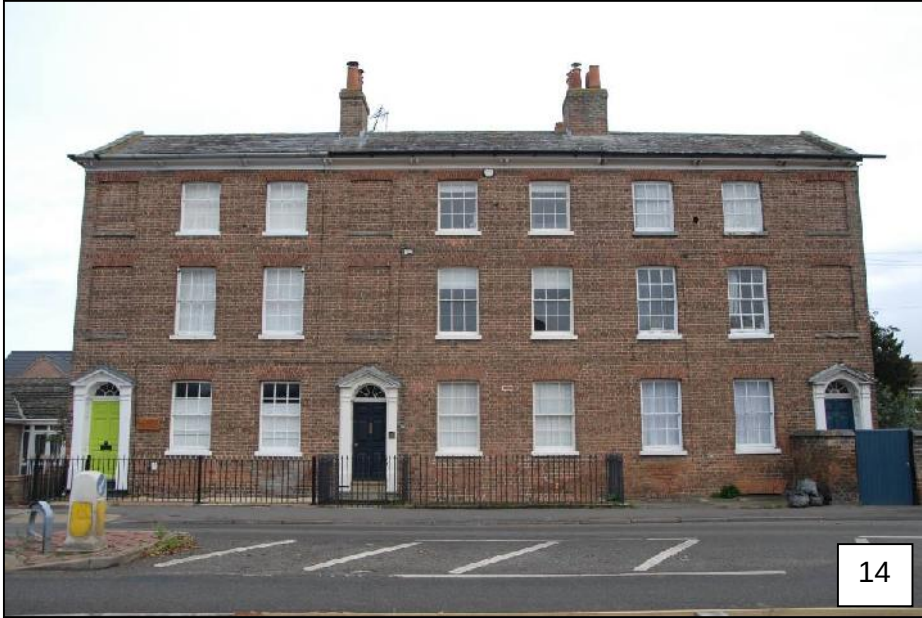
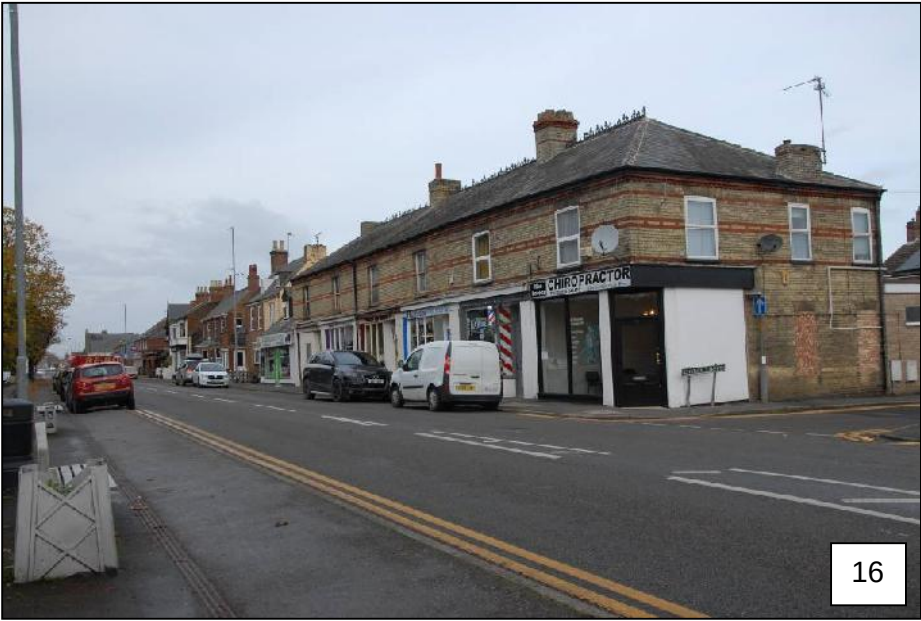
**Neighbouring Buildings**

No 68, Bridge Road is the western of a terrace of three prestigious residential properties, with a formal south façade to Bridge Road. The terrace is constructed of dark red/orange brick (brick size: 9" x 4½" x 2½-2⅞"; 3 courses = 9½") with 3½" sandstone sills. The south side is in Flemish bond (alternating headers and stretchers in each course),

The group is clearly of a larger scale than the surrounding properties, although the immediate neighbours to the west have been replaced with more recent bungalows. The scar of the former neighbouring terrace can still be made out on the west wall of no.68.

This is a fine example of early/mid-19<sup>th</sup> century residential property and would not have looked out of place in London – however, its situation in Sutton Bridge makes it even more imposing. The church is situated to the southwest, while Bridge Road becomes more commercial to the west (these buildings also appear later 19<sup>th</sup> century).

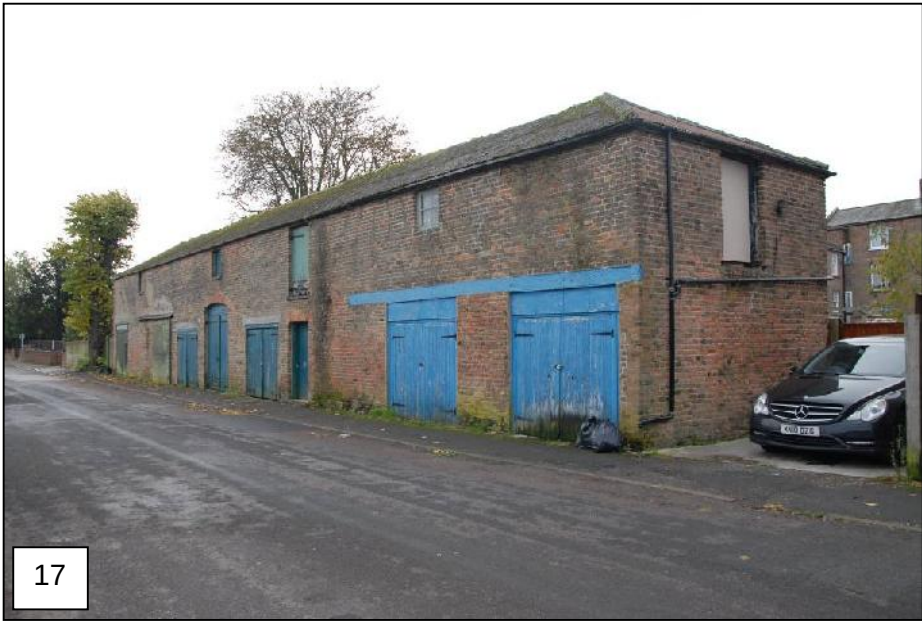
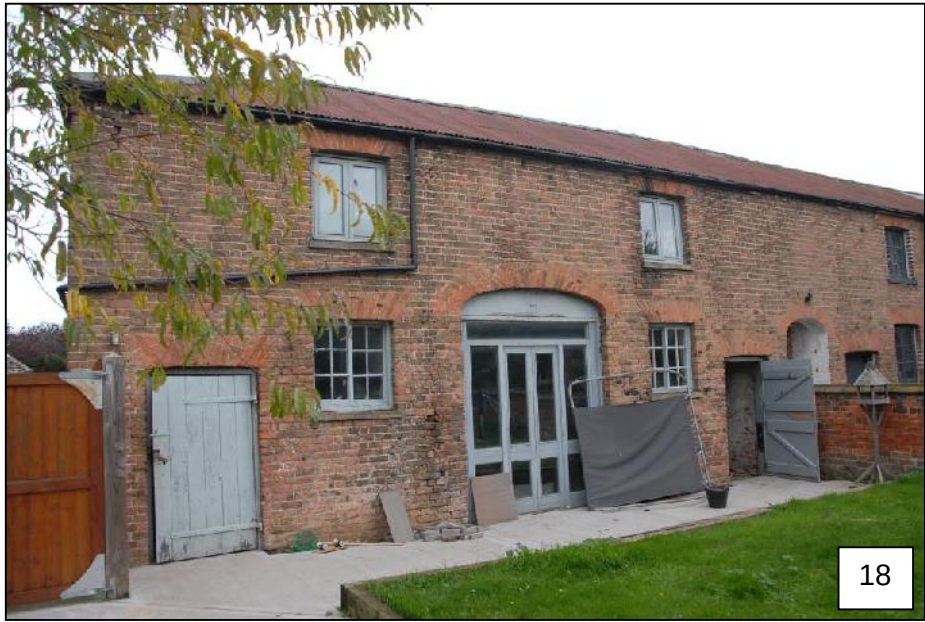
**Outbuilding**

The coach house/stable range is constructed of a red/orange brick including some overfired brick (brick size: 9¼-9¾" x 4½" x 2⅝"; 3 courses = 10") set in a gritty lime mortar. Walls are 14" in thickness throughout.

The brick bond is a 3-course English Garden Wall bond (three courses of stretchers to each course of headers) at the rear and side, but not entirely consistent, with some patches of English bond. The south side is Flemish bond.

The roof coverings throughout the group have been renewed with corrugated asbestos/cement sheets to the north pitch and various corrugated sheets to the other sides.

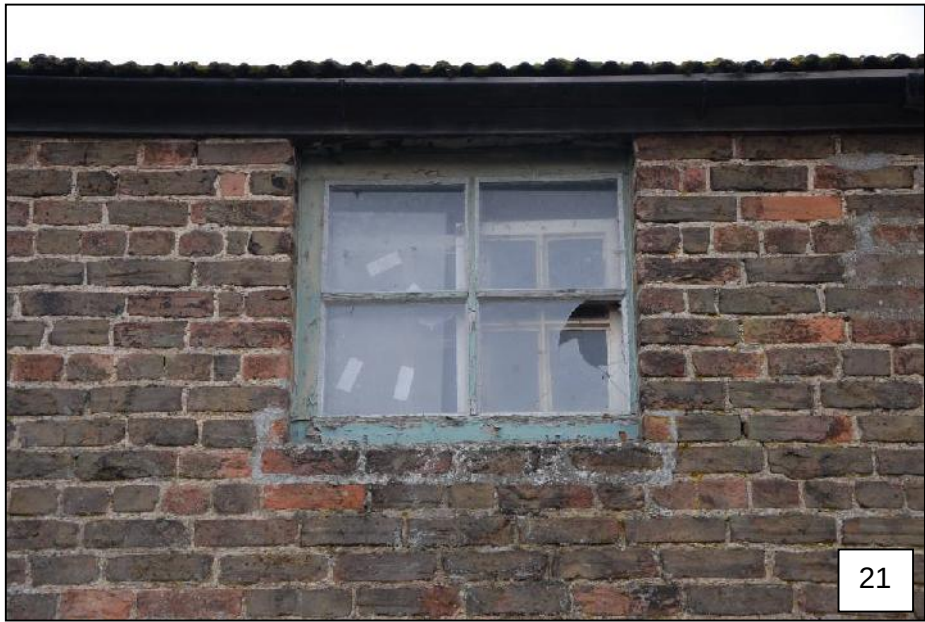
**North Side (West Part)**

It is clear that the two double doors at ground floor level here are more recently inserted. It is likely that there were originally no ground floor openings in this side.

The north doors are modern framed (85mm) 135mm matchboard, set below a shared heavy timber lintel.

The first floor window has an edge-set header lintel, but has lost its stone sill.

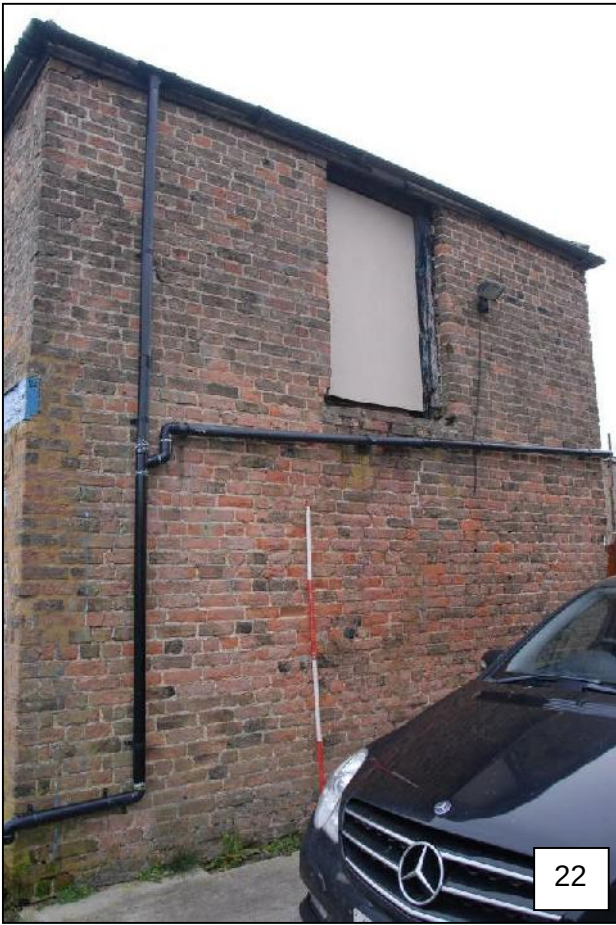
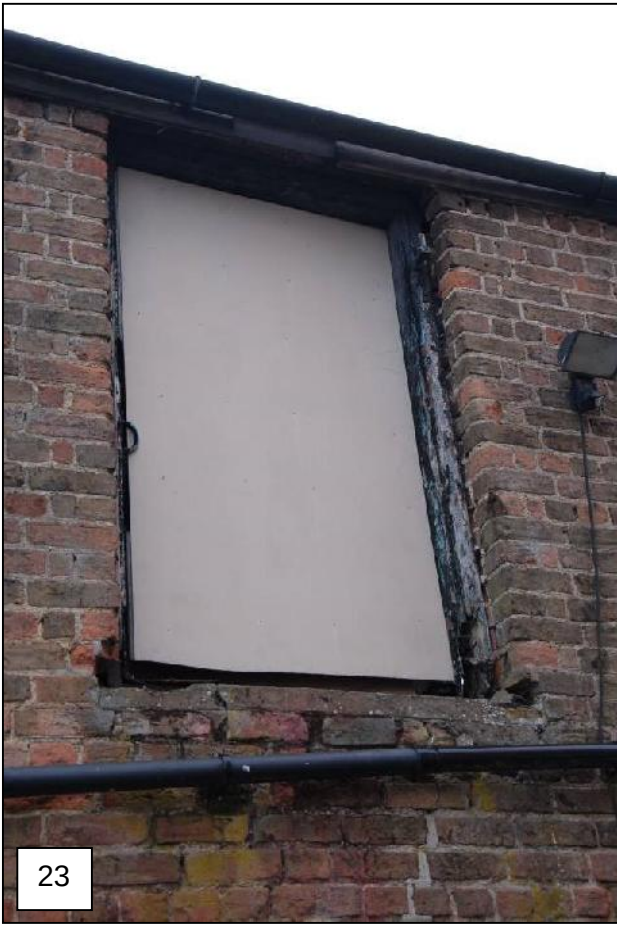
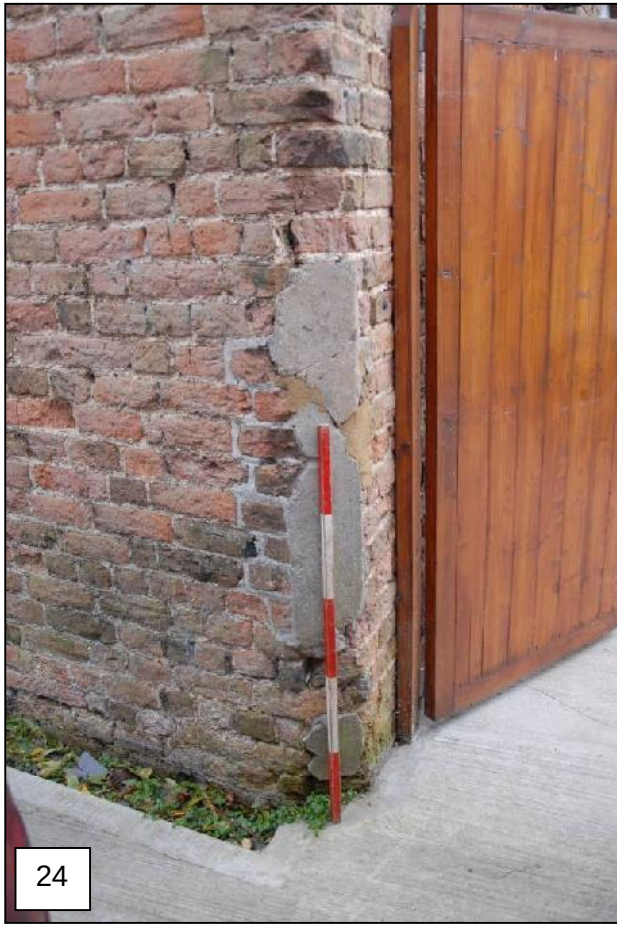
**West Gable**

The west wall has only a large first-floor loading door opening, set immediately below the wall plate. This opening would have allowed hay to be loaded into the first-floor hayloft from a cart or wagon.

The southwest corner of the building is chamfered with an axed brick run-out head – such corners are often employed where animals would have passed.

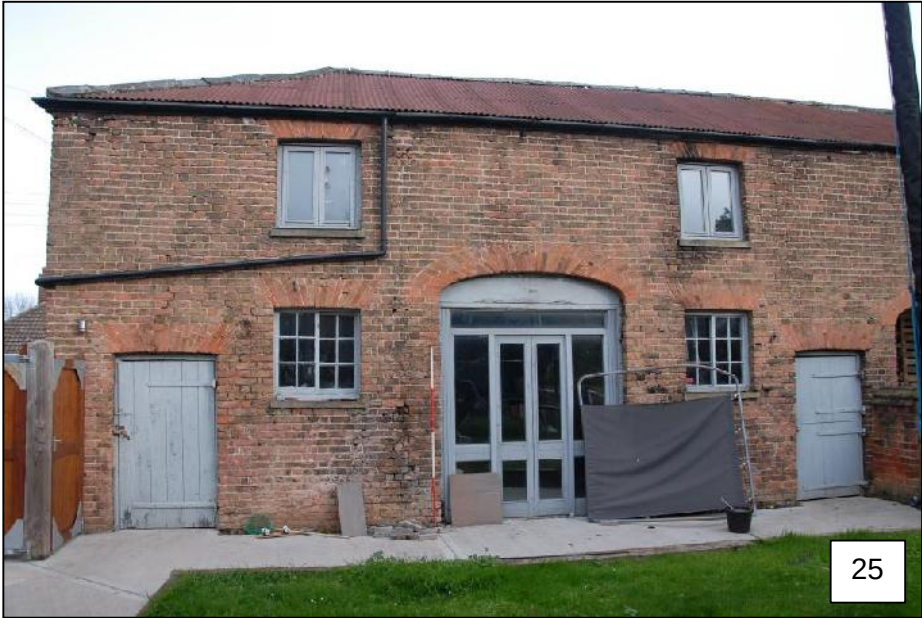
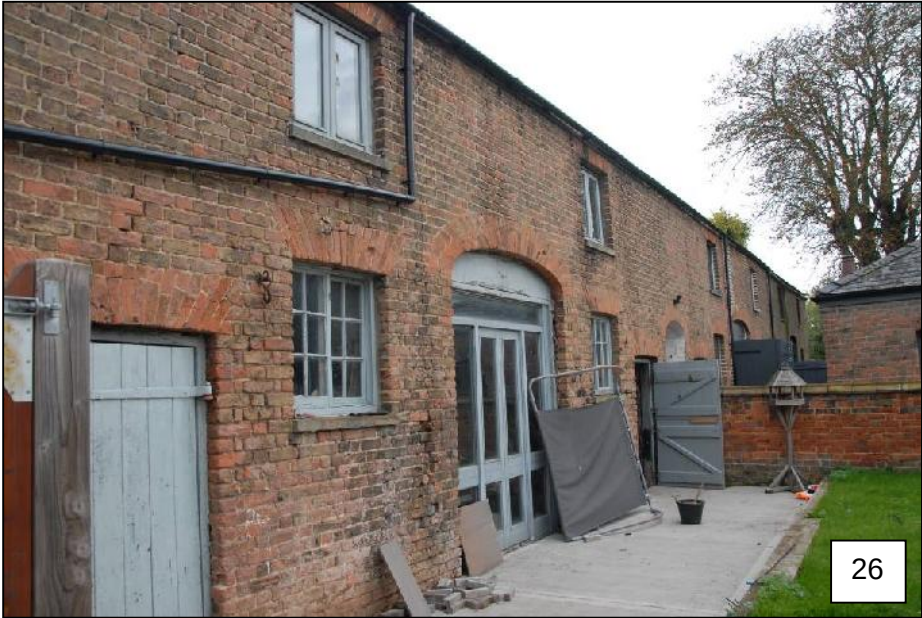
**South Side**

The south side of the outbuilding presented a symmetrical 3-bay appearance. While built of the same brick as the north and west sides, here the brickwork is Flemish bond – designed to be seen from the house.

The south side of the outbuilding group is all similar, with conventional door and window openings flanking a large central arch – like the north side, this symmetry differs in the central section, with a passage providing pedestrian access to Wharf St to the immediate east of the property under study, below a taller, segmental arch.

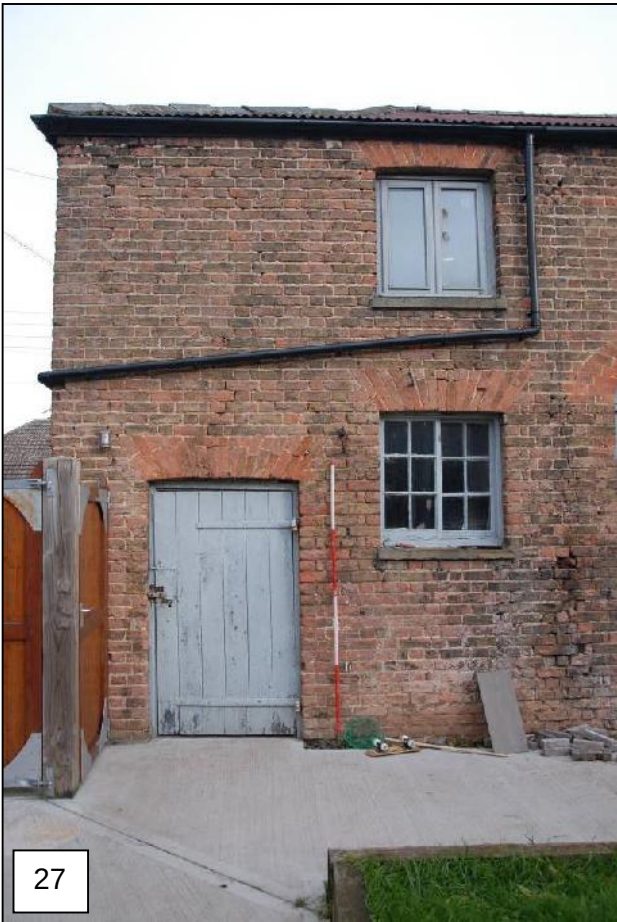
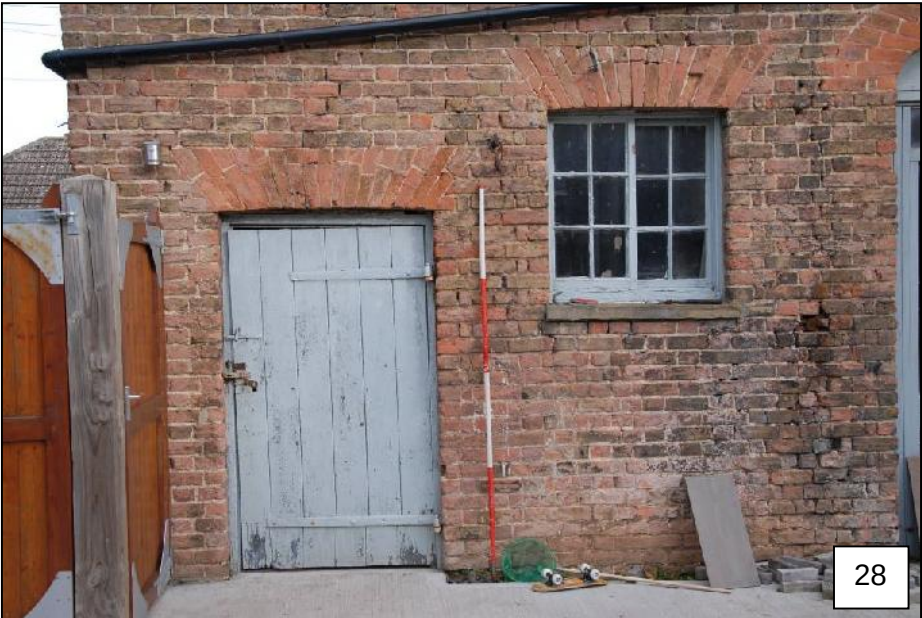
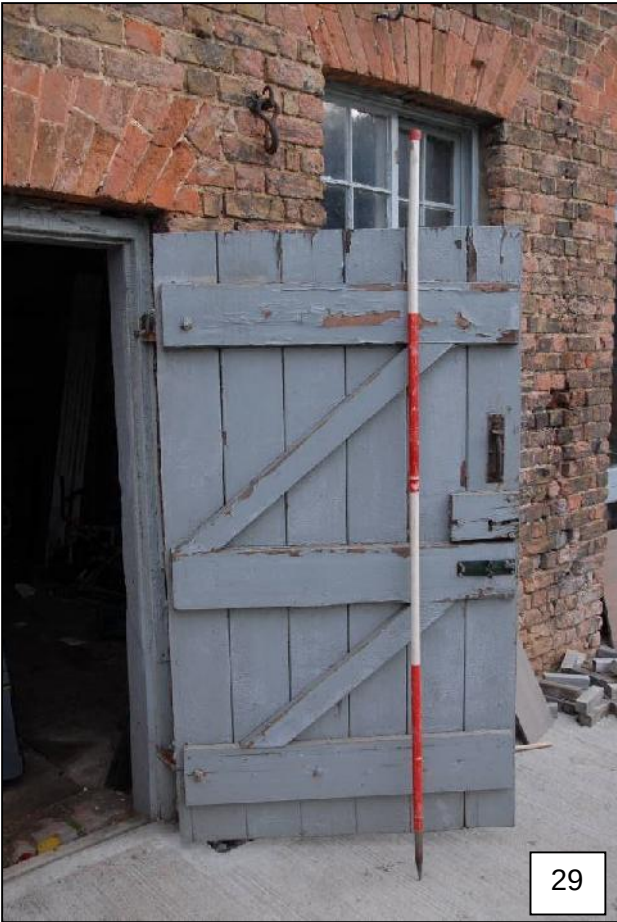
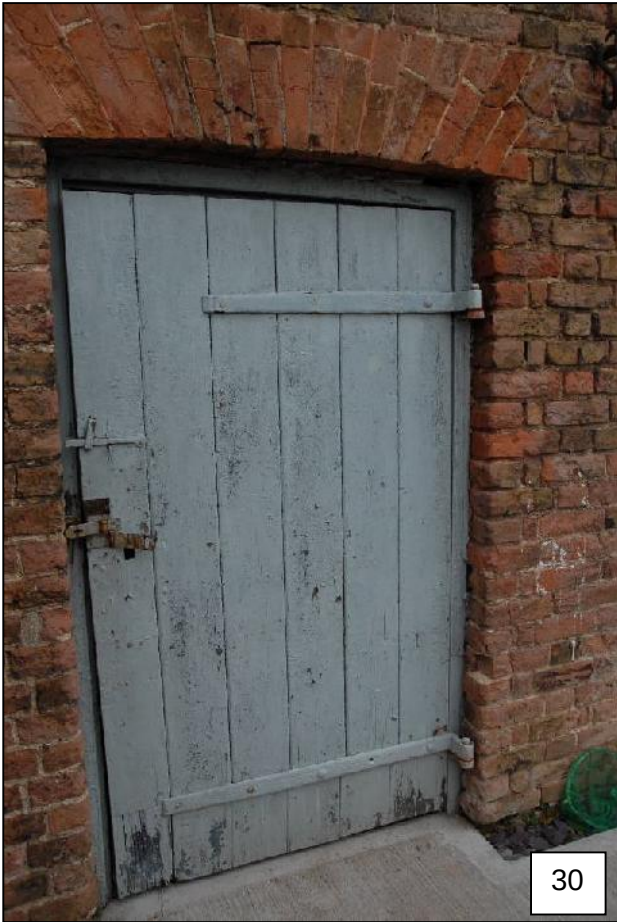
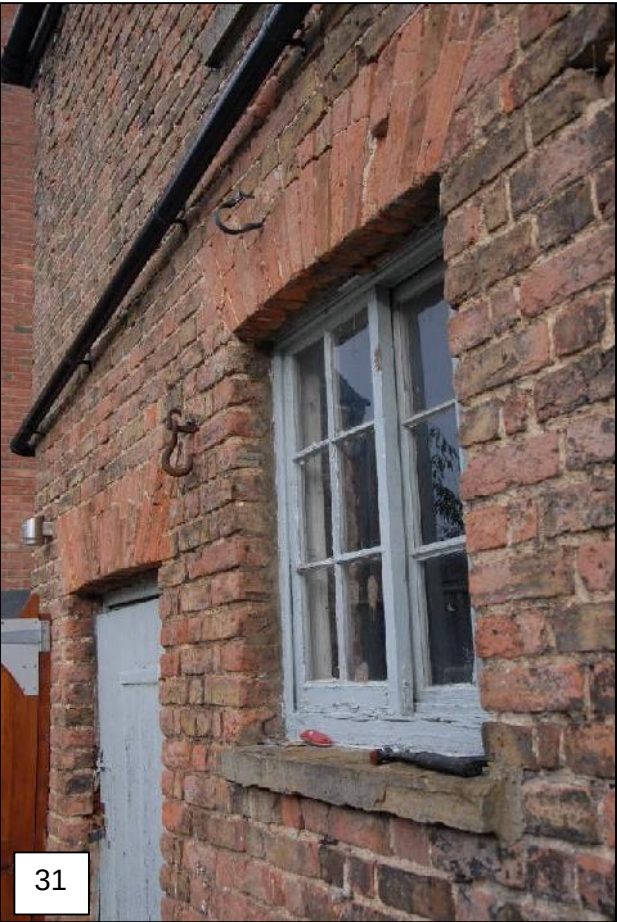
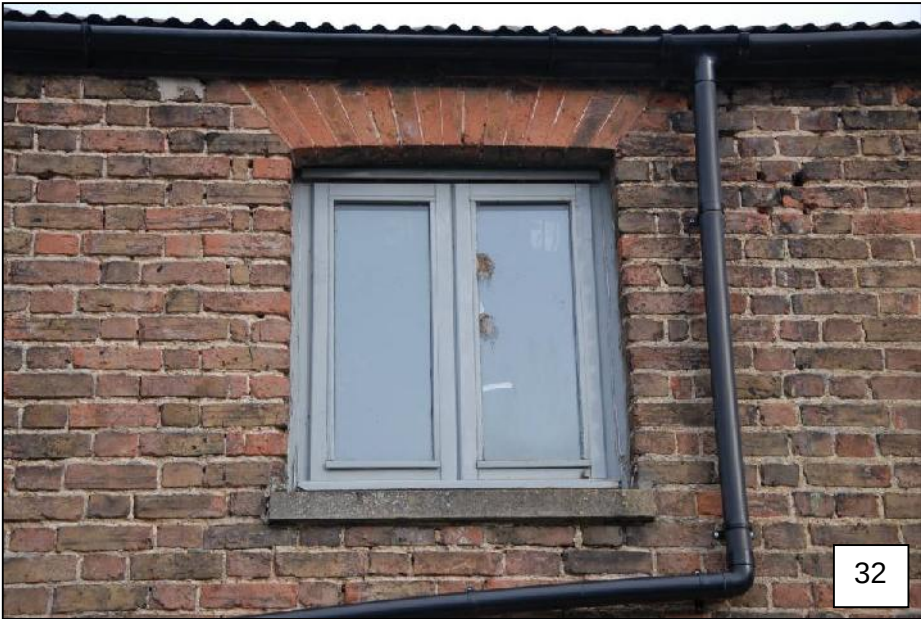
**Western bay**

This bay has a door and window at ground floor level and a window above. All have cambered rubbed brick lintels; the windows have 3" limestone sills.

The ground floor window has a Yorkshire horizontal sliding sash, while the first-floor window has a replacement UPVC unit.

The door here is original - It is hung on heavy 2¼" strap hinges which have a 3½" bend in a 5" x 3" frame. A heavy iron hook is suspended from an iron staple between the door and the ground floor window – possibly used to suspend a lantern.

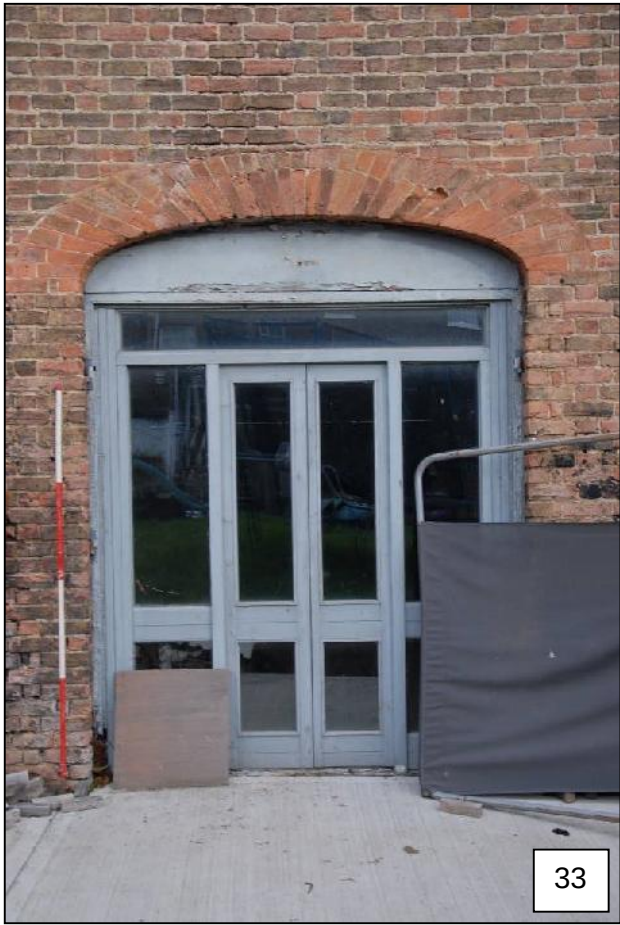
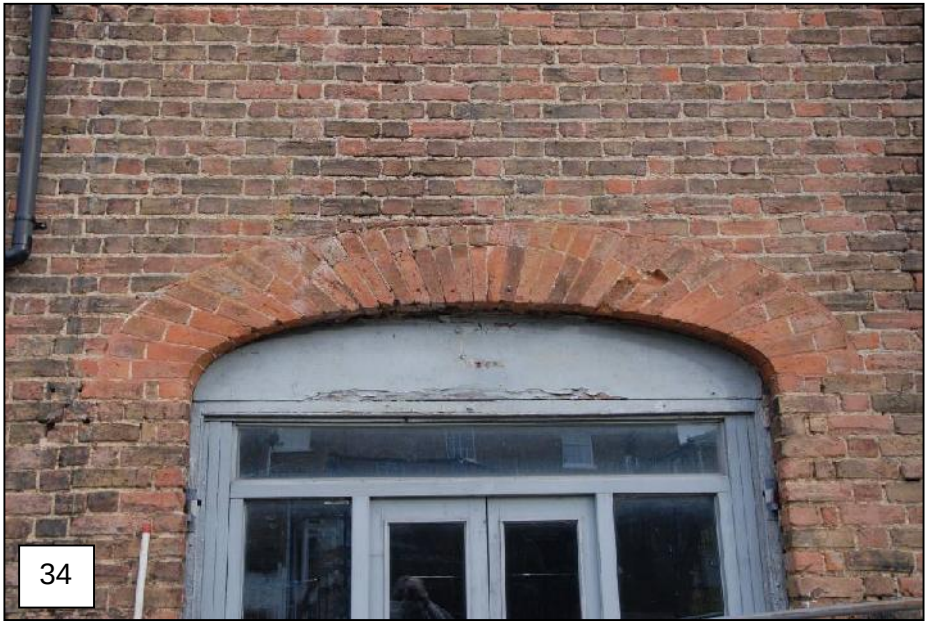
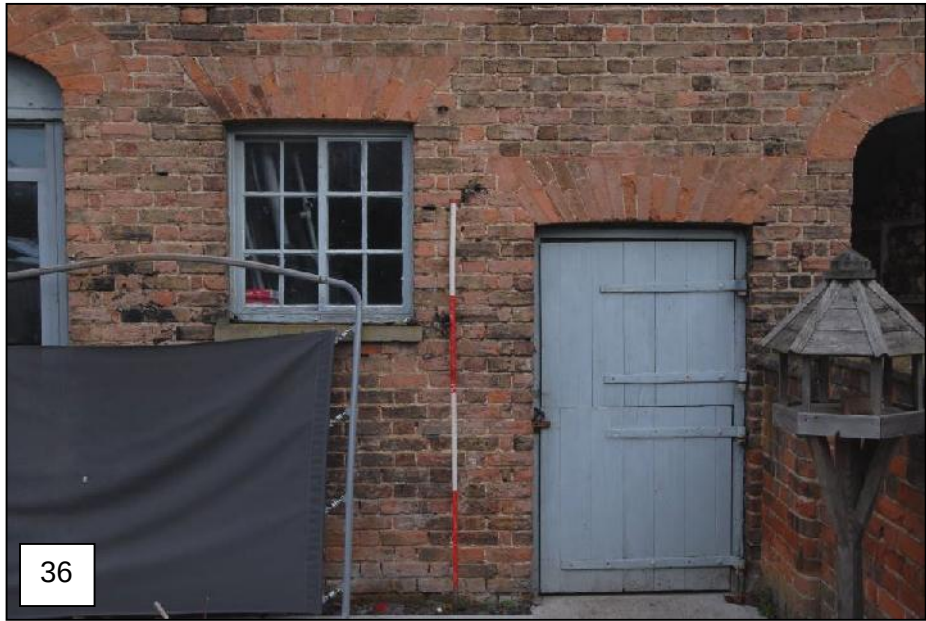
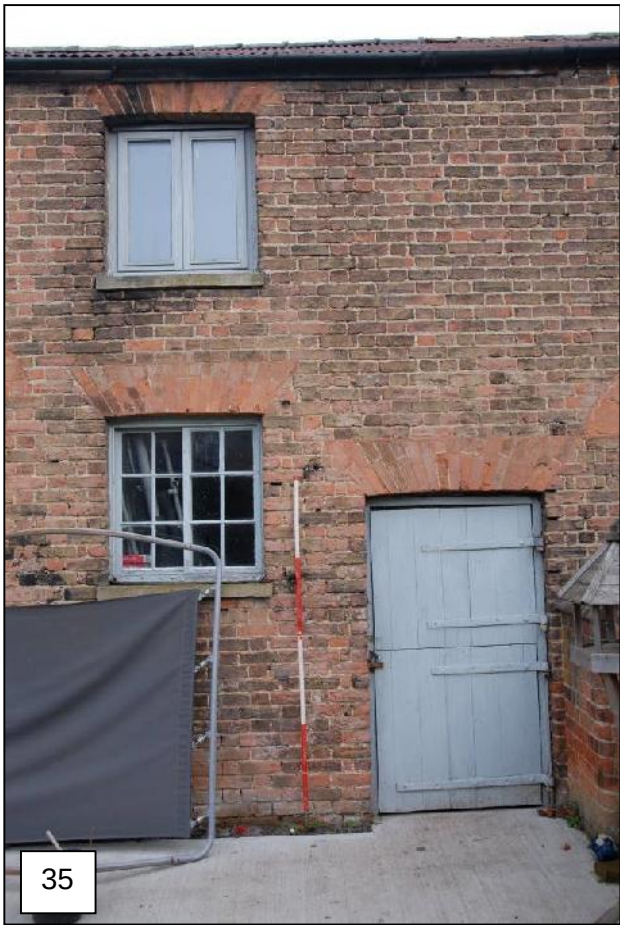
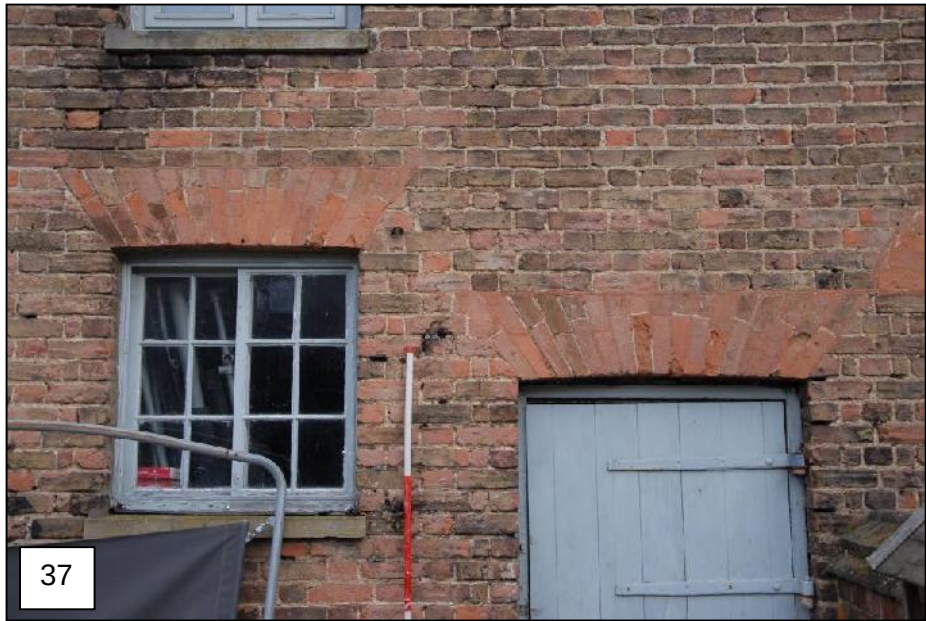
**Central bay**  
The central bay contains only a large opening with a segmental rubbed brick lintel. This carriage arch dominates the appearance of this side of the building.
