# OUTBUILDING TO REAR OF NO. 68, BRIDGE ROAD, SUTTON BRIDGE, LINCOLNSHIRE

## HISTORIC BUILDING SURVEY

Report prepared for G. R. Merchant Ltd.

December 2023

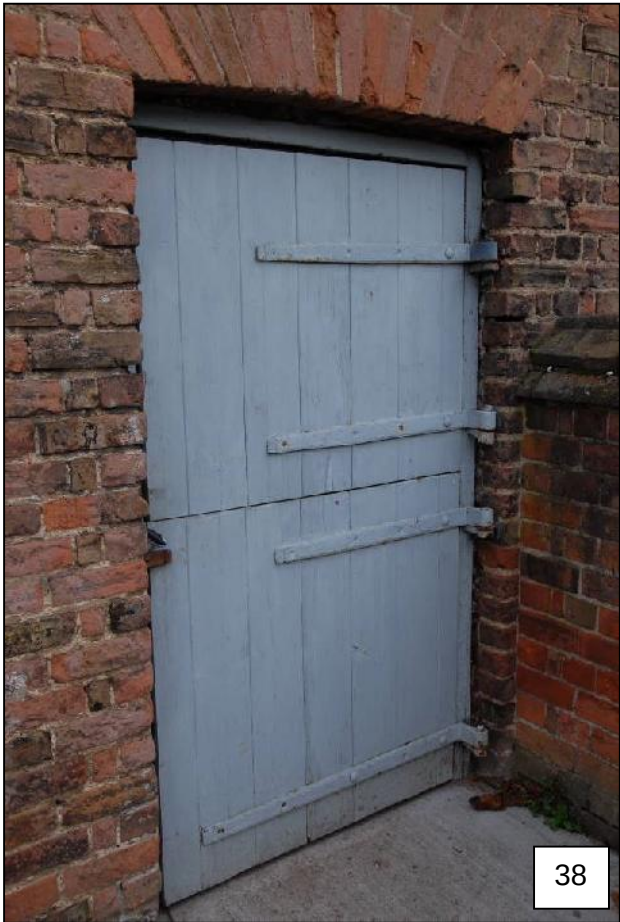
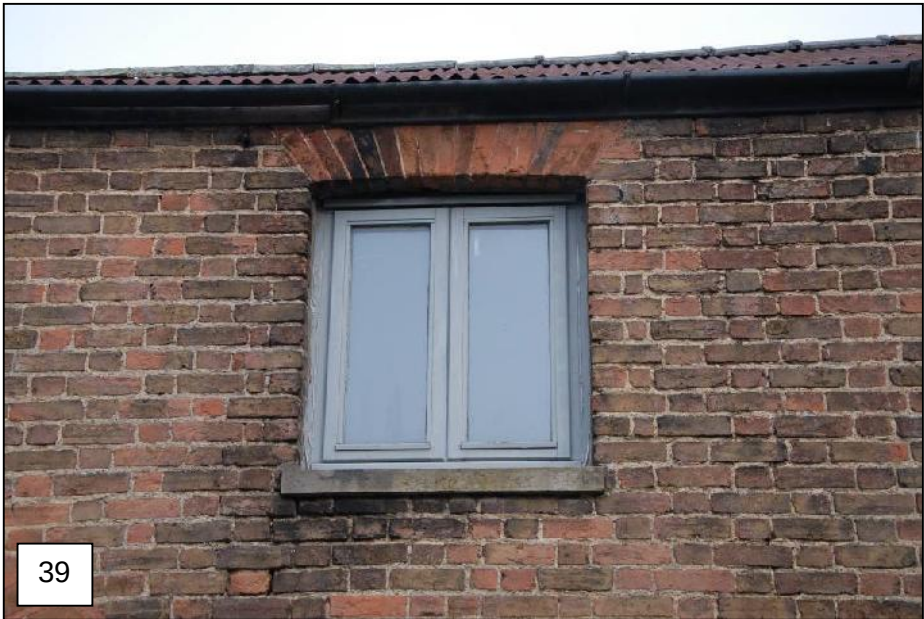
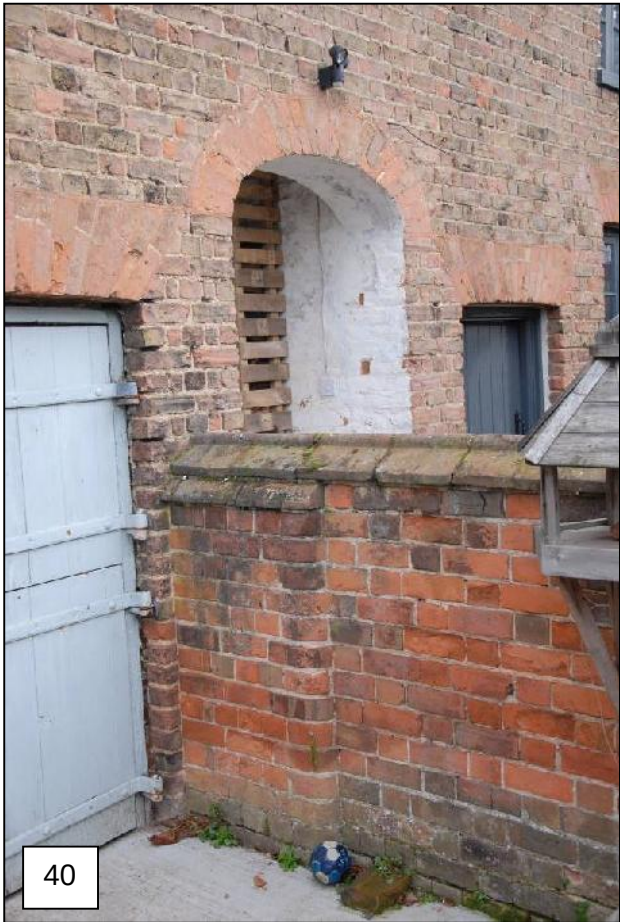
**Eastern bay**  
The eastern bay is a symmetrical reflection of that to the west. The door has been replaced, but the original hinges have been re-used – this is a stable-type door.

The boundary wall separating this property from its eastern neighbour is clearly later. It is built of red and dark red brick (brick size: 9" x 4¼" x 3"; 3 courses = 10½") in Flemish bond with brick pyramidal coping and a chamfered detail to its pilasters.

The passage affording access to Wharf Street for no.66 Bridge Street is situated to the immediate east of the boundary wall.

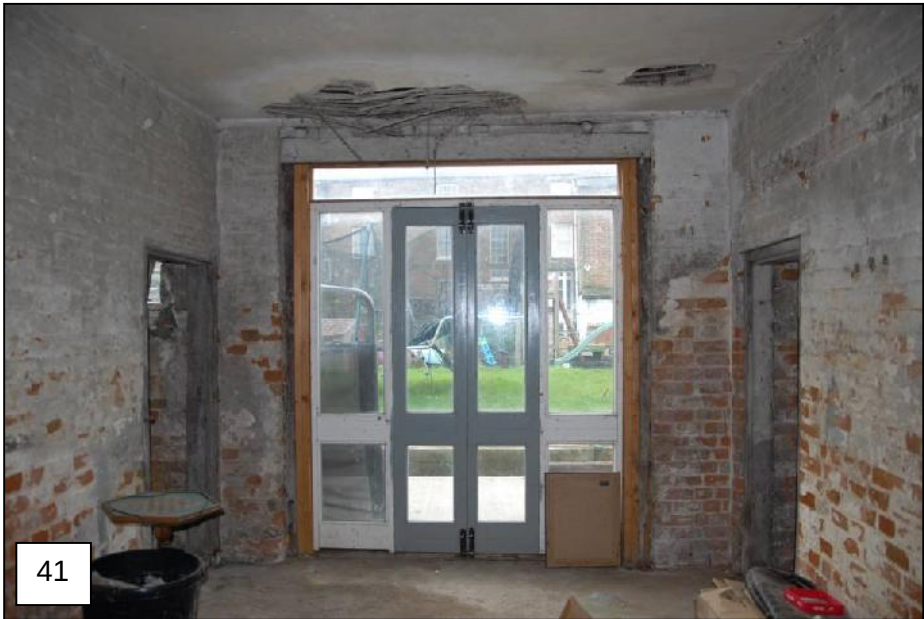
**Room 1 – Coach house**

This room occupies the central bay of the ground floor of the outbuilding.

It has a plaster/lath ceiling. The doors at the north side are modern inserts below a common heavy timber lintel shared with Room 2 and has chamfered cemented jambs; the 4" square timber frame is also modern. The floor is poured concrete.

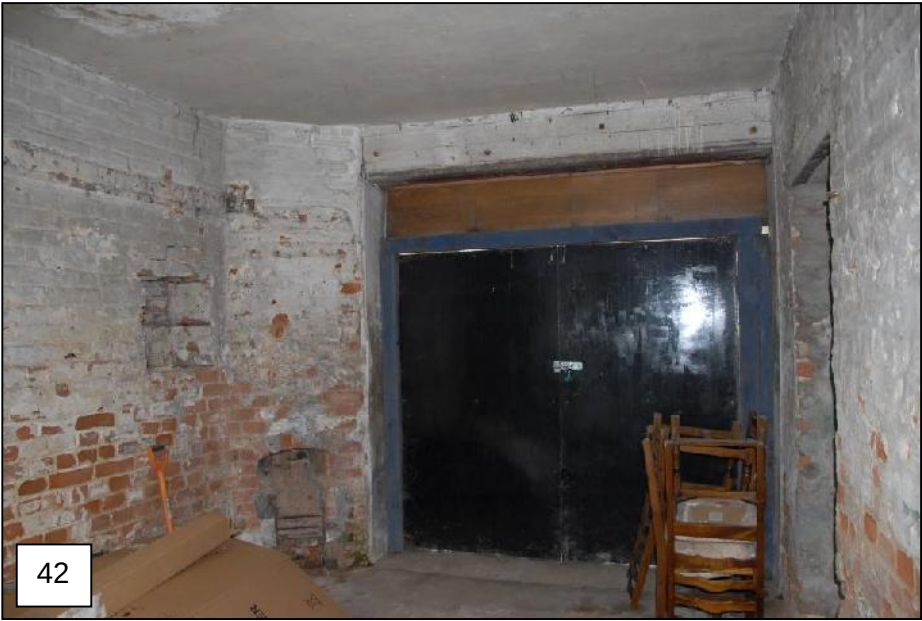
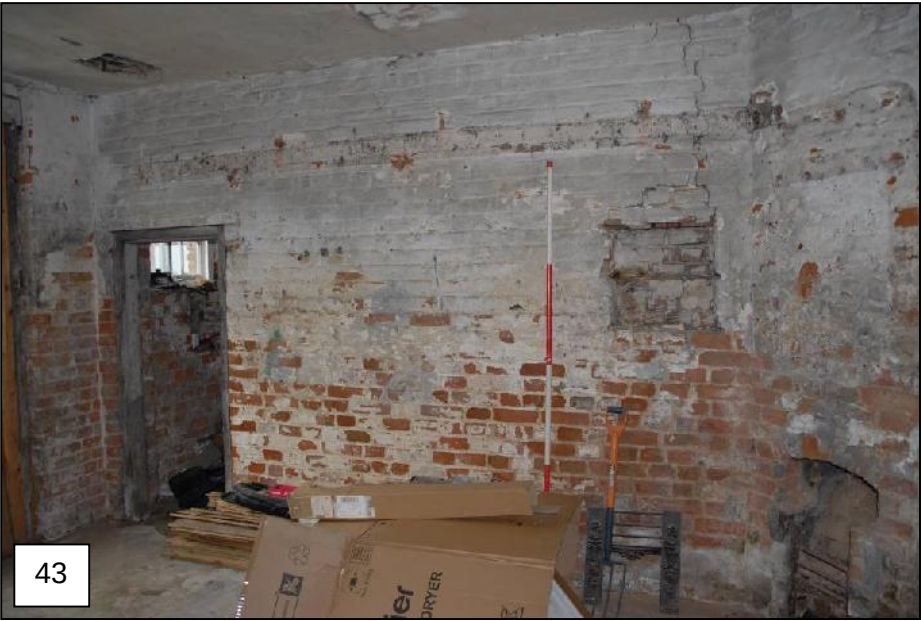
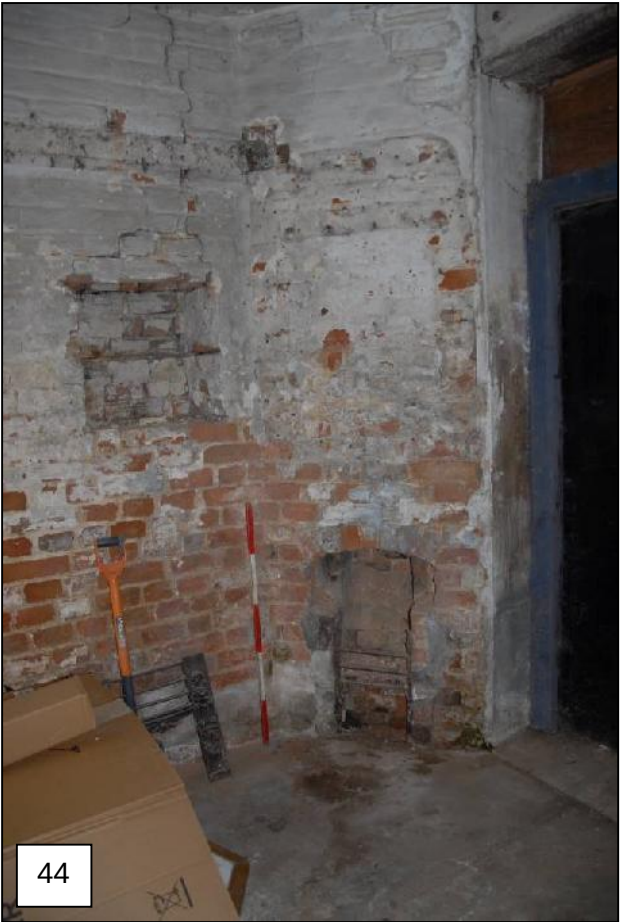
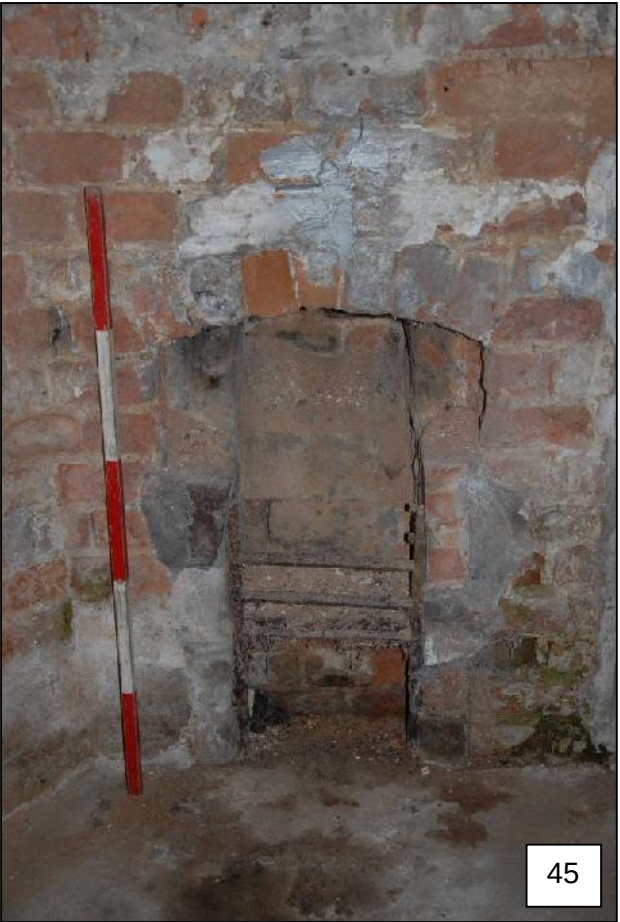
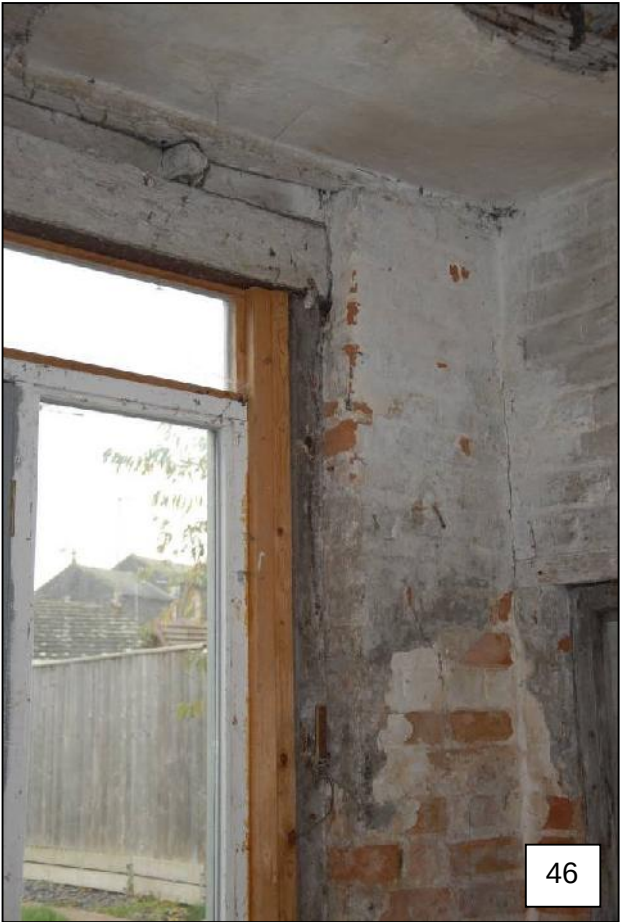
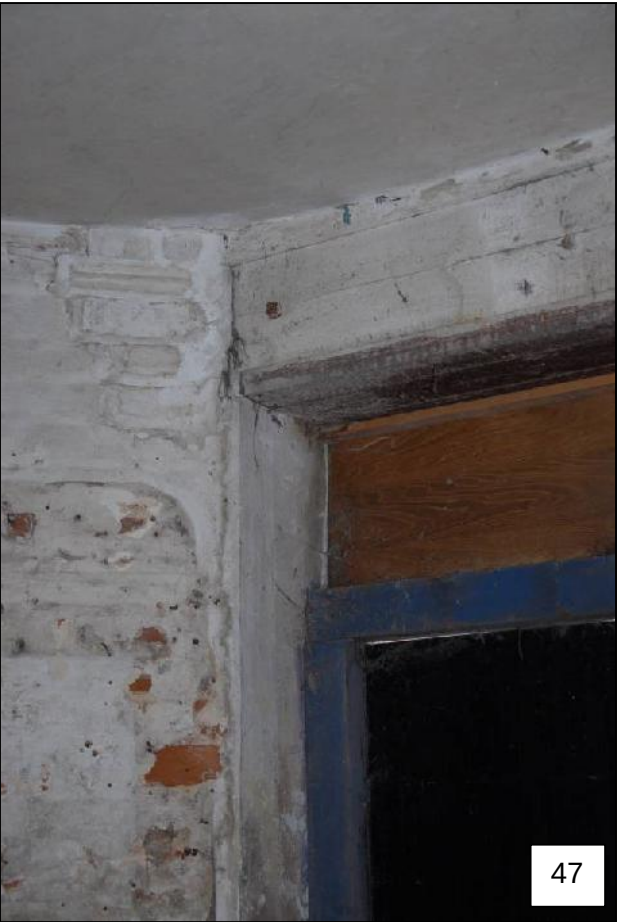
The south doors are late 20<sup>th</sup>-century double glazing, but set in the original 2¾" timber frame which retains a wrought hinge at the west side and a bar keep to the east. The room is whitewashed throughout, heavily worn in the lowest 3ft.

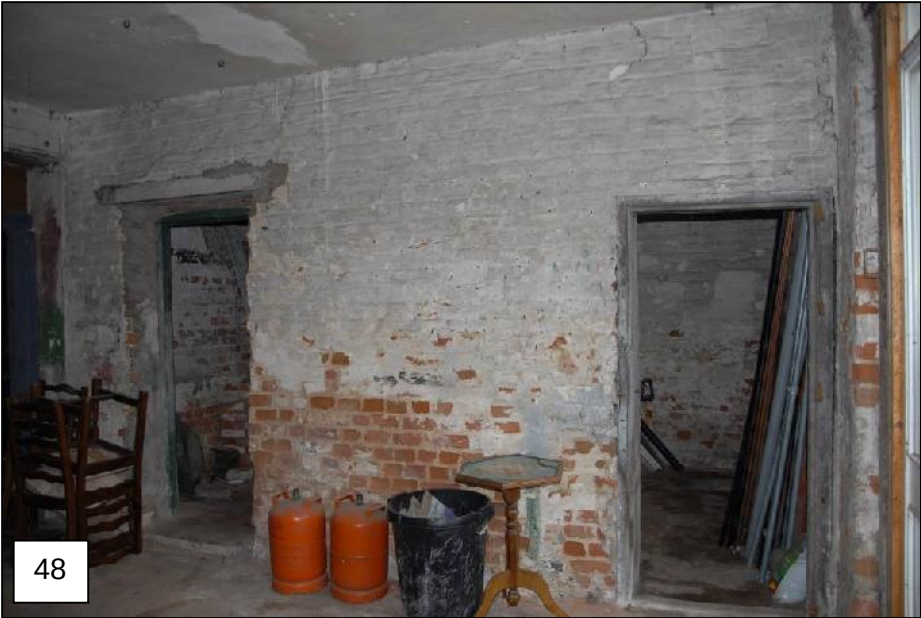
A fireplace in the northwest corner retains its grate with ½" firebars. A 19" wide x 20" high recess with a ½" timber shelf is situated adjacent in the west wall. The scar of a 6" tack rail is present above.

The areas at the top corners of the openings to south and north clearly demonstrate how the modern doors have been inserted.

The north door to Room 3 is inserted below a concrete lintel. The south door opening is original, but retains only its frame. A series of graffiti initials are recorded here scratched into the paint. These initials include: IO, FOI, EH, FT, EC, AL, ND, DD, ER, FS and HS.

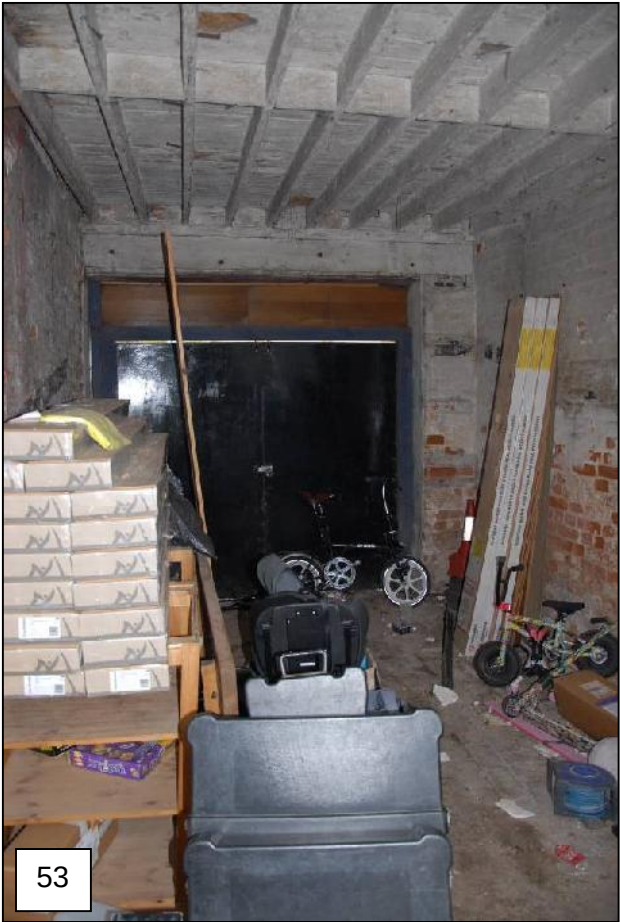
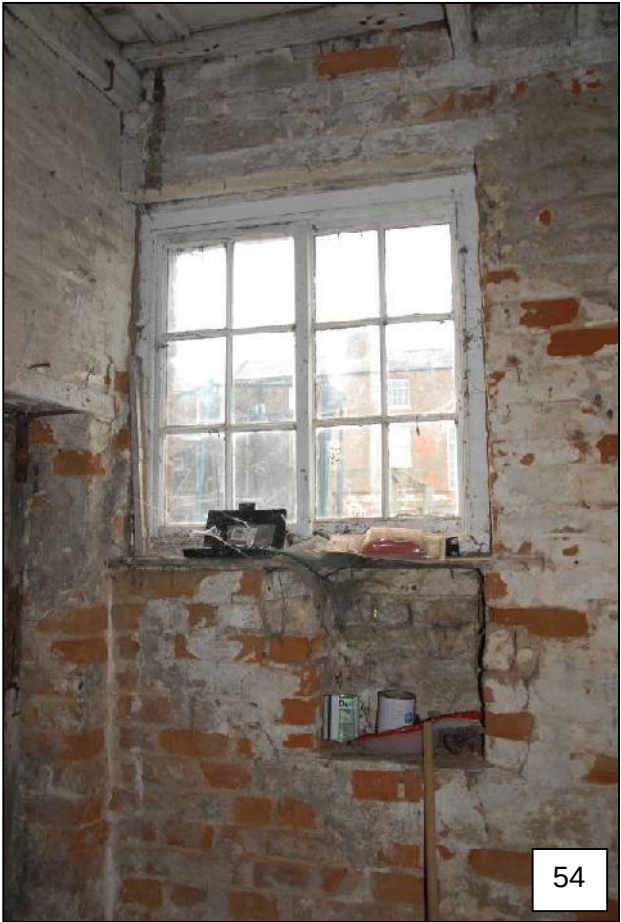
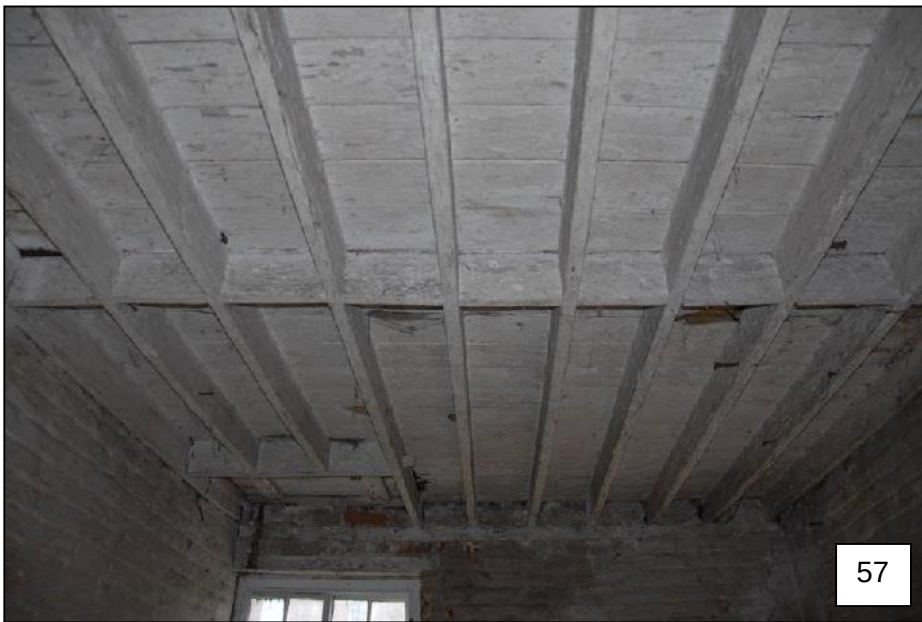
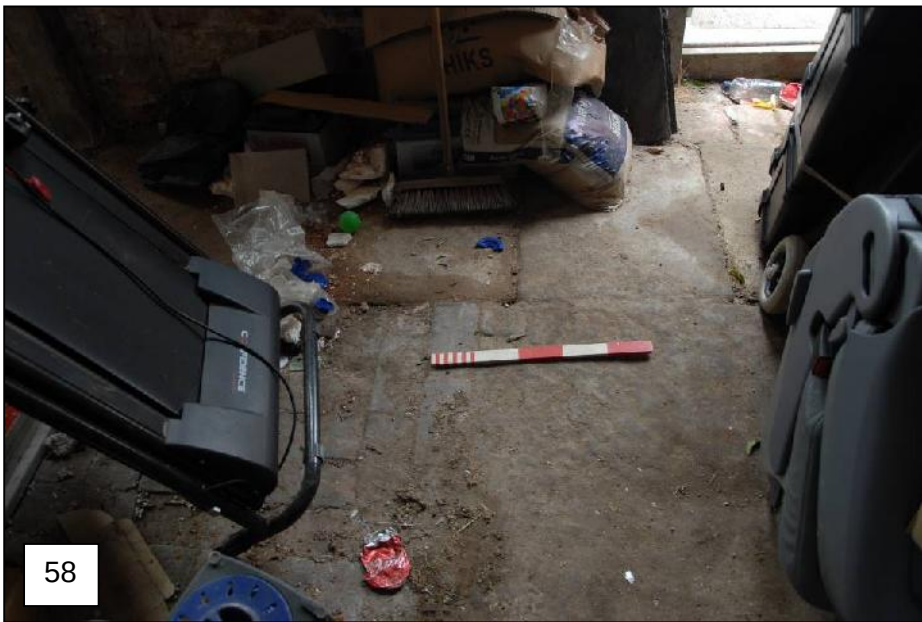
The room is lit by a Yorkshire sliding sash at the east side of the south wall (panes 10¾" x 8"). A 17" wide x 19" high alcove is present below this window.

The door opening to Room 1 retains its 5" x 2¾" frame only, very worn at its north side.

Traces of black paint on the east, west and north walls indicate stalls: these are 5" wide and 59" from the floor at the south side, rising to 79" to the north, with a 7" diameter ball on top.

The ceiling comprises the exposed north-south joists to the floorboards (E-W) of first floor. A ledged trap door is situated in the southeast corner.

The floor at the south side is of 2ft x 21" and 30" x 26" flagstones, infilled with 9" x 4½" blue pammets which are laid on flat in half-overlapping north-south rows. A modern concrete strip is present to the northern 39" of the floor.

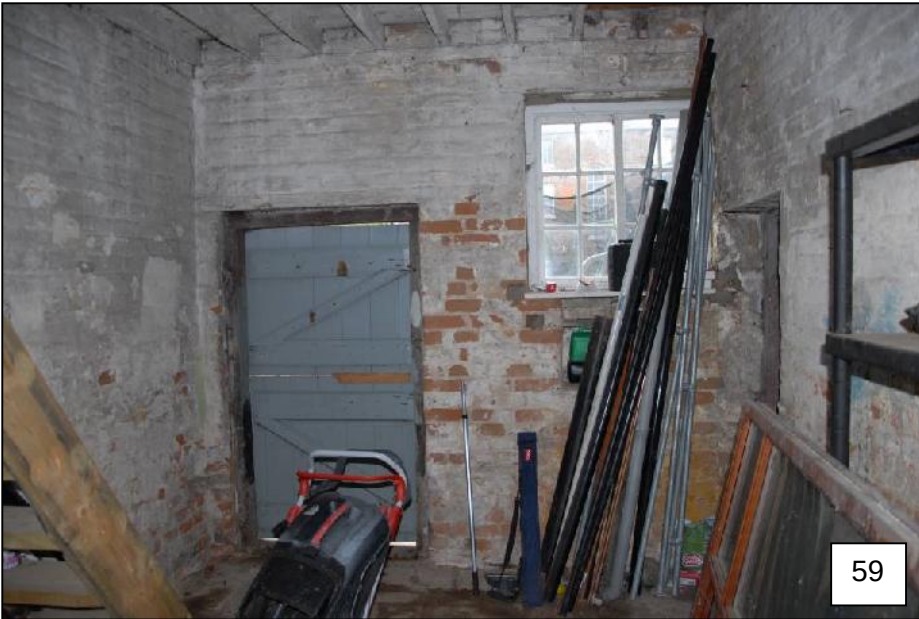
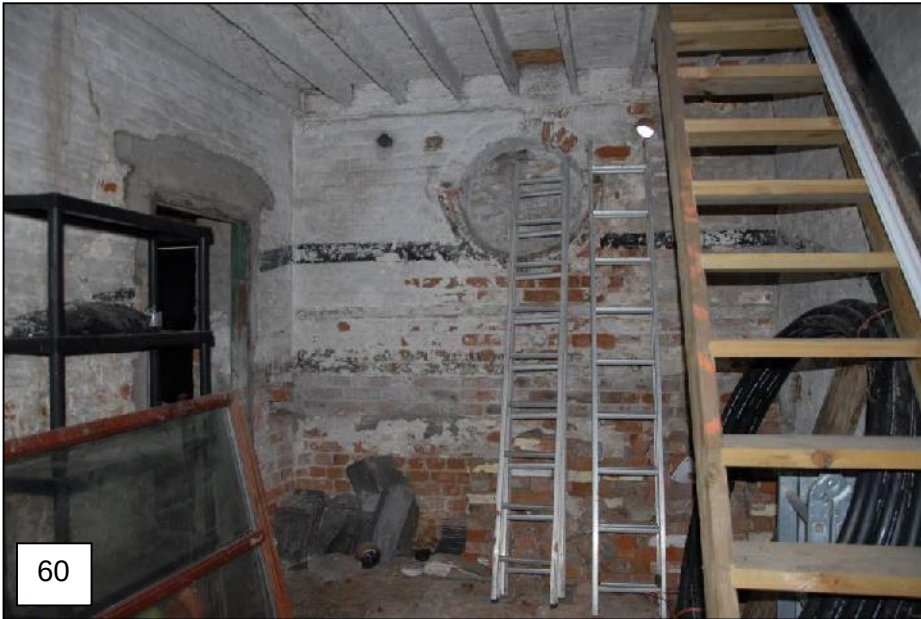
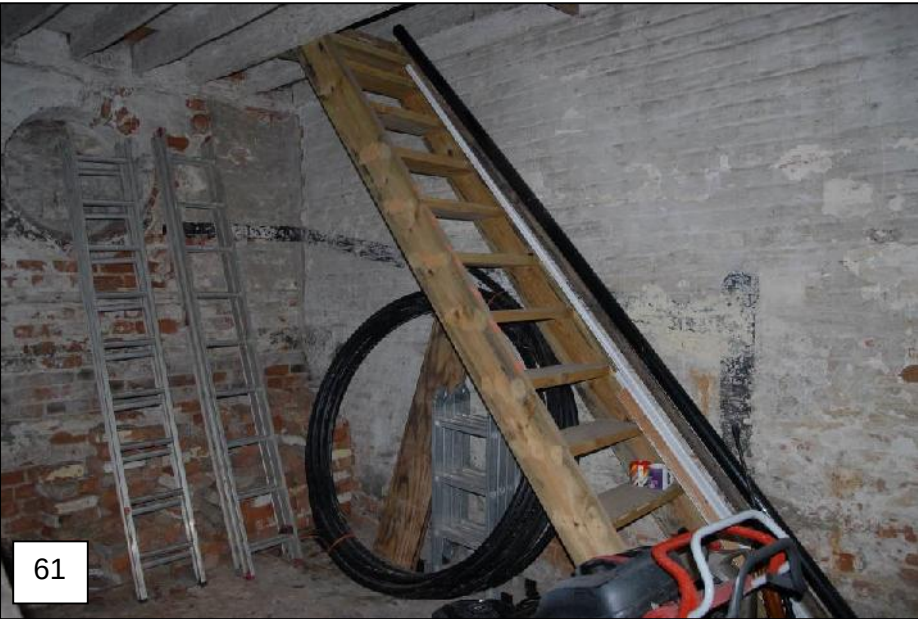
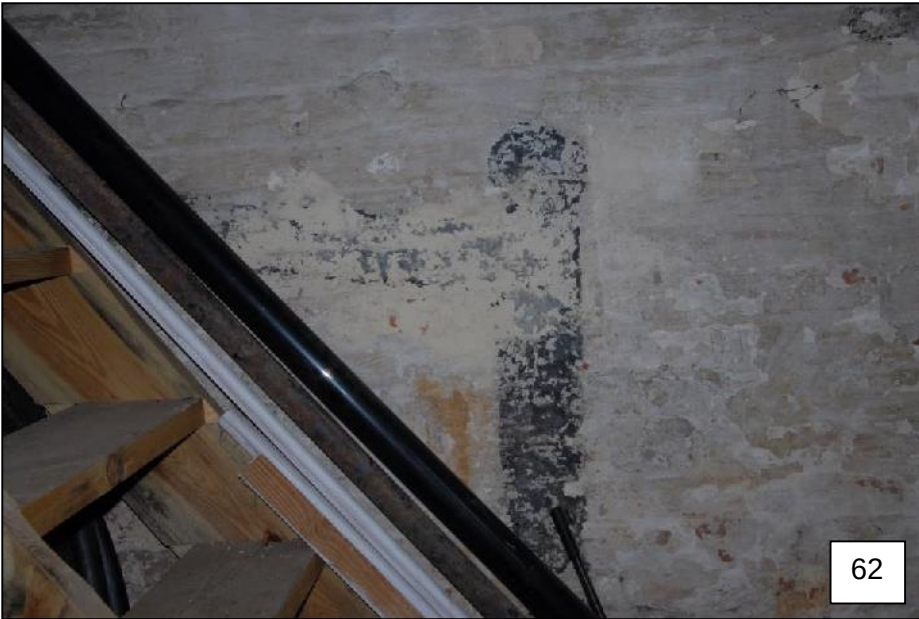
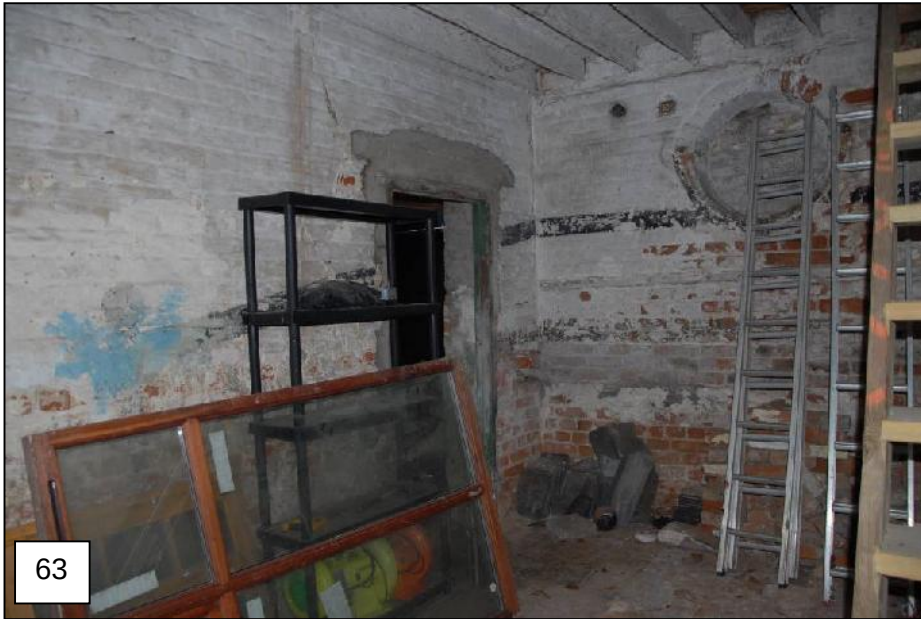
**Room 3 - Stable**

A modern chamfered 4½" x 2" timber frame is present to the north door opening to Room 1. The south door opening to Room 1 is similar to that of Room 2: again, the frame only survives, here with hinges for a stable door – graffiti is present on the north side – see Room 1.

The exterior door in the south wall is more recently renewed – it is of 6½" plain planks, with 7"chamfered ledges and 3¼" diagonal braces.

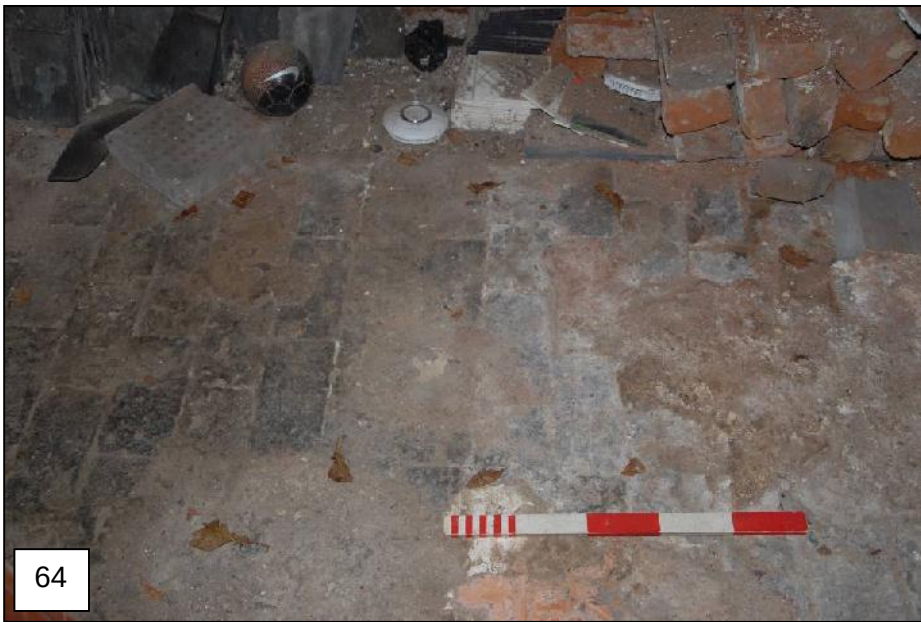
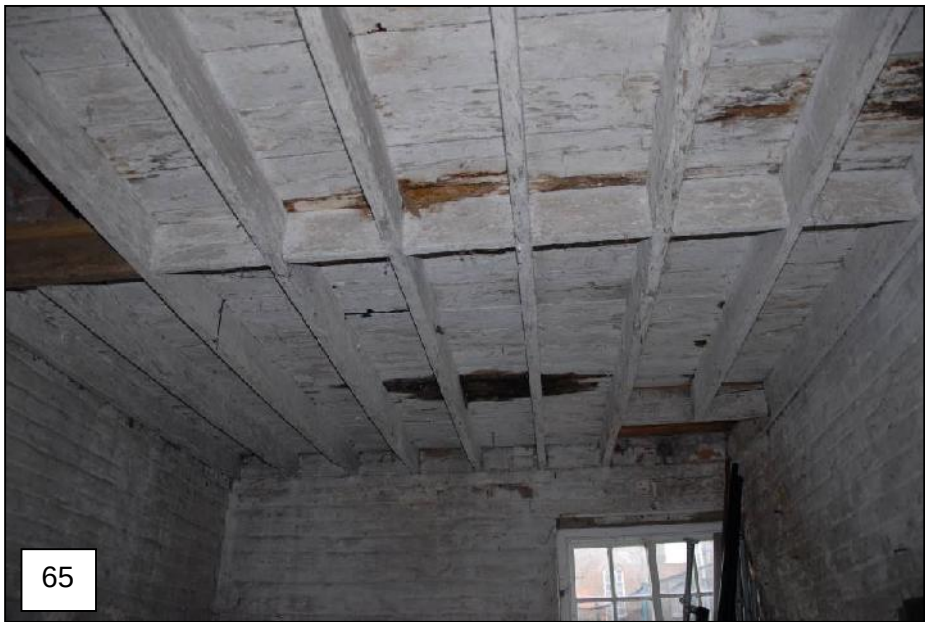
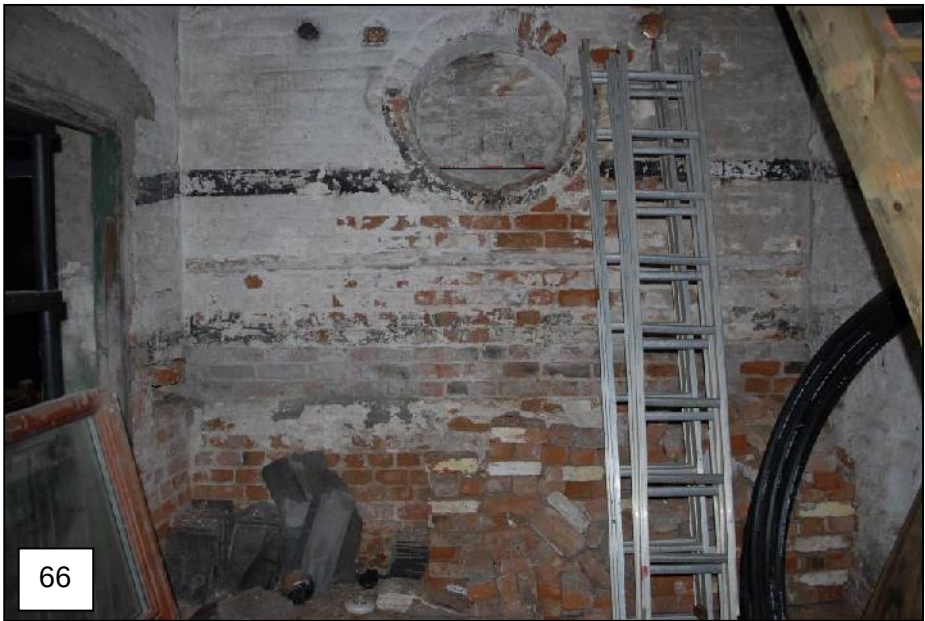
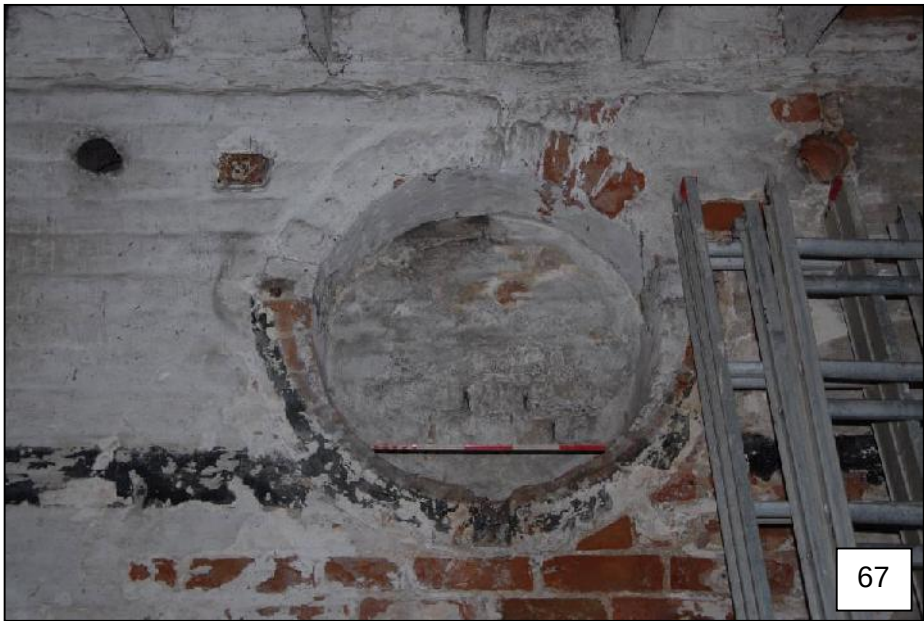
This room occupies the eastern bay of the ground floor of the outbuilding.

The floor and ceiling are as described in Room 2, but the trap door is situated to the southwest of the ceiling. The south window and alcove are also as Room 2.

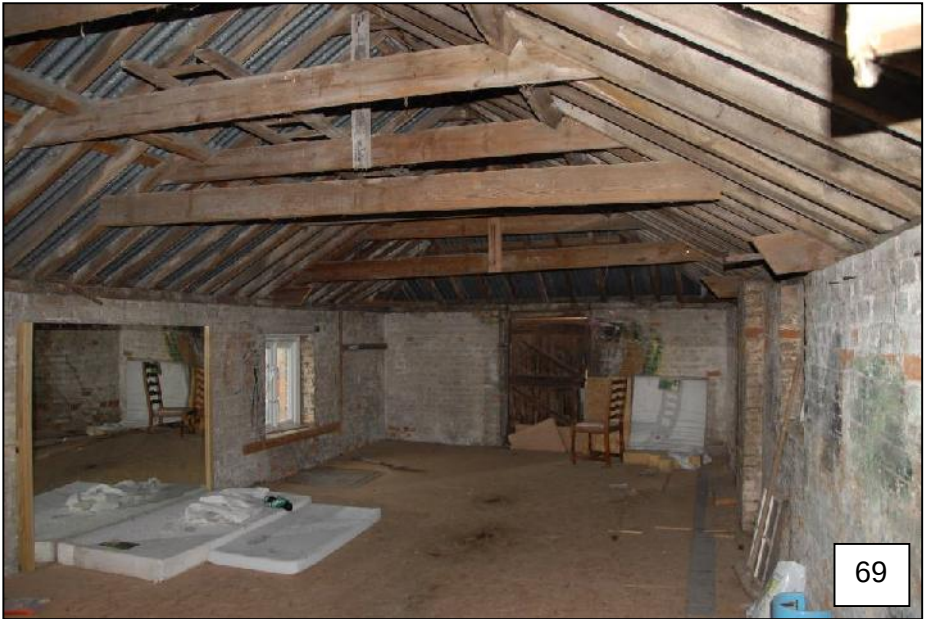
**First Floor  
Room 4 – Hay loft**

This is a large open room occupying the entire first floor of the outbuilding.

The modern access is up the timber steps from Room 3 at the east side of the room. Originally access was through the trap doors in Rooms 1 and 3 and through an original loading door at the west side.

The room is open to the exposed timber elements of the roof.

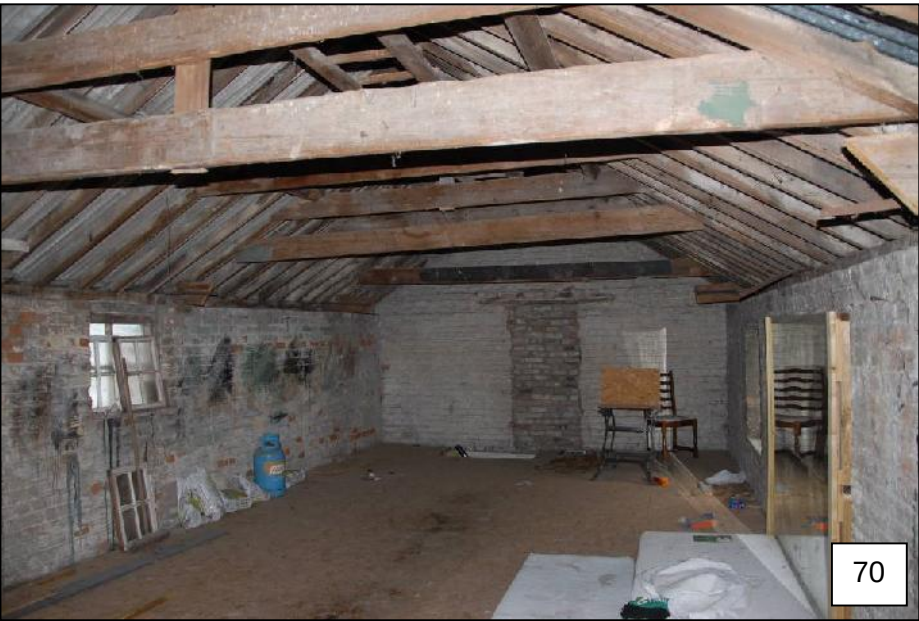
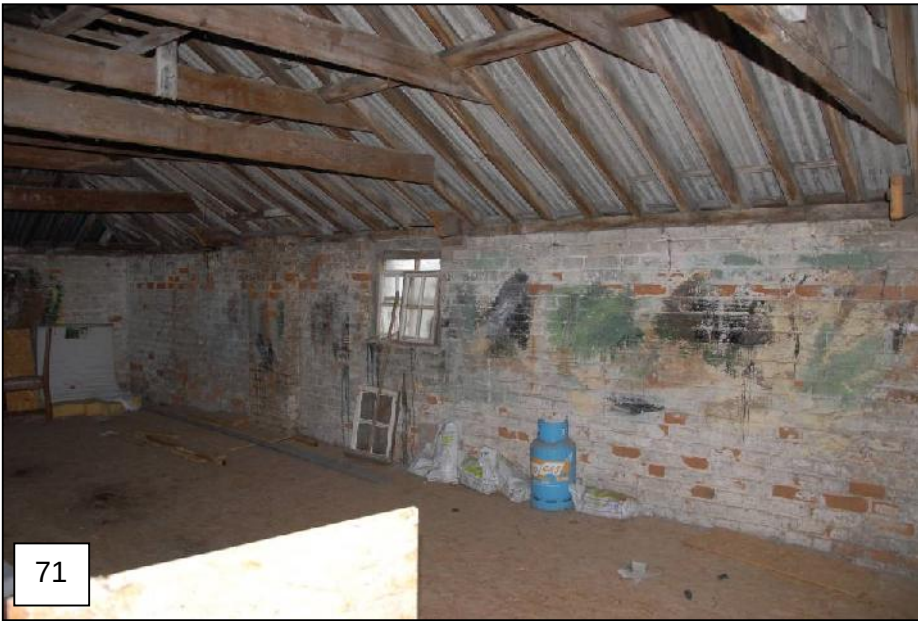
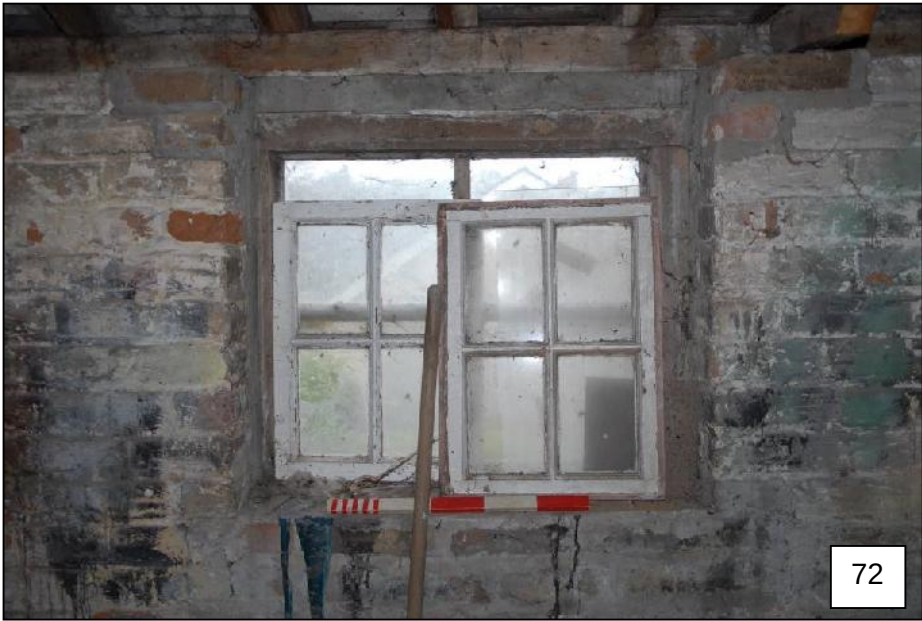
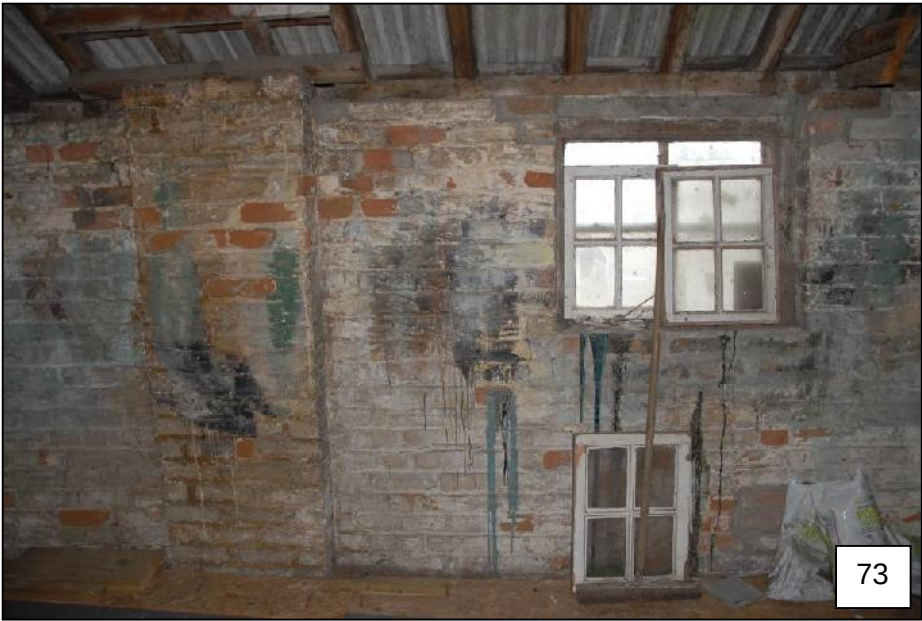
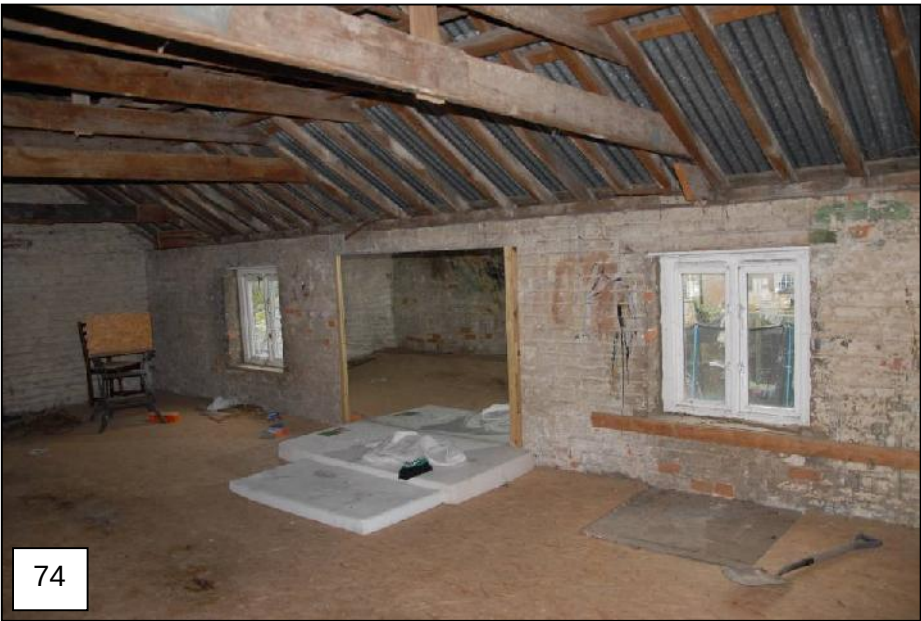
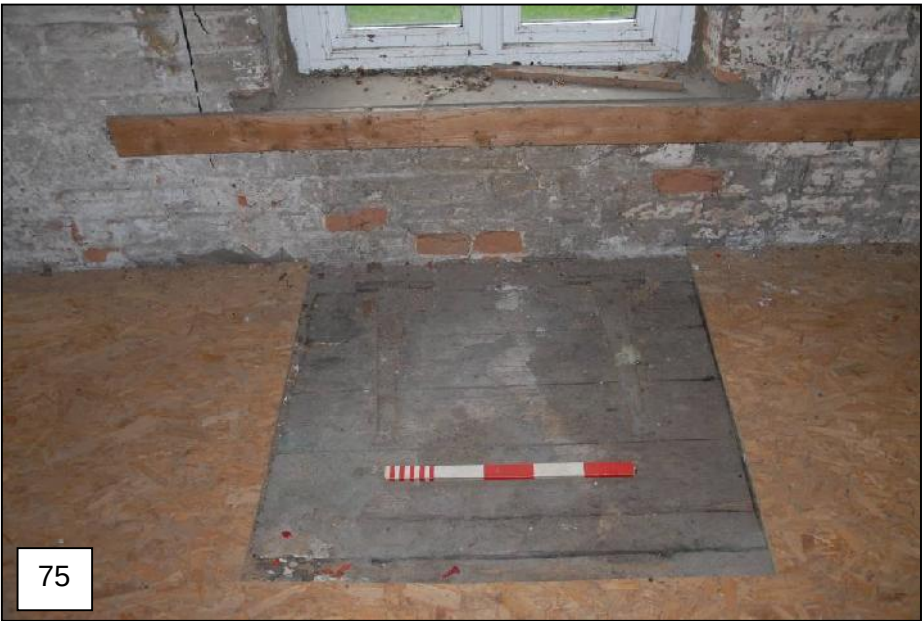
The room is lit by a 4-pane fixed window in the centre of the north wall and two windows in the south wall. The north window is not set squarely in a 2½" and 1" frame (chamfered with run-out stops). All exterior openings have 3¾" timber lintels.

The southern windows are replacement UPVC units.

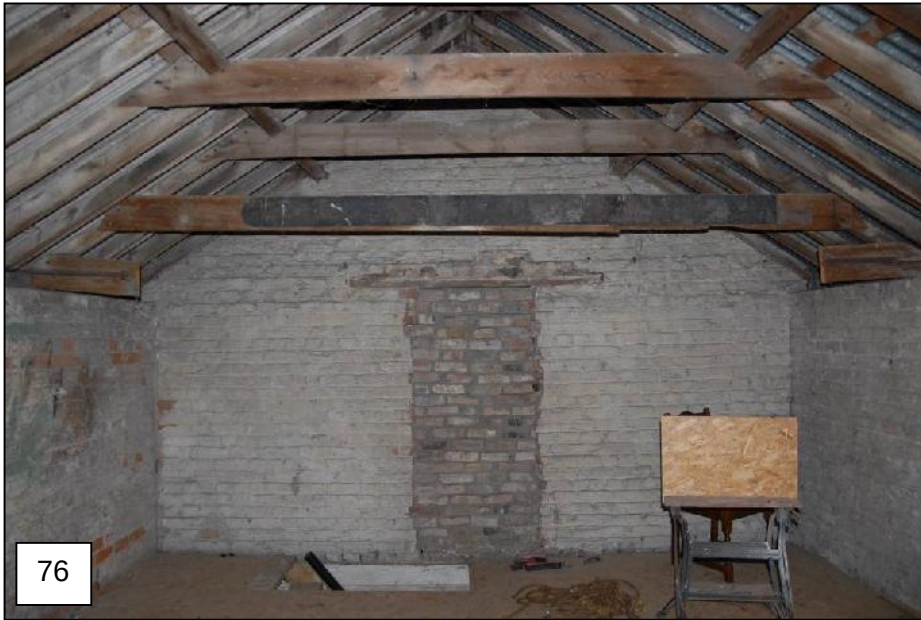
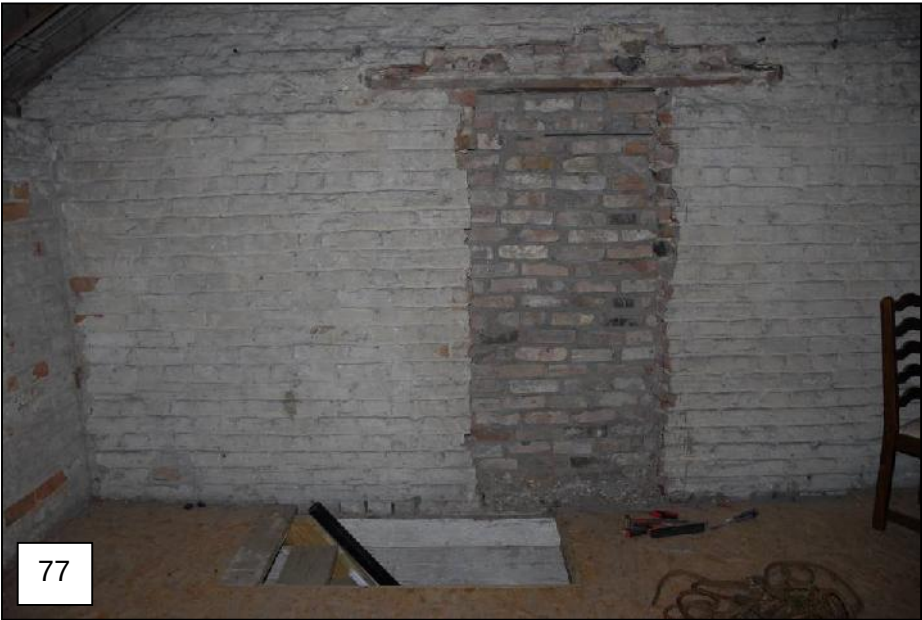
**East Side**

A central communicating door opening has been inserted in the east wall below a 1 3/4" timber lintel – this opening has been subsequently bricked up.

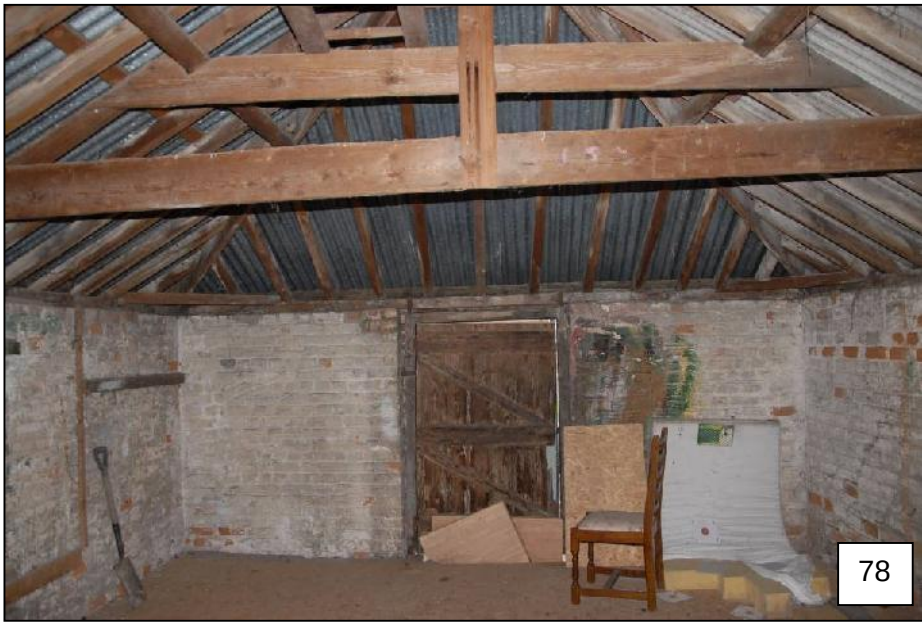
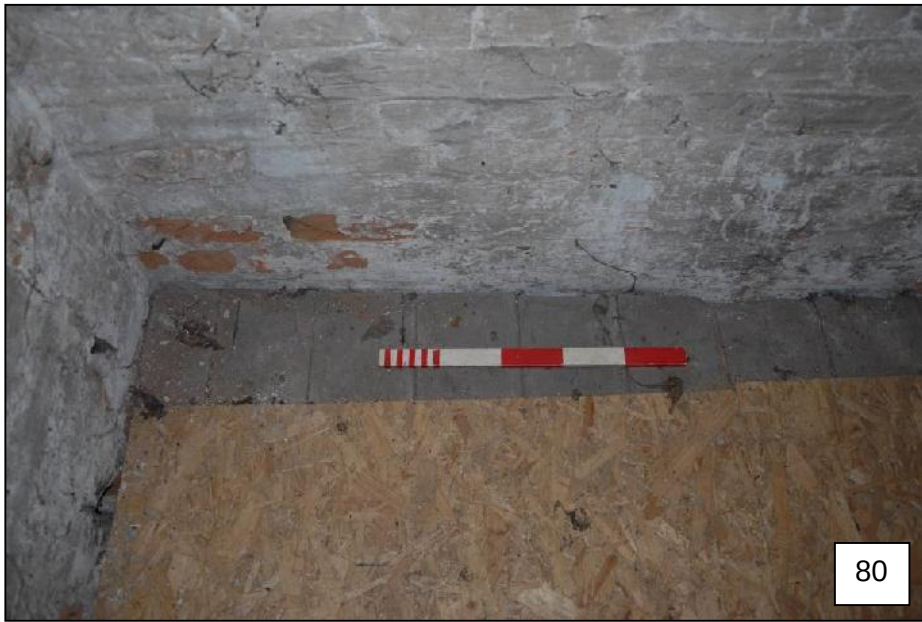
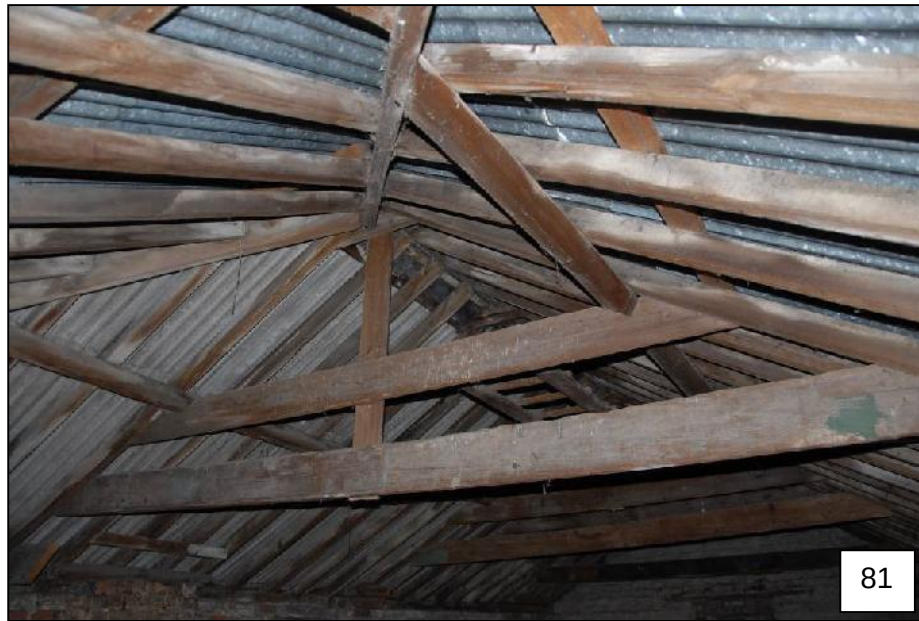
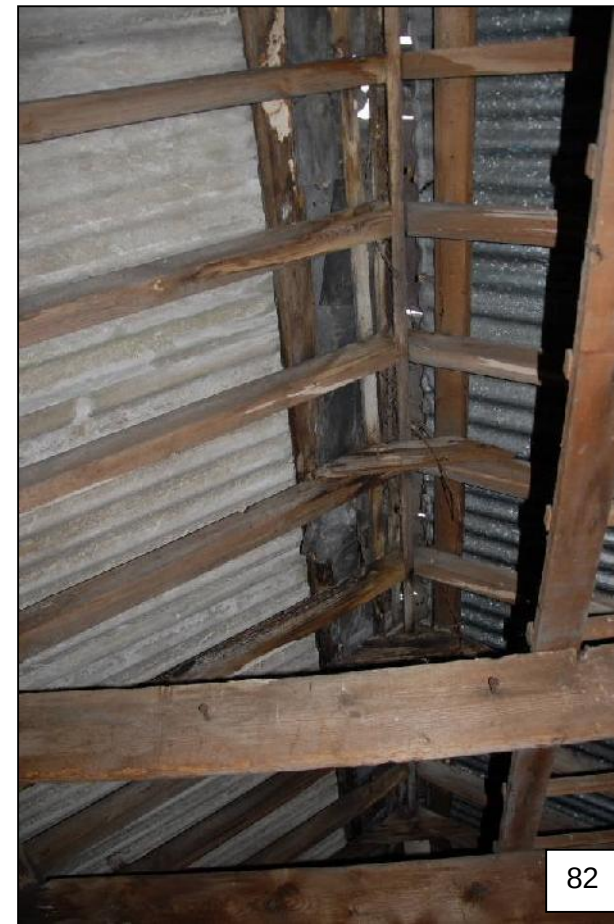
**West Side**

An original loading door at the west side retains a 5" x 3" frame situated immediately below the 3" x 4" wall plate. The door here is of ledged and diagonally braced 6 1/2" vertical tongue and grooved planks (ledges 5 3/4", diagonal braces 3").
