# OUTBUILDING TO REAR OF NO. 68, BRIDGE ROAD, SUTTON BRIDGE, LINCOLNSHIRE

## HISTORIC BUILDING SURVEY

Report prepared for G. R. Merchant Ltd.

December 2023

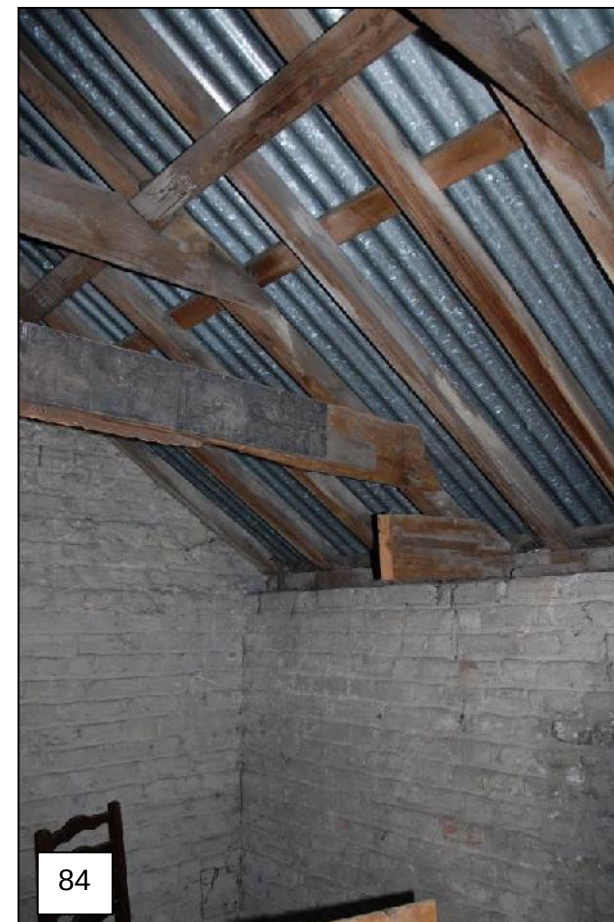
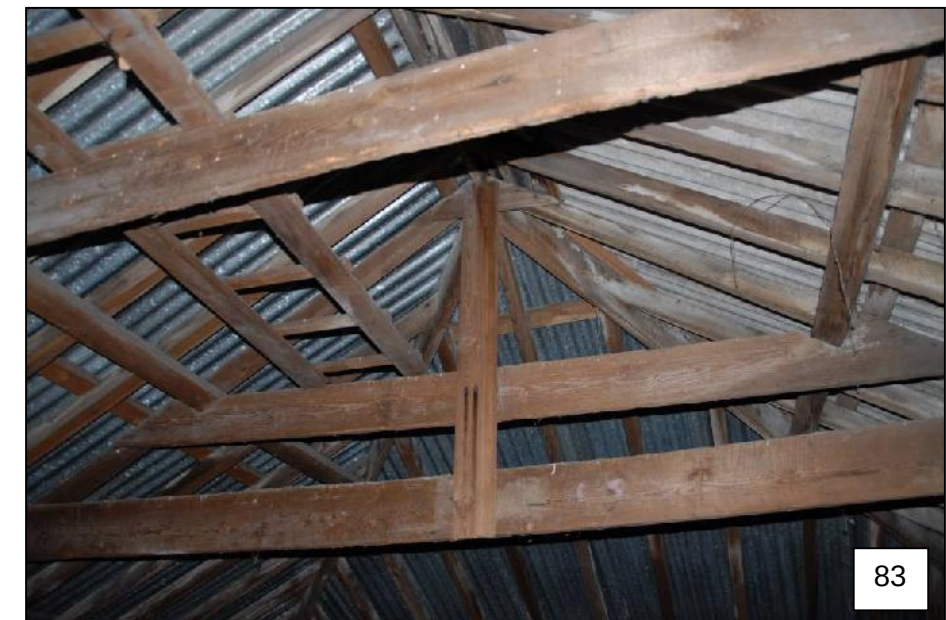
### Roof

The roof is of common rafter construction with ridge collars and a ridgeboard, hipped at the west end. The rafters are 3" square at 13" centres. The three original 7" x 2½" tie beams have been cut-off and replaced with raised 7" x 1¾" planks secured with vertical planks to the ridge collars. Collars are 6¾" x 1½". Horizontal elements are clenched straight-scarfed through-purlins 3¼-3½" square.

Collars occur every 3<sup>rd</sup> rafter and do occur at the ties. Ridge collars and a ridgeboard are present – the remains of an original slate roof are retained at the apex.

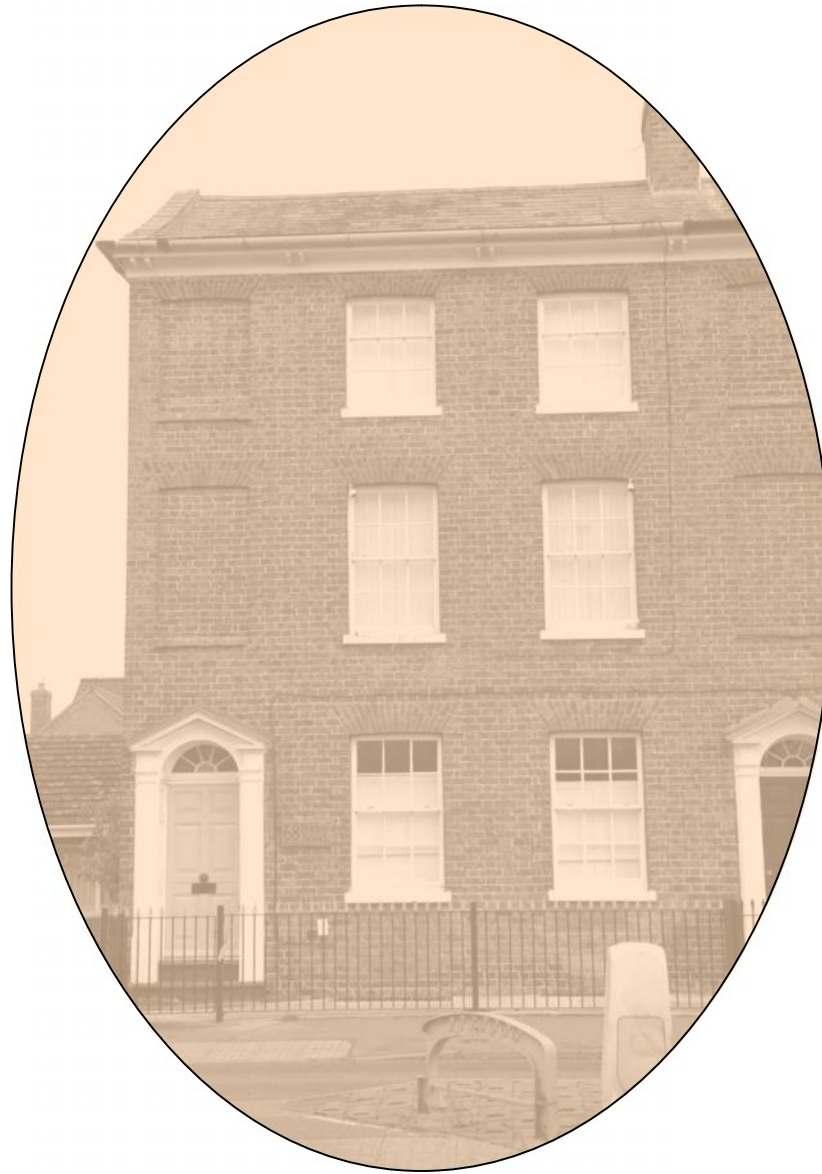
**Front Cover Photograph:** General view of the coach house/stable group from Wharf Street, looking SE.
