# OUTBUILDINGS AT THE OAKS, SUTTON S<sup>T</sup>. EDMUND, LINCOLNSHIRE

## HISTORIC BUILDING SURVEY

June 2019

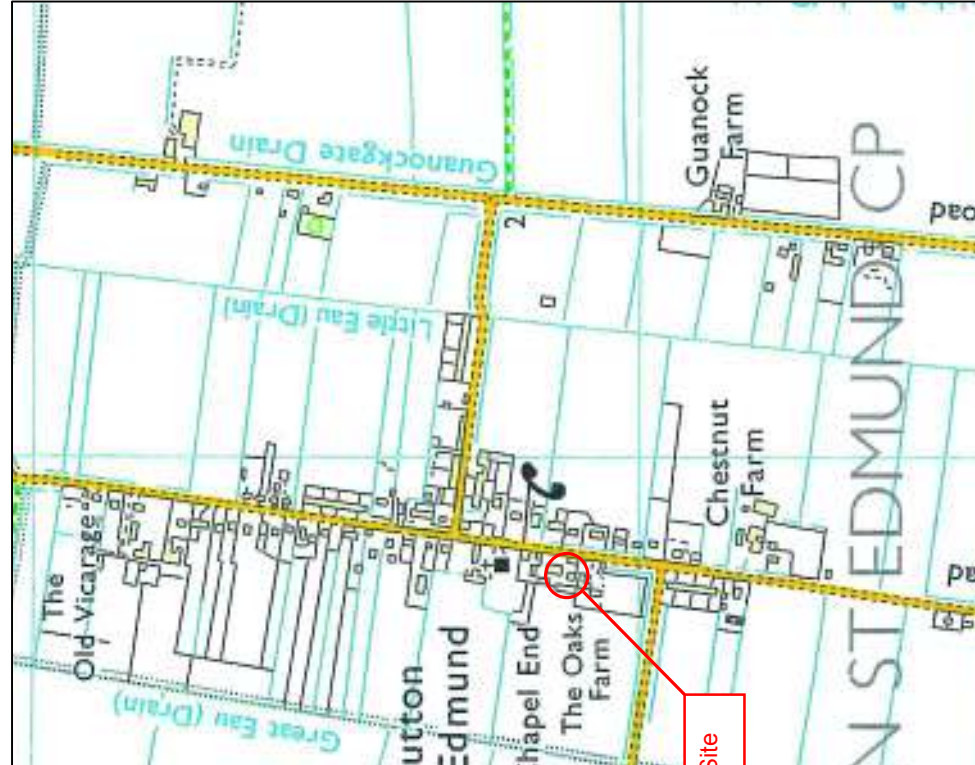
**Fig. 1: Site Location**  
at 1:12,500. The  
development site is  
highlighted in red

Edmund, Spalding, Lincolnshire. The site is centred on NGR TF 36815 13104.

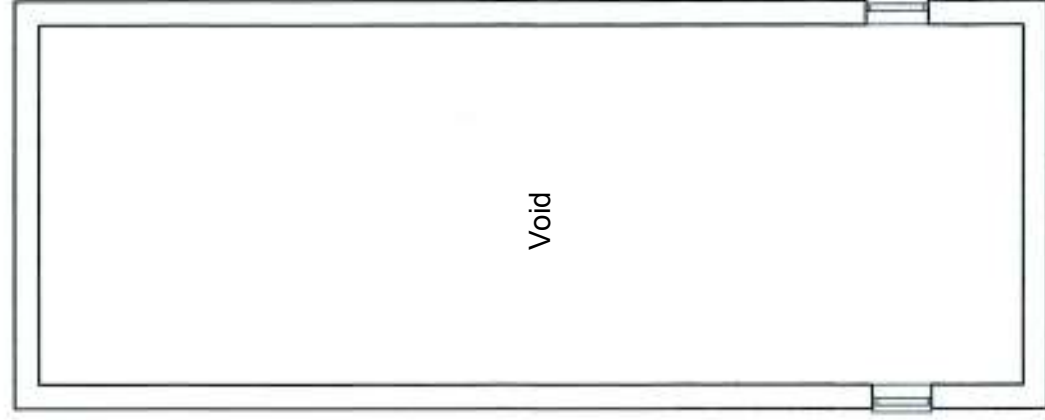
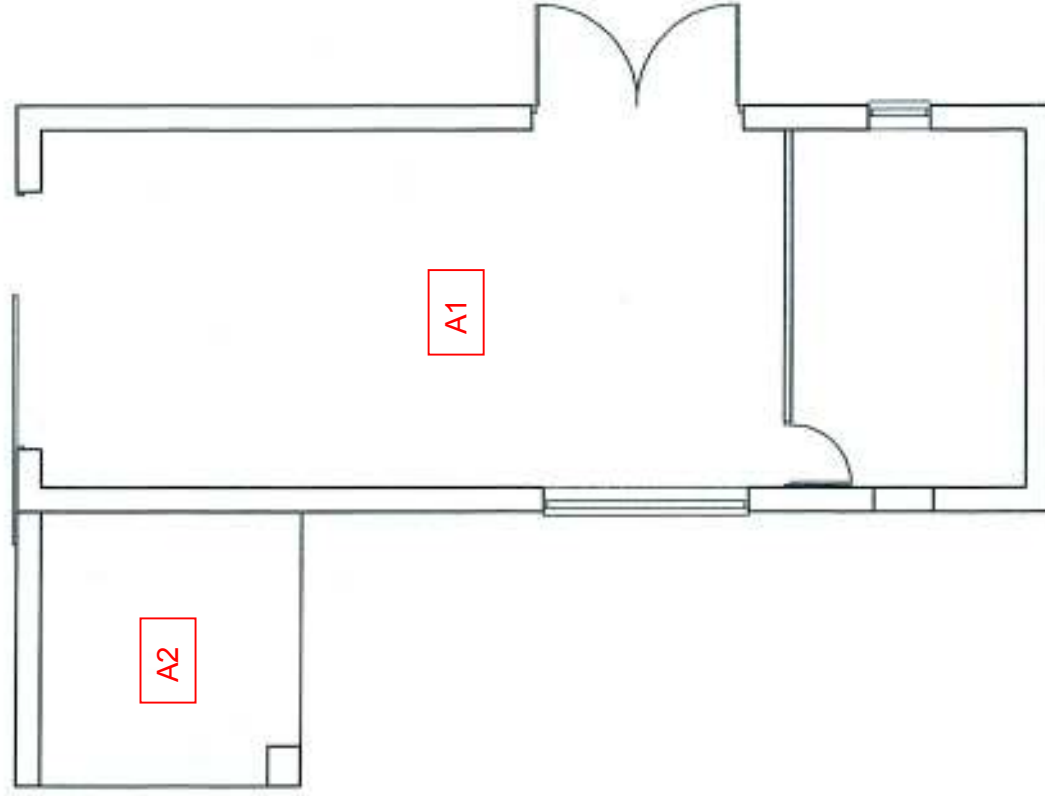
Figure 8: Floorplans of Building

FIRST FLOOR

GROUND FLOOR

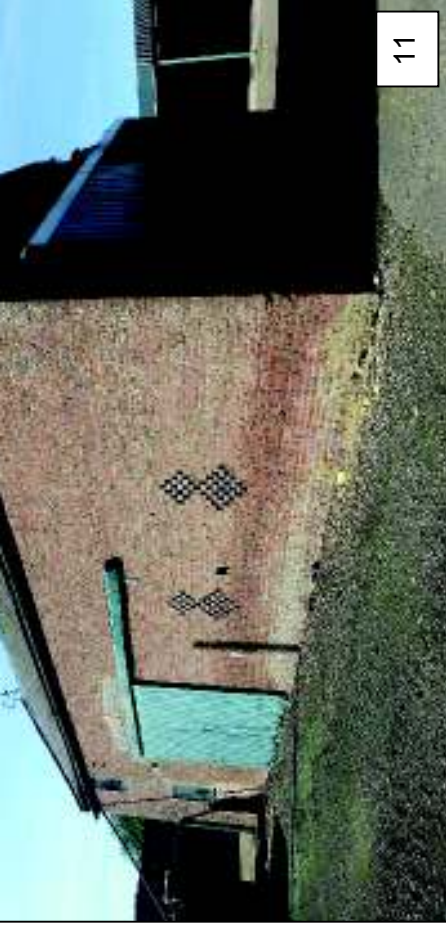
11

The main elevation of the building and is of red and orange brick. The original large threshing-door opening is located to the south of the centreline of the building and modern sliding doors were present here.

Double diamond vents were present in the north of the threshing doors, while windows had been inserted at ground and first floor levels at the south side.

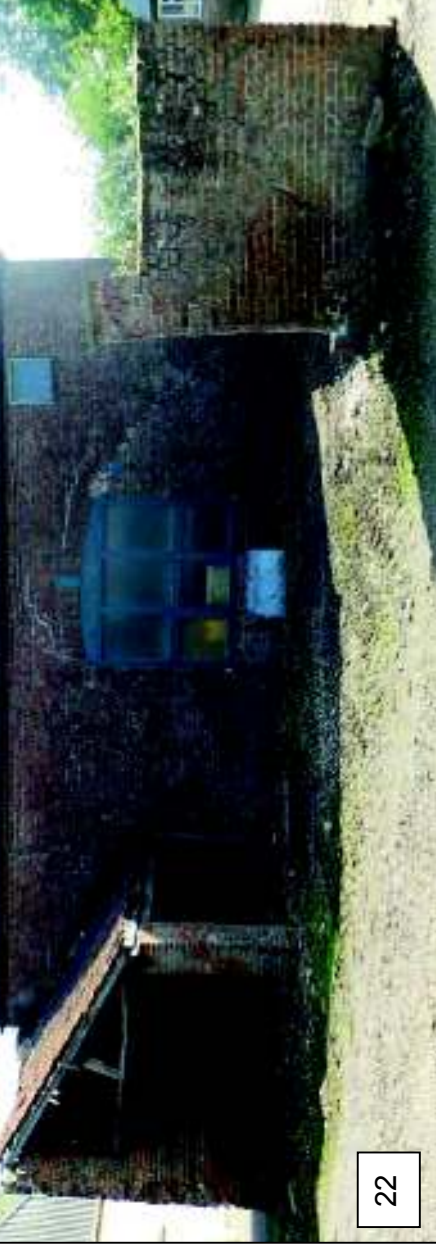
22

building (threshing floor) b  
A brick roof was present a  
concrete floor otherwise prese  
floor storage platform was pre  
part of the building, to the so  
door openings.

The roof was of slate with  
supported off two king-post  
square, adzed. The wall-plat  
timber with rafters occurring at  
straight-scarfed purlins were r  
sawn timber.

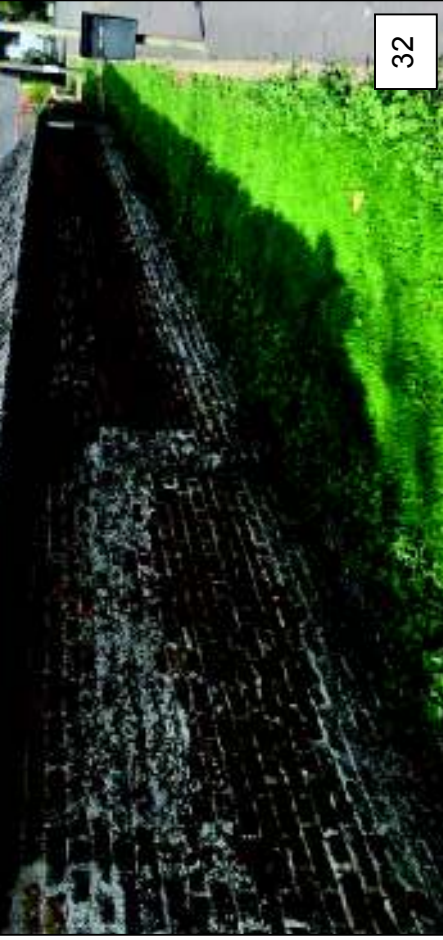
32

bays had packed earth floors with a concrete floor south bay only (Room B3). The interior was some bitumen present in the lower walls.

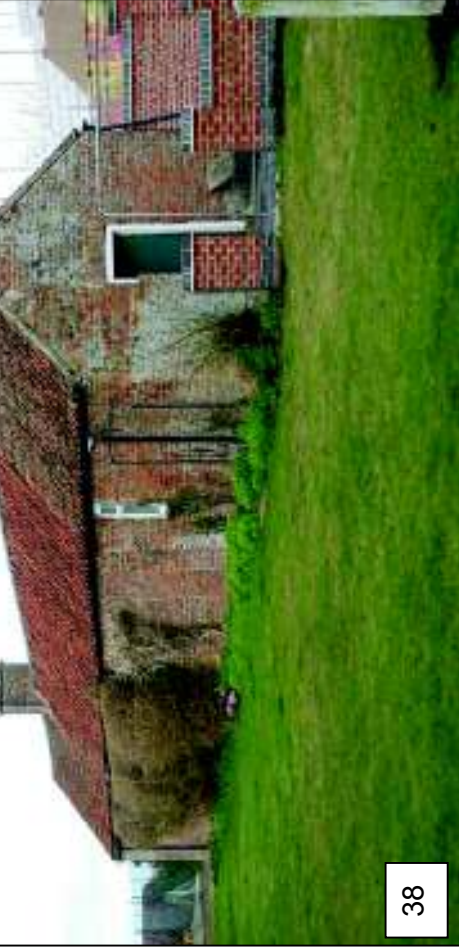
38

is built of red  $2\frac{3}{4}$ " brick, 3C= $8\frac{3}{4}$ ", in 3-course Wall bond.

early a modern insert at the east side. Plank to the interior below segmental brick lintels, tie-rod endplates corresponding to internal tie-rods are also evident.

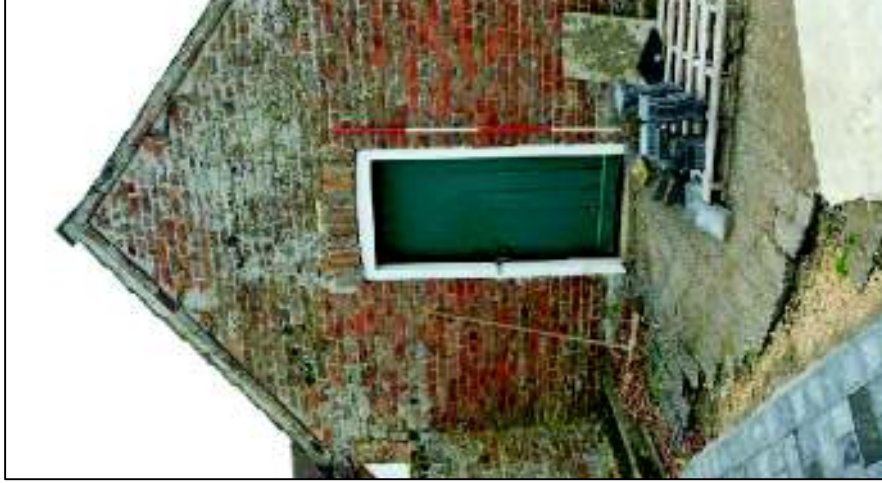
The east elevation has a central conventional door with a segmental soldier lintel. It is built of similar brick to the north side in 3-course English Garden Wall bond.

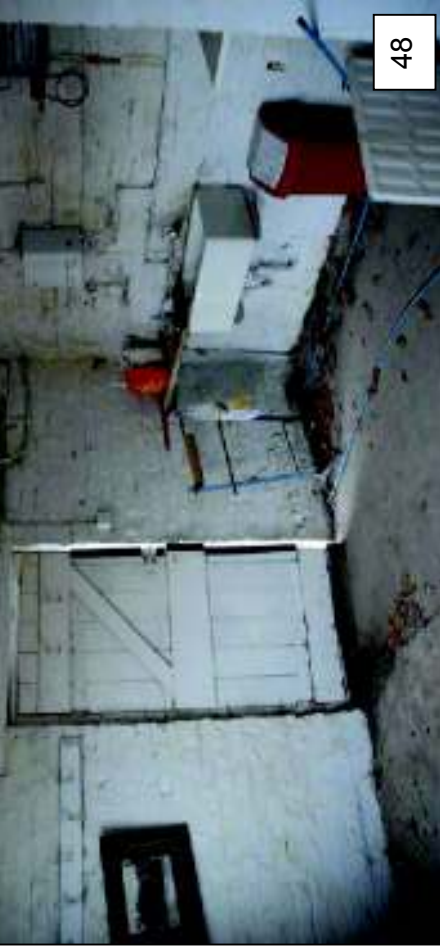
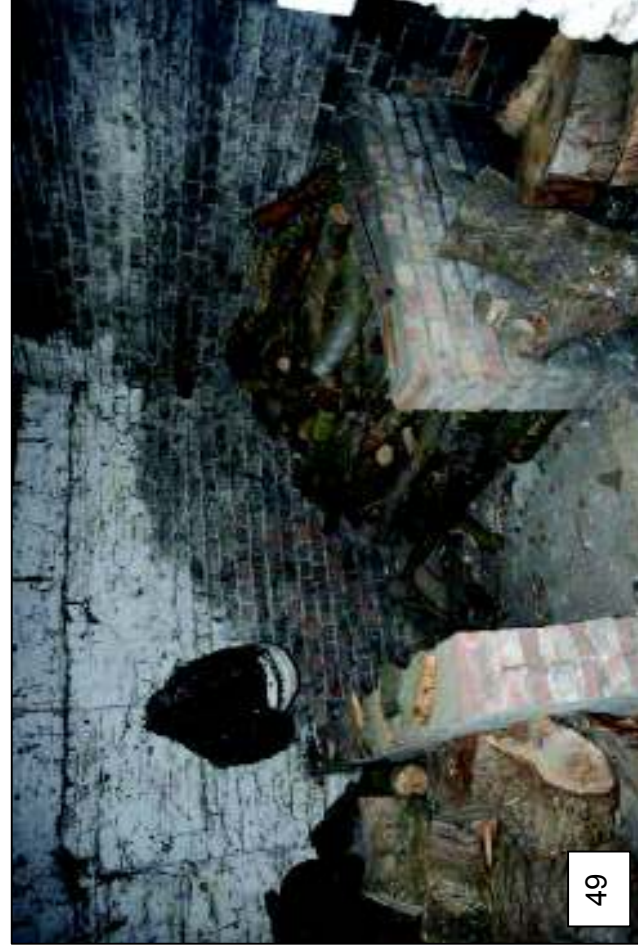
Building C

were of whitewashed brick; the floor of more recent 9" brick partition (LBC) is the SW corner, 35" high – perhaps a recent use as accommodation for pigs. As exposed here, roof is collar-principal a ridgeboard and ridge collars, the main in offset from the ties – frequently every fifth rafter. Ties are 5" x 2 1/2", 1 1/2". The entire roof is in sawn timber.

Rooms 2 and 3 are of ledged and braced vertical planks, here re-used 7 1/2" grooved floorboards.

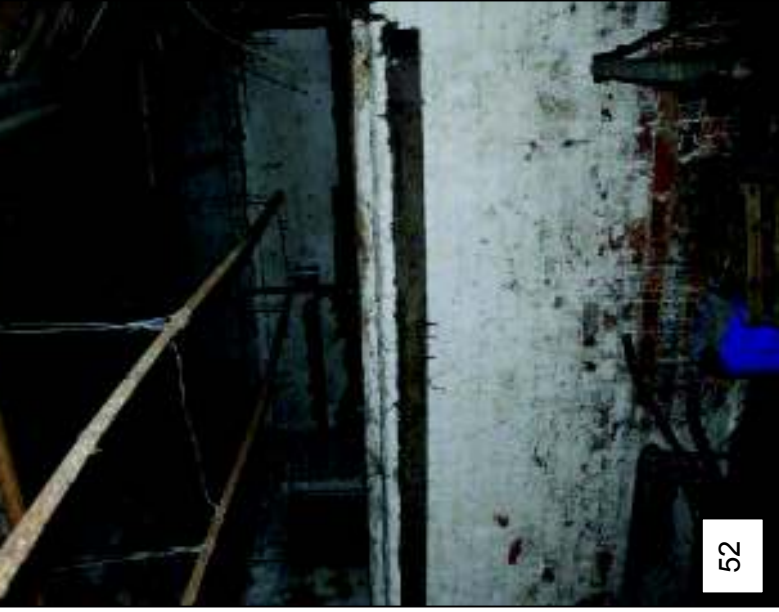
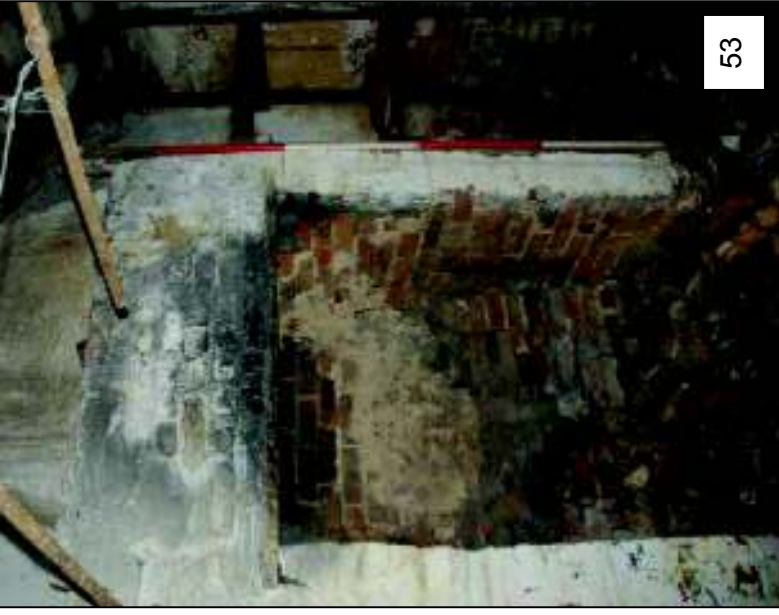
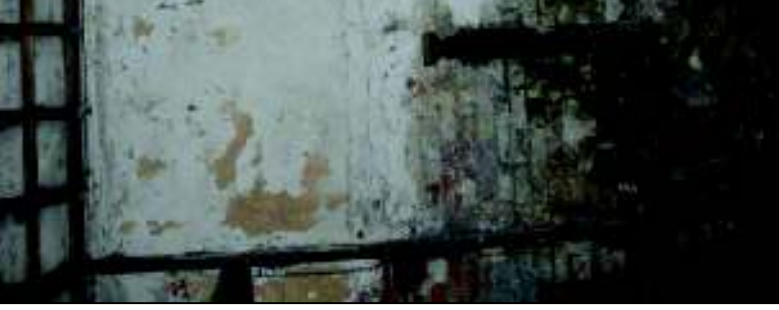
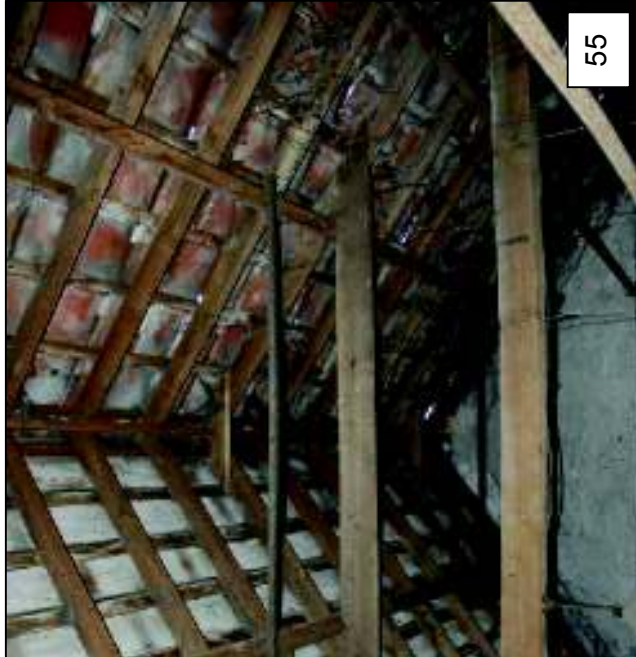
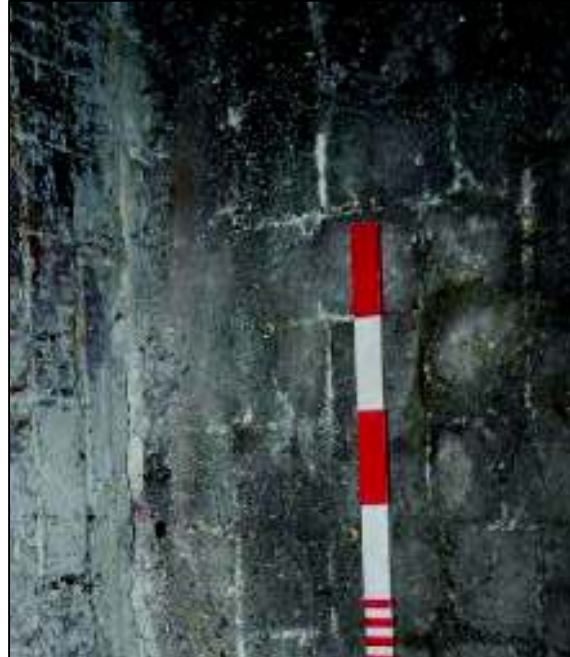
**Room C3**  
Room C3 was divided by a central north-south brick partition, 63" high. The eastern bay was a log

present between the laths (below

smoke darkening below the hood

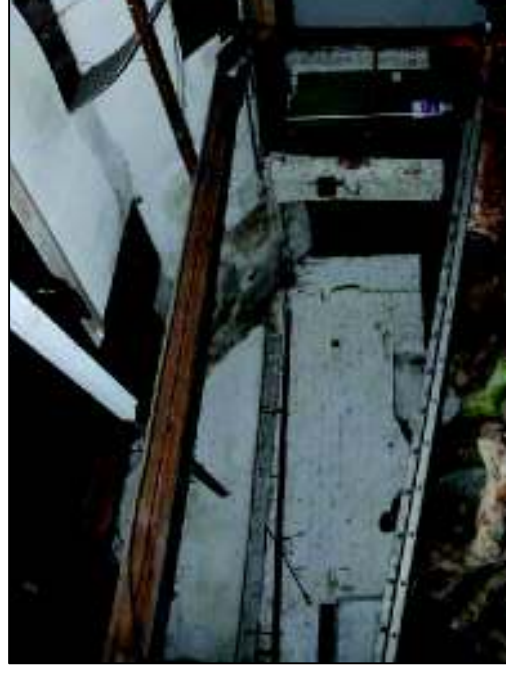
### Room C4

Room C4, converted to a two-bay traphouse, occupied the western part of the building.

This room had a concrete floor and part hardboard ceiling. A composite sliding door was present in the enlarged northern opening.

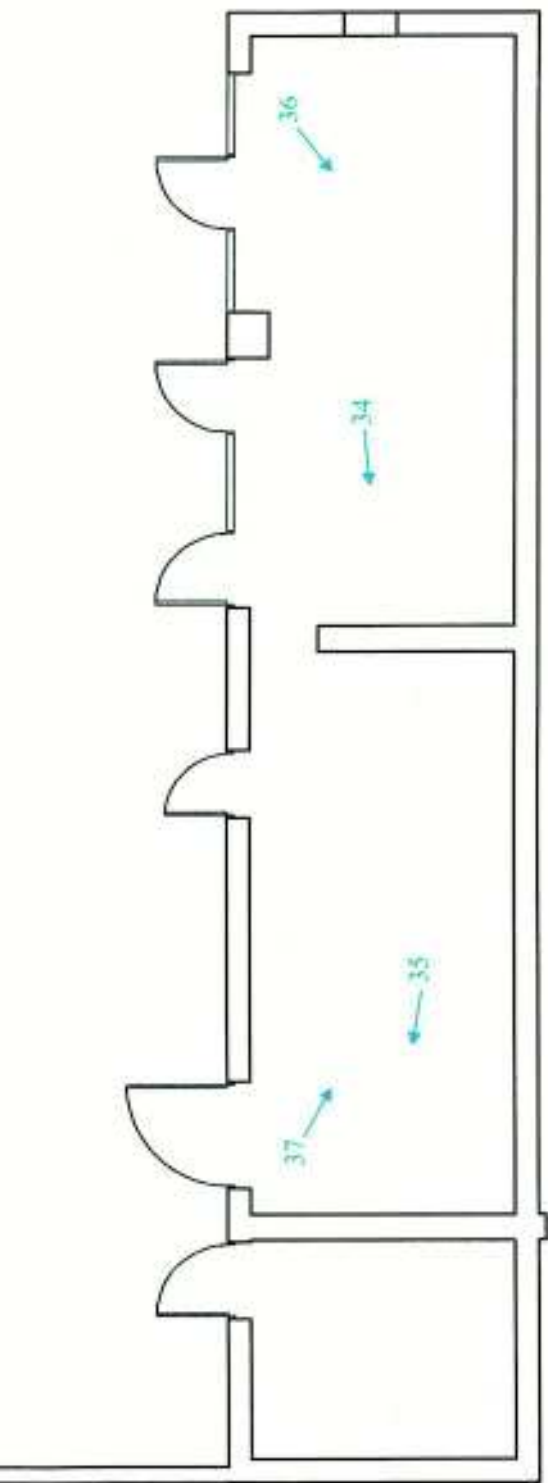
Floor plan of Building B at scale 1:10  
The position and direction of interior  
detail photographs is shown in blue.
