**PROPOSED RESIDENTIAL  
DEVELOPMENT  
THE OAKS  
215 BROADGATE  
SUTTON ST EDMUND  
SPALDING**

**GEOENVIRONMENTAL  
DESK STUDY**

**Report Ref.: 0346/1**

February 2016

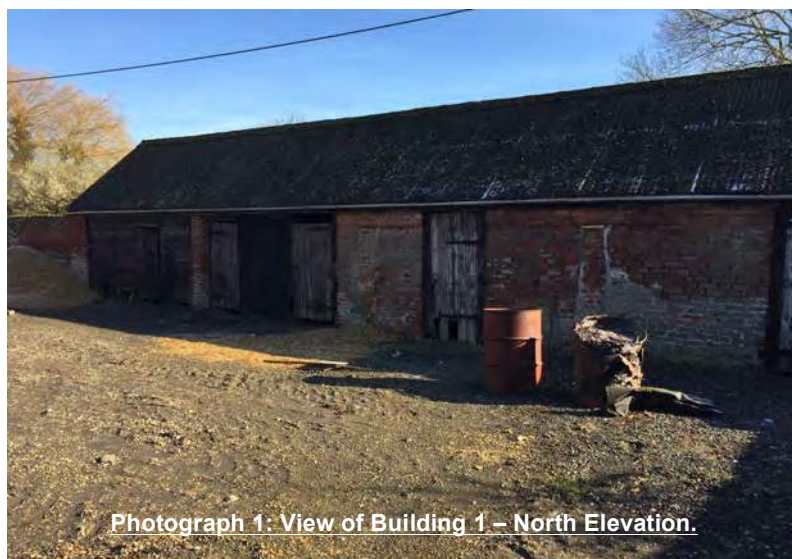
Photograph 1: View of Building 1 – North Elevation.

Long, rectangular, and fronting the public highway this building was of brick and timber construction with a roof of corrugated panelling as shown in Photograph 1 and 2 below.

As can be seen from Photograph 1 the building was subdivided internally with separate pedestrian accesses in the northern elevation into the various rooms. This building was empty with the exception of occasional disused work benches. There were no specific features of note within this structure in the context of land quality.

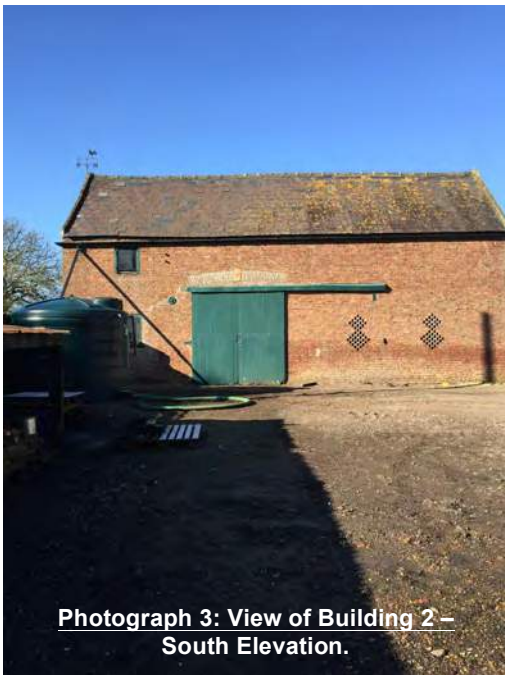
Photograph 3: View of Building 2 – South Elevation.

This building was located towards the approximate site centre, two-storey in height, with a lean-to addition on its northern side, and constructed from brick and timber with a tiled roof over a concrete slab floor, as can be seen in Photograph 3 below.

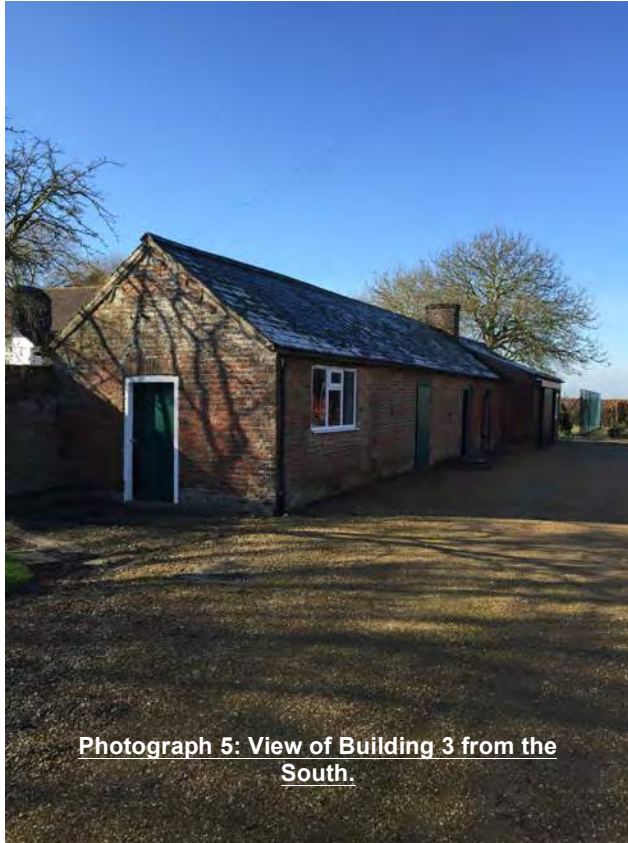
**Photograph 5: View of Building 3 from the South.**

Building 3 was located in the southern part of the site and is shown in Photograph 5.

Also constructed from brick with a tiled roof and internally divided as can be seen by the doors in Photograph 5.

The pedestrian door shown in Photograph 5 lead to a small 'rest' area which contained chairs and a microwave cooker and a television set with tea and coffee making facilities. It was understood this room was used by farm workers at break and lunch times.

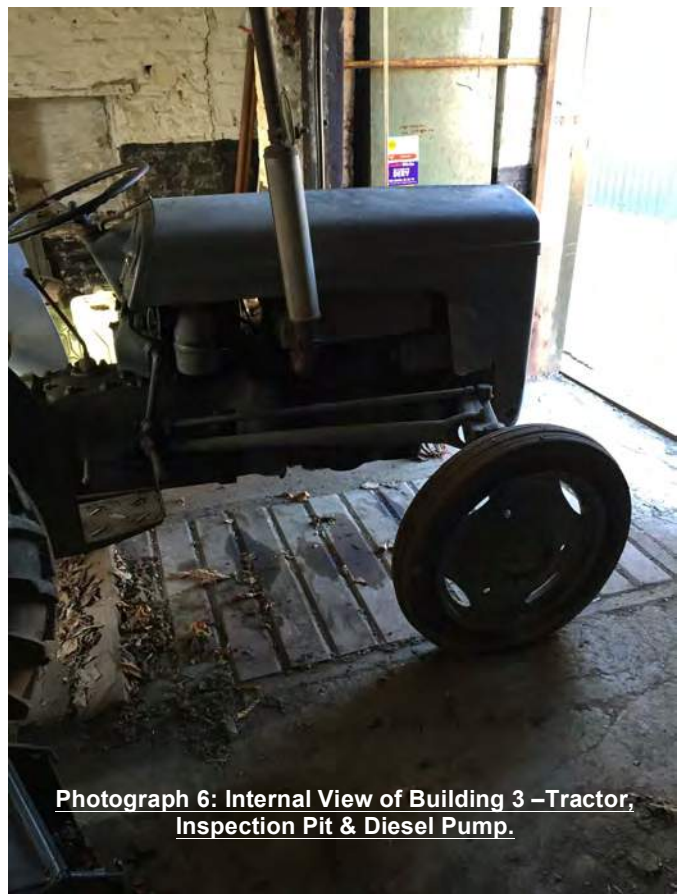
**Photograph 6: Internal View of Building 3 –Tractor, Inspection Pit & Diesel Pump.**

Other parts of this structure appeared to be empty except however, the northern end which contained a small tractor parked over an inspection pit as shown in Photograph 6.

The reader will also note in the background of Photograph 6 (on the right) a green tank.

This contained 'road diesel' ('DERV'), and a dispensing pump was also installed on the wall on the left hand side of the tank.

A small diesel tank and dispensing pump was noted in Building 3. It is assumed by this Author that this feature will be removed off site in the early stages or prior to commencement of the development. It is considered unlikely that the staining has penetrated the concrete slab and impacted the underlying soils.

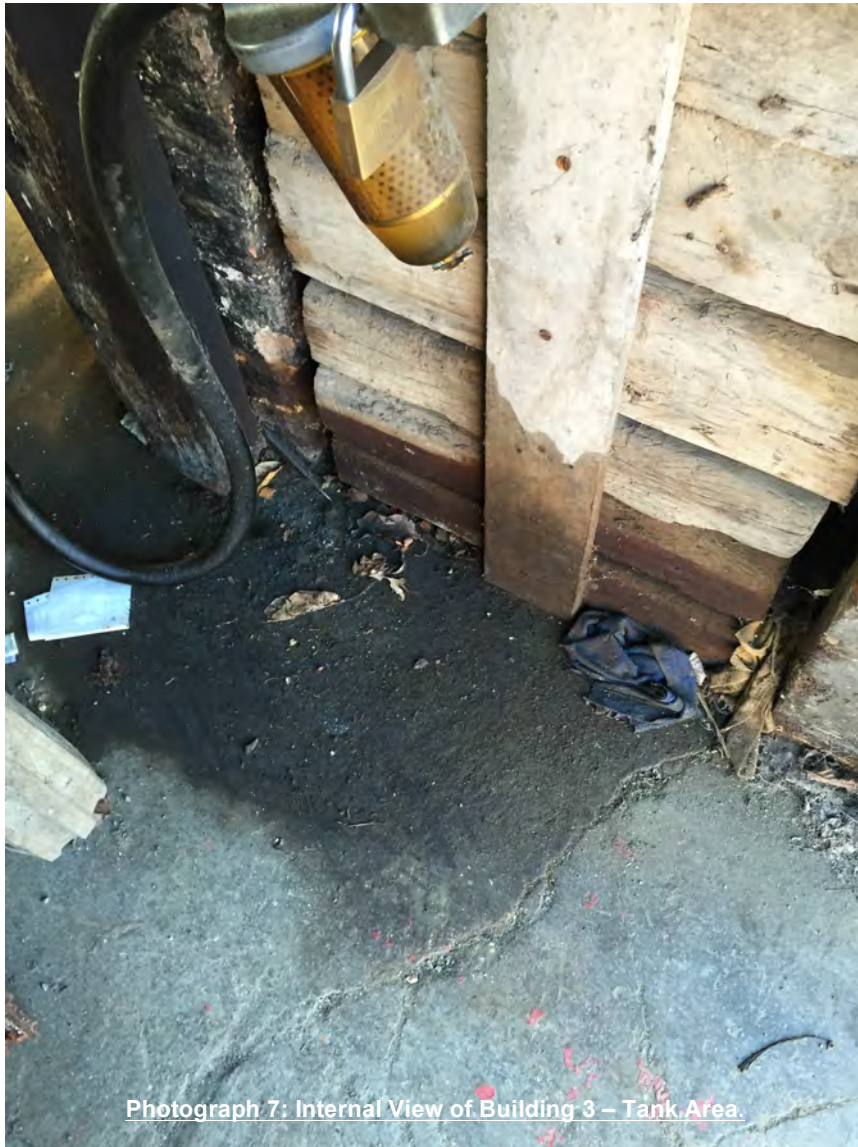
Photograph 7: Internal View of Building 3 – Tank Area.

The floor in this part of the building close to the tank was stained with hydrocarbons. This area of staining was very localised to the base of the tank as can be seen in Photograph 7 overleaf.

In the three buildings inspected as part of the walkover survey only the area by this tank showed any evidence of 'contamination'. While some weathering of the concrete surfaces can be seen in Photograph 7 it is reasonably asserted by this author that the underlying soils in this area are unlikely to have been impacted by the hydrocarbon stains seen as the cracking and crazing was not considered 'severe' or 'advanced' enough to open a plausible pathway to the underlying soils.

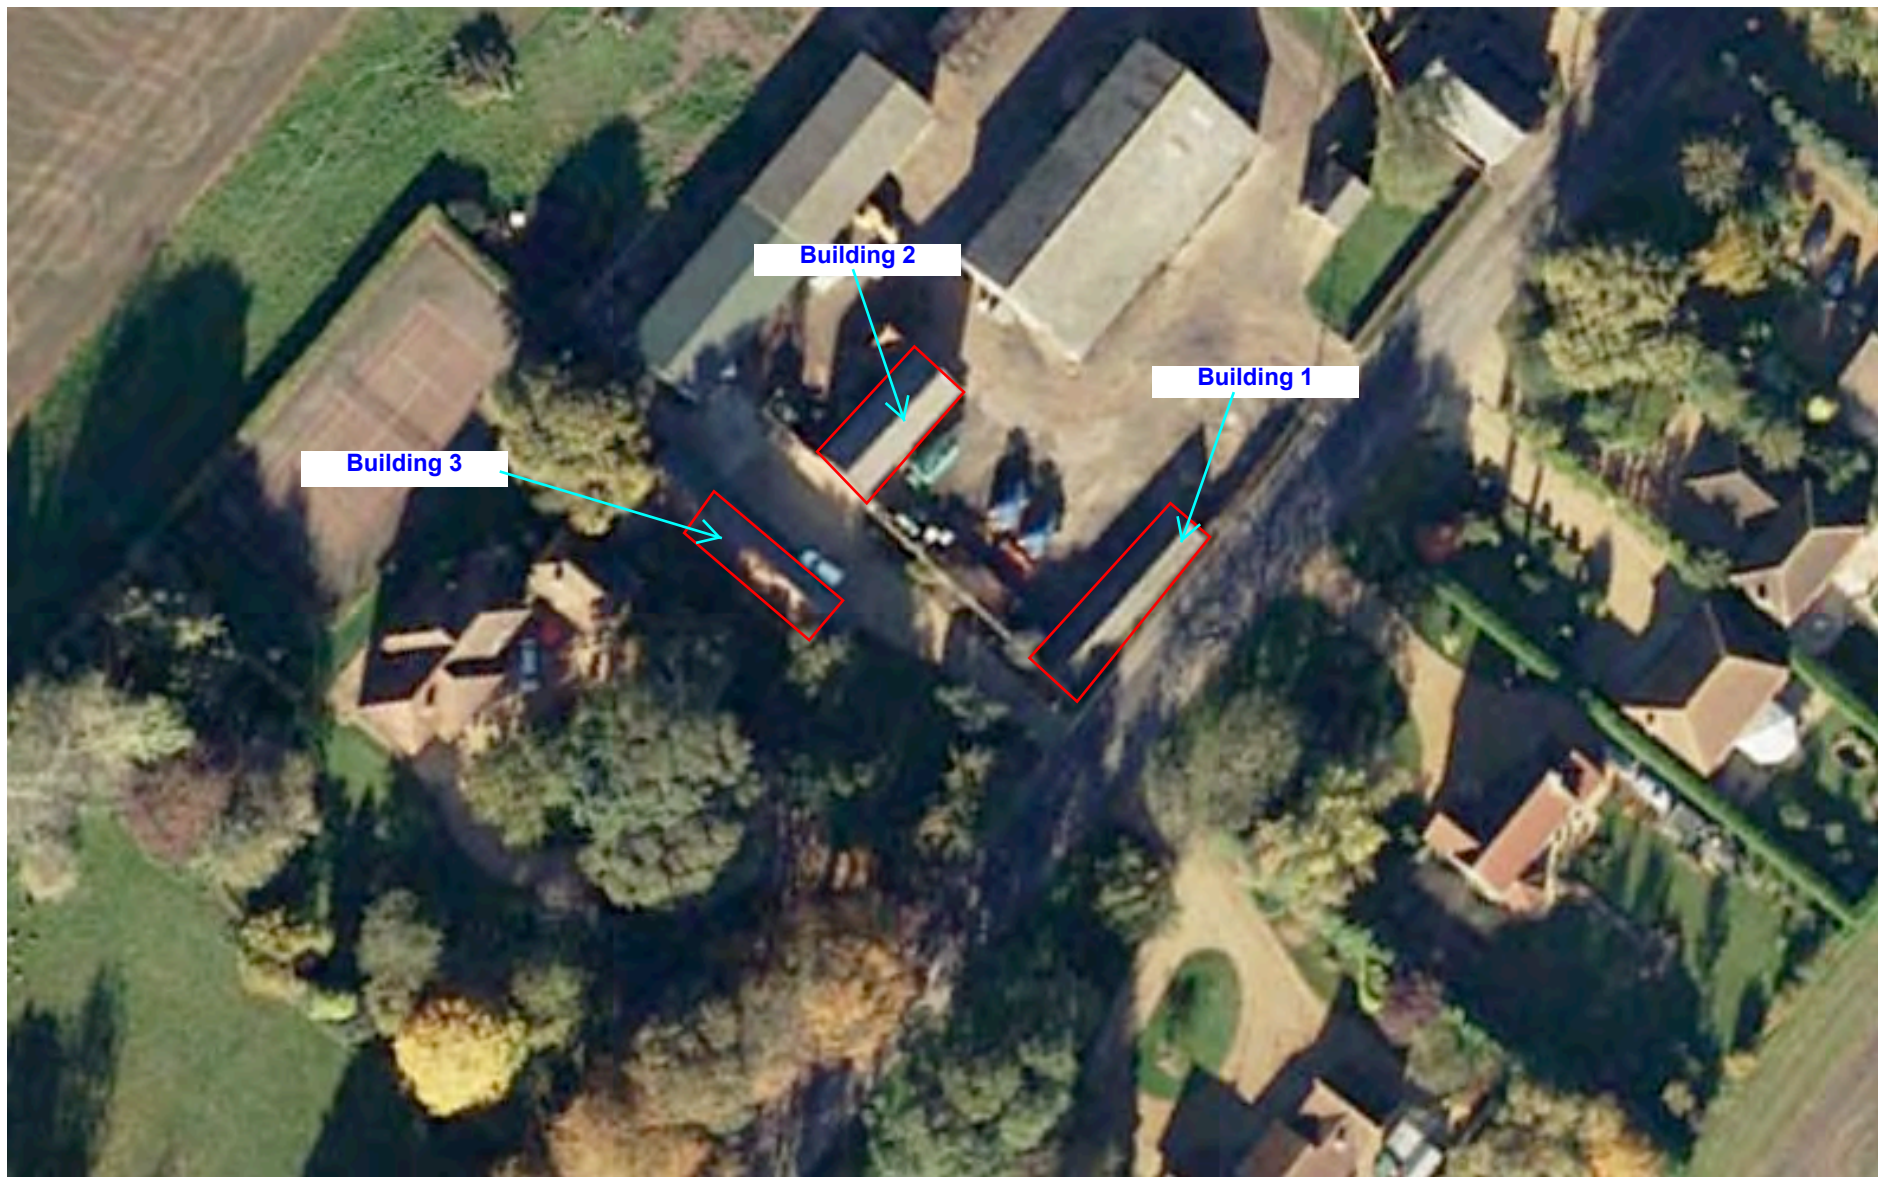
Aerial Plan (2006)

At the time of the site walkover survey the site was almost entirely capped with 'hard' surfacing which included the footprints of the three buildings present at the site. For the purposes of clarity the buildings have been described as 'Building 1', 'Building 2' and 'Building 3' as shown on Figure 2 (Aerial Plan (2006)) towards the back of this report.
