# **GEO-ENVIRONMENTAL PHASE 2 INVESTIGATION**

**LAND WEST OF BANK HOUSE FARM**

**SOUTH EAU BANK  
THROCKENHOLT  
PE12 0QW**

**Report No.: 9698076-R02**

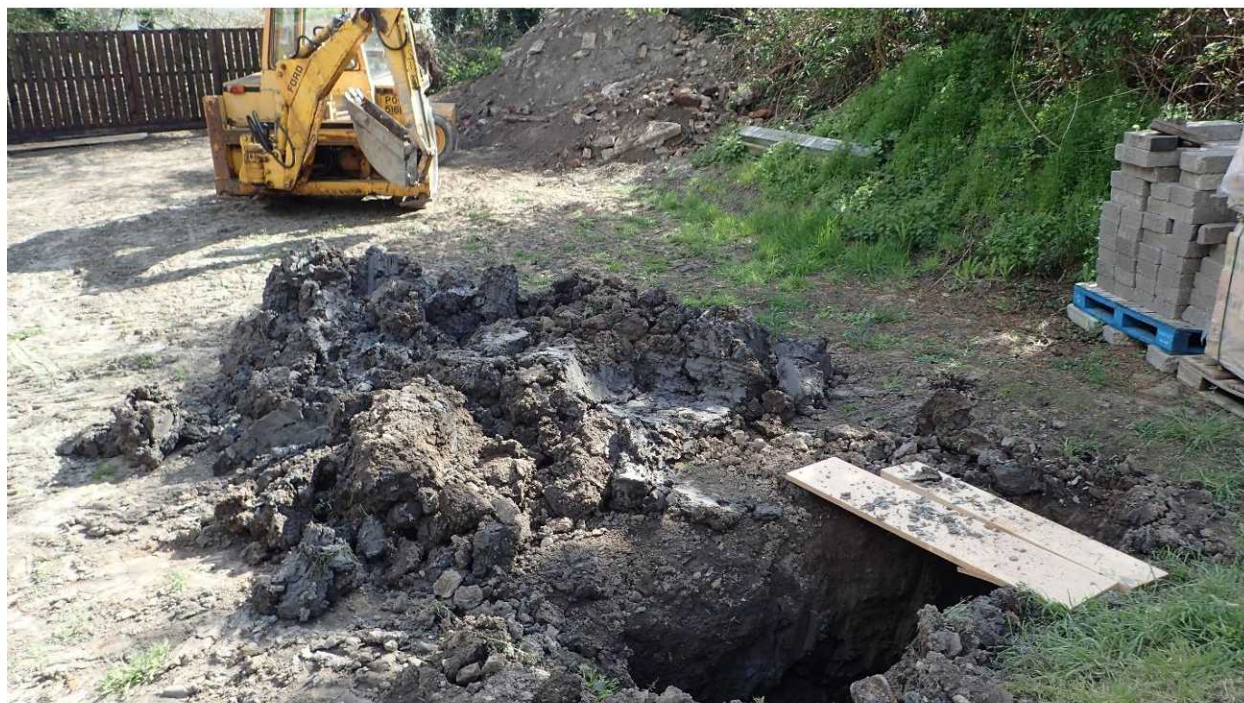
| Location Reference and Rationale | | Method | Max Depth (bgl) | Strata Descriptions |
|---|---|---|---|---|
| <b>TP1</b> | A ca. 3m excavation had been formed at the south of the plot to allow geotechnical inspection by others. Samples were taken from its sidewall both at and 0.6m below the surface. Future garden. | <b>Open Trial Pit</b> | ~3m | Stiff brown becoming grey CLAY (TIDAL FLAT DEPOSITS) |

As suggested at the surface since reduction of site levels by around 0.4m, stiff clay was encountered in all exploratory locations, and could be seen to extend to depths greater than 3m in the open deep trial pit.

With reference to the potential ground gas risk identified in the desk study, the presence of a deep trial pit on site enabled inspection of the ground profile to a significant depth. Inspection confirmed the Tidal Flats (alluvial) Deposits, as observed in the excavation walls and arisings pile, to consists of stiff, low permeability clays, with no silt, rootlets of general organic matter of note.

*Photo 1 – Trial Pit 1*

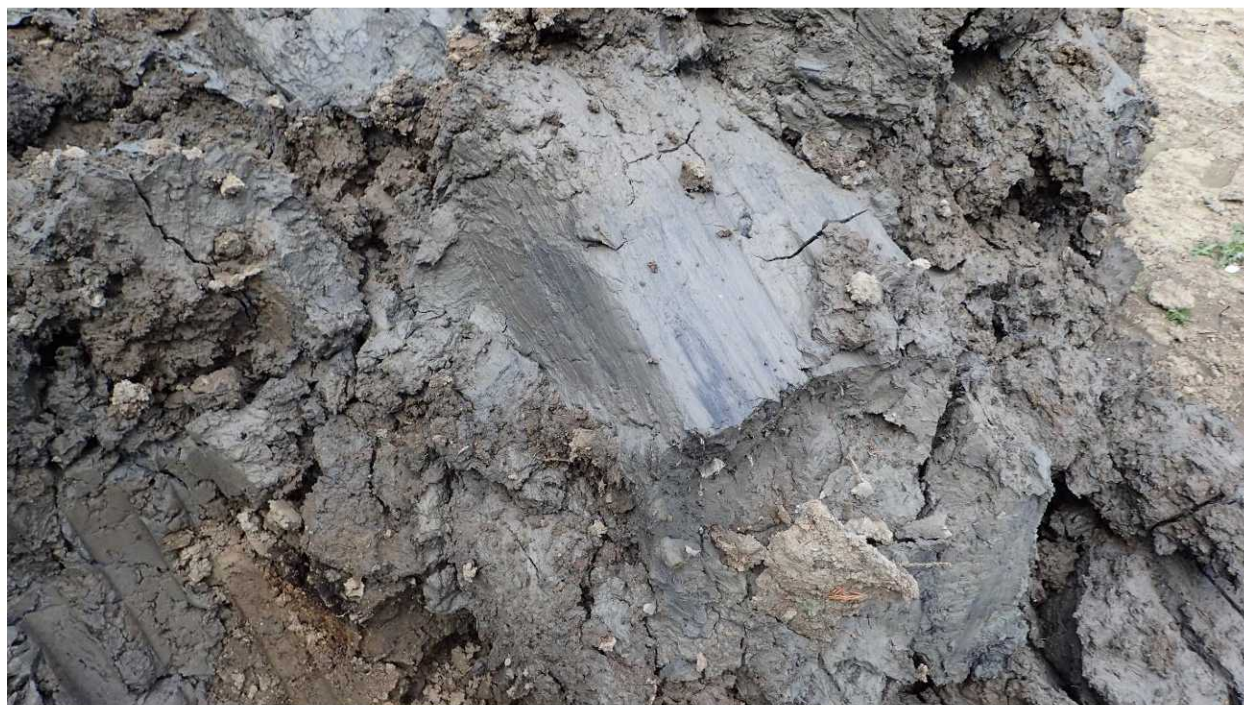
*Photo 2 – Trial Pit 1 Arisings*

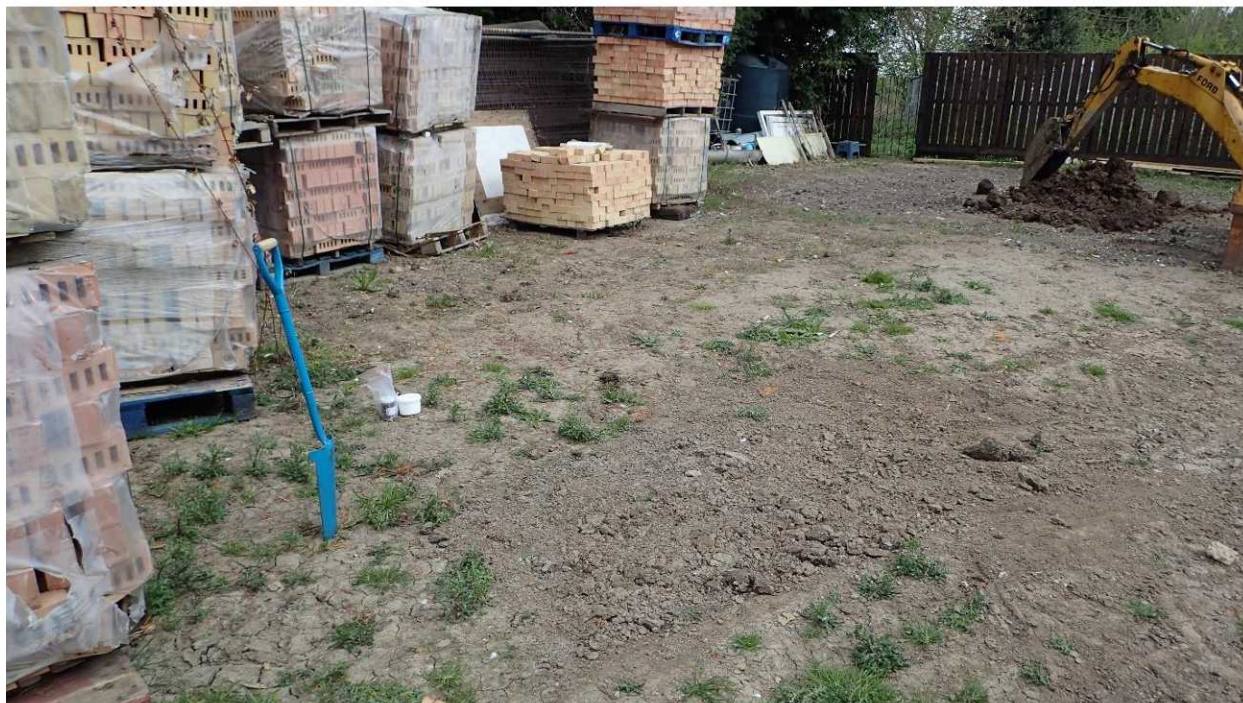
| Location Reference and Rationale | | Method | Max Depth (bgl) | Strata Descriptions |
|---|---|---|---|---|
| <b>HP2</b> | Surface soil at the west of the plot. Future garden. | <b>Hand Pit</b> | 0.15m | Stiff brown CLAY (TIDAL FLAT DEPOSITS) |

*Photo 3 – Hand Pit 2 Location*

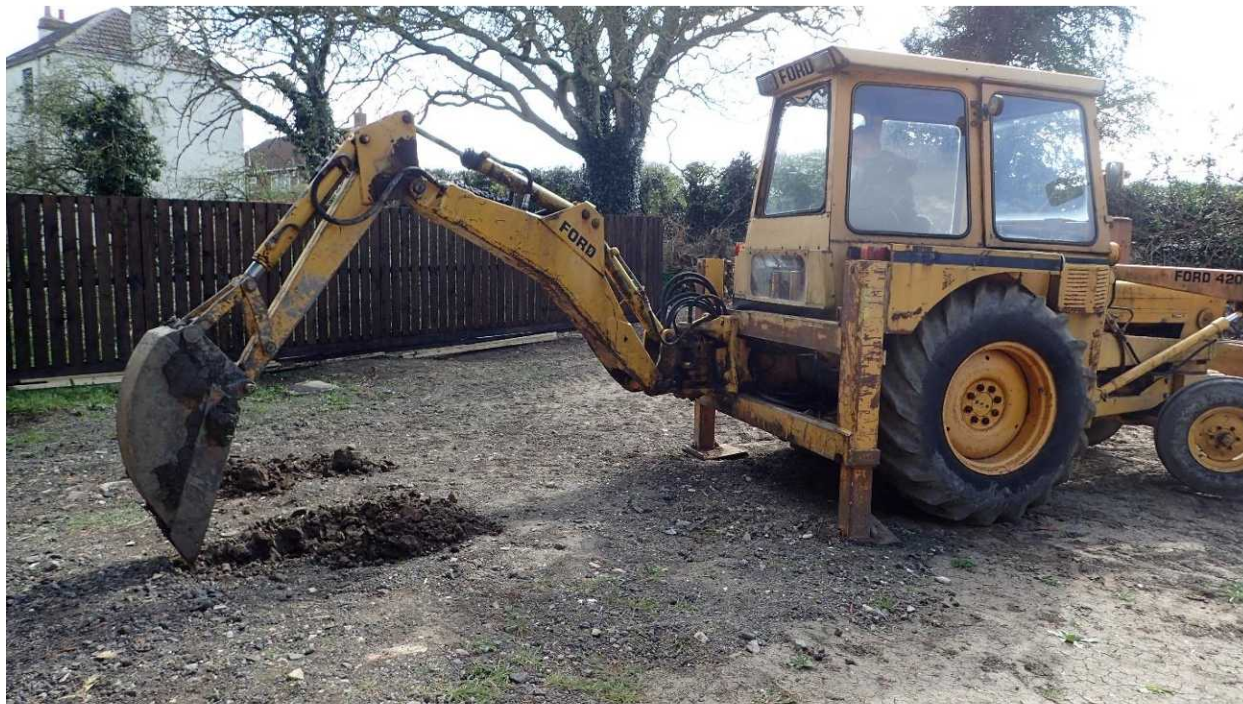
| <b>TP3</b> | Surface and near surface soil at the north of the plot. Future garden. | <b>Trial Pit</b> | 0.02m | MADE GROUND: Medium dense dark grey sandy slightly silty subrounded fine to medium gravel of tarmac, concrete and occasional brick. |
| | | | 0.6m | Stiff brown becoming grey CLAY (TIDAL FLAT DEPOSITS) |

Remnants of the former hardstanding consisting of tarmac debris and/or road planings were noted at the surface in the locations of TP3 and HP4, and this material was not segregated for the purposes of the surface sampling.

A number of PAH species considerably exceeded screening levels in both of the surface soil samples in the above locations. This is particularly true for sample TP301, which contained the highest proportion of tarmac material. Beryllium was also exceeded screening level in TP301, which is also attributed to the tarmac content of the sample.

*Photo 4 – Trial Pit 3 Location*

In respect of the scattering of remnant tarmac planings material exhibiting GAC exceedances in the vicinity of TP3 and HP4, removal of this source may be achieved manually or by mechanical means.

The material in question should be scraped away until the underlying clean soil is visible with no particles of stone, mortar or asphalt present. The arising should be transferred into a skip or similar for removal off-site.
