**PROPOSED RESIDENTIAL  
DEVELOPMENT  
LAND AT 67 CHAPELGATE  
SUTTON ST JAMES  
SPALDING  
LINCS**

**GEOENVIRONMENTAL  
DESK STUDY**

**Report Ref.: 0440/1**

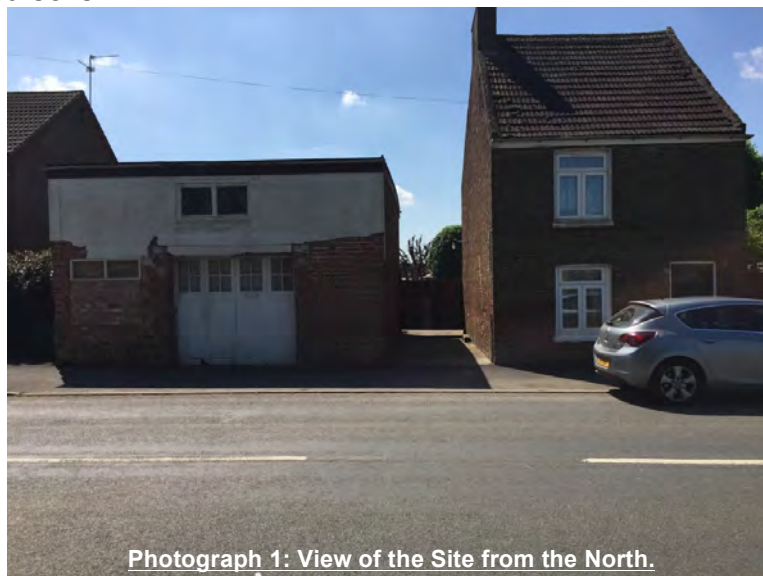
Photograph 1: View of the Site from the North.

As can be seen in Photograph 1, the two buildings in the northern part of the site fronting the public highway are of predominantly brick construction with the one on the right having been a former residential dwelling and the one to the left having accommodated a vehicle repair garage. At the time of the site walkover survey these buildings were unoccupied. Equally there was no evidence of the former existence of fuel storage tanks at the site e.g. inspection covers, ventilation pipes etc.

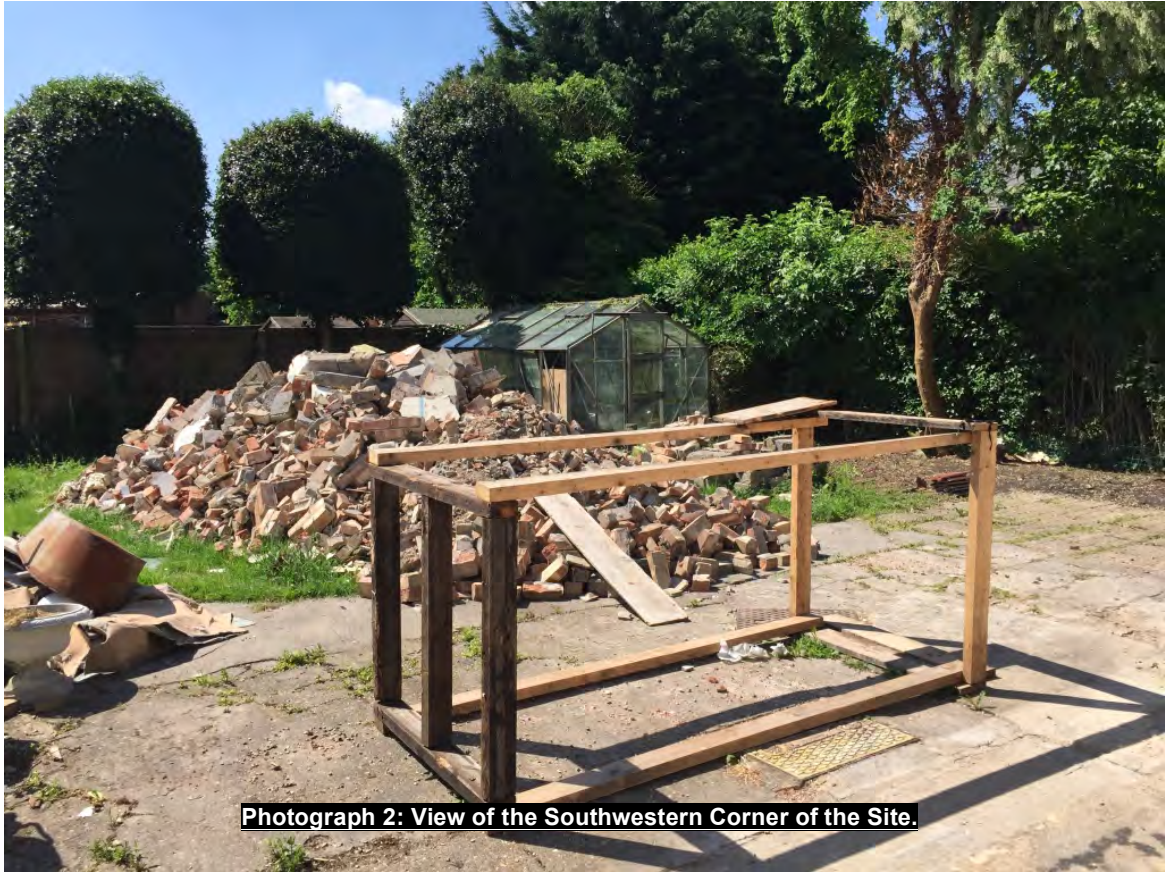
**Photograph 2: View of the Southwestern Corner of the Site.**

The southern part of the site was generally down to a cover of grass and exposed soils as referred above. In the southwestern corner was a small 'domestic' scale greenhouse which contained a number of black plastic sacks which contained garden prunings and grass cuttings. On its eastern side a stockpile of crushed brick and other 'aggregates' which resulted from some partial demolition which had taken place at the site.

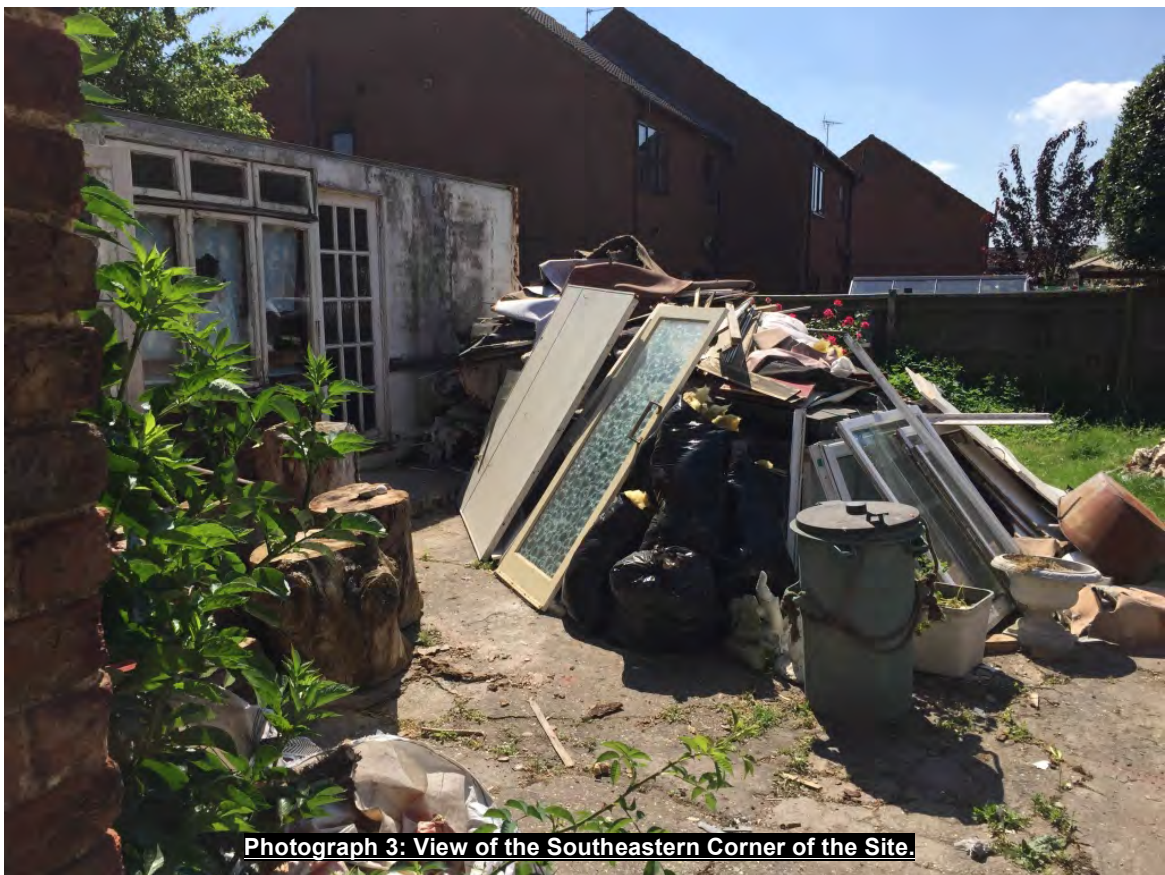
**Photograph 3: View of the Southeastern Corner of the Site.**

Further to the east were a stockpile of window frames (PVC double glazed units), an old metal bath, garden ornaments, textiles (old carpets), timber which included a glazed door.

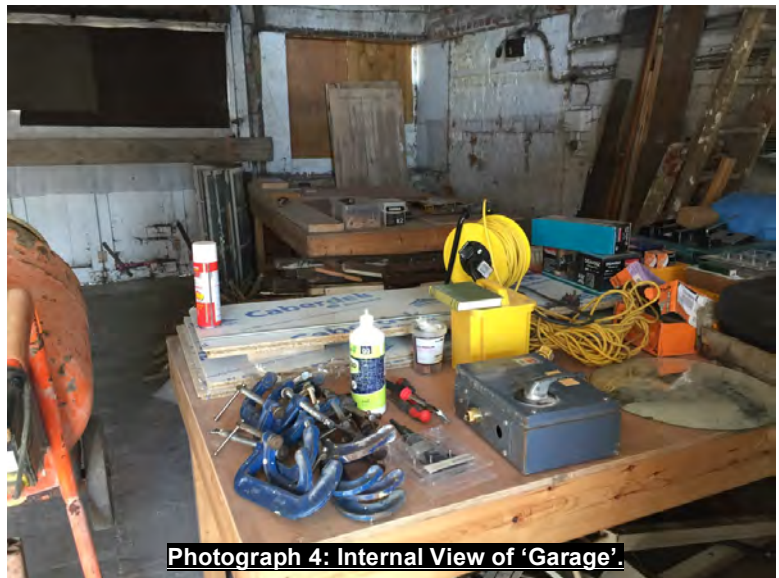
The former Garage building could be accessed either by folding wooden doors which made up much of the northern elevation or via a pedestrian doorway in the southern (rear) elevation. Internal inspection revealed it had been constructed over a concrete slab floor and was being used for 'storage' as shown in Photograph 4 and 5 below.

**Photograph 4: Internal View of 'Garage'.**

While the internal area of the former Garage contained workbenches and a variety of materials which included timber, glass, metalwork, together with electric cabling, an electric concrete mixer and small handtools the exposed concrete surfaces appeared to be relatively stain-free suggesting that when the garage was in operation that 'housekeeping' had been to a good standard and that there was very limited or no potential for impact of the underlying soils from

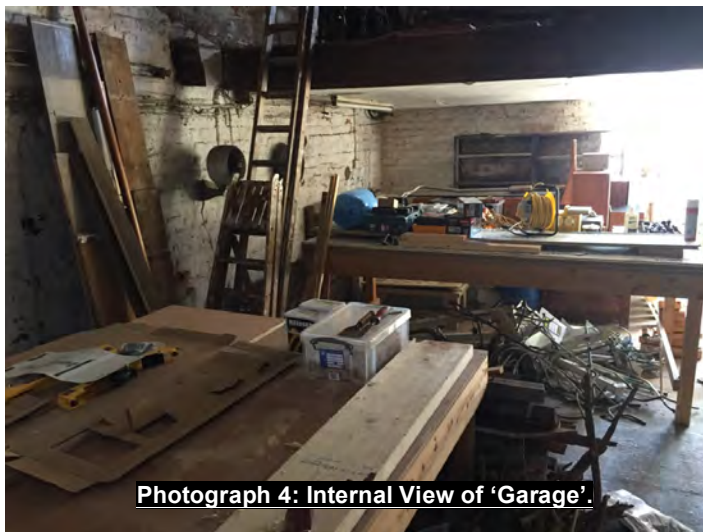
**Photograph 4: Internal View of 'Garage'.**
