# **GROUND ENGINEERING**

## **SITE INVESTIGATION REPORT**

**SMALL DROVE**  
**WESTON**  
**NEAR SPALDING**  
**LINCOLNSHIRE**

**Report Reference No. C14022**

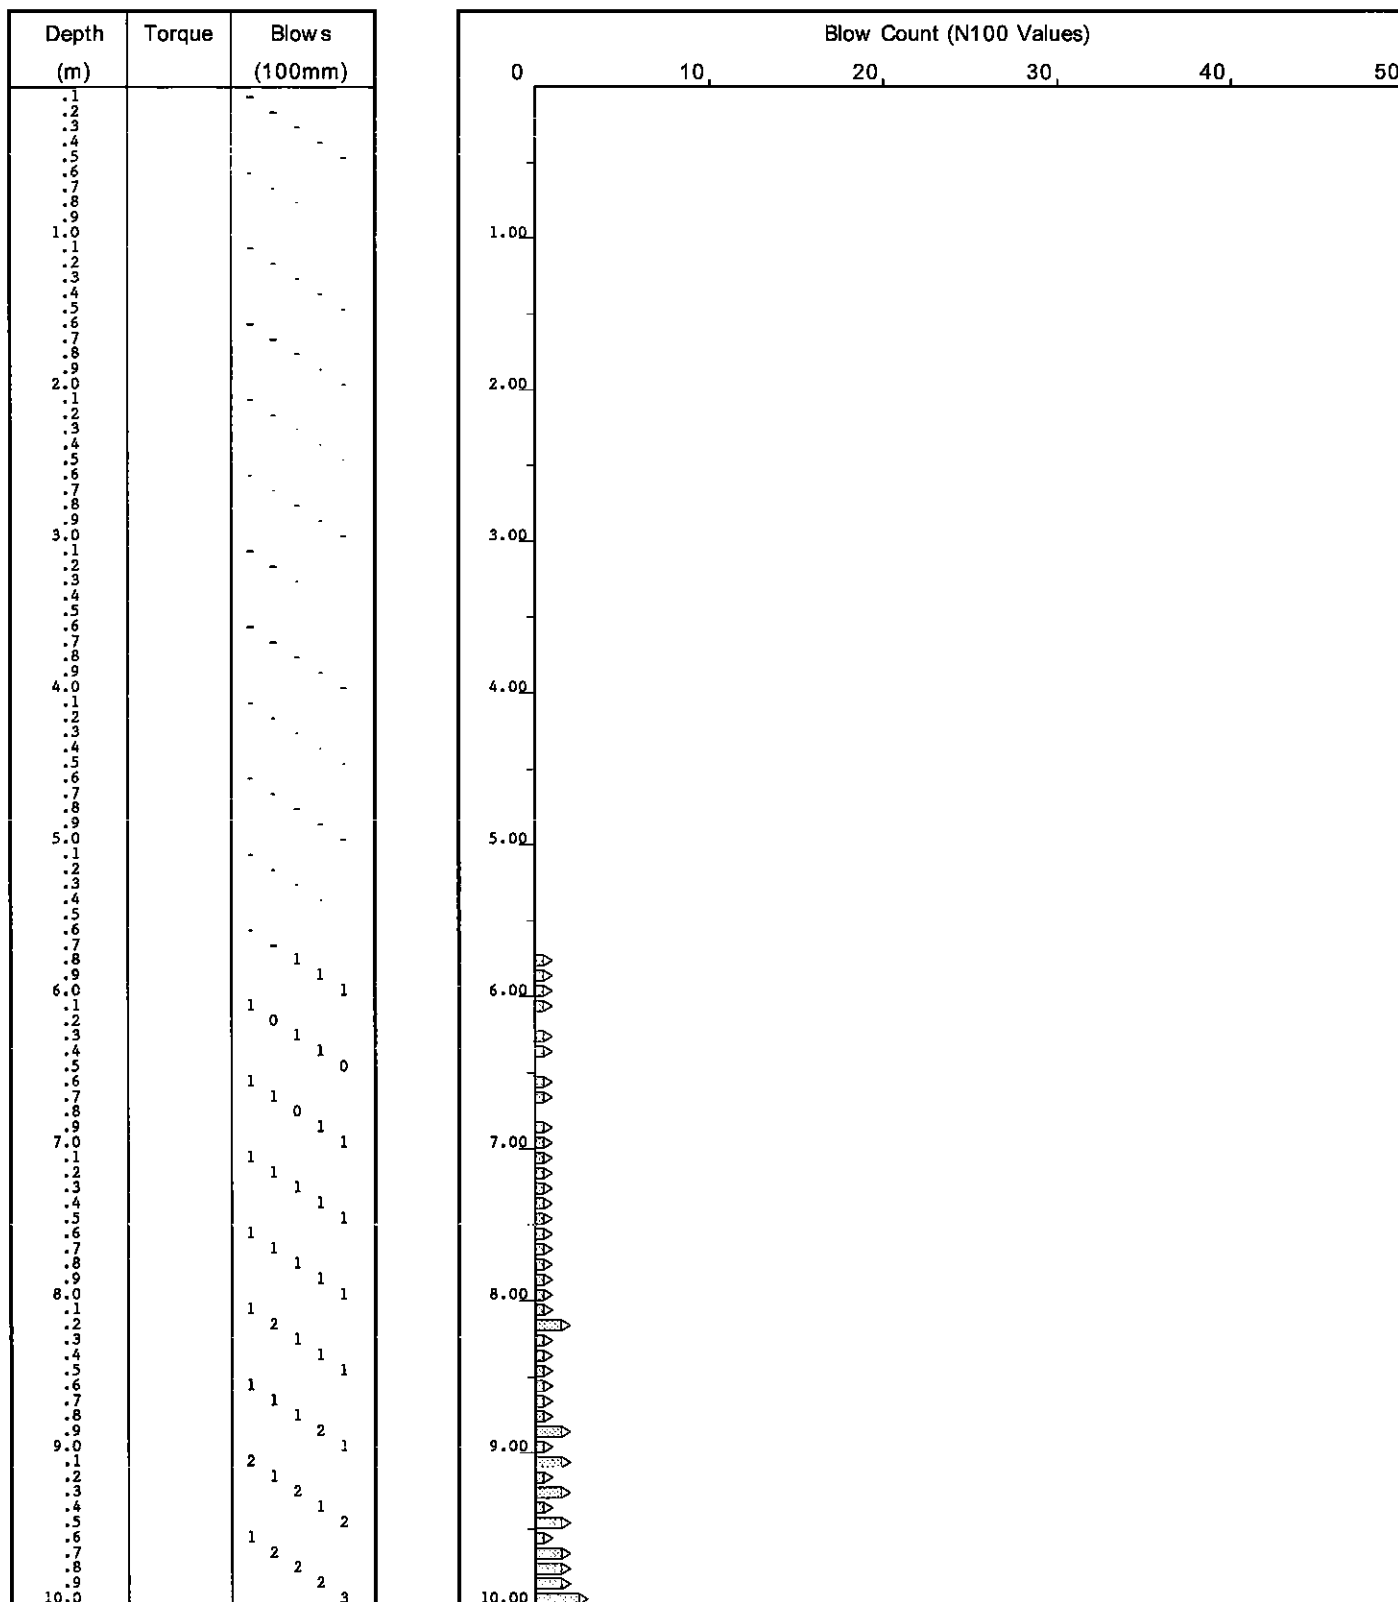
| <b>GROUND<br/>ENGINEERING</b><br>L I M I T E D<br>Tel: 01733-566566 www.groundengineering.co.uk | <b>DYNAMIC PROBE<br/>PENETRATION<br/>TEST</b> | Date 14/12/16<br>Project<br>Number 14022 | <b>PROBE No<br/>WS6</b><br>Sheet 1 of 2 |

| Remarks<br>Probing undertaken from base of borehole. Probe rods sank 'under own weight' to 5.80m depth. | Hammer 63.5 kg | 14022 |

At depths of between 1.80m and 3.00m the boreholes entered a very soft, grey and dark grey, silty, organic clay. This very soft, organic clay extended to at least the base of each borehole, which was terminated at 3.45m depth. Dynamic probing indicated the very soft Tidal Flat Deposits to have a thickness of 6.80m to 8.00m, extending to depths of 9.60m and 10.00m below ground level, where firm or loose conditions were found.

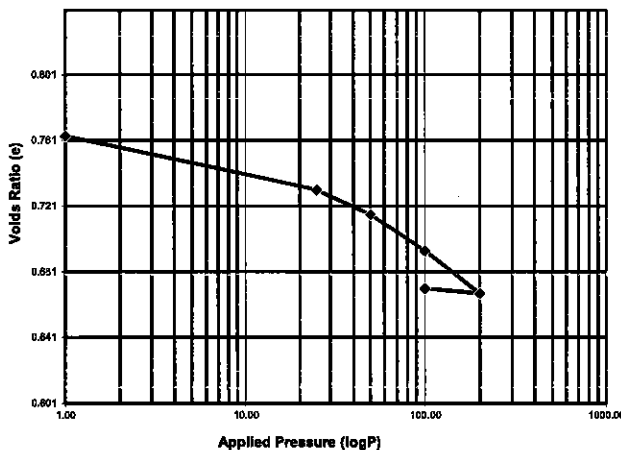
**Voids Ratio against logarithm of Applied Pressure**

| Applied Pressure (kPa) | Coefficient of Compressibility $m_v$ ( $\text{m}^2/\text{MN}$ ) | Coefficient of Consolidation $c_v$ ( $\text{m}^2/\text{year}$ ) |

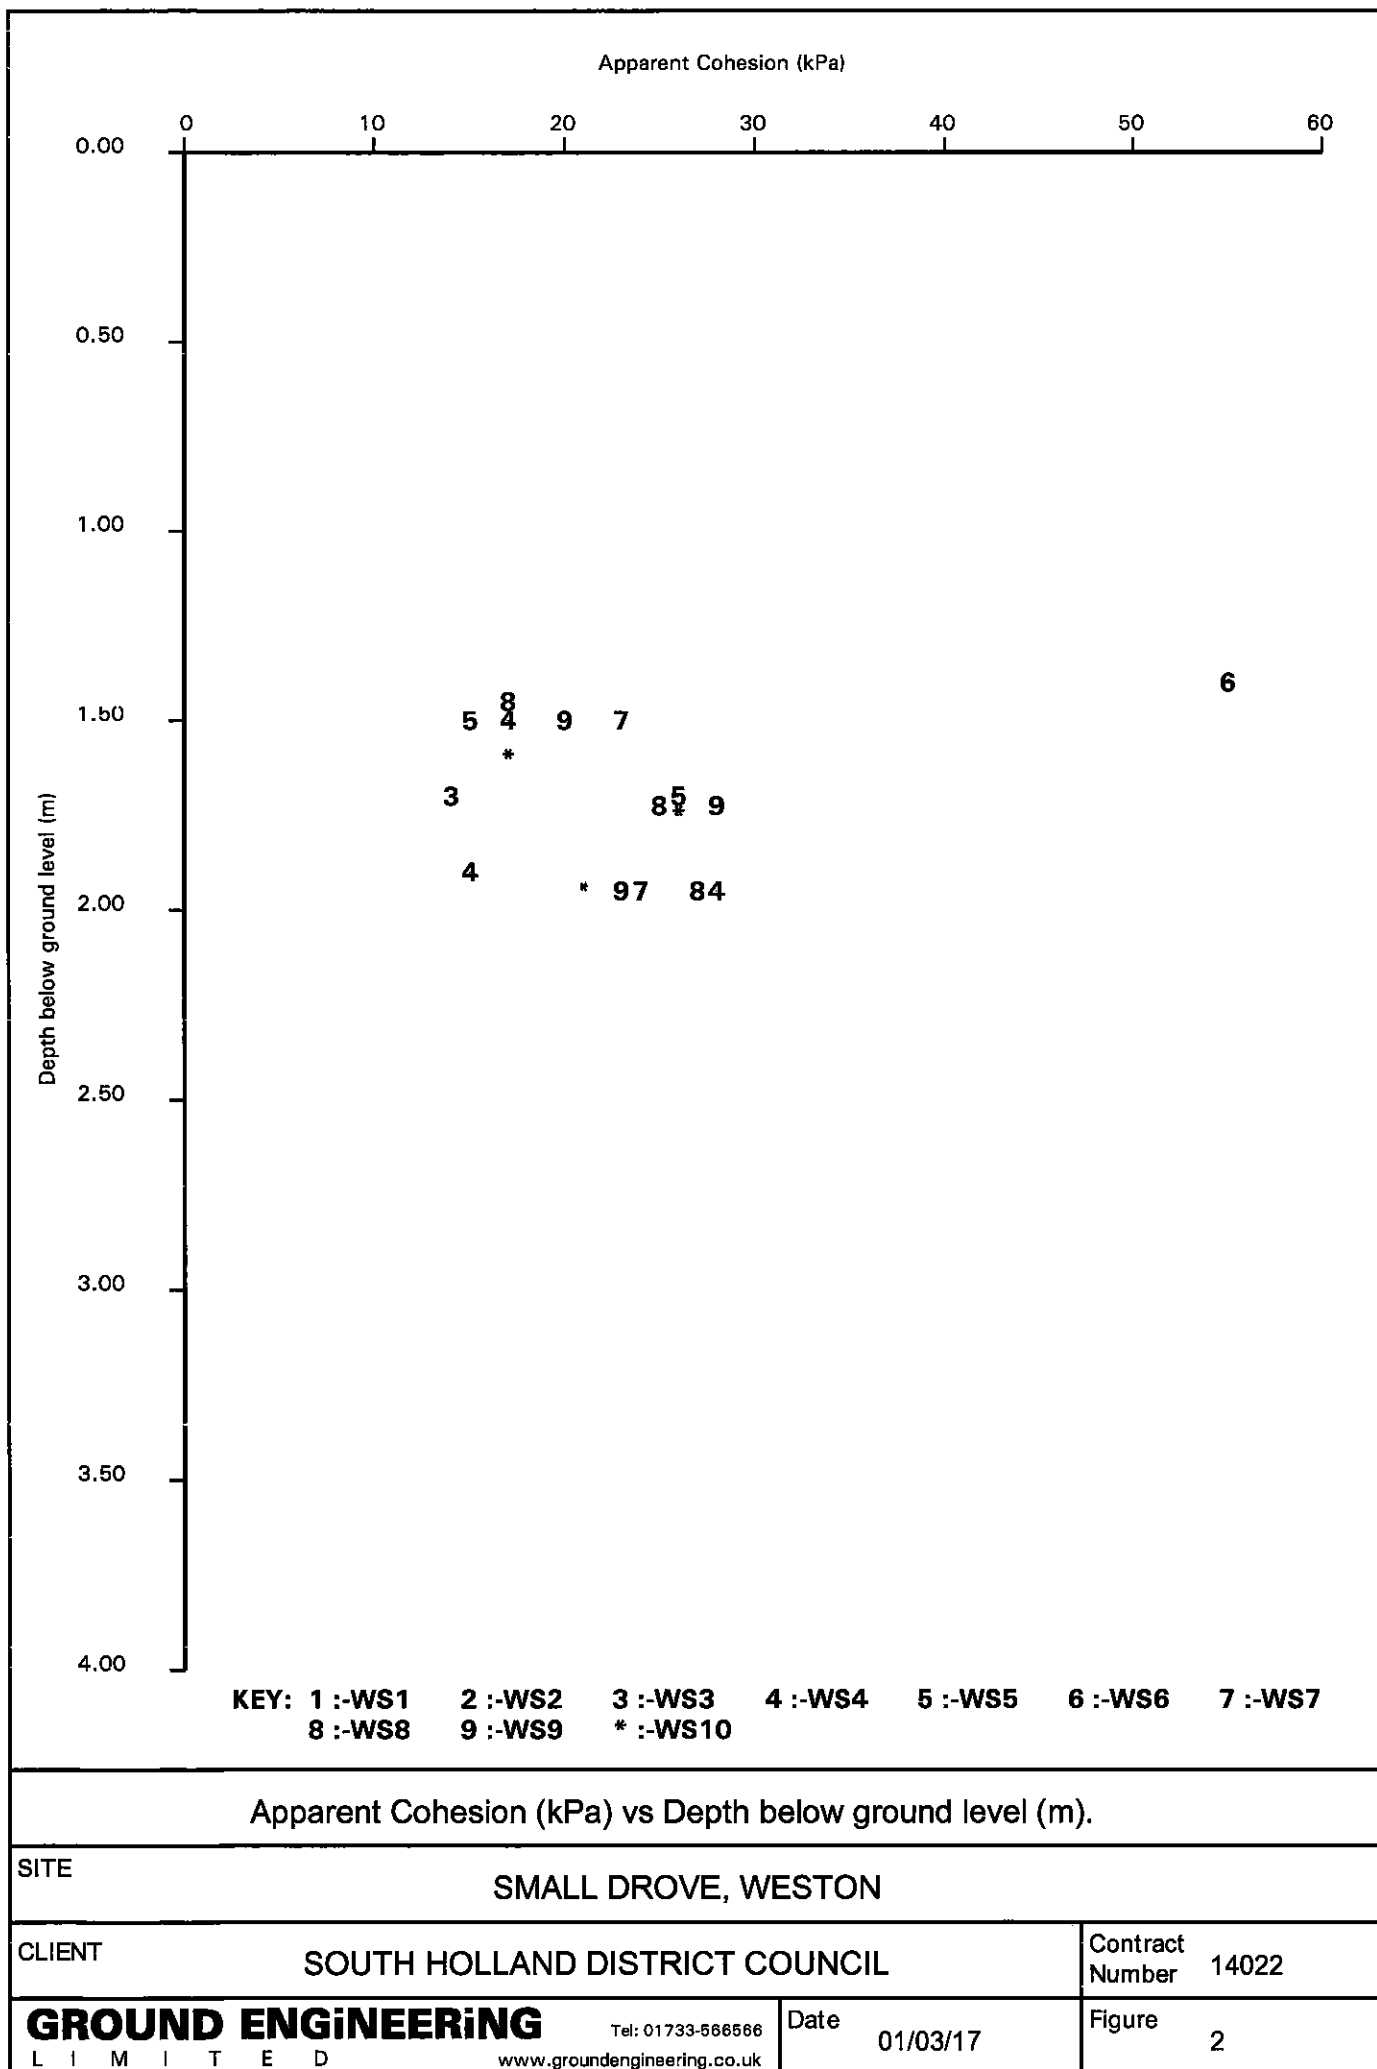
| <b>GROUND ENGINEERING</b><br>L I M I T E D | | Tel: 01733-566566<br>www.groundengineering.co.uk | Date 01/03/17<br>Figure 2 |

Apparent Cohesion (kPa) vs Depth below ground level (m).

Test specimens were prepared at full diameter from selected undisturbed samples. Immediate undrained triaxial compression tests were undertaken on the samples under three cell pressures using the 'multistage' technique. The moisture content and bulk density of each specimen was also determined. The values of apparent cohesion have been plotted against depth, together with the hand shear vane test results in Figure 2.

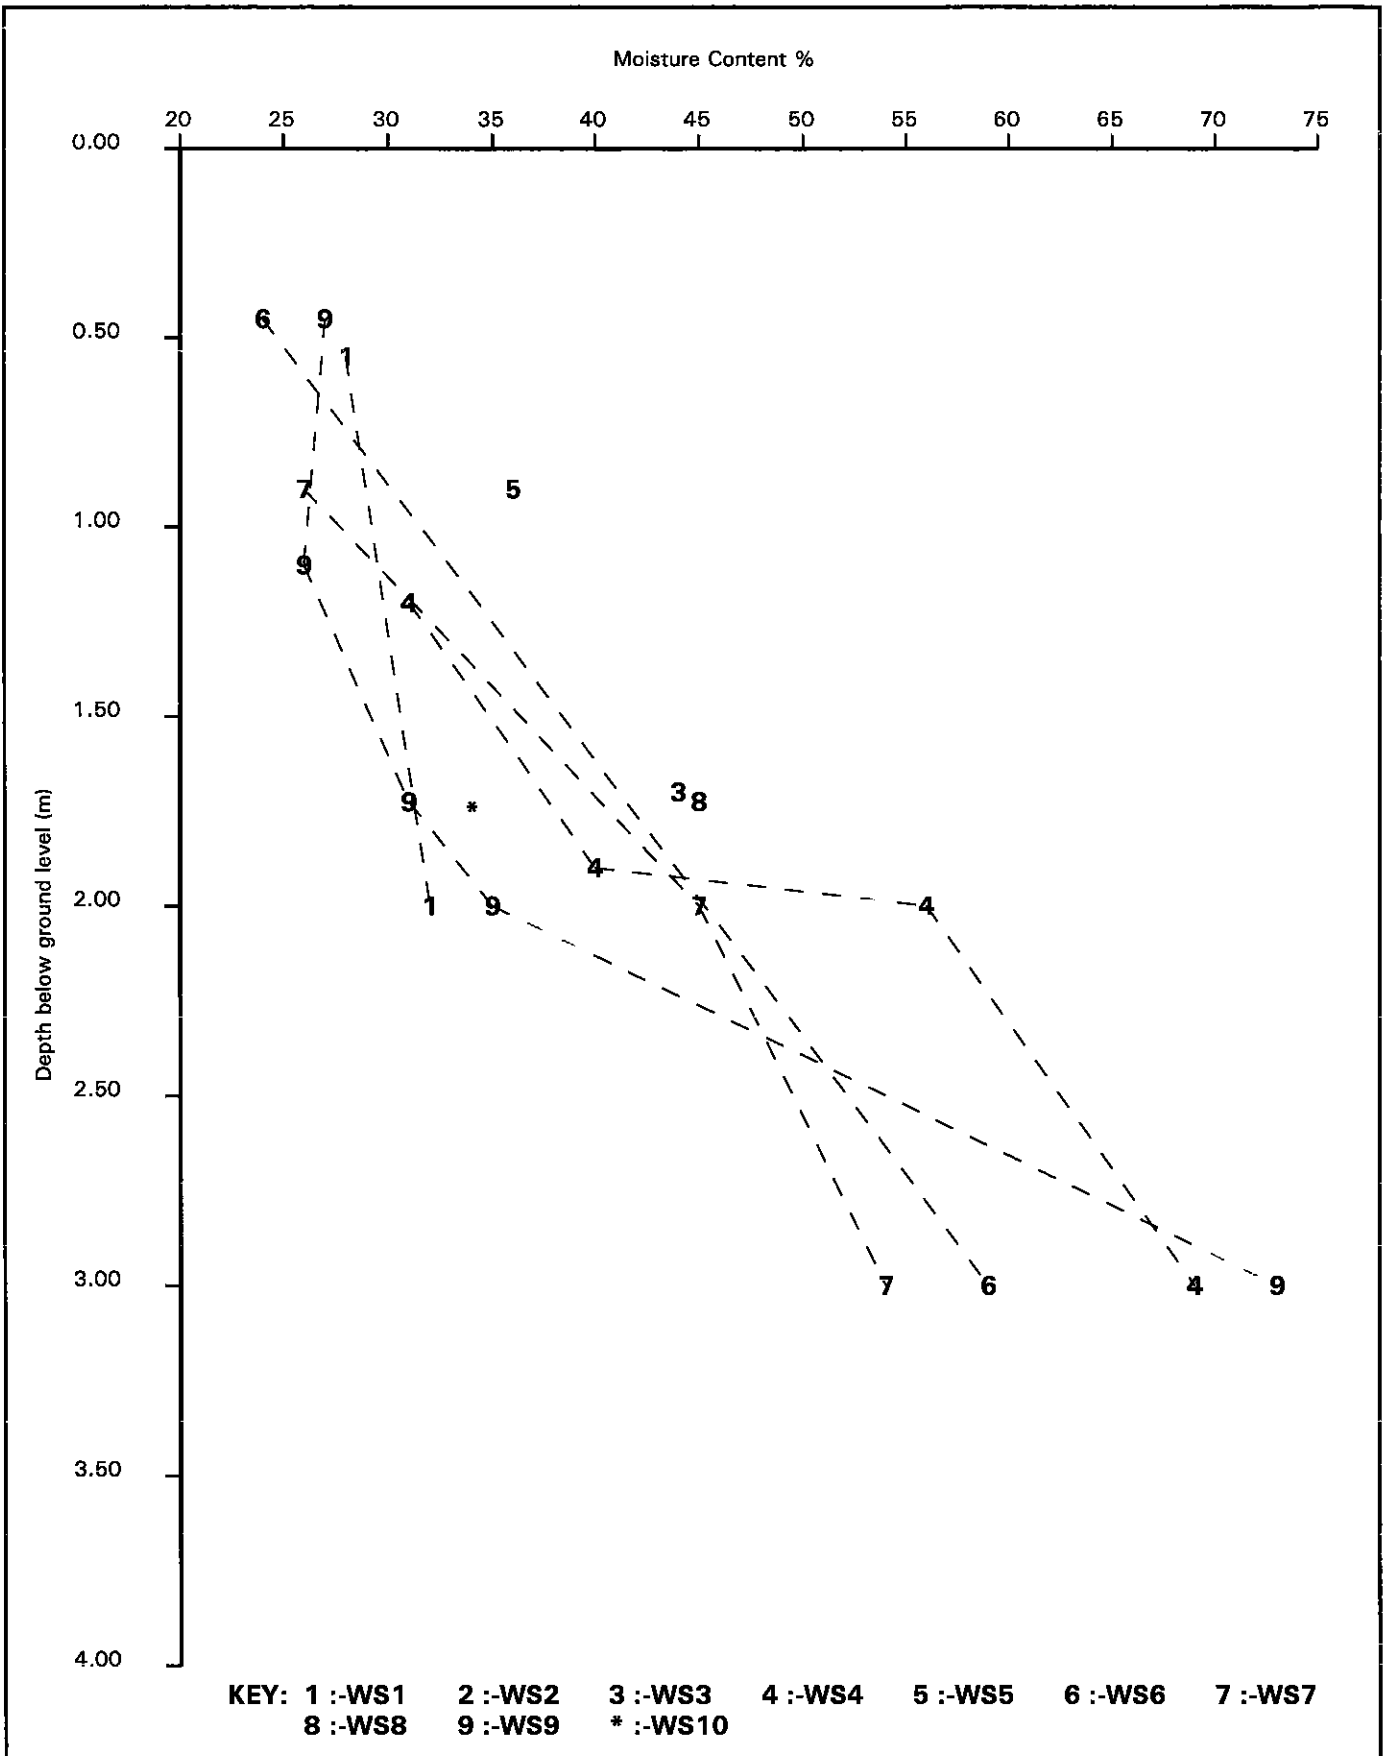
Moisture Content % vs Depth below ground level (m).

The moisture contents plotted in Figure 3, suggest that the clays showed some evidence of slight desiccation within WS6 and WS9, extending to approximately 1.50m depth at the latter position, within the influence zone of the neighbouring Lime tree, below which moisture contents were at or in excess of their equilibrium moisture contents. This would be expected within such soils below the groundwater table.

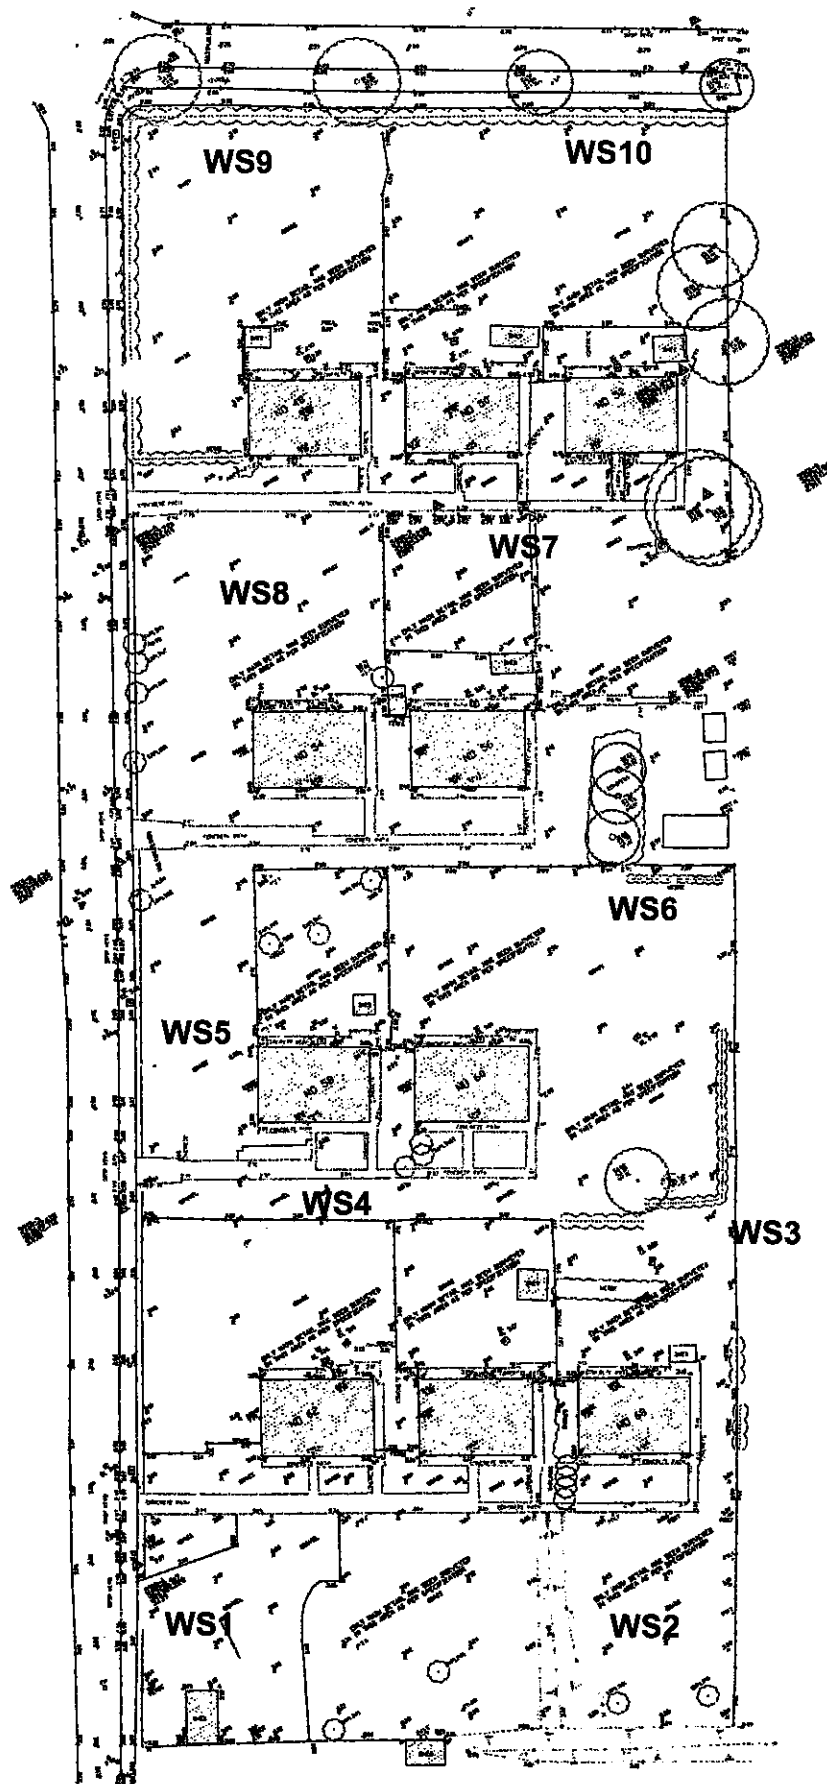
# Borehole Location Plan

Based on a topographic survey plan provided by the client. Not to Scale
