**DESIGN & ACCESS STATEMENT  
(including Heritage Impact Assessment)**

**PROPOSED CONVERSION AND EXTENSION OF BARN**

**BROADGATE BARNS  
694 BROADGATE  
WESTON  
SPALDING  
LINCOLNSHIRE  
PE12 6JA**

**PLANNING & LISTED BUILDING CONSENT APPLICATION ISSUE**

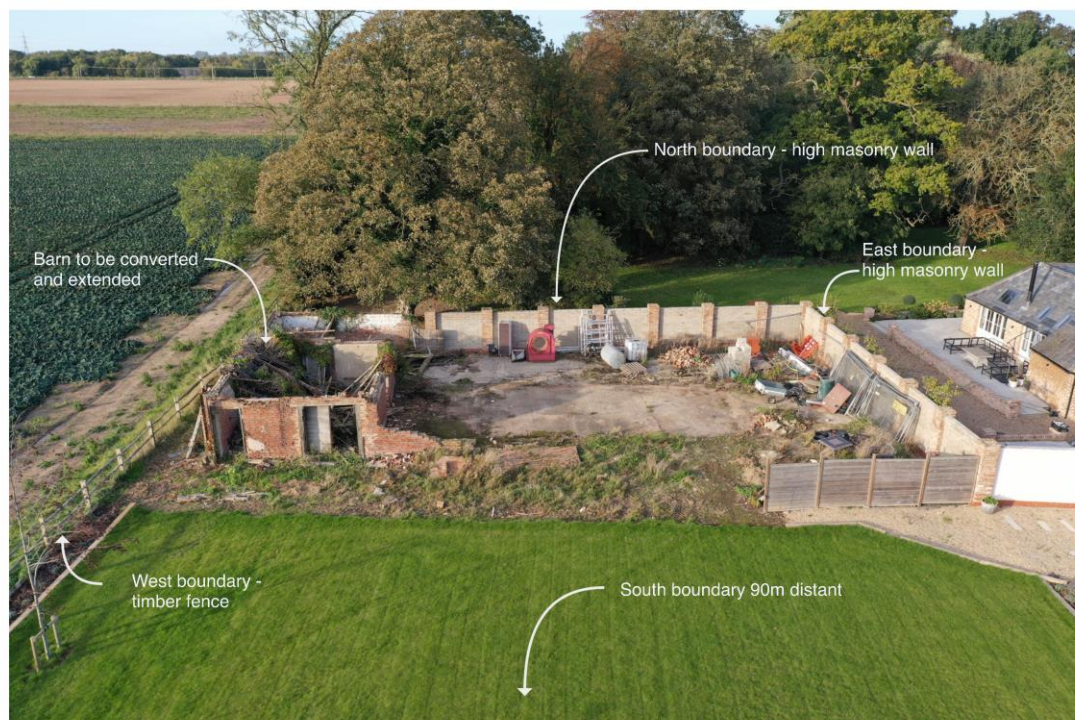
Fig. 01 – Aerial view showing the barn in relation to the various site boundaries.

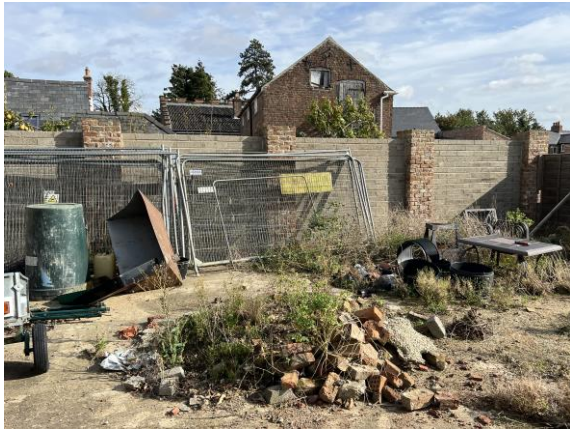
Fig. 02 – East boundary, high boundary wall.

The east boundary of the site is formed by a modern masonry wall comprising blockwork panels between brickwork piers. This wall stands approximately 2200mm high (fig. 02). Beyond this boundary wall is the rear yard area associated with the adjacent dwelling (the Principal Farmhouse).

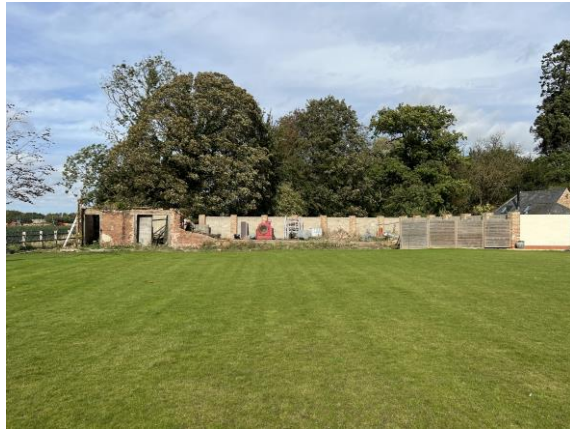
Fig. 03 – South boundary, open to lawn.

The south boundary is effectively open to the rear garden of the host dwelling (fig.03). This lawned garden extends to a thicket. The wider site boundary is some 90m distant, at the far edge of the thicket, beyond which are open fields in agricultural use.

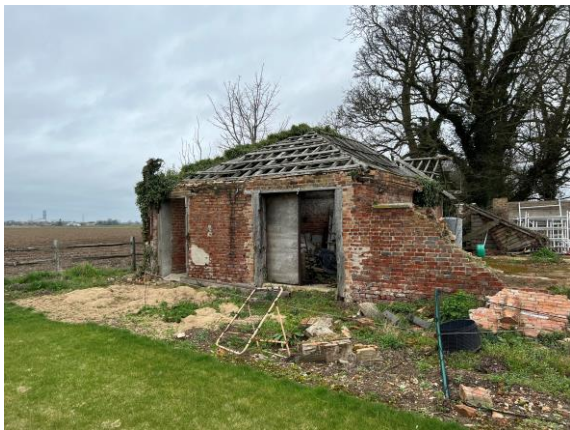
Fig. 04 – West boundary, timber fence (to left of barn).

The west boundary is defined by a timber post and rail fence approximately 1200mm high (fig. 04). This is set between 2m and 3m from the west elevation of the barn. Beyond this boundary open fields in agricultural use extend over 800m to Swindler's Drove.

Figure 4 earlier in this report was taken earlier in 2023 and shows what remained of the roof structure prior to its collapse later in 2023.

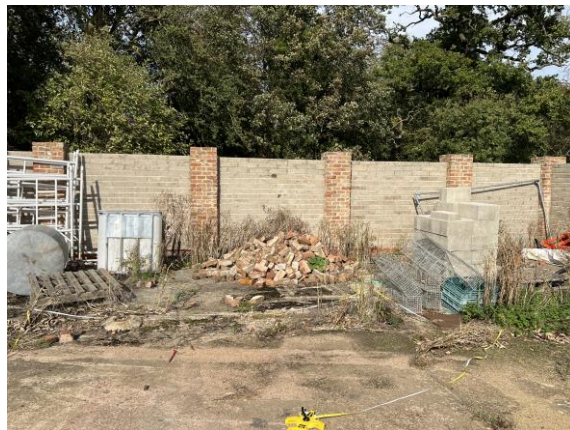
Fig. 05 – North boundary, high boundary wall.

The north boundary is formed by the north wall of the existing barn building. To the east of the barn, the boundary is formed by a modern wall of the same construction as that along the east boundary (fig. 05). Beyond the north boundary wall stands the rear garden of the Principal Farmhouse, which contains numerous mature trees.

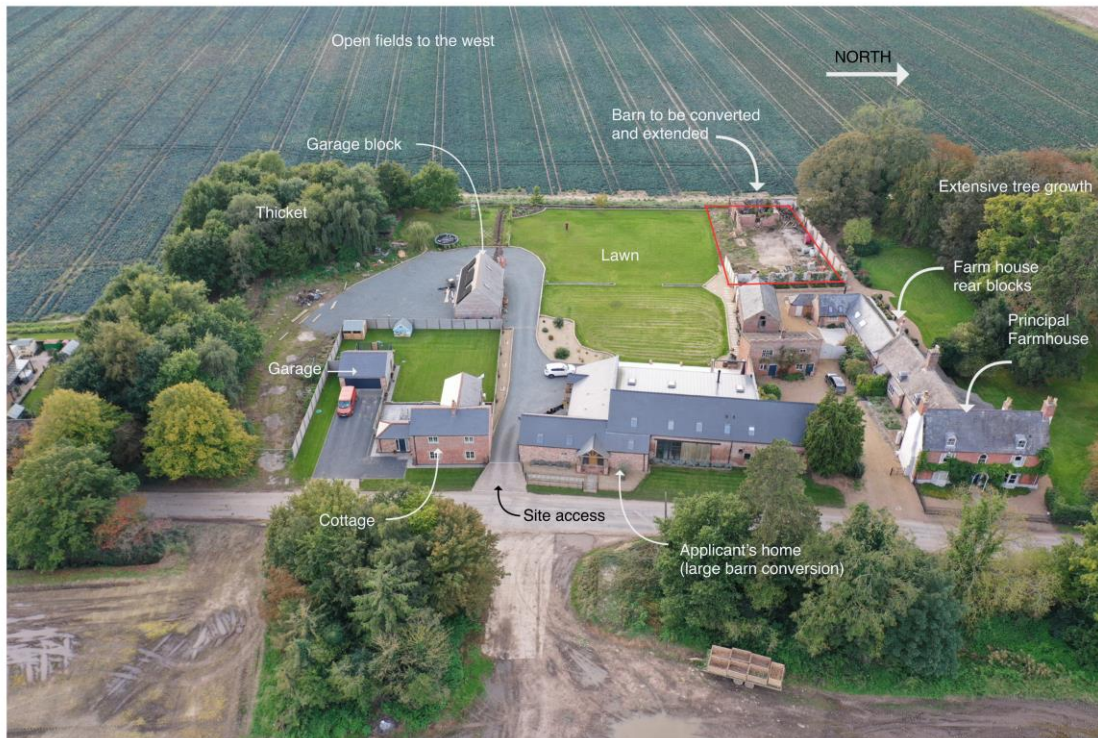
Fig. 06 – Aerial view showing surrounding architectural context.

General development in the vicinity of the site can be seen on the aerial photograph below (fig. 06).

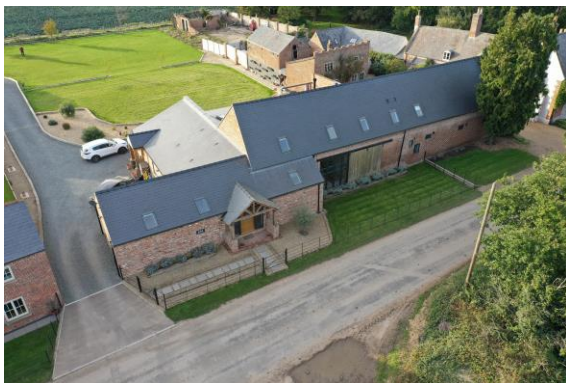
Fig. 07 – View of larger barn from south-east.

South of the Principal Farmhouse is a large barn that stands parallel to Broadgate and was converted since 2017 (figs. 07 & 08). This is the private dwelling of the applicant. This retains much of its original brickwork beneath a slate covered pitched roof. The rear of the barn has been re-roofed and features extensive glazing and some more modern, but sympathetic details.

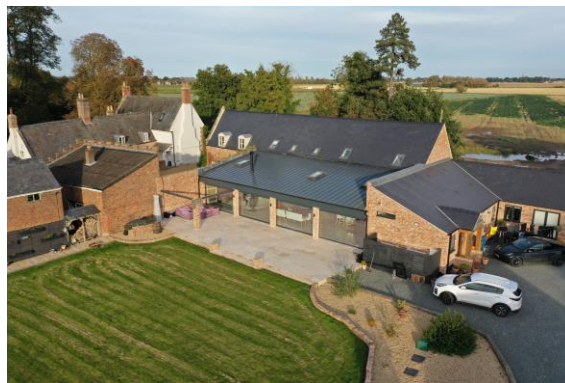
Fig. 08 – View of larger barn from south-west.

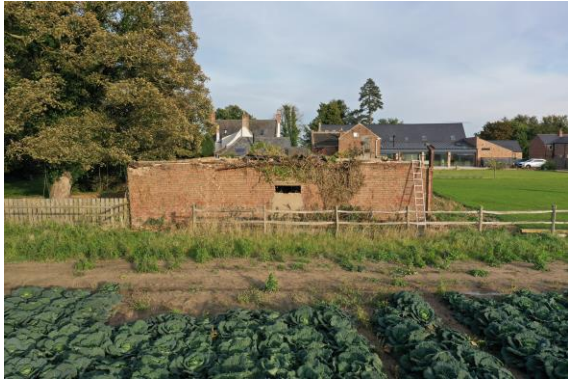
Fig. 09 – View of barn from west.

The barn here proposed for conversion and extension is rectangular on plan and is of single storey construction (figs 09 & 10). The external walls are constructed of red brick. The roof structure was originally hipped, and is known to have had a slate covering. The original covering has however been removed and the timber structure has extensively collapsed. Window and door frames, where extant, are generally of timber construction, though one window on the west elevation is a single glazed, Crittall type steel window.

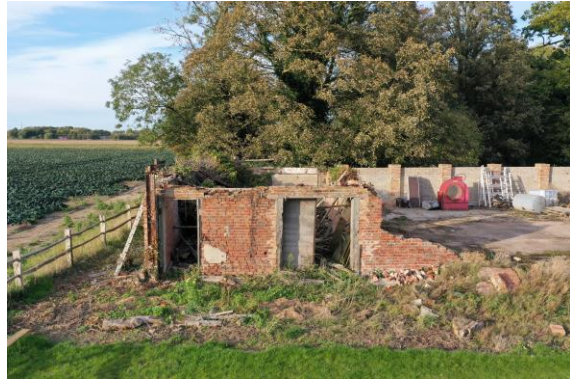
Fig. 10 – View of barn south.

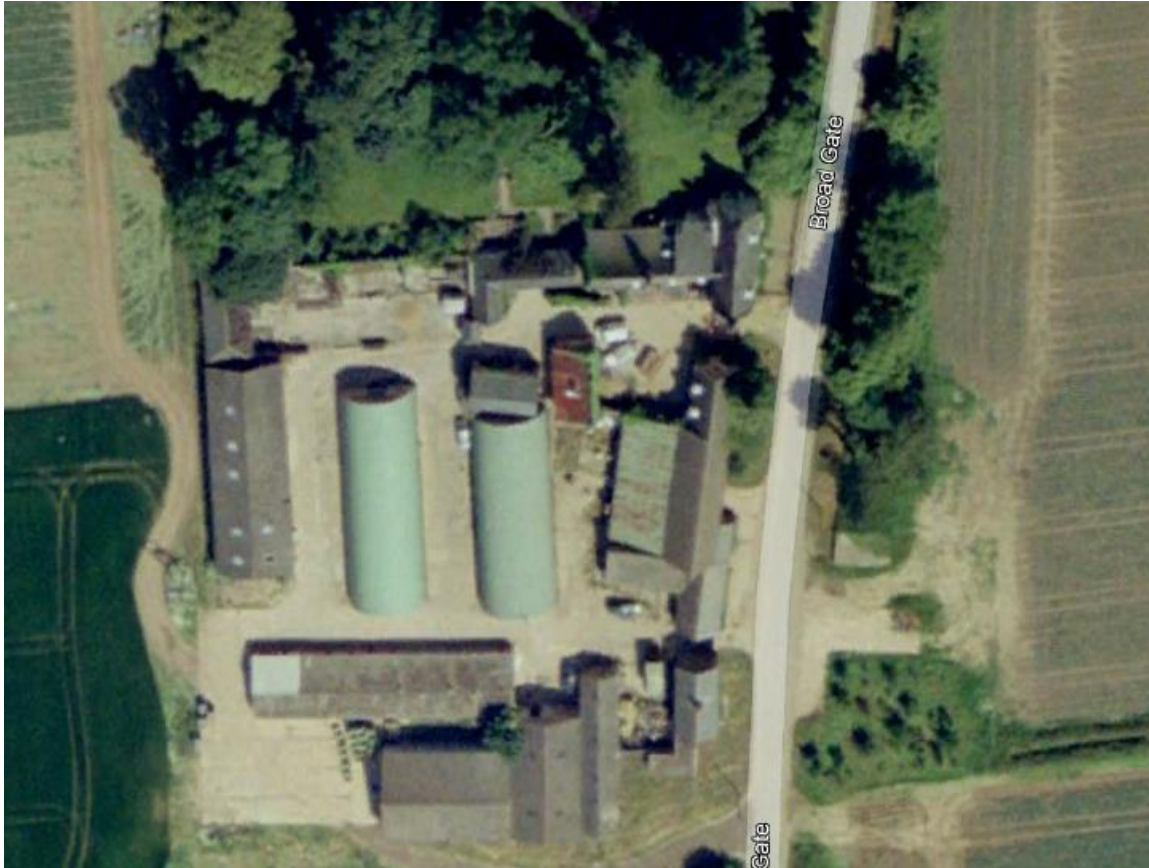
Fig. 14 – Aerial image from 1999.

The image from 1999 (fig. 14) clearly indicates much more dense development of the area of the site to the south-west of Broadgate House. The site now features numerous C20 buildings. At this time the roof of the barn in question can clearly be identified but most of the range across the north of the site appears to have lost its roof by this date. It is clear that there is a yard area south of the north range, that is hard surfaced and partially enclosed.

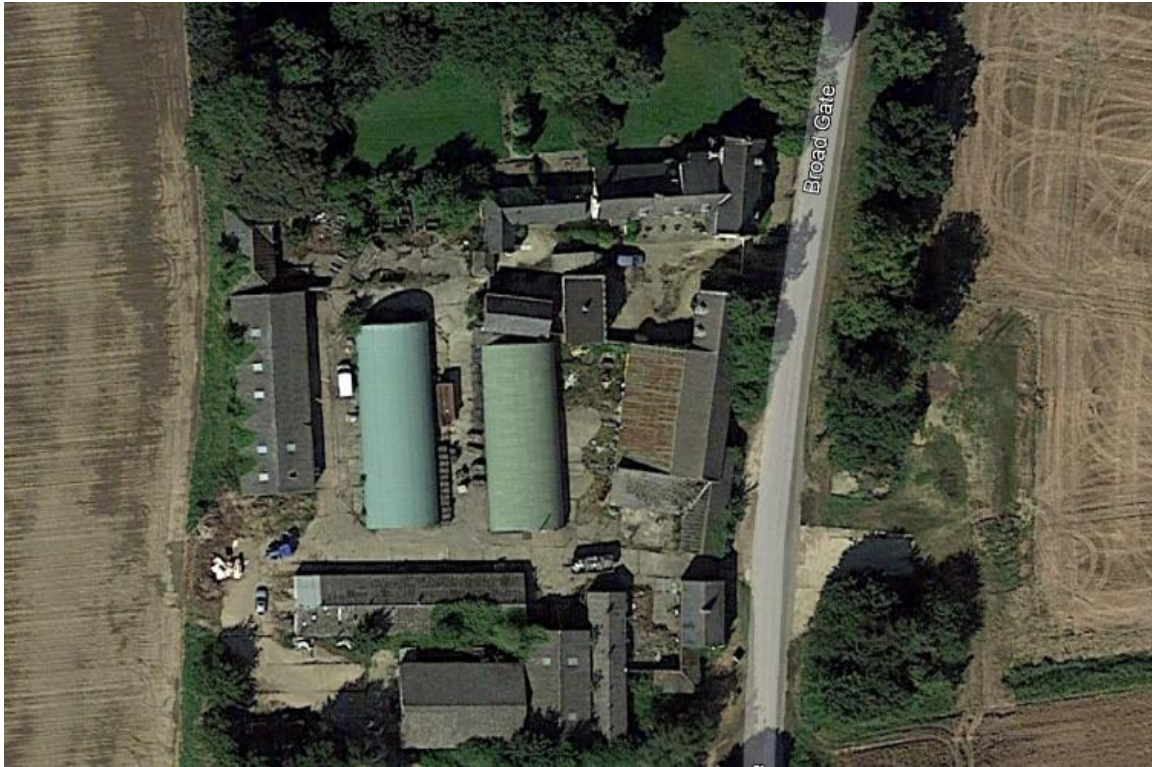
Fig. 15 – Aerial image from 2016.

The image from 2016 (fig. 15) is largely unchanged from the 1999 image. There appear to be signs of general deterioration, possibly associated with reduced maintenance. The site was sold shortly after this image was taken so it is suspected that its life as a working farm had either greatly reduced, or ceased.

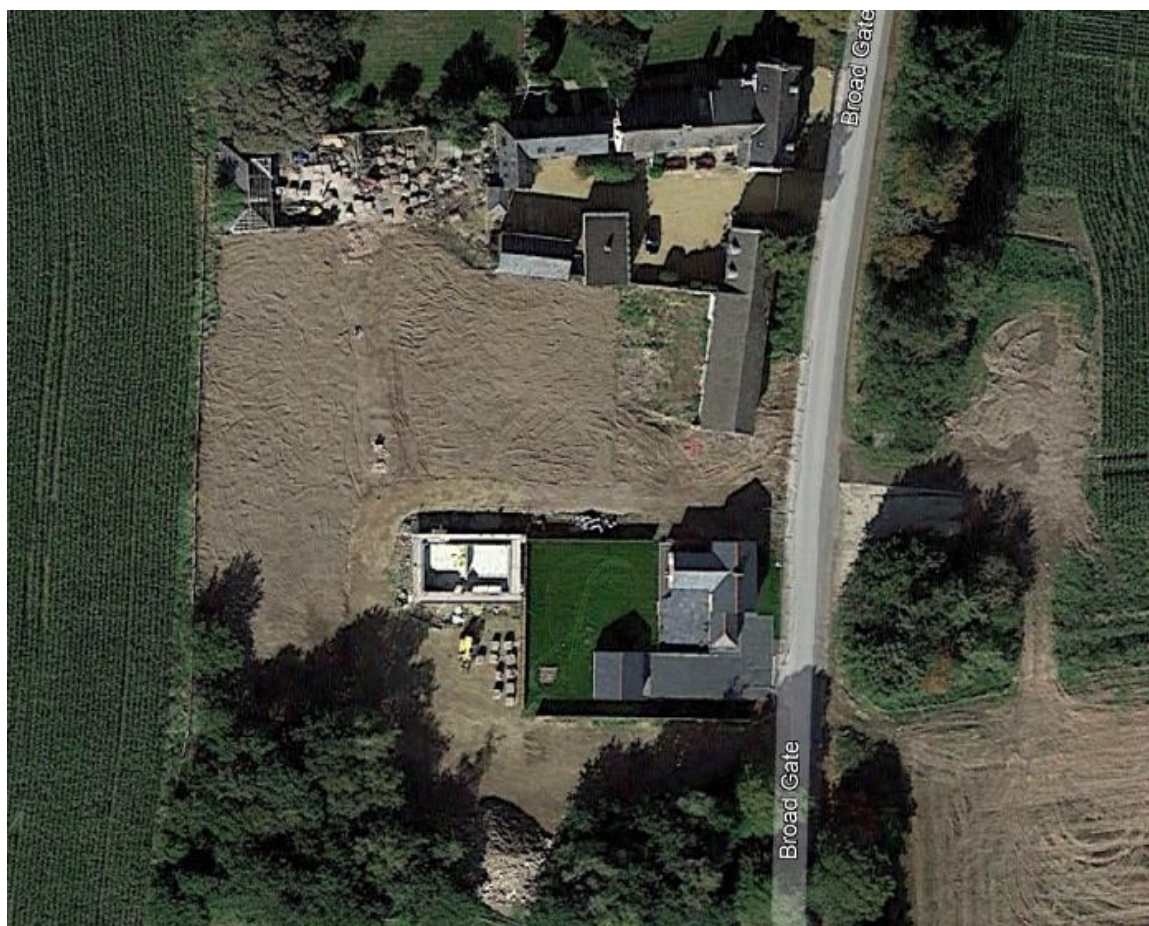
Fig. 16 – Aerial image from 2018.

The image from 2018 (fig. 16) is significantly different from the 2016 image. In the intervening period, most of the C20 buildings have been demolished and the site has been extensively cleared. The cottage at the south-east corner of the site has been restored and has been set within its own curtilage. The area of the proposed works appears to have been used to store items and appears unmaintained.

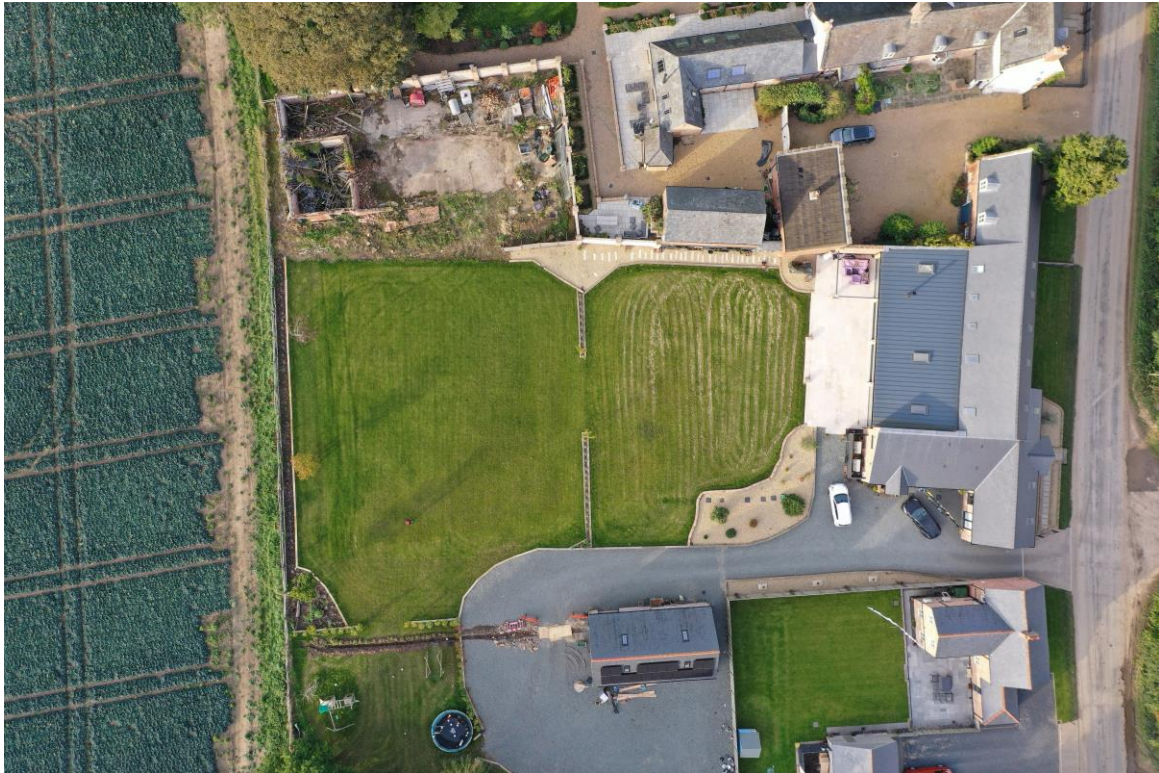
Fig. 17 – Aerial image from 2023.

The image from 2023 (fig. 17) is significantly different from the 2018 image. In the intervening period, the main barn fronting on to Broadgate has been converted to a dwelling and the central areas of the site have been extensively landscaped. The garage block associated with the main barn has been completed (in construction in the previous image). The roof over the barn in question has collapsed and much of the debris east of it has been cleared. A new boundary wall separating this area off from Broadgate House has been constructed east of the proposal site.
