**Phase 2 (site investigation) report**

**Corner House, Church Gate, Whaplode**

| <i>Report number:</i> | 0991/4873/P/P2 |

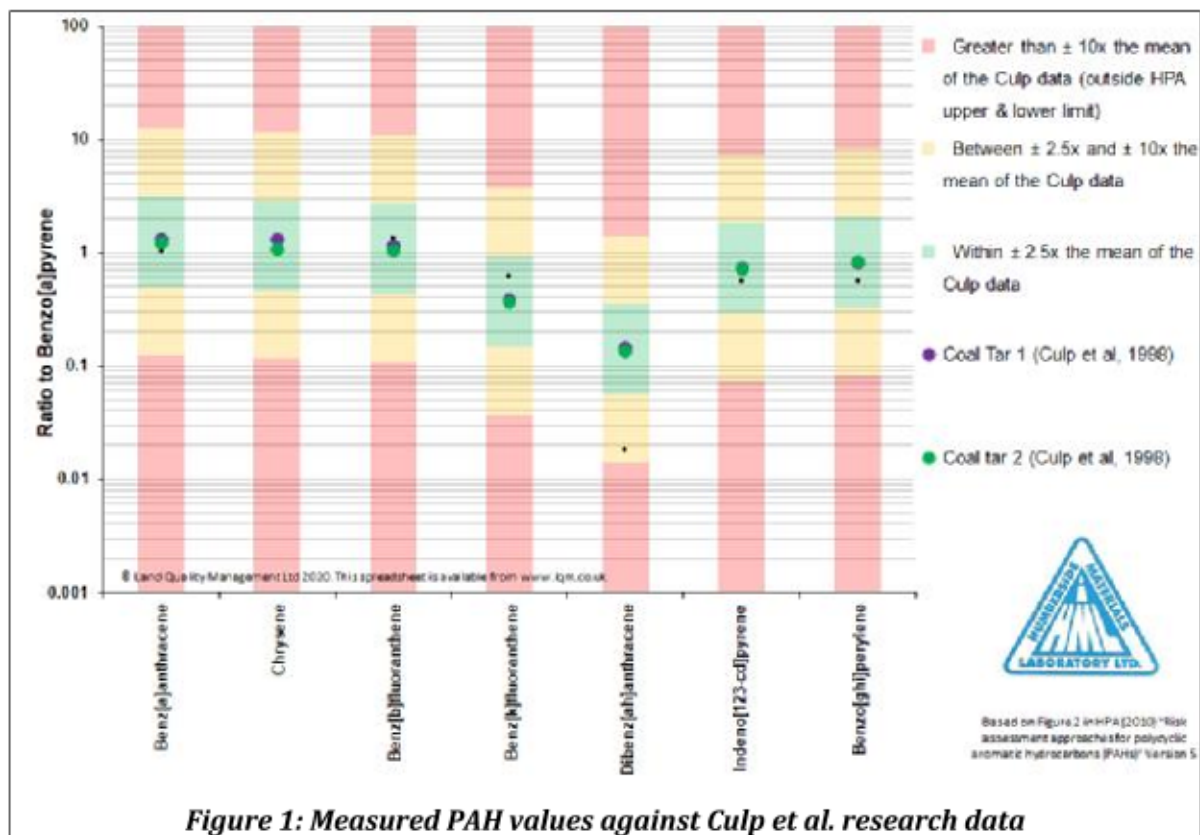
Figure 1 shows the measured data generally lies reasonably close (within 2.5 times the mean) to the Culp et al. (1998) data. Only the dibenzo(a,h)anthracene is outside this factor, which is not surprising as the concentration of dibenzo(a,h)anthracene was found to be below the test detection limits. Therefore, PAH double ratio profiling should be generally applicable to the data.

Double ratios and PAH profiling has been undertaken on the data for the sample which indicated PAHs mostly above the detection limits. This was the made ground sample from WS4 (0.1m to 0.5m bgl). The plots are shown below (in Figures 1 to 4).

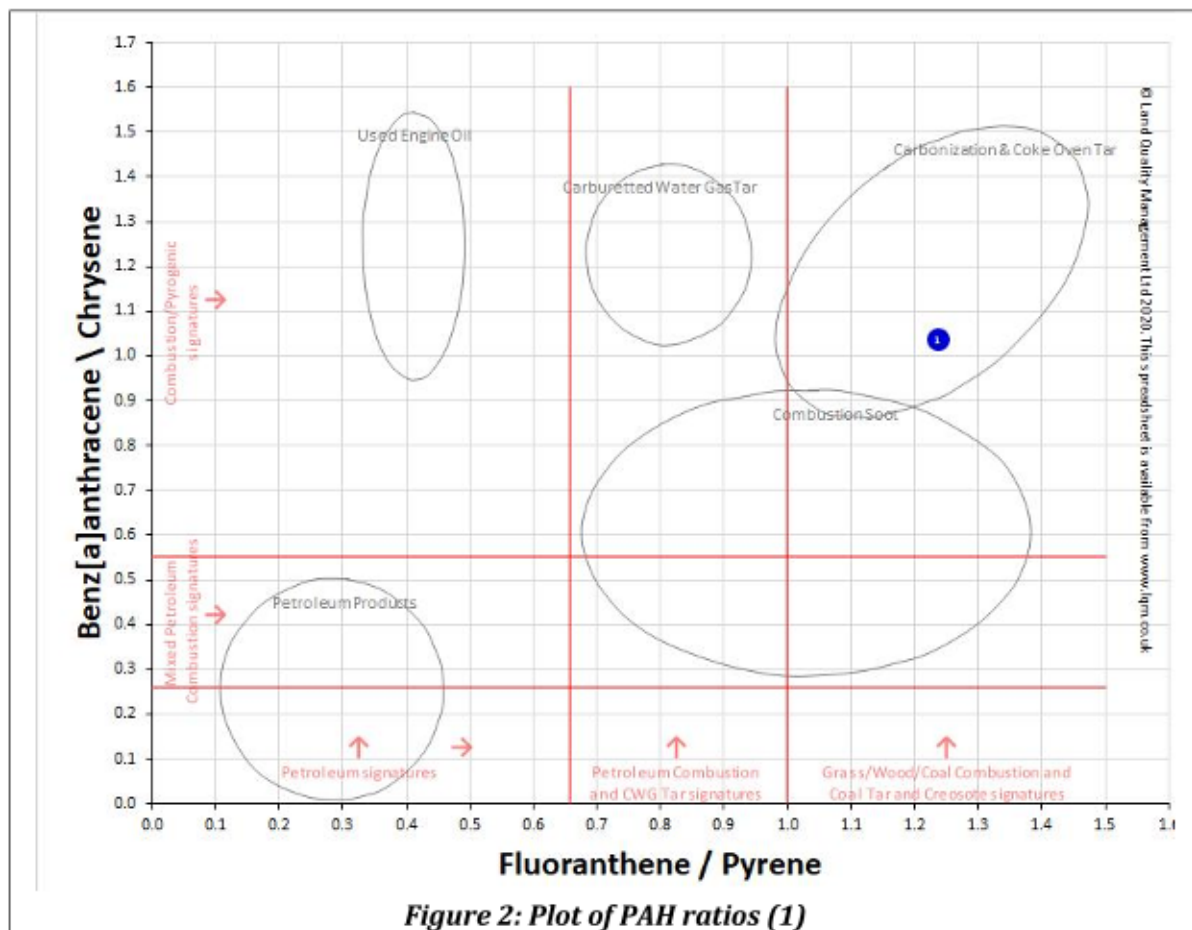
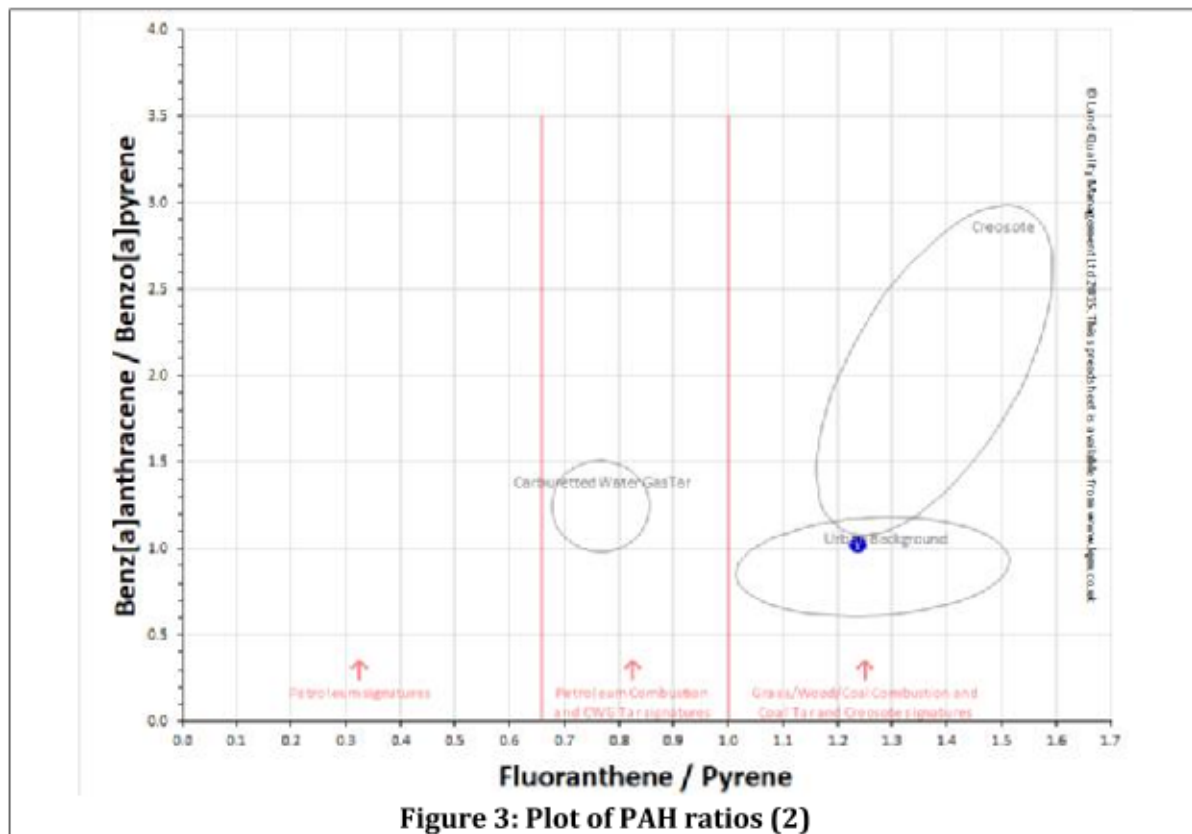
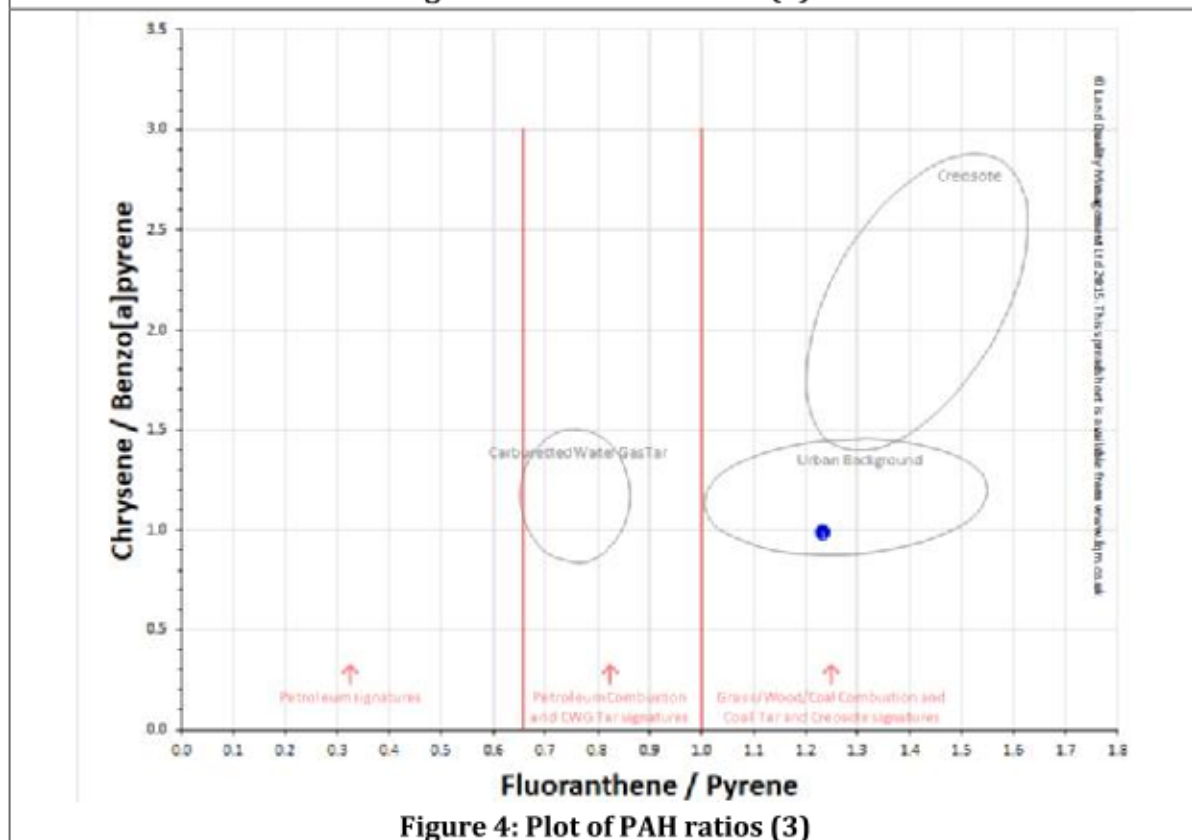
The profiling plots below (Figures 2 to 4) indicate the PAH concentrations in the sample have the signature of a *carbonization or coke oven tar*. The profile clearly falls into the

category of *Grass/Wood/Coal Combustion and Coal Tar and Creosote* signatures. However, the profiles are closer to an *Urban Background* than *Creosote*.

Therefore, the source of the PAH contamination in the sample is likely to be either (A) ash or clinker from burnt wood or coal or (B) coal tar. Given the lack of asphalt in the made ground descriptions, option A (ash or clinker) seems more likely, especially when rare clinker fragments were noted in the topsoil in WS1.

It is noted that the double ratio profiles do not indicate any potential petroleum signatures.
