**Report number 16-04-01**

## **Environmental Risk Assessment of site off Kirkgate &**

## **Cross Street, Whaplode, Spalding, Lincolnshire, PE12 6TF**

**Planning Application No. H23-0434-14**

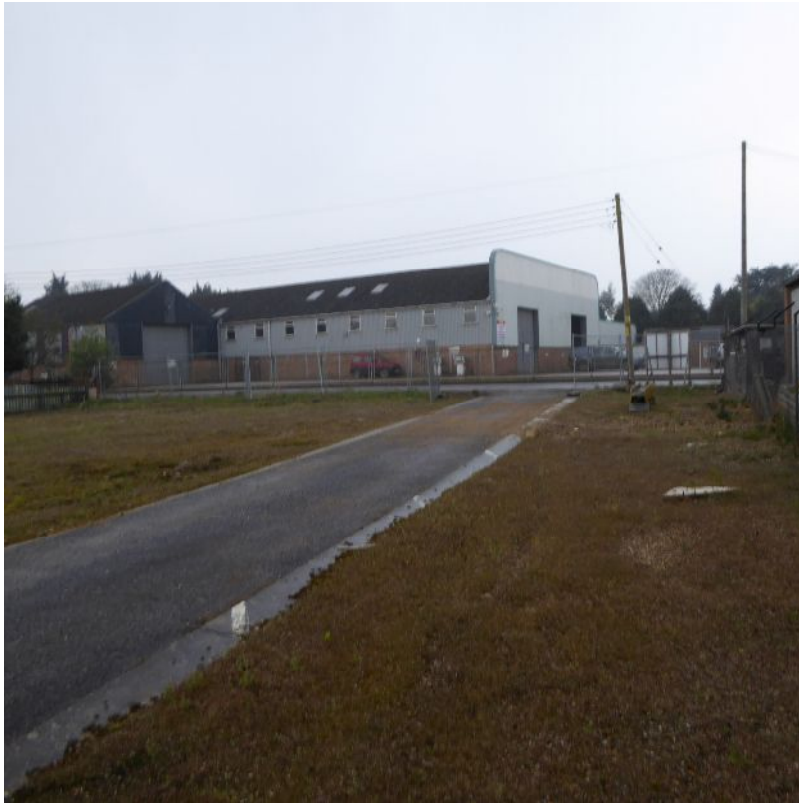
Photo 1 Site entrance on Kirkgate

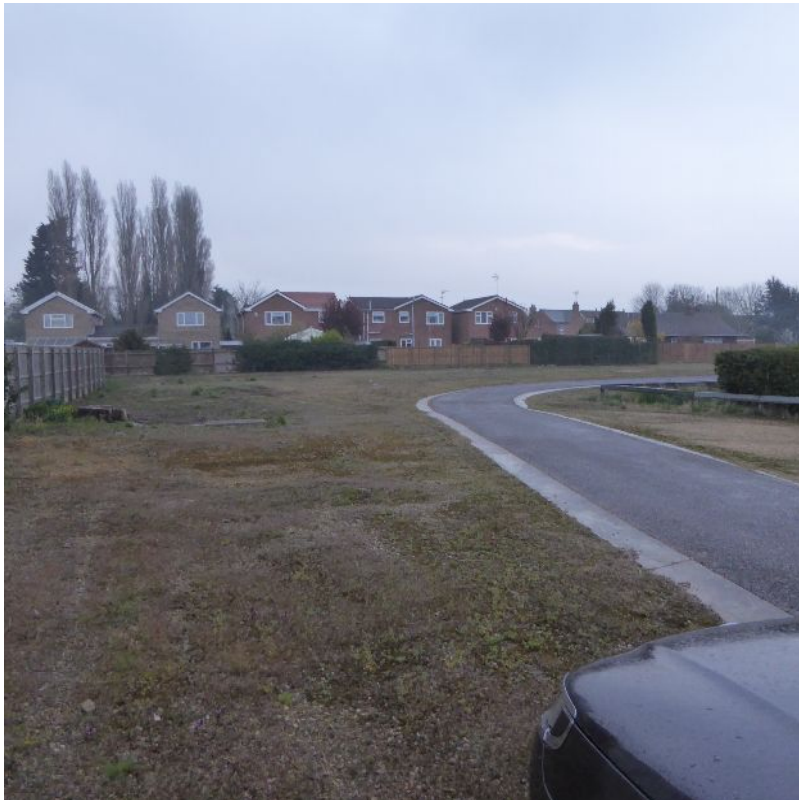
Photo 2 Houses on north eastern side of site

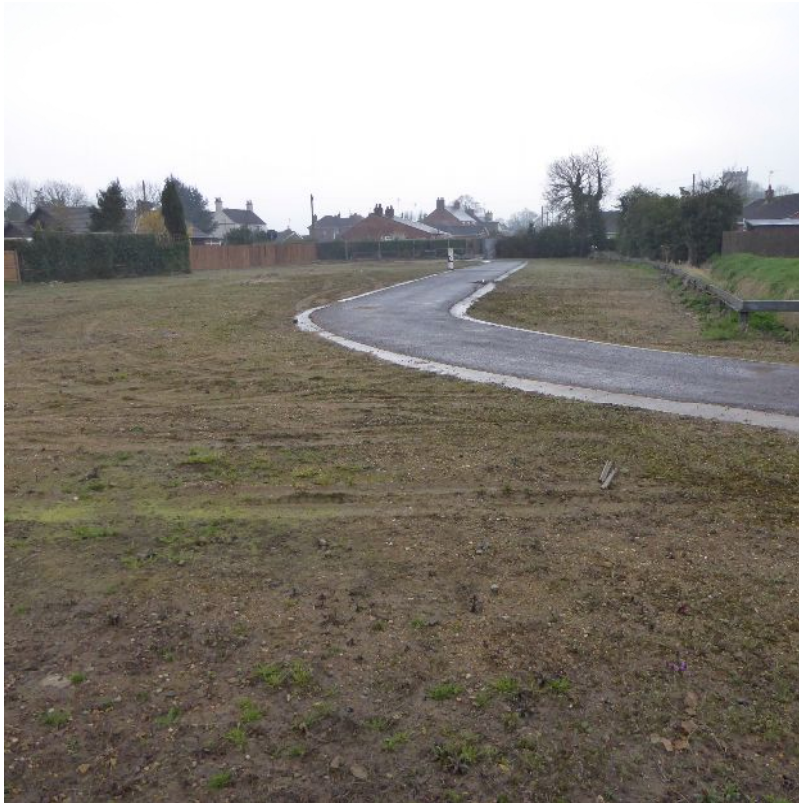
Photo 3 South towards entrance on Cross Street with ditch to right

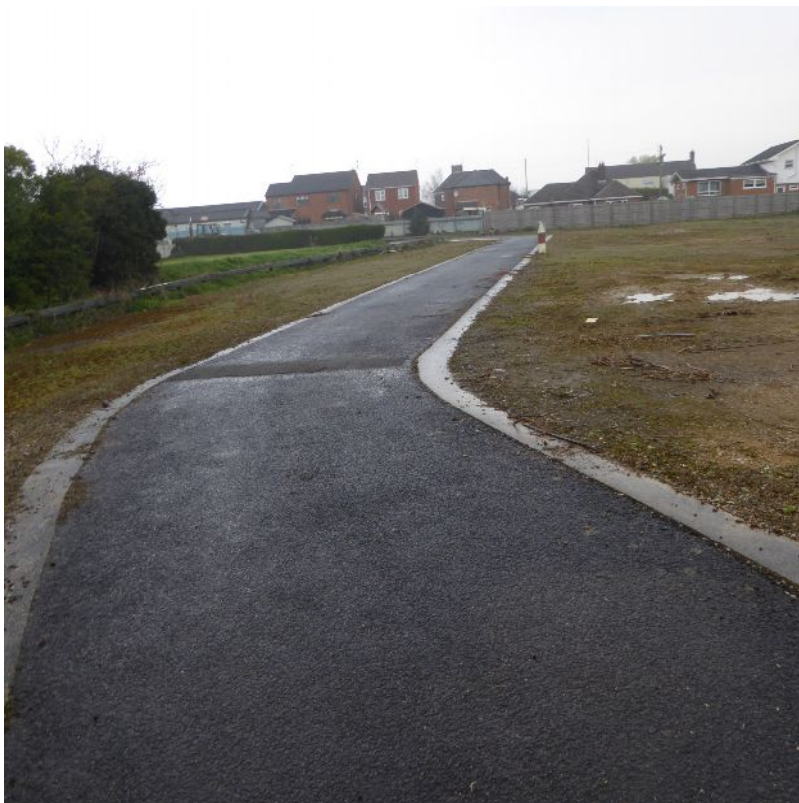
Photo 4 Northern boundary with ditch on left and trees alongside it

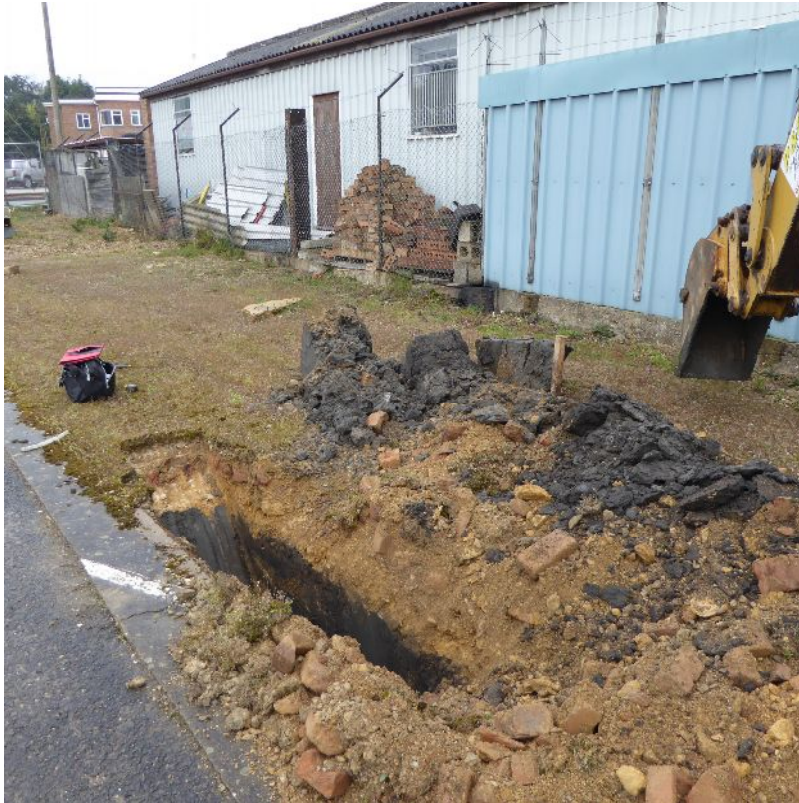
#### TP1 in northwest corner of site (photo 5)

| Depth | Description of ground |
|---|---|
| 0 – 0.300 m | Yellow sand, bricks, stones – fill hard standing |
| 0.3 – 1.4 m | Black dry friable clay |

Photo 5 TP1 near to site of potential fuel tanks

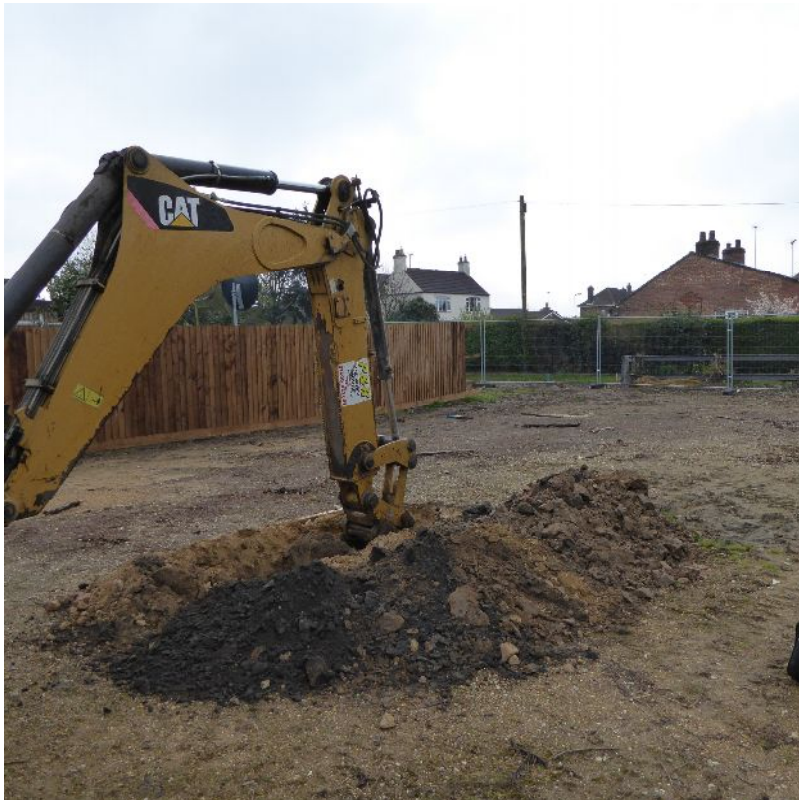
#### TP2 near Cross Street and BH4 (photo 6)

| Depth | Description of ground |
|---|---|
| 0 – 0.250 m | Yellow sand, bricks, stones – fill hard standing |
| 0.3 – 1.2 m | Dark brown silty clayey sand |

Photo 6 TP2 at south eastern part of site and near BH4

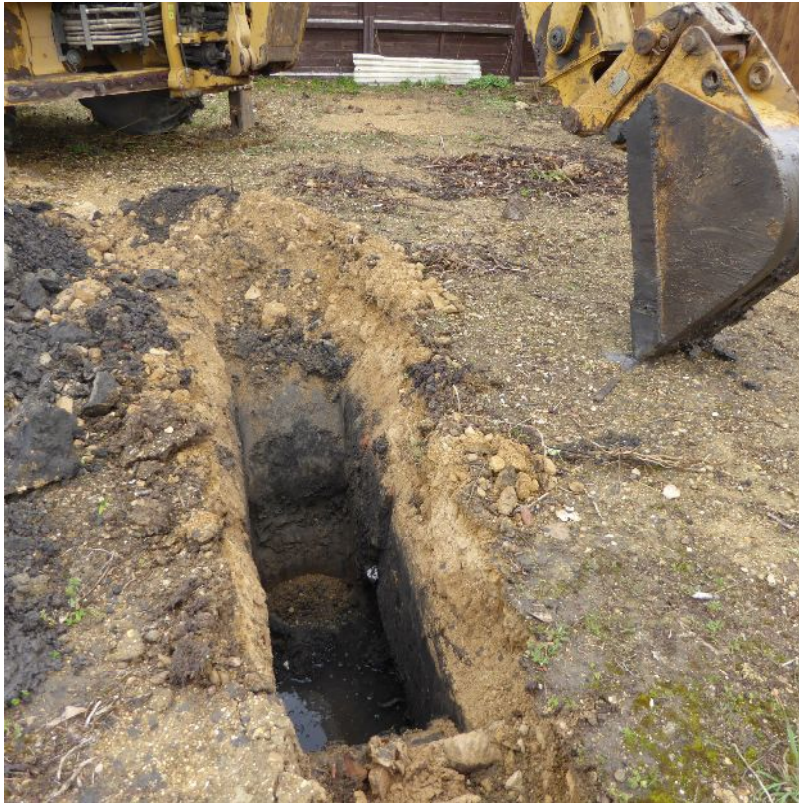
#### TP3 near fence extending onto site (photo 7)

| Depth | Description of ground |
|---|---|
| 0 – 350 mm | Yellow sand, bricks, stones – fill hard standing |
| 0.35 – 0.55m | Black dry friable silty clay |
| 0.9 – 1.2 m | Black dry friable clay hit buried rubbish, metal, pots, glass – water ingress |
| 1.1 – 1.3 m | Light gray very wet silty coarse sand |

Photo 7 TP3 in garden area of plot 3

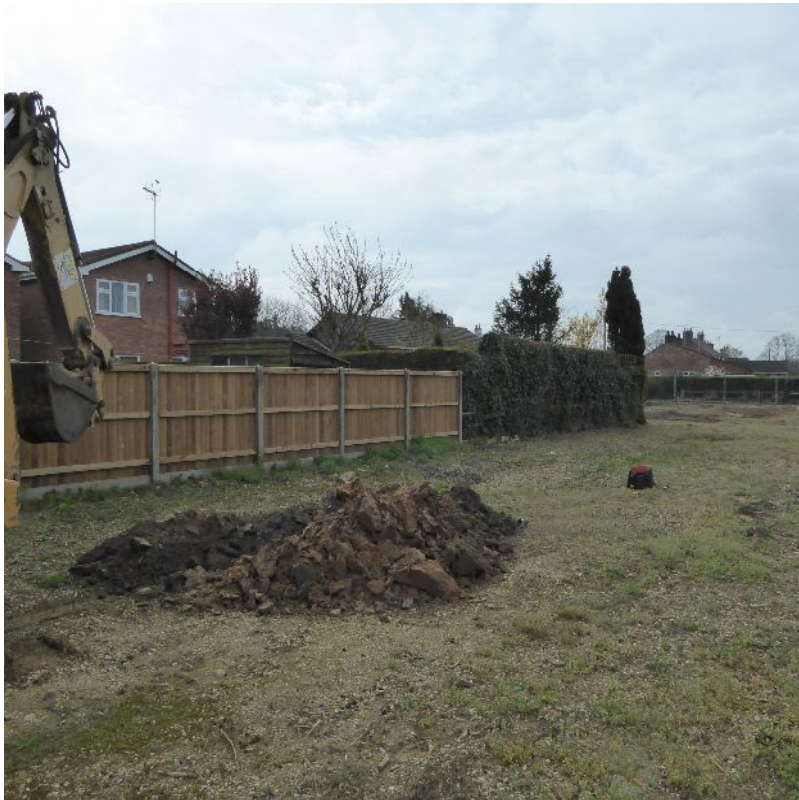
#### TP4 half way down long fence on eastern side of site (photo 8)

| Depth | Description of ground |
|---|---|
| 0 – 400 mm | Dirty dark grey sand, bricks and a few stones |
| 0.4 – 0.7 m | Black friable silty clay |
| 0.7 – 1.6 m | Damp soft brown silty sand |

Photo 8 TP4 in southern part of garden of plot 5

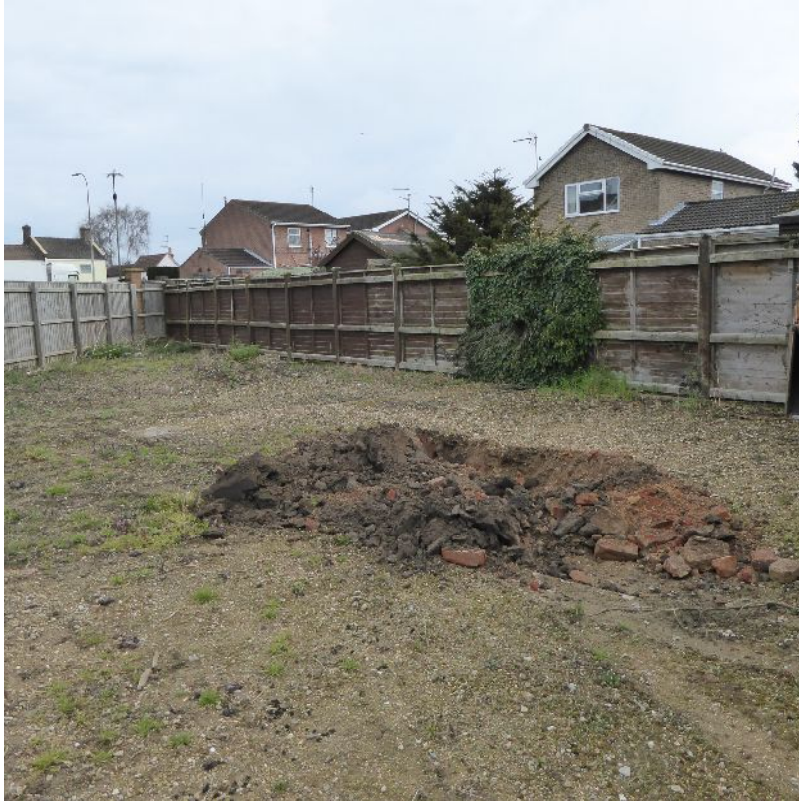
#### TP5 near northwest corner of site (photo 8)

| Depth | Description of ground |
|---|---|
| 0 – 250 mm | Dirty yellow sand, bricks and some stones |
| 0.25 – 0.9 m | Black dry friable silty clay |
| 0.9 – 1.5 m | Damp soft brown silty sand |

Photo 9 TP5 in northern part of garden of plot 5

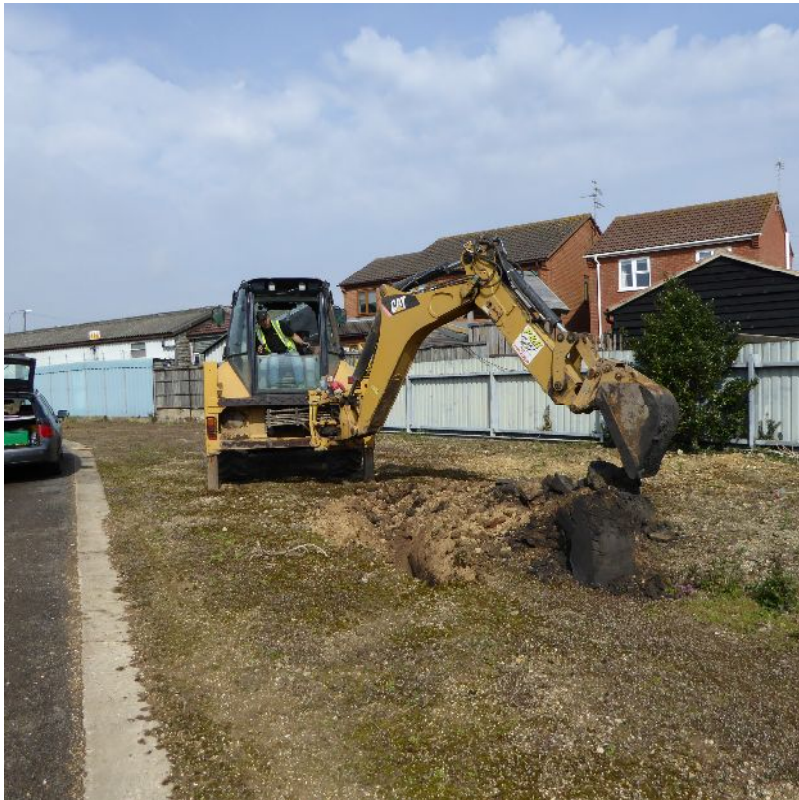
TP6 garden of plot 6 (photo 8)

| Depth | Description of ground |
|---|---|
| 0 – 350 mm | Yellow sand, copious small stones and a few bricks |
| 0.35 – 1.3 m | Black damp friable silty clay |
| 1.3 – 1.6 m | Dark grey silty coarse sand |

Photo 10 TP6 garden area of plot 6

6.1 The top layer of stones, bricks and sand should be removed from garden areas as this is not suitable for plant growth. Soil of suitable quality, as approved by the Local Authority Land Contamination Officer, should be applied to the garden areas to make up the levels.
