# OUTBUILDINGS AT CROWN FARM, STOCKWELL GATE WEST, WHAPLODE, LINCOLNSHIRE

## HISTORIC BUILDING SURVEY

NGR: TF 3306 2504  
PCAS job no. 2840  
Site code: CFWH 23  
Planning ref. H23-1116-21  
Archive acc. no.: LCNCC: 2023.77

Report prepared for G. R. Merchant Ltd.

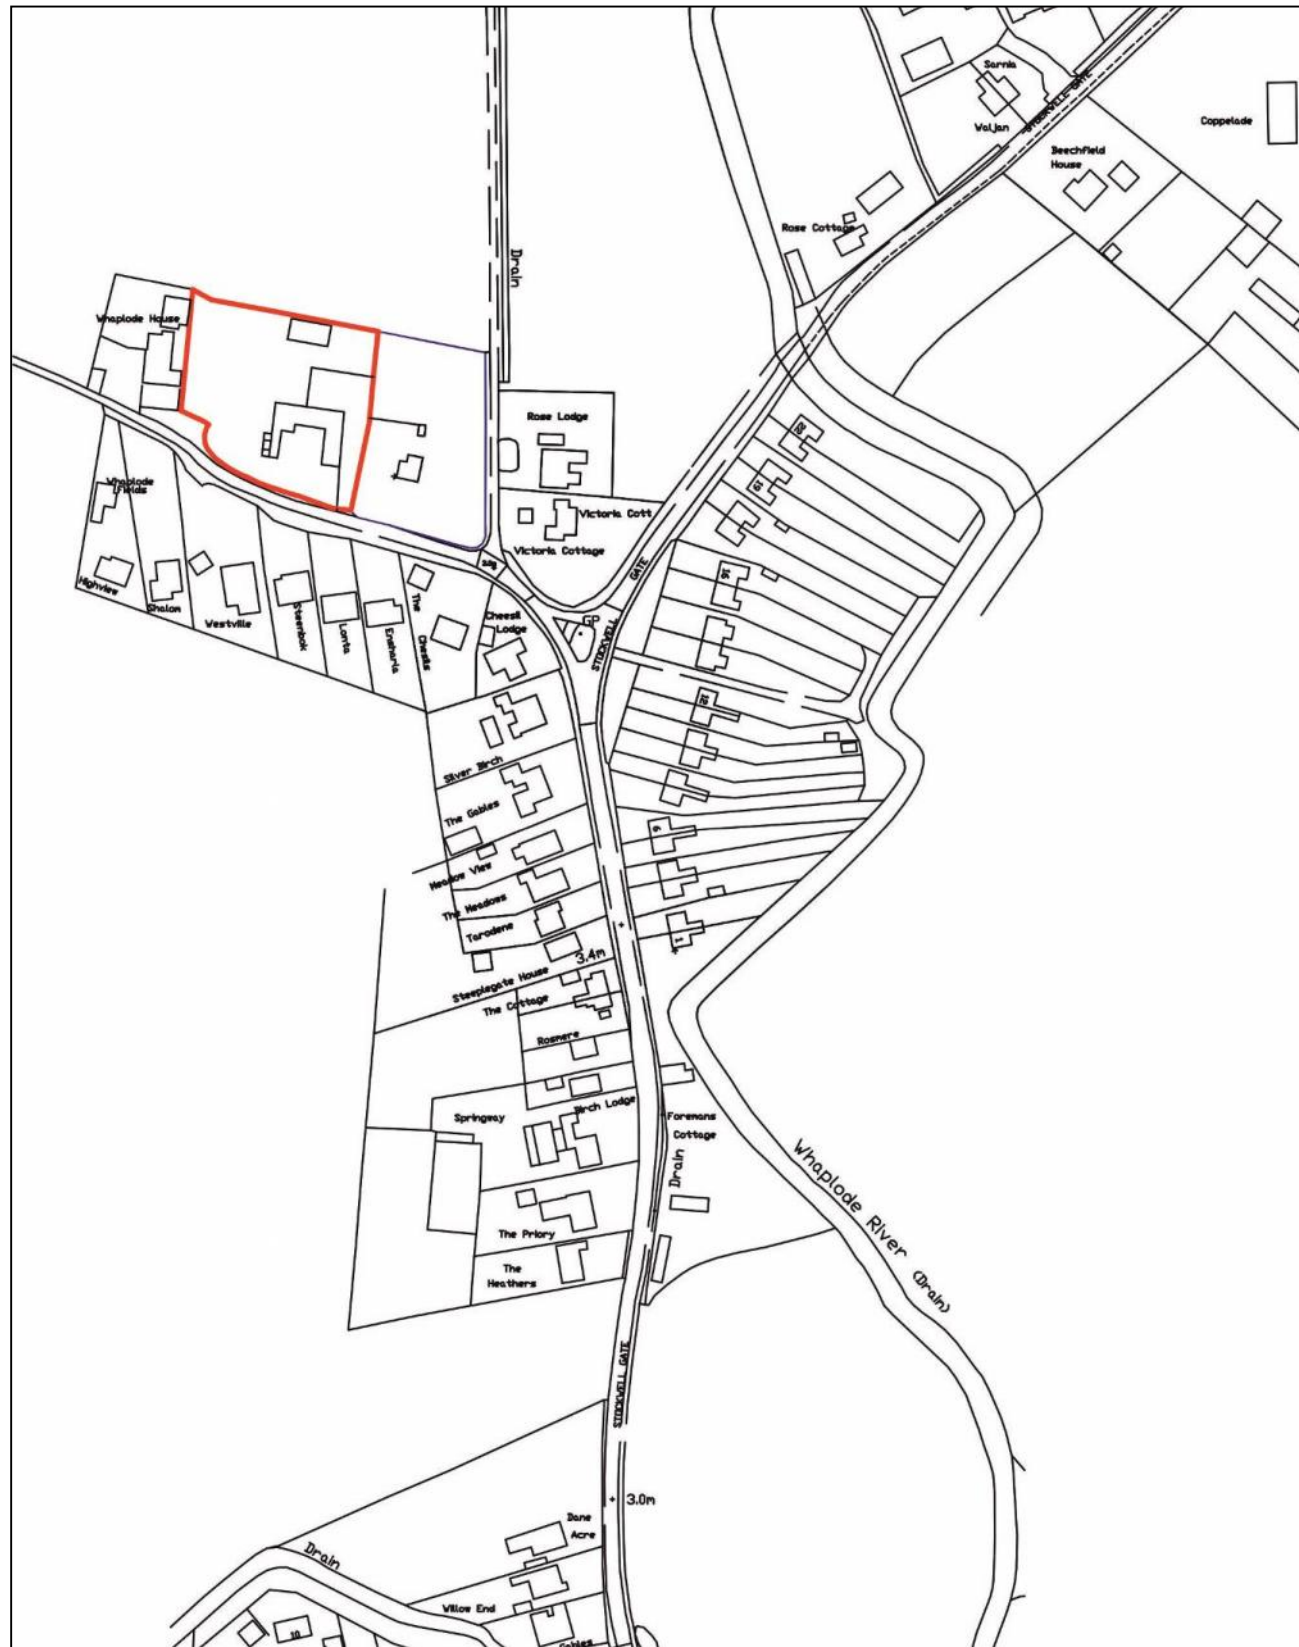
**Figure 2:** Location plan of the proposed redevelopment site at scale 1:2500. The area marked in red denotes the farm outbuilding complex. Plan supplied by developer.

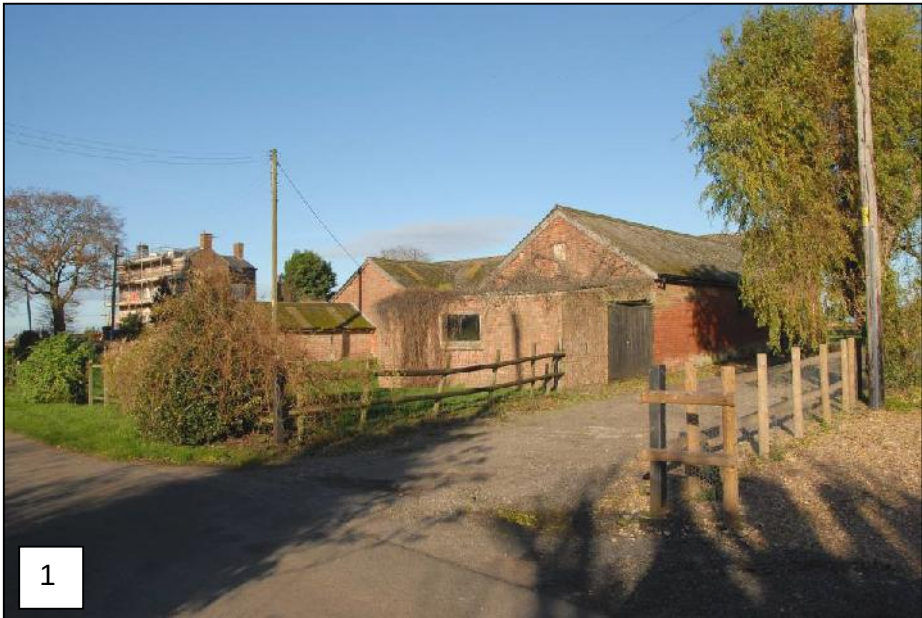
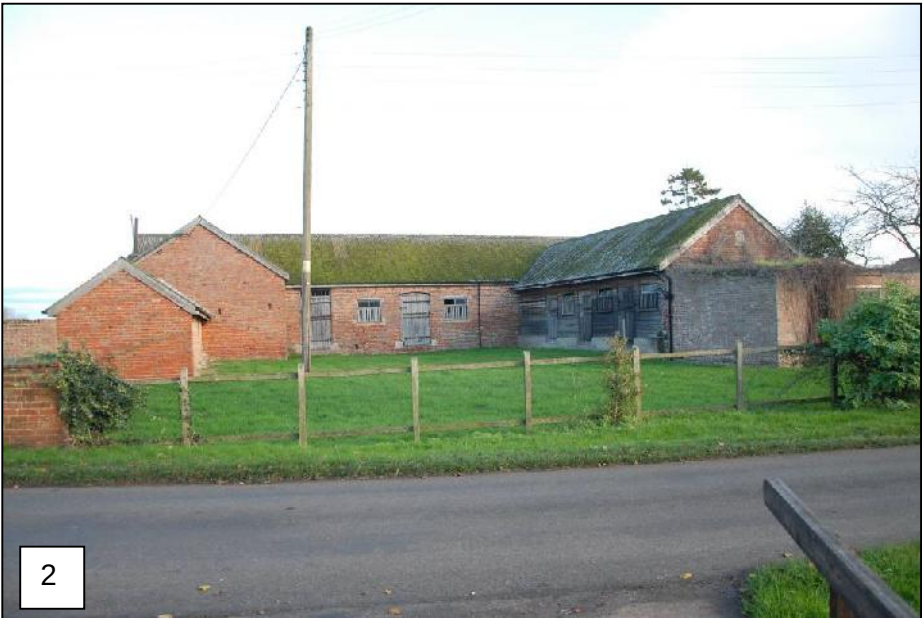
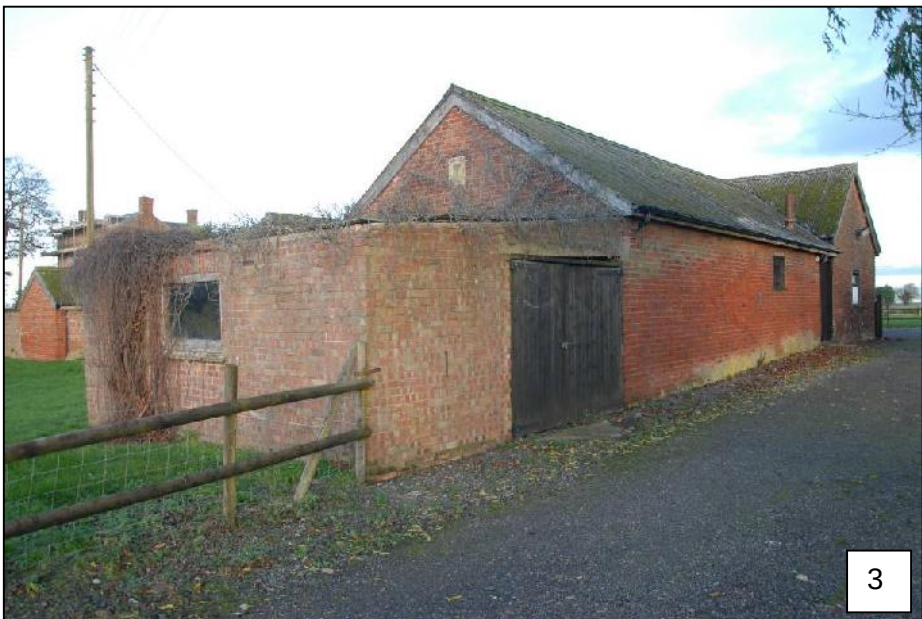
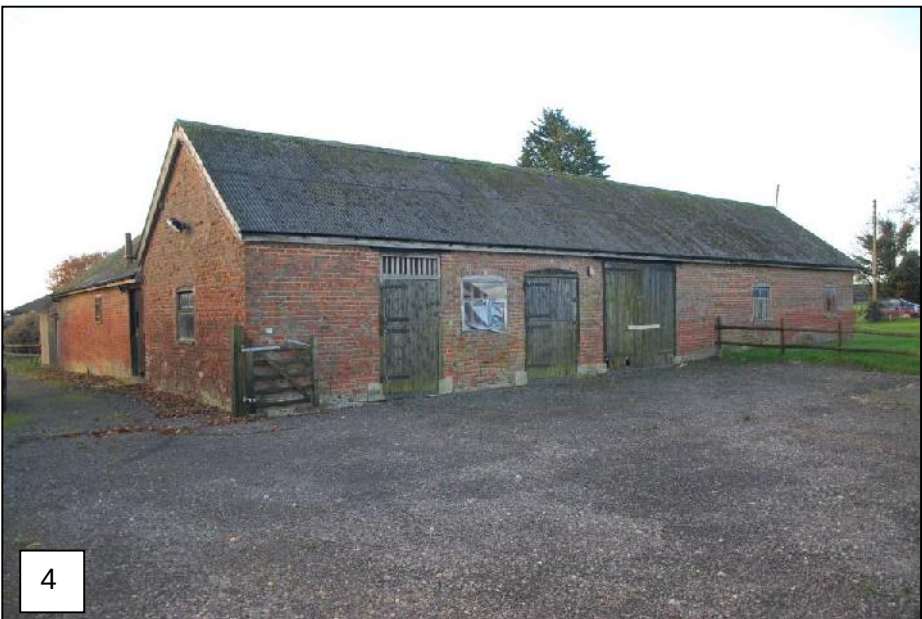
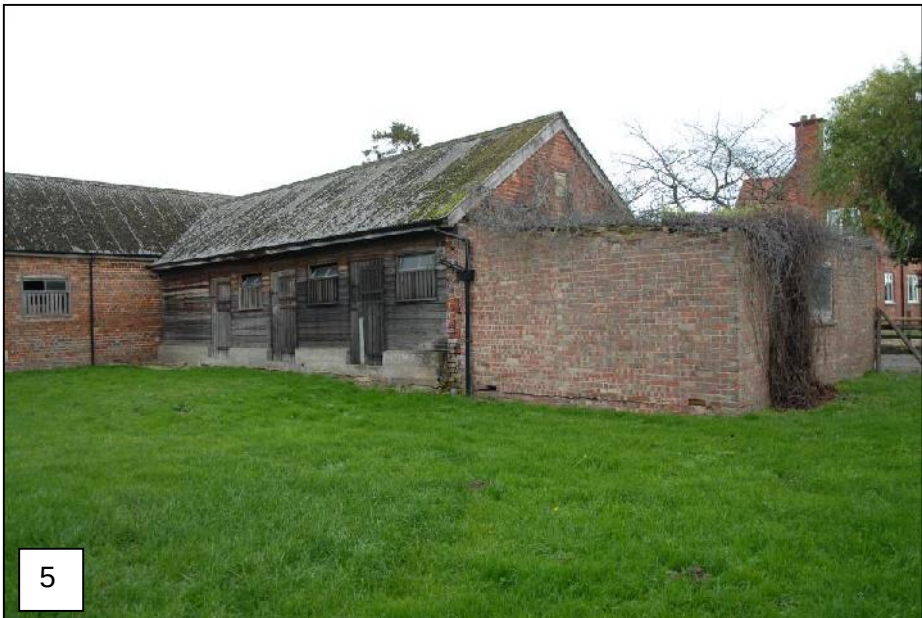
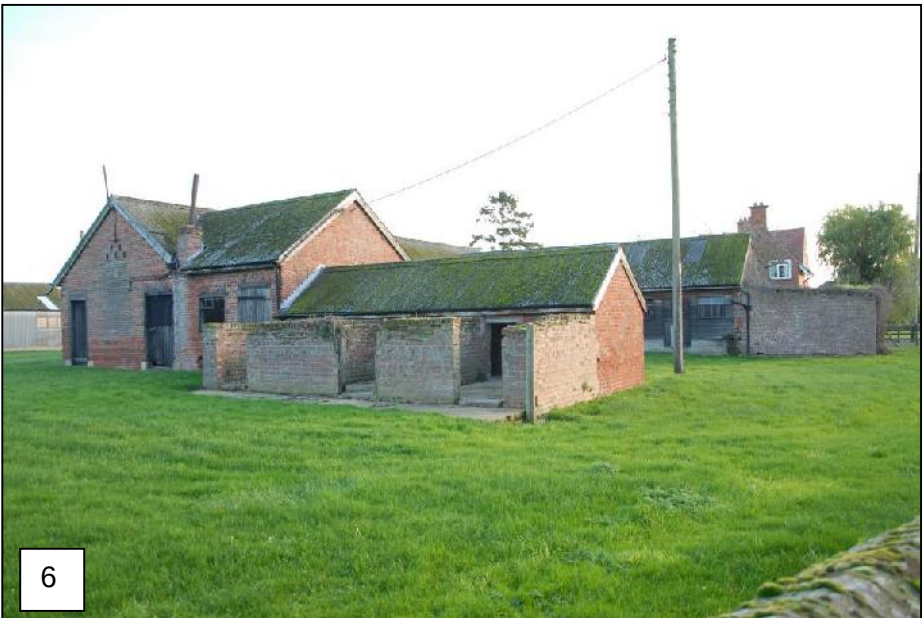
The farm occupies a relatively level and low-lying fenland position; the surrounding ground slopes gently from the north boundary of the site towards Stockwell Gate West, the buildings occupy a fairly level platform. Threshold levels within the crewyard indicate that some ground has been lost here. The total slope is perhaps 0.5m over the length of the site.

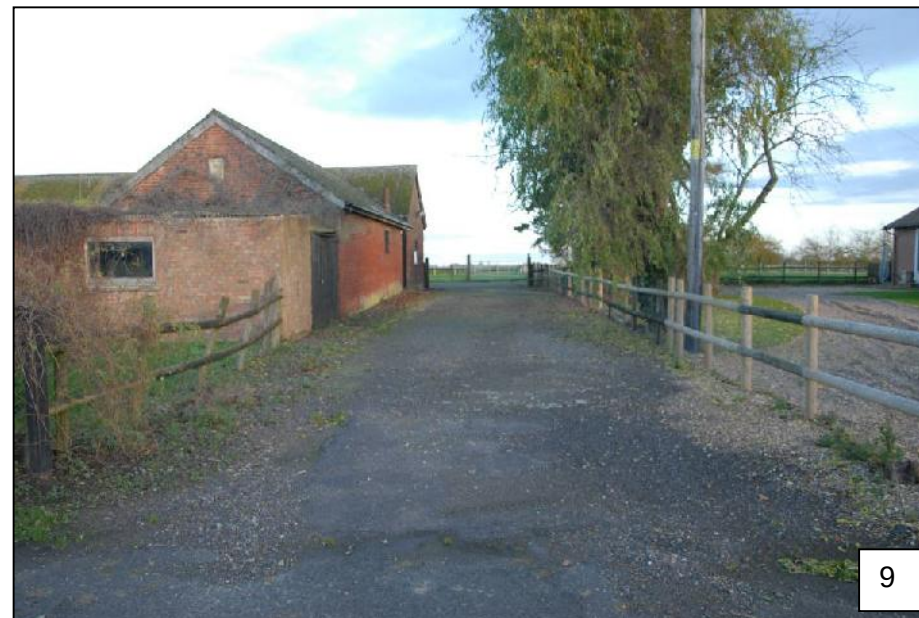
With the farmhouses now in separate ownership, the only remaining access to the group is along a track at the east side of the buildings. It is clear that this track has always served this purpose, as a row of mature trees separates it from the access to Crown Farmhouse.

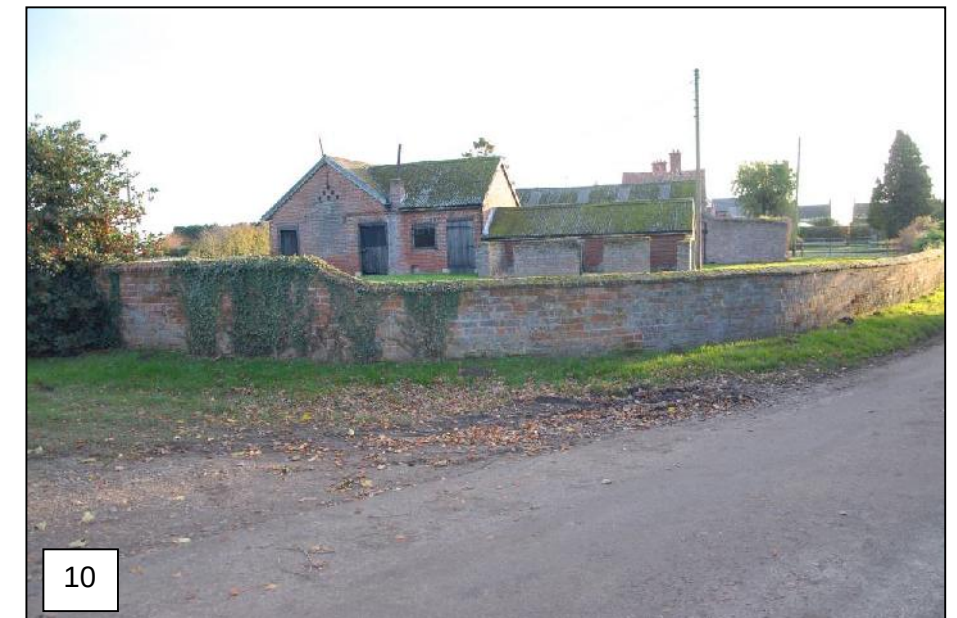
The southwestern boundary of the group is defined by a brick wall, originally shared with Whaplode House. This is of red/orange brick - some overfired - (brick size: 8-9" x 4" x 2¼-2¾"; 3 courses = 8½"), in English bond; it reduces in thickness to 9" (top course) with a pyramidal brick coping.

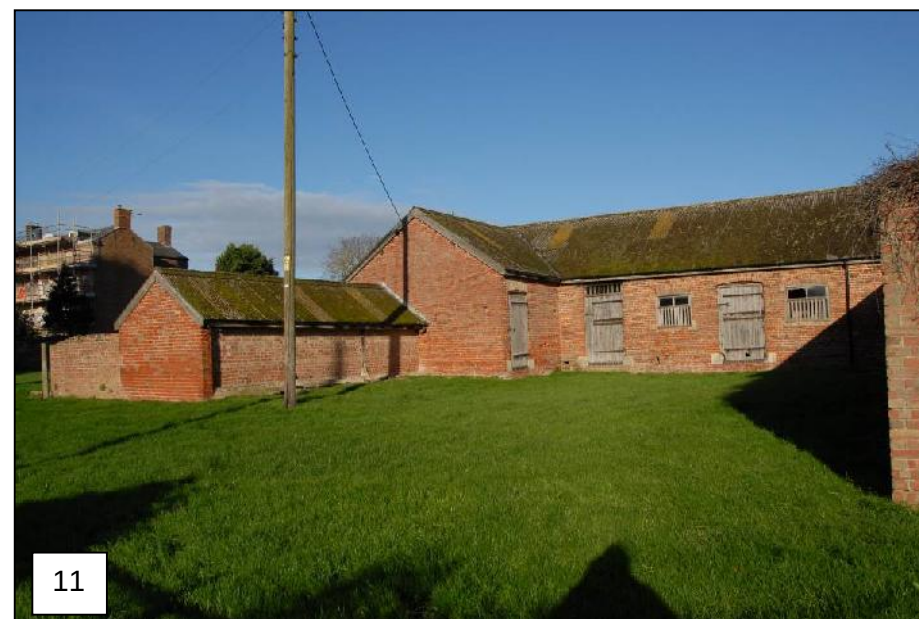
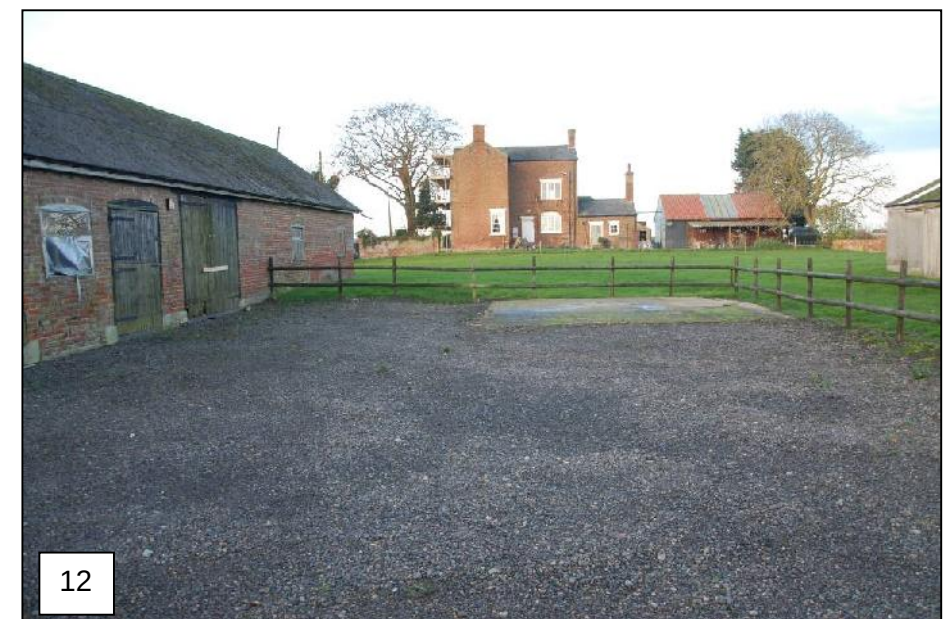
The area to the north of the farm was the traditional stackyard. This area is now divided by a post and rail fence and the eastern part surfaced in scalplings.

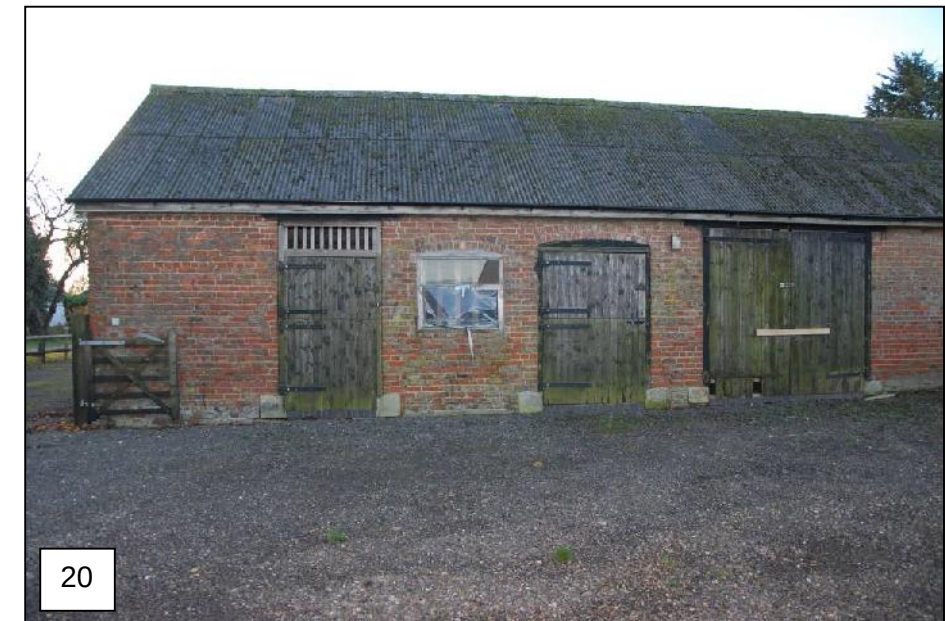
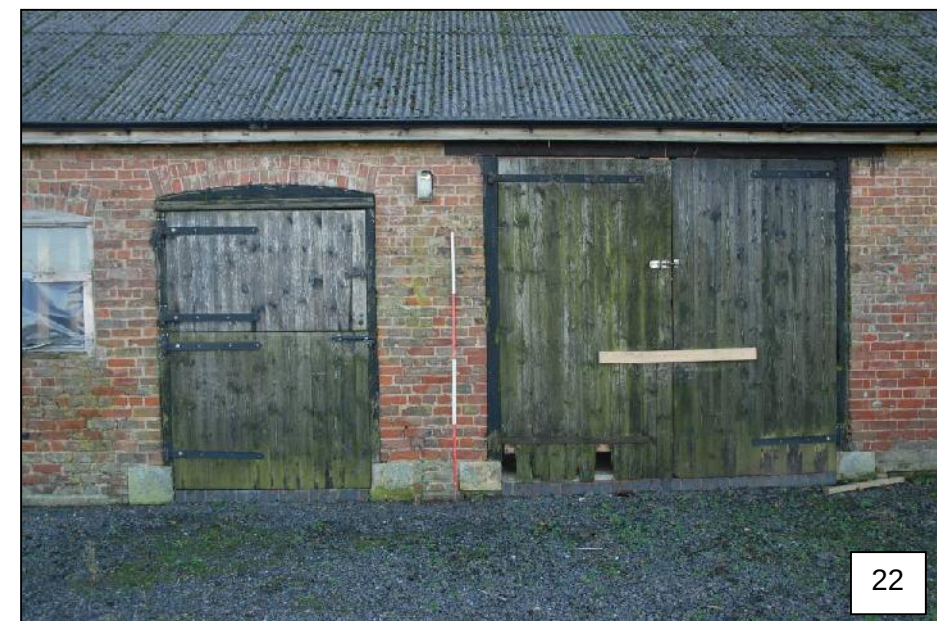
The eastern part of the north elevation has four openings - all can be attributed to the crew yard conversion of the farm. They do provide typical examples of their types, which (except for the double doors) appear repeatedly throughout the group.

**Windows:** where originals survive, these are 2-pane over hit-and-miss ventilators. All door and window openings are 1890s phase.

**Doors:** these have sandstone lower hinge blocks and engineering brick thresholds.

Openings generally have segmental lintels composed of a double row of edge-set headers with a stretcher at each side; some doors have timber slat ventilators above them.

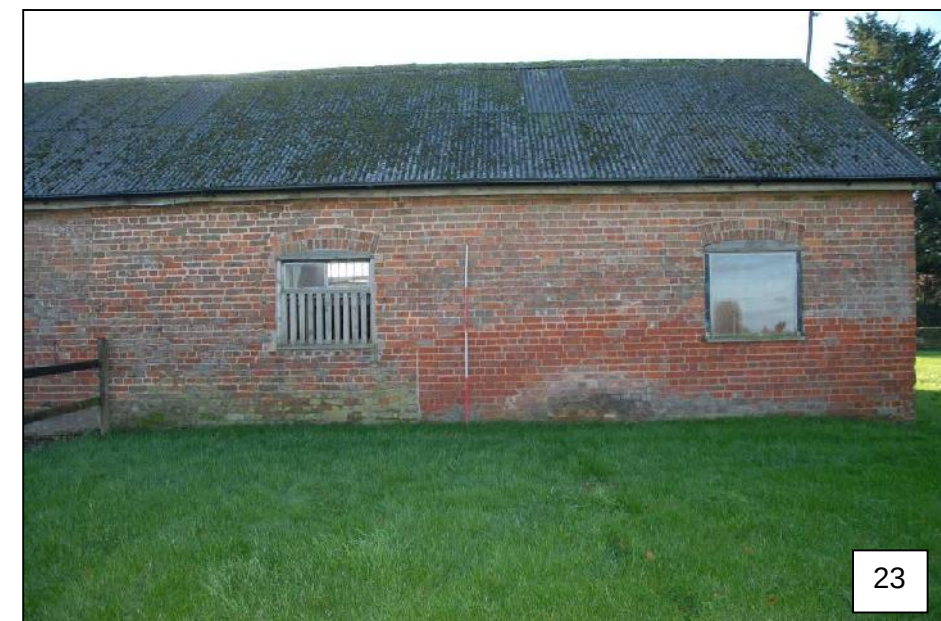
It is at the west side of the north elevation that the building phases are clearly displayed. Here, a straight joint and an area of English bond brickwork suggest an earlier phase while the distinctive Flemish bond continues around the west gable.

A further change in the brickwork can be noted to the immediate west of the double door opening, where an original large opening may have been bricked up.

The hit and miss ventilators are clearly inserted into the surrounding brickwork.

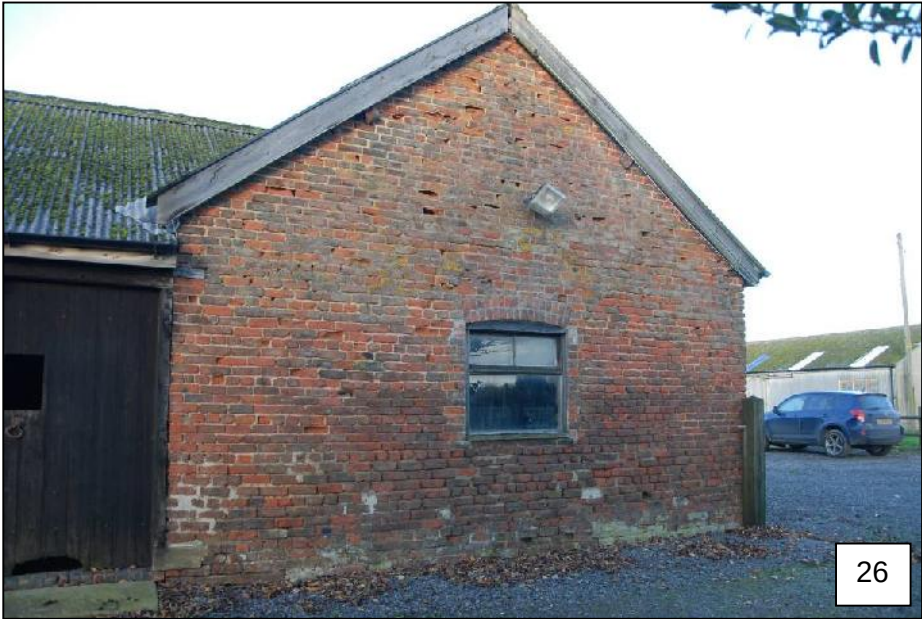
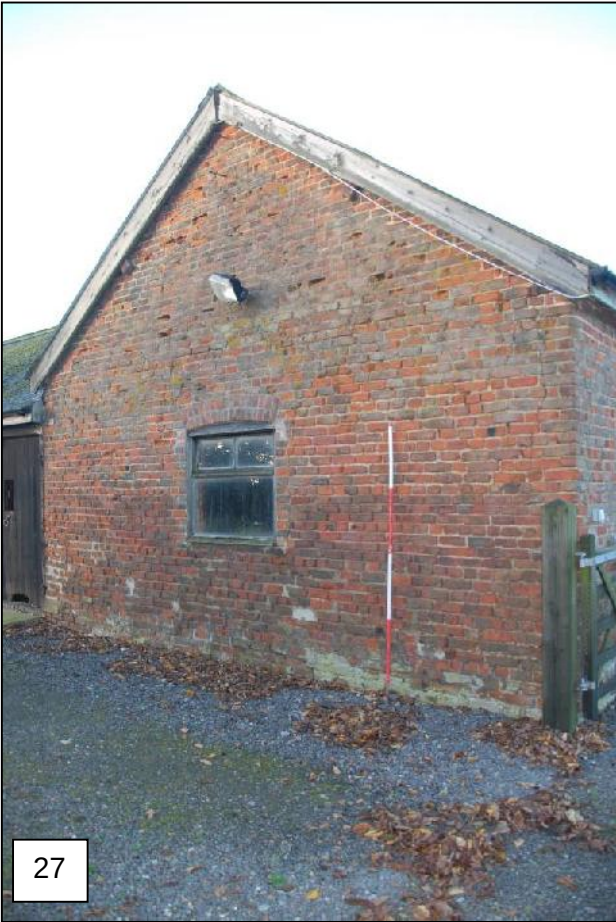
The east gable has only a single central window converted from a hit and miss ventilator. Its lintel is a match for those seen elsewhere in the group.

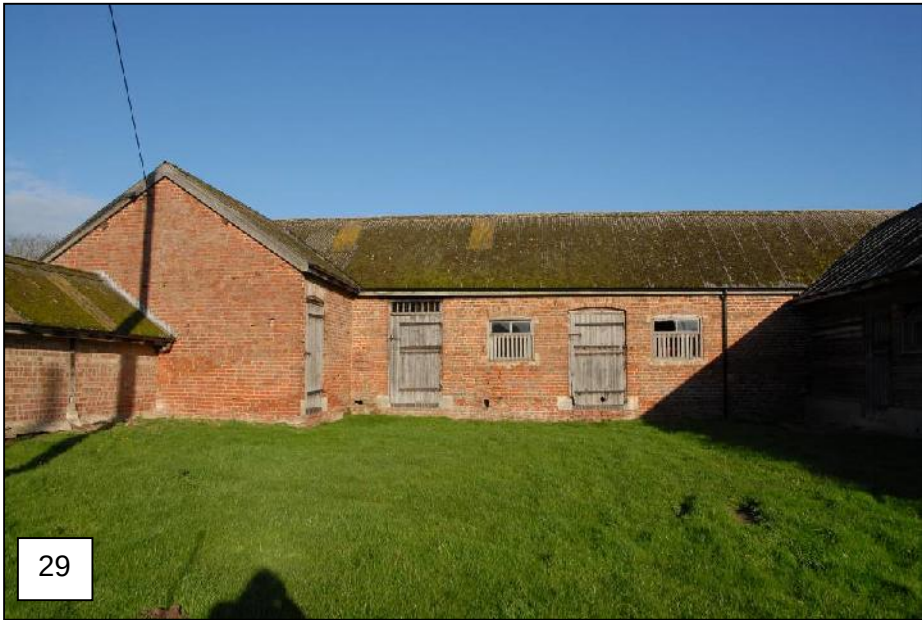
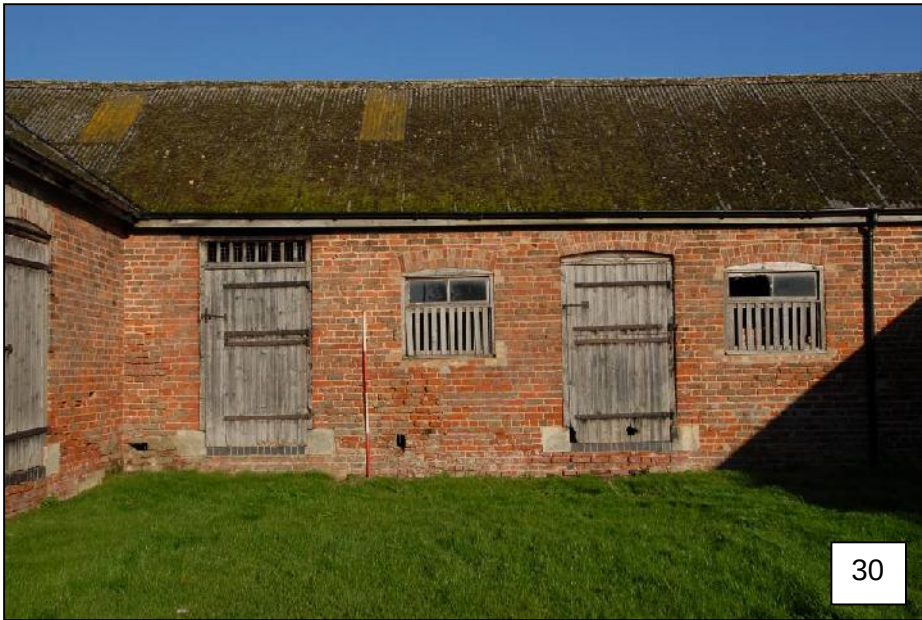
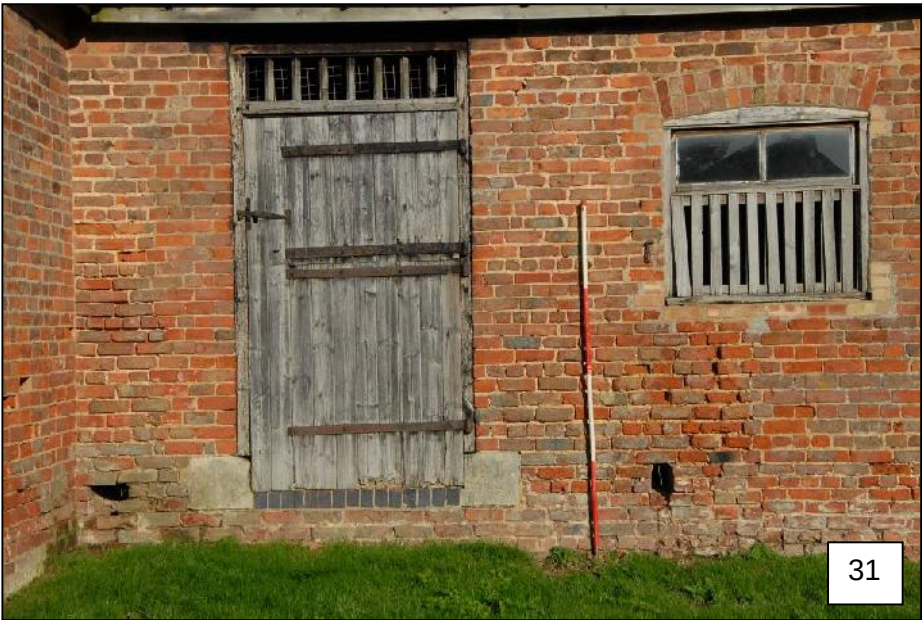
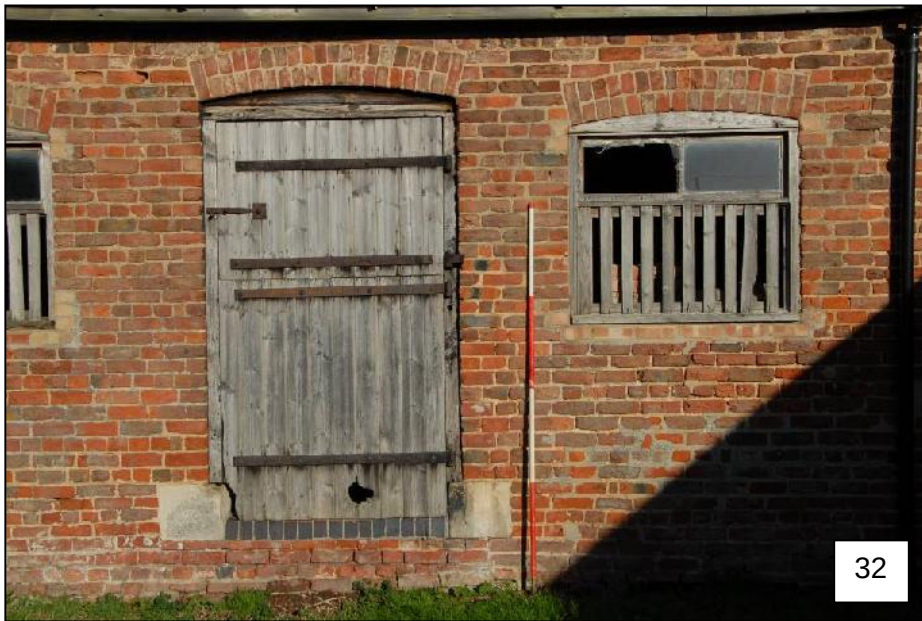
While the brickwork is part of the original building, the openings are all inserted as part of the crew yard conversion.

Two stable type doors are present along with two hit and miss ventilators. All show the distinctive lintels identified on the north side; the western door has a timber vent above.

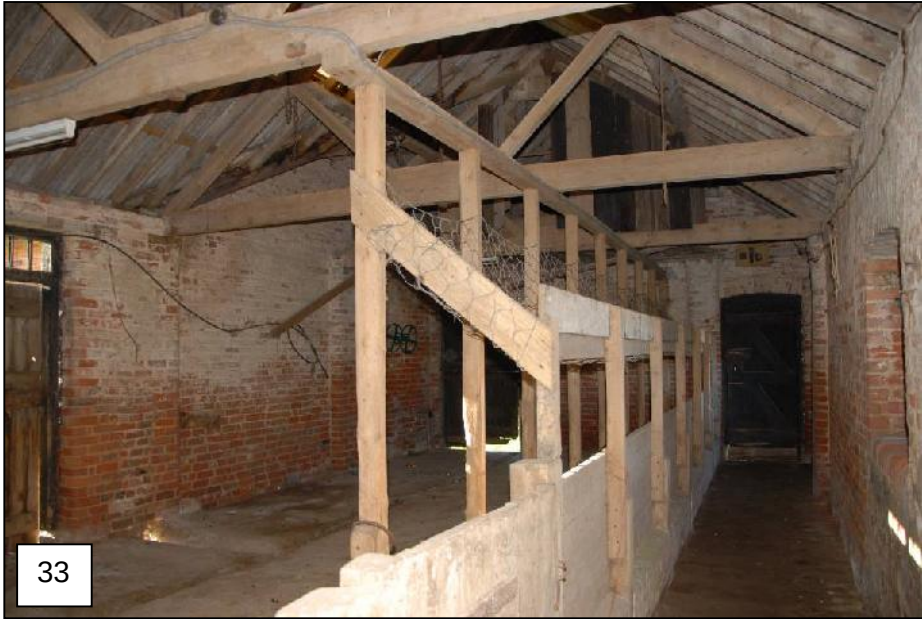
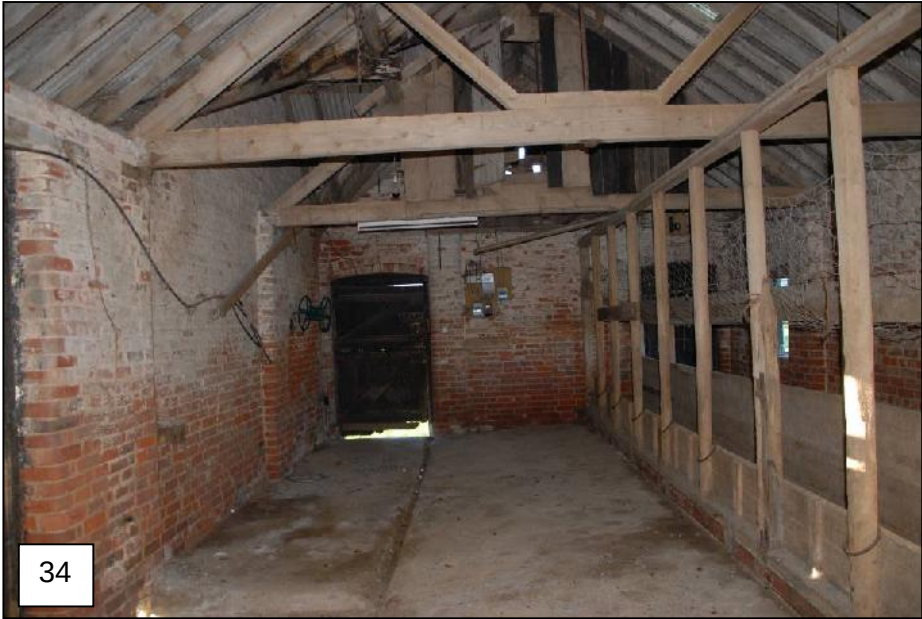
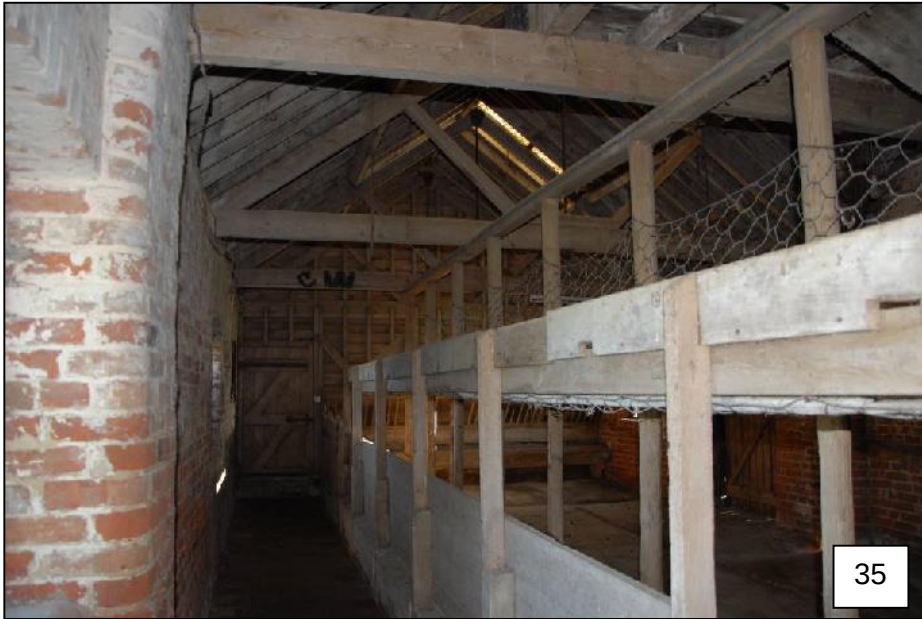
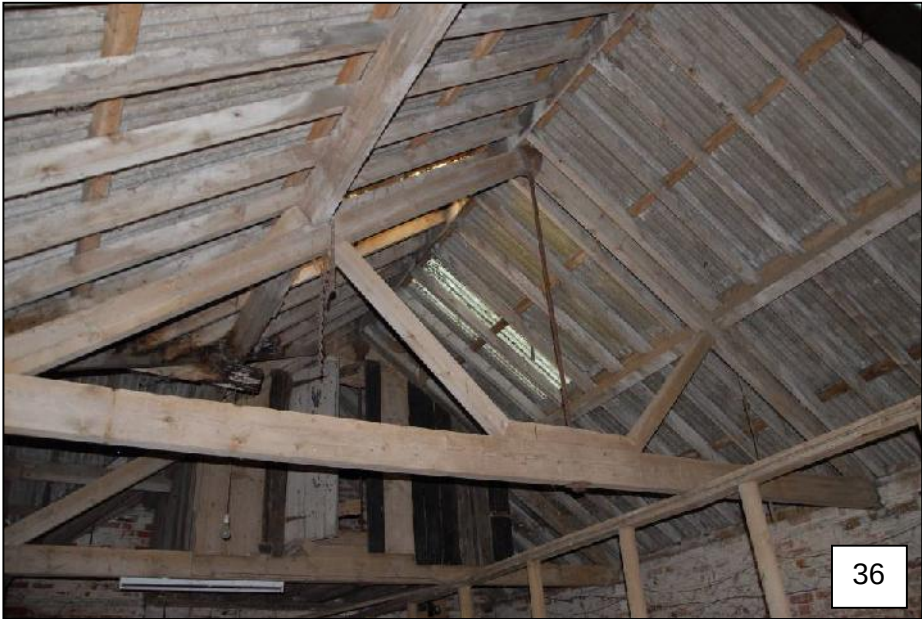
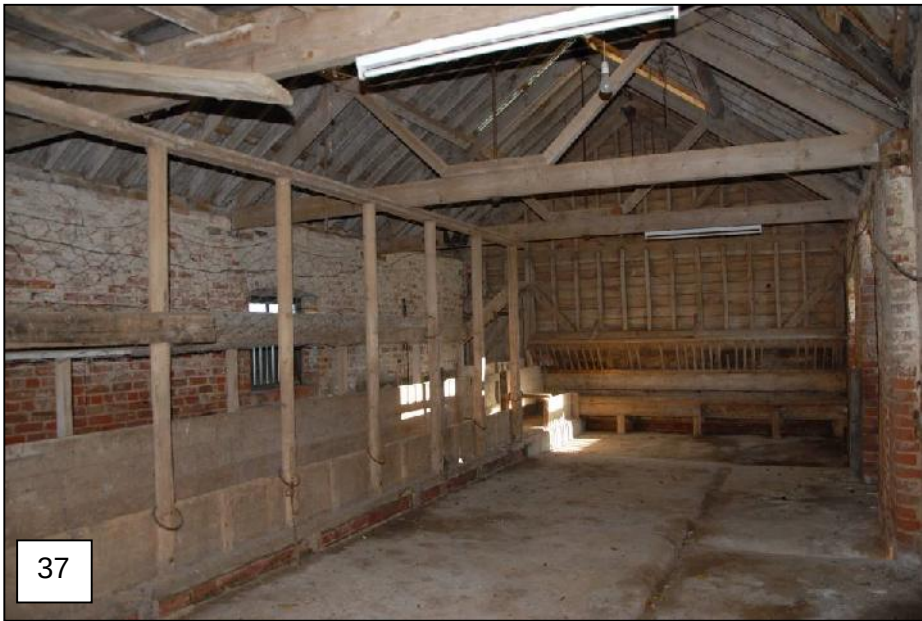
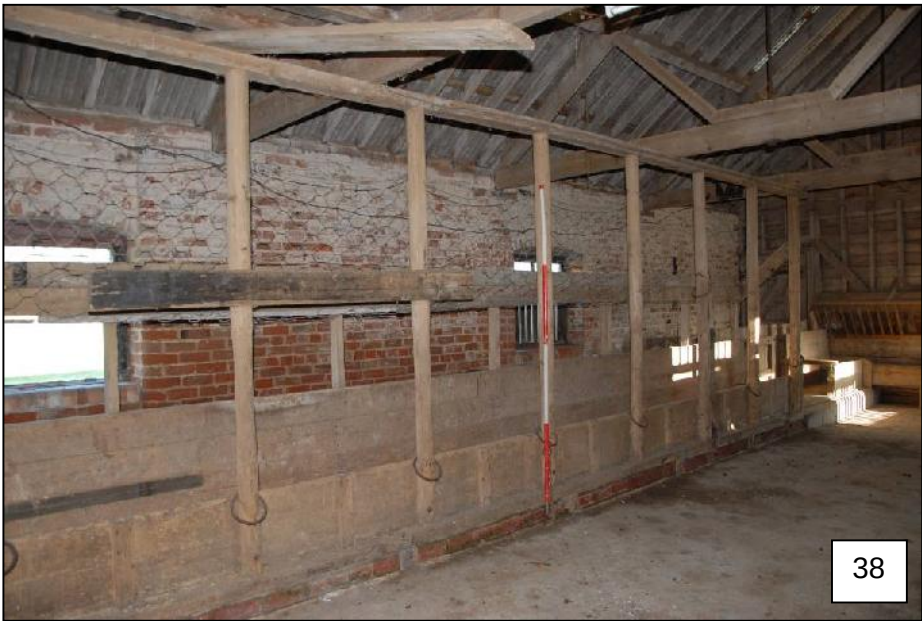
The roof is of common rafters (4" x 2½" at 13" centres), supported on trusses with timber struts and a central vertical iron rod. This has the appearance of a modified king-post arrangement, with the post replaced by a tie-rod; however, as the struts are not supported from the king post, they are simply butted against a horizontal member of similar size laid on the tie-beam. The trusses have 7½" x 3" ties, 6" x 3" blades and 4" x 3" struts. Through-purlins (6" x 4") are trenched and chocked at the blades and a ridgeboard is present.

The timber partition separating the passage from the cattle has 4" square posts, 3" x 2" uprights and 7" x 1½" planks. An integral feeding trough is 21" wide and supported from the underside of the roof trusses on a series of round wood posts (3¼" - 3¾" in diameter) - some of chamfered timber, worn smooth. 6½" diameter tether rings are secured to these posts. The trough itself has a breeze block/single course brick plinth. Access at the east side has 5" square posts.

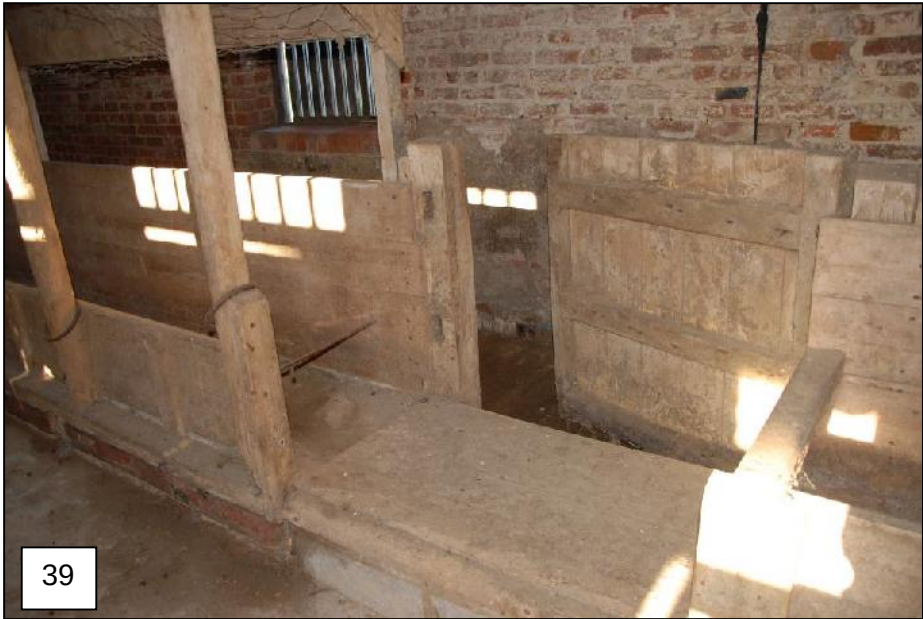
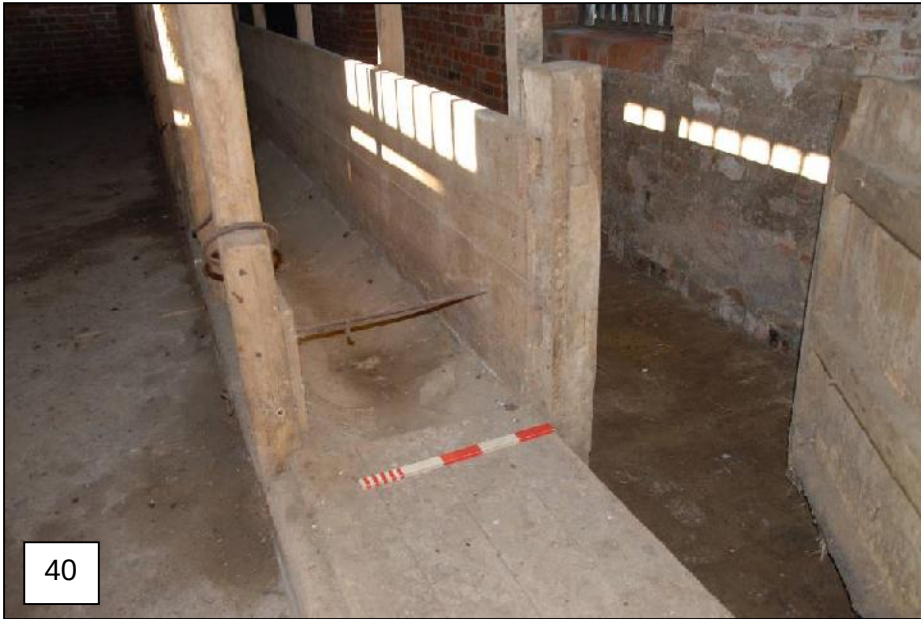
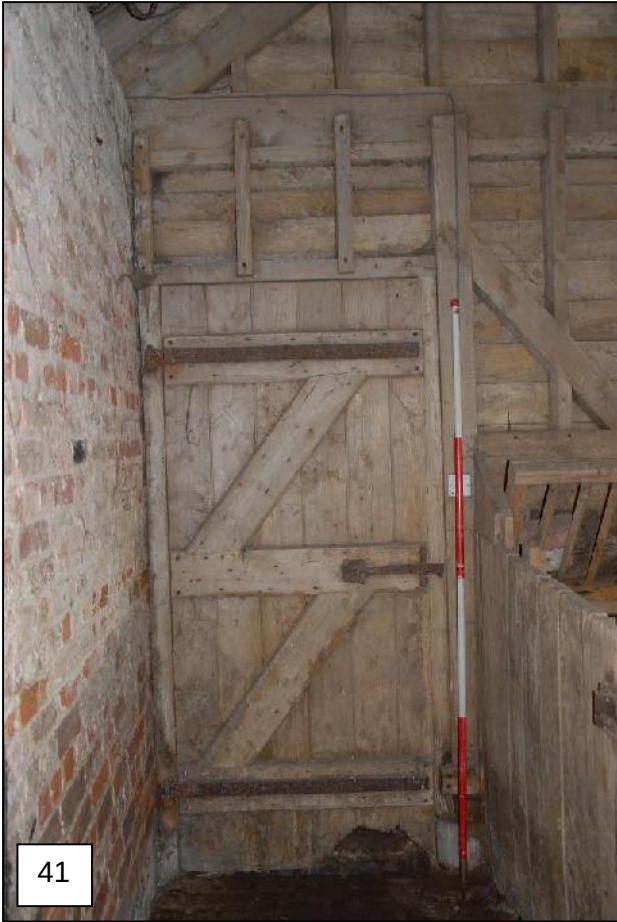
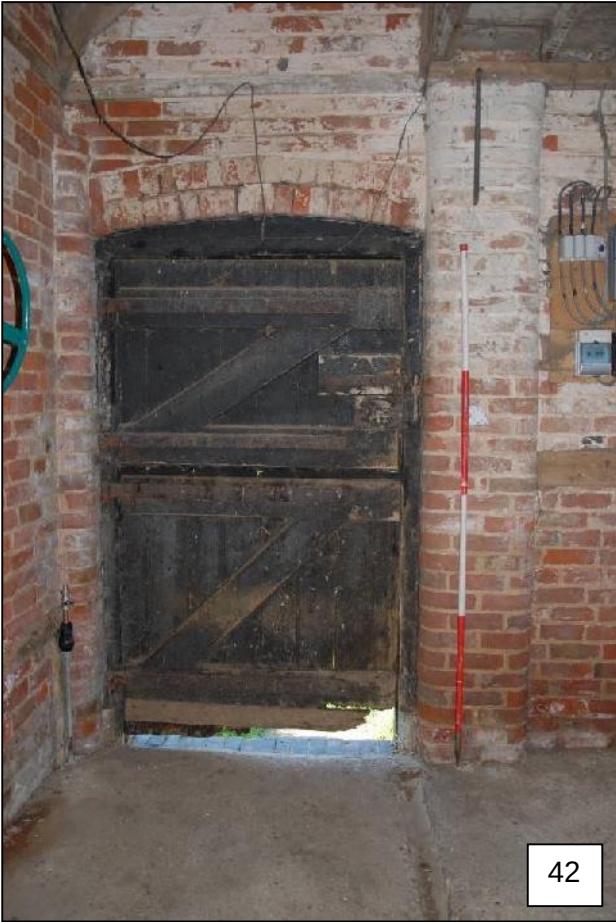
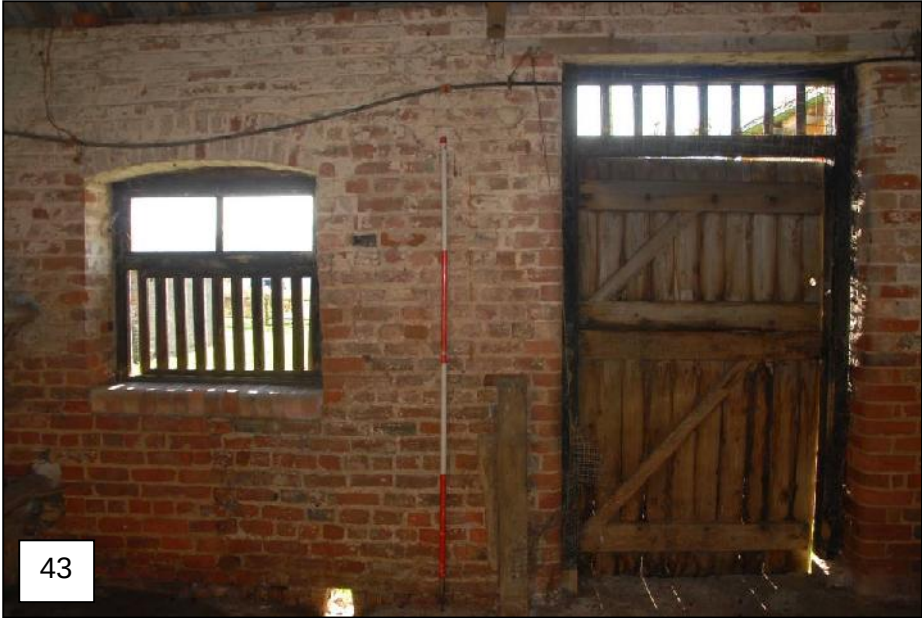
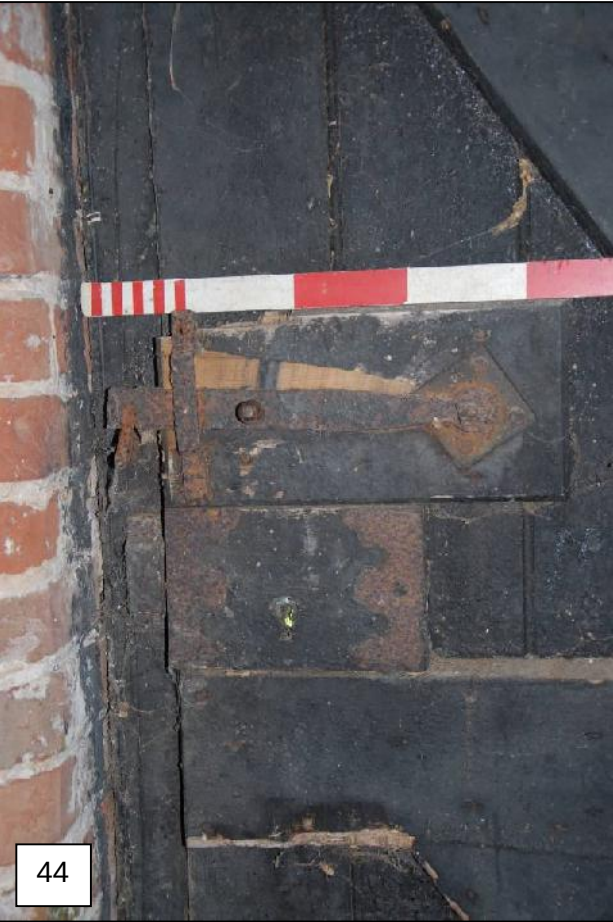
The room is accessed through several doors. Those at the north side are conventional doors of ledged and diagonally braced vertical plank construction of 6½" bead-edged 1¼" planks with 6½" ledges and braces in 1½" timber. They are hung on heavy 2¼" strap hinges and are secured with latches and ornate lock boxes.

The door at the SW side is identical materials and similar construction, but is a stable-type door. To the south, the door is ledged and diagonally-braced 5" vertical matchboard on 2" strap hinges. Where present the doorframes are 3¾" x 5½" with run-out chamfered lintels; the south door has a timber slat fanlight.

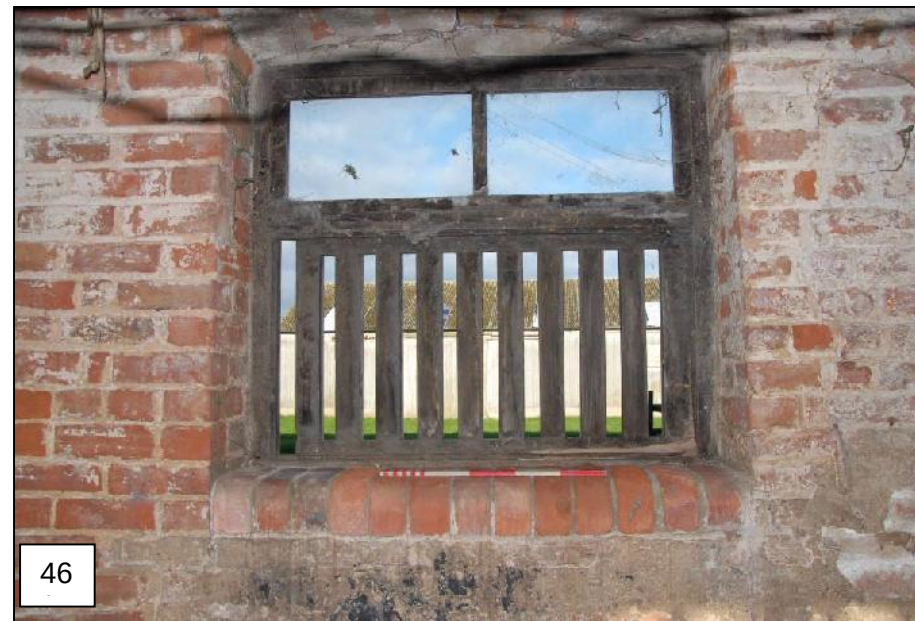
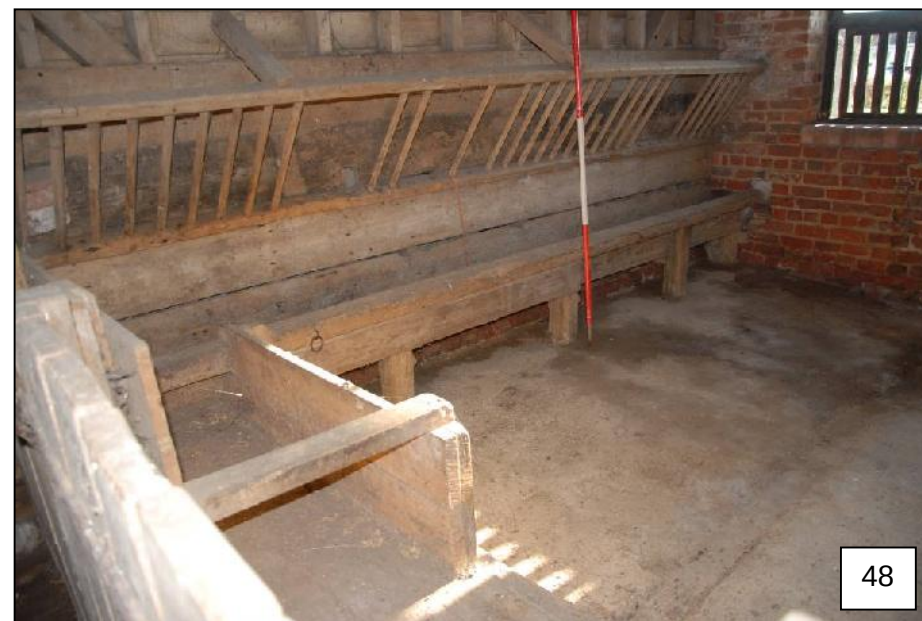
The room is lit by part-glazed hit-and-miss ventilators. These have 2½" x 3¼" sliding slats in a 2" x 4" frame with 18½" x 10¾" panes above. The openings have bullnosed brick sills.

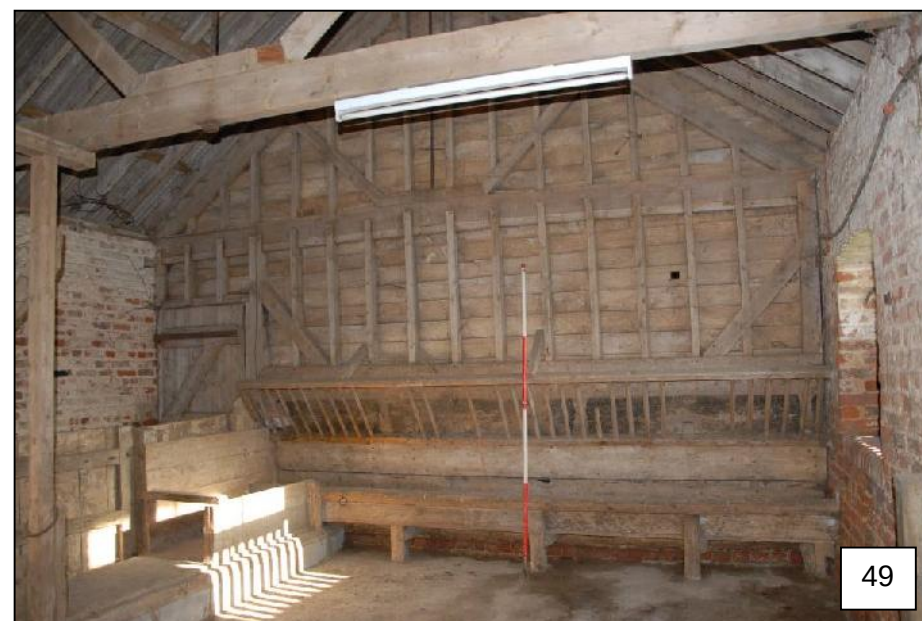
The east end of the room (presumably a calf pen) has a timber feeding trough: of 6¾" planks, it is 21" in height with a 4" x 3½" rail. It projects 16" from the wall; it is 11" deep and supported on 4" square posts. A timber hay rack above has 3" x 2¼" rails and 1" square slats at 4½" centres. This is 55" from the floor (max).
