# OUTBUILDINGS AT CROWN FARM, STOCKWELL GATE WEST, WHAPLODE, LINCOLNSHIRE

## HISTORIC BUILDING SURVEY

NGR: TF 3306 2504  
PCAS job no. 2840  
Site code: CFWH 23  
Planning ref. H23-1116-21  
Archive acc. no.: LCNCC: 2023.77

Report prepared for G. R. Merchant Ltd.

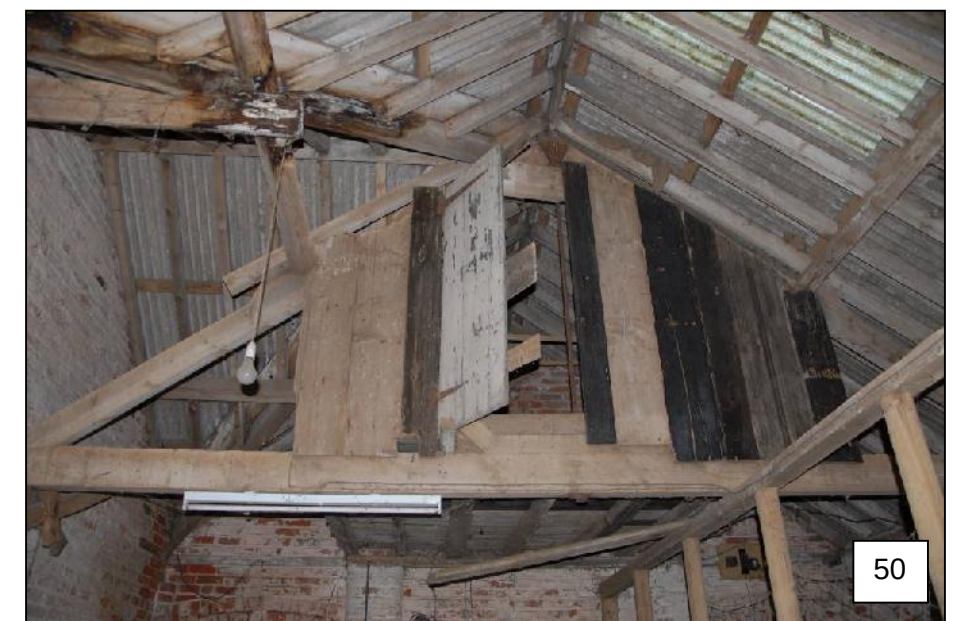
An area between the western roof truss and the west gable has been enclosed as a pigeon loft – this appears to be an improvised construction using a variety of re-used timber.

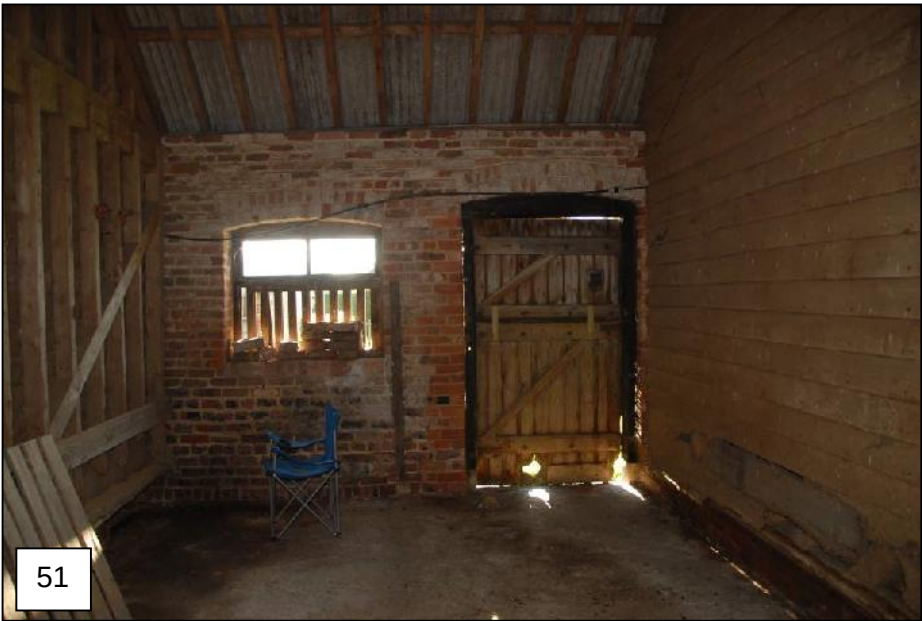
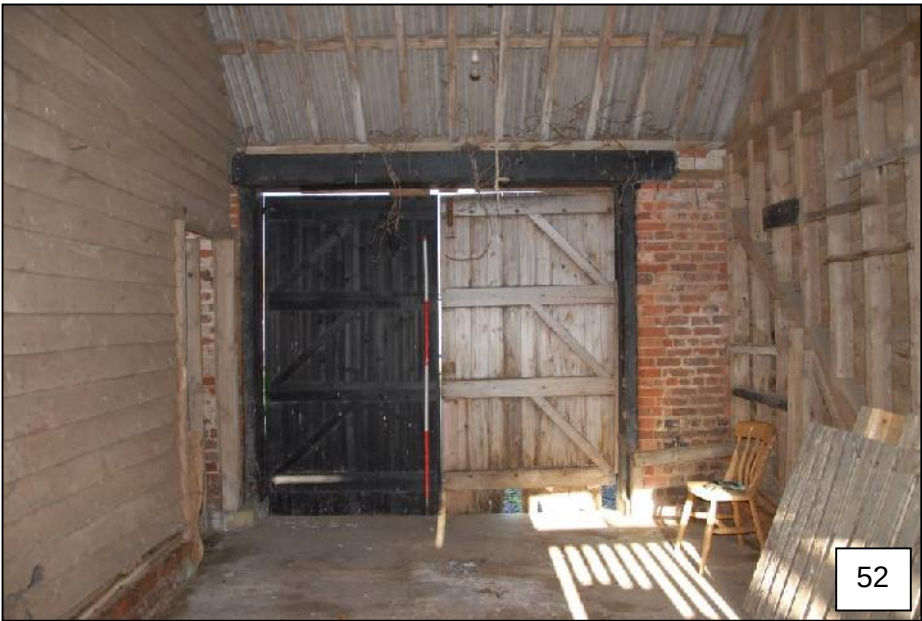
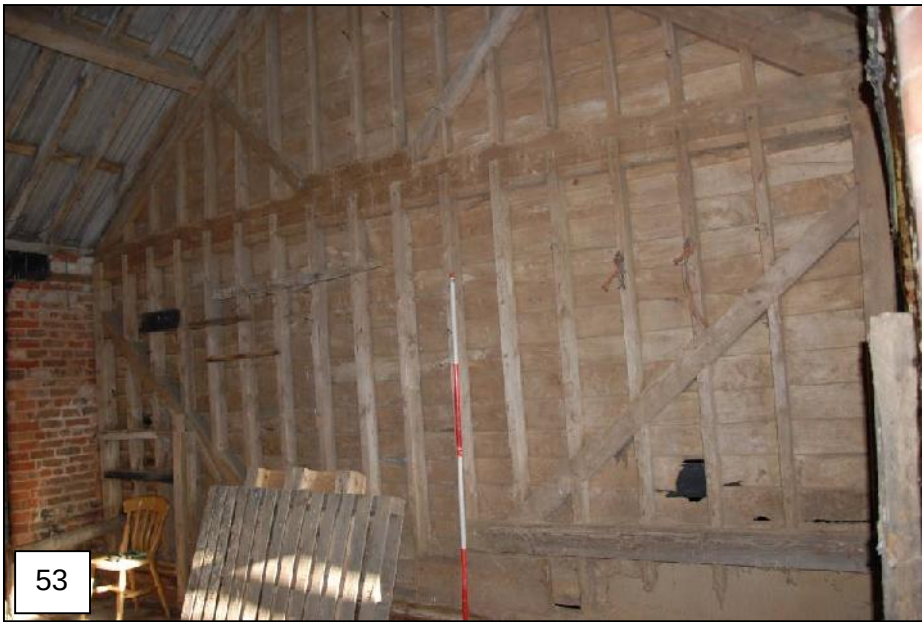
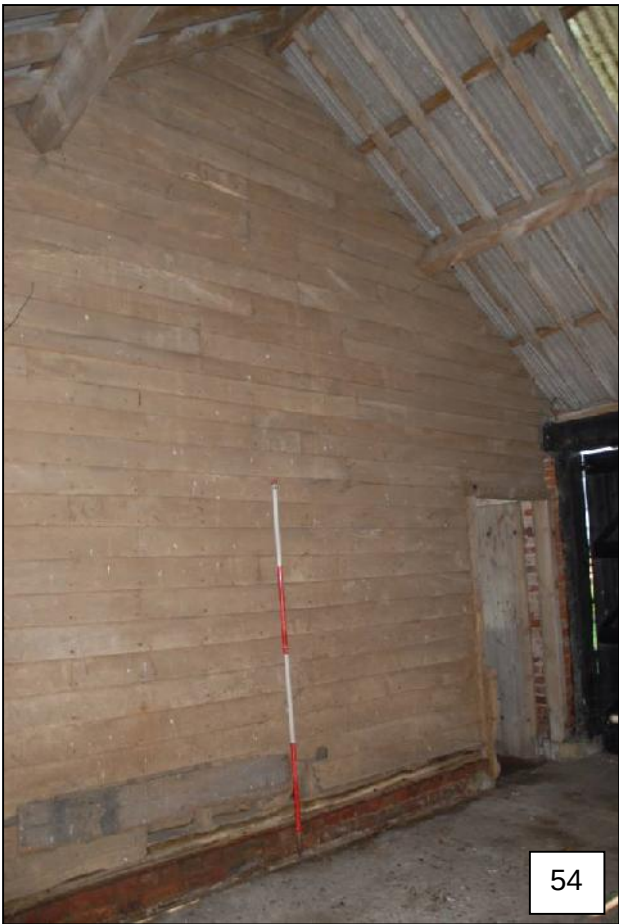
A further door is present in the south wall and is a match of the one in the south wall of Room 1; a hit-and-miss ventilator is also present to the east here.

This part of the building is divided by timber partitions: these have 4" x 2" studs at 13-14" centres. At each side is a 5" x 4" diagonal brace. The studs are secured to the trusses by half-lap joints. The horizontal planking is of 6¾" x ¾" plain planks which overlap ½". At ground level, a 3-course brick plinth is present.

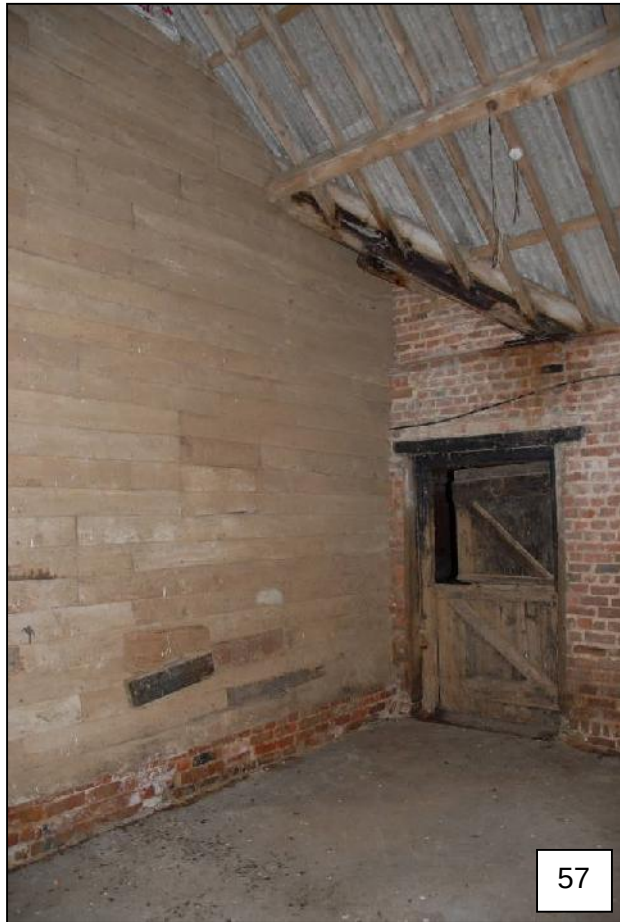
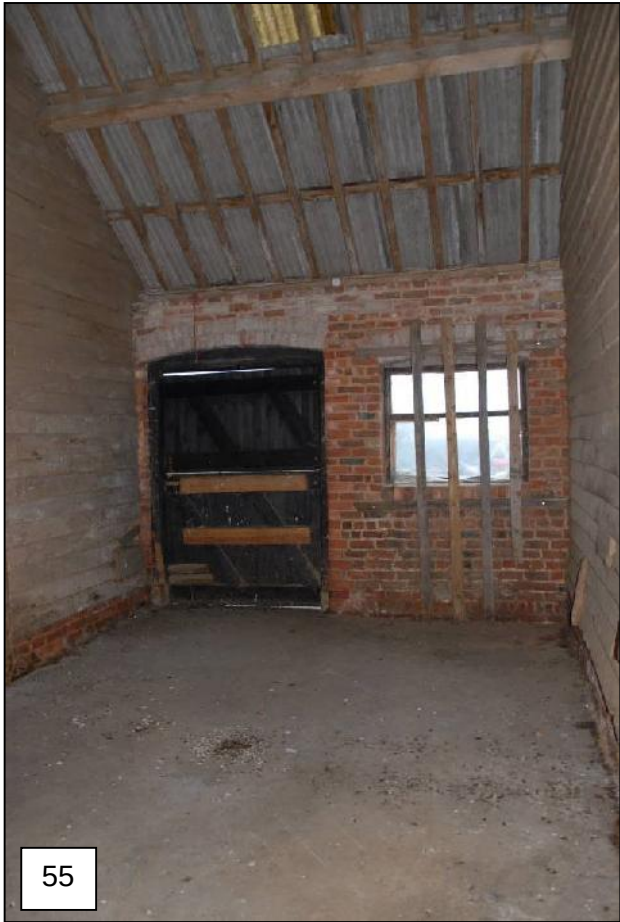
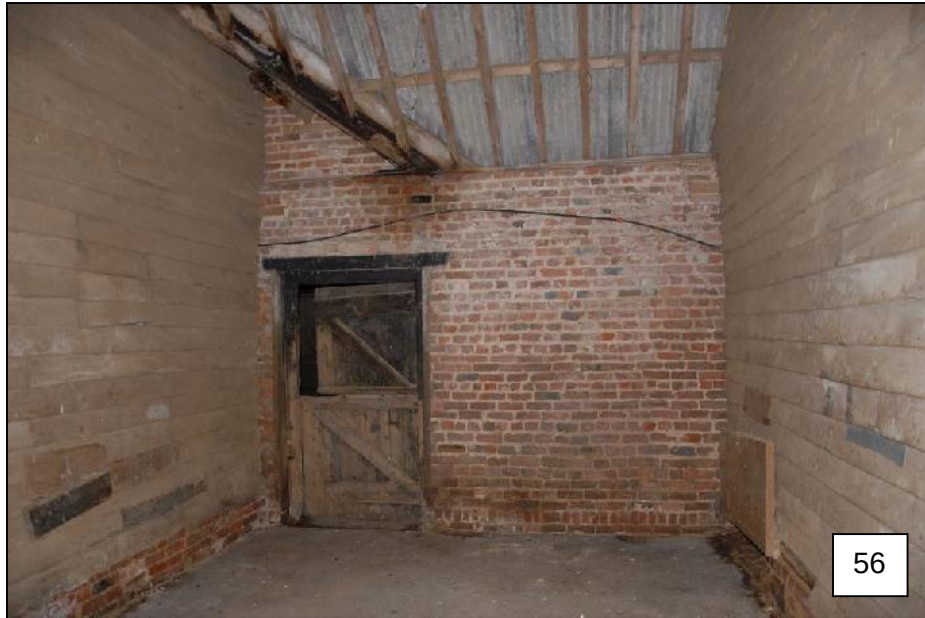
Room 3 is accessed through a door at the east side of the south wall from Room 6, this is of ledged and diagonally braced (6½" ledges and braces 1½" thick) 6½" bead-edged vertical planks (1¼" thick) on heavy 2¼" hinges.

Exterior access is through a door at the west side of the north wall (of ledged and diagonally braced (plain 5¾" ledges and braces, 7⁄8" thick) 4½" plain vertical planks (¾" thick) on modern 2¼" hinges in a 4½" x 3" frame. Adjacent to this door, the frame only survives of a part-glazed hit-and-miss vent (temporarily covered in plastic sheet).

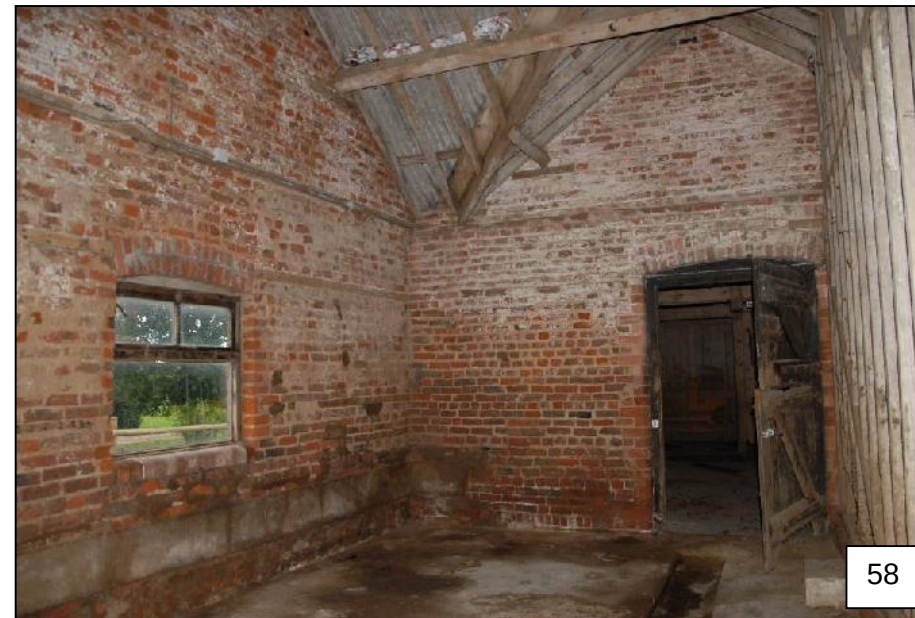
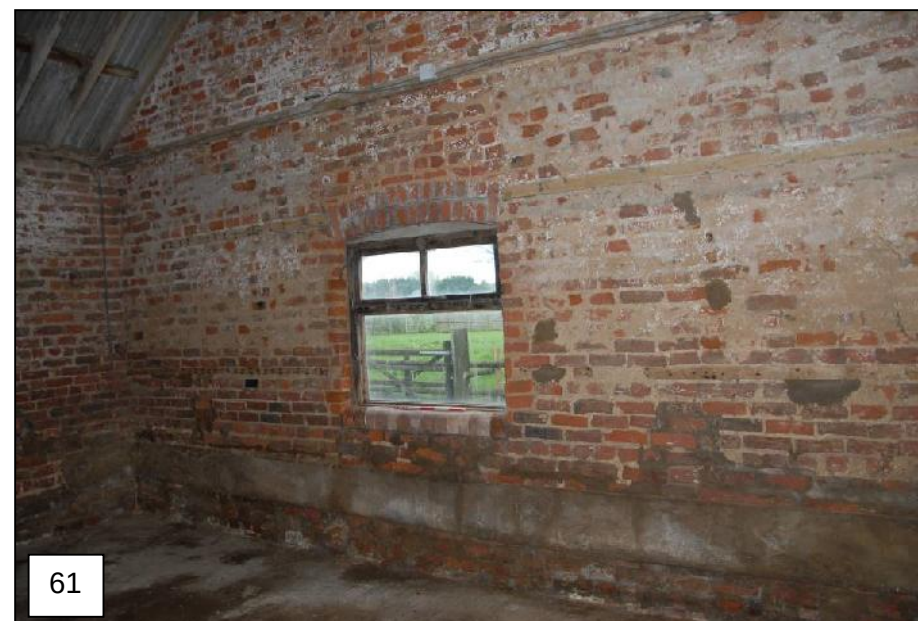
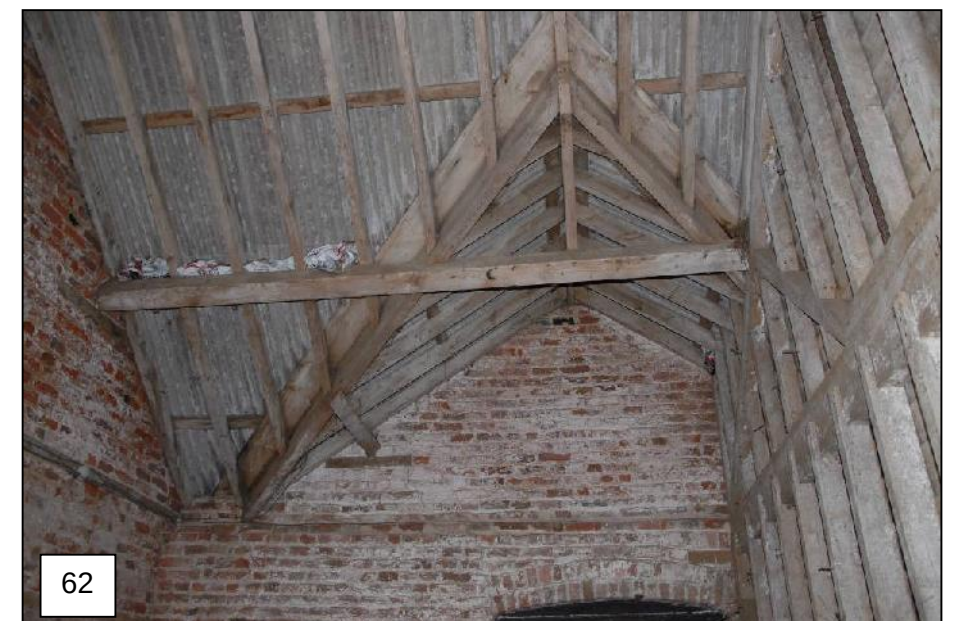
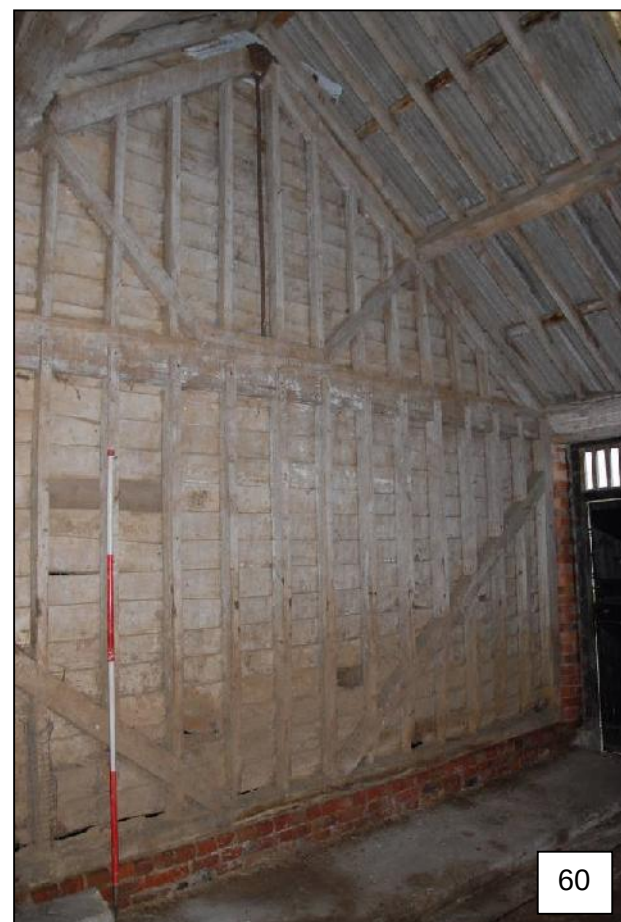
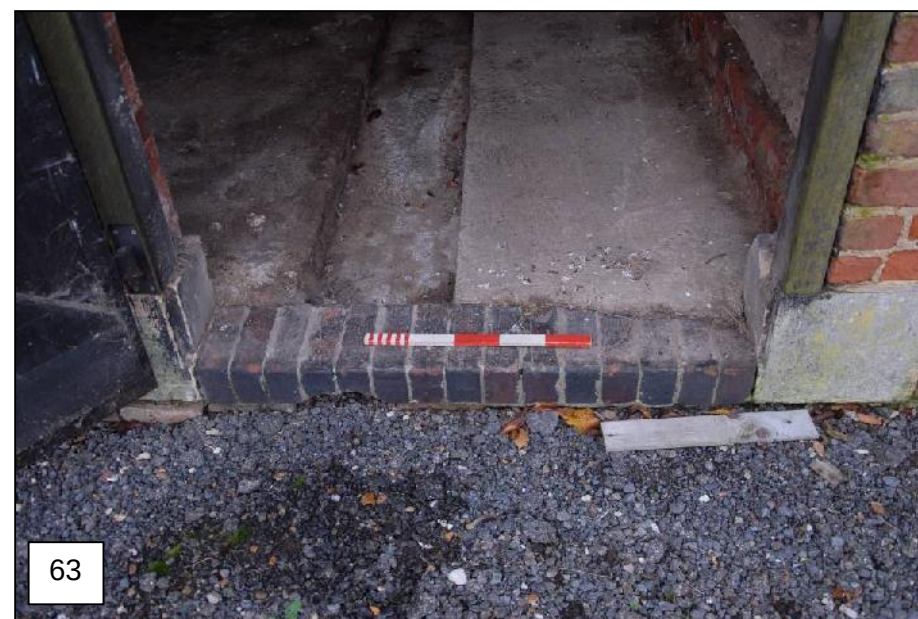
The west wall, dividing this room from Room 3 to the west is a timber partition. (see Room 2 for description). The room is lit by a window in the east wall.

The roof is complex here as it turns to join the roof above the east range – this is awkwardly achieved with the lower part of the eastern valley supported off a projecting purlin from Room 6.

This room is lit by a central window in the west wall, originally a hit-and-miss ventilator, but with a single pane inserted to replace the slats of the ventilator.

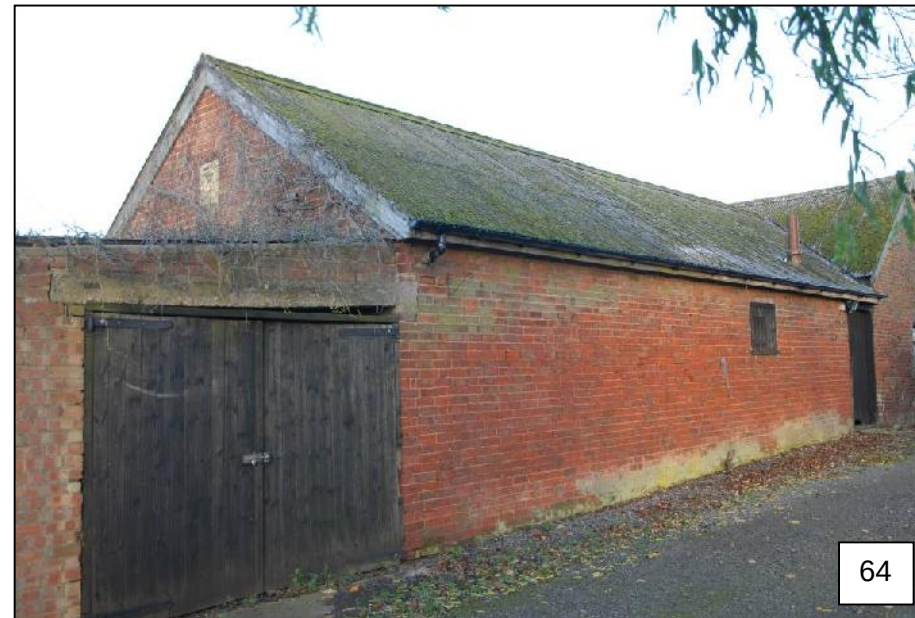
This was a large cattle shed forming the east range of the farm outbuilding group. It is a single-storey brick outbuilding of four bays.

It is built as part of the crew yard conversion of the farm in a dark orange brick (brick size: 9" x 4¼" x 2¾"; 3 courses = 9½") in a distinctive variation of Flemish bond with 2-3 stretchers to each header in each course. The walls are 9" thick throughout.

While the date stone on the south gable is badly weathered, a crown with the initials VR and the date 18—can be made out. This dates the crewyard conversion to the period between 1887 (the date of the 1<sup>st</sup> edition OS map on which it is not shown) and 1899.

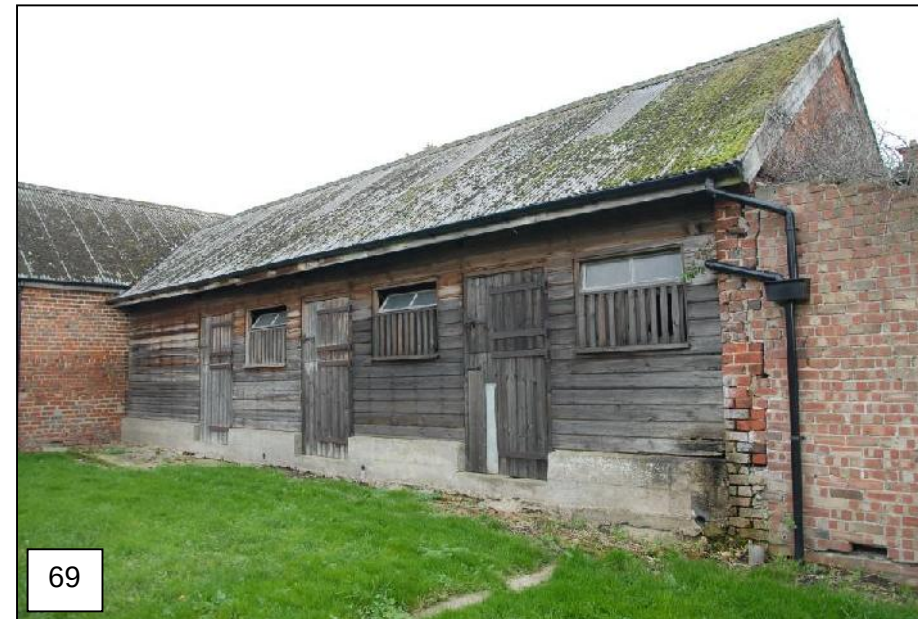
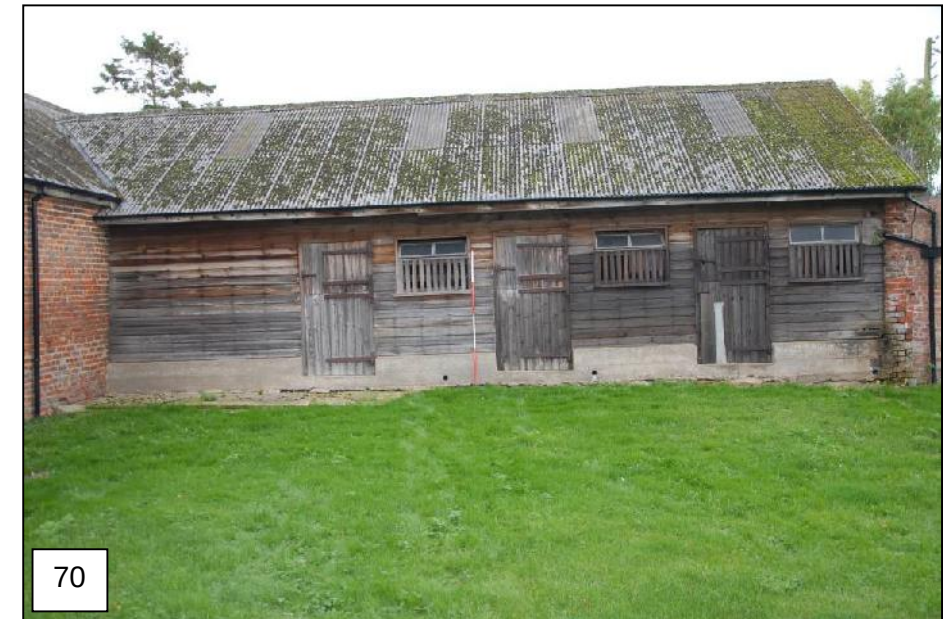
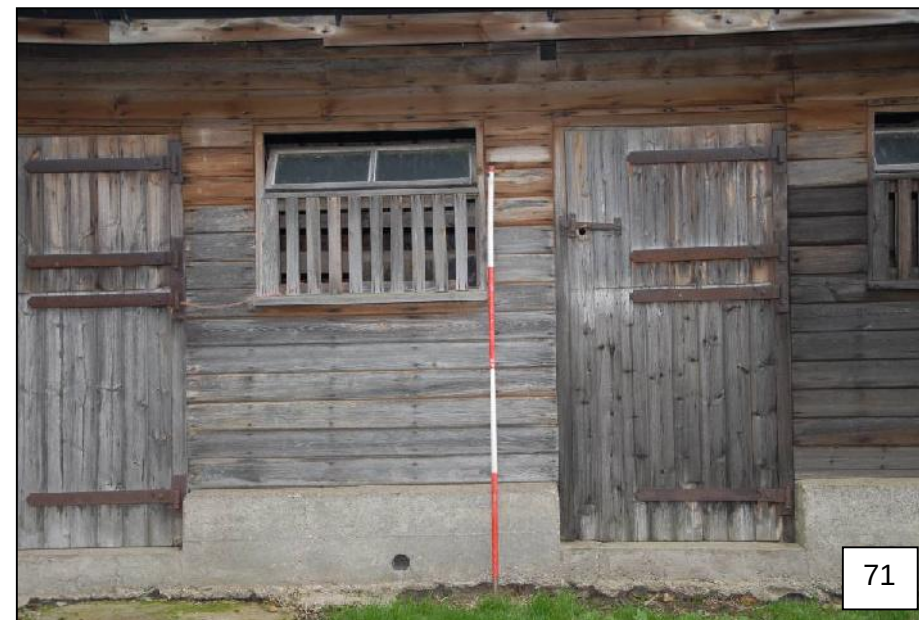
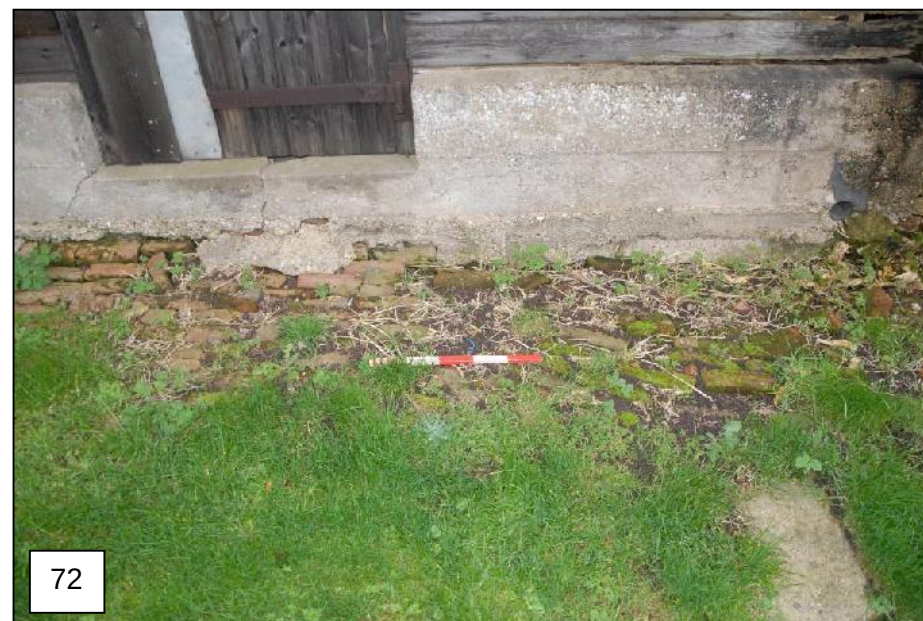
Originally an open-fronted crew shed, this side has been closed in horizontal shiplap with a concrete dwarf wall.

Three stable-type plank doors and hit-and-miss ventilators are present here.

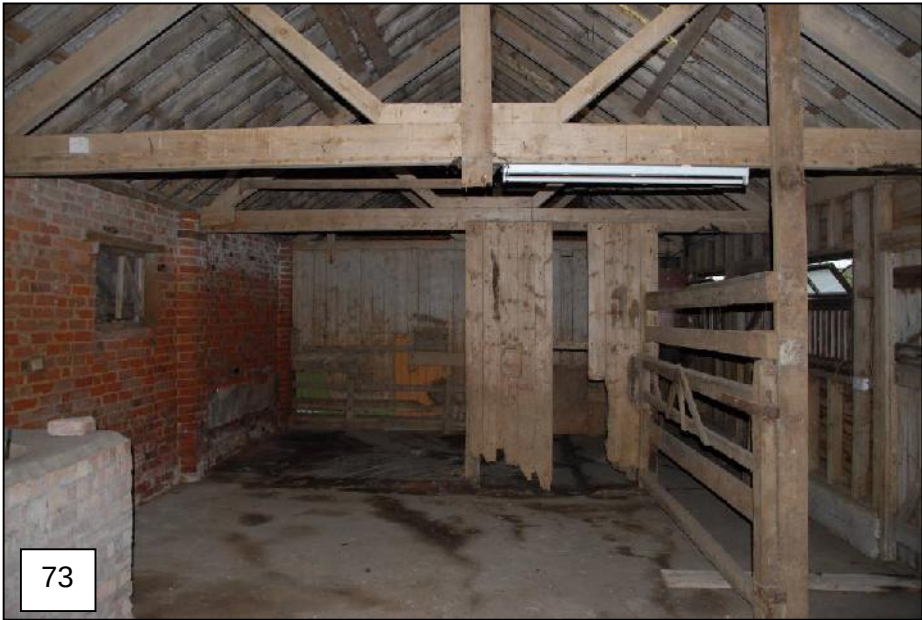
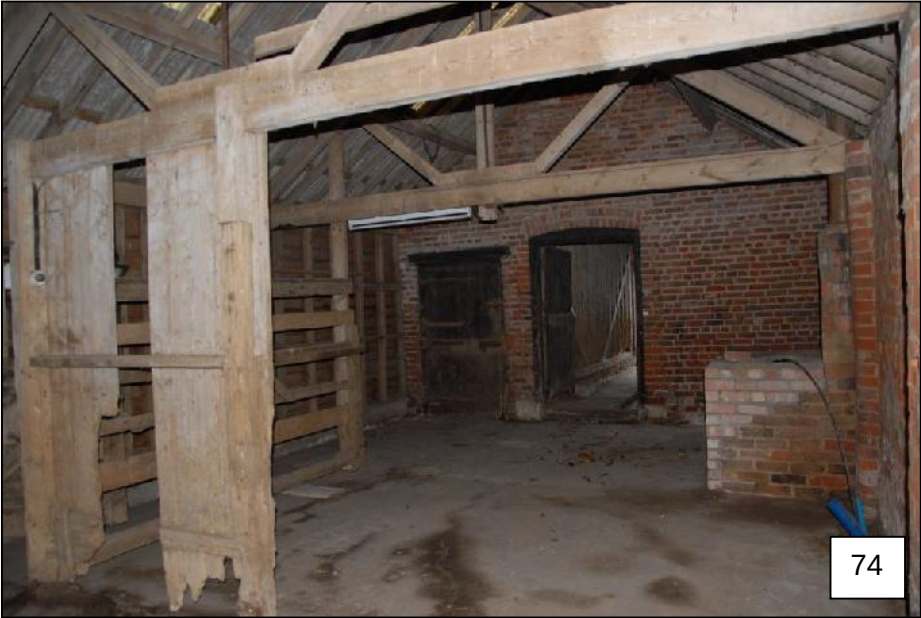
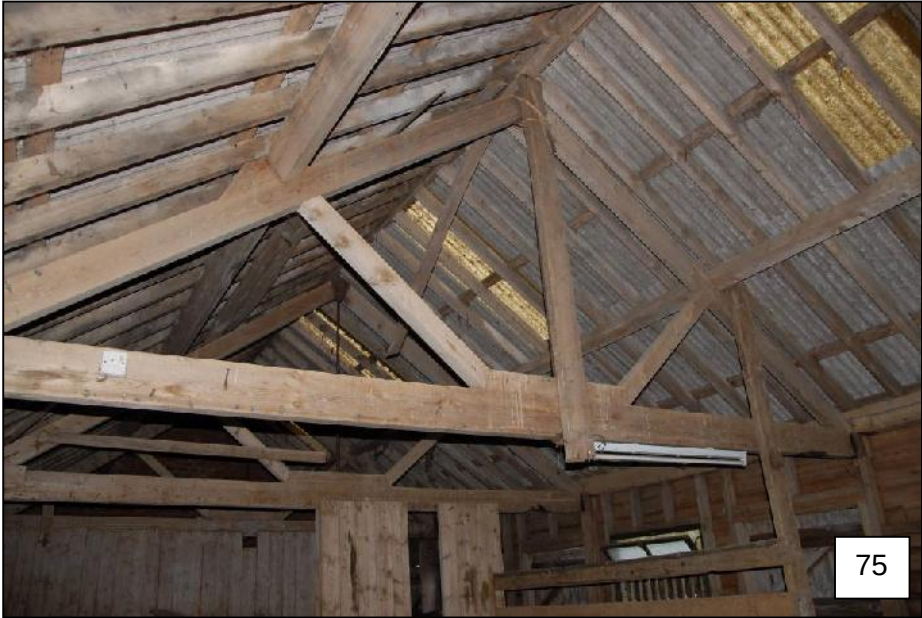
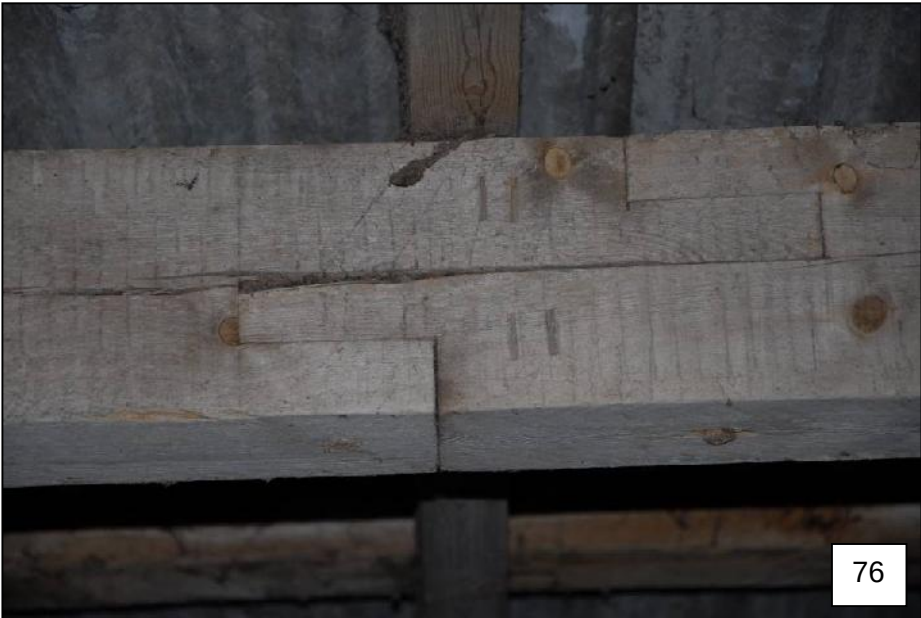
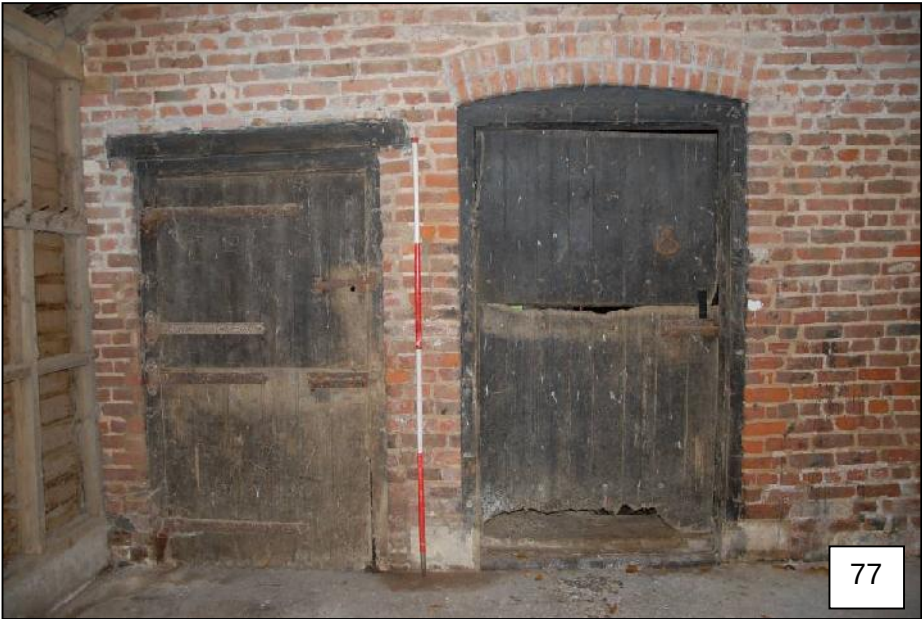
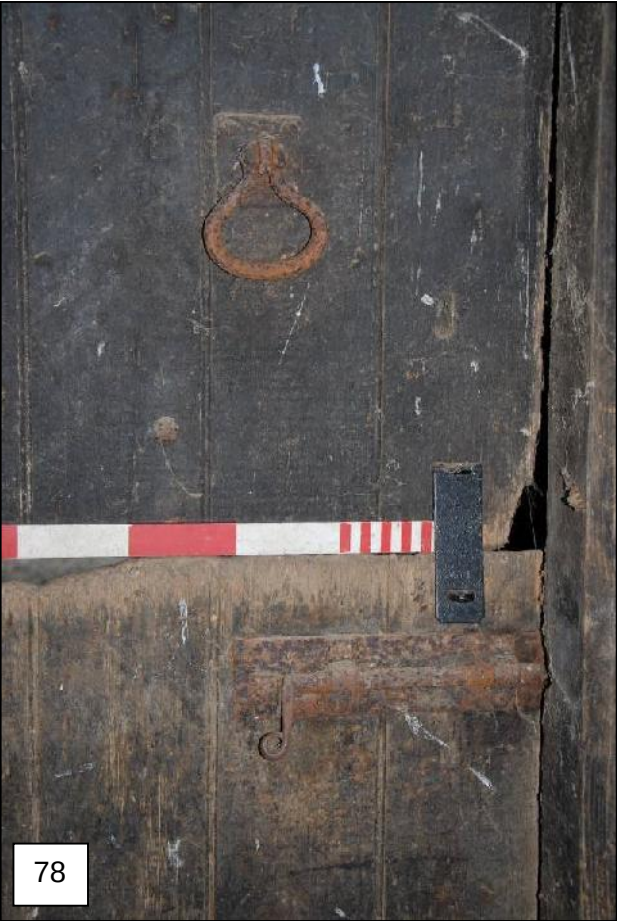
The floor was of poured concrete throughout. It is likely that this range was originally an open-fronted crew shed to the crewyard; however, the original open front has been enclosed with a timber partition of 5½" horizontal shiplap supported on a framework of 4" x 2" timber studs at 19½-21" centres resting on an 18" high concrete dwarf wall.

The roof is identical to that described previously, with the truss ties dictating the position and size of the bay partitions. The complex jointing of the through-purlins can be clearly seen here, along with framing marks.

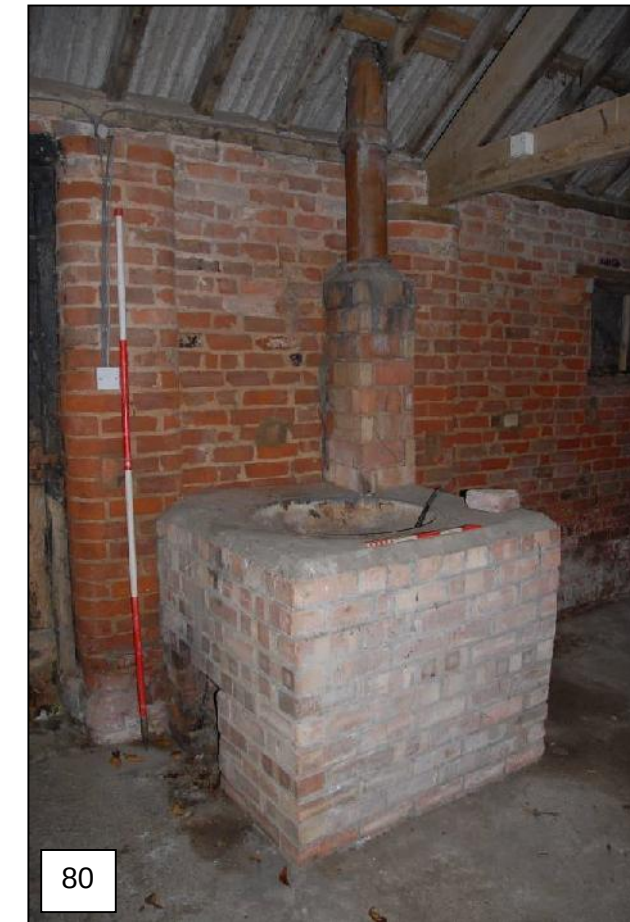
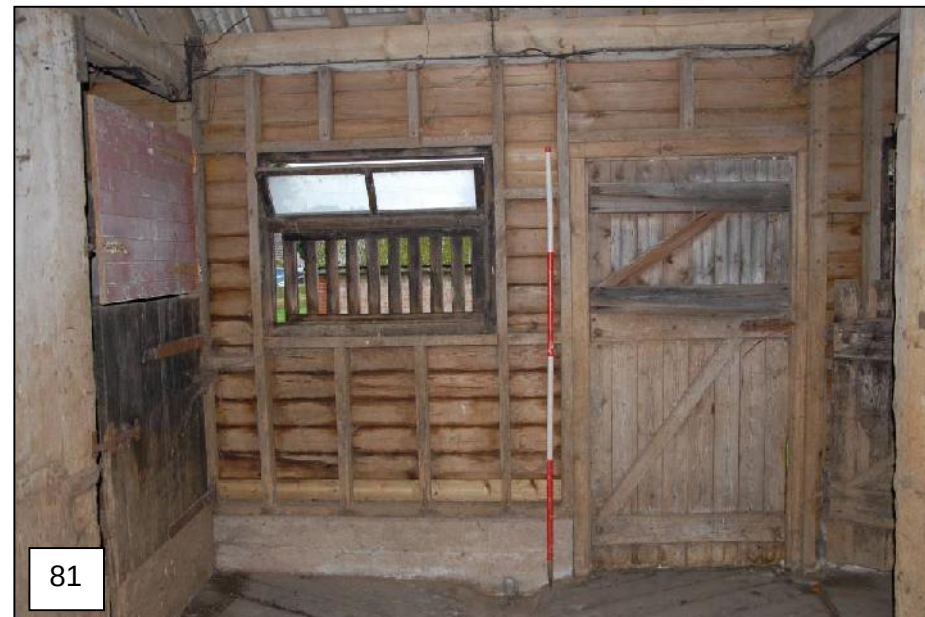
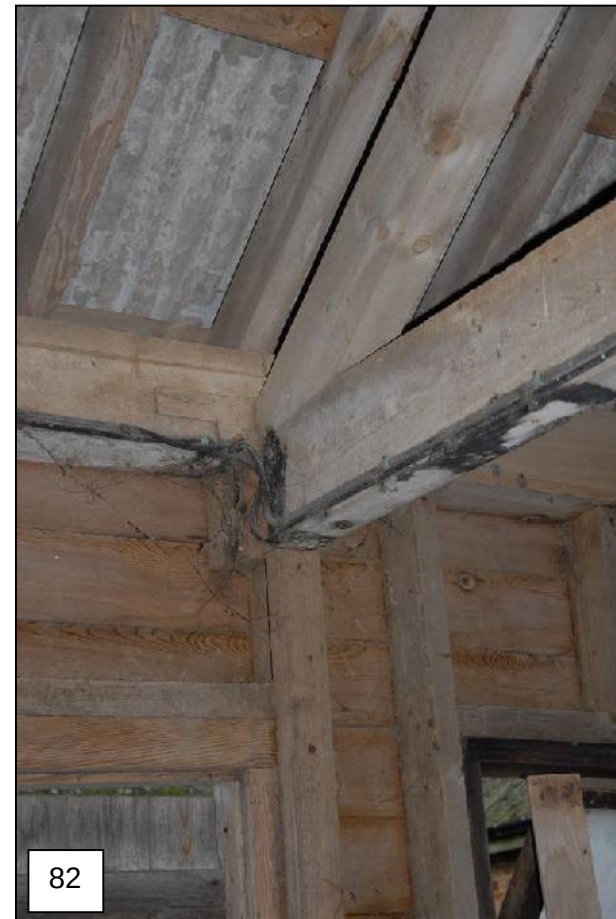
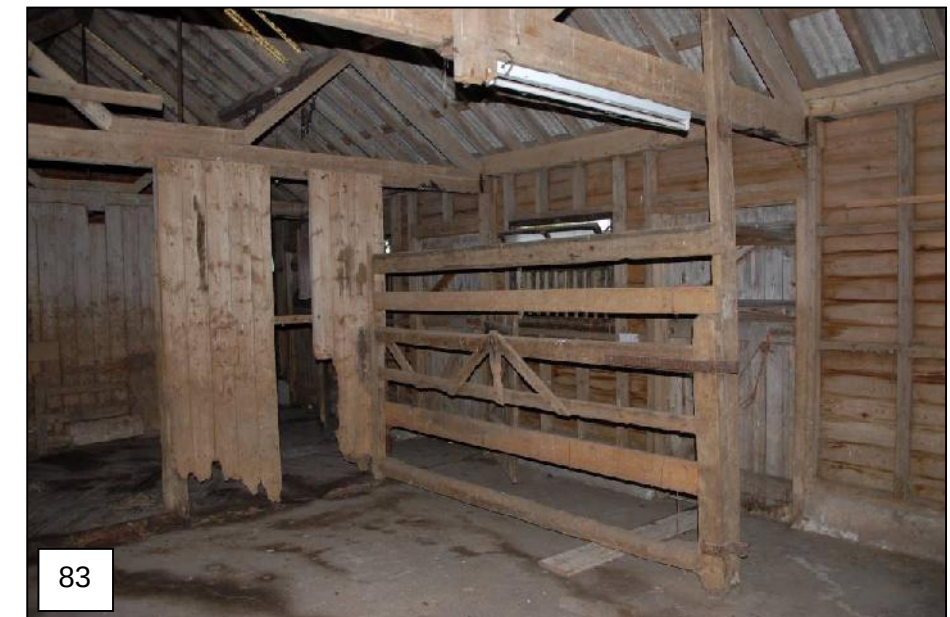
The northern bay was dedicated to storage and food preparation – a copper was present adjacent to the east door. This was of modern common brick 4ft wide (east-west), 46½" (north-south) and 39" high with a chimney of edge-set bricks topped with two lengths of sewer pipe (the upper serving as a chimney pot). The bowl was of steel, 29" interior diameter with a 1½" lip and 22" deep.

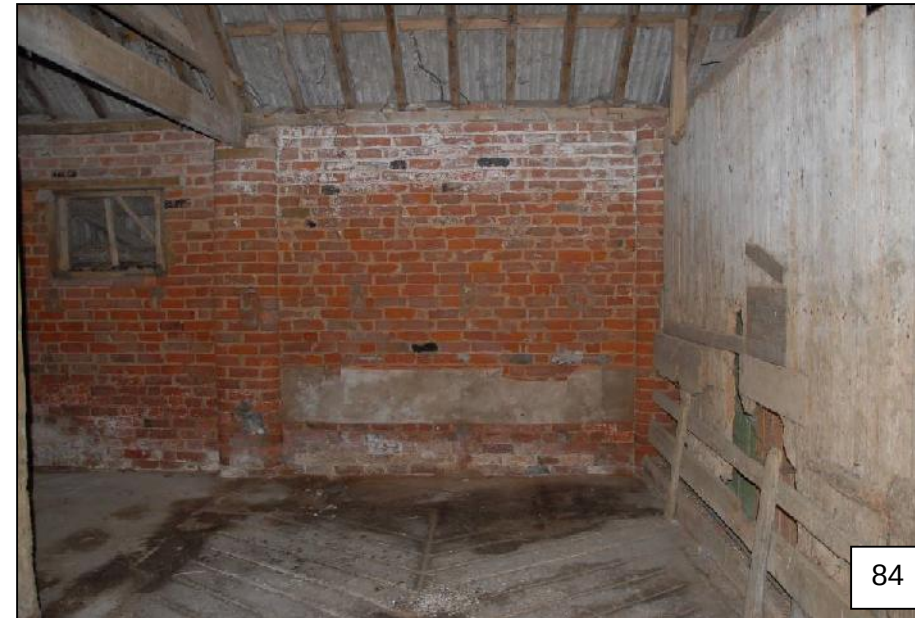
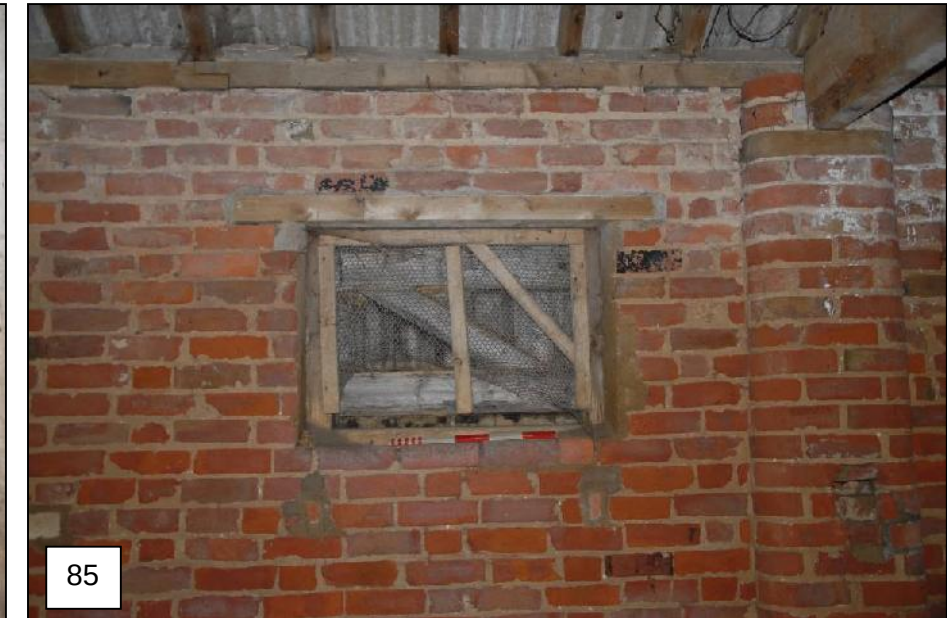
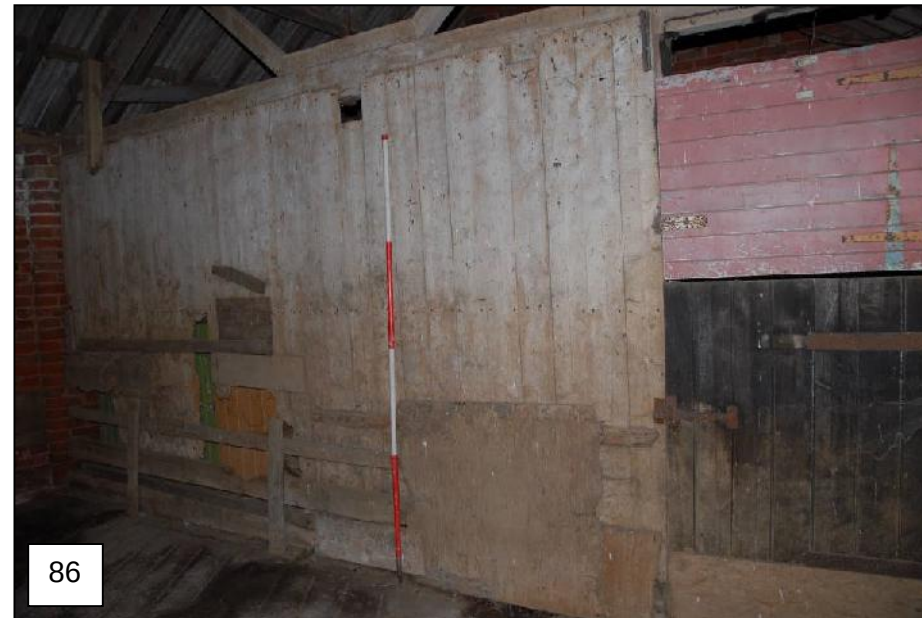
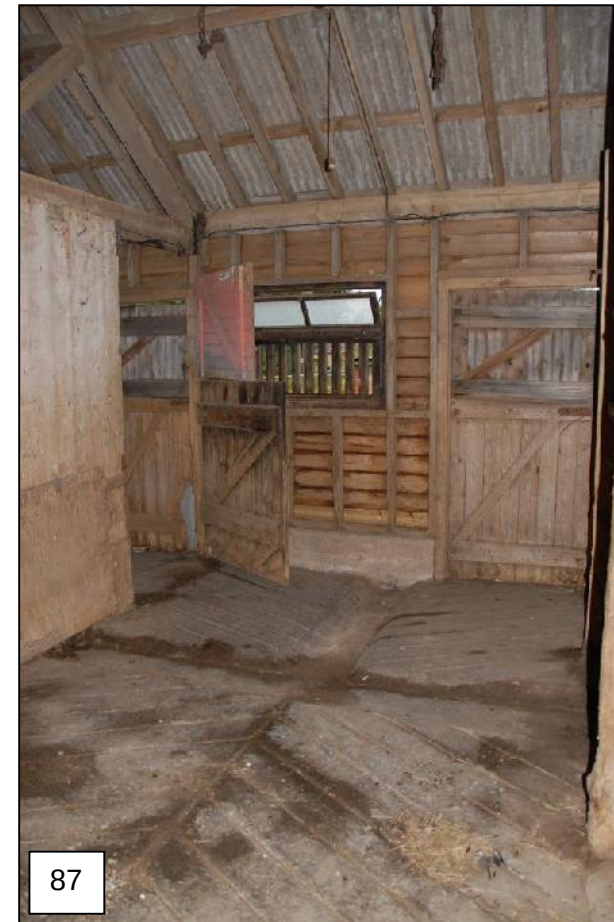
The southern three bays were cattle loose boxes with a door and window corresponding in the west wall. The doors were ledged and diagonally braced 5" vertical matchboard stable-type doors, while the windows were timber hit-and-miss ventilators with a two-pane hopper-opening upper casement.

Little remained of the northern pen, only the corner upright which supported a re-used five-bar gate with two horizontal timber rails above.

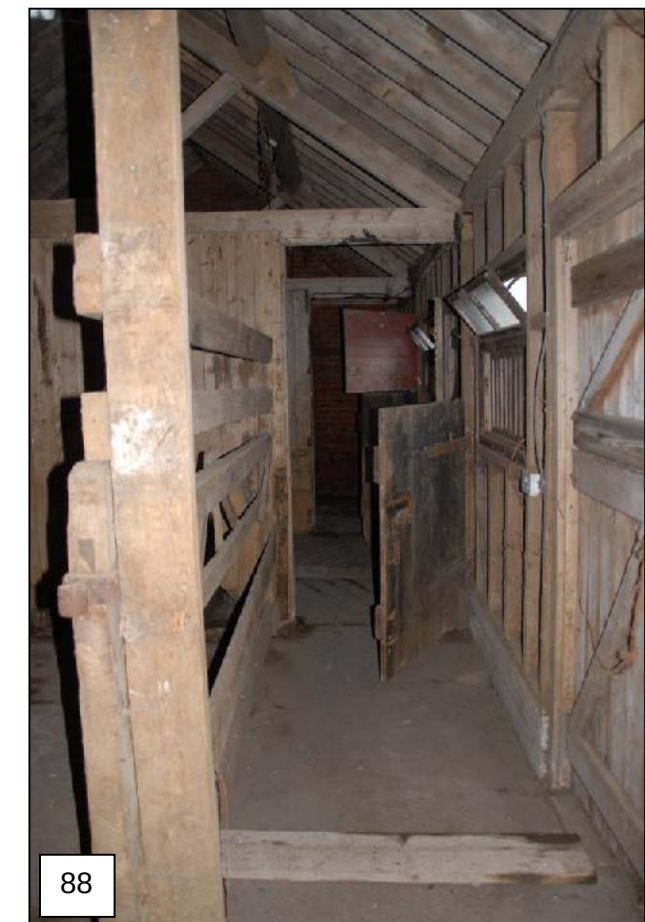
The central loose box retained only a part of its vertical plank partition (of 6½" x 1½" plain timber planks. A strip of concrete on the east wall like that seen in Room 4 was again indicative of a lost feeding trough – this strip was 14" in height, 15" from the floor. The concrete floor had a herringbone pattern to assist with drainage into a 12" wide drainage channel which ran north-south towards the rear of the stall with two channels leading off to the west.

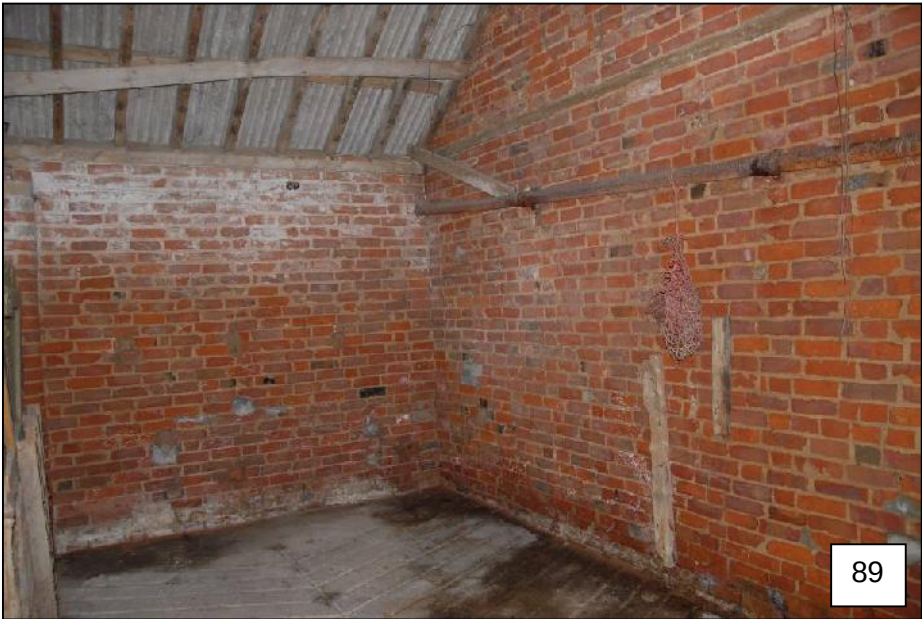
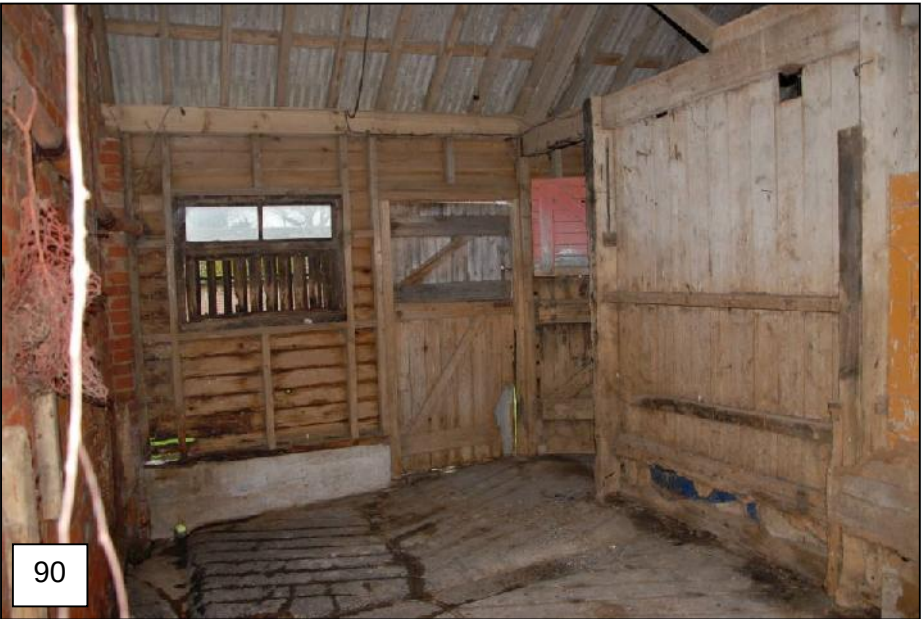
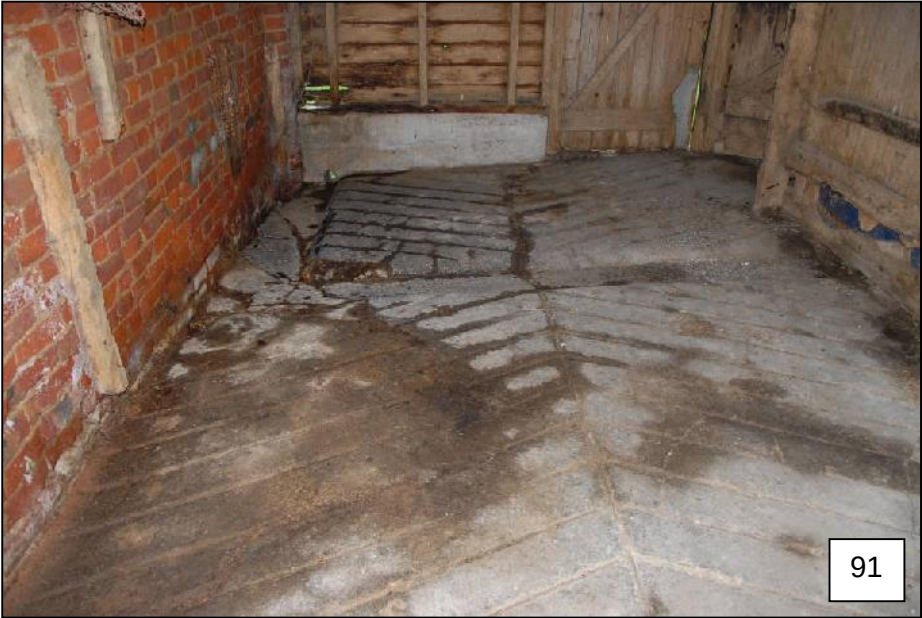
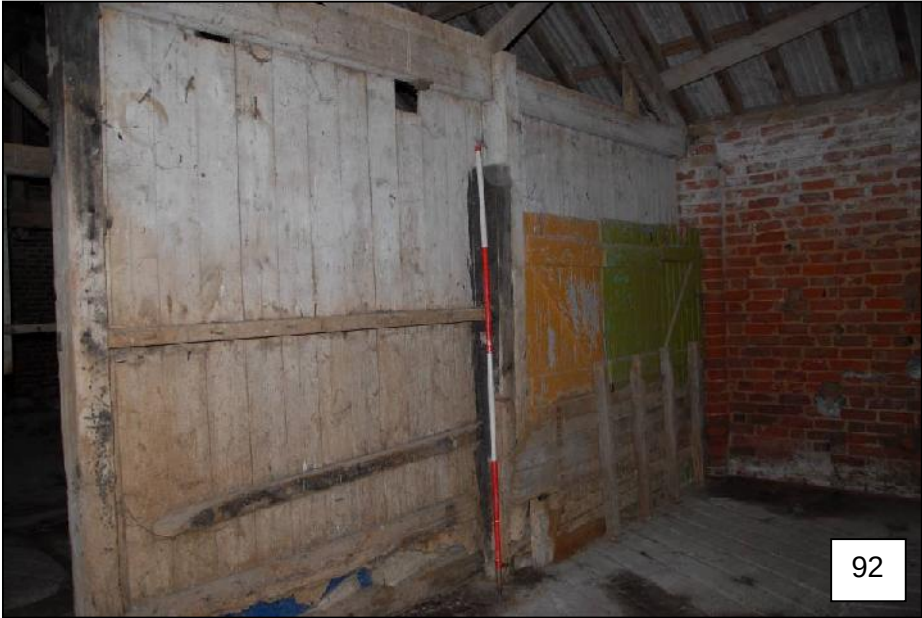
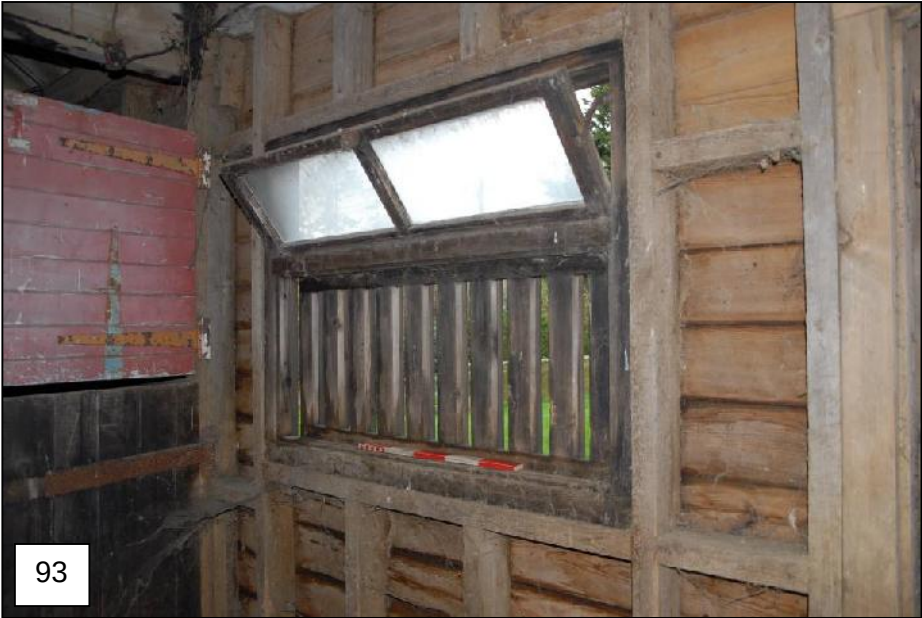
The southern loose box was the best preserved, with its timber partition largely intact, reinforced at the east side by three re-used doors (possibly from the pig pens opposite). It had a concrete floor incised with a herringbone pattern as described above.

At the west side of the partitions, each had a door which allowed passage along the rear of the looseboxes. These were variously repaired, including the re-use of an interior door turned 90°.
