# OUTBUILDINGS AT CROWN FARM, STOCKWELL GATE WEST, WHAPLODE, LINCOLNSHIRE

## HISTORIC BUILDING SURVEY

NGR: TF 3306 2504  
PCAS job no. 2840  
Site code: CFWH 23  
Planning ref. H23-1116-21  
Archive acc. no.: LCNCC: 2023.77

Report prepared for G. R. Merchant Ltd.

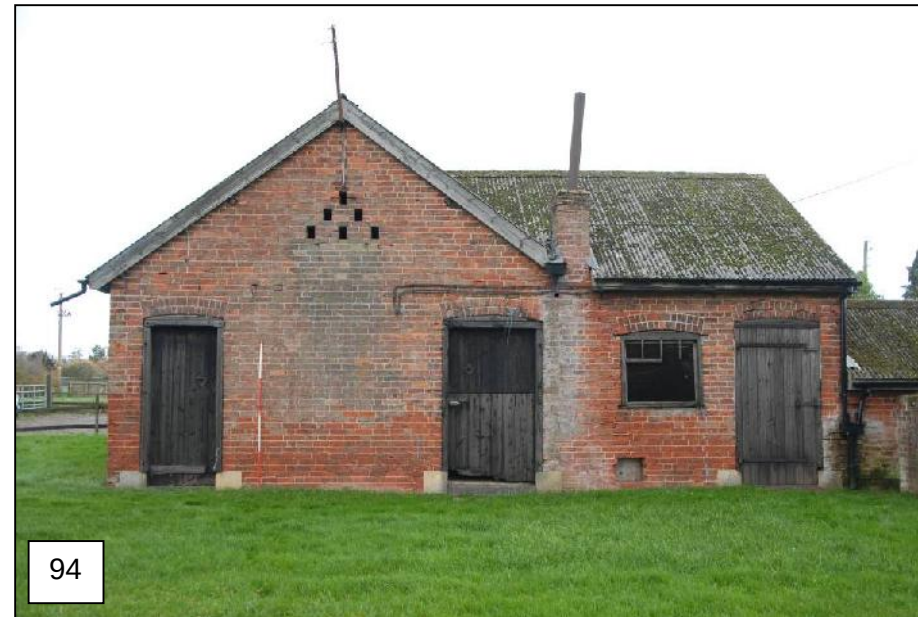
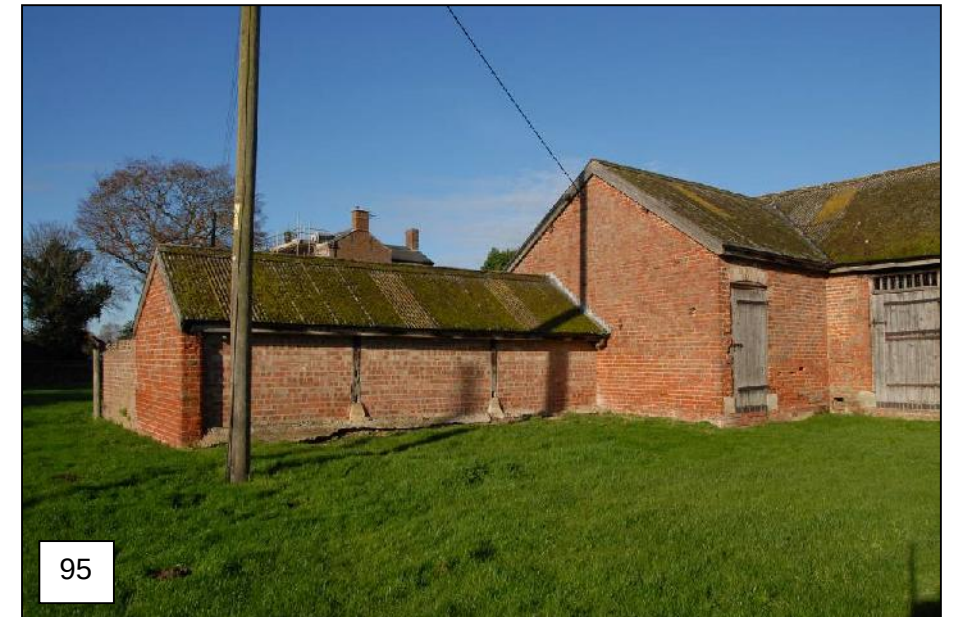
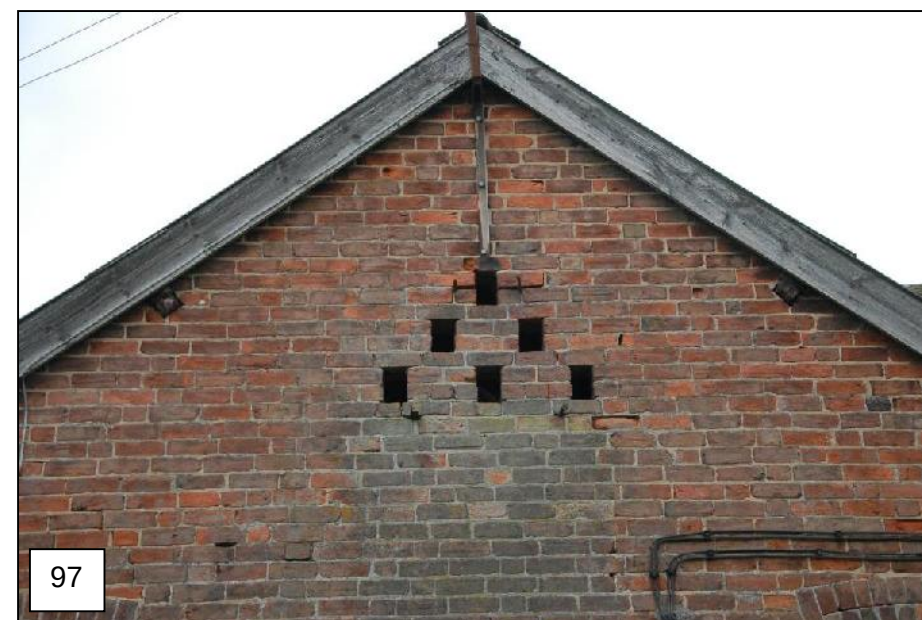
Like the east range, it is constructed of dark orange brick (brick size: 9" x 4¼" x 2¾"; 3 courses = 9½"), carried out in a distinctive modified Flemish bond with 2-3 stretchers to each header in each course.

The walls are 9" thick throughout.

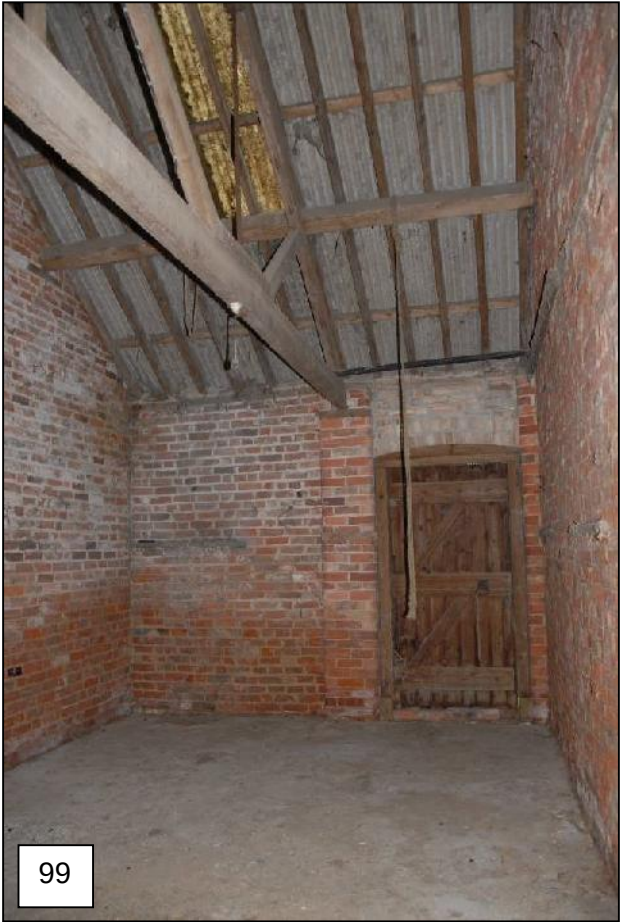
This room occupied the southern part of the west range. It had a plain floor of poured concrete. Door openings at the south sides of the east and west walls gave access to the exterior and crew yard respectively. Both had ledged and diagonally braced (chamfered 7½" and 3¼", 1⅜" thick) doors of 5" vertical matchboard (1" thick) on 2" strap hinges, housed in a 3¾" x 5½" frame. The lintel and wall above the eastern door have been rebuilt in a modern pink common brick.

The roof was again exposed here, a single truss spanning the centre of the room supported on bullnosed brick pilasters. The room was lit by a hit-and-miss ventilator in the west wall, retaining little but its frame.

A chimney was present in the northwest corner of the room, 13" square, however this only reached to approximately 11 courses from the floor (which was broken out here) leaving no clear idea of its purpose.

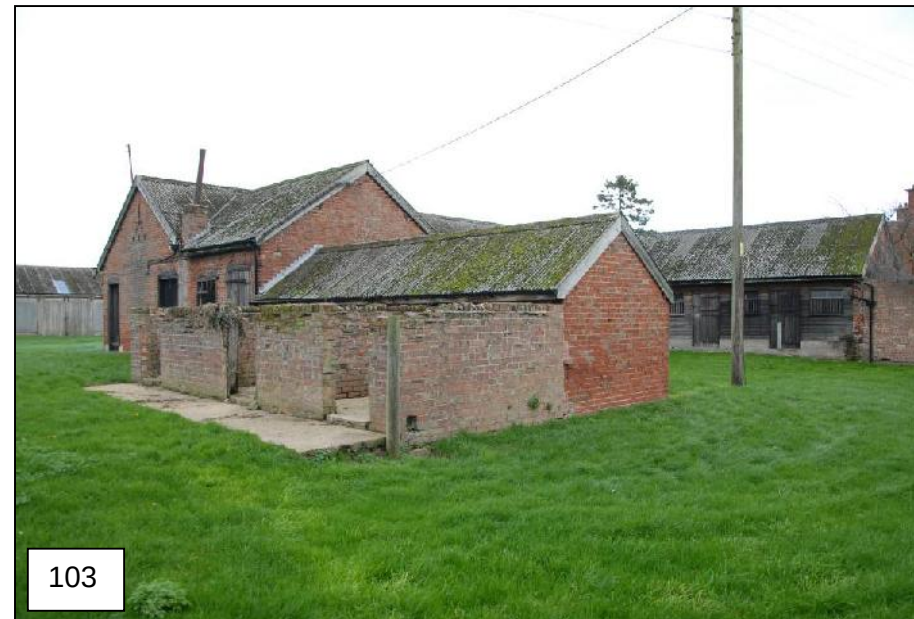
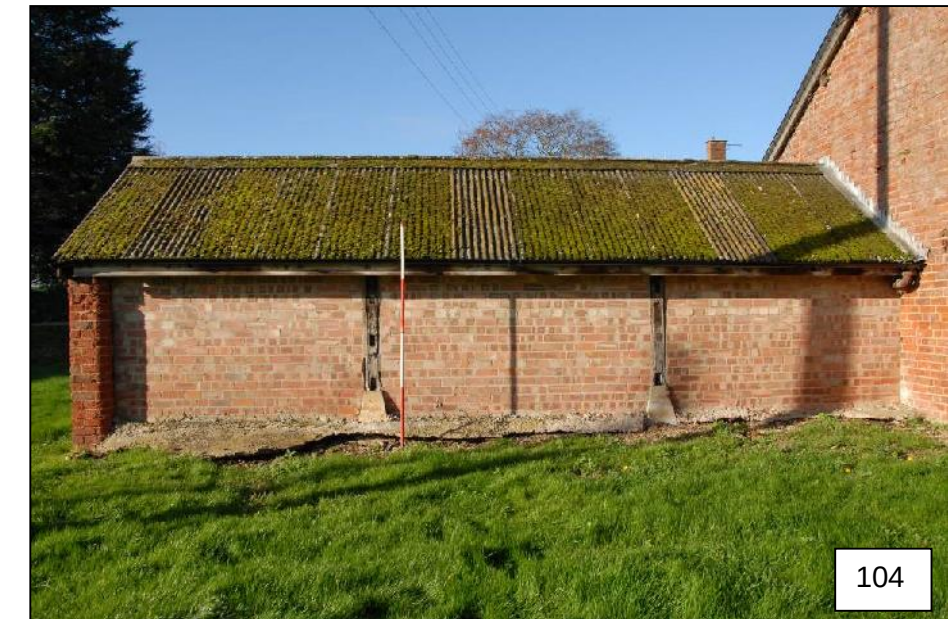
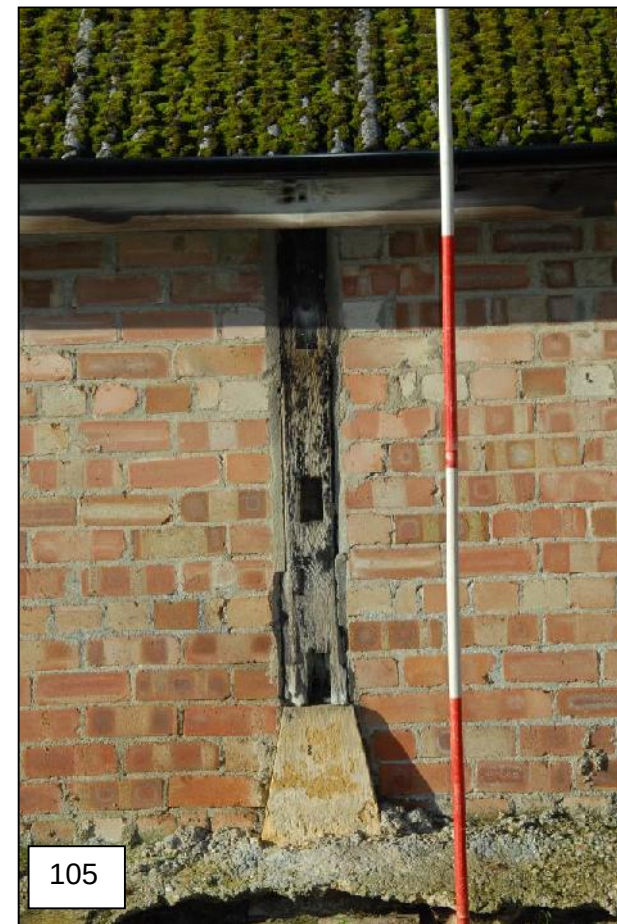
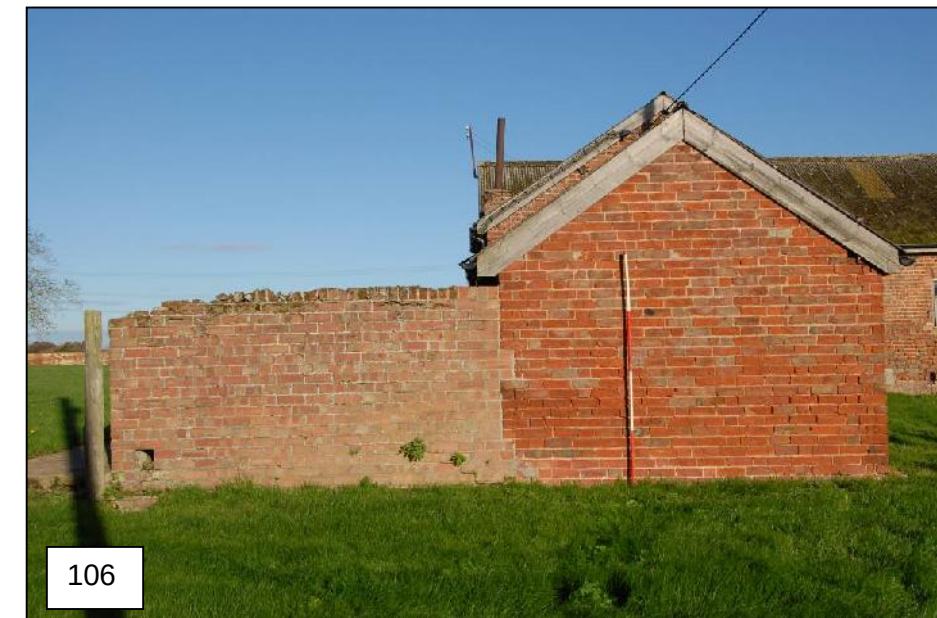
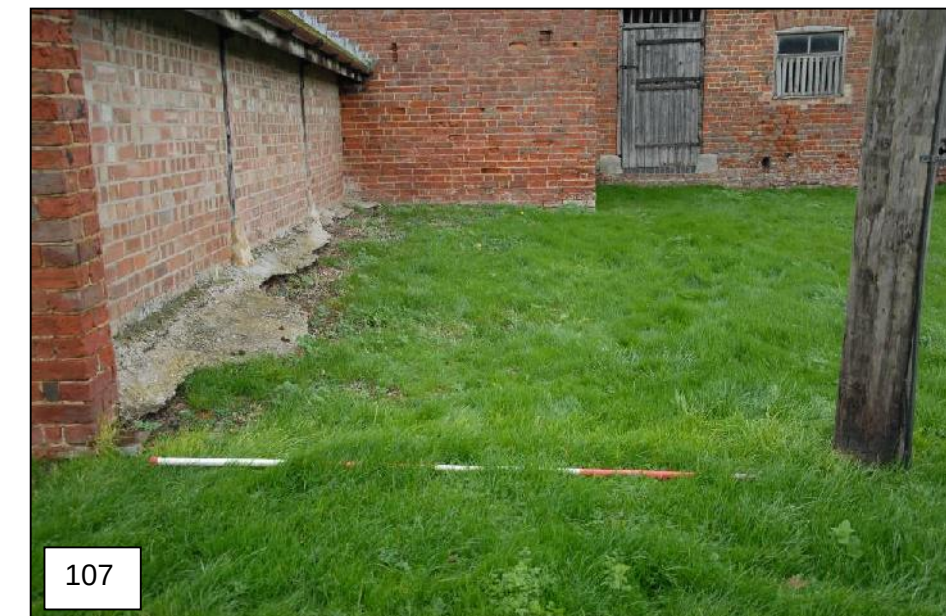
The original open fronts had 5½" chamfered posts with 4 x 2" mortices in their east faces, demonstrating that the enclosures were once present to this side, while a parchmark in the grass further demonstrated their extent. The posts rested on 16" high pyramidal stone blocks.

The original shed can be seen in the south elevation, where the brickwork is a match for that of the east and west ranges. The east side is blocked in pink salt-glazed brick (brick size: 8½" x 4¼" x 2¾"; 3 courses = 10") in 5-course EGV bond.

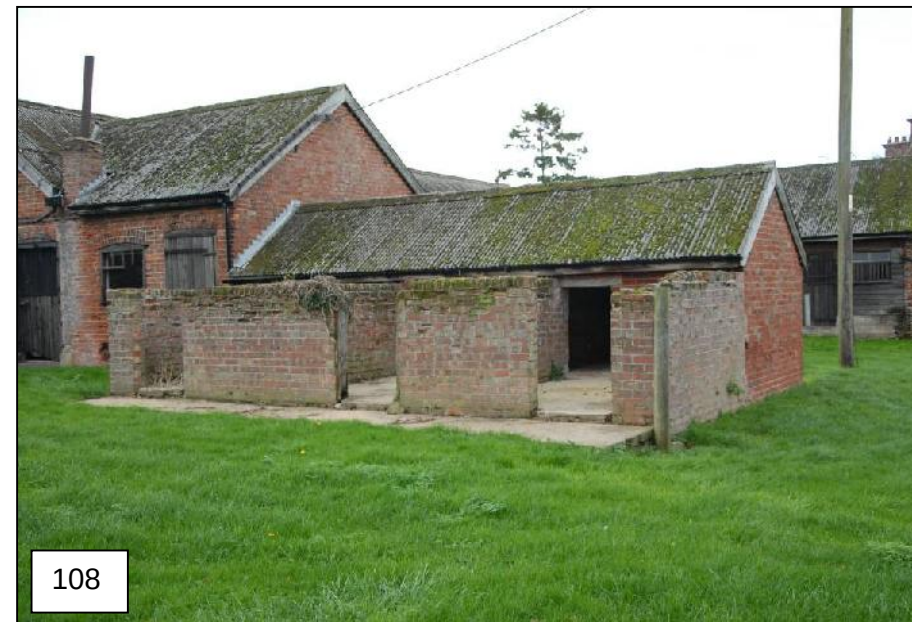
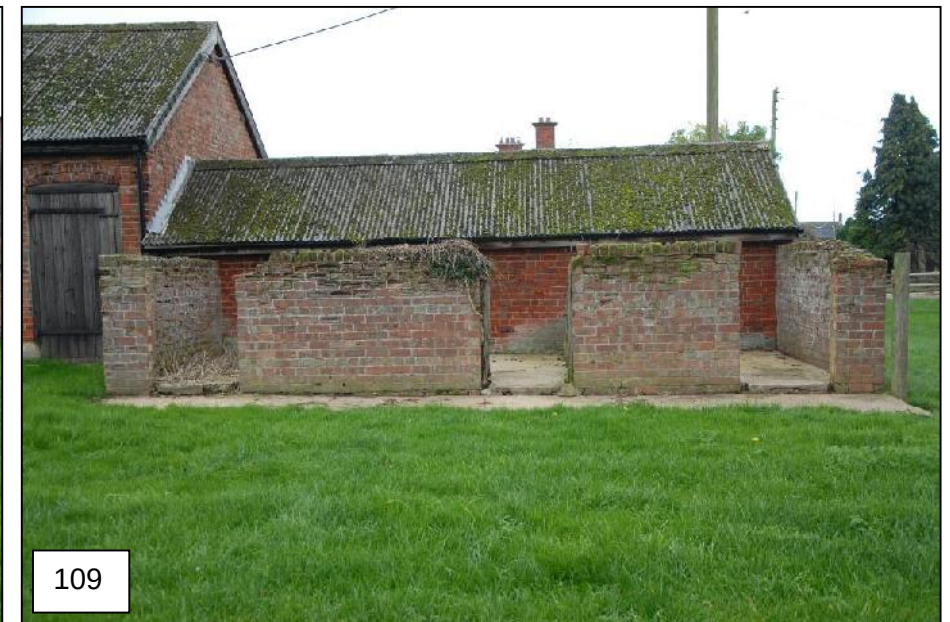
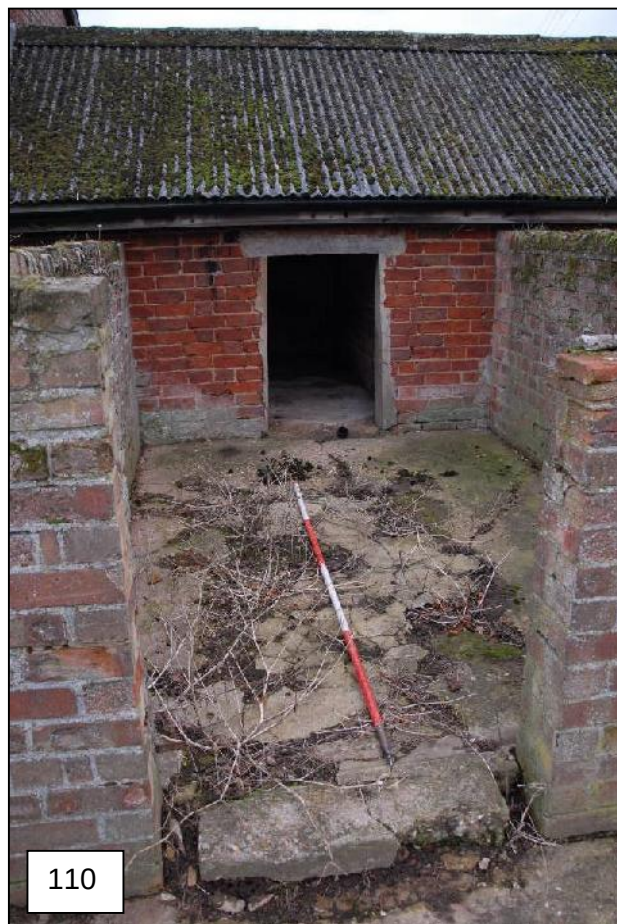
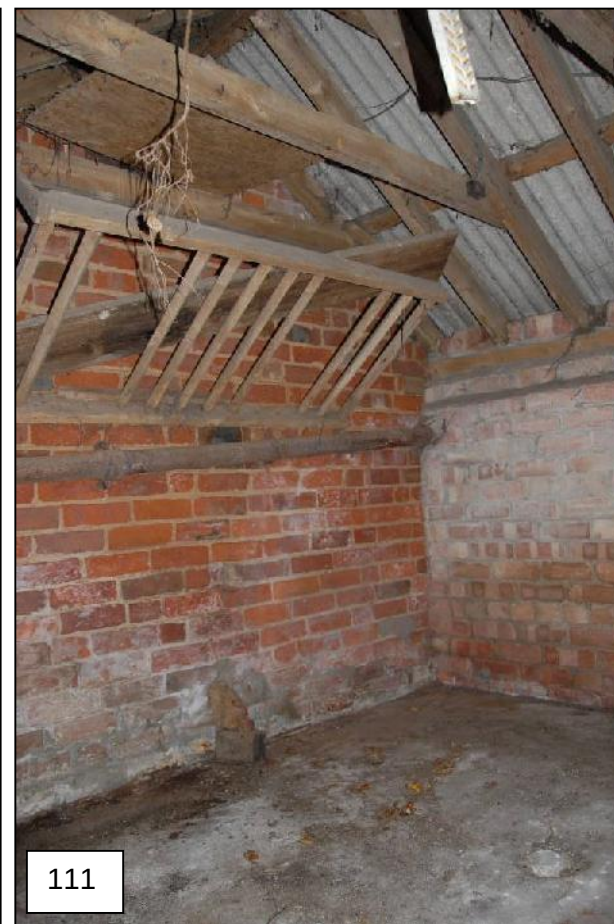
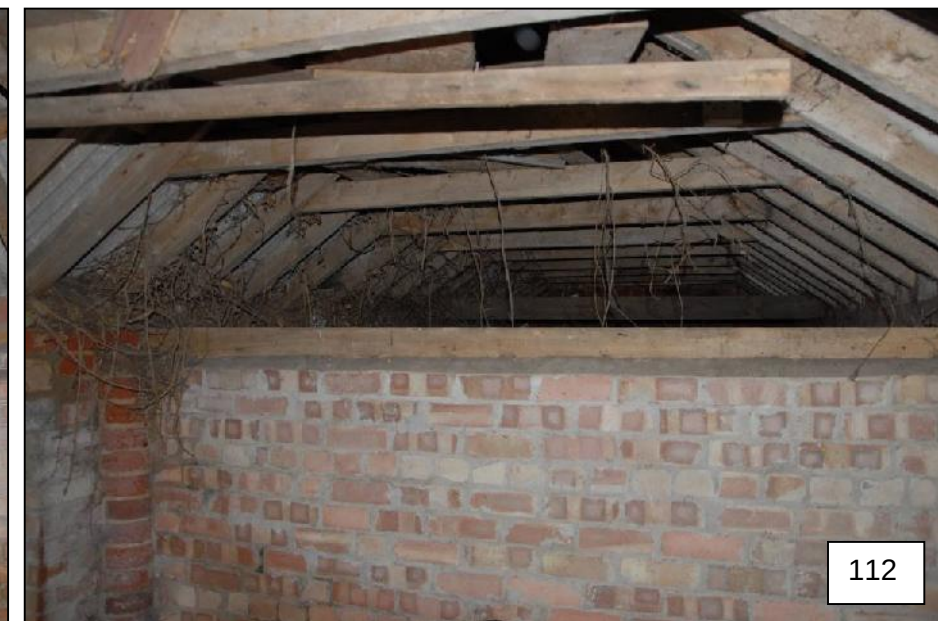
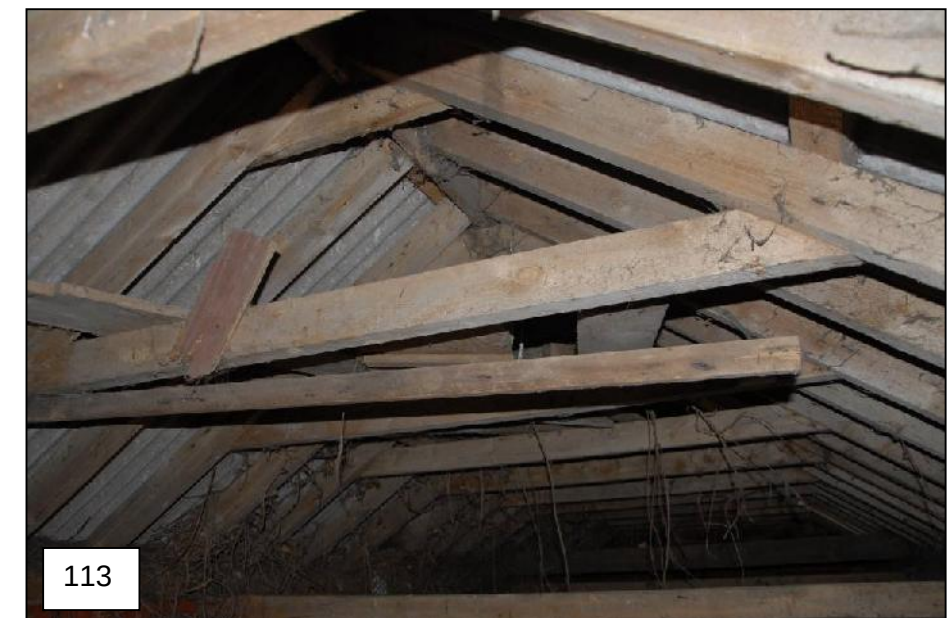
The pens constructed here are in a similar brick to the blocking of the open east side but have weathered redder.

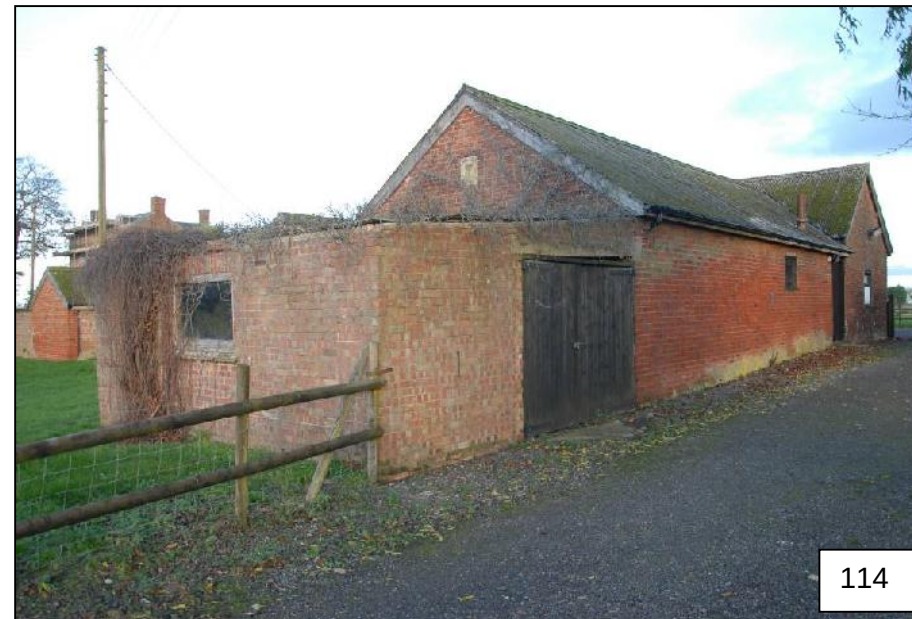
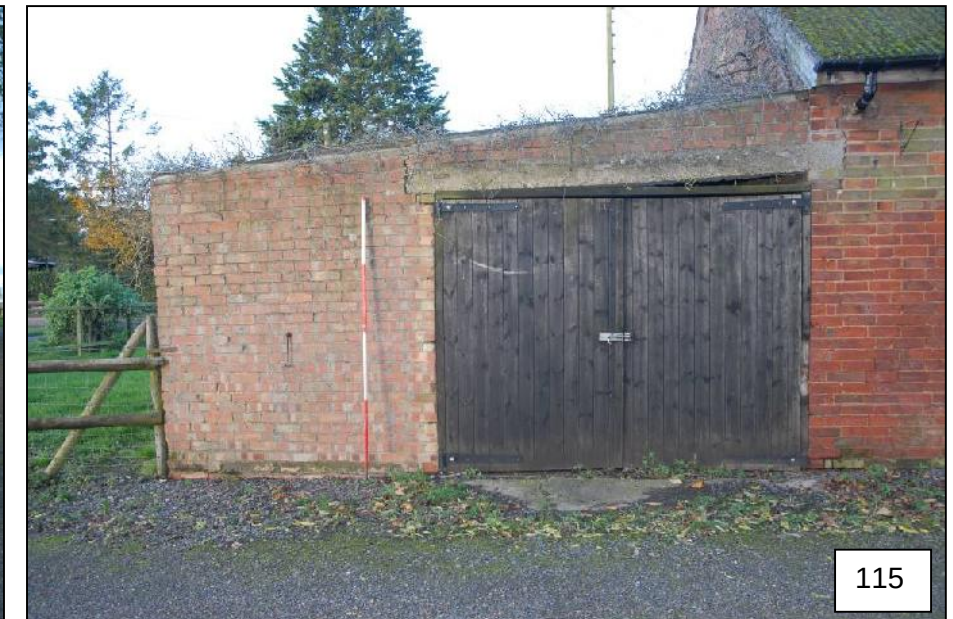
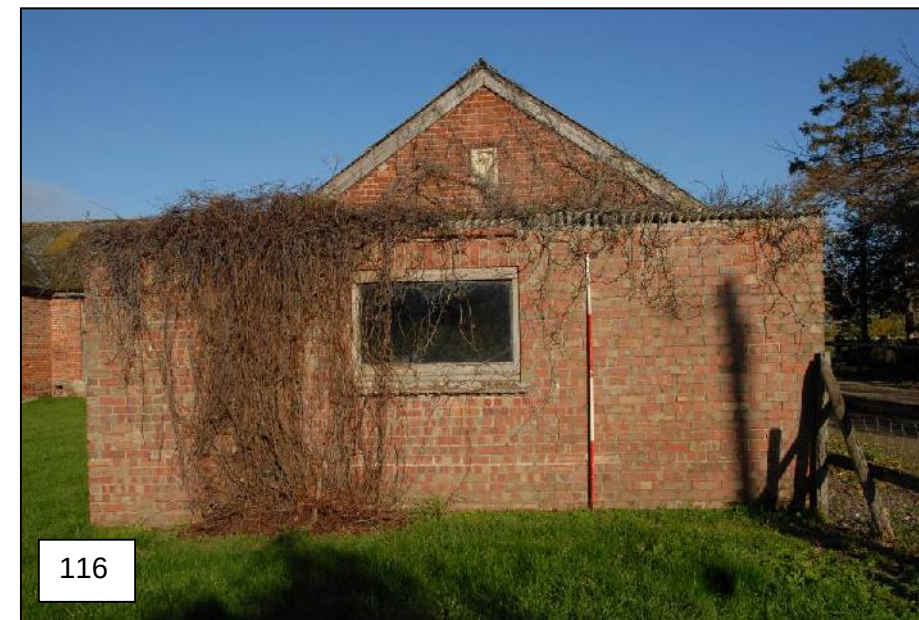
This is a recent lean-to structure at the south side of the east range. It is built of pink 65mm commons (brick size:  $8\frac{1}{2}" \times 4" \times 2\frac{1}{2}"$ ; 3 courses = 9") in Stretcher bond (4" walls). It has a shallow monopitched roof of corrugated asbestos-cement sheets.

A pair of framed matchboard doors is present at the east side below a concrete cast lintel, while it is lit by a single fixed window in the south wall.

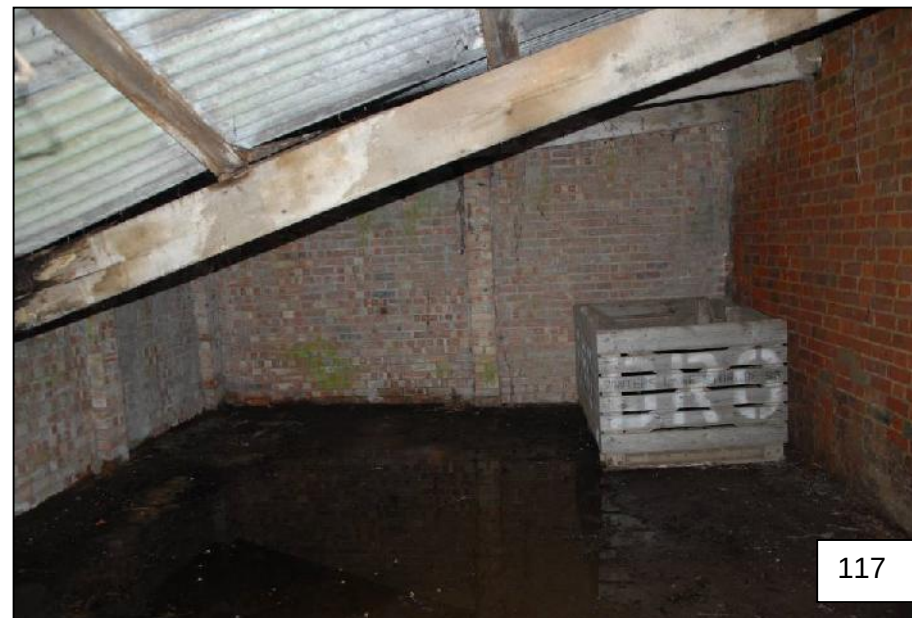
The floor was of plain poured concrete. The roof, of corrugated sheets, was supported on 4" x 2" purlins (east-west) in turn supported on 9" x 1½" 'beams' one of which had failed. The room was accessed through double doors of framed, ledged and diagonally braced (all 3½" x 1½") vertical 4½" matchboard (½" thick) in a 4½" x 2" frame.

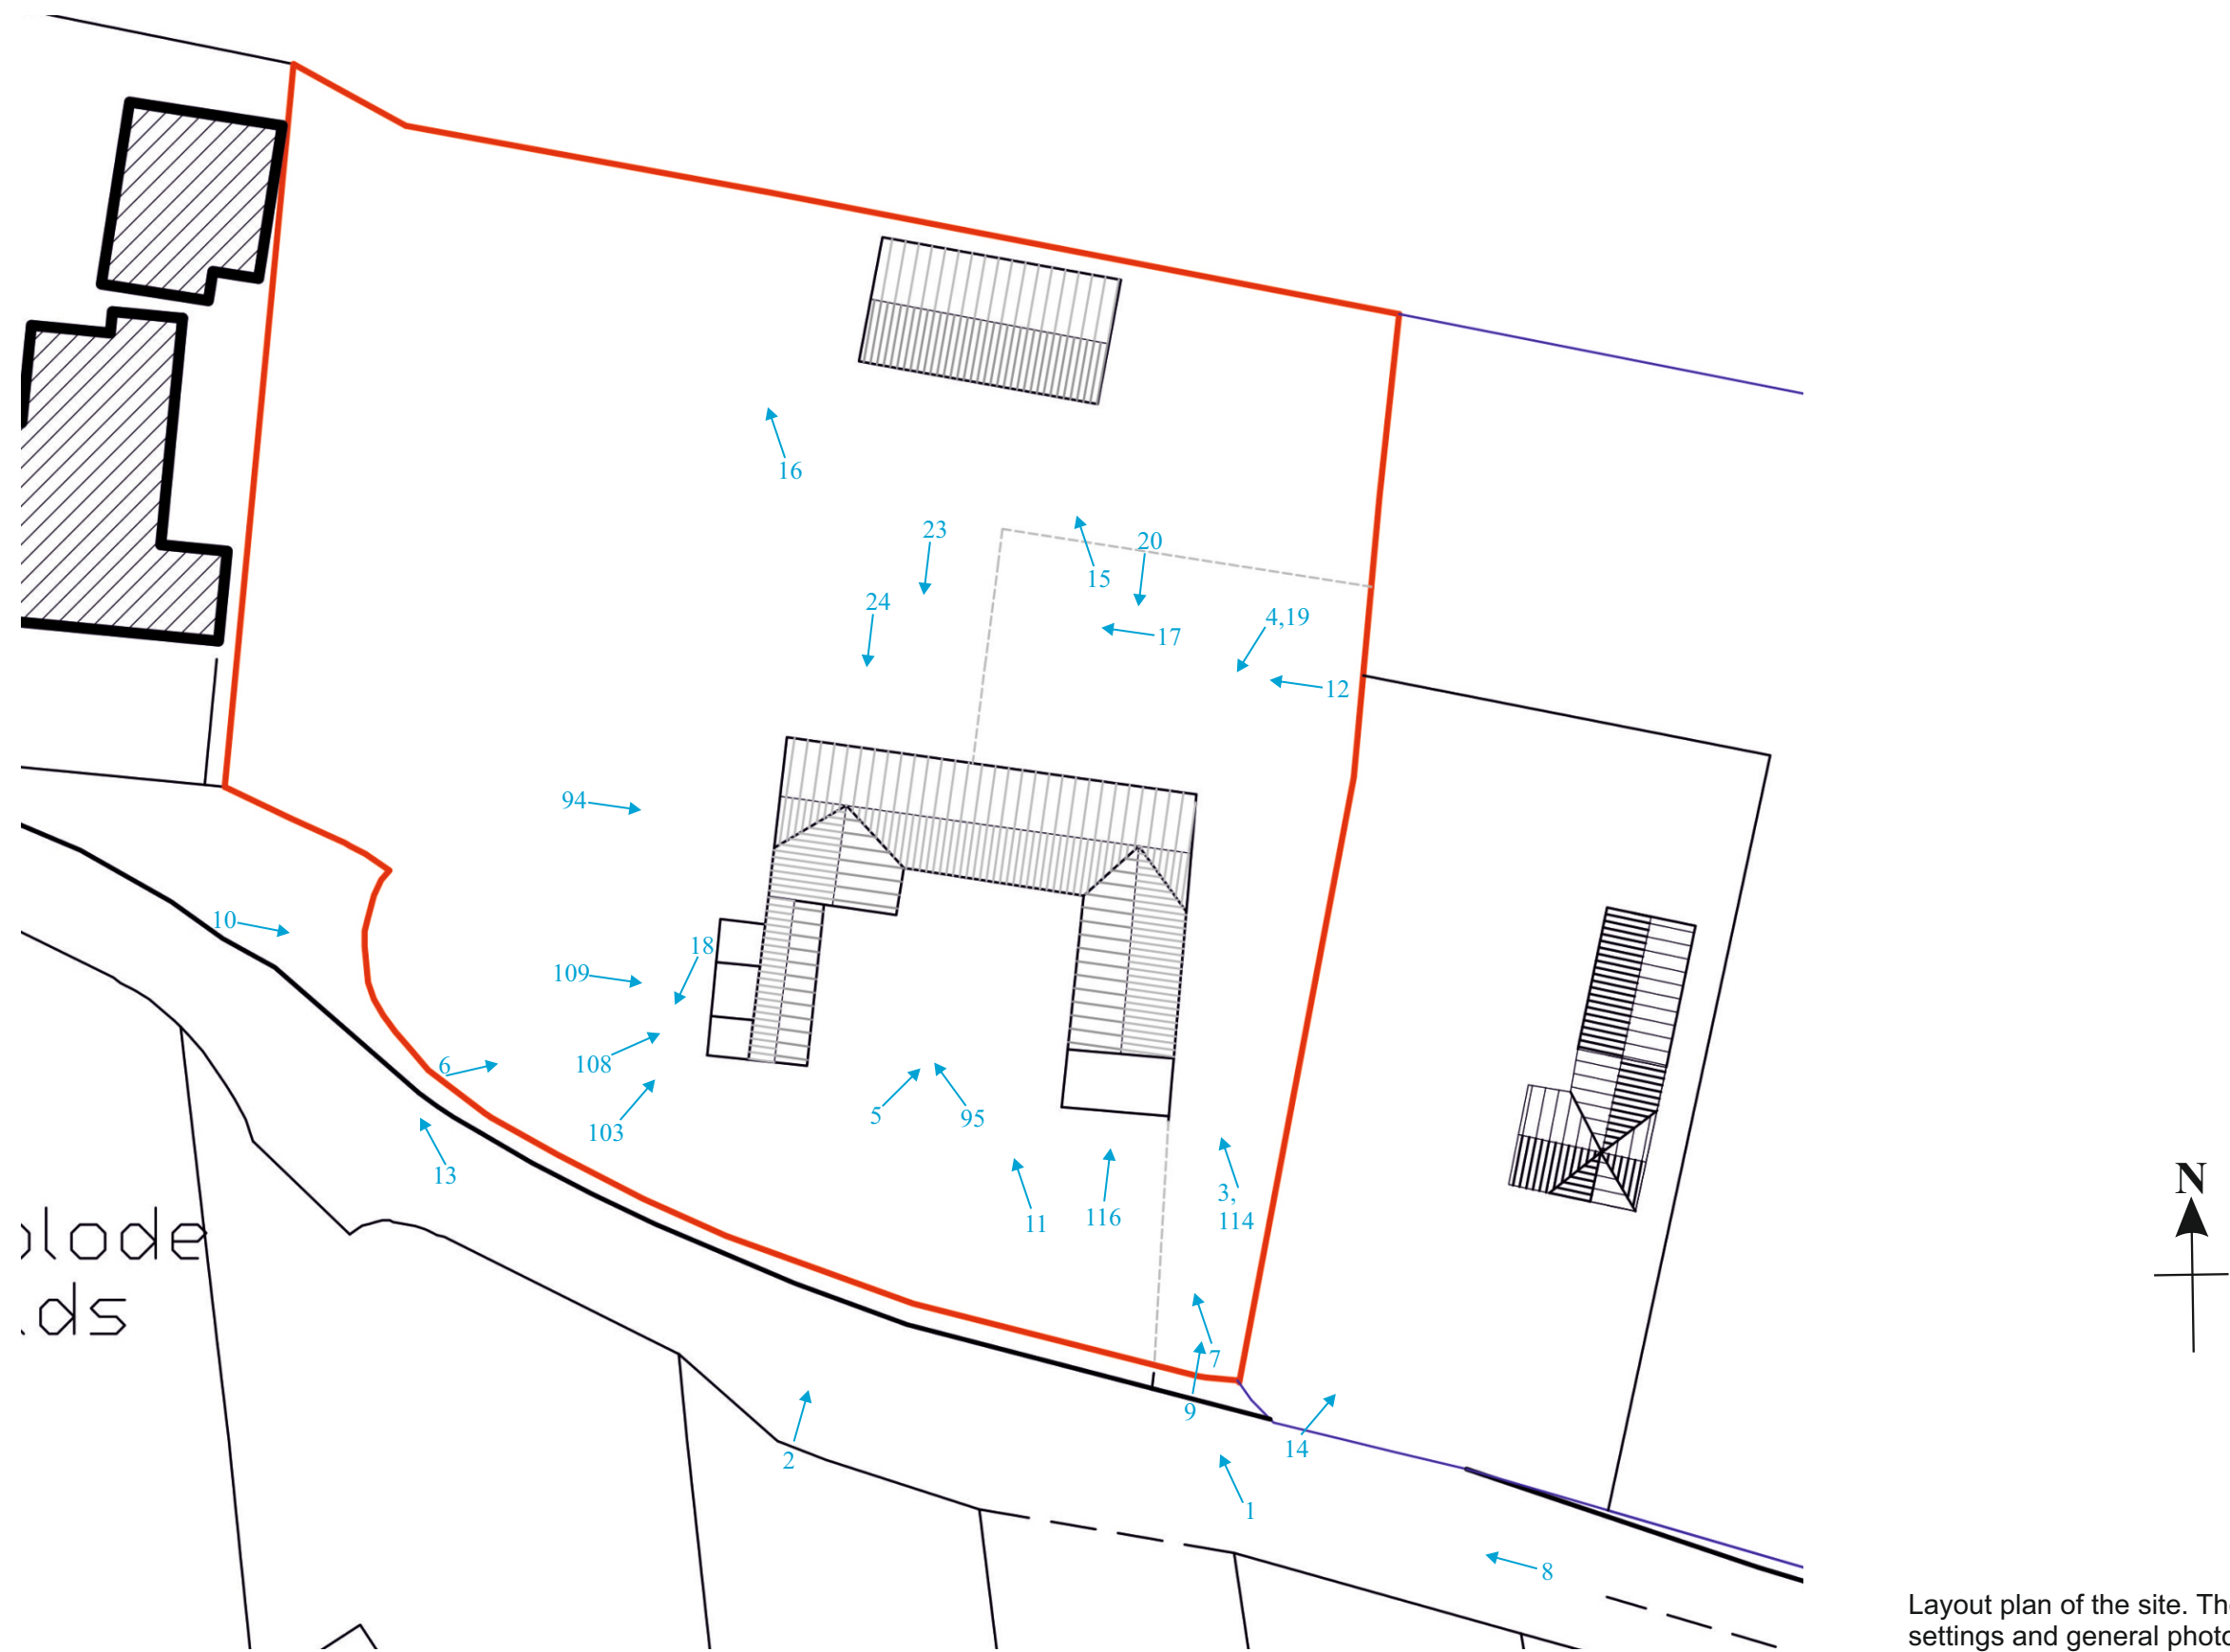
Layout plan of the site. The position and direction of settings and general photographs is shown in blue. Scale 1:400. (Based on a plan supplied by client)
