**NEVILLE HALL  
FREELANCE ARCHAEOLOGIST & CONSULTANT**

HISTORIC BUILDING RECORDING AT  
CROWN FARM, STOCKWELL GATE WEST,  
WHAPLODE, LINCOLNSHIRE.

**National Grid Reference: TF 3306 2504**  
**Planning Reference: H23-1116-21**  
**Site Code: CFWH23**  
**Accession Number: LCNCC: 2023.77**

July 2023

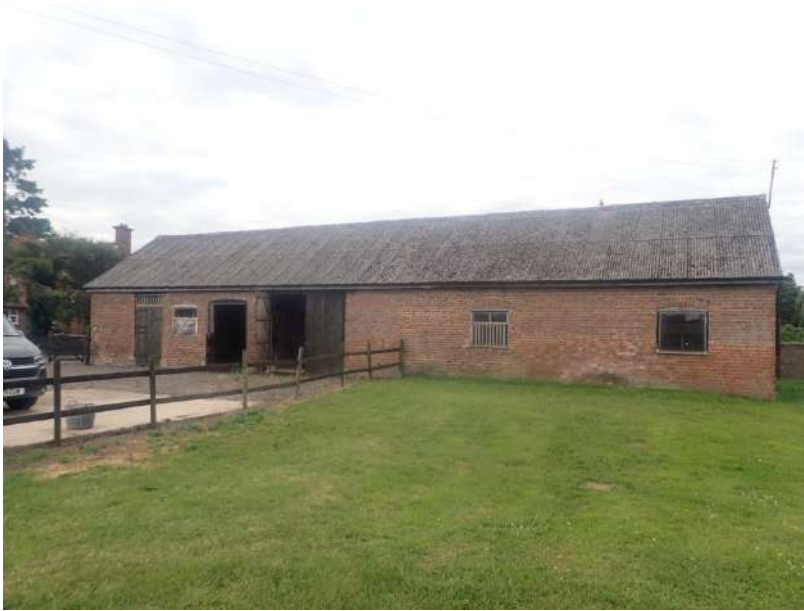
**Plate 1: General view of the outbuilding complex, from the north**

**Plate 1** provides a general view of the two storey North Range of this outbuilding complex from a northern position.

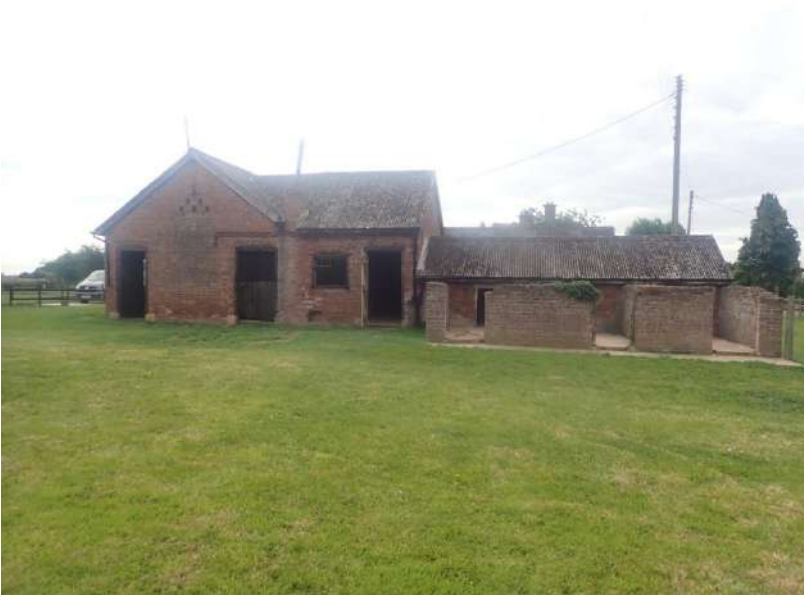
**Plate 2: General view of the outbuilding complex, from the west**

**Plate 2** presents a general view of this outbuilding complex from a western perspective and features the western end of the two storey North Range and of the West Range with its two storey outbuilding to the north and single storey outbuilding to the south.

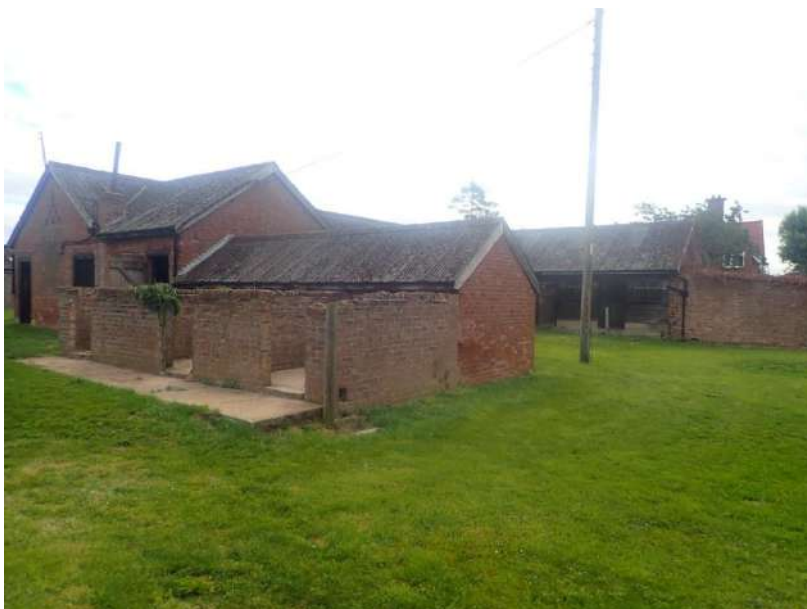
**Plate 3** provides a further general view of the West Range with its two storey outbuilding to the north and single storey outbuilding to the south with the North Range and East Range in the background.

**Plate 3: General view of the outbuilding complex, from the south-west**

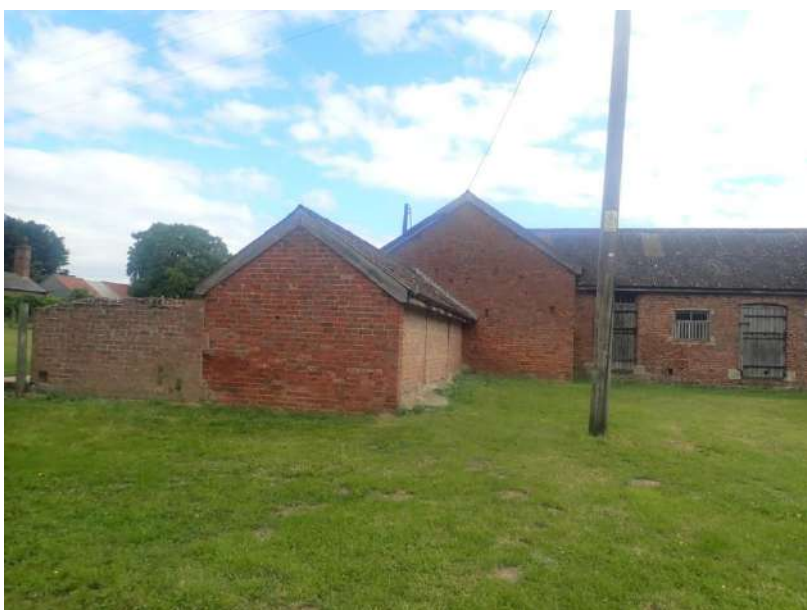
**Plate 4: General view of the outbuilding complex, from the south**

**Plate 4** furnishes a general view of this outbuilding complex from a southern vantage point and shows the West Range with its two storey outbuilding to the north and single storey outbuilding to the south and the two storey North Range in the background.

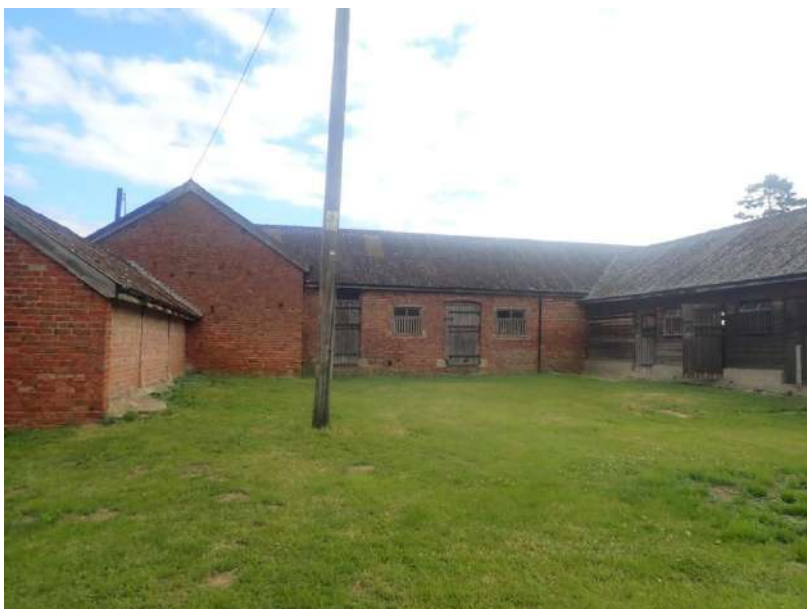
**Plate 5: General view of the outbuilding complex, from the south**

**Plate 5** presents a further general view of this outbuilding complex from a similar southern position and features the two storey North Range in the background along with the northern portion of the East Range with its two storey outbuilding here.

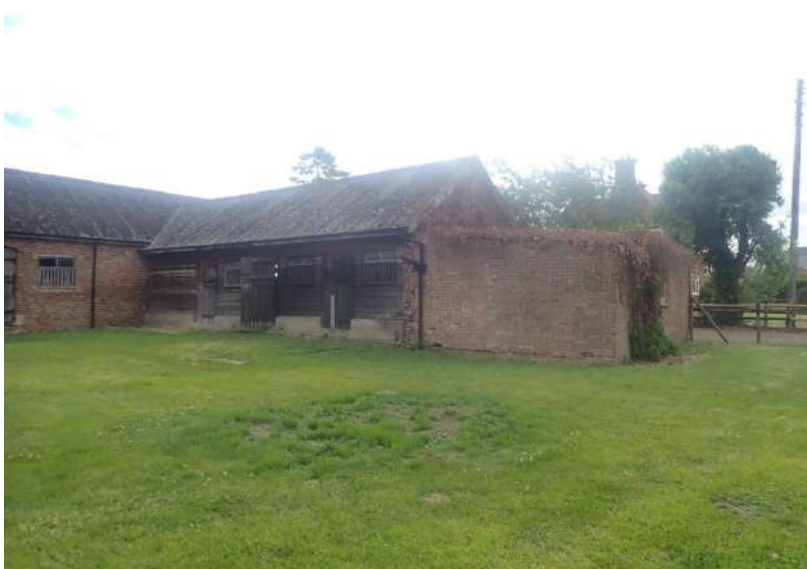
**Plate 6: General view of the outbuilding complex, from the south-west**

**Plate 6** presents a general view of the East Range of this outbuilding complex showing the two storey outbuilding to the north along with the single storey modern lean-to/garage to the south.

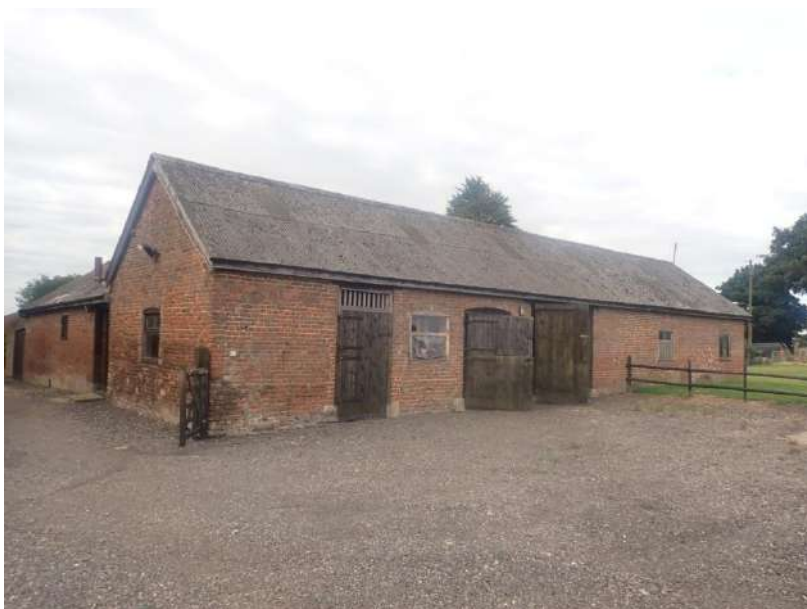
**Plate 7** furnishes a general view of the two storey North Range of this outbuilding complex.

**Plate 7: General view of the outbuilding complex, from the north-east**

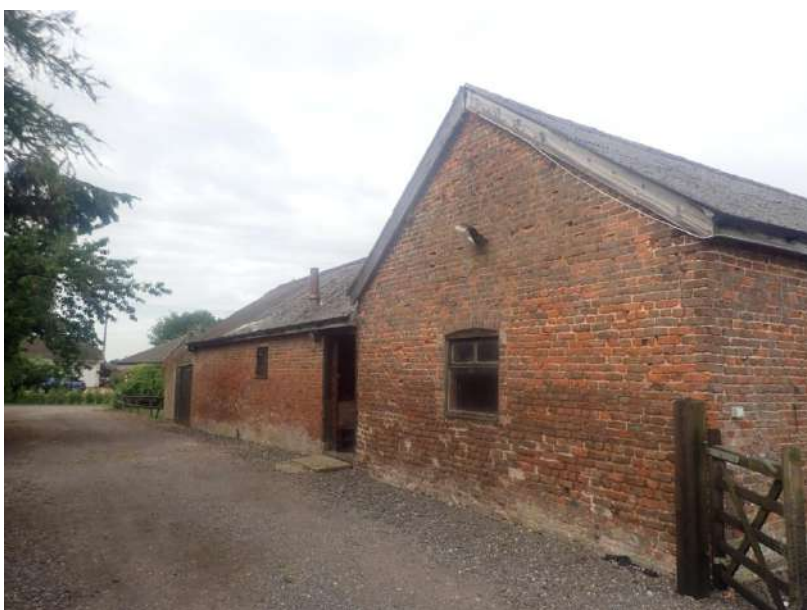
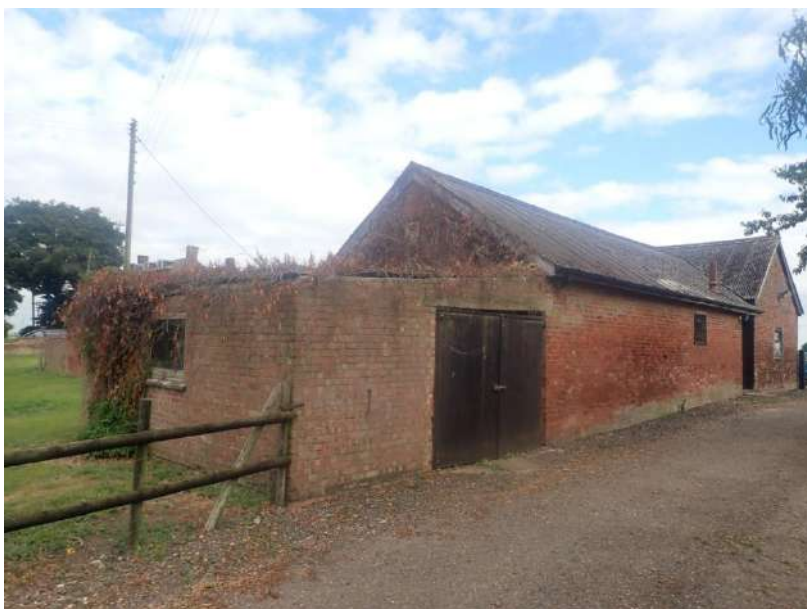
**Plate 8: General view of the outbuilding complex, from the north-east**

**Plates 8 and 9** feature the East Range of this outbuilding complex from different south-eastern and north-eastern positions and show the two storey outbuilding to the north along with the single storey modern lean-to/garage to the south.

**Plate 9: General view of the outbuilding complex, from the south-east**

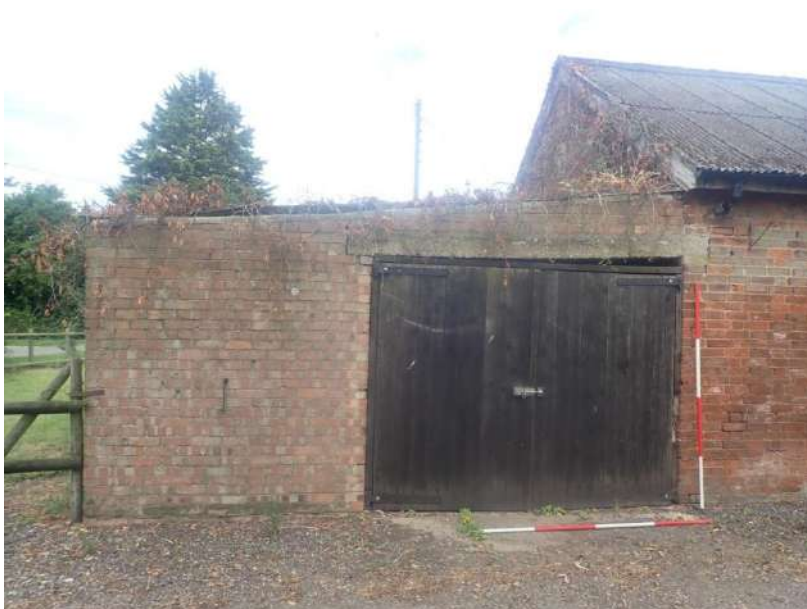
This outbuilding is a single storey modern 20th century addition to the southern end of the East Range, which formerly functioned as a garage. It has a very low angled half gabled roof with a roof covering of corrugated asbestos sheeting. This is bonded to the southern end of the two storey northern outbuilding within this East Range.

**Plate 10: View of the East Elevation of the Modern Lean-to/Garage, from the east**

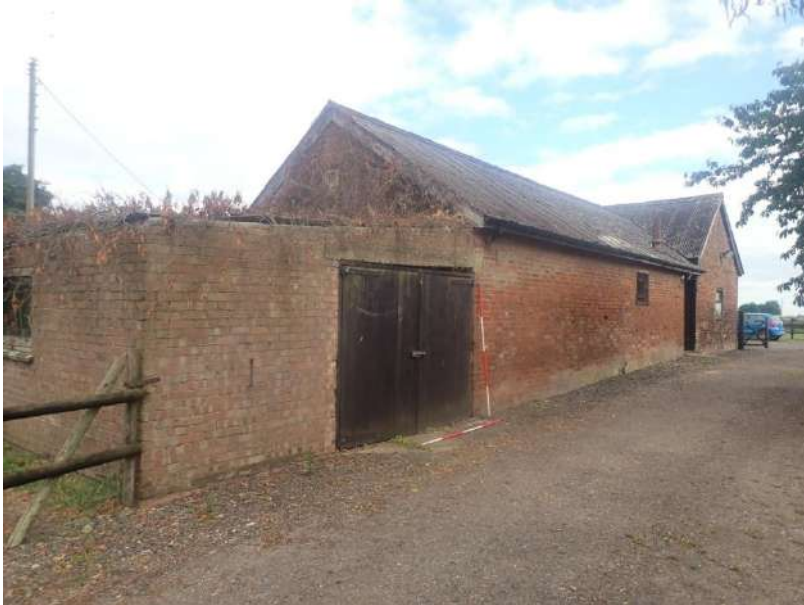
**Plate 11: View of the East Elevation of the Modern Lean-to/Garage, from the south-east**

**Plates 10 and 11** feature the East Elevation of this modern lean-to/garage from two different vantage points. The brickwork wall fabric of this East Elevation is composed of courses of brick stretchers in Stretcher Bond. The main feature of this East Elevation is the east facing entrance

opening. This opening is occupied by a timber frame of a head and surrounds and by a pair of modern timber doors. Each door is composed of a series of vertical tongued and grooved timber planks that are attached the frame surrounds by two pairs of horizontal cast metal strap hinges. Above the opening and incorporated into the brickwork wall fabric here is an horizontal concrete lintel.

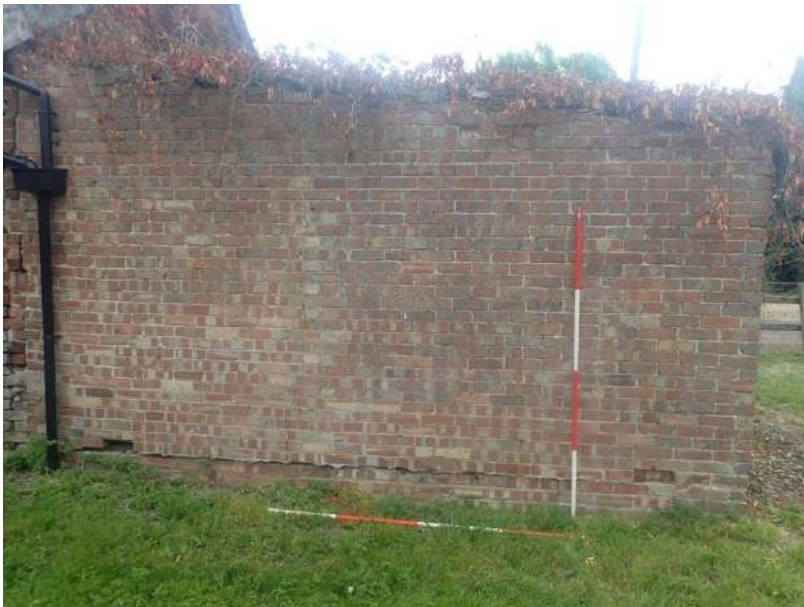
**Plate 12: View of the West Elevation of the Modern Lean-to/Garage, from the west**

**Plate 12** presents a detailed view of the West Elevation of this modern lean-to/garage. The brickwork wall fabric of this West Elevation is composed of the same courses of brick stretchers in Stretcher Bond. To the left (north) and attached to this brickwork is a vertical modern Upvc downpipe.

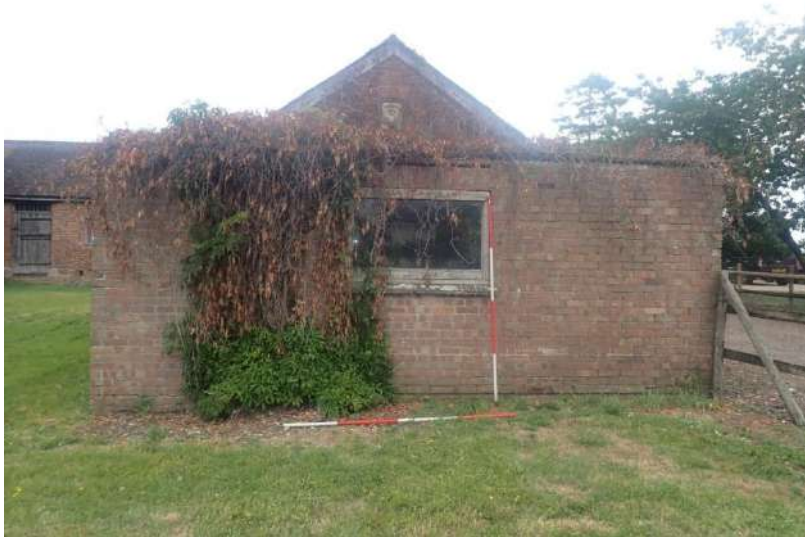
**Plate 13: View of the South Elevation of the Modern Lean-to/Garage, from the south**

**Plate 13** furnishes a view of the South Elevation of this modern lean-to/garage. The brickwork wall fabric of this South Elevation is also composed of the same courses of brick stretchers in Stretcher Bond. The central feature of this South Elevation is the south facing window opening. This opening is occupied by a modern glazed and single light timber casement window with a timber frame of a head and surrounds and a concrete tiled sill at the base of the opening. Above the opening and incorporated into the brickwork is a head that is composed of brick stretchers laid on end.

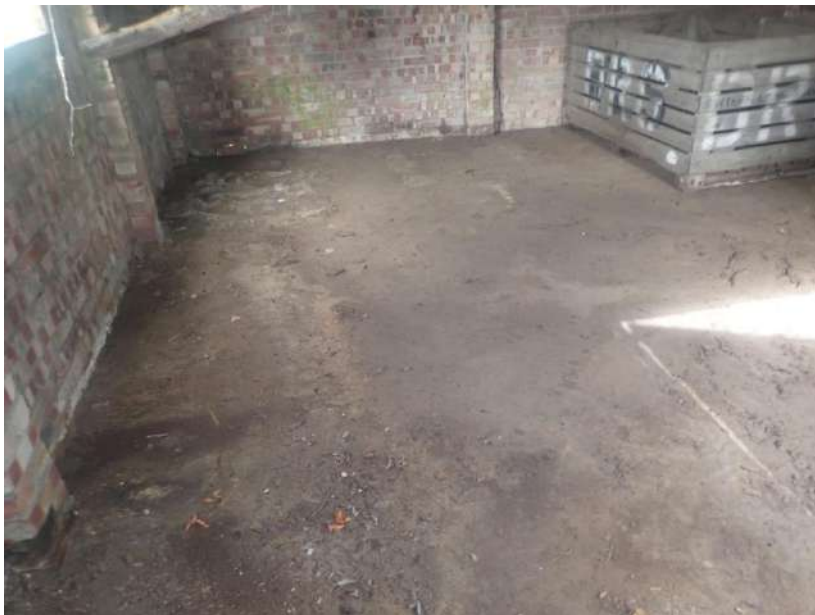
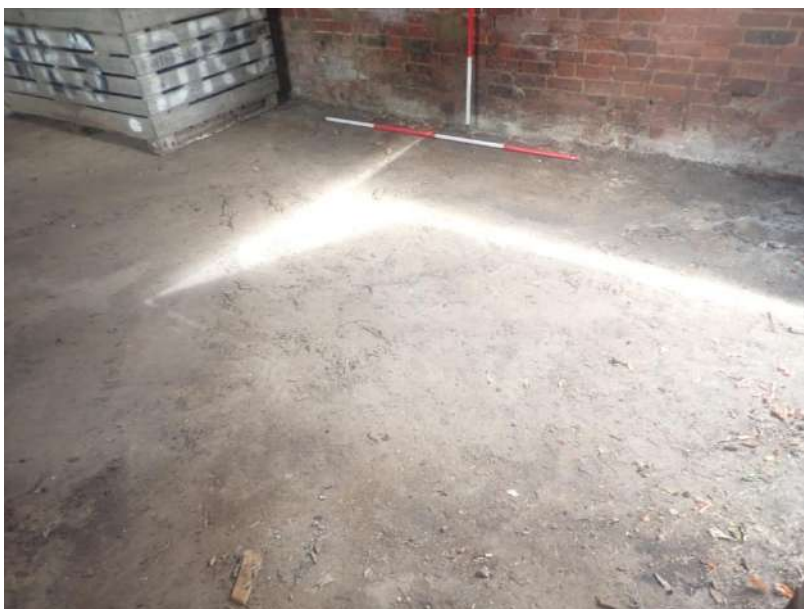
**Plates 14 and 15** presents views of the nature of the flooring of the interior of this modern lean-to/garage, which is of modern concrete.

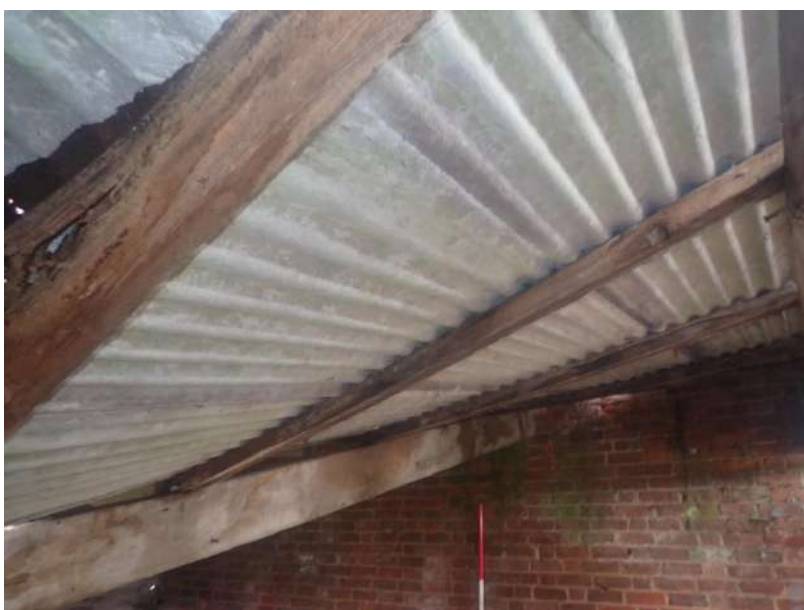
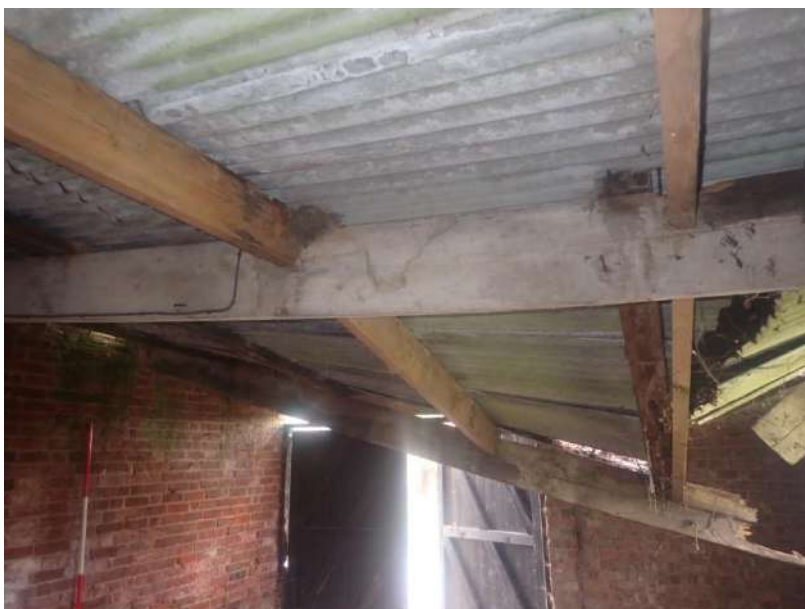
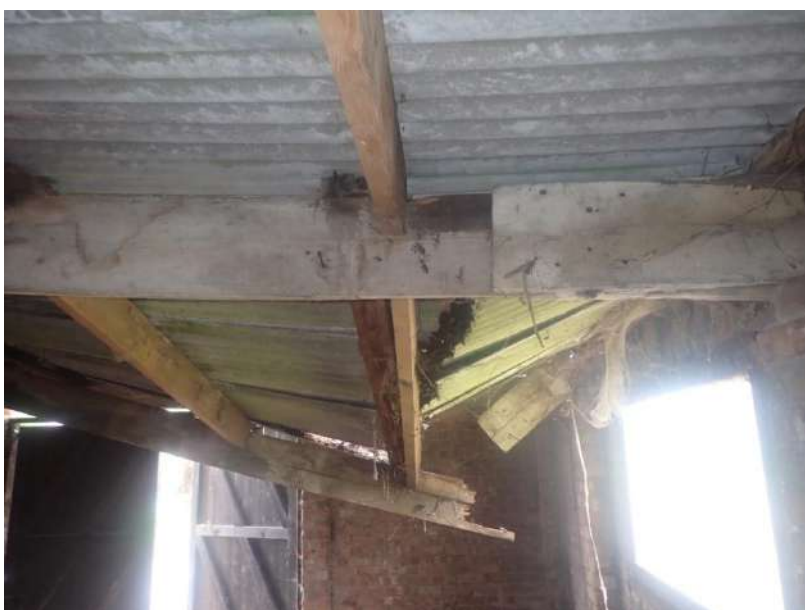
**Plates 16-20** present a number of views from differing vantage points of the nature of the roof supporting structure of this modern lean-to/garage. This is a relatively simple structure, which is of a very low angled half gabled nature. The roof structure is composed of a series of north-south orientated low angled timber planked rafters, the ends of which are inserted into the fabric of the north and south walls. These are in turn attached to a further series of east-west aligned low angled timber purlins. Both rafters and purlins support the roof covering of asbestos roof sheeting. The ends of the purlins are affixed to the timber planked rafters.

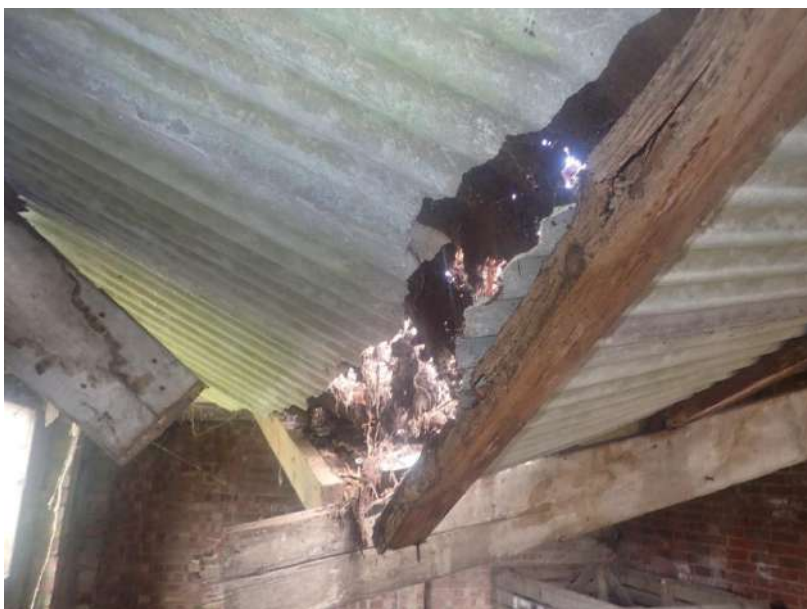
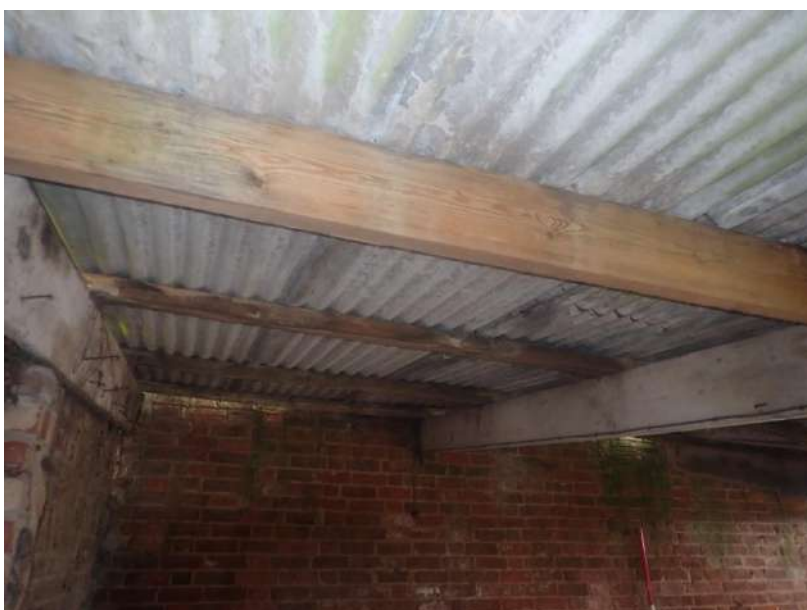
**Plate 17: View of the roof supporting structure of the modern lean-to/garage, from the east**

**Plate 18: View of the roof supporting structure of the modern lean-to/garage, from the south**

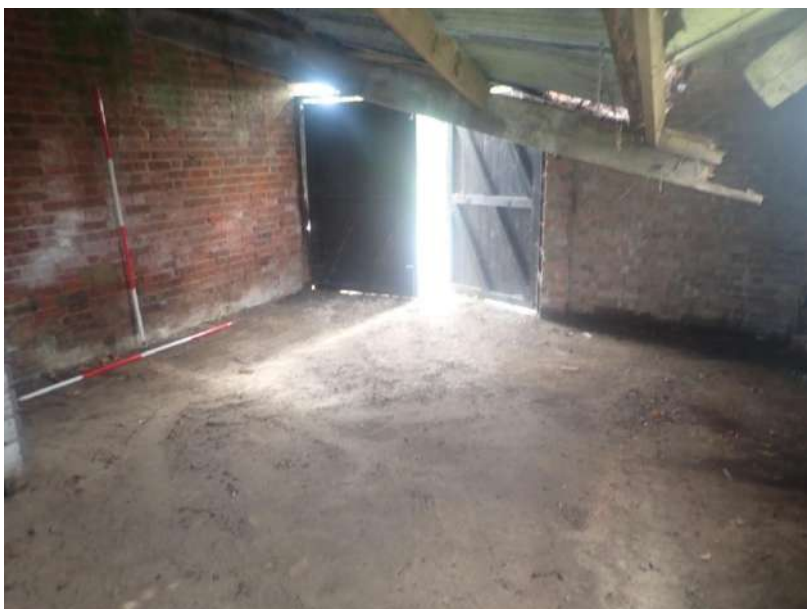
**Plate 21** presents a general view of the interior of the modern lean-to/garage from a western perspective.

**Plate 21:** General view of the interior of the modern lean-to/garage, from the west

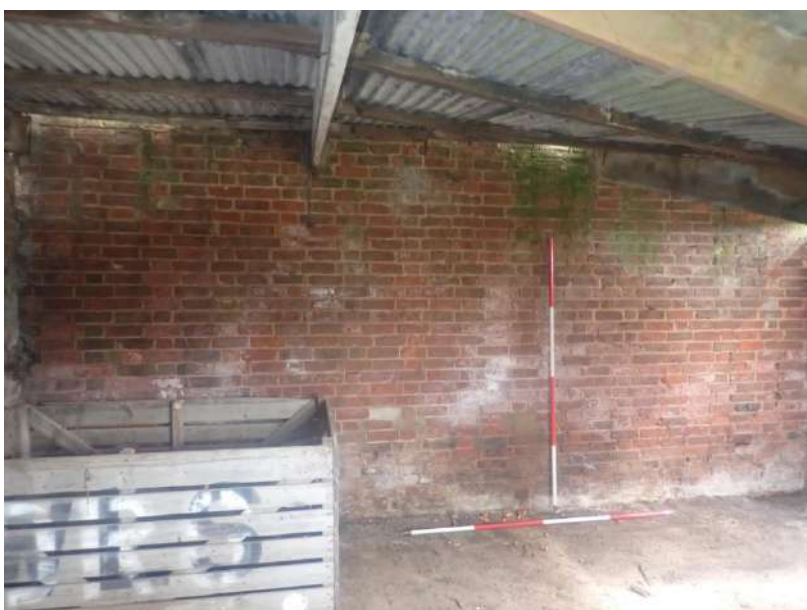
**Plate 22:** View of the north wall of the modern lean-to/garage, from the south

**Plate 22** presents a detailed view of the north wall of this modern lean-to/garage, which is also part of the lower levels of the South Elevation of the adjoining **Outbuilding 1** of the remainder of the East Range. The brickwork wall fabric here is composed of courses of mixed brick headers and brick stretchers in a variation of Flemish Bond.

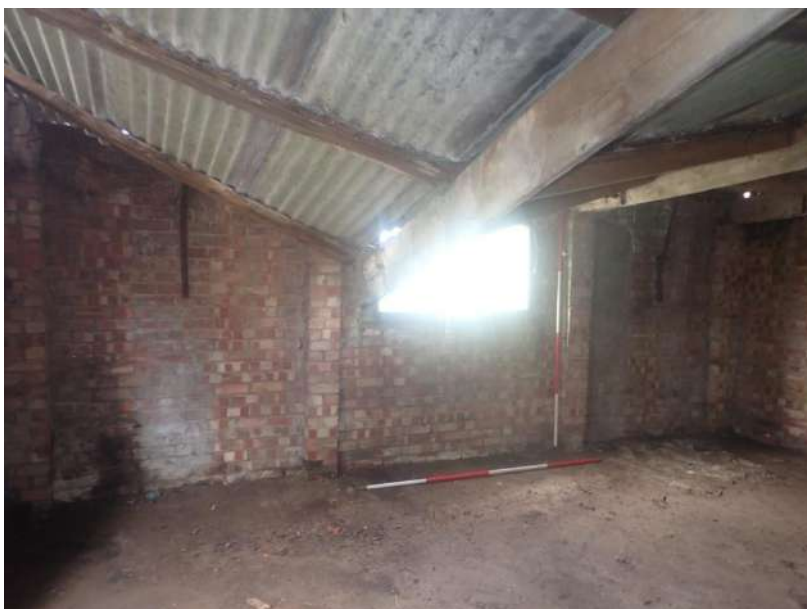
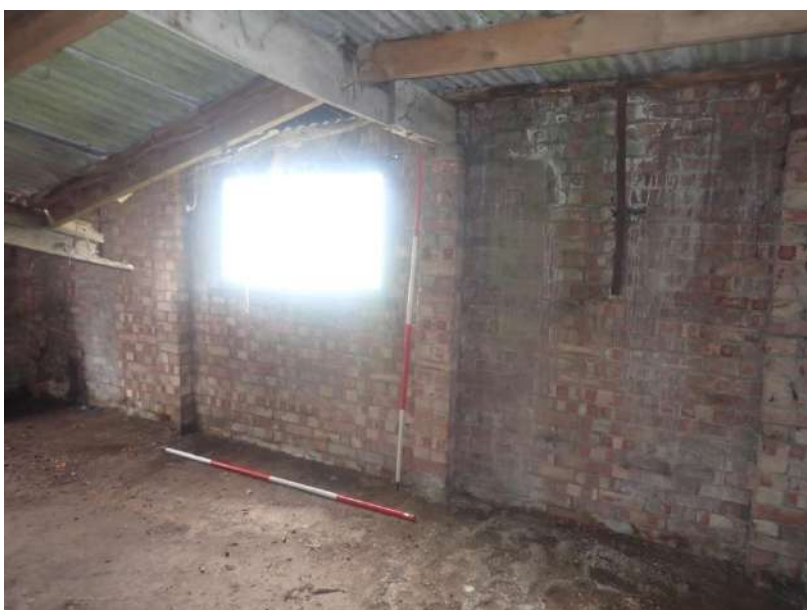
**Plates 23 and 24** furnish several views of the south wall of this modern lean-to/garage from differing positions. The brickwork wall fabric of this south wall is composed of courses of brick stretchers in Stretcher Bond. Also bonded to this brickwork are four vertical brick columns, each composed of courses of brick stretchers. The southern ends of the timber planked rafters are inserted into each of these brick columns. The inner face of the south facing modern window opening that was recorded externally at the South Elevation of this building, is also shown.

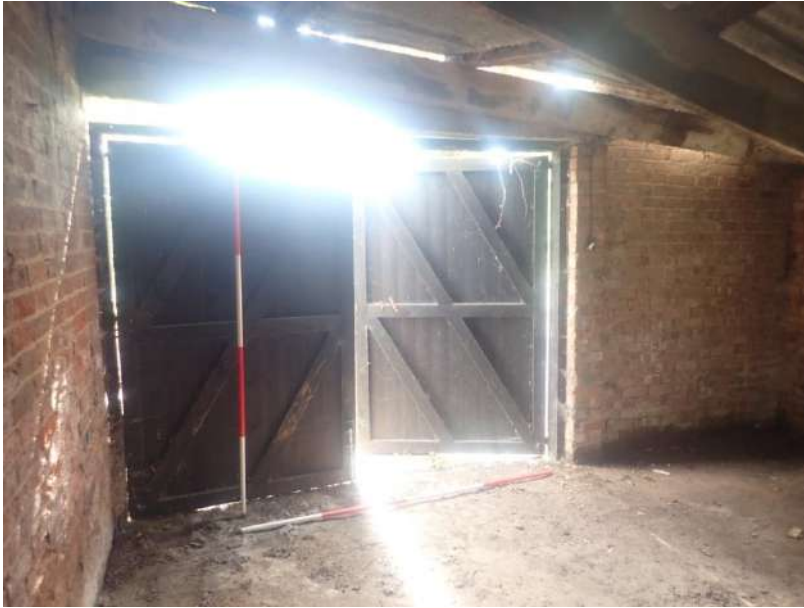
**Plate 25: View of the east wall of the modern lean-to/garage, from the west**

**Plate 25** presents a detailed view of the east wall of the modern lean-to/garage. The brickwork wall fabric of this east wall is composed of courses of brick stretchers in Stretcher Bond. Also featured is the inner face of the east facing entrance opening that was recorded externally at the East Elevation of this building. The vertical tongued and grooved timber planks of the pair of

timber doors are attached to an internal timber framework of angled, vertical and horizontal timbers.

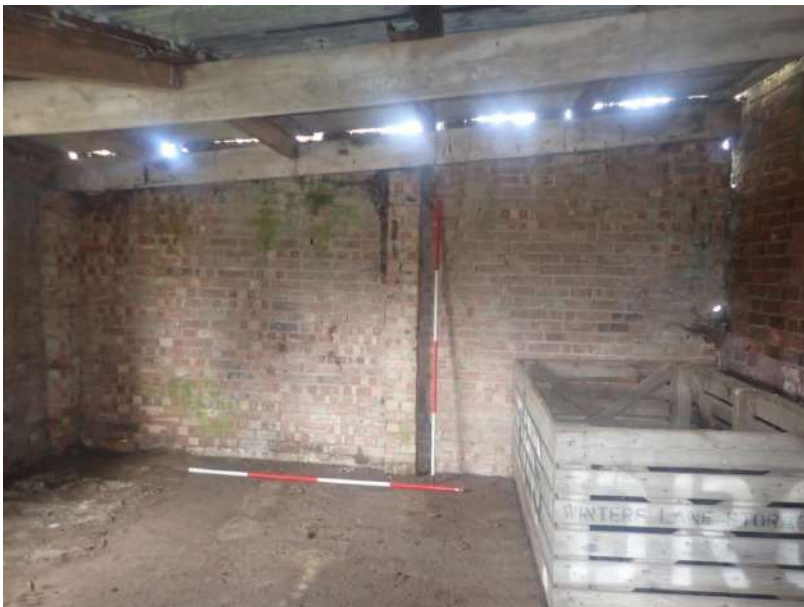
**Plate 26: View of the west wall of the modern lean-to/garage, from the east**

**Plate 26** provides a detailed view of the west wall of this modern lean-to/garage. The brickwork here is also composed of the same courses of brick stretchers in Stretcher Bond. Attached to this brickwork is a further vertical column of brick also composed of courses of brick stretchers.

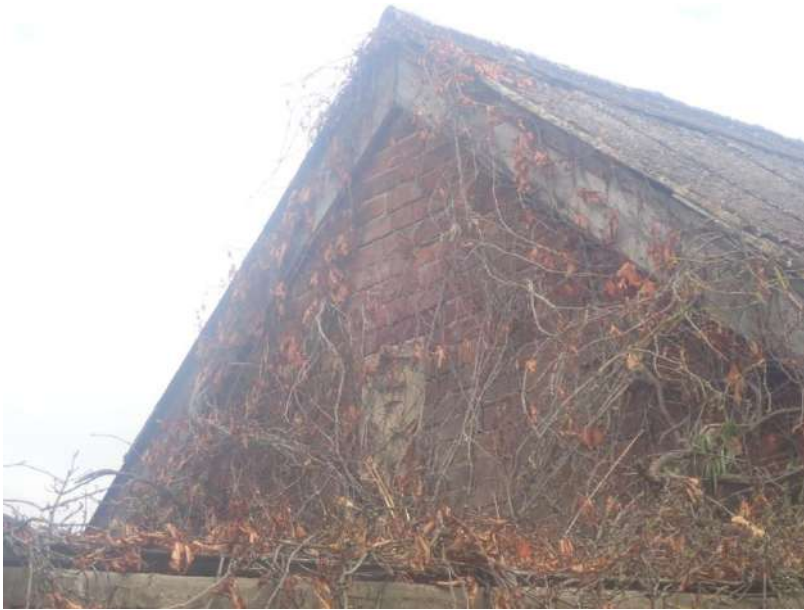
**Plate 27: View of the South Elevation of Outbuilding 1, from the south-east**

**Plate 27** presents a view of the upper levels of the South Elevation of **Outbuilding 1**. The brickwork wall fabric here is composed of courses of mixed brick headers and brick stretchers in a variation of Flemish Bond. Inserted into this brickwork is a probable datestone with a coat of arms on it, though an actual date is not visible.

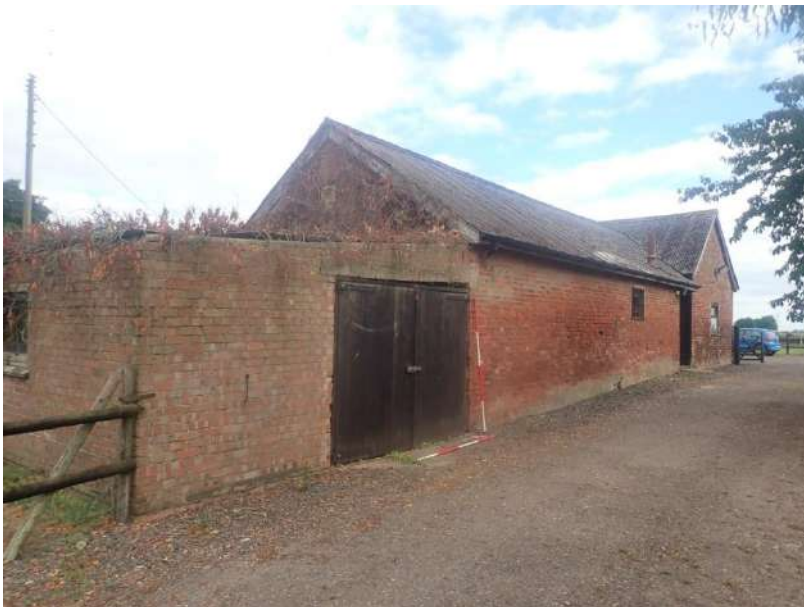
**Plate 28: General view of the East Range of the outbuilding complex, from the south-east**

**Plate 28** provides a general view of the East Range of this outbuilding complex from a south-eastern vantage point. This image also features the merging of the gabled roof structures of the East and North Ranges at their intersection.

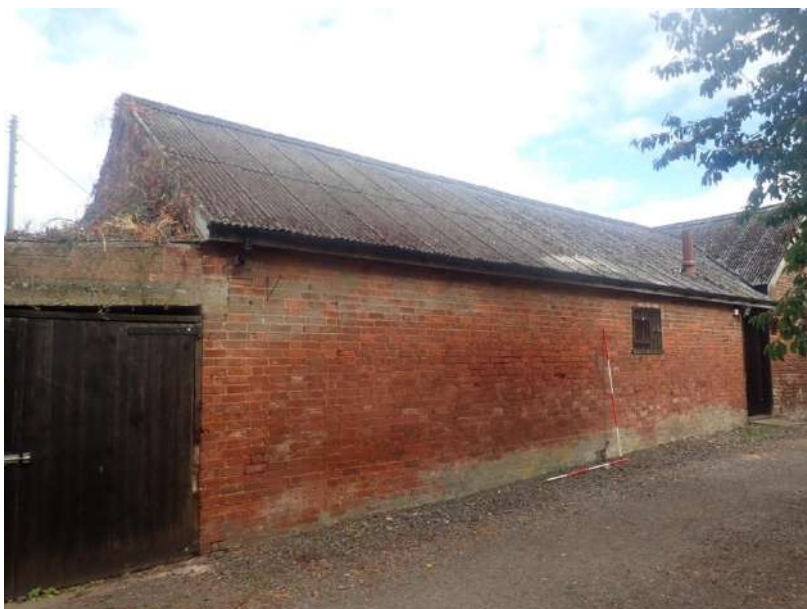
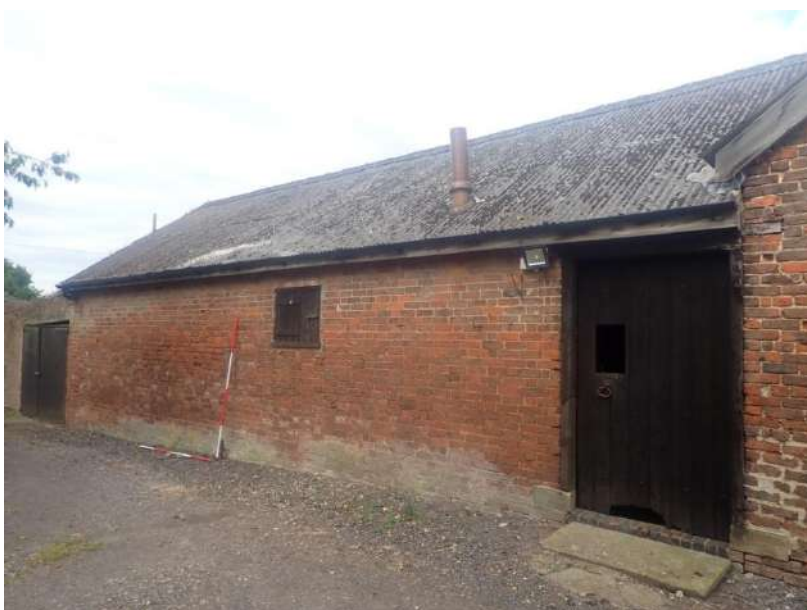
**Plates 29 and 30** present several images of the East Elevation of **Outbuilding 1** from two differing vantage points. The brickwork wall fabric of this East Elevation is composed of courses of mixed brick headers and brick stretchers in a variation of Flemish Bond. Inserted into the roof covering is a vertical ceramic chimney pot. At just below roof levels are horizontal timber fascia boards, to which is attached modern Upvc horizontal guttering. To the left (south), is an east facing window opening. This opening is occupied by a timber frame of a head and surrounds and by a timber shutter that is composed of a series of vertical tongued and grooved timber planks. The shutter is attached to the timber frame by two horizontal cast metal strap hinges. At the northern end of this East Elevation is an east facing entrance opening. This opening is occupied by a timber frame of a head and surrounds. The bottom ends of the surrounds lie upon two worked, shaped and faced stone ashlar that are incorporated into the brickwork wall fabric. Attached to the timber frame is a door that is composed of a series of vertical tongued and

grooved timber planks. At the base of the opening is a threshold of brick composed of stretchers laid on edge. Above the opening and also incorporated into the wall fabric here is an horizontal timber lintel.

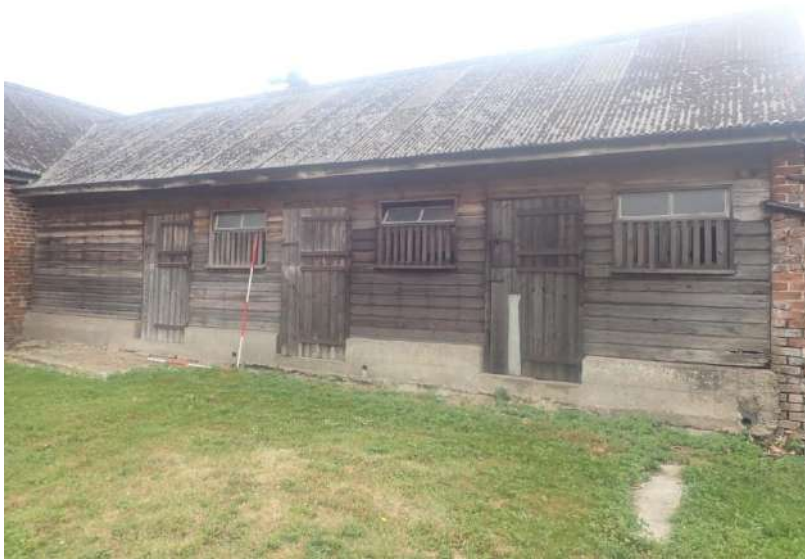
**Plate 31: View of the West Elevation of Outbuilding 1, from the south-west**

**Plates 31 and 32** present detailed views of the West Elevation of **Outbuilding 1**. At just below roof levels are horizontal timber fascia boards to which is attached modern horizontal Upvc guttering. This extends onto a vertical Upvc downpipe to the south. The wall fabric of this West Elevation is composed of timber weatherboarding that is composed of a series of horizontal tongued and grooved timber planks that rest on a low foundation of modern concrete. Also featured are three west facing entrance openings. Each opening is occupied by timber frames of heads and surrounds and each by two timber half doors. Each half door is in turn composed of a series of vertical tongued and grooved timber planks that are affixed to the timber frames by

horizontal metal strap hinges. There are also in addition, three east facing window openings. Each opening is occupied by timber frames of heads, surrounds and sills. Each window is partially glazed at the upper levels of two lights with one vertical timber glazing bar each with the remainder of each opening at the lower levels occupied by a series of vertical timber ventilation slats.

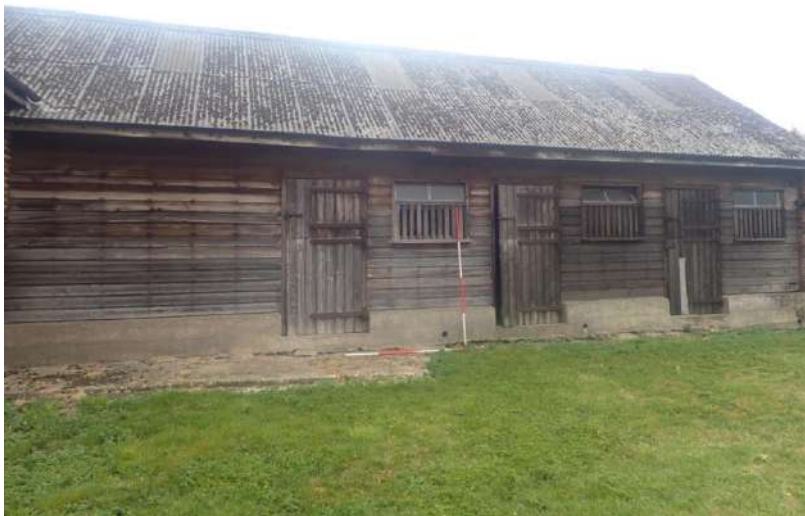
**Plate 32: View of the West Elevation of Outbuilding 1, from the west**

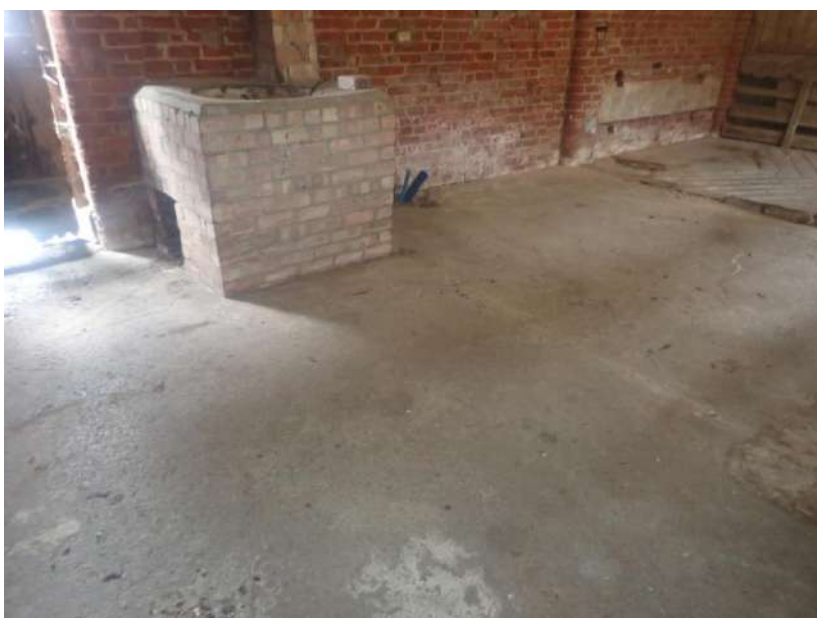
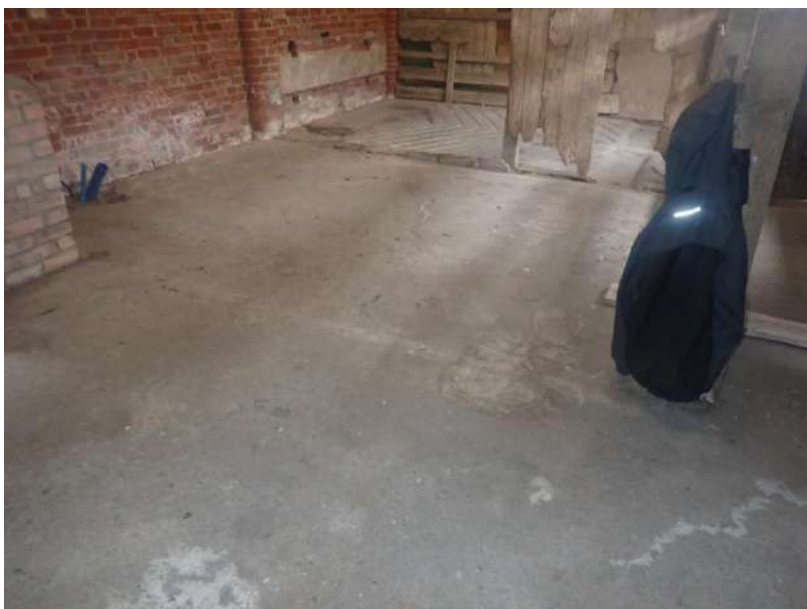
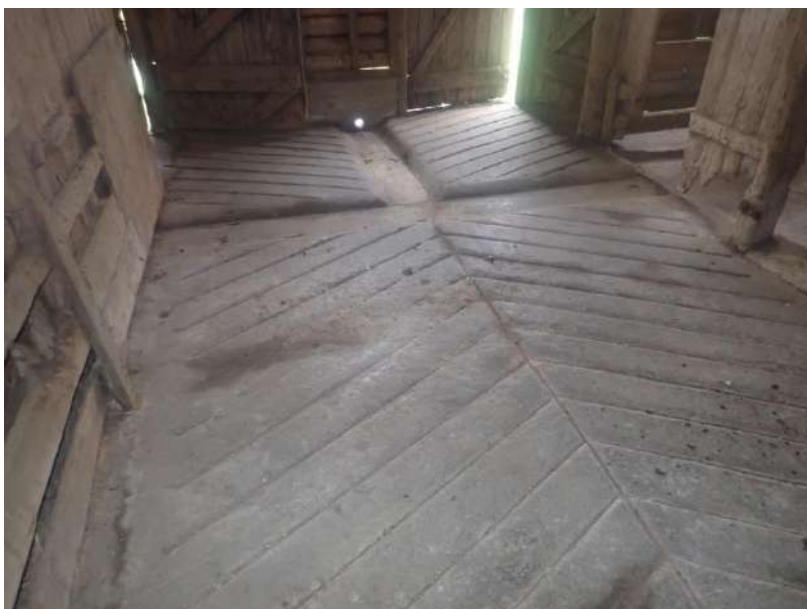
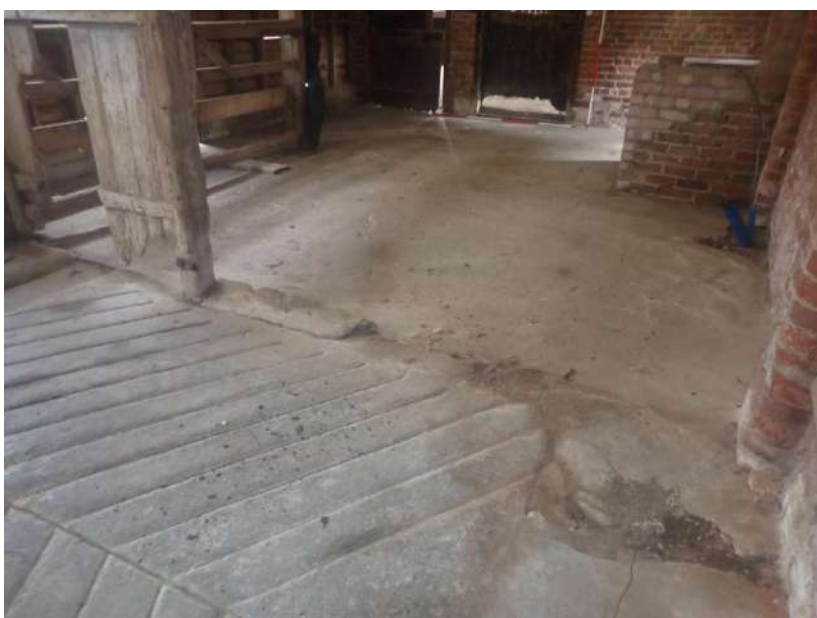
**Plates 38-42** feature images of the nature of the flooring of **Cell 1**, which is of modern concrete.

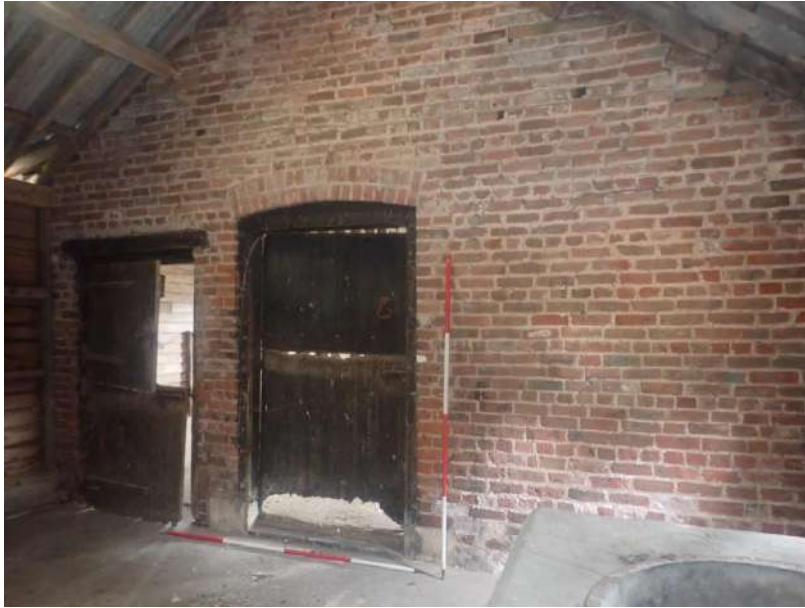
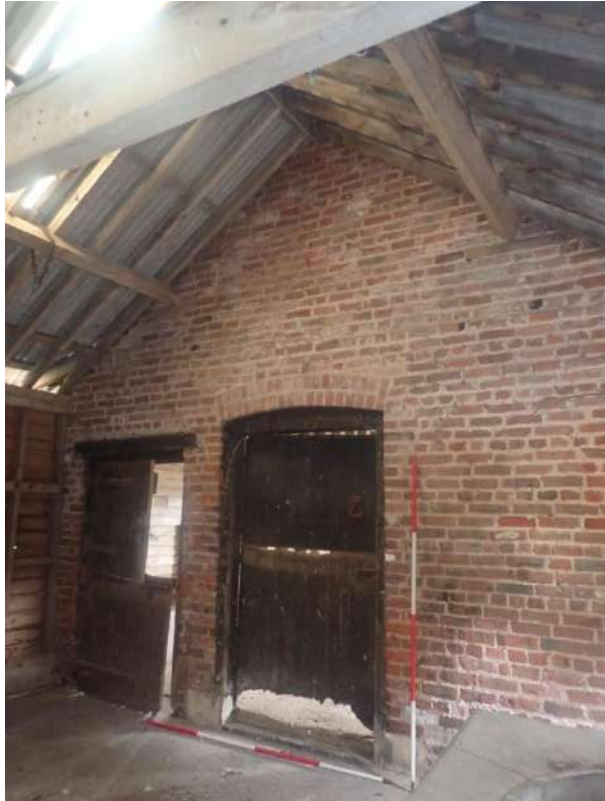
**Plates 43-45** furnish several views of the north wall of **Cell 1**, which is also the internal dividing wall with the adjacent North Range of this outbuilding complex to the north. The brickwork wall fabric of this north wall is composed of three courses of brick stretchers that alternate with single courses of brick headers in English Garden Wall Bond. It may also be observed that the northern ends of the horizontal timber purlins of the overlying roof structure of the East Range may be seen to be inserted into the uppermost levels of this brickwork.

To the right (east), is the first north facing entrance opening that extends onto the North Range. This slightly recessed opening is occupied by a timber frame of a head and surrounds and by a pair of timber half doors. Each half door is composed of a series of vertical tongued and grooved timber planks. Above the opening is a curved head in brick that is composed of two courses of brick stretchers laid on edge along with two brick headers at the end of the head laid on end.

To the left (west), is the second north facing entrance opening that extends onto the North Range. This second opening is also occupied by a timber frame of a head and surrounds along with two further timber half doors, each of which are composed of a series of vertical tongued and grooved timber planks. Above the opening and incorporated into the brickwork is an horizontal timber lintel.

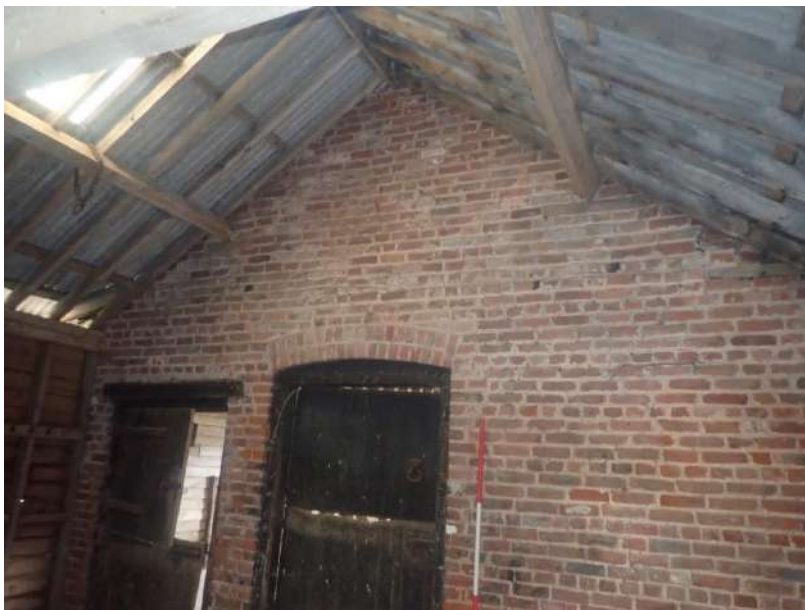
**Plate 44: View of the north wall of Cell 1, from the south**
