**NEVILLE HALL  
FREELANCE ARCHAEOLOGIST & CONSULTANT**

HISTORIC BUILDING RECORDING AT  
CROWN FARM, STOCKWELL GATE WEST,  
WHAPLODE, LINCOLNSHIRE.

**National Grid Reference: TF 3306 2504**  
**Planning Reference: H23-1116-21**  
**Site Code: CFWH23**  
**Accession Number: LCNCC: 2023.77**

July 2023

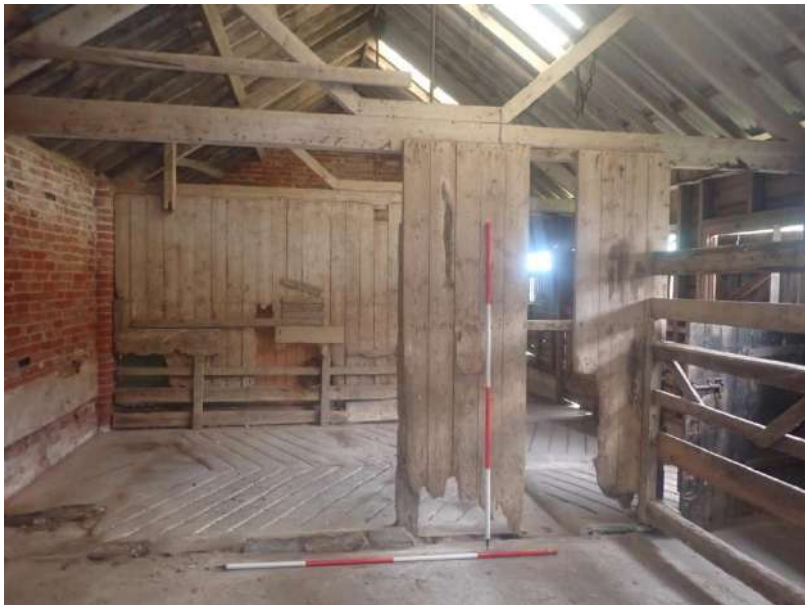
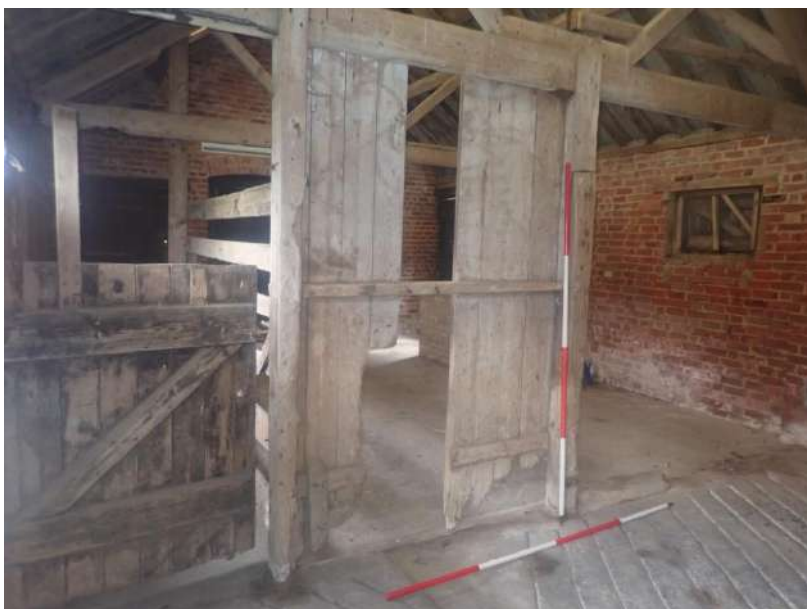
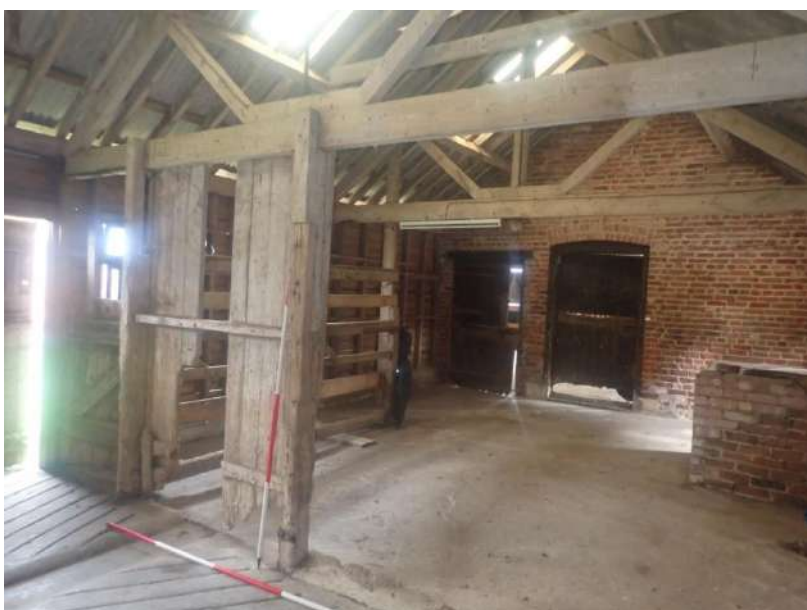
**Plate 46: View of the internal timber partition within Cell 1, from the north**

**Plate 47: View of the internal timber partition within Cell 1, from the south-west**

**Plate 48: View of the internal timber partition within Cell 1, from the south-east**

**Plates 46-48** present several views of the remnants of an internal timber partition within the interior of **Cell 1**, which was probably once more extensive and which probably originally extended along the whole width of this room space. This partition is composed of a series of vertical timber planks that are in turn affixed to a timber framework of vertical timber posts and horizontal timbers. The ends of the vertical timber posts are sunk into the concrete floor and attached to a timber tie beam of an overlying roof truss. To the right (west), is a low timber gate that is attached to one of the vertical timber posts. The gate itself is composed of a series of vertical timber planks attached to an internal framework of angled and horizontal timbers.

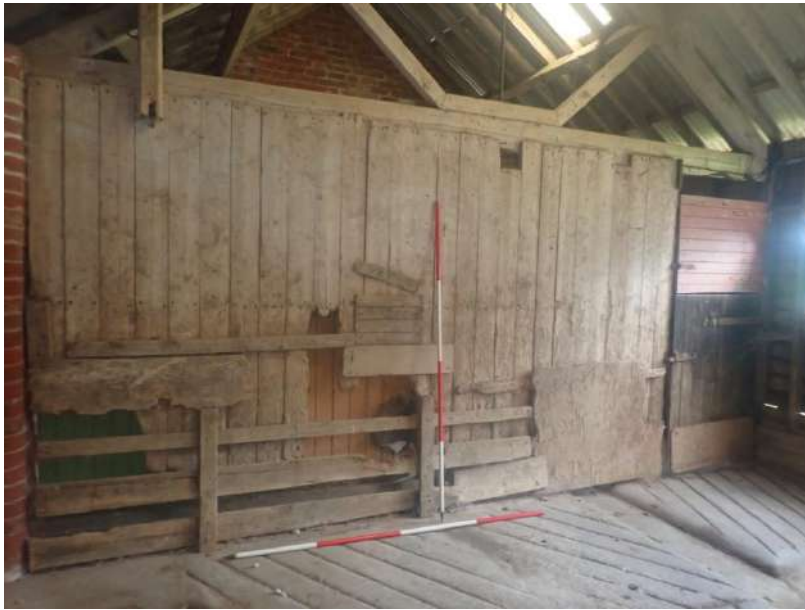
**Plate 49** presents a detailed view of the south wall of **Cell 1**, which is also the internal dividing wall with the adjoining **Cell 2** to the south. This is a second internal timber partition wall that is also made up of a series of vertical timber planks. The upper ends of the planks are attached to

the timber tie beam of an overlying roof truss. At the base of the wall and attached to it is a low timber fence made up of a series of vertical timber posts sunk into the concrete floor with horizontal timber rails attached to them.

**Plate 49: View of the south wall of Cell 1, from the north**

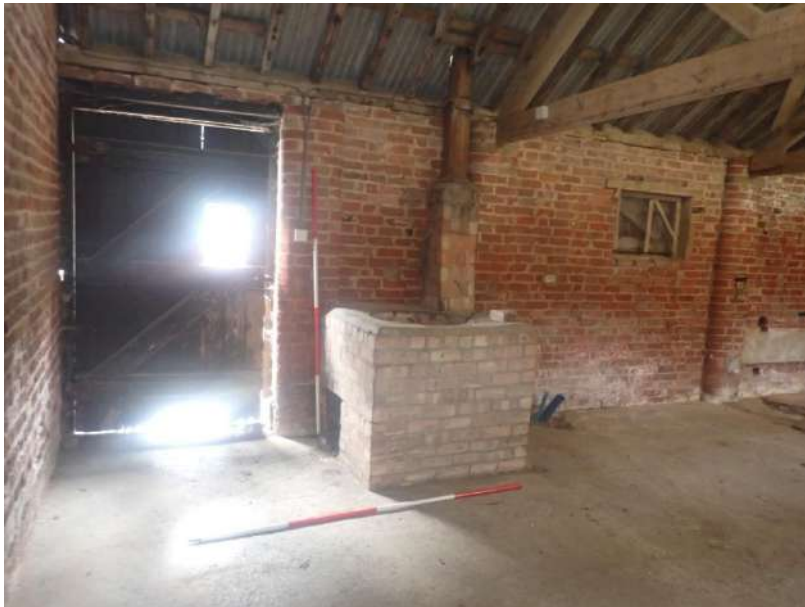
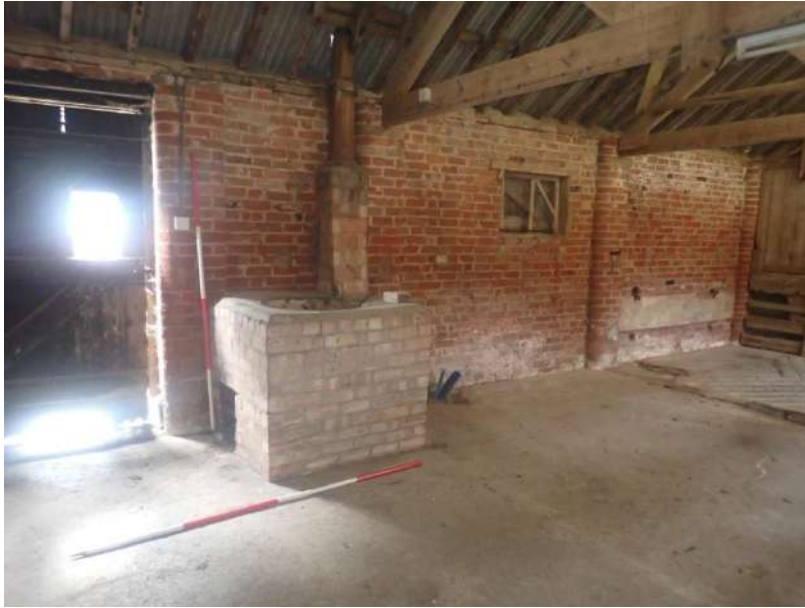
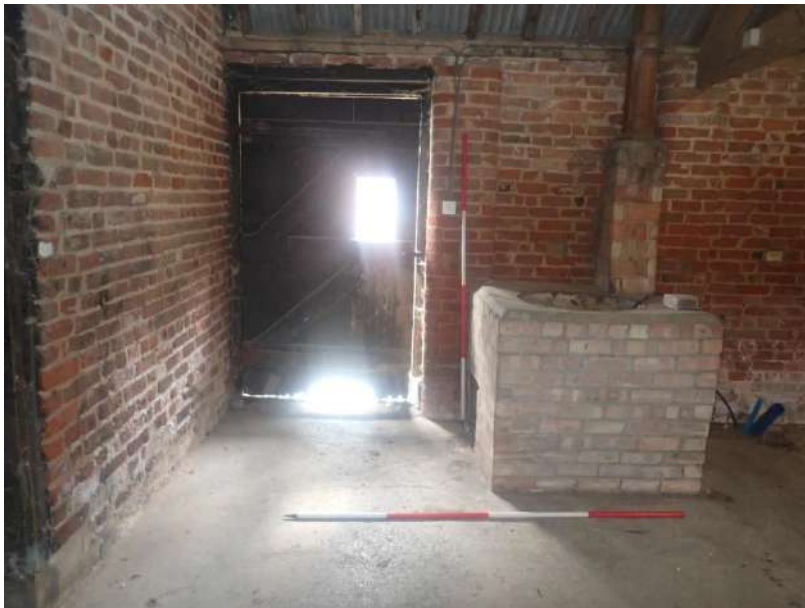
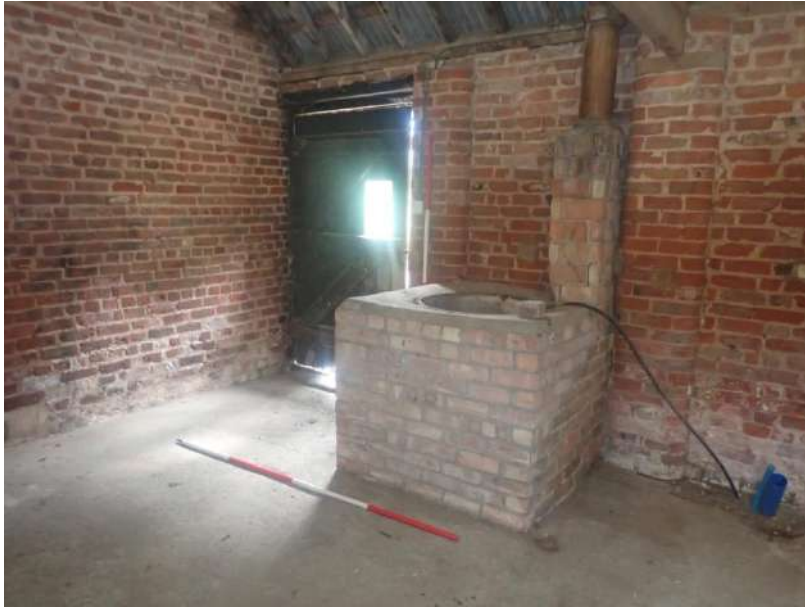
**Plate 50: View of the east wall of Cell 1, from the west**

**Plates 50-53 and 56-58** present a number of views of the east wall of **Cell 1**. The brickwork wall fabric of this east wall is composed of courses of mixed brick headers and brick stretchers in a variation of Flemish Bond. Extending along the top of this east wall are a series of horizontal timber wallplates. Bonded to this brickwork are a series of four vertical brick columns, each of which are composed of courses of brick stretchers and of bull nosed brick stretchers. The eastern ends of the tie beams of the overlying roof trusses of the roof structure may be seen to be inserted into the uppermost levels of these brick columns.

**Plate 51: View of the east wall of Cell 1, from the north-west**

**Plate 52: View of the east wall of Cell 1, from the west**

At the northern end of this east wall is the inner face of the east facing entrance opening that was recorded externally at the East Elevation of this outbuilding. This opening is occupied by a timber frame of a head and surrounds and by a door that is composed of a series of vertical tongued and grooved timber planks that are attached to an internal framework of angled and horizontal timbers. The door is attached to a frame surround by two horizontal cast metal strap hinges.

To the right (south), is the inner face of the small east facing window opening that was also recorded externally at the East Elevation of this outbuilding. Shown is the timber frame of a head and surrounds and the inner face of the timber shutter, whose vertical timber planks are affixed to an internal framework of angled and horizontal timbers. Above the opening and incorporated into the brickwork wall fabric here is an horizontal timber lintel.

**Plate 53: View of the east wall of Cell 1, from the south-west**

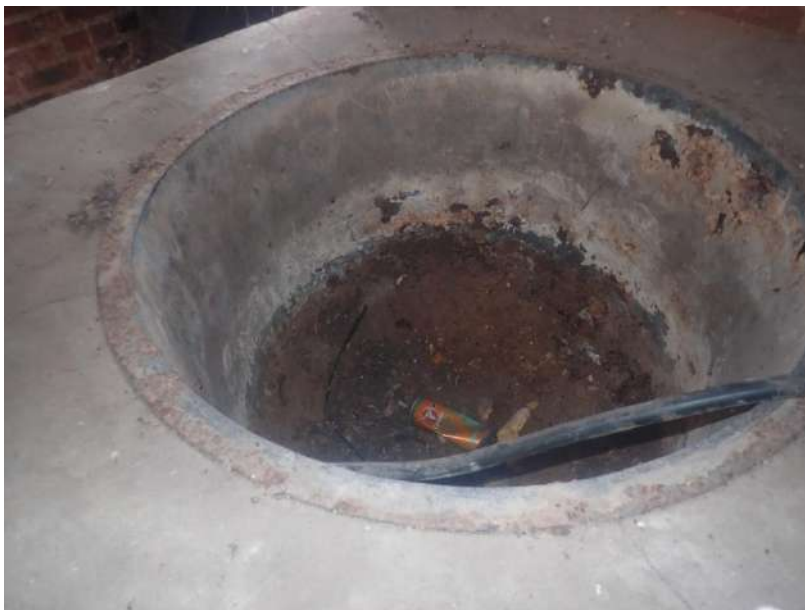
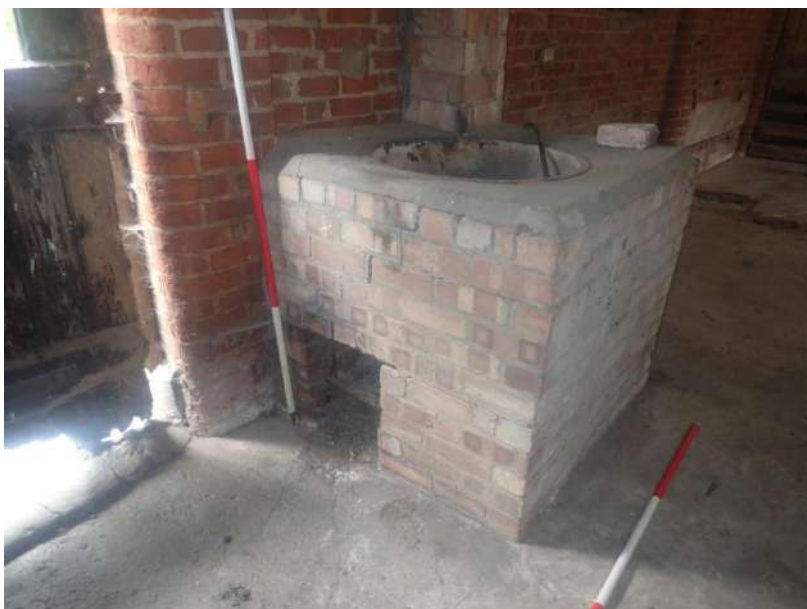
**Plate 54: View of the interior of the animal feed preparation area, from the south-west**

**Plates 50-53, 55 and 58** also show a modern animal feed preparation area, probably to create hot mash/gruel for horse feed. This is a brick built furnace mostly composed of courses of brick stretchers with a course of brick headers at the top of the structure. To the left (north) and at ground floor levels is an open aperture (**Plate 55**) within which a fire was lit at the base of the structure to heat water or feed in a metal bowl inserted into the top of the structure (**Plate 54**). The fumes/smoke from the furnace went out of the building through a chimney/flue also made up of a combination of brick and of a ceramic chimney pot, which extended through the roof covering.

**Plate 55: View of the interior of the animal feed preparation area, from the north**

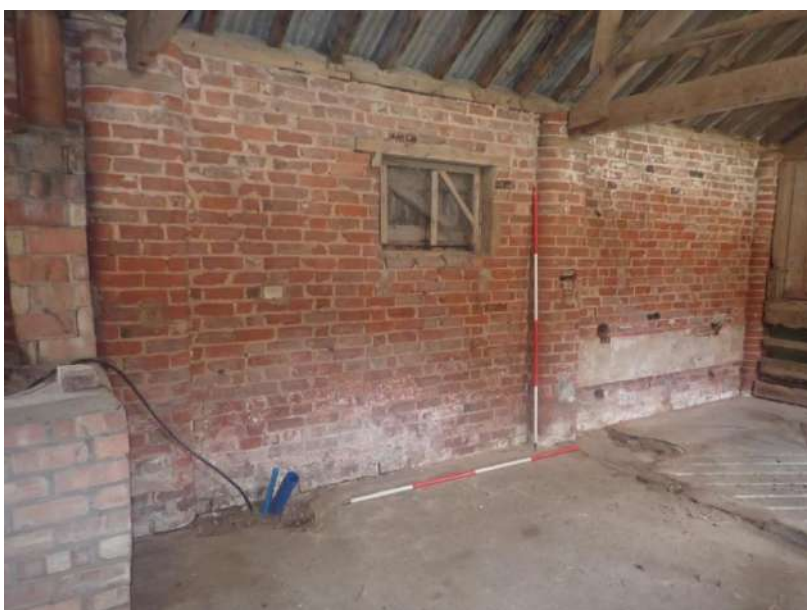
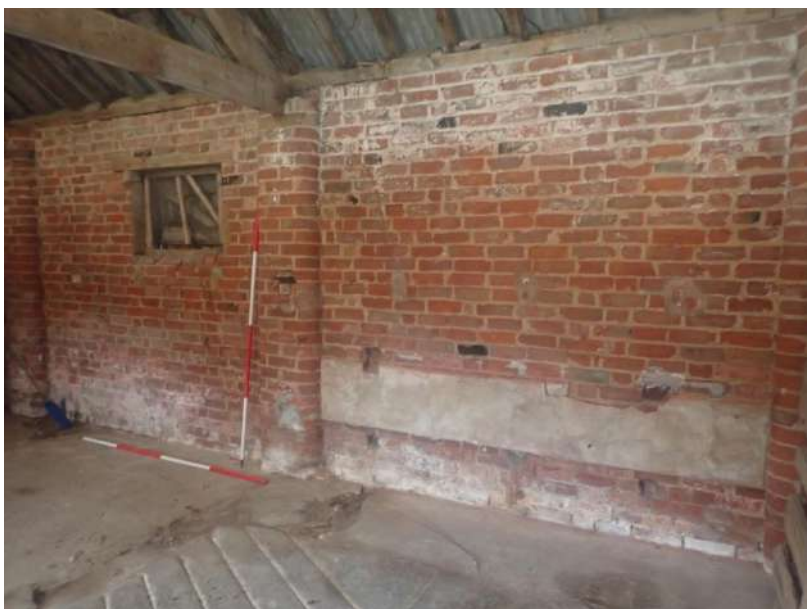
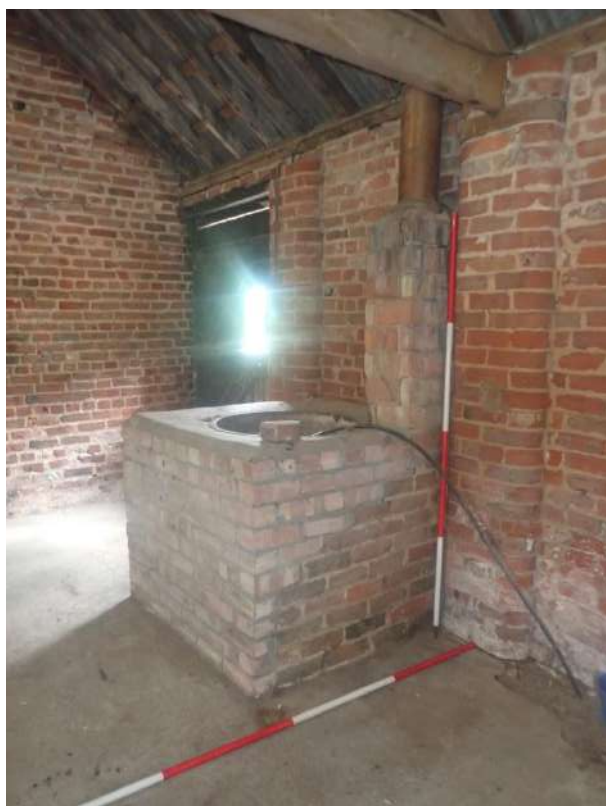
**Plate 56: View of the east wall of Cell 1, from the north-west**

**Plate 57: View of the east wall of Cell 1, from the south-west**

**Plate 58: View of the east wall of Cell 1, from the south-west**

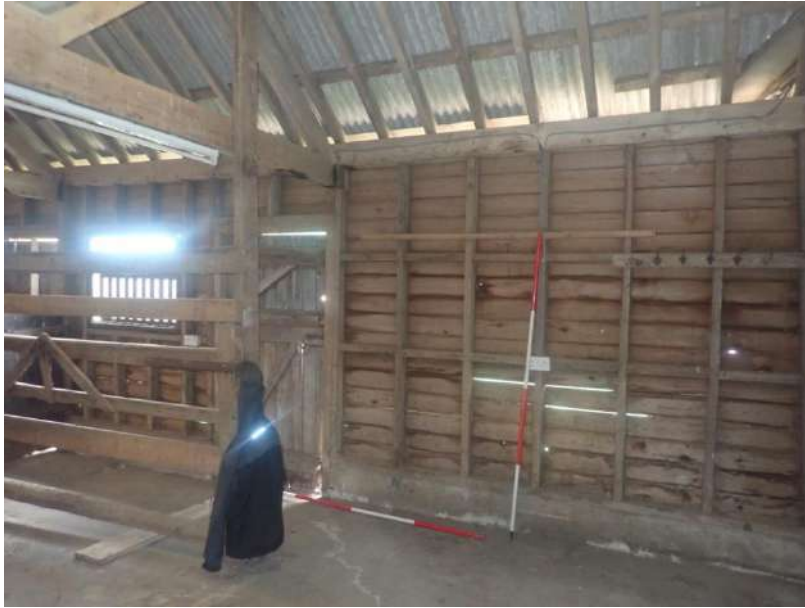
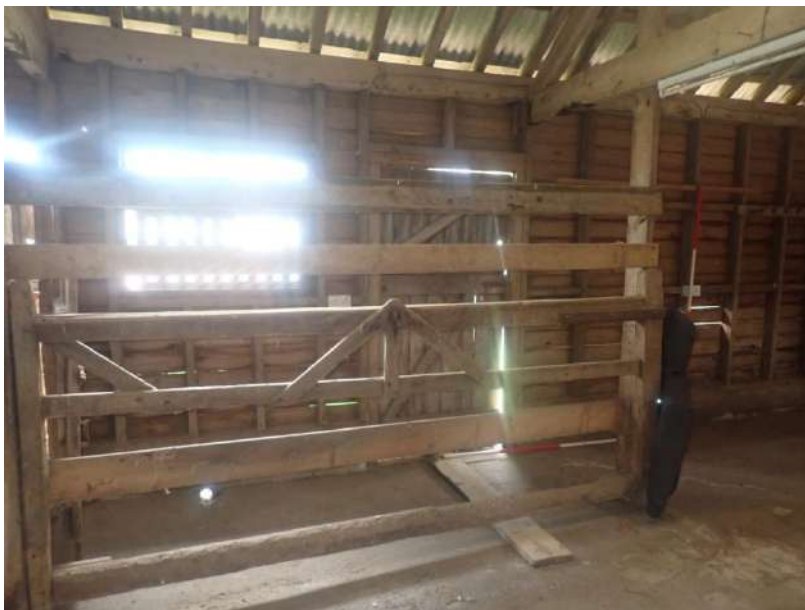
**Plate 59: View of the west wall of Cell 1, from the east**

**Plate 60: View of the west wall of Cell 1, from the east**

**Plates 59 and 60** present detailed views of the inner face of the northern portion of the west wall of **Cell 1**. These show the inner face of the external horizontal timber weatherboarding that is attached to an internal framework of vertical and horizontal timbers. Substantial horizontal timber wallplates may also be seen to extend along the top of this west wall. Also featured are the inner faces of a west facing window opening and a west facing entrance opening that were recorded externally at the West Elevation of this outbuilding. The inner face of the timber door is shown with the vertical timber planks attached to an internal framework of angled and horizontal timbers.

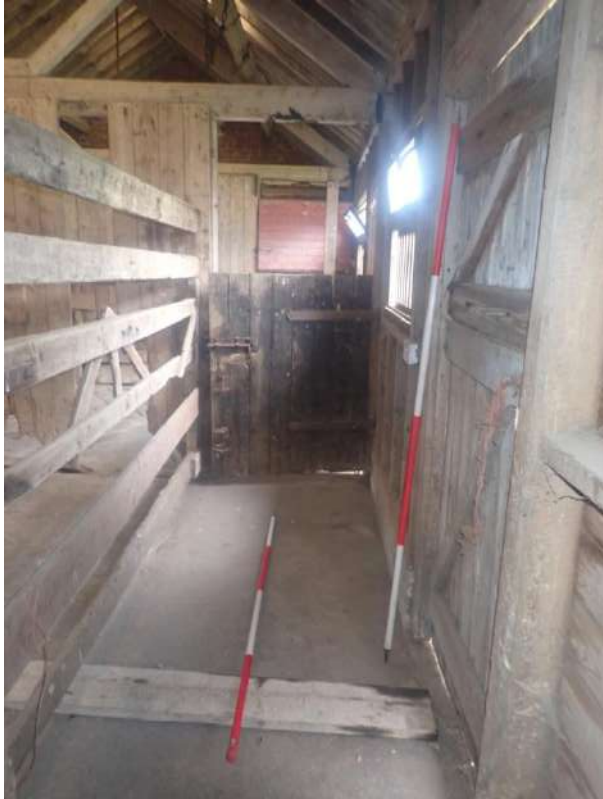
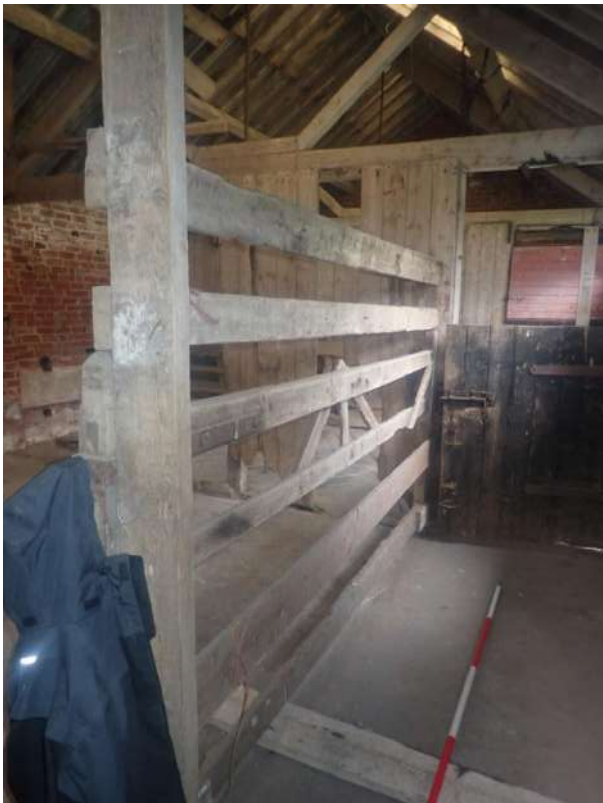
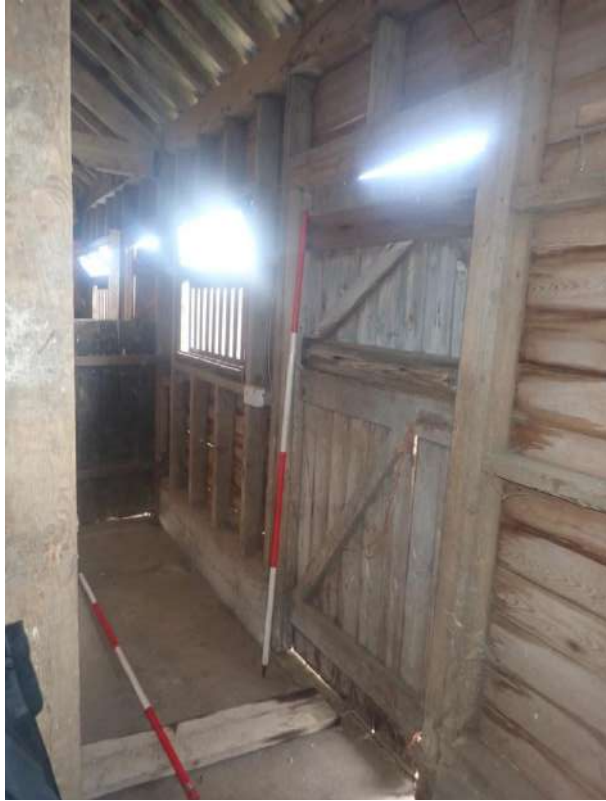
**Plates 61-63** also show a small internal passageway within **Cell 1**, which is fenced off to the left (east) by an internal timber partition that is made up of two vertical timber posts that are sunk into the concrete floor to which are attached a series of horizontal timber rails. Also attached to the

southern end of this partition is a low timber gate composed of a framework of vertical

**Plate 61: View of the interior of Cell 1, from the north**

**Plate 62: View of the interior of Cell 1, from the north**

**Plate 63: View of the interior of Cell 1, from the north**

timbers, which is attached to a vertical timber post affixed to the west wall by two horizontal metal strap hinges.

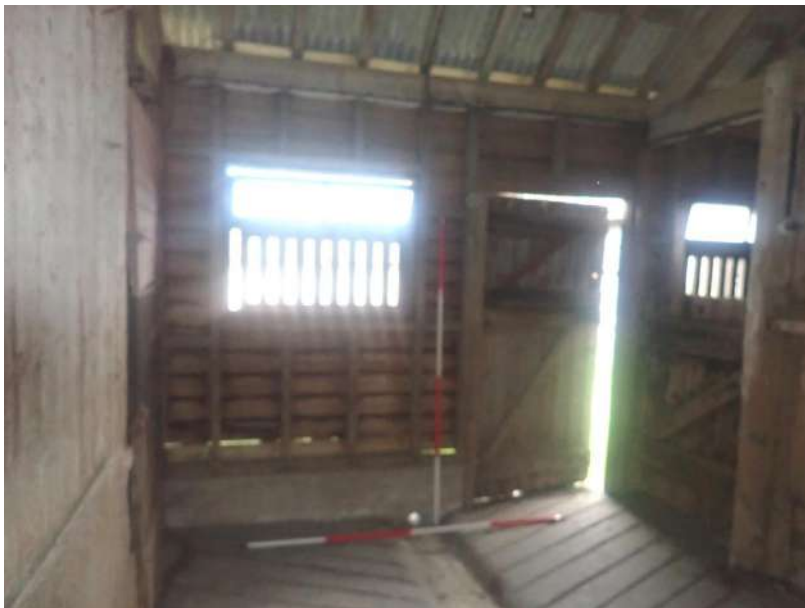
**Plate 64: View of the west wall of Cell 1, from the east**

**Plate 64** features the southern portion of the west wall of **Cell 1**. These show the inner face of the external horizontal timber weatherboarding that is attached to an internal framework of vertical and horizontal timbers. Substantial horizontal timber wallplates may also be seen to extend along

the top of this west wall. Also featured are the inner faces of a west facing window opening and a west facing entrance opening that were recorded externally at the West Elevation of this outbuilding. The inner face of the timber door is shown with the vertical timber planks attached to an internal framework of angled and horizontal timbers.

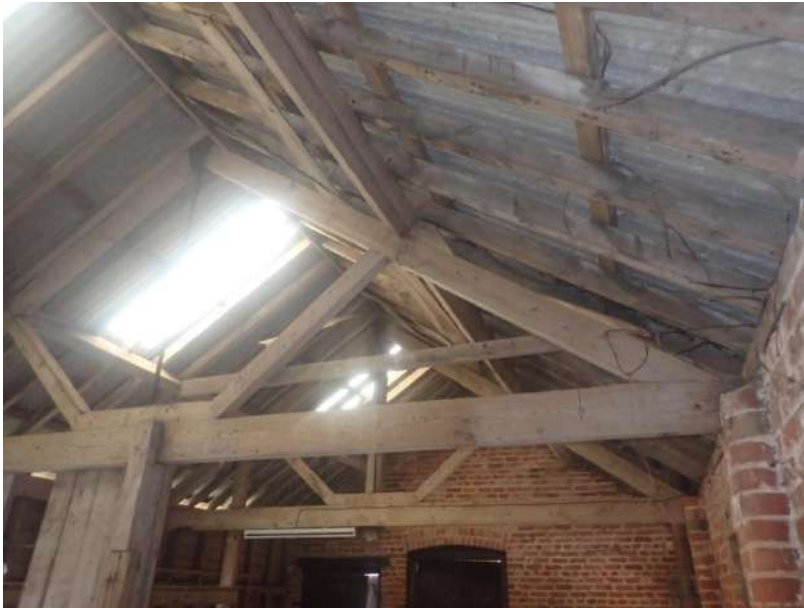
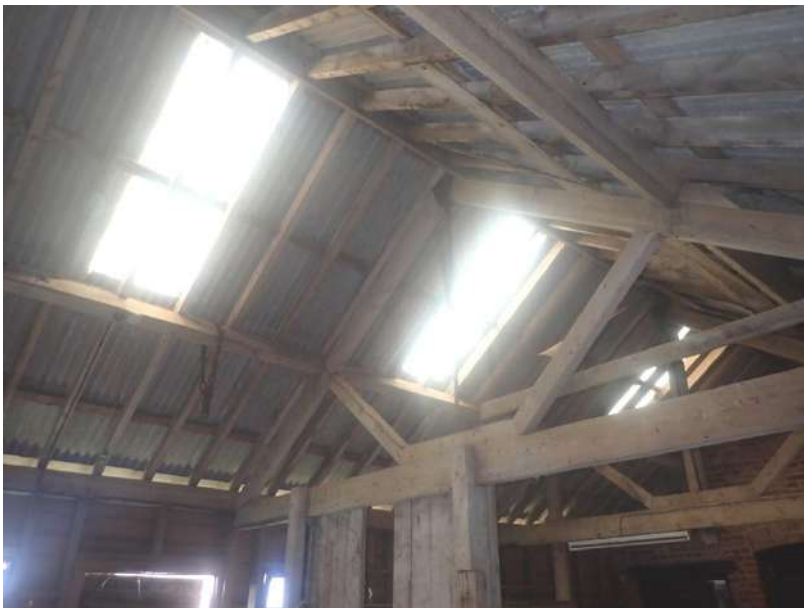
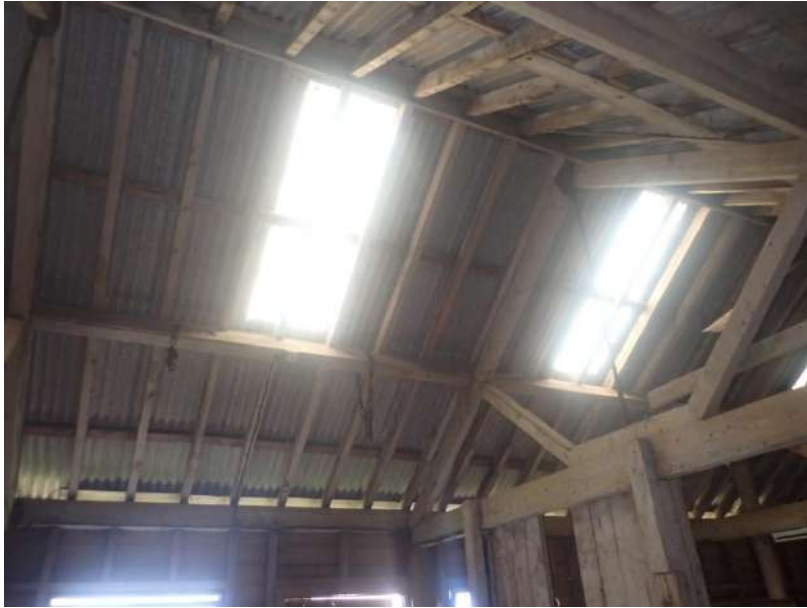
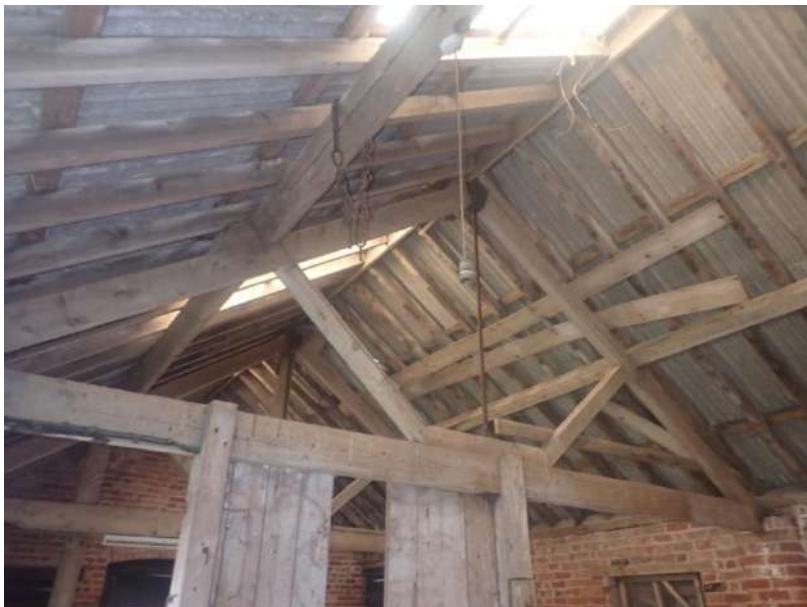
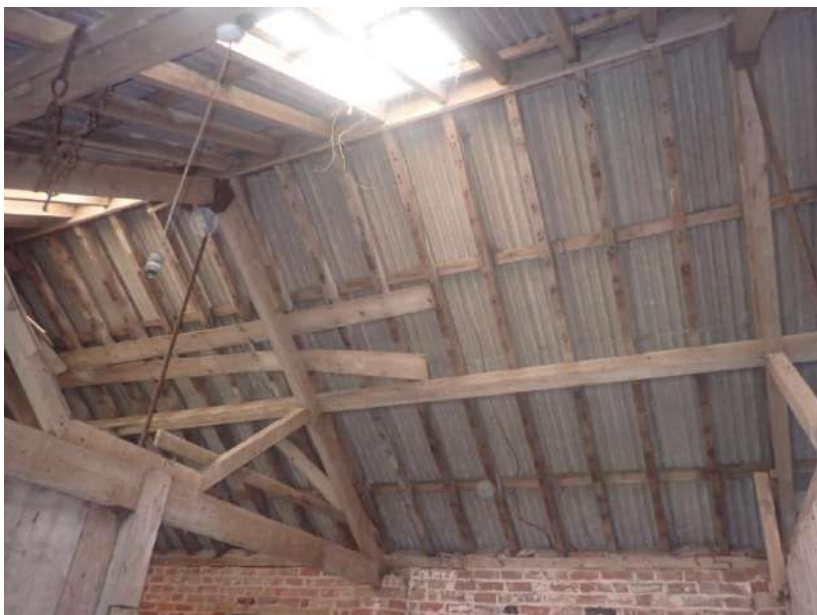
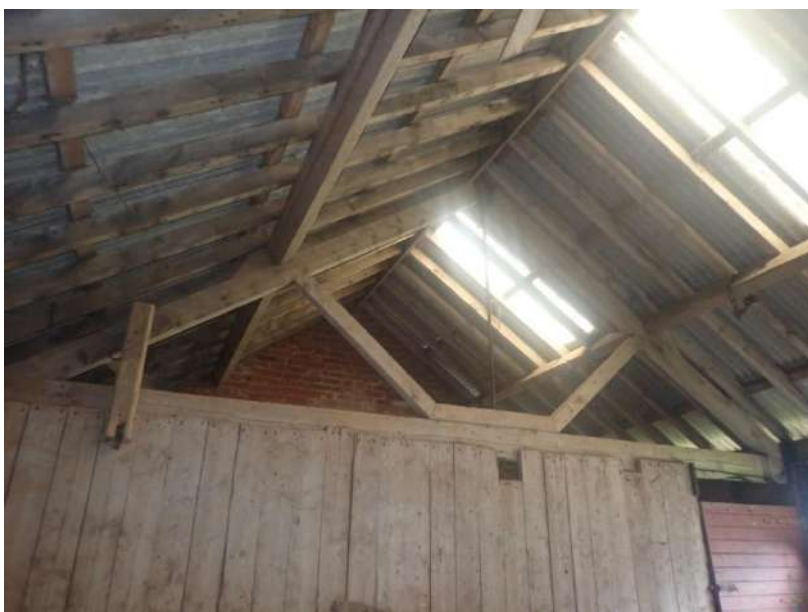
**Plate 65: View of the roof supporting structure of Cell 1, from the south**

**Plate 66: View of the roof supporting structure of Cell 1, from the south-east**

**Plates 65-75** present a number of views of the nature of the roof supporting structure of **Cells 1 and 2** and hence of the East Range or of **Outbuilding 1**. The principal component parts of this structure comprise a series of three king post timber roof trusses. The eastern and western ends of the tie beams of these trusses are attached to the horizontal timber wallplates that extend along the top of the east and west walls and also rest upon the top of the various vertical brick columns on the east wall. The remainder of this roof structure comprises a framework of timber

rafters and of horizontal timber purlins that extend along both sides of this structure along with further horizontal timber purlins at the roof apex. The trusses are also attached to the purlins.

**Plate 67: View of the roof supporting structure of Cell 1, from the east**

**Plate 68: View of the roof supporting structure of Cell 1, from the south**

**Plate 69: View of the roof supporting structure of Cell 1, from the west**

**Plate 70: View of the roof supporting structure of Cell 1, from the north**

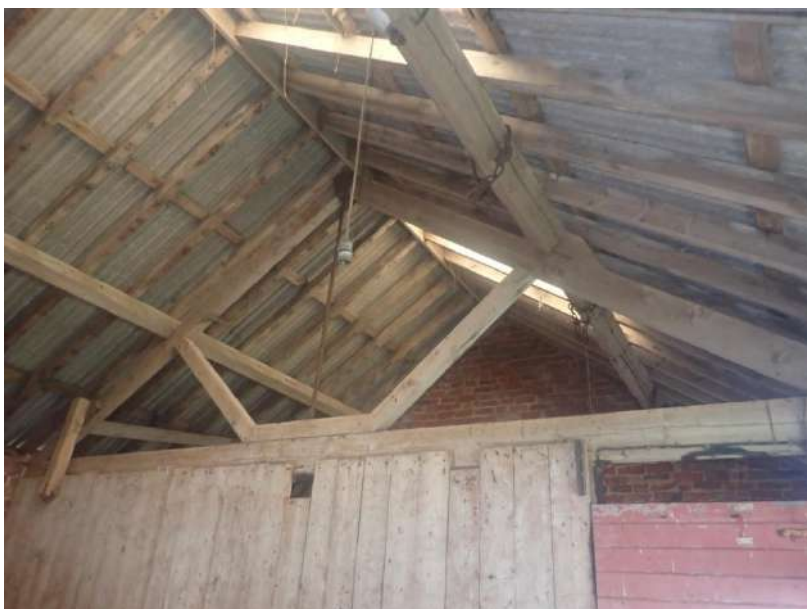
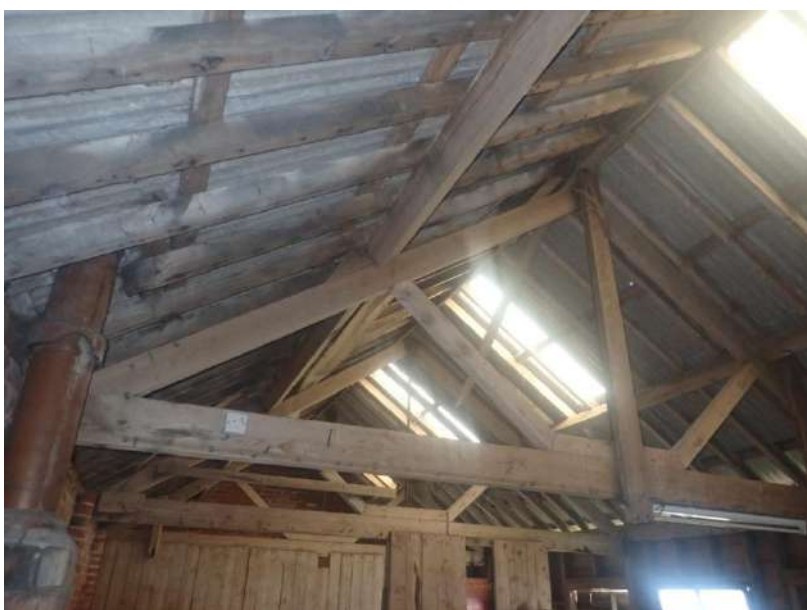
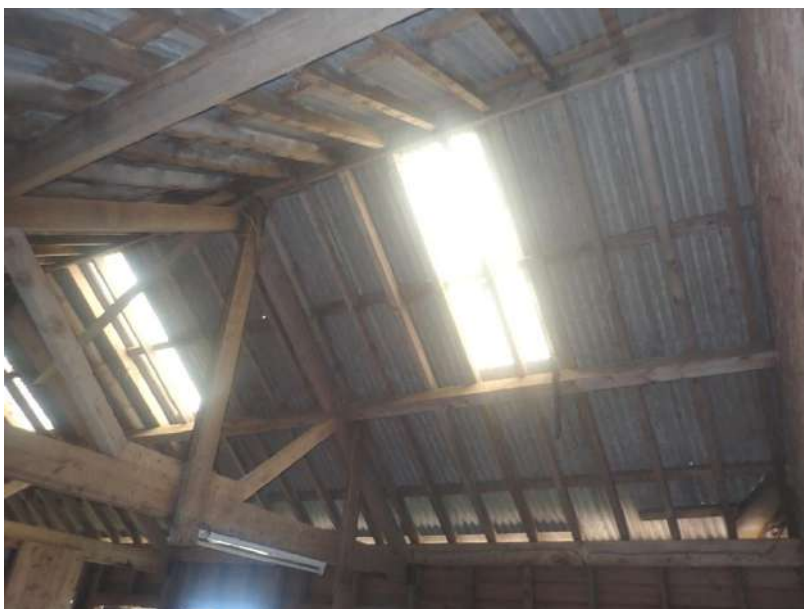
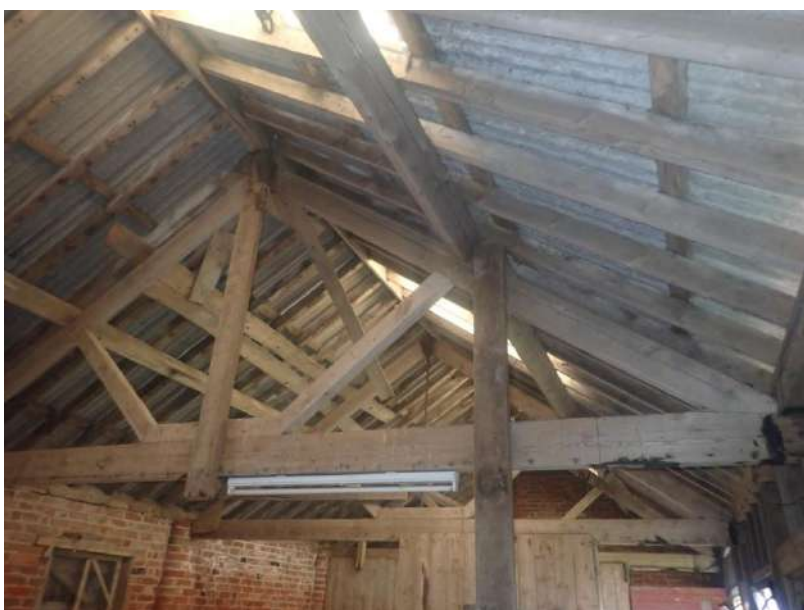
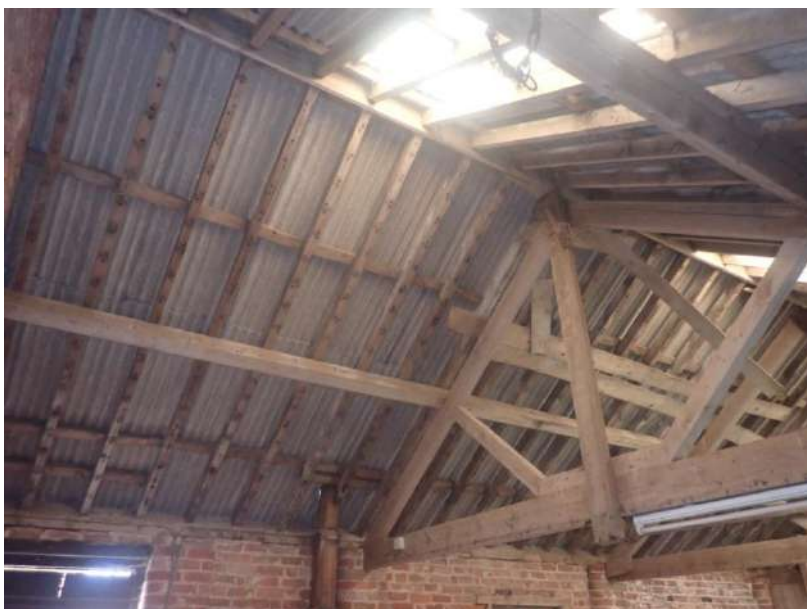
**Plate 71: View of the roof supporting structure of Cell 1, from the north**

**Plate 72: View of the roof supporting structure of Cell 1, from the north**

**Plate 73: View of the roof supporting structure of Cell 1, from the east**

**Plate 74: View of the roof supporting structure of Cell 1, from the north**

**Plate 75: View of the roof supporting structure of Cell 1, from the north-west**

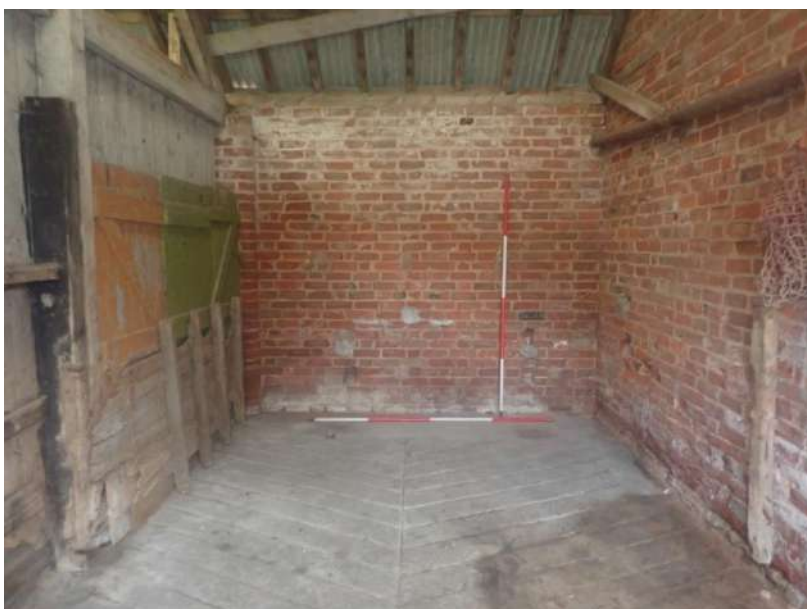
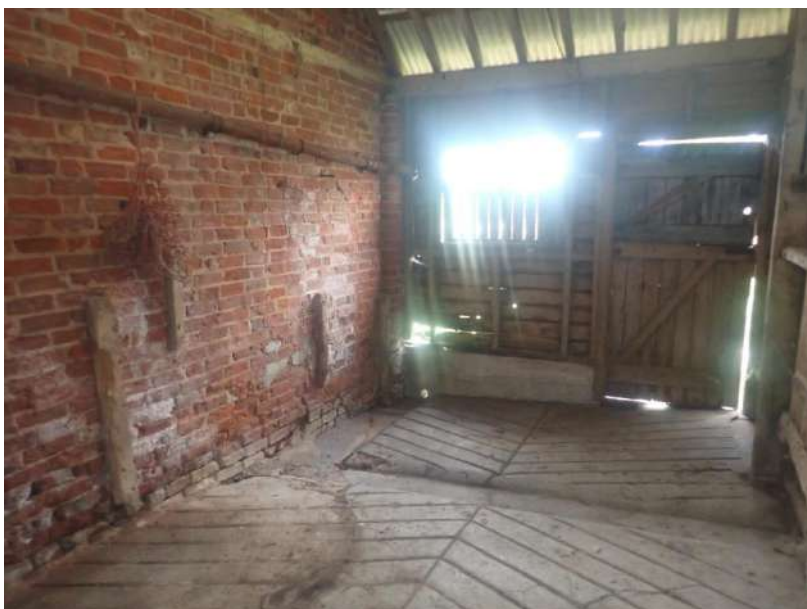
**Plate 76: General view of the interior of Cell 2, from the west**

**Plates 76 and 77** provide general views of the interior of **Cell 2** from both eastern and western viewpoints.

**Plate 77: General view of the interior of Cell 2, from the east**

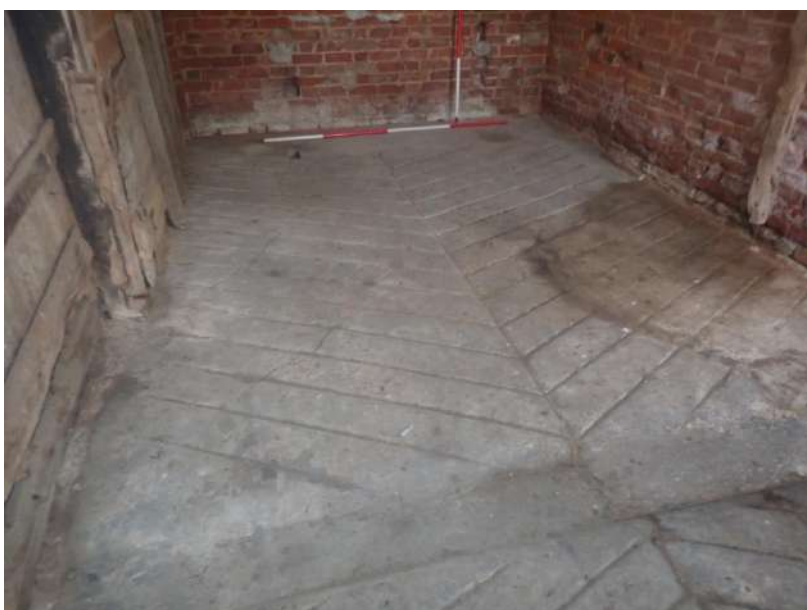
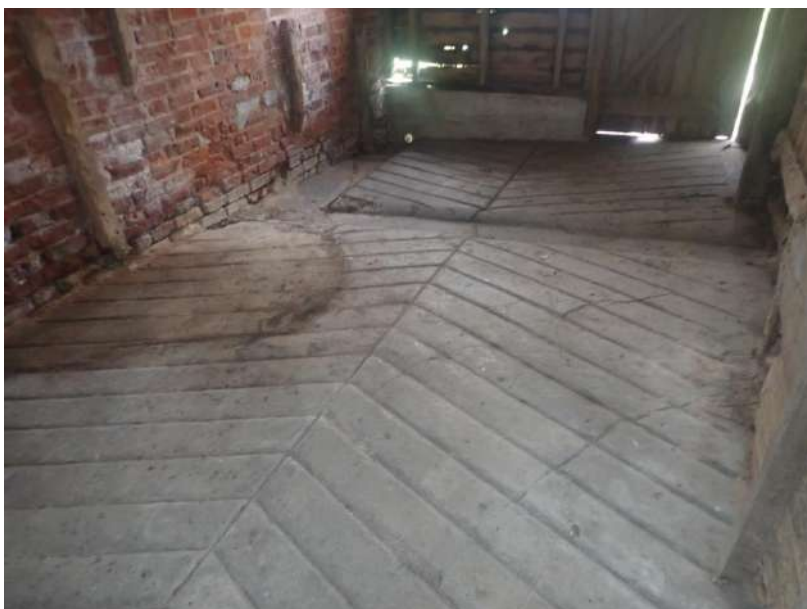
**Plate 78: View of the flooring of Cell 2, from the west**

**Plates 78 and 79** feature the nature of the flooring of **Cell 2**, which is of modern concrete.

**Plate 79: View of the flooring of Cell 2, from the east**

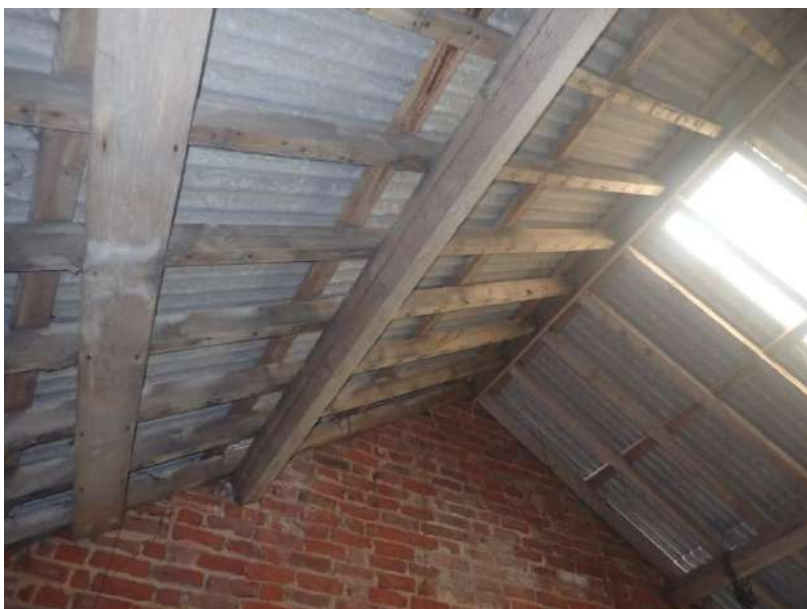
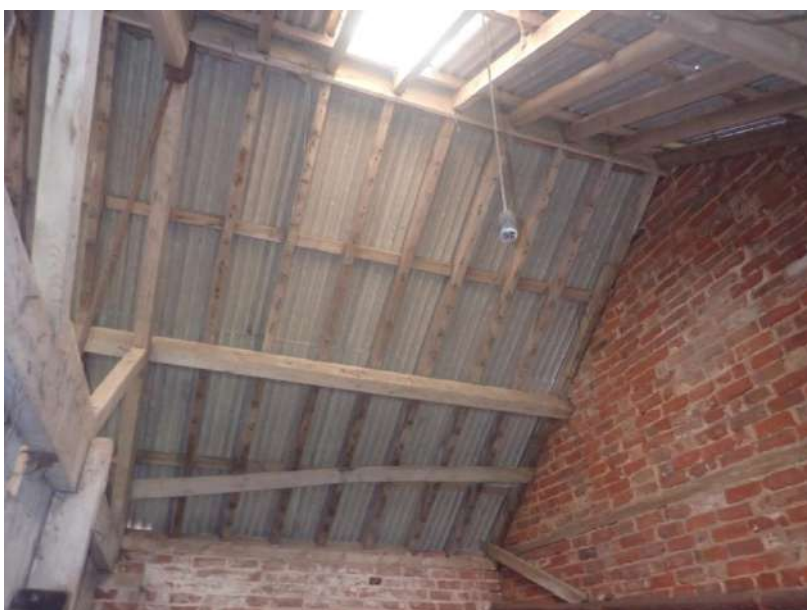
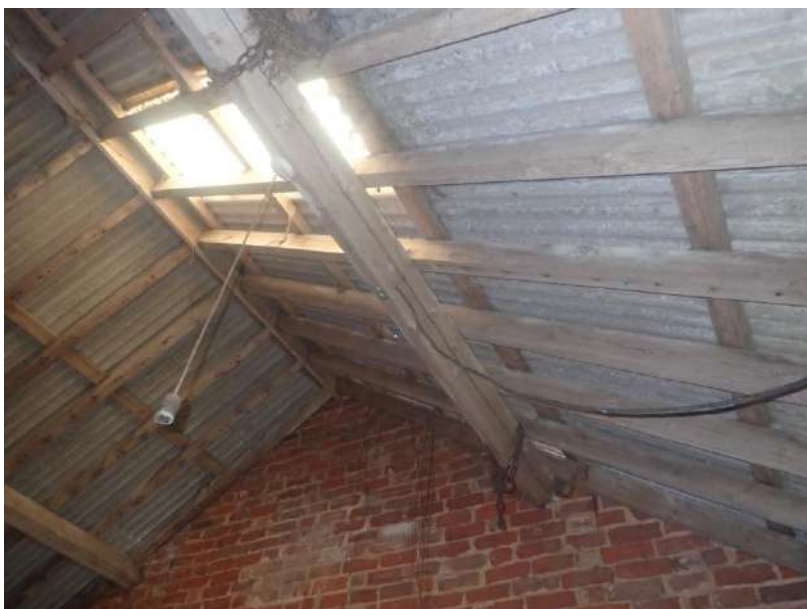
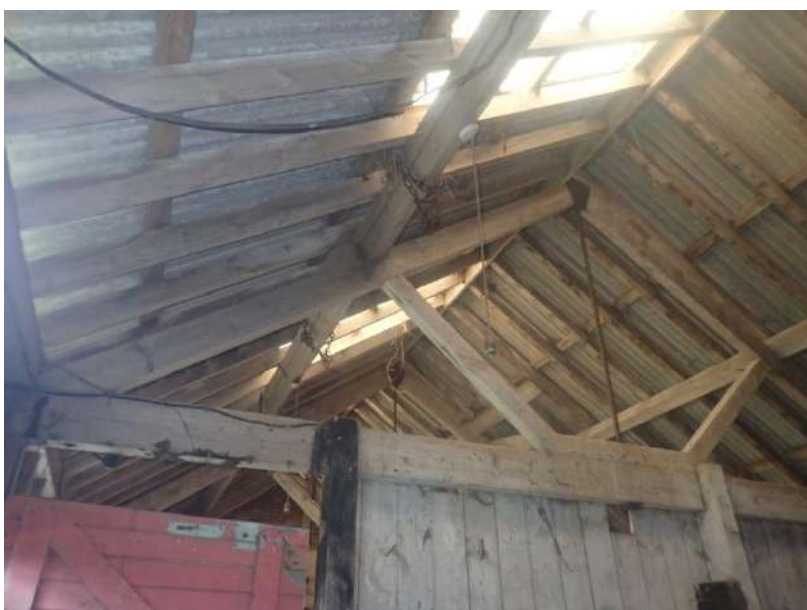
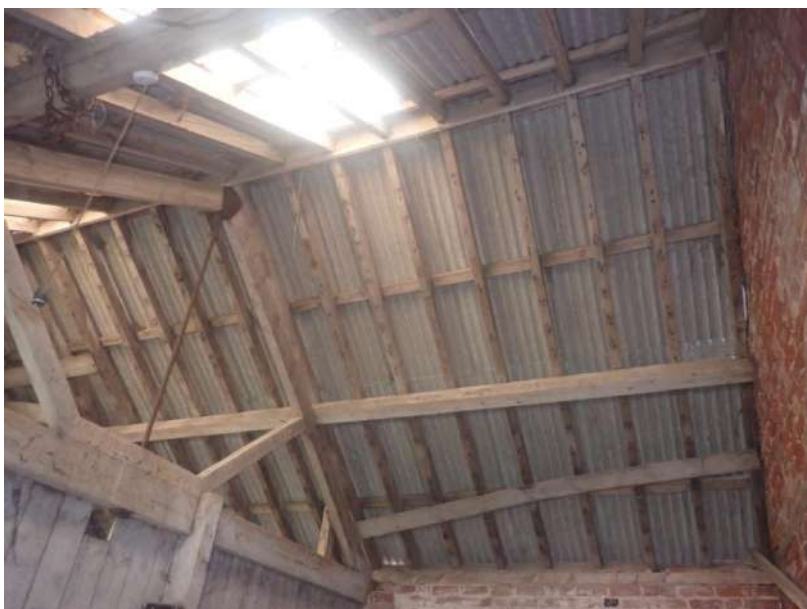
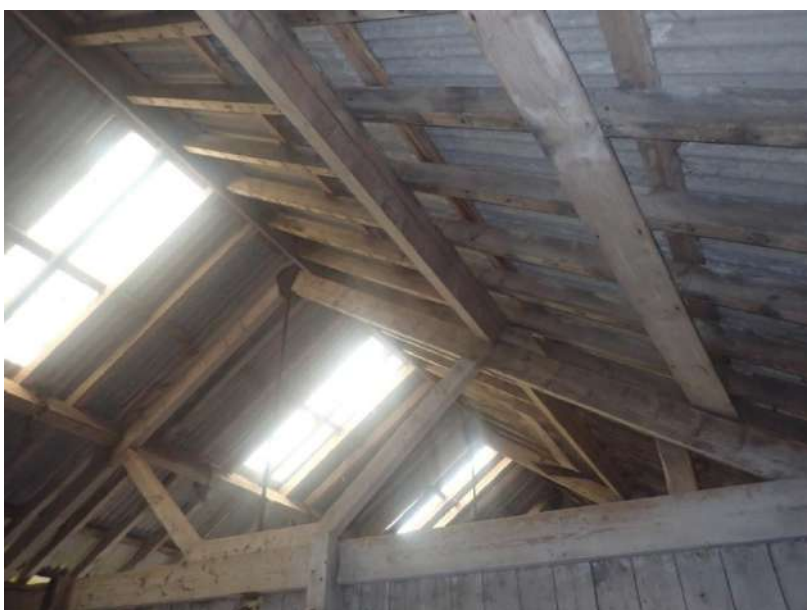
**Plates 80-87** furnish further views from differing positions of the nature of the roof supporting structure of **Cell 2** and thus of the southern end of **Outbuilding 1** of the East Range.

**Plate 81: View of the roof supporting structure of Cell 2, from the north**

**Plate 82: View of the roof supporting structure of Cell 2, from the west**

**Plate 83: View of the roof supporting structure of Cell 2, from the north**

**Plate 84: View of the roof supporting structure of Cell 2, from the south**

**Plate 85: View of the roof supporting structure of Cell 2, from the west**

**Plate 86: View of the roof supporting structure of Cell 2, from the south**

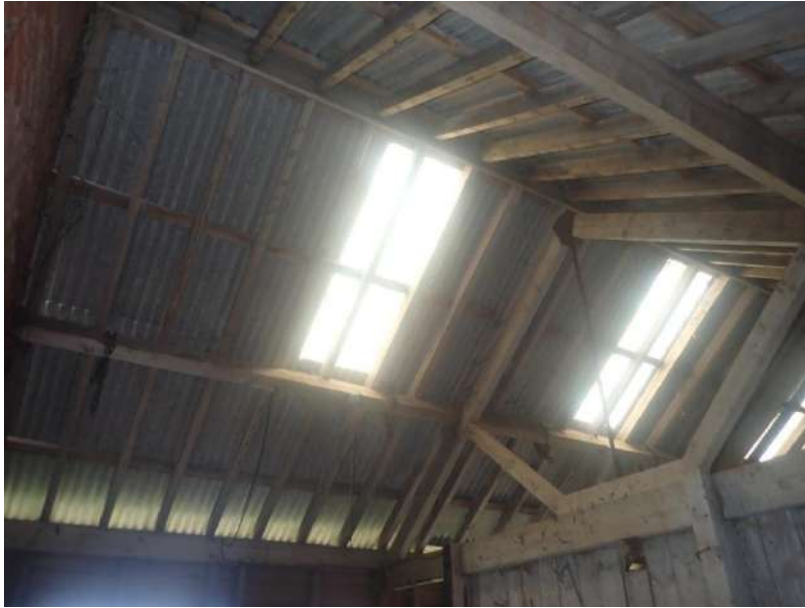
**Plate 87: View of the roof supporting structure of Cell 2, from the east**
