**NEVILLE HALL  
FREELANCE ARCHAEOLOGIST & CONSULTANT**

HISTORIC BUILDING RECORDING AT  
CROWN FARM, STOCKWELL GATE WEST,  
WHAPLODE, LINCOLNSHIRE.

**National Grid Reference: TF 3306 2504**  
**Planning Reference: H23-1116-21**  
**Site Code: CFWH23**  
**Accession Number: LCNCC: 2023.77**

July 2023

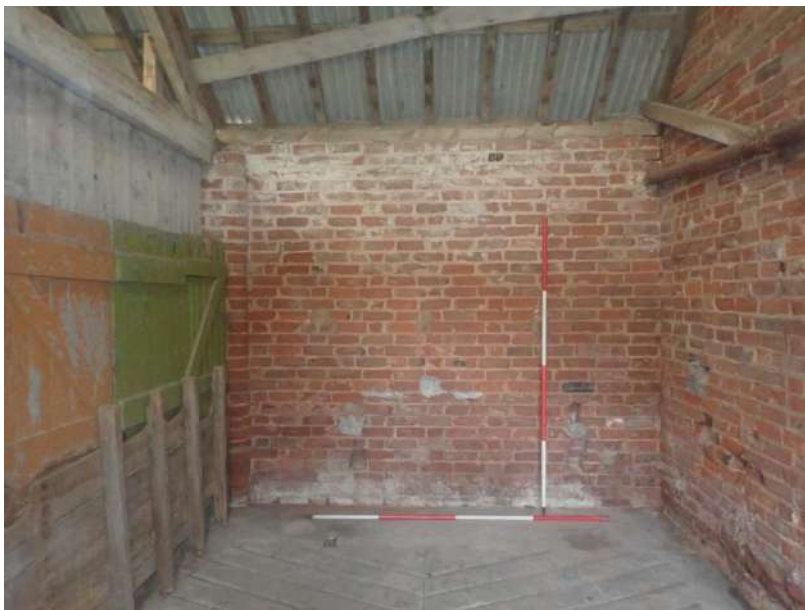
**Plate 88: View of the east wall of Cell 2, from the west**

**Plate 88** presents a detailed view of the east wall of **Cell 2**. The brickwork wall fabric of this east wall is composed of courses of mixed brick headers and brick stretchers in a variation of Flemish Bond. Horizontal timber wallplates may be seen to extend along the top of this east wall.

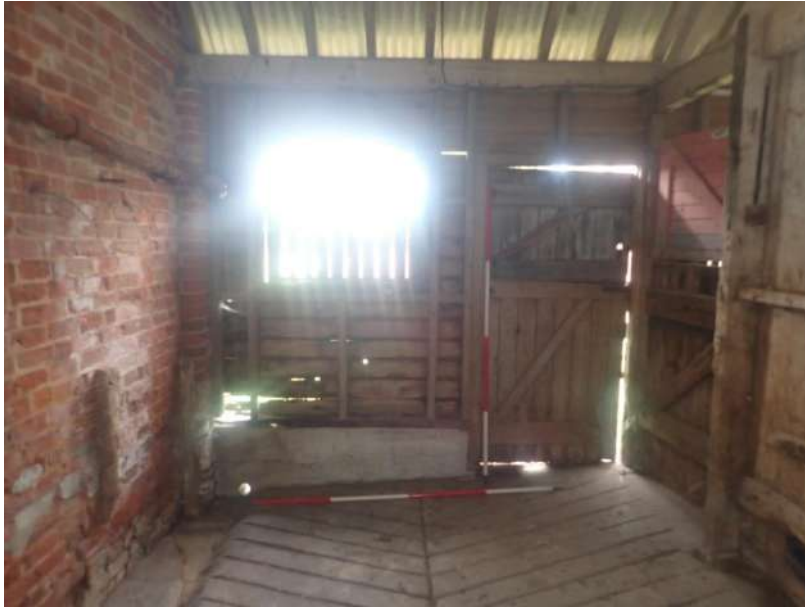
**Plate 89** furnishes an image of the west wall of **Cell 2**. Here may be observed the inner face of the external horizontal timber weatherboarding, which is attached to an internal framework of vertical and horizontal timbers. Also shown are the inner faces of a west facing window opening along with an west facing entrance opening that were recorded externally at the West Elevation of this outbuilding. The vertical timber planks of the two timber half doors may be seen to be attached to internal timber frameworks of angled and horizontal timbers.

**Plate 89: View of the west wall of Cell 2, from the east**

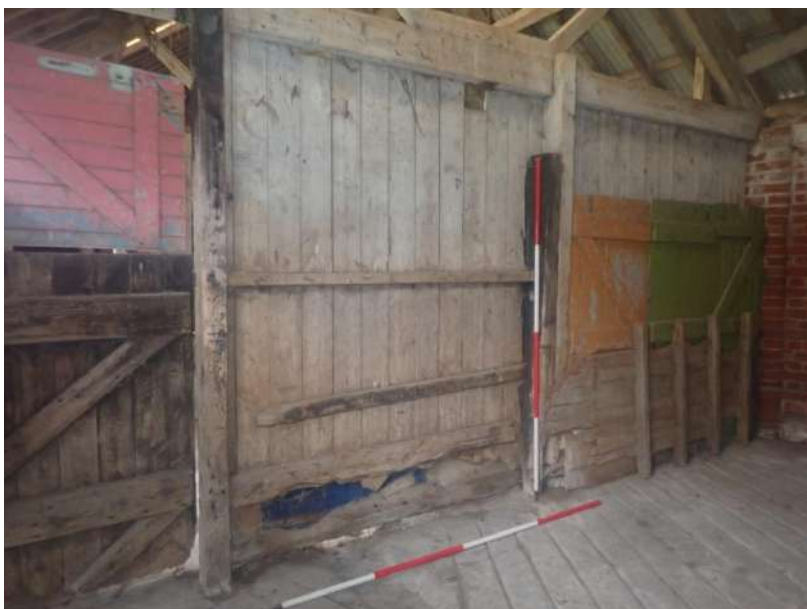
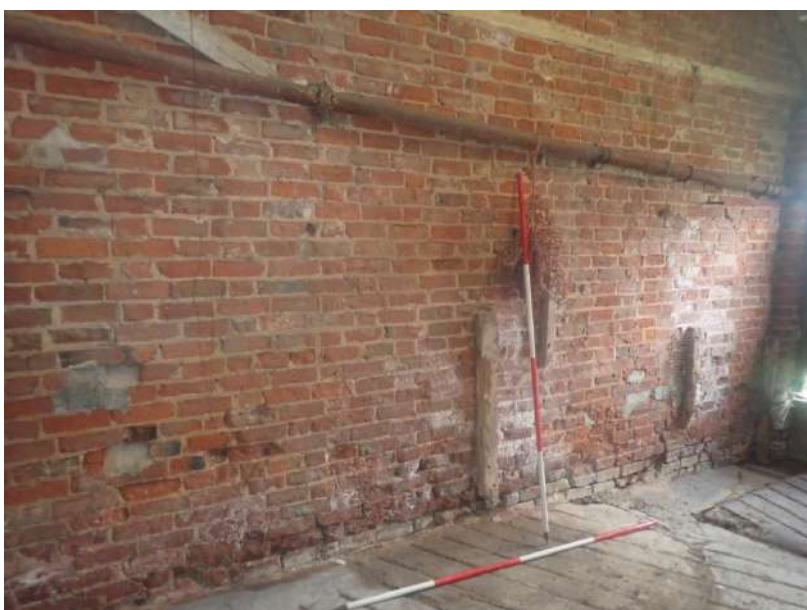
**Plates 90 and 91** feature the north wall of **Cell 2**, which is an internal partition wall with the adjoining **Cell 1** to the north. This partition wall is composed of a series of vertical timber planks, which are attached in turn to an internal framework of vertical timber posts and horizontal timbers. The vertical posts are sunk into the concrete flooring. The upper ends of the planks are attached to a timber tie beam of the overlying roof truss. To the left (west), is a low timber gate that is attached to one of the vertical timber posts. The gate itself is composed of a series of vertical timber planks attached to an internal framework of angled and horizontal timbers.

**Plate 91: View of the north wall of Cell 2, from the south-west**

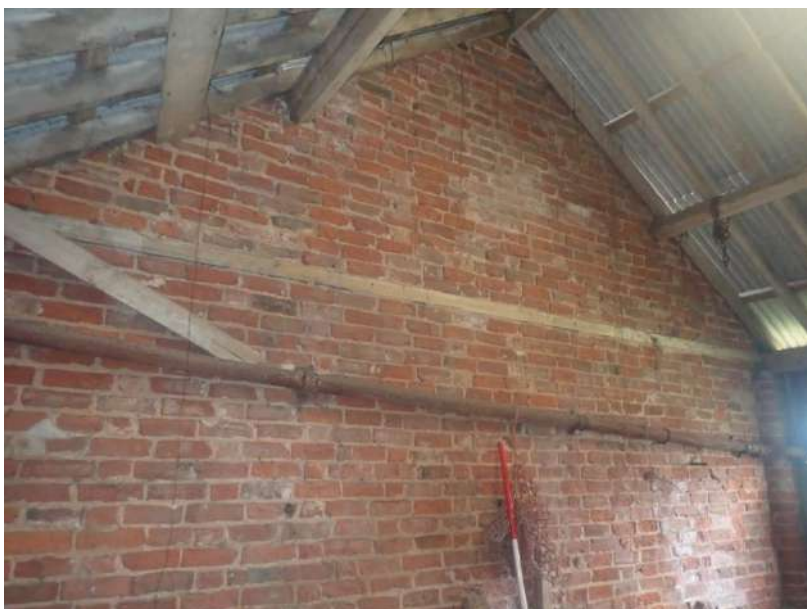
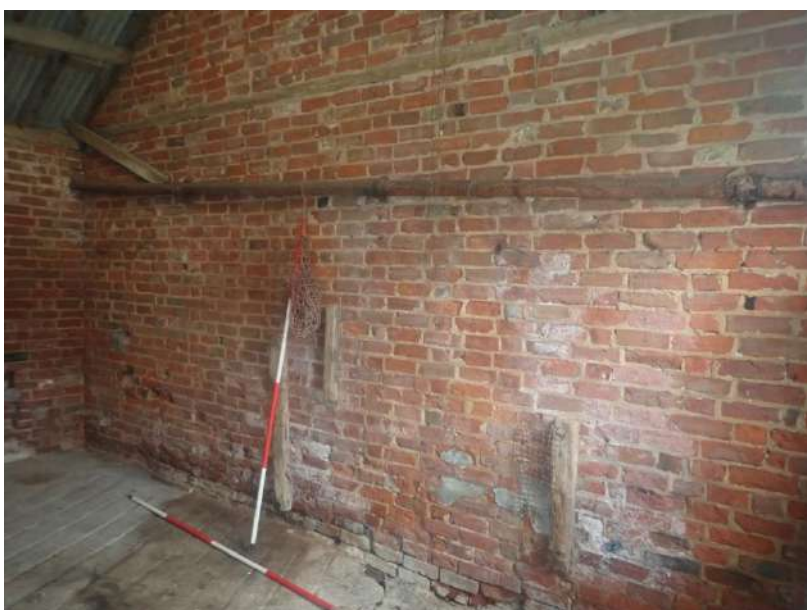
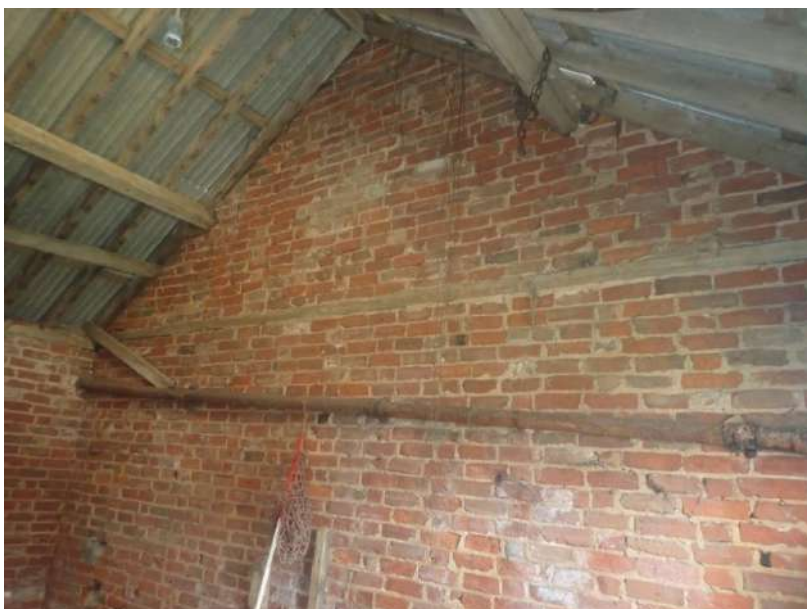
**Plates 92-95** present a number of views of the south wall of **Cell 2** from different positions. The brickwork wall fabric of this south wall is composed of courses of mixed brick headers and brick stretchers in a variation of Flemish Bond. At mid levels and incorporated into this brickwork wall fabric is an horizontal timber wallplate. The southern ends of the horizontal timber purlins of the overlying roof structure may be seen to be inserted into the uppermost levels of this wall fabric.

**Plate 93: View of the south wall of Cell 2, from the north-east**

**Plate 94: View of the south wall of Cell 2, from the north-west**

**Plate 95: View of the south wall of Cell 2, from the north-west**

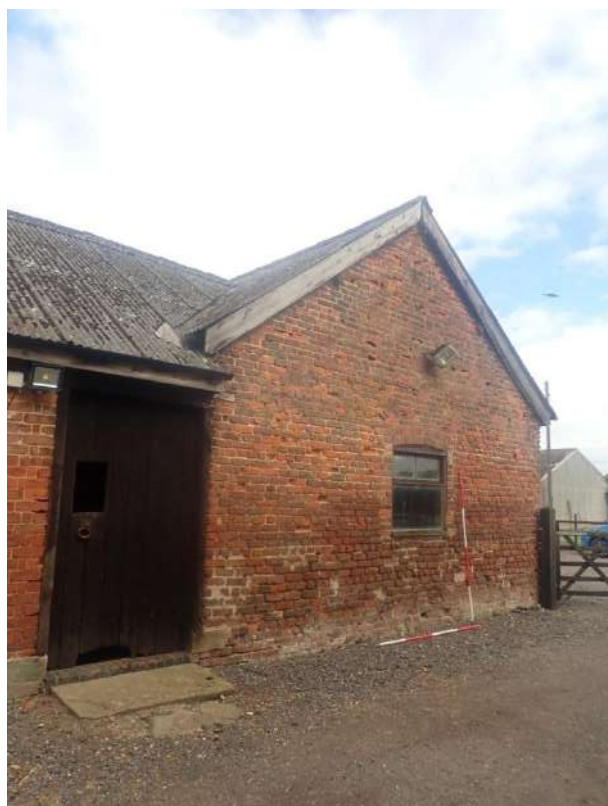
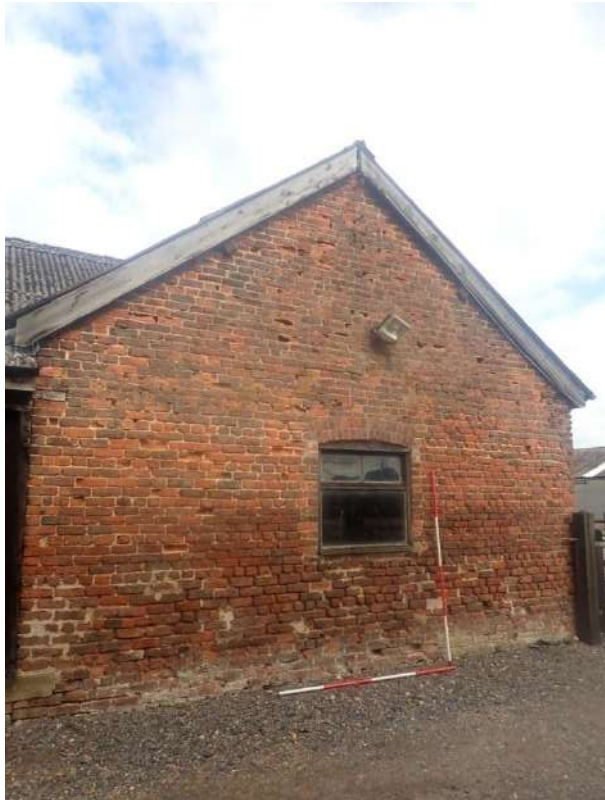
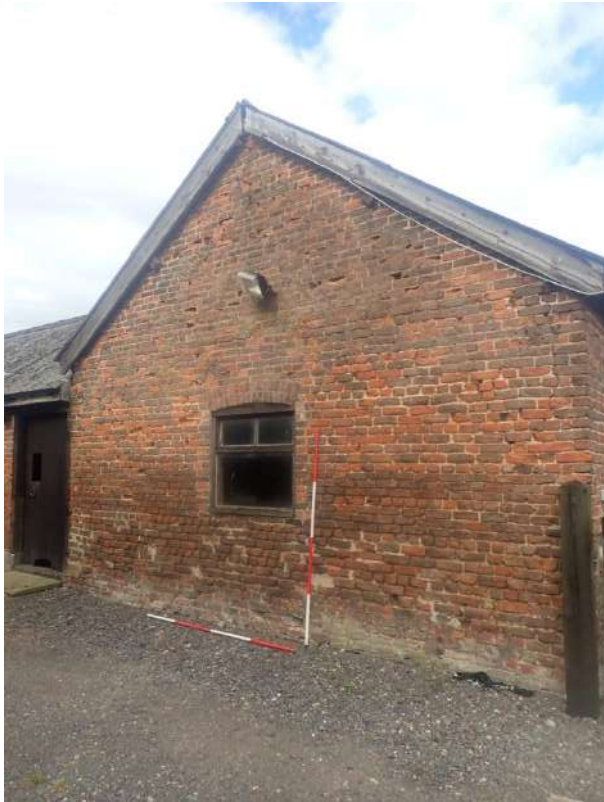
**Plate 96: View of the East Elevation of the North Range, from the south-east**

The North Range of this outbuilding complex is of two storeys in height and has a gabled roof with a roof covering of modern asbestos sheeting.

**Plates 96-98** present several views of the East Elevation of this North Range from several vantage points. The brickwork wall fabric of this East Elevation is composed of 2-3 courses of brick stretchers that alternate with single courses of brick headers in English Garden Wall Bond. The eastern gabled end of the outbuilding is furnished with angled timber eaves. At the lower levels of this Elevation is an east facing window opening, which is occupied by a modern glazed three light timber casement window with one vertical timber glazing bar and a horizontal timber transom along within a timber frame of a head and surrounds. Above the opening is a curved head in brick composed of two courses of brick stretchers laid on edge along with two brick headers at each end of the head laid on end.

**Plate 97: View of the East Elevation of the North Range, from the east**

**Plate 98: View of the East Elevation of the North Range, from the north-east**

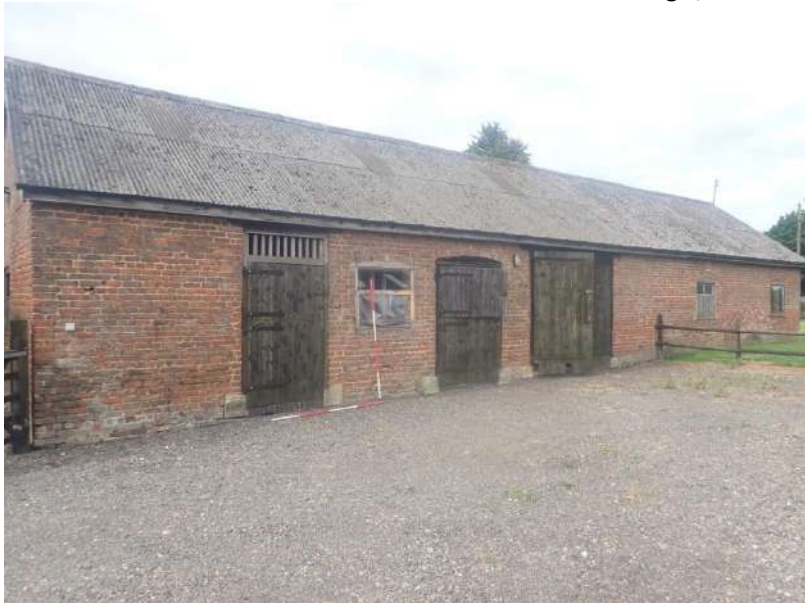
**Plate 99** presents a general view of the North Elevation of this North Range from a north-eastern perspective. At just below roof levels are horizontal timber fascia boards to which is attached modern Upvc horizontal guttering. This leads onto a modern vertical Upvc downpipe at the western end of this Elevation.

**Plate 99: View of the North Elevation of the North Range, from the north-east**

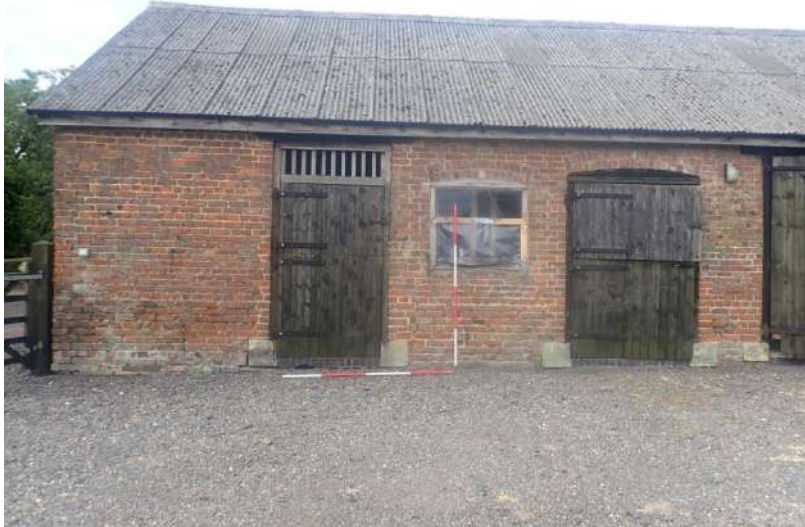
**Plate 100** furnishes a detailed view of the eastern portion of this North Elevation. The brickwork wall fabric here is composed of three courses of brick stretchers that alternate with single courses of brick headers in English Garden Wall Bond. At the eastern end of this Elevation is the first north facing entrance opening. This is occupied by a timber frame of a head and surrounds, with the basal ends of the surrounds resting atop two worked, shaped and faced stone ashlar that are incorporated into the brickwork. Attached to a surround by two pairs of horizontal metal strap hinges are two timber half doors. Each is composed of a series of vertical tongued and grooved timber planks. Above the door is a ventilation panel that is made up of a series of vertical timber slats. Above the opening and also incorporated into the wall fabric and at just below roof levels is an horizontal timber lintel. There is a brick threshold at the base of the opening.

To the right (west) of this, is the first north facing window opening. This opening is occupied by a timber frame of a head and surrounds and is unglazed. Above the opening is a curved head in

brick that is composed of two courses of brick stretchers laid on edge along with two brick headers at each end of the head laid on end.

To the right (west) of this, is the second north facing entrance opening, which is occupied by a timber frame of a head and surrounds and by two timber half doors, which are attached to a frame surround by two pairs of horizontal cast metal strap hinges. The basal ends of the door frame surrounds rest on the top of two worked, shaped and faced stone ashlar that are

incorporated into the brickwork wall fabric. Above the opening is a curved head in brick that is composed of two courses of brick stretchers laid on edge along with two brick headers at each end of the head laid on end. There is a brick threshold at the base of the opening.

**Plate 100: View of the North Elevation of the North Range, from the north**

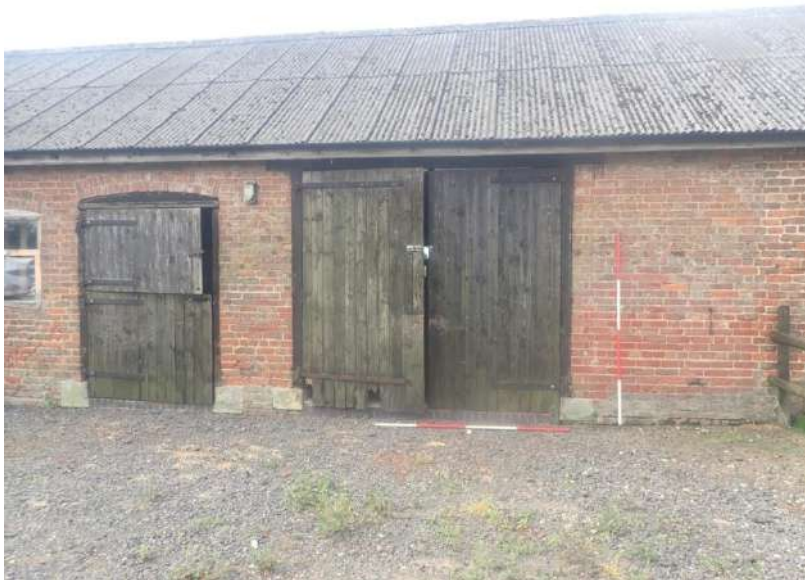
**Plate 101: View of the North Elevation of the North Range, from the north**

**Plate 101** provides a detailed view of the central portion of the North Range. The brickwork wall fabric here is composed of 2-3 courses of brick stretchers that alternate with single courses of brick headers in English Garden Wall Bond. Also featured is the third north facing entrance opening within this North Elevation. This opening is occupied by a timber frame of a head and surrounds with the basal ends of the surrounds resting on two worked, shaped and faced, stone ashlar that are also incorporated into the brickwork wall fabric here. Attached to the frame surrounds by two pairs of horizontal cast metal strap hinges are a pair of large timber doors, each

of which is composed of a series of vertical tongued and grooved timber planks. There is a brick threshold at the base of the opening.

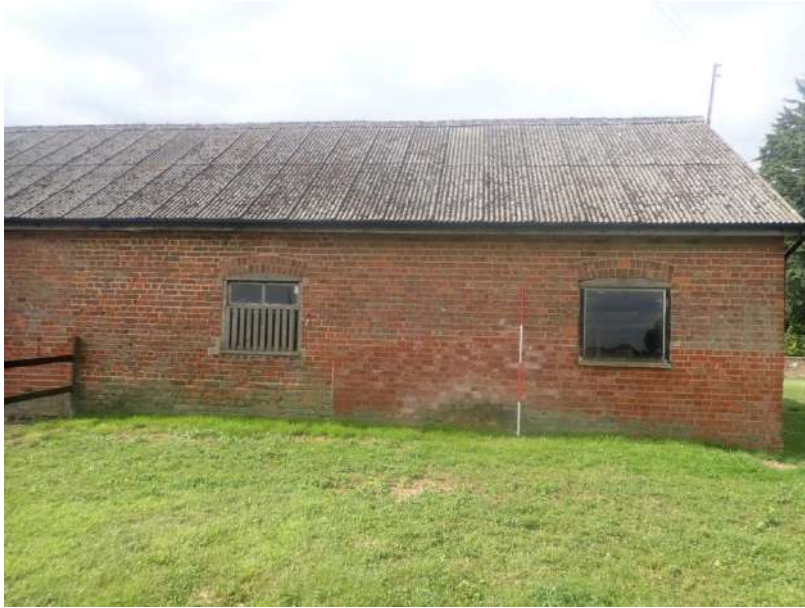
**Plate 102: View of the North Elevation of the North Range, from the north**

**Plate 102** presents a detailed view of the western portion of this North Elevation. The brickwork wall fabric here is in two different and distinctive brick bonds. To the left (east), is a visible physical vertical dividing line in the wall fabric here, the brickwork to the east of this line is composed of the same three courses of brick stretchers alternating with single courses of brick headers in English Garden Wall Bond. To the west, the brickwork wall fabric here is composed of alternating courses of brick headers and brick stretchers in English Bond. It is considered that this second area of brick bonding is a probable slightly later addition or alteration to this North Elevation. an area of later brick repair.

Also shown are two north facing window openings. The first opening to the left (east) is occupied by a timber frame of a head, surrounds and a sill. The upper levels of the window are glazed of two lights with a horizontal timber transom and one vertical timber glazing bar. The lower levels are unglazed with a series of vertical timber ventilation slats. Above the opening is a curved head in brick that is composed of two courses of brick stretchers laid on edge along with two brick headers at each end of the head laid on end.

The second opening to the right (west) is occupied by a timber frame of a head, surrounds and a sill. The window is unglazed and infilled with modern plastic clear sheeting. Above the opening is a curved head in brick that is composed of two courses of brick stretchers laid on edge along with two brick headers at each end of the head laid on end.

- 8.5 It was noted that a difference of brickwork bonding at the western end of the North Elevation of the North Range and of Outbuilding 2 of the West Range, which have English Bond brickwork as compared with the English Garden Wall brick bonding of the remainder of the North Range may suggest that the North Range was perhaps slightly earlier in origin than its western portion and Outbuilding 2, which may have been constructed slightly later.

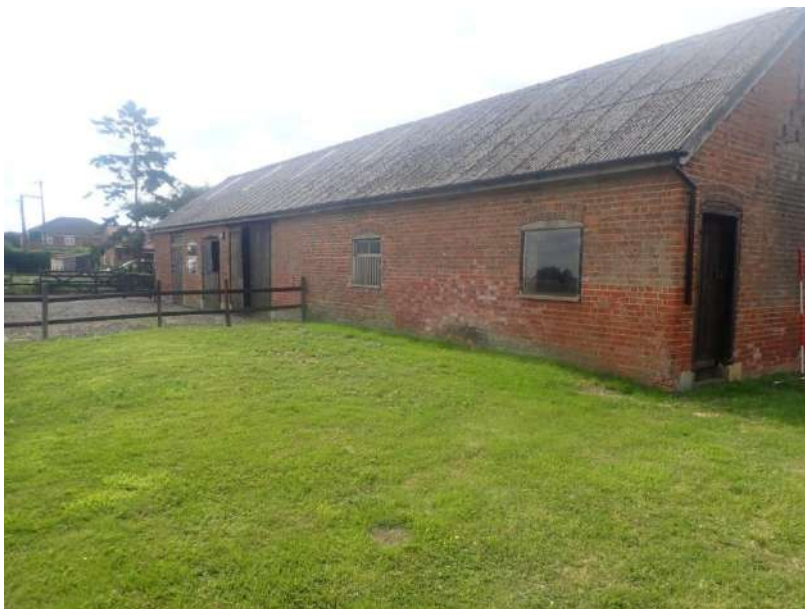
**Plate 103: View of the North Elevation of the North Range, from the north-west**

**Plate 103** presents a further general overall view of this North Range from a different north-western vantage point.

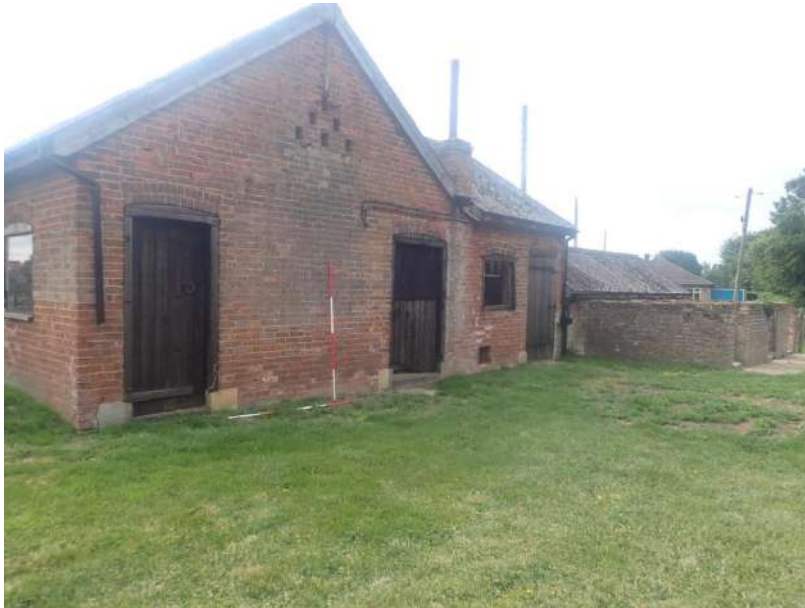
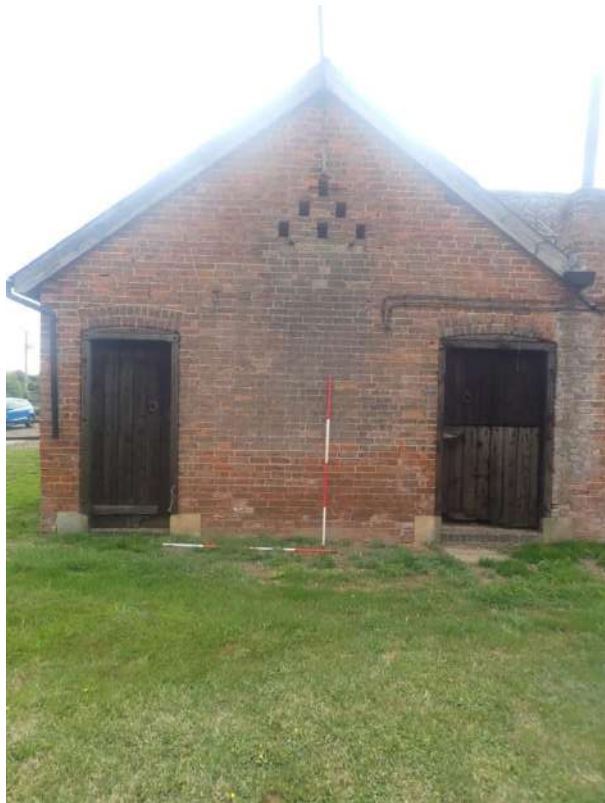
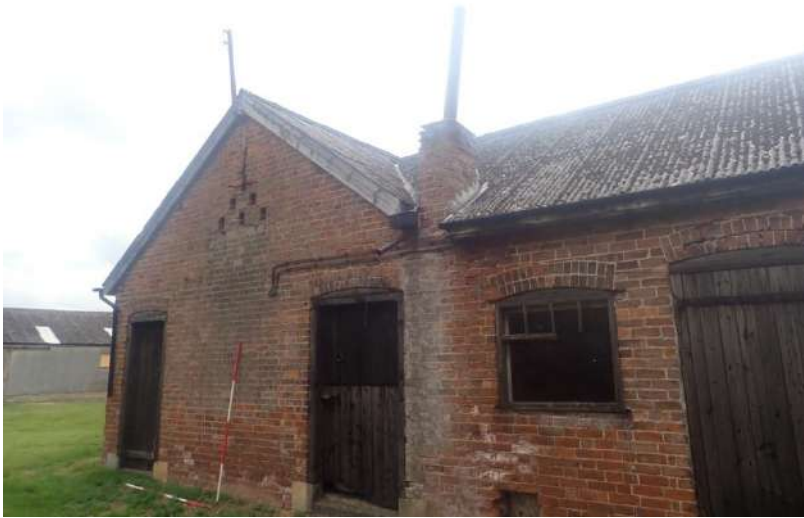
**Plate 104: View of the West Elevation of the North Range, from the north-west**

**Plate 105: View of the West Elevation of the North Range, from the west**

**Plate 106: View of the West Elevation of the North Range, from the south-west**

**Plates 104-106** furnish several views from different positions of the West Elevation of this North Range. The western gabled end is furnished with two angled timber eaves. The brickwork wall fabric here is the same as that of the adjoining western end of the North Range and is composed of alternating courses of brick headers and brick stretchers in English Bond, which are considered to be probable slightly later additions or alterations to this North Range. At the upper levels of this brickwork are a series of small and rectangular shaped ventilation apertures in the brickwork arranged in a triangle, marking the presence of a former dovecote here.

Also shown are two west facing entrance openings. The first opening to the left (north) comprise a timber frame of a head and surrounds with a brick threshold at the base of the opening. Attached to a timber frame surround is a timber door composed of a series of vertical tongued and grooved timber planks. The basal ends of the frame surrounds rest upon two worked, shaped and faced stone ashlar that are incorporated into the brickwork wall fabric here. Above the opening is a curved head in brick that is composed of two courses of brick stretchers laid on edge along with two brick headers at each end of the head laid on end.

The second opening to the right (south) is occupied by a timber frame of a head and surrounds with a brick threshold at the base of the opening. The basal ends of the frame surrounds rest upon two worked, shaped and faced stone ashlar that are incorporated into the brickwork wall fabric here. Attached to a timber frame surround are two timber half doors, each of which are composed of a series of vertical tongued and grooved timber planks. Above the opening is a curved head in brick that is composed of two courses of brick stretchers laid on edge along with two brick headers at each end of the head laid on end.

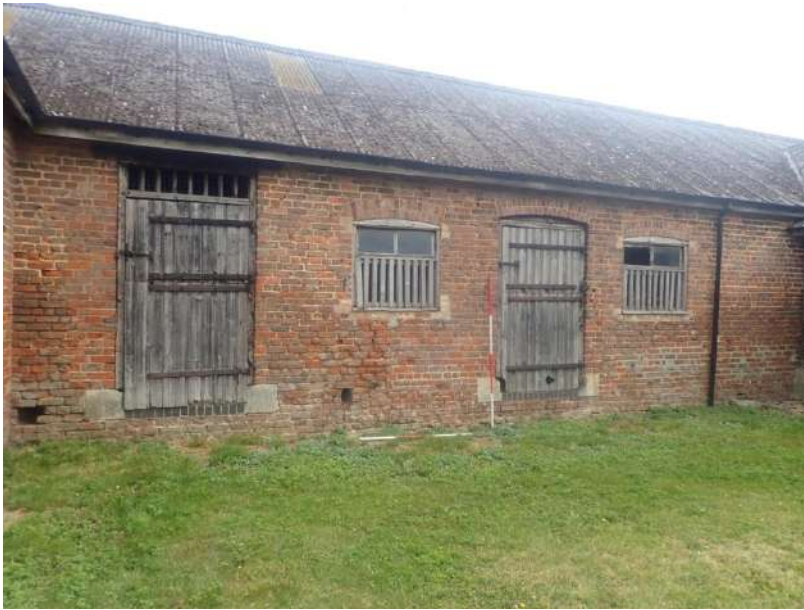
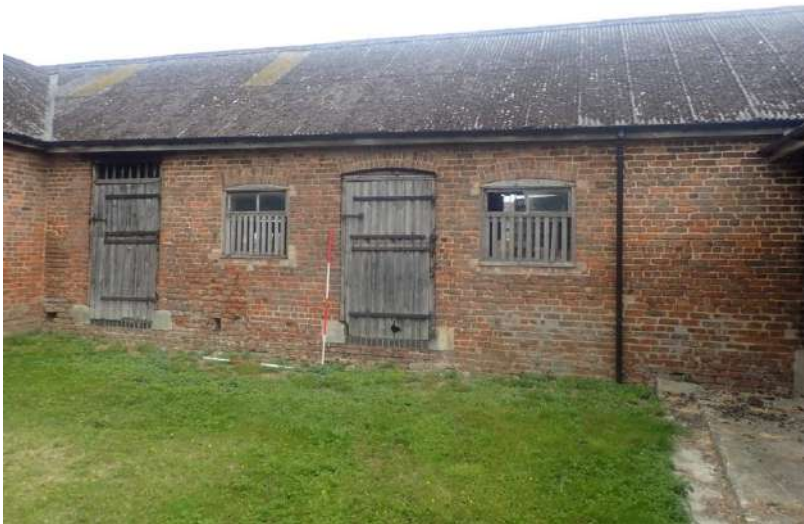
**Plates 107 and 108** present detailed views of the South Elevation of this North Range. At just below roof levels are horizontal timber fascia boards, to which is attached modern horizontal Upvc guttering. This in turn extends to a modern vertical Upvc downpipe to the right (east).

**Plate 107: View of the South Elevation of the North Range, from the south**

**Plate 108: View of the South Elevation of the North Range, from the south**

The brickwork wall fabric of this South Elevation is composed of three courses of brick stretchers that alternate with single courses of brick headers in English Garden Wall Bond. Also shown are two south facing window openings. The first opening to the right (east) comprises a timber frame of a head, surrounds and a sill at the base of the opening. The window is partially glazed at its upper levels of two lights with one vertical timber glazing bar and an horizontal timber transom. The lower levels of the window are occupied by a series of vertical timber ventilation slats. Above the opening is a curved head in brick that is composed of two courses of brick stretchers laid on

edge along with two brick headers at each end of the head laid on end. There is some limited modern brick repair below the opening.

To the left (west), is the second south facing window opening. This is occupied by a timber frame of a head, surrounds and a sill at the base of the opening. The window is partially glazed at its upper levels of two lights with one vertical timber glazing bar and an horizontal timber transom. The lower levels of the window are occupied by a series of vertical timber ventilation slats. Above the opening is a curved head in brick that is composed of two courses of brick stretchers laid on edge along with two brick headers at each end of the head laid on end. There is some limited modern brick repair below the opening.

Also featured are two south facing entrance openings. Both are slightly elevated above present ground levels, suggesting that there was once an elevated yard surface here, which has gone. The first entrance opening to the right (east), is occupied by a timber frame of a head and surrounds with the basal ends of each surround resting upon two worked, shaped and faced stone ashlar that are each incorporated into the brickwork wall fabric. Attached to a frame surround by two pairs of horizontal cast metal strap hinges are two timber half doors, each of which are composed of a series of vertical tongued and grooved timber planks. At the base of the opening is a brick threshold. Above the opening is a curved head in brick that is composed of two courses of brick stretchers laid on edge along with two brick headers at each end of the head laid on end.

to the left (west), is the second entrance opening. This is occupied by a timber frame of a head and surrounds with a threshold in brick at the base of the opening. The basal ends of each surround rest upon two worked, shaped and faced stone ashlar that are each incorporated into the brickwork wall fabric. Attached to a frame surround by two pairs of horizontal cast metal strap hinges are two timber half doors, each of which are composed of a series of vertical tongued and grooved timber planks. The upper levels of the opening are occupied by a series of open vertical timber ventilation slats. Above the opening is an horizontal timber lintel that is also incorporated into the wall fabric.

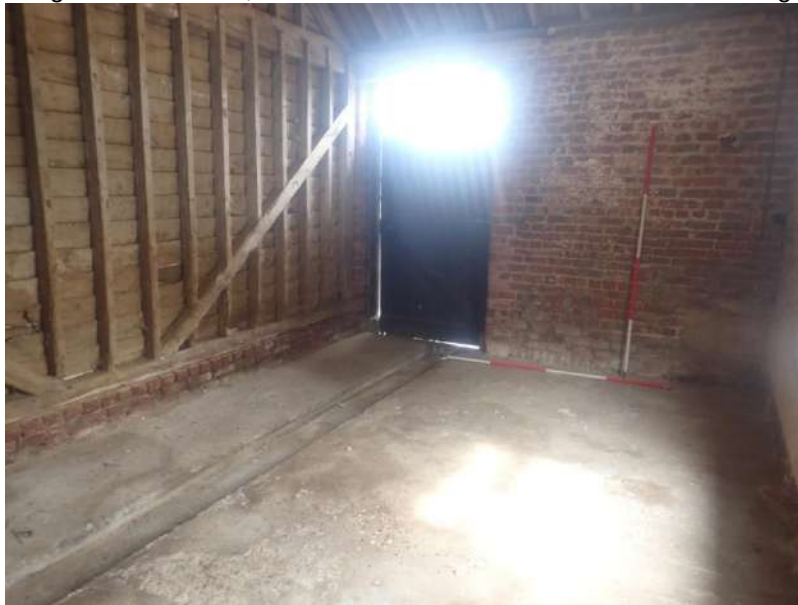
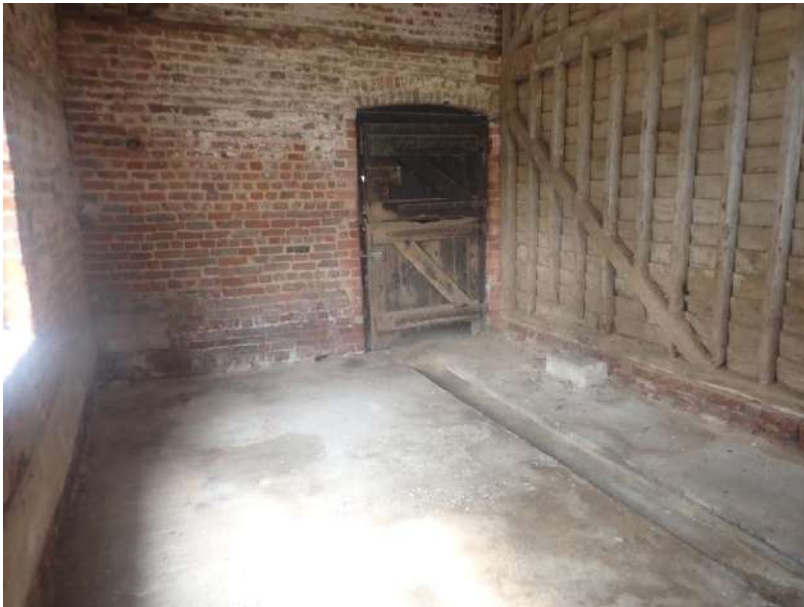
**Plate 109: General view of the interior of Cell 3, from the south**

**Plates 109 and 110** provide general views of the interior of **Cell 3**, from different perspectives.

**Plate 110: General view of the interior of Cell 3, from the north**

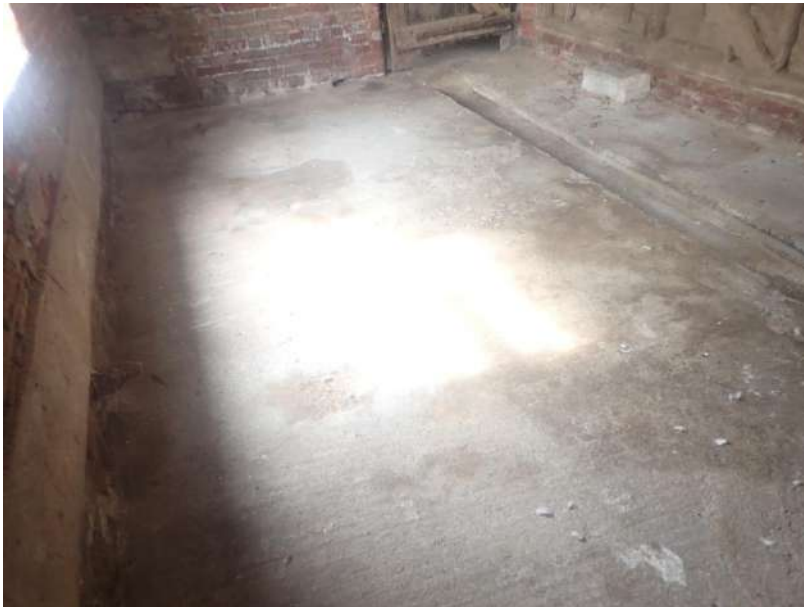
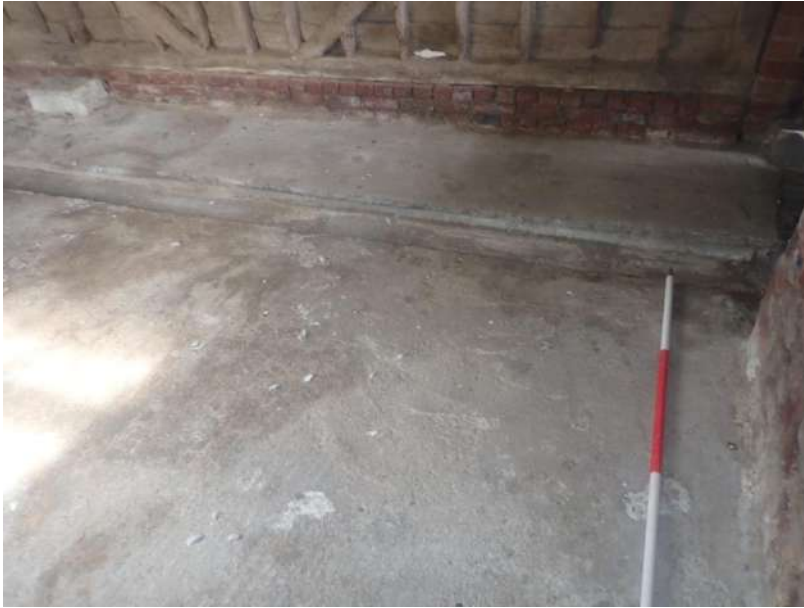
**Plate 111: View of the flooring of Cell 3, from the north**

**Plates 111 and 112** feature the nature of the flooring of **Cell 3**, which is of modern concrete,. A shallow north-south orientated drainage channel may be seen to be cut into this flooring.

**Plate 112:** View of the flooring of Cell 3, from the east

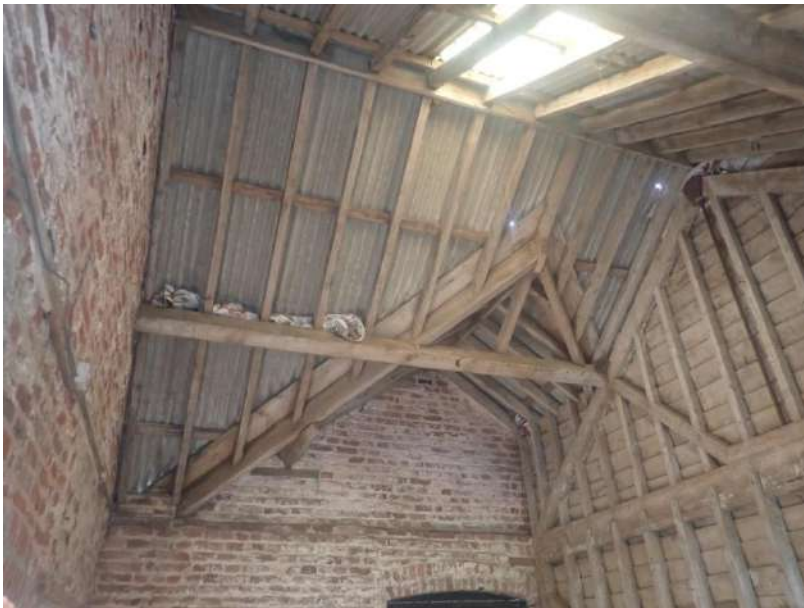
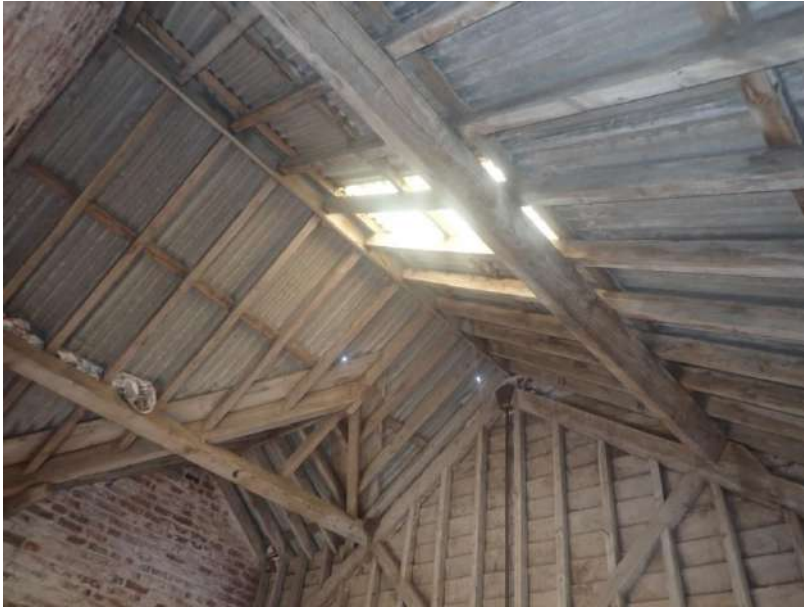
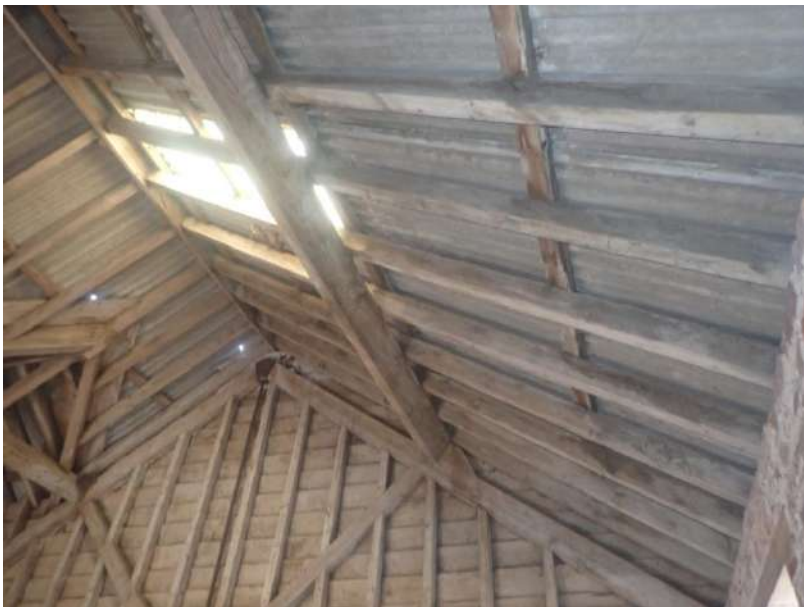
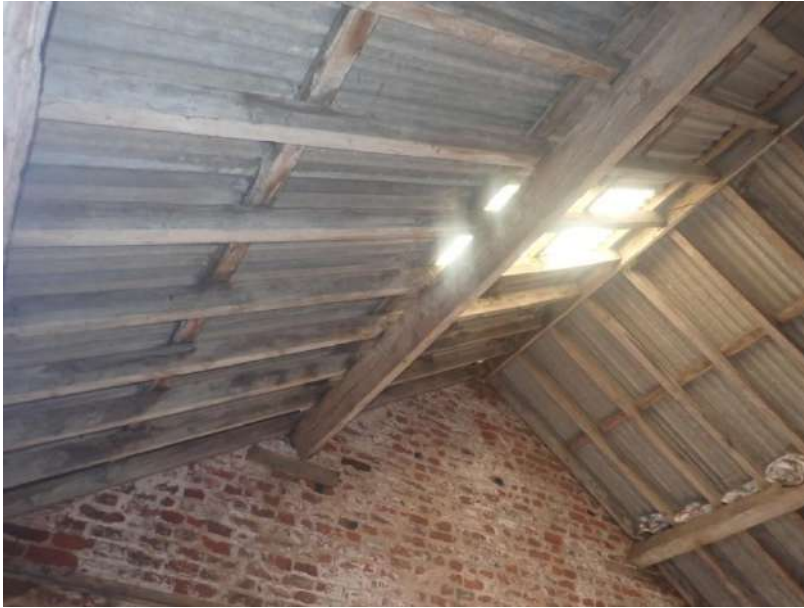
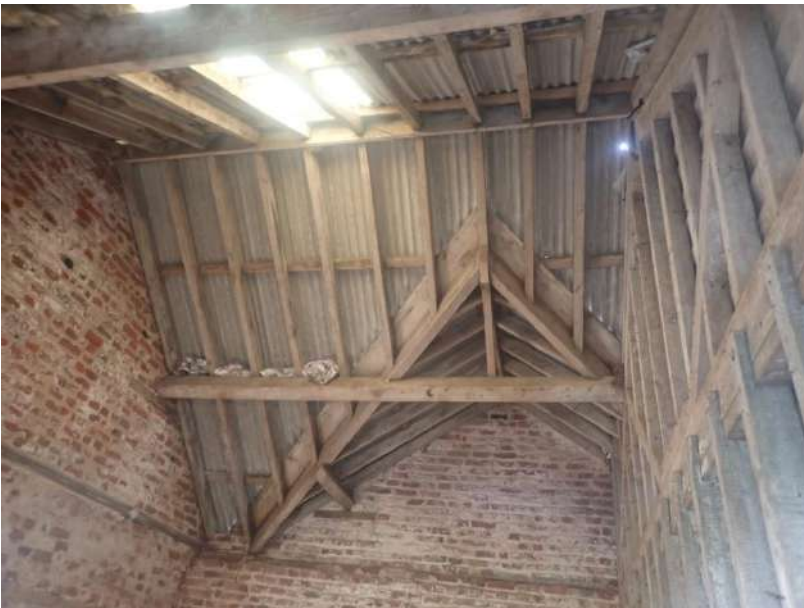
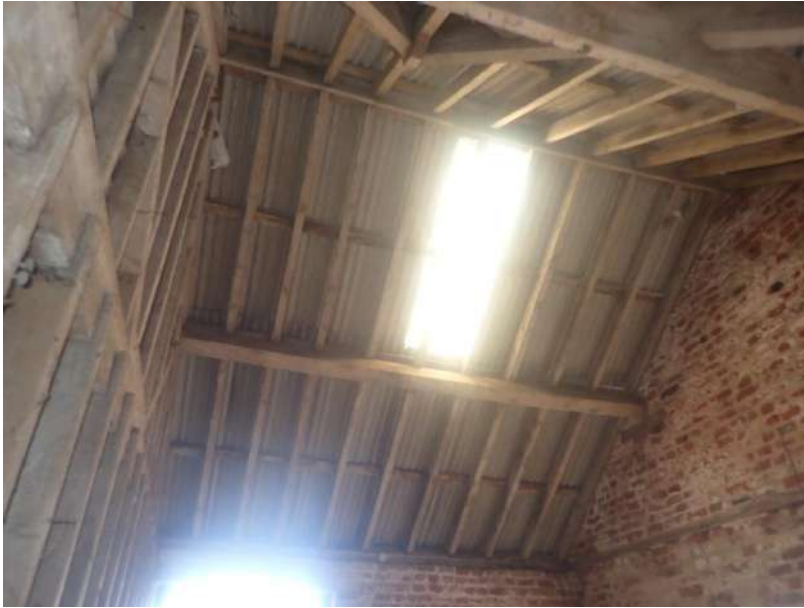
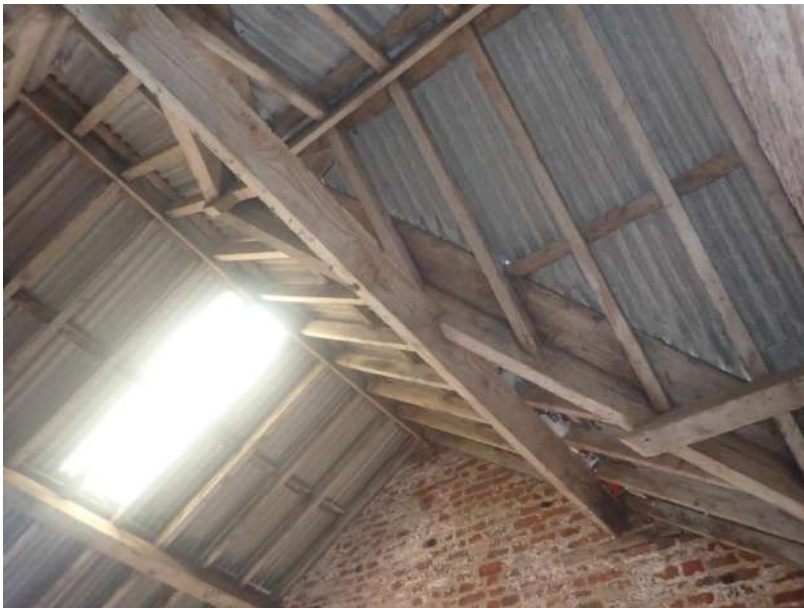
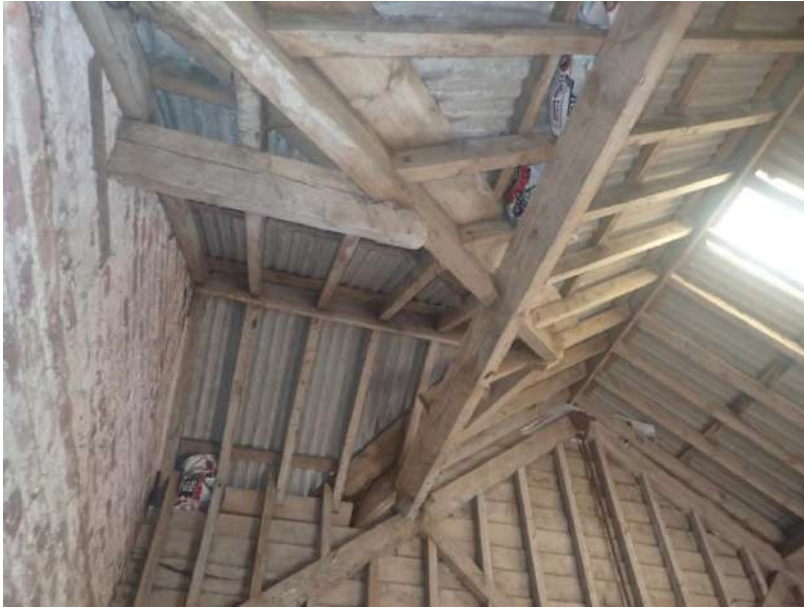
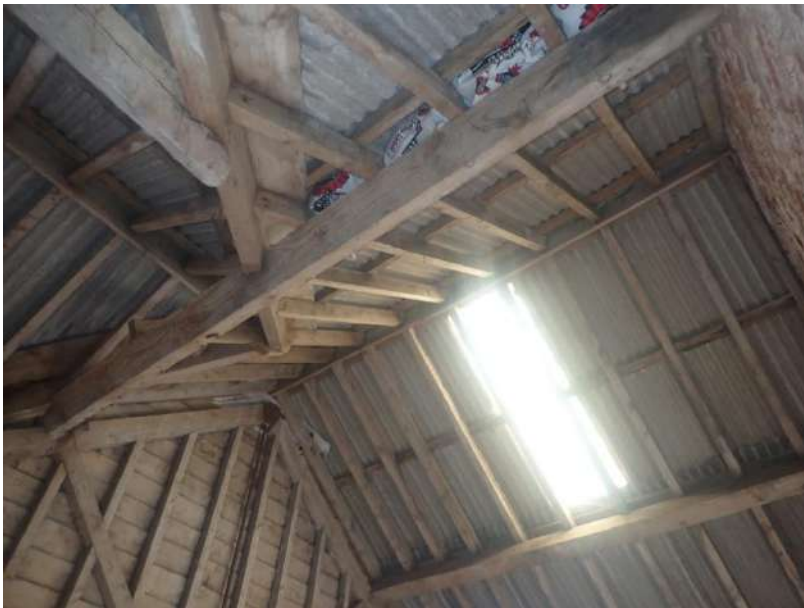
**Plates 113-121** present a number of views from different positions of the nature of the roof supporting structure of **Cell 3** and hence of the eastern end of the North Range. Of particular note is the intersection with or merging of the gabled roof structure of the bonded and adjoining East Range with that of the gabled roof structure of this North Range. The detail of the northern end of the gabled roof structure of the East Range (which has been described in detail earlier) is featured and terminates with the two principal and angled end rafters, which in turn form part of the gabled roof structure of this North Range.

The principal component part of the gabled roof structure of **Cell 3**, is the king post roof truss, which is also incorporated into the upper levels of the fabric of the west wall of **Cell 3**. The remainder of this roof structure is composed of a framework of timber rafters and horizontal

timber purlins that extend along both sides of this structure along with further horizontal timber purlins that extend along the roof apex. The roof truss is attached to the timber purlins.

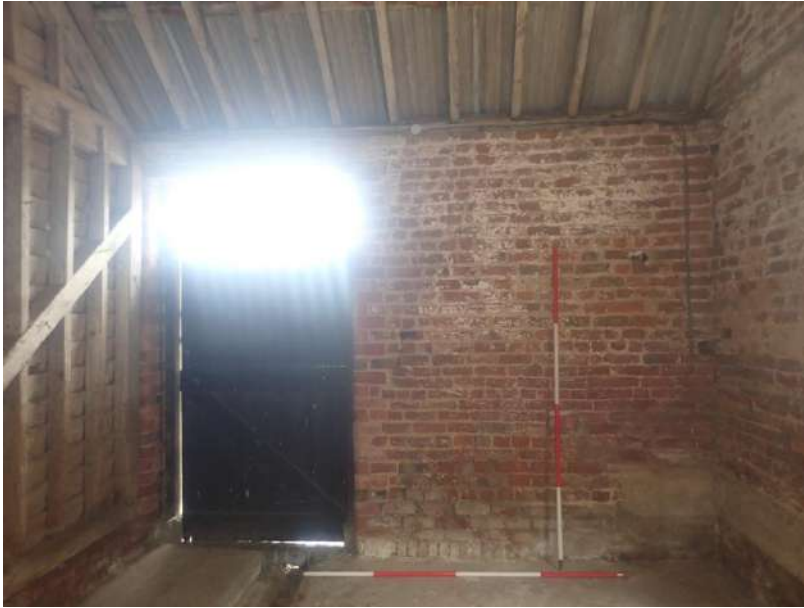
**Plate 122** presents a detailed view of the north wall of **Cell 3**. The brickwork wall fabric of this north wall is composed of three courses of brick stretchers that alternate with single courses of brick headers in English Garden Wall Bond. Horizontal timber wallplates may be seen to extend along the top of this north wall, to which the basal ends of the timber rafters of the roof structure are attached to. Also shown and to the left (west), is the inner face of the north facing entrance opening that was recorded externally at the North Elevation of this outbuilding. The vertical timber planks of the doors are attached to an internal framework of angled and horizontal timbers. Above the opening and incorporated into the brickwork here is an horizontal timber lintel.

**Plate 122: View of the north wall of Cell 3, from the south**
