**NEVILLE HALL  
FREELANCE ARCHAEOLOGIST & CONSULTANT**

HISTORIC BUILDING RECORDING AT  
CROWN FARM, STOCKWELL GATE WEST,  
WHAPLODE, LINCOLNSHIRE.

**National Grid Reference: TF 3306 2504**  
**Planning Reference: H23-1116-21**  
**Site Code: CFWH23**  
**Accession Number: LCNCC: 2023.77**

July 2023

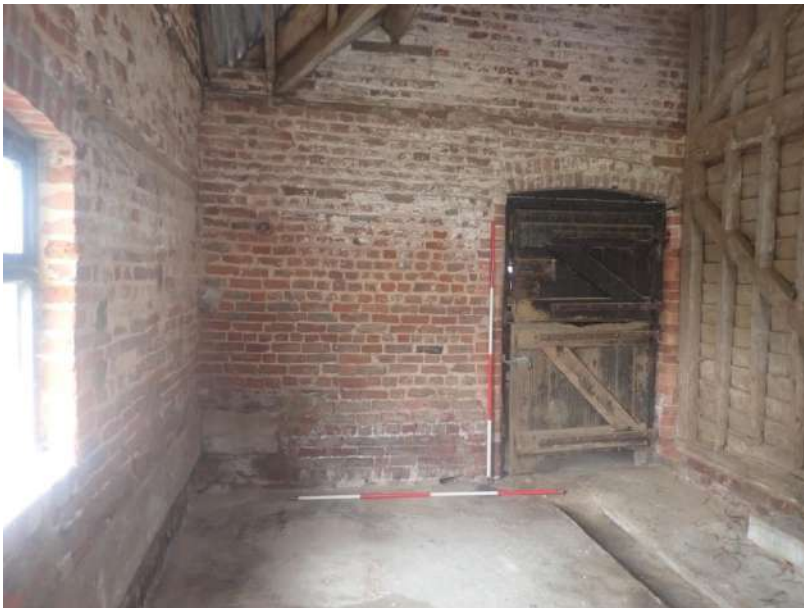
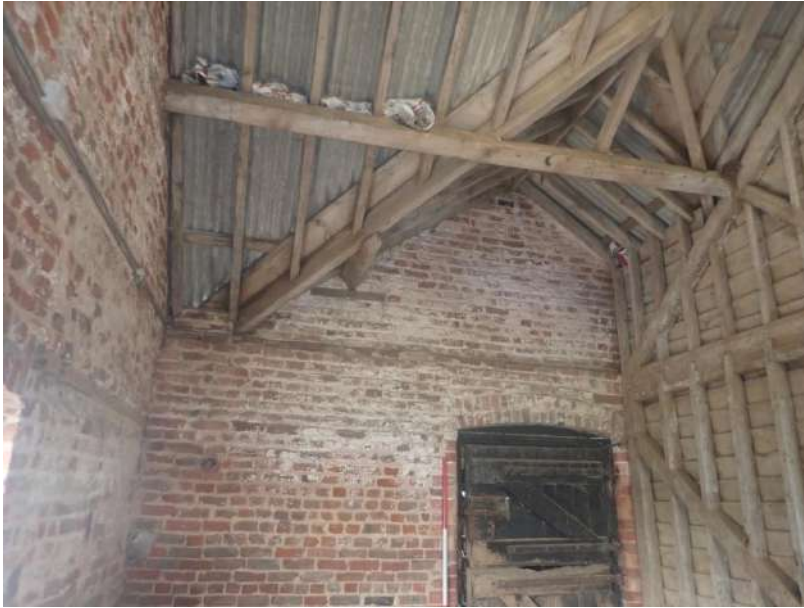
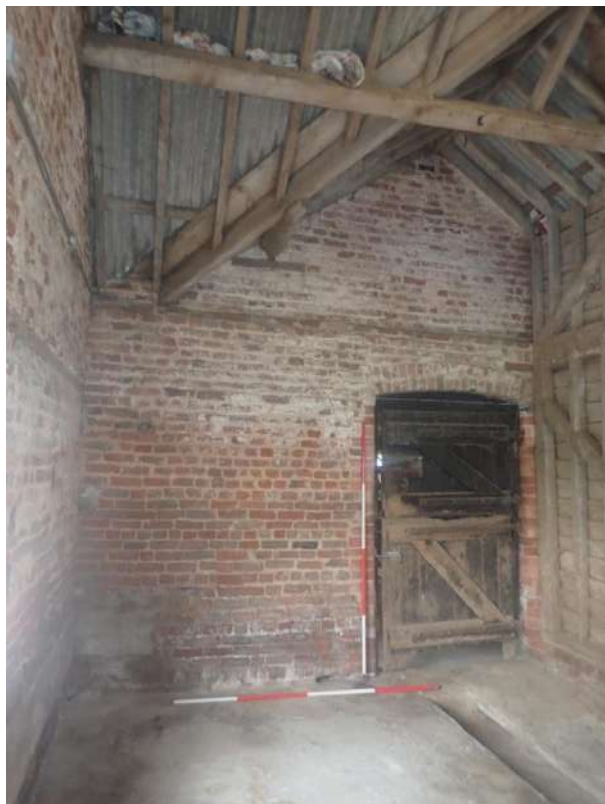
**Plate 123: View of the south wall of Cell 3, from the north**

**Plates 123-125** feature the south wall of **Cell 3**, which is also the internal dividing wall with the adjoining **Cell 1** of the East Range to the south. The brickwork wall fabric of this south wall is composed of three courses of brick stretchers alternating with single courses of brick headers in English Garden Wall Bond. The detail of the brickwork at the upper levels has become partially obscured by the remains of plaster or mortar rendering. Incorporated into this wall fabric and at its mid levels is an horizontal timber wallplate. Also shown is the inner face of the south facing entrance opening that was also recorded within **Cell 1** of the East Range. The vertical timber planks of the two timber half doors are attached to an internal framework of angled and horizontal timbers. The doors are affixed to a frame surround by two pairs of horizontal cast metal strap hinges. Above the opening is a curved head in brick that is composed of two courses of brick stretchers laid on edge.

**Plate 124: View of the south wall of Cell 3, from the north**

**Plate 125: View of the south wall of Cell 3, from the north**

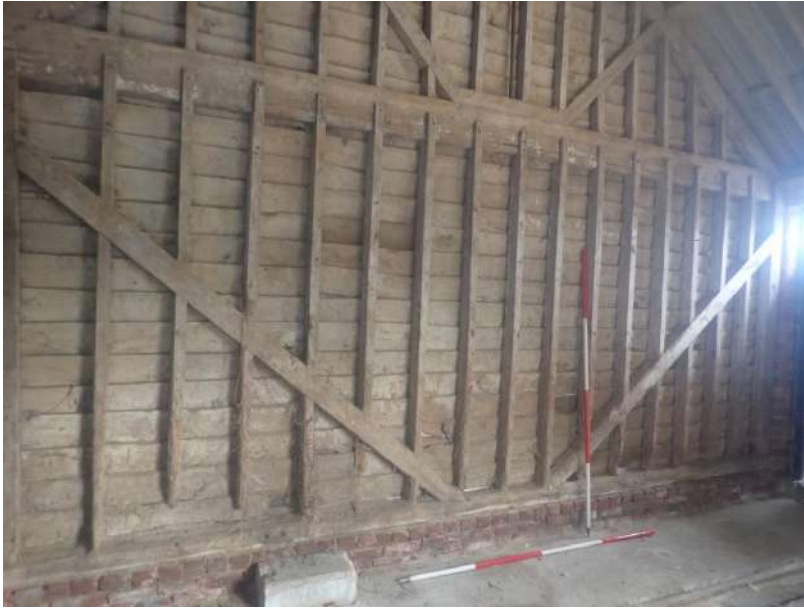
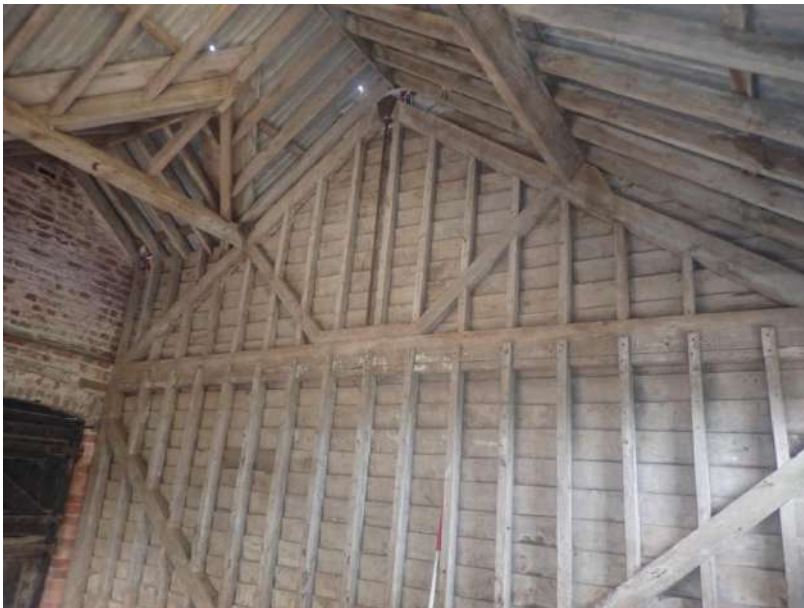
**Plate 126: View of the west wall of Cell 3, from the east**

**Plates 126-129** feature in detail the west wall of **Cell 3**, which is also the internal dividing wall with the adjacent **Cell 4** of the North Range to the west. As noted earlier, one of the king post timber roof trusses of the overlying roof structure is incorporated into the fabric at the upper levels of this west wall. Otherwise, this wall fabric is composed of horizontal timber weatherboarding that is attached to the roof truss and at the mid and lower levels, to a framework of angled and horizontal timbers. This wall also rests on a brick base composed of an uppermost course of brick headers with two courses of brick stretchers below this.

**Plate 129: View of the west wall of Cell 3, from the east**

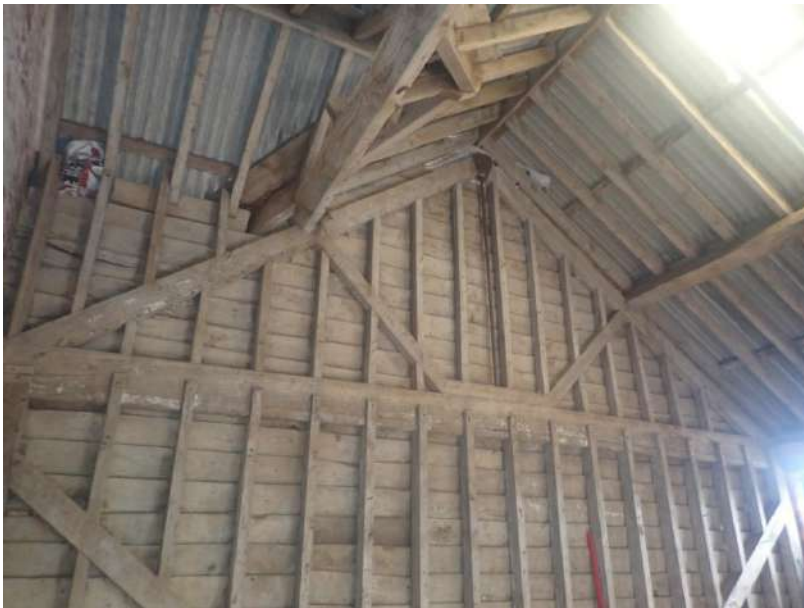
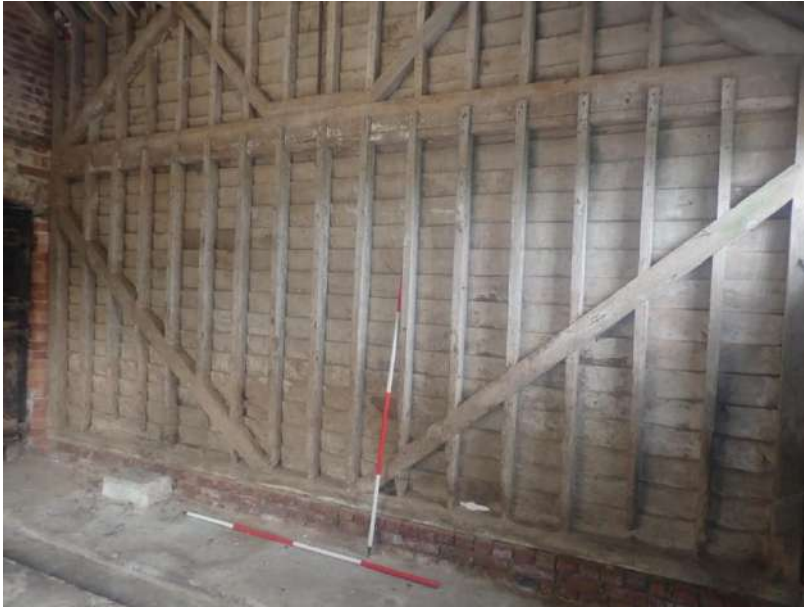
**Plate 127: View of the west wall of Cell 3, from the east**

**Plate 128: View of the west wall of Cell 3, from the east**

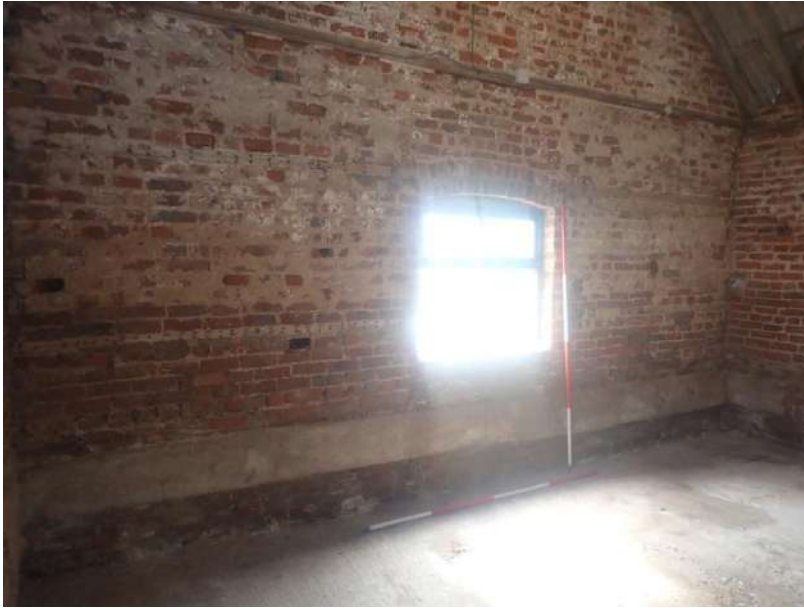
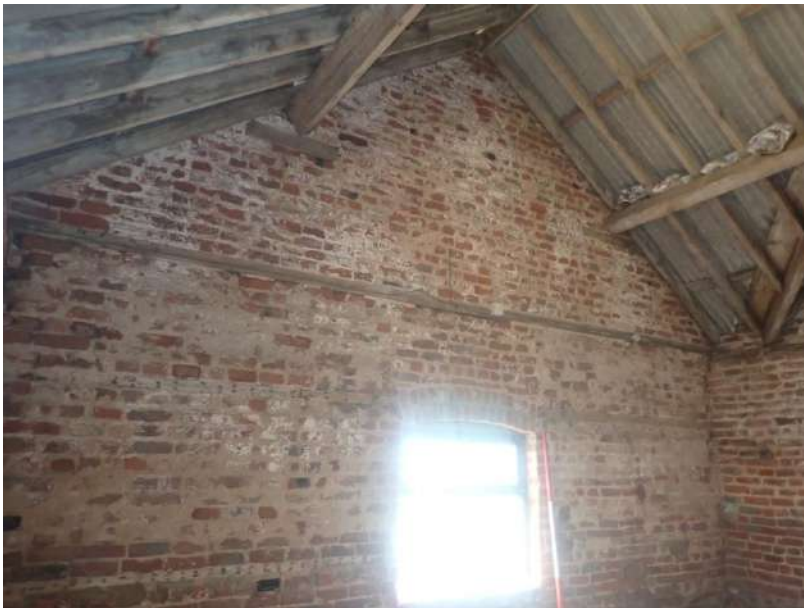
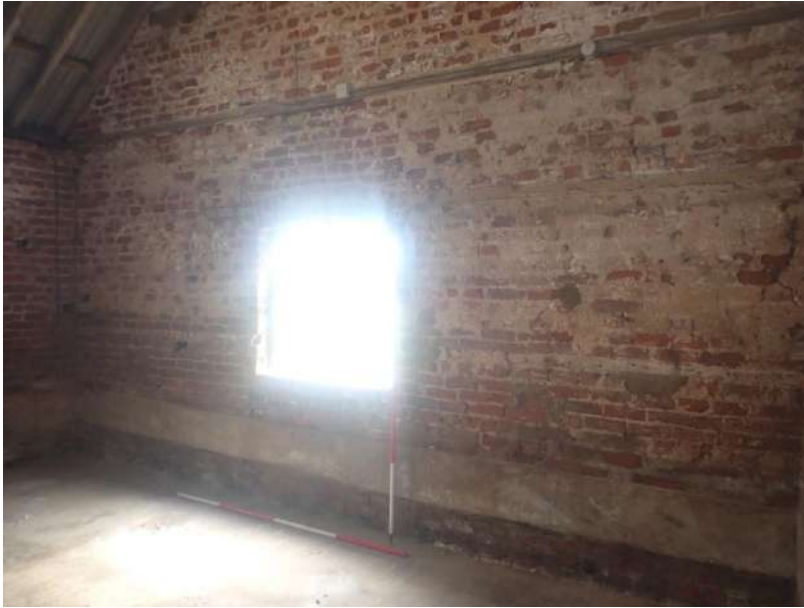
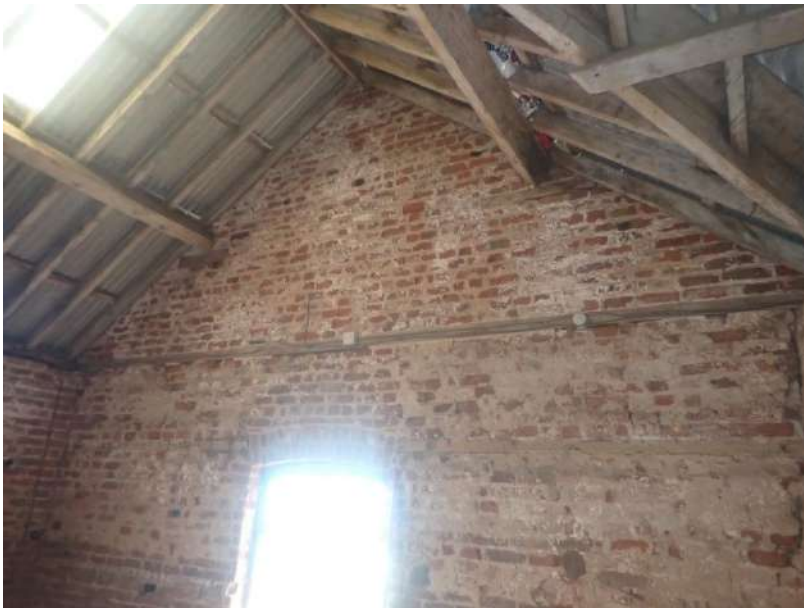
**Plates 130-133** present views of the east wall of **Cell 3**. The brickwork wall fabric of this east wall appears to be composed of three courses of brick stretchers alternating with single courses of brick headers in English Garden Wall Bond, though much of the detail of this brickwork has become obscured by being partially covered over with plaster or mortar rendering. Also shown is the inner face of the east facing window opening that was recorded externally at the East Elevation of this North Range. Incorporated into this brickwork and at mid levels are horizontal timber wallplates. At the base of the wall is a band of mortar or cement rendering. It may also be observed that the eastern ends of the horizontal timber purlins of the overlying roof structure may be seen to be inserted into the uppermost levels of the brickwork.

**Plate 130: View of the east wall of Cell 3, from the west**

**Plate 131: View of the east wall of Cell 3, from the west**

**Plate 132: View of the east wall of Cell 3, from the west**

**Plate 133: View of the east wall of Cell 3, from the west**

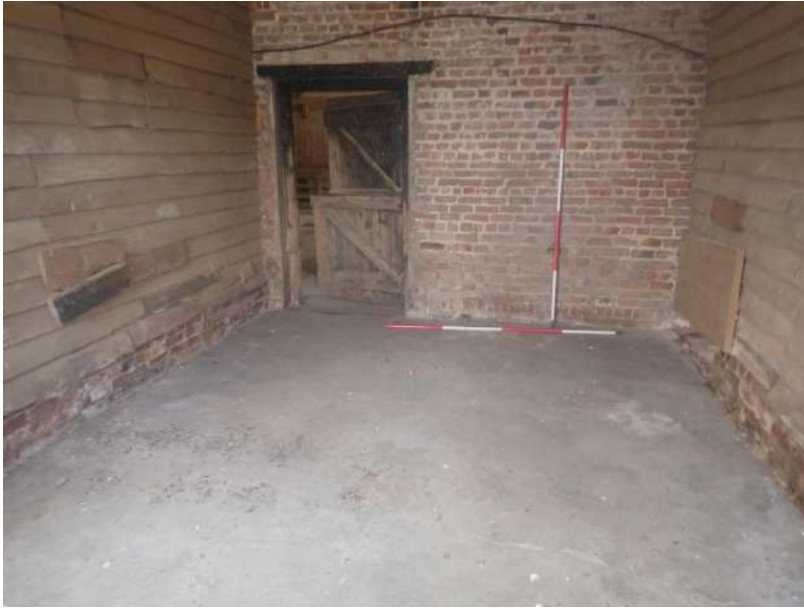
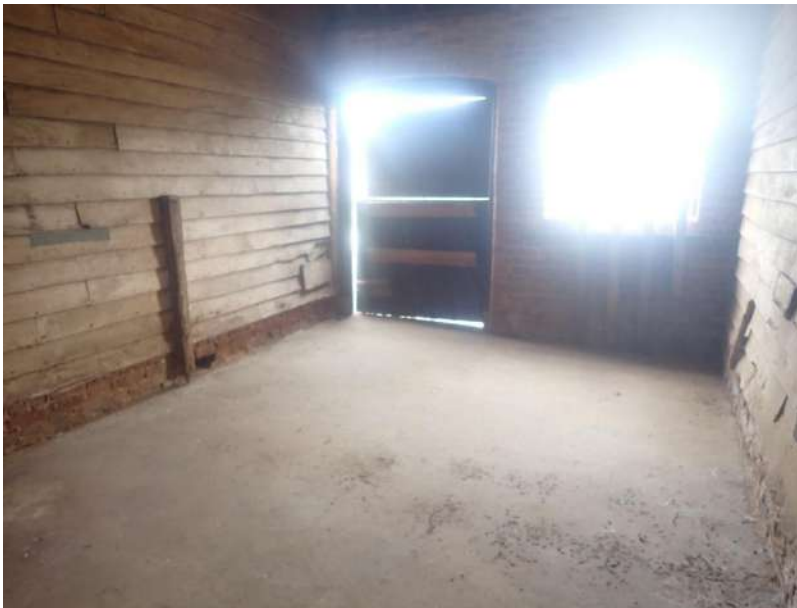
**Plates 134 and 135** provide general views of the interior of **Cell 4** from different positions.

**Plate 134: General view of the interior of Cell 4, from the north**

**Plate 135: General view of the interior of Cell 4, from the south**

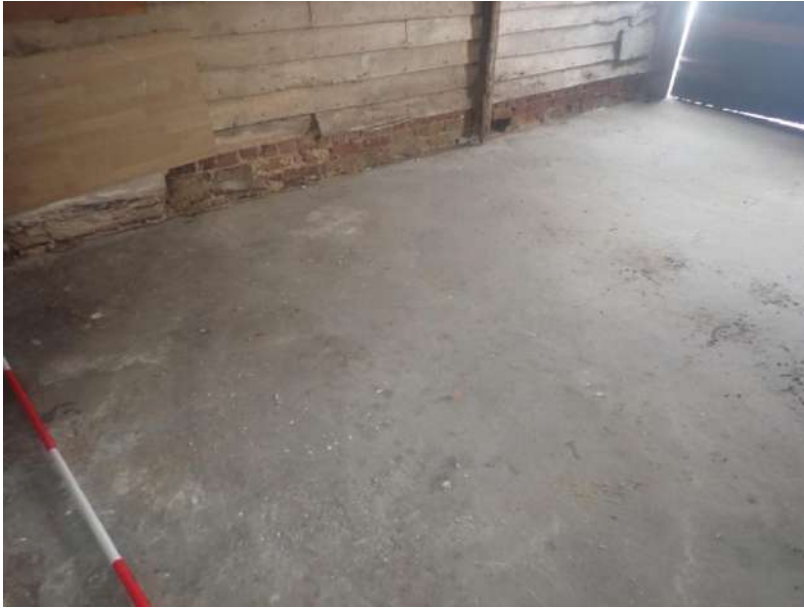
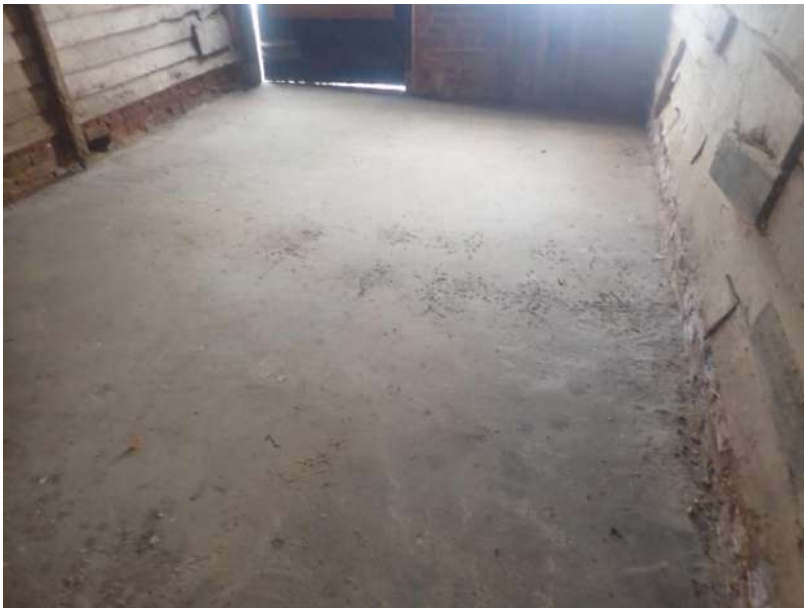
**Plates 136 and 137** feature the nature of the flooring of **Cell 4**, which is of modern concrete.

**Plate 136: View of the flooring of Cell 4, from the east**

**Plate 137: View of the flooring of Cell 4, from the south**

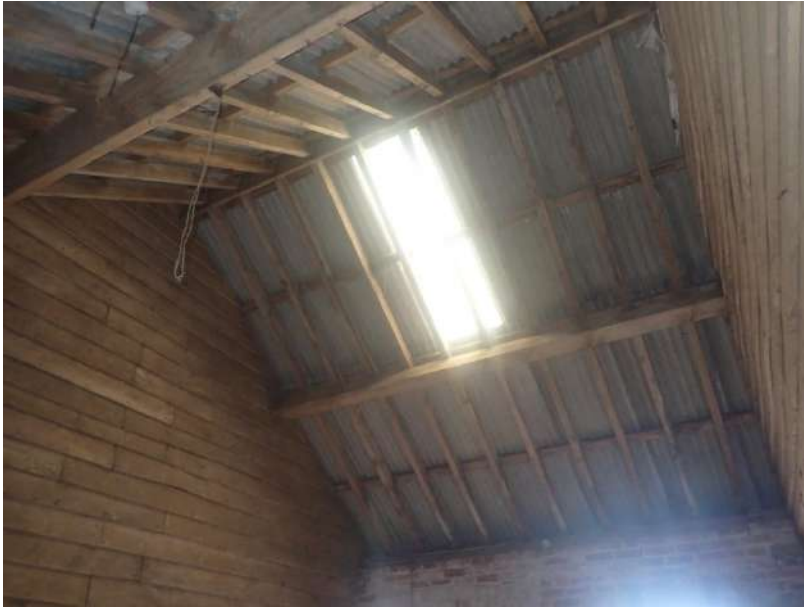
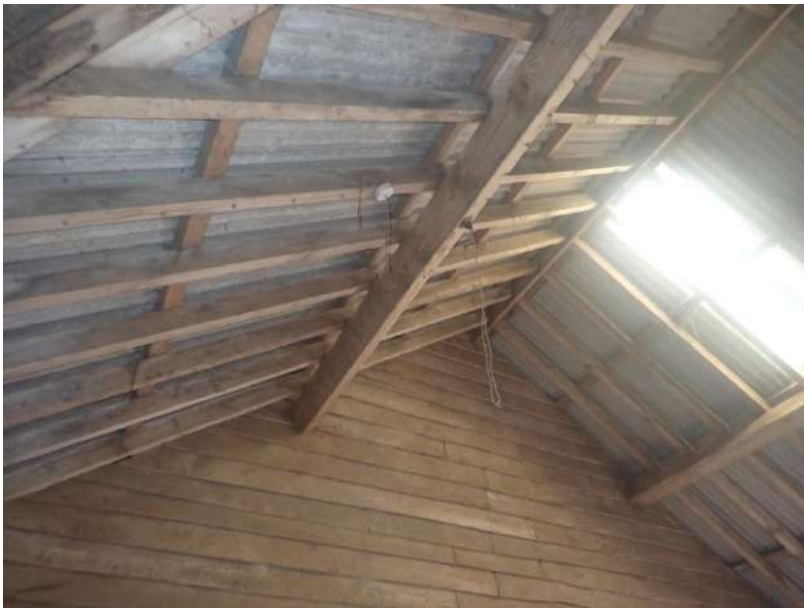
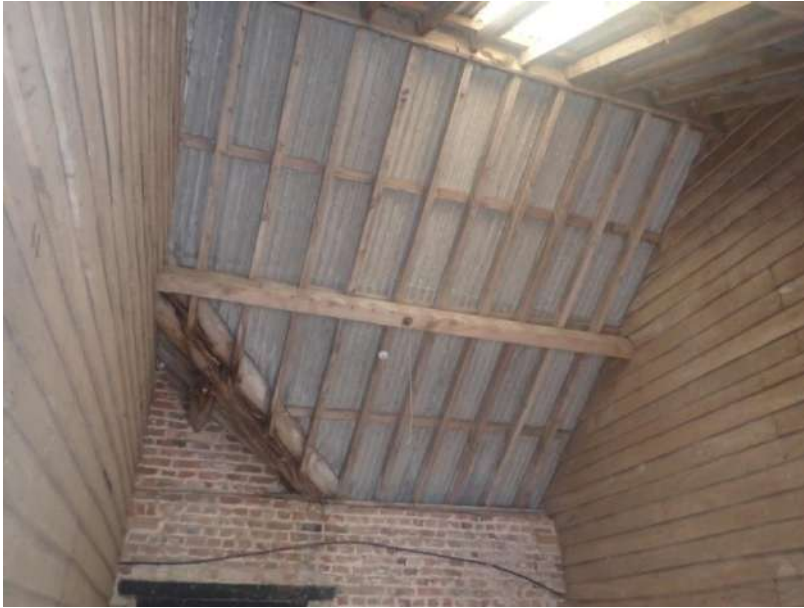
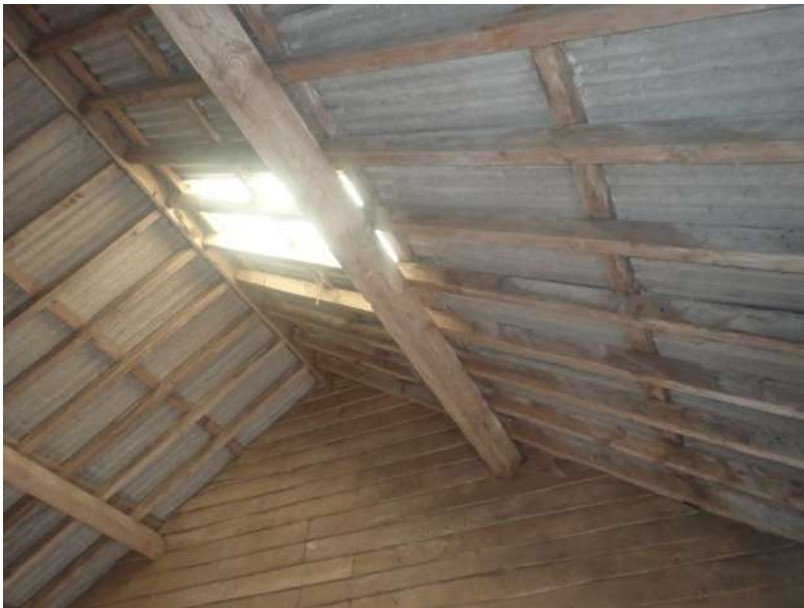
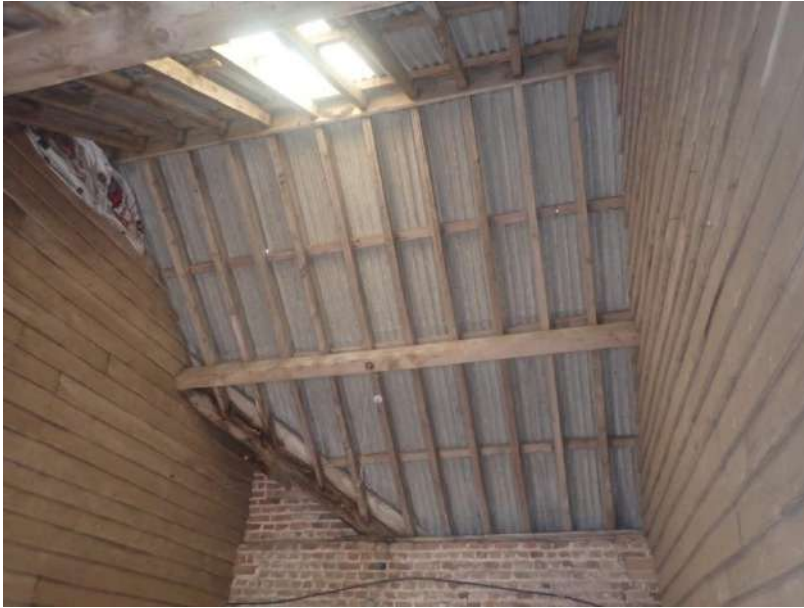
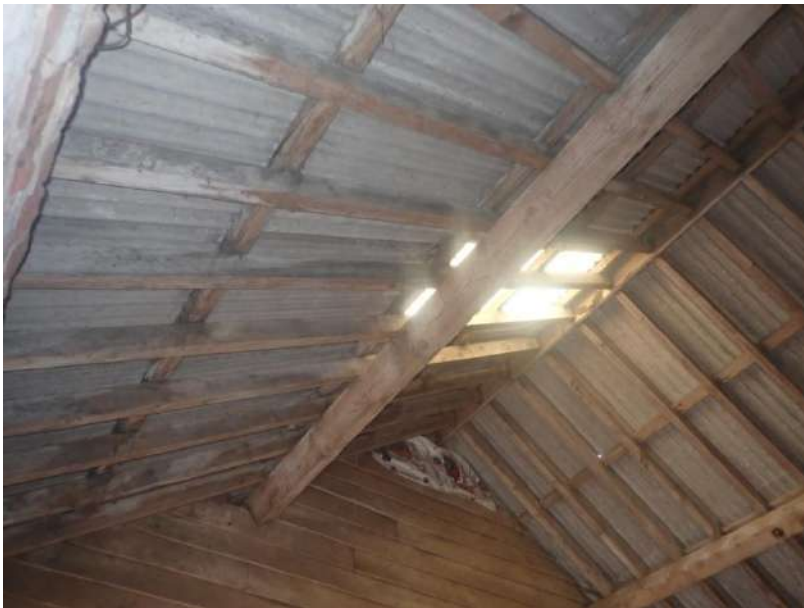
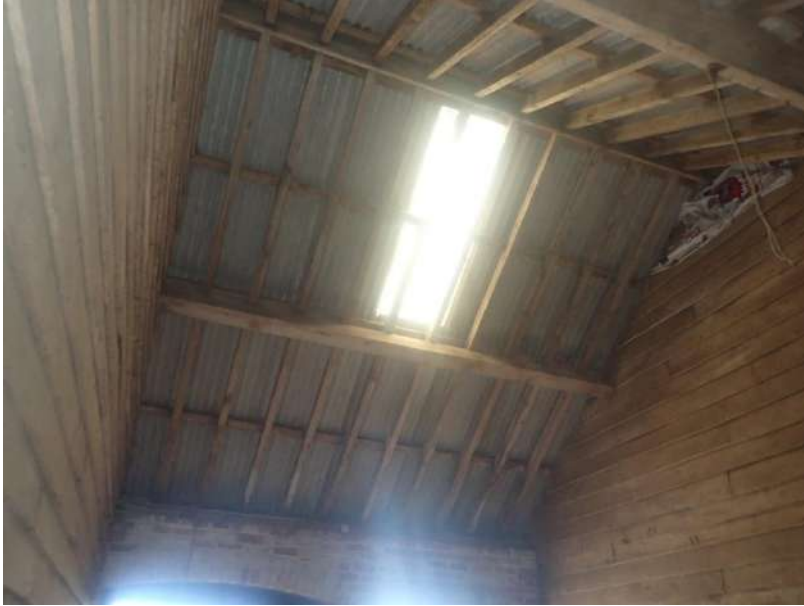
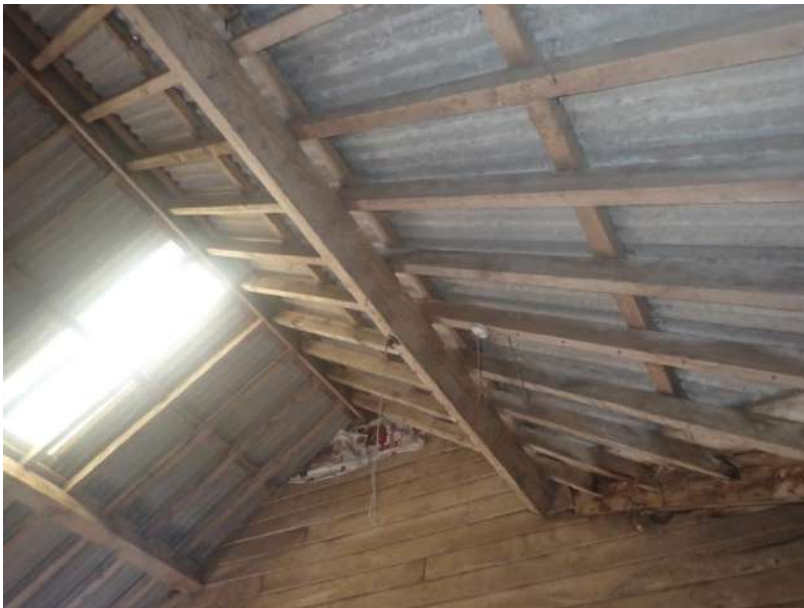
**Plate 138: View of the roof supporting structure of Cell 4, from the south**

**Plate 139: View of the roof supporting structure of Cell 4, from the east**

**Plates 138-145** provide a number of views of the nature of the roof supporting structure above **Cell 4**. This is a relatively simple structure that is composed of a framework of timber rafters and of horizontal timber purlins that extend along both sides of this structure along with further horizontal timber purlins that extend along the roof apex. **Plates 140 and 142** also feature the northern end of the gabled roof structure of the adjoining and bonded East Range.

**Plate 140: View of the roof supporting structure of Cell 4, from the north**

**Plate 141: View of the roof supporting structure of Cell 4, from the east**

**Plate 142: View of the roof supporting structure of Cell 4, from the north**

**Plate 143: View of the roof supporting structure of Cell 4, from the west**

**Plate 144:** View of the roof supporting structure of **Cell 4**, from the south

**Plate 145:** View of the roof supporting structure of **Cell 4**, from the west

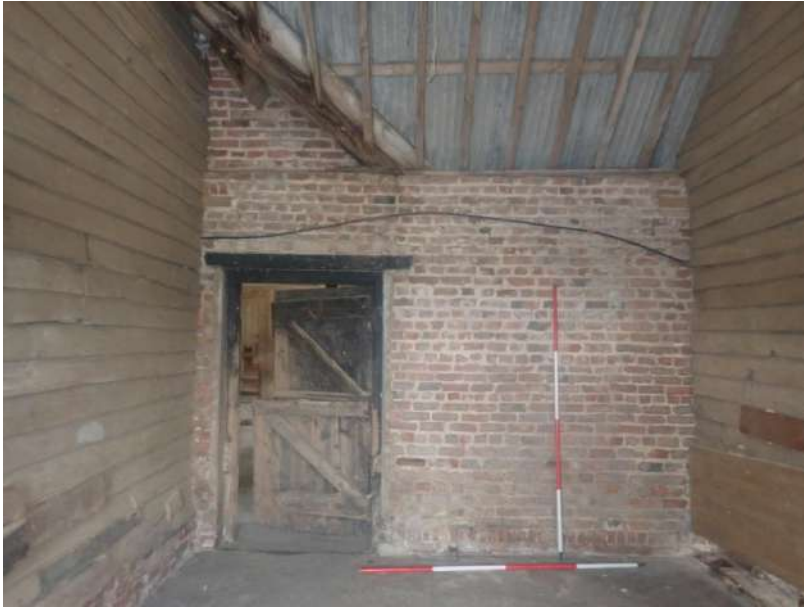
**Plate 146:** View of the south wall of Cell 4, from the north

**Plate 146** presents a detailed view of the south wall of **Cell 4**, which is also the internal dividing wall with the adjoining **Cell 1** of the East Range to the south. The brickwork wall fabric of this south wall is composed of three courses of brick stretchers that alternate with single courses of brick headers in English Garden Wall Bond. An horizontal timber wallplate may be seen to be incorporated into the wall fabric of the upper levels of this south wall. Also featured is the inner face of the south facing entrance opening that was also recorded within **Cell 1** of the adjoining East Range. The two timber half doors are attached to an internal framework of angled and horizontal timbers. Above this opening and also incorporated into the brickwork is an horizontal timber lintel.

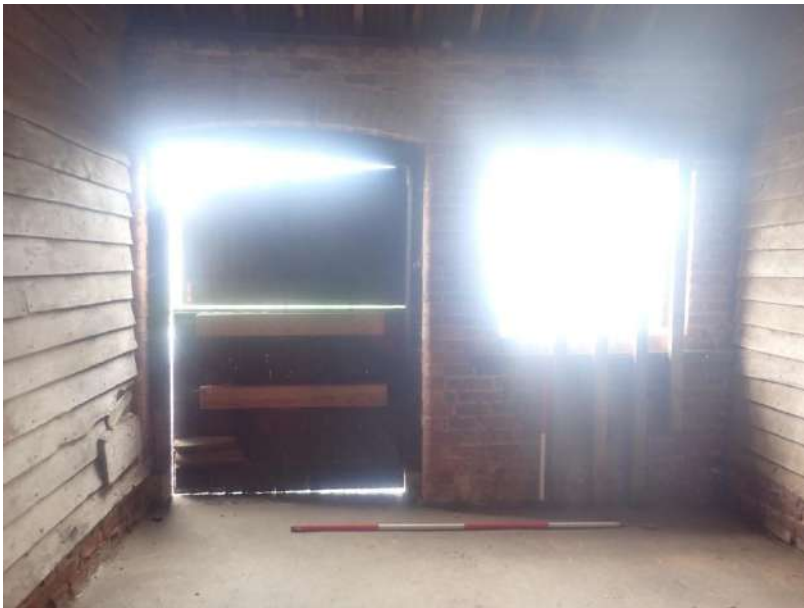
**Plate 147:** View of the north wall of Cell 4, from the south

**Plate 147** features the north wall of **Cell 4**. Here also, the brickwork wall fabric is in the same English Garden Wall Bond. The inner faces of the north facing window and entrance openings that were recorded externally at the North Elevation of this North Range are also shown. An horizontal timber wallplate may be seen to extend along the top of this north wall. The vertical timber planks of the two timber half doors are each attached to an internal framework of angled and horizontal timbers.

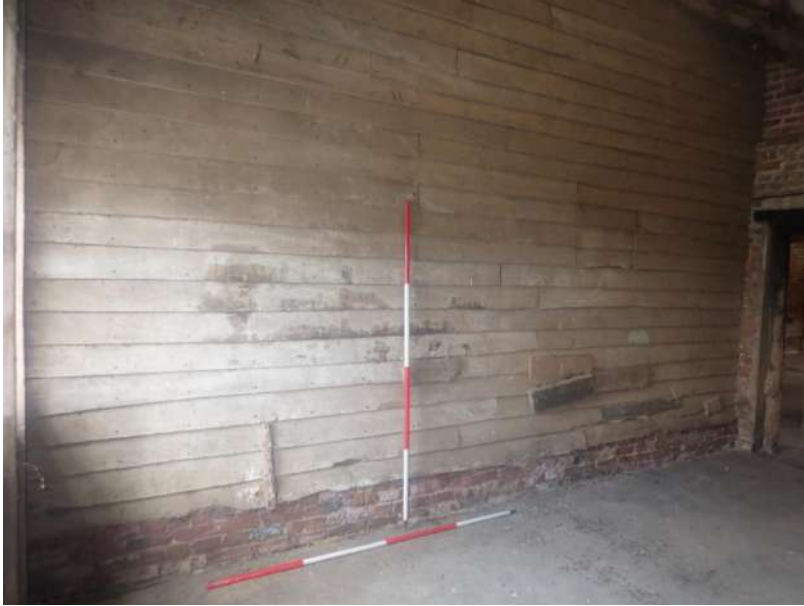
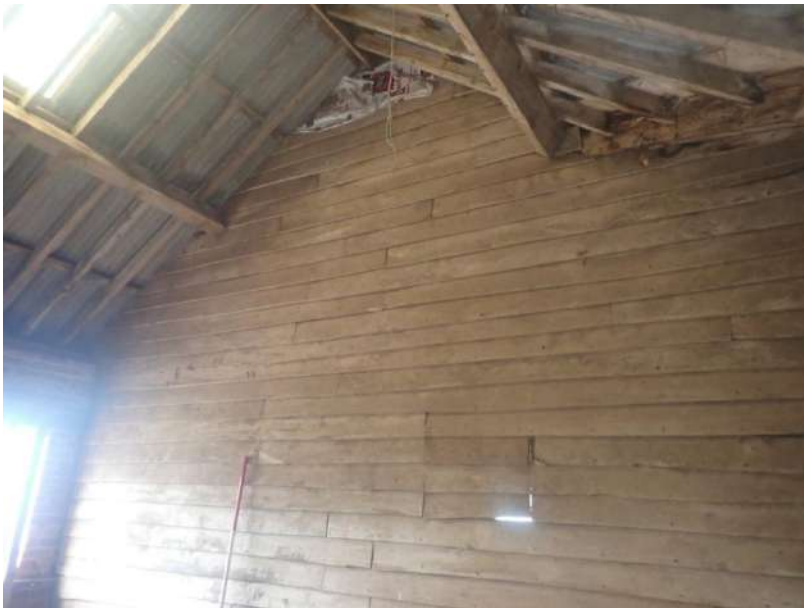
**Plate 148: View of the east wall of Cell 4, from the west**

**Plates 148-151** feature the east wall of **Cell 4**, which is also the internal dividing wall within the North Range with the adjoining **Cell 3** to the west. The wall fabric here is composed of horizontal timber weatherboarding. It may also be observed that the eastern ends of the horizontal timber purlins of the overlying roof structure may be seen to be inserted into the uppermost levels of this wall fabric. This wall fabric rests upon a brick base of four courses in height with the uppermost course of brick headers and the three remaining courses, composed of brick stretchers.

**Plate 151: View of the east wall of Cell 4, from the west**

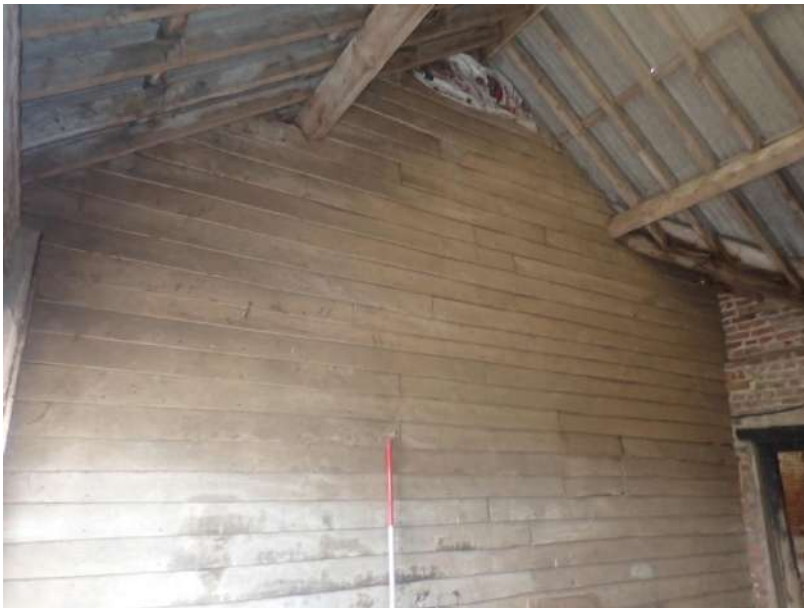
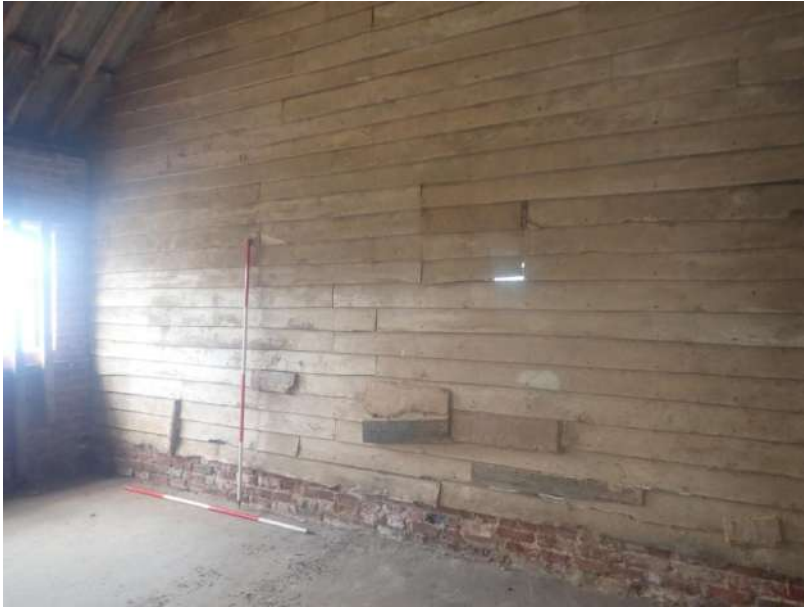
**Plate 149: View of the east wall of Cell 4, from the west**

**Plate 150: View of the east wall of Cell 4, from the west**

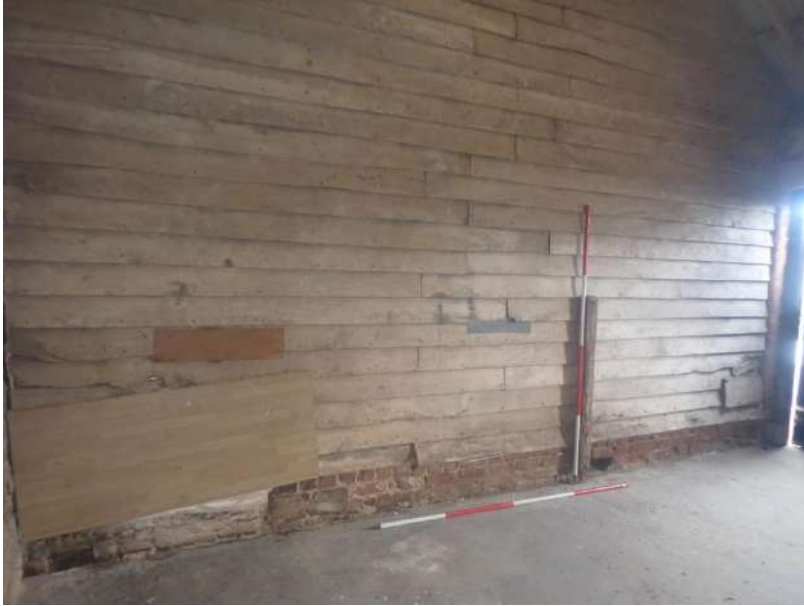
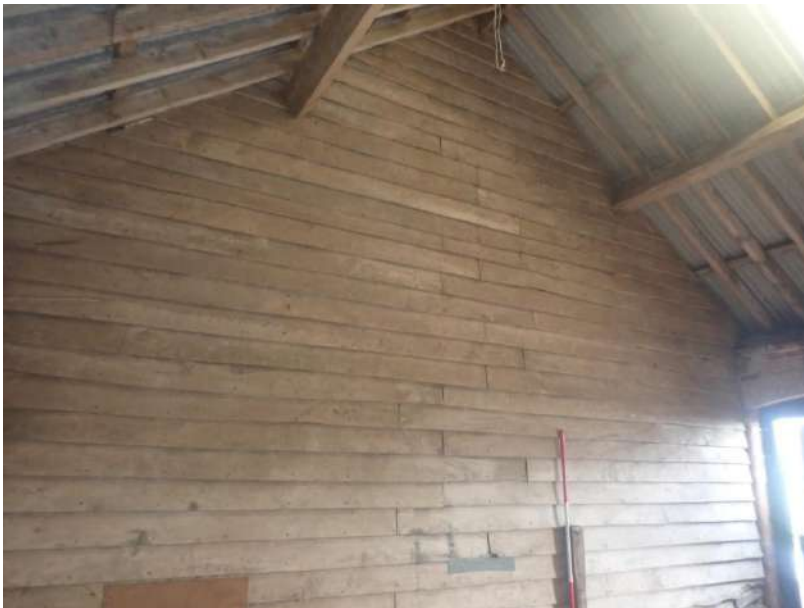
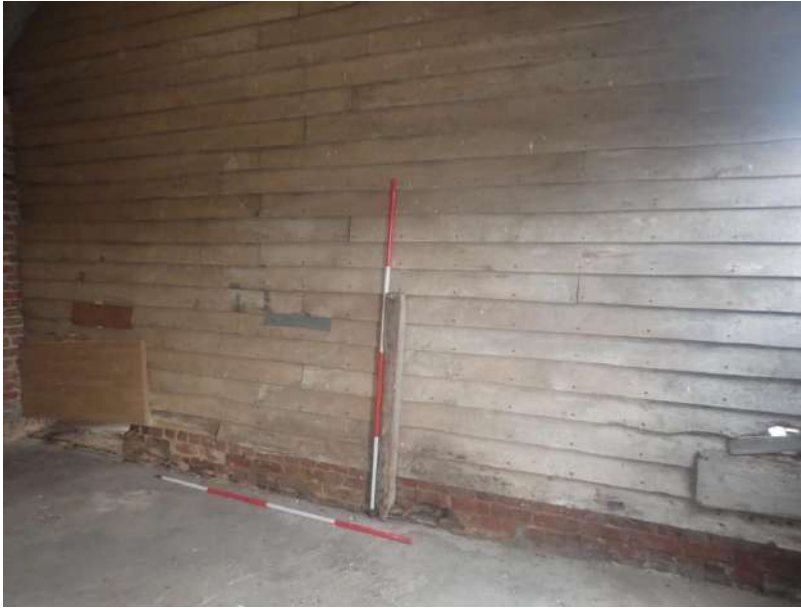
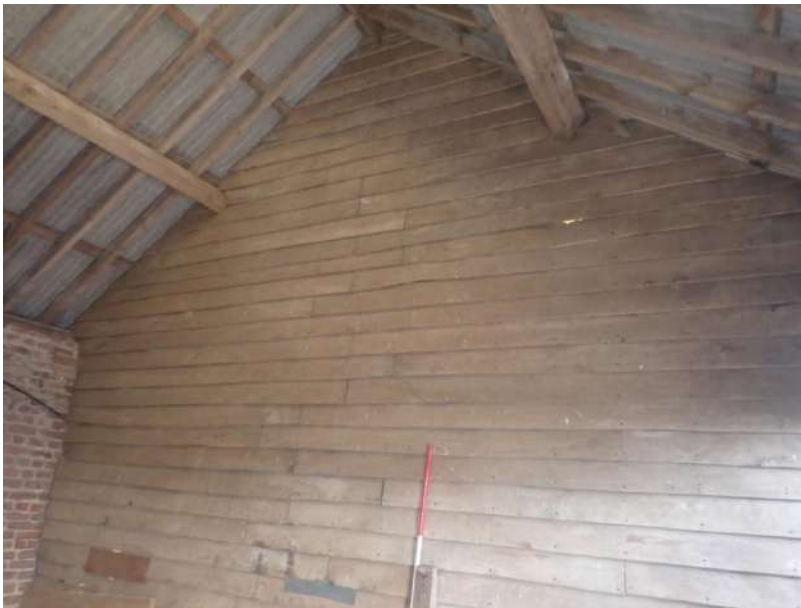
**Plate 152: View of the west wall of Cell 4, from the east**

**Plate 153: View of the west wall of Cell 4, from the east**

**Plates 152-155** feature images of the west wall of **Cell 4**, which is also the internal dividing wall with the adjoining **Cell 5** of this North Range to the west. Here also, the wall fabric is composed of the same horizontal timber weatherboarding. This wall fabric may also be seen to rest upon a brick base, which is of three courses in height with the uppermost course being of brick headers, with the remaining two courses of brick stretchers. The western ends of the horizontal timber purlins of the overlying roof structure may also be seen to be inserted into the uppermost levels of the wall fabric.

**Plate 154: View of the west wall of Cell 4, from the east**

**Plate 155: View of the west wall of Cell 4, from the east**

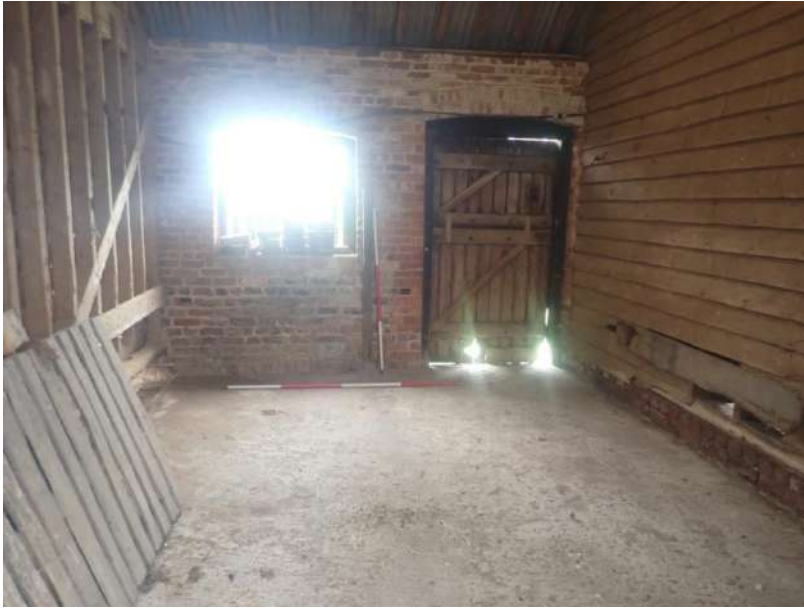
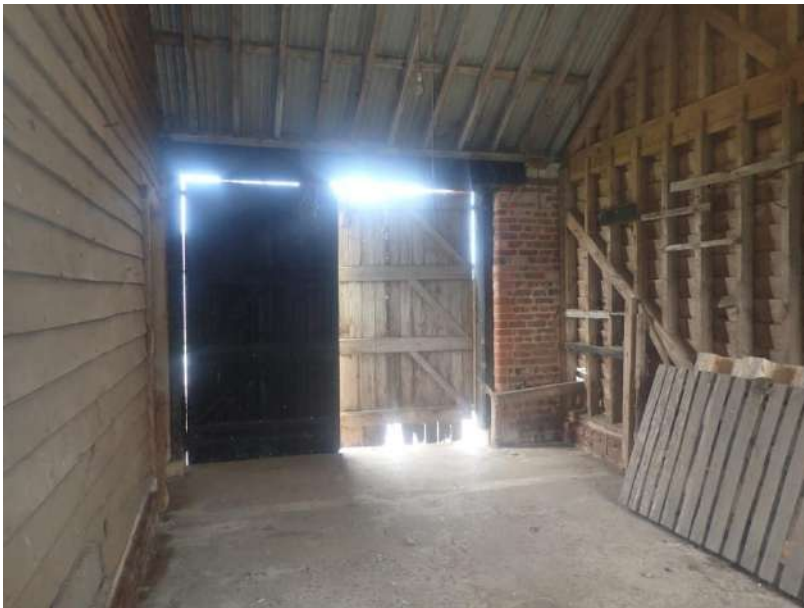
**Plates 156 and 157** furnish general views of the interior of **Cell 5** from different vantage points.

**Plate 156: General view of the interior of Cell 5, from the north**

**Plate 157: General view of the interior of Cell 5, from the south**

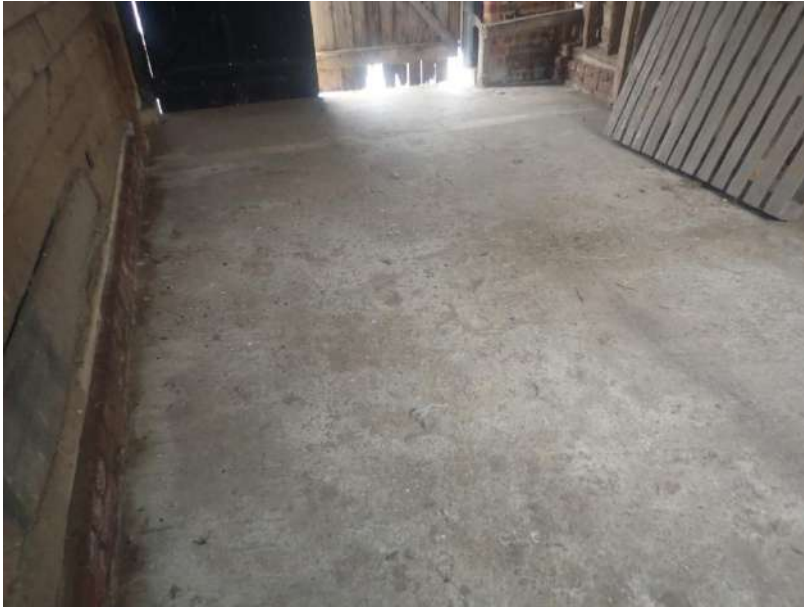
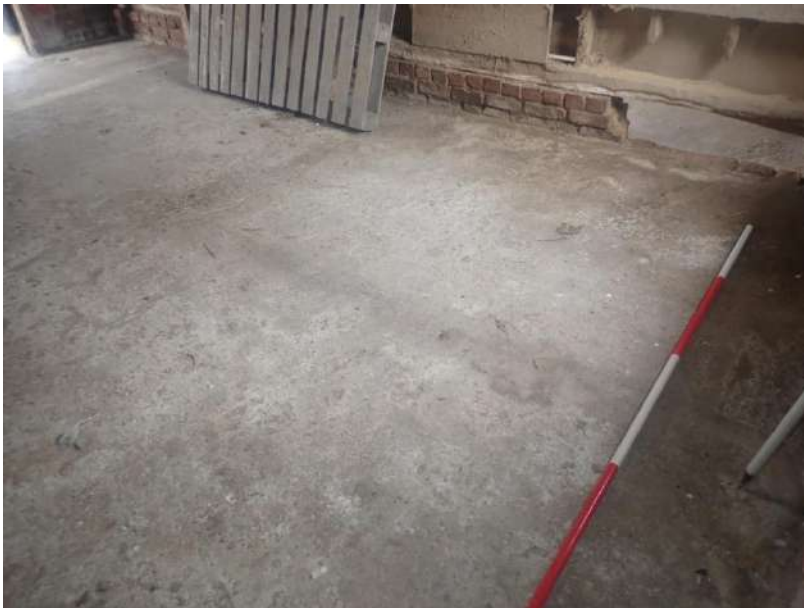
**Plates 158 and 159** feature the nature of the flooring of **Cell 5**, which is of modern concrete.

**Plate 158: View of the flooring of Cell 5, from the south**

**Plate 159: View of the flooring of Cell 5, from the south-west**
