**NEVILLE HALL  
FREELANCE ARCHAEOLOGIST & CONSULTANT**

HISTORIC BUILDING RECORDING AT  
CROWN FARM, STOCKWELL GATE WEST,  
WHAPLODE, LINCOLNSHIRE.

**National Grid Reference: TF 3306 2504**  
**Planning Reference: H23-1116-21**  
**Site Code: CFWH23**  
**Accession Number: LCNCC: 2023.77**

July 2023

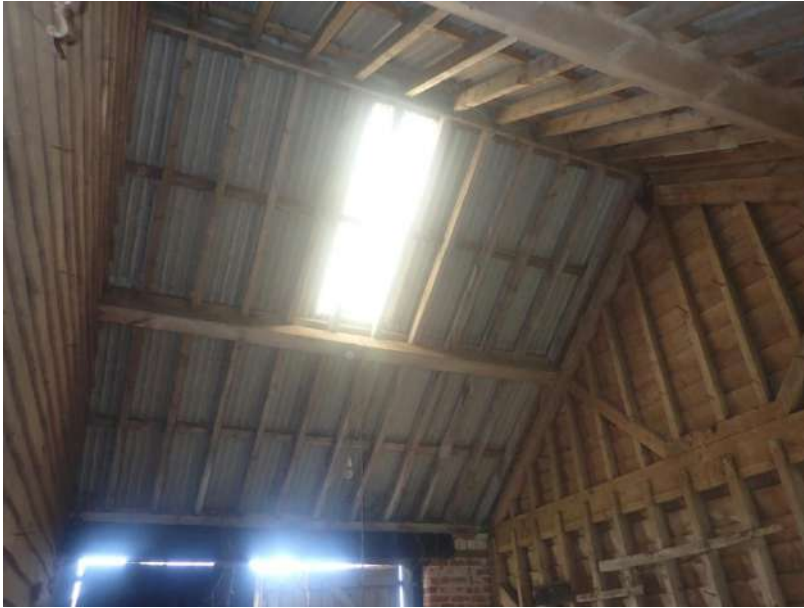
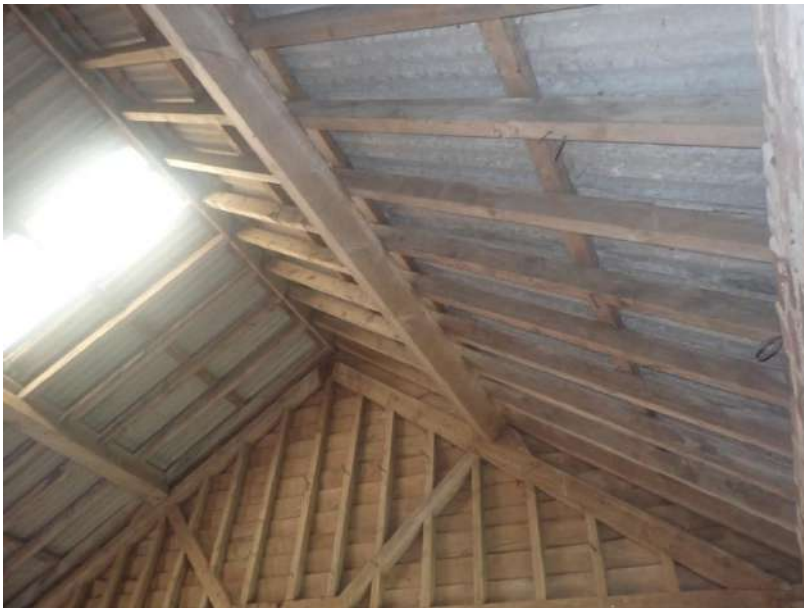
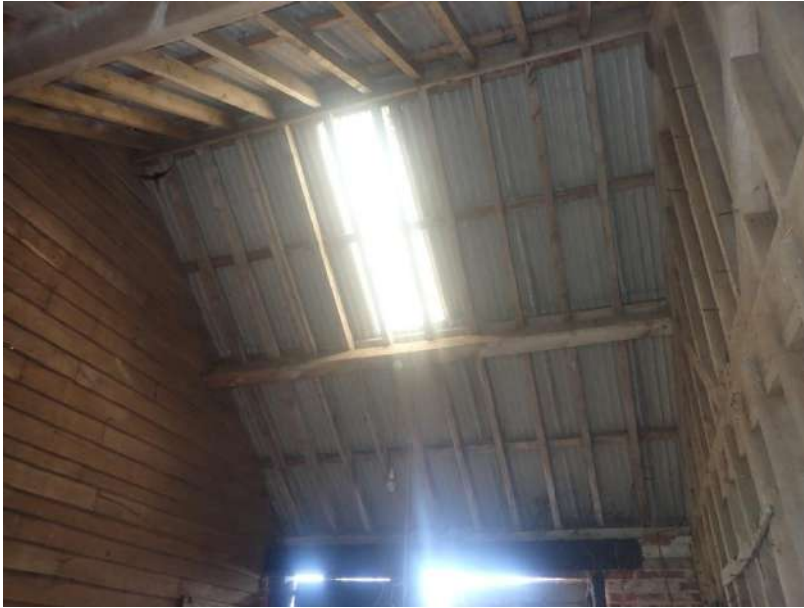
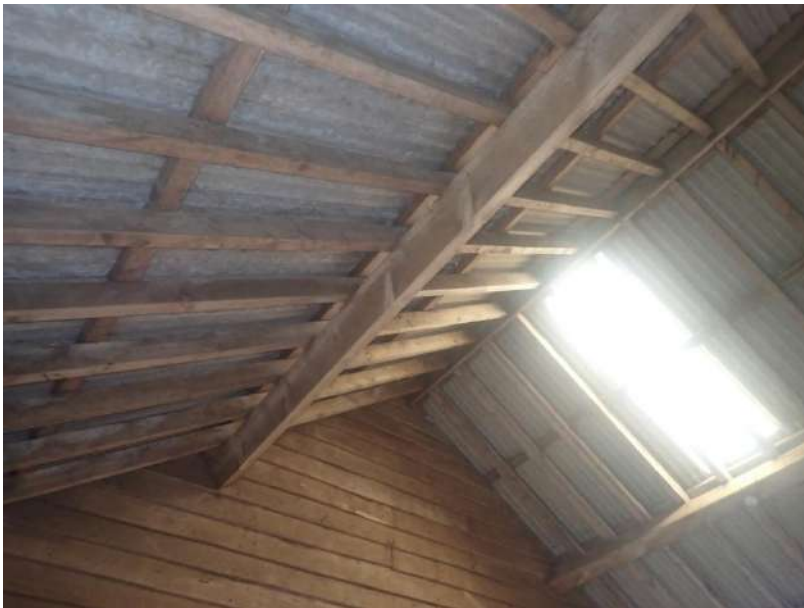
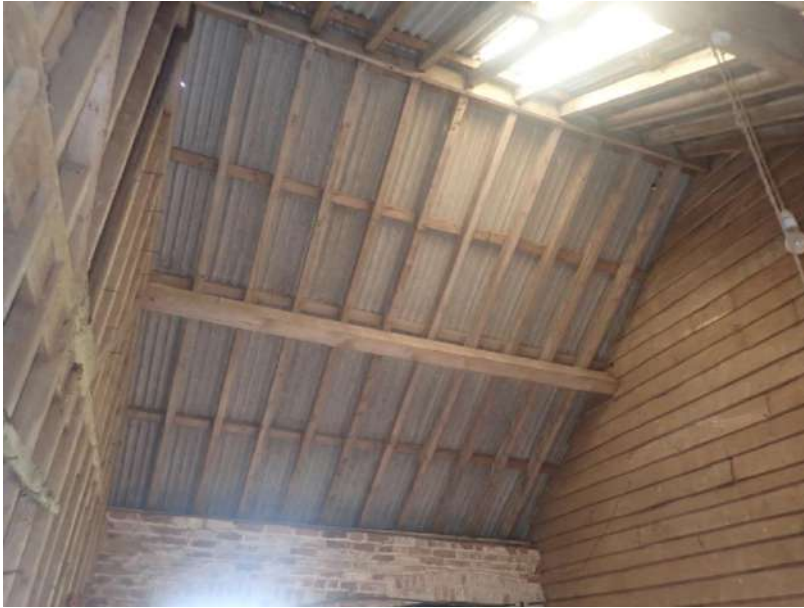
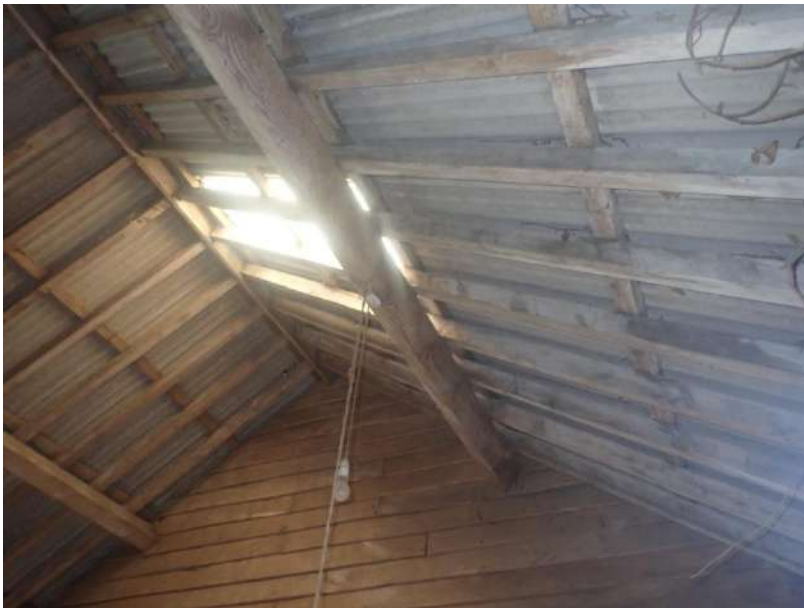
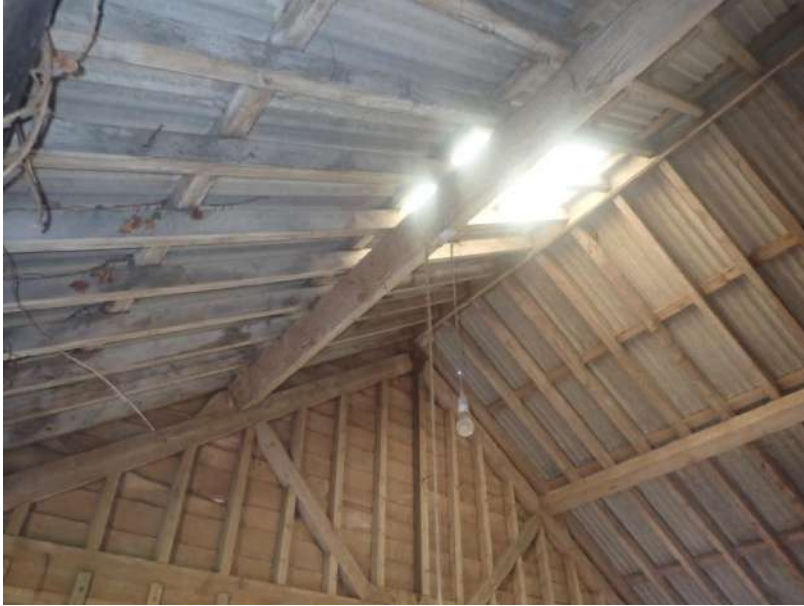
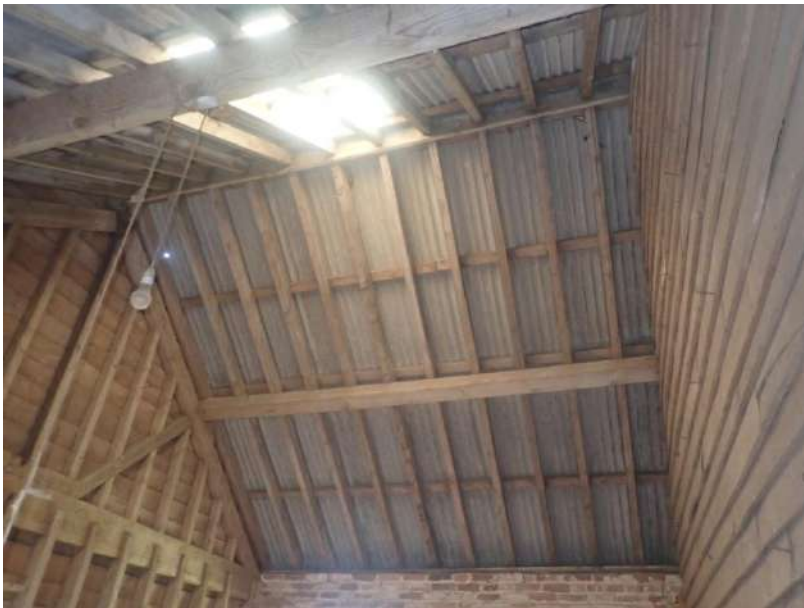
**Plates 160-167** feature a number of views of the nature of the roof supporting structure of **Cell 5**. The principal component part of this section of the roof structure is the king post roof truss, (which has had the central king post removed), which has been incorporated into the fabric of the east wall of **Cell 5**. The remainder of the roof supporting structure here is made up of a framework of timber rafters and of horizontal timber purlins that extend along both sides of this structure along with further horizontal timber purlins, which run along the roof apex.

**Plate 160: View of the roof supporting structure of Cell 5, from the south**

**Plate 161: View of the roof supporting structure of Cell 5, from the west**

**Plate 162: View of the roof supporting structure of Cell 5, from the south**

**Plate 163: View of the roof supporting structure of Cell 5, from the east**

**Plate 164: View of the roof supporting structure of Cell 5, from the north**

**Plate 165: View of the roof supporting structure of Cell 5, from the east**

**Plate 166:** View of the roof supporting structure of Cell 5, from the west

**Plate 167:** View of the roof supporting structure of Cell 5, from the north

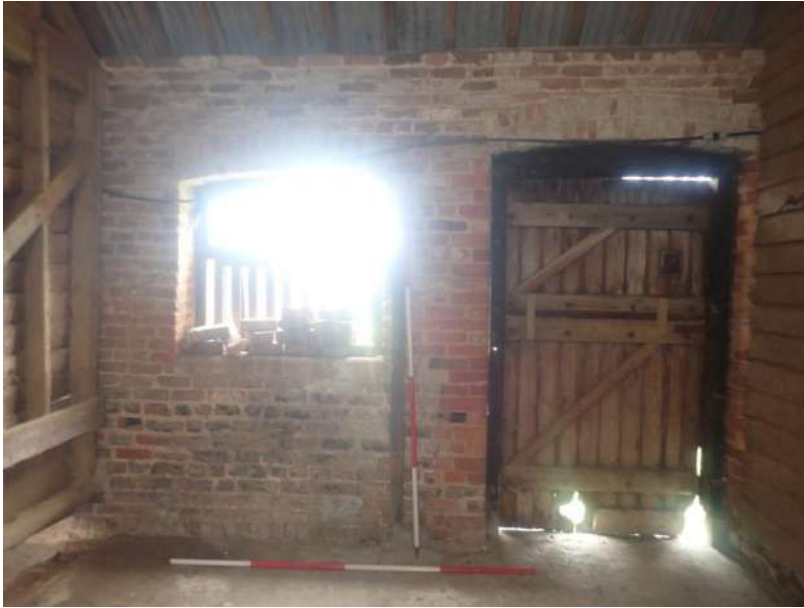
**Plate 168** furnishes a detailed view of the south wall of **Cell 5**. The brickwork wall fabric here is composed of three courses of brick stretchers that alternate with single courses of brick headers in English Garden Wall Bond. An horizontal timber wallplate may be seen to extend along the top of this south wall. The slightly recessed inner face of the south facing window opening, which was recorded externally at the South Elevation of this building may also be observed. The inner face of a south facing entrance opening, which was also recorded externally at the South Elevation of this building is also featured. The vertical tongued and grooved timber planks of the two timber half doors within this opening are attached to an internal framework of angled and horizontal timbers.

**Plate 168:** View of the south wall of Cell 5, from the north

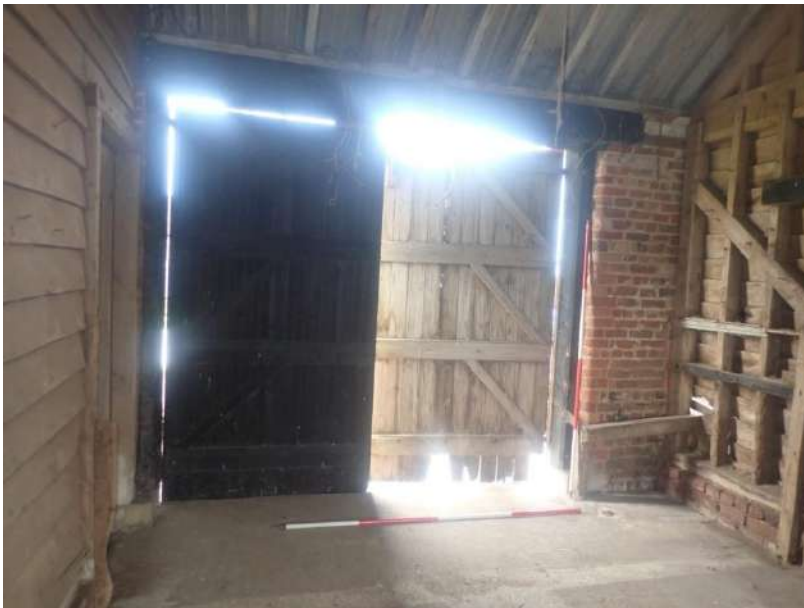
**Plate 169:** View of the north wall of Cell 5, from the south

**Plate 169** presents a detailed view of the opposing north wall of **Cell 5**. The panel of brickwork to the right (east) is composed of three courses of brick stretchers alternating with one course of brick headers in English Garden Wall Bond. Much of this north wall is occupied by the inner face of the north facing entrance opening, which was recorded externally at the North Elevation of the North Range. The tongued and grooved timber planks of the pair of doors are each attached to internal frameworks of angled and horizontal timbers. Above the opening and extending up to a horizontal timber wallplate that extends along the top of this north wall, is a substantial horizontal timber lintel.

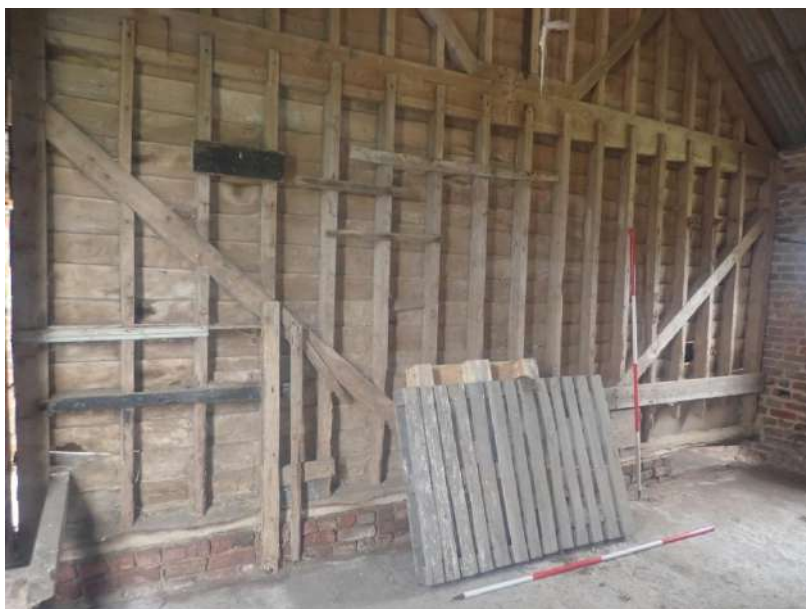
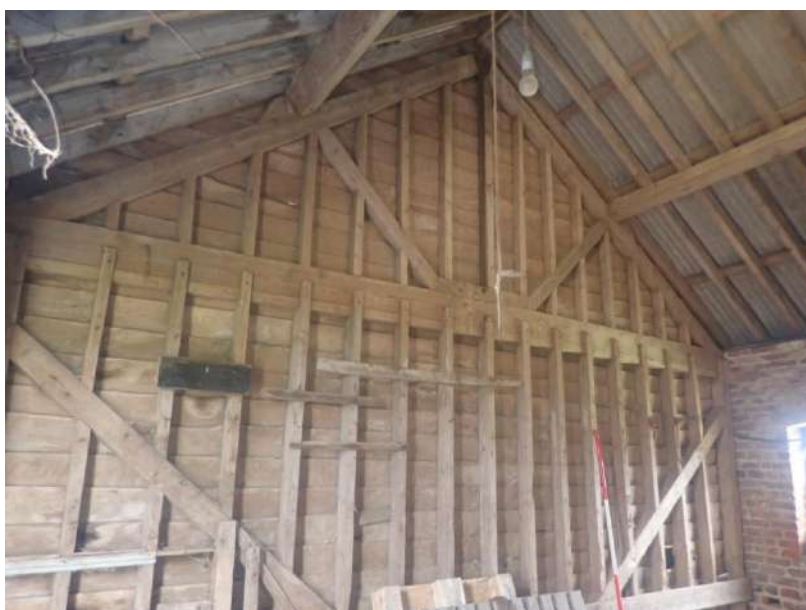
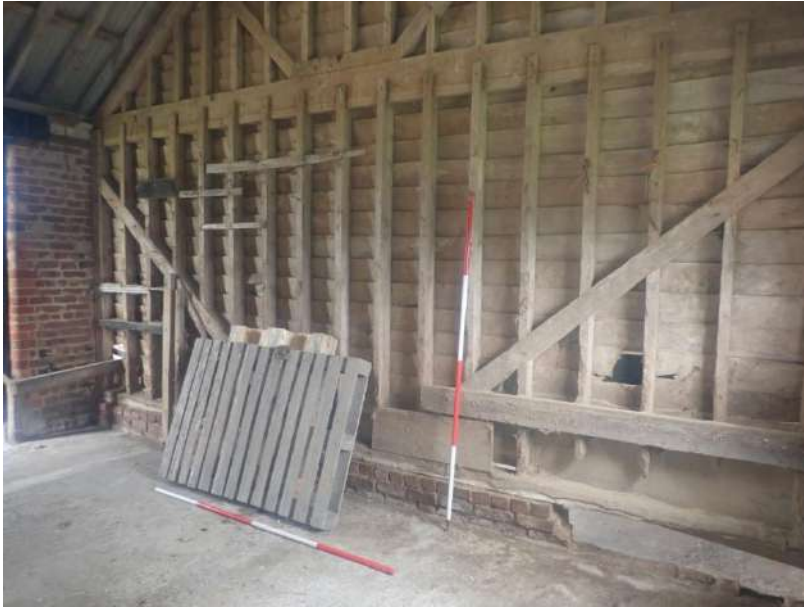
**Plate 170: View of the east wall of Cell 5, from the west**

**Plate 171: View of the east wall of Cell 5, from the west**

**Plates 170-173** provide several views of the east wall of **Cell 5**, which is also the internal dividing wall with the adjoining **Cell 4** to the east. At the upper levels of this east wall and incorporated into this wall fabric, is one of a series of king post roof trusses of the overlying roof structure of this North Range. The king post itself appears to have been removed from this truss. Otherwise the wall fabric is composed of the inner face of horizontal timber weatherboarding, which is in turn attached to an internal framework of mostly vertical along with other angled and horizontal timbers. This wall fabric rests upon a brick base which is of three visible courses in height. The uppermost course is of brick headers, whilst the two courses below this are of stretchers. The eastern ends of the horizontal timber purlins of the overlying roof structure are inserted into the uppermost levels of the wall fabric.

**Plate 172: View of the east wall of Cell 5, from the west**

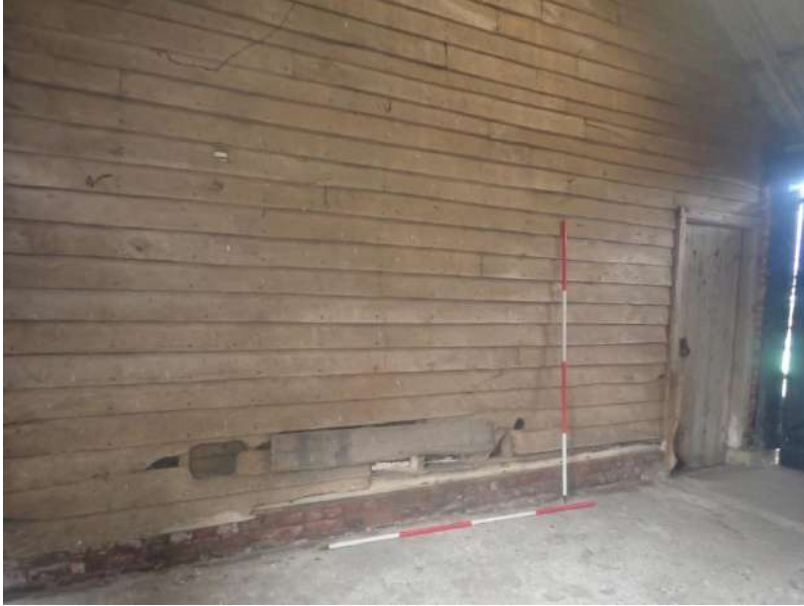
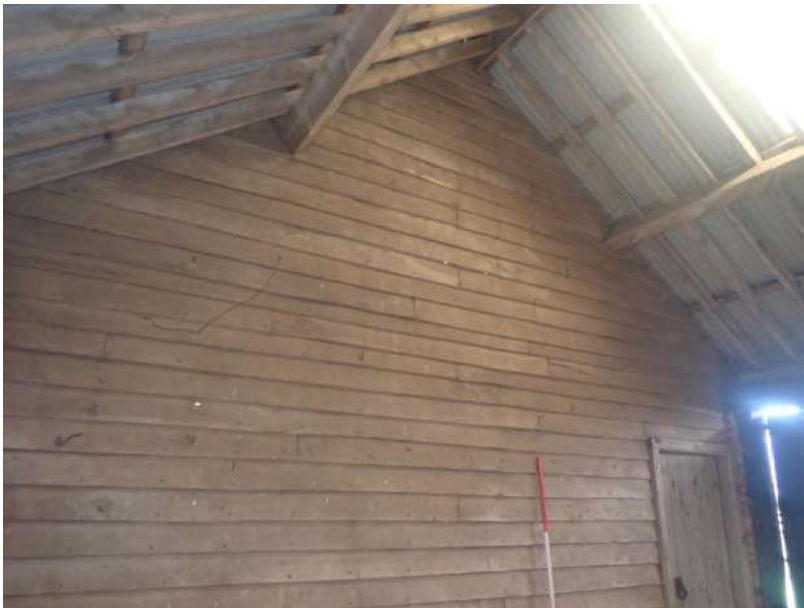
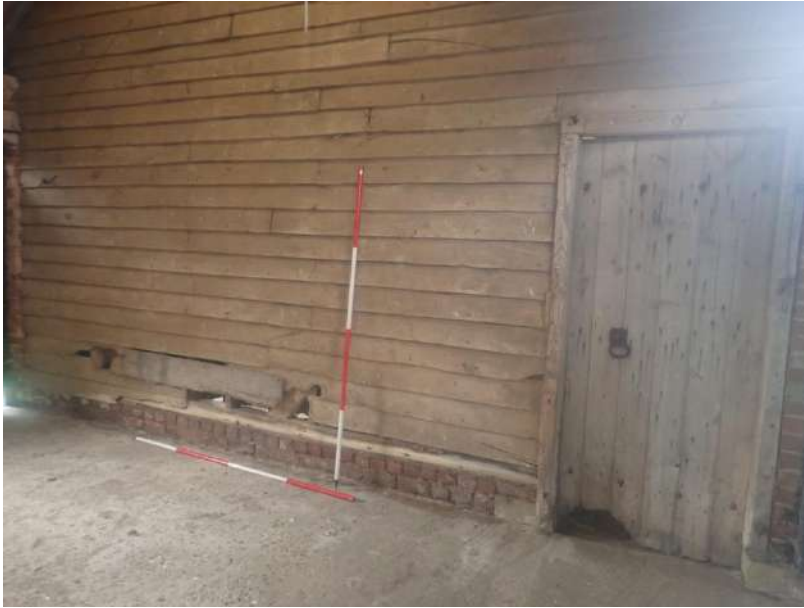
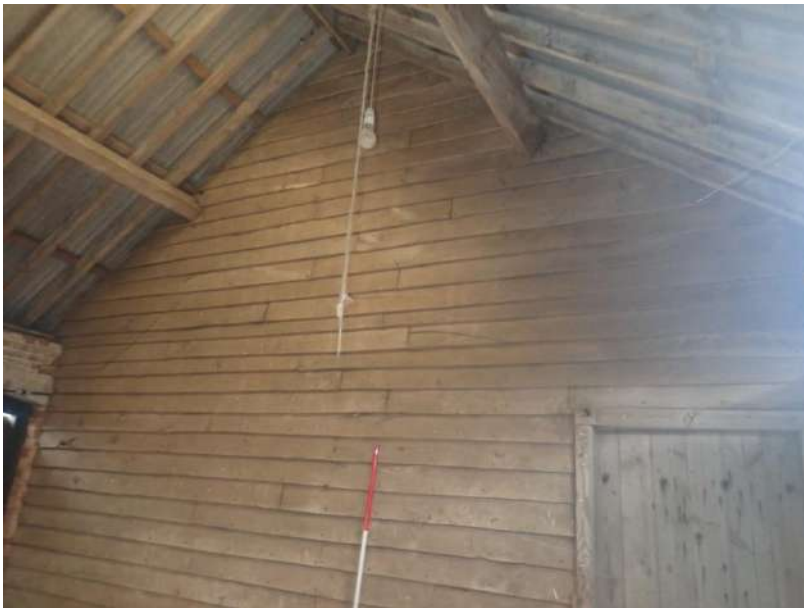
**Plate 174: View of the west wall of Cell 5, from the east**

**Plate 175: View of the west wall of Cell 5, from the east**

**Plates 174-177** present several views of the west wall of **Cell 5**, which is also the internal dividing wall within this North Range with the adjoining **Cell 6**, to the west. The wall fabric here is also composed of internal horizontal timber weatherboarding. The western ends of the horizontal timber purlins of the overlying roof structure are inserted into the uppermost levels of this wall fabric. This boarding rests upon a brick base that is composed of one course of brick headers and below this one course of brick stretchers. At the northern end of this west wall and inserted into this wall fabric is a wrest facing entrance opening. This opening is occupied by a timber frame of a head and surrounds and by a timber door that is made up of a series of vertical tongued and grooved timber planks.

**Plate 176: View of the west wall of Cell 5, from the east**

**Plate 177: View of the west wall of Cell 5, from the east**

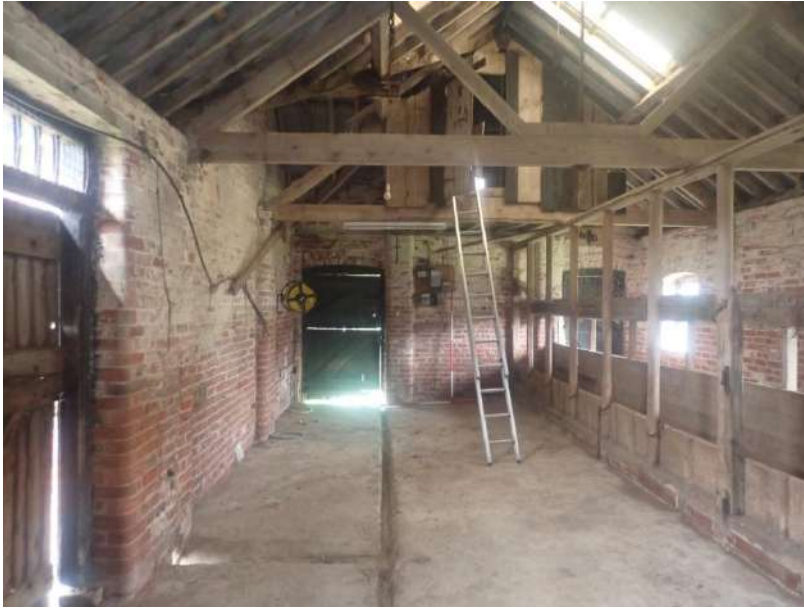
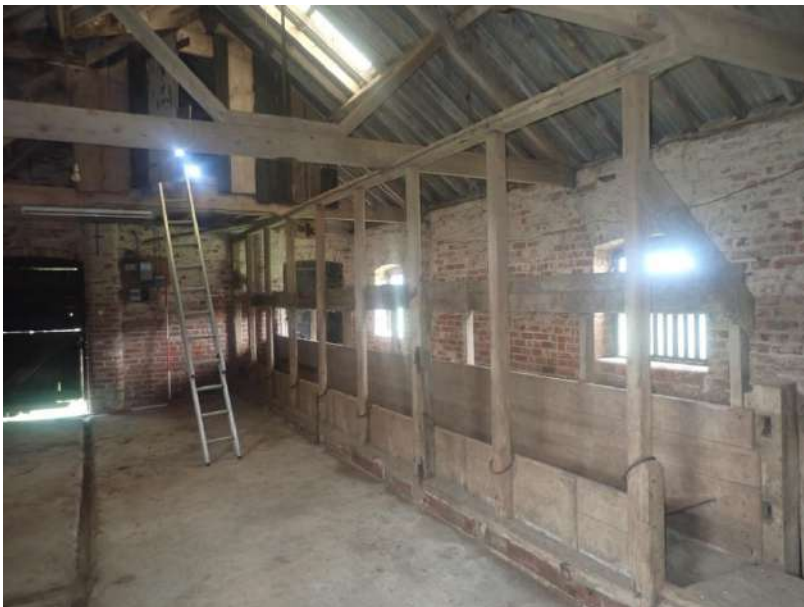
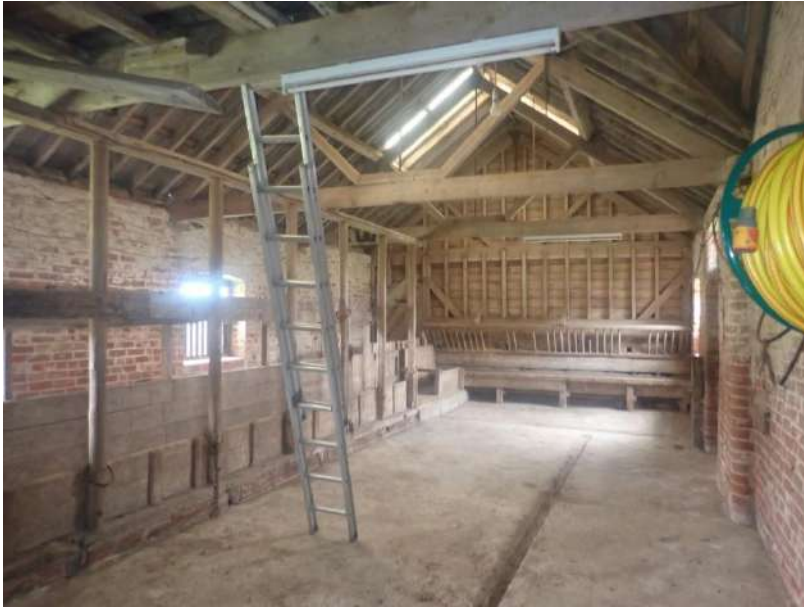
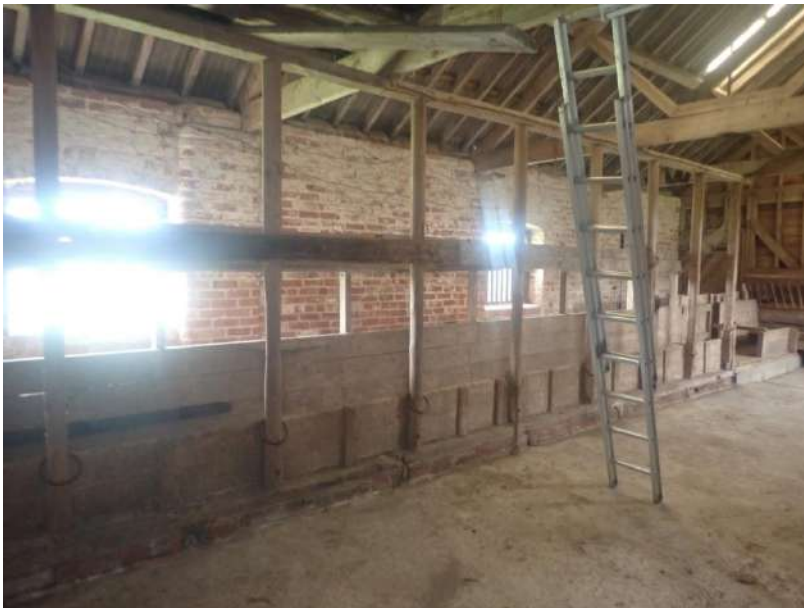
**Plate 178: General view of the interior of Cell 6, from the east**

**Plate 179: General view of the interior of Cell 6, from the east**

**Plates 178-181** provide general views of the interior of **Cell 6** from both eastern and western vantage points.

**Plate 180: General view of the interior of Cell 6, from the west**

**Plate 181: General view of the interior of Cell 6, from the south-west**

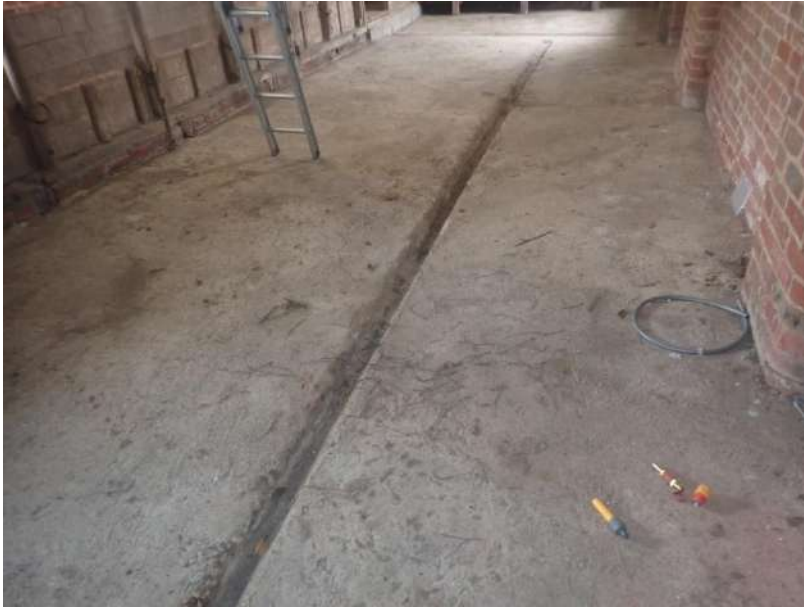
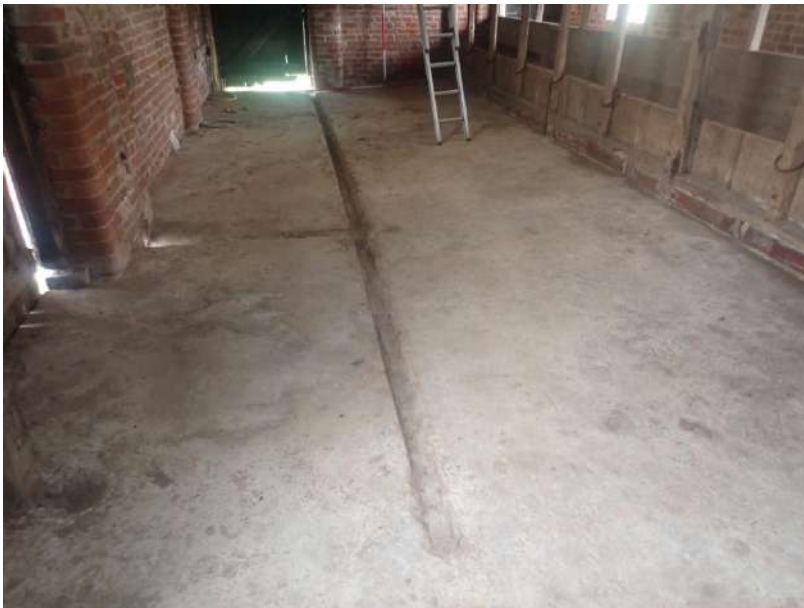
**Plates 182 and 183** feature the nature of the flooring of **Cell 6**, which is of modern concrete and which is on two slightly different levels.

**Plate 182: View of the flooring of Cell 6, from the west**

**Plate 183: View of the flooring of Cell 6, from the east**

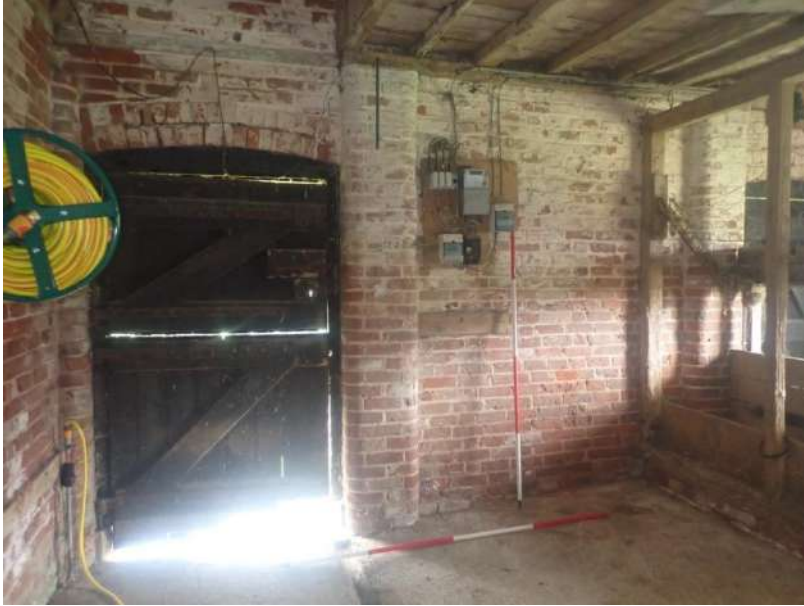
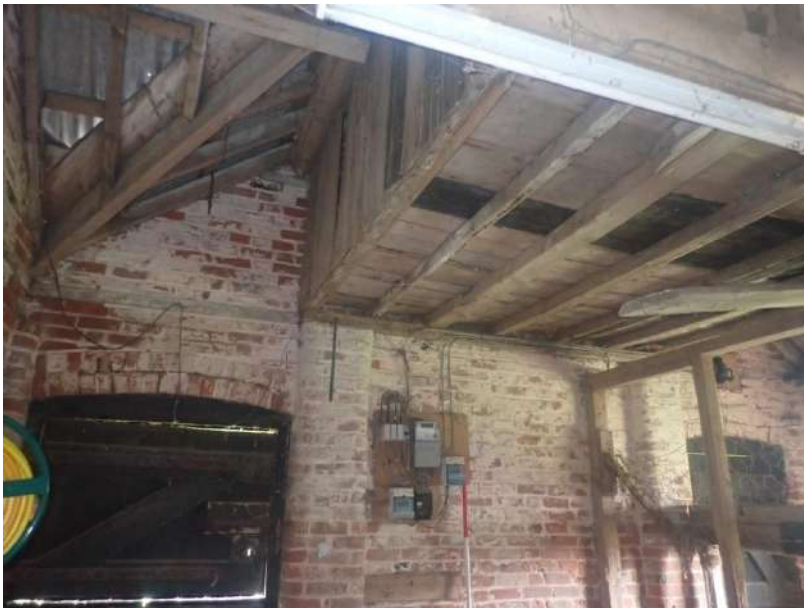
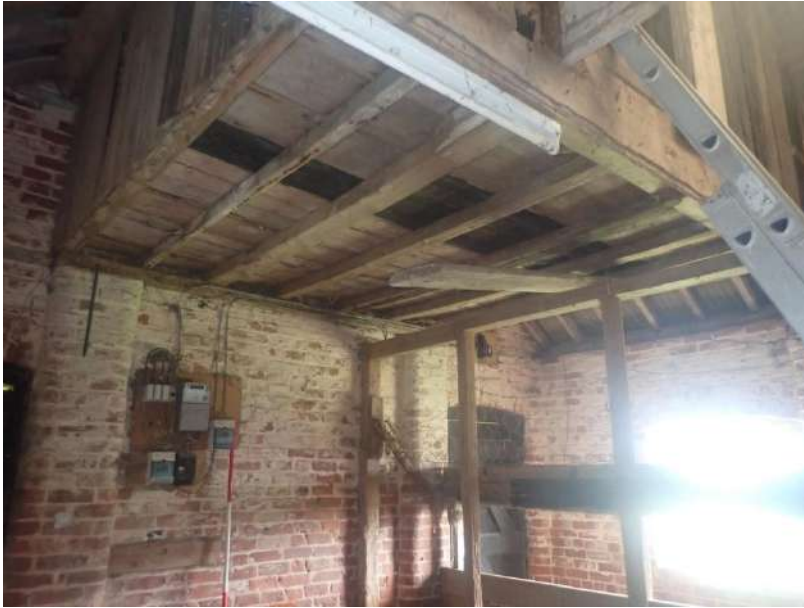
**Plate 184: View of the west wall of Cell 6, from the east**

**Plate 185: View of the west wall of Cell 6, from the east**

**Plates 184-186** furnish several views of the southern portion of the west wall of **Cell 6**. The brickwork wall fabric here is composed of courses of mixed brick headers and brick stretchers in a variation of Flemish Bond. An horizontal timber wallplate may be seen to be incorporated into this brickwork wall fabric at mid levels. To the left (south) and which is flanked to the right (north) by a vertical brick column, (which is composed of courses of a mix of brick stretchers and of bull nosed brick stretchers), is the inner face of a west facing entrance opening that was recorded externally at the West Elevation of this North Range. The two timber half doors are affixed to an internal framework of angled and horizontal timbers.

**Plate 186: View of the west wall of Cell 6, from the south-east**

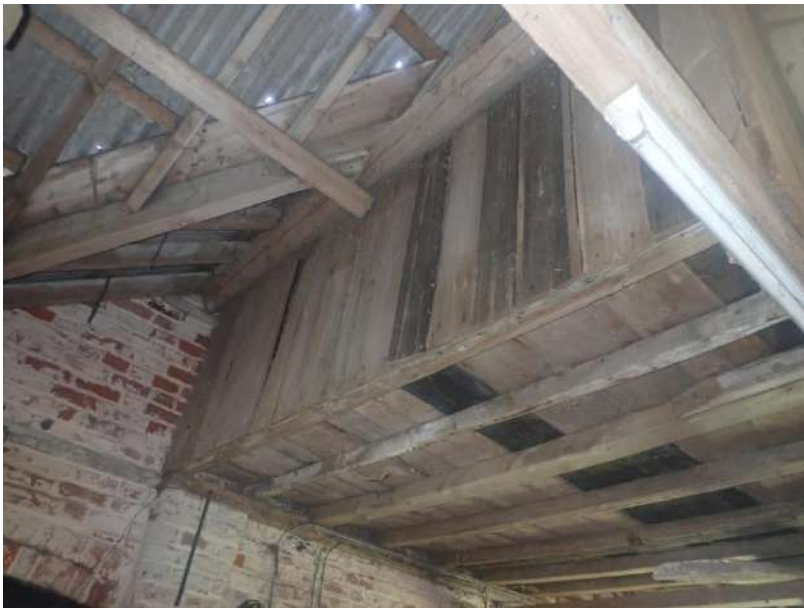
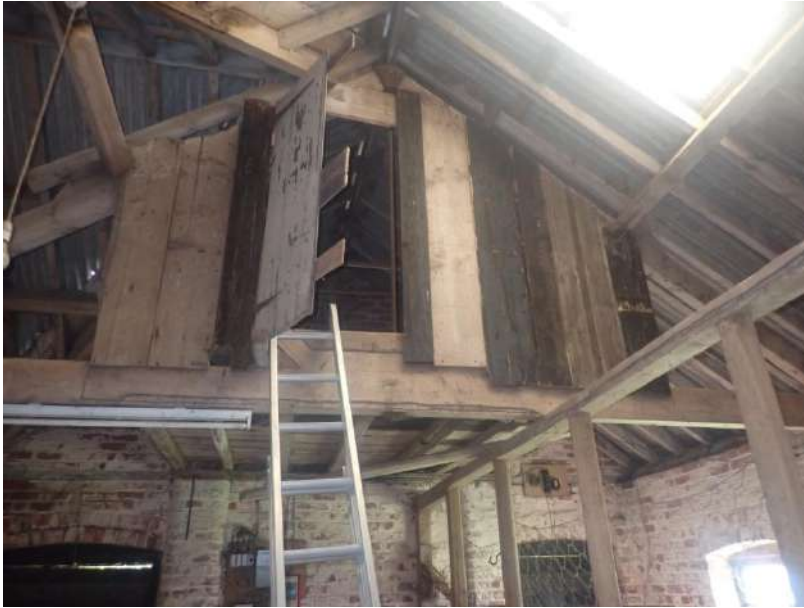
**Plate 187: View of the former dovecote attached to the west wall of Cell 6, from the south-east**

**Plates 187-189** present several views of a timber box-like structure that is attached to the upper levels of this west wall to the west and to a king post roof truss to the east. It was noted earlier that there is a triangular shaped arrangement of small ventilation apertures at the upper levels of the external West Elevation of this North Range here associated with a possible dovecote. It is considered that this timber structure may perhaps have a former dovecote itself. This is a relatively simple timber box like structure with a flat base and two sides. The base is composed of a series of horizontal timbers, the ends of which are inserted into the west wall to the west and into a king post roof truss to the east with a timber floor of horizontal planking attached to these timbers. The sides are made up of a series of further timber planks, which are attached to the roof rafters and to the roof truss. The dovecote is accessed via small timber door to the east.

**Plate 188:** View of the former dovecote attached to the west wall of Cell 6, from the east

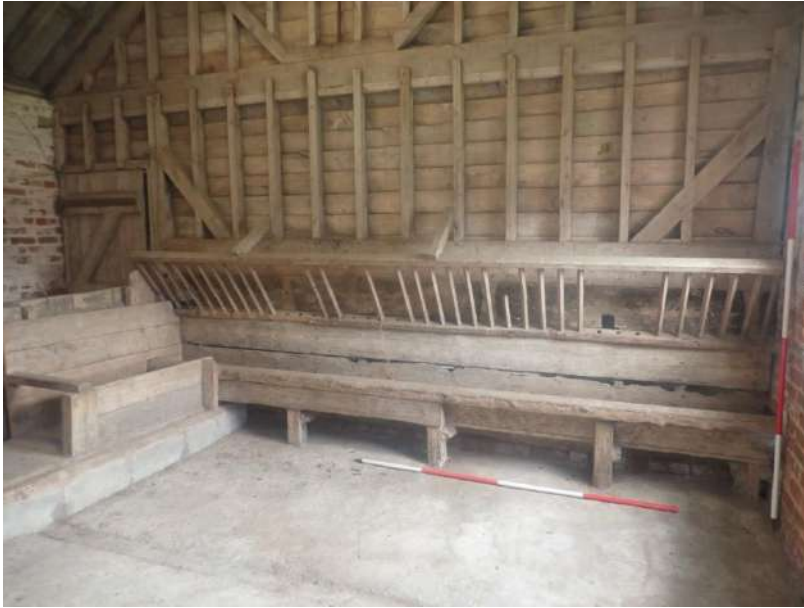
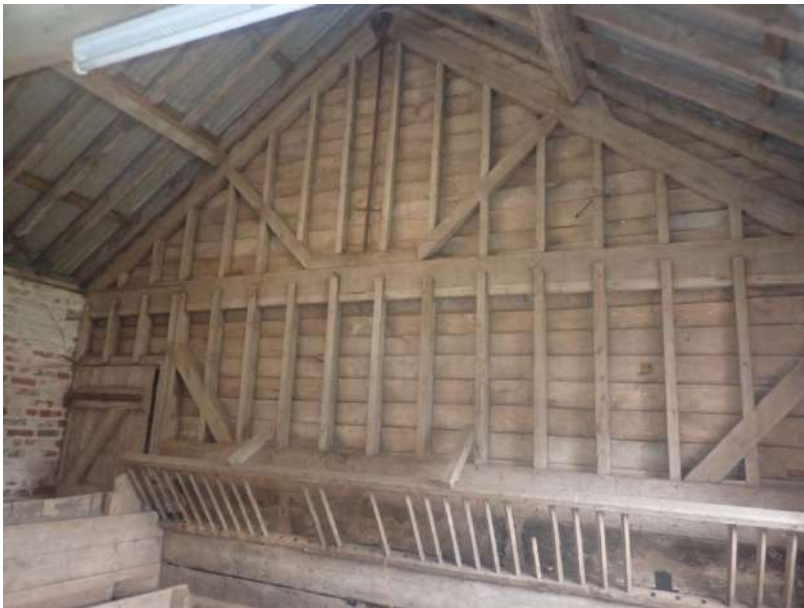
**Plates 190 and 191** present views of the east wall of **Cell 6**, which is also the internal dividing wall within the interior of the North Range with the adjoining **Cell 5** to the east. Featured is the inner face of the horizontal timber weatherboarding, which comprises the fabric of this east wall. These horizontal timbers are attached to an internal framework composed of one of the king post timber roof trusses along with a further series of vertical timbers. At the lower levels of this east wall and attached to it, is a timber animal feed byre and below this and at floor levels is a part of low level timber feed trough. It is considered that this testifies to a probable former dual use of **Cell 6**, latterly as an animal shelter, possibly for sheep given the low level nature of the food trough and perhaps also to an earlier use as a horse stable as proven by the feed byre and the timber half doors on the South Elevation of **Cell 6**.

**Plate 190: View of the east wall of Cell 6, from the west**

**Plate 191: View of the east wall of Cell 6, from the west**

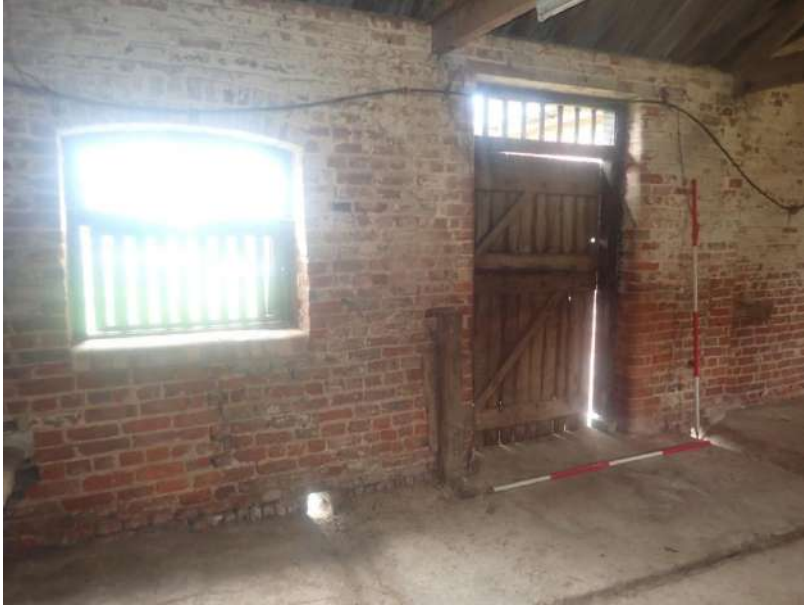
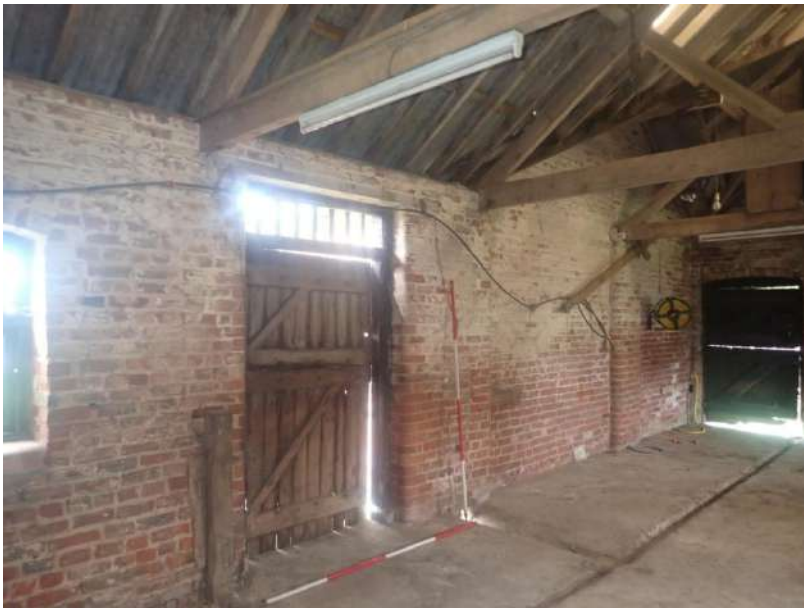
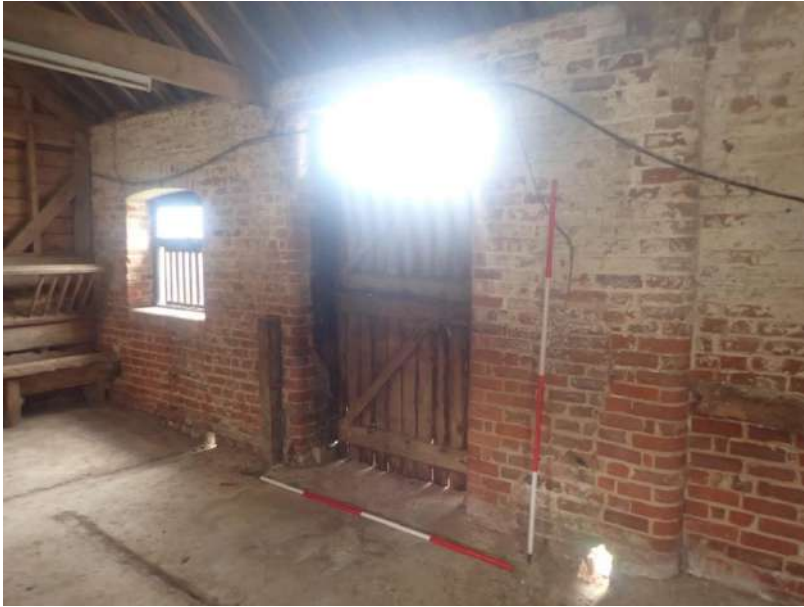
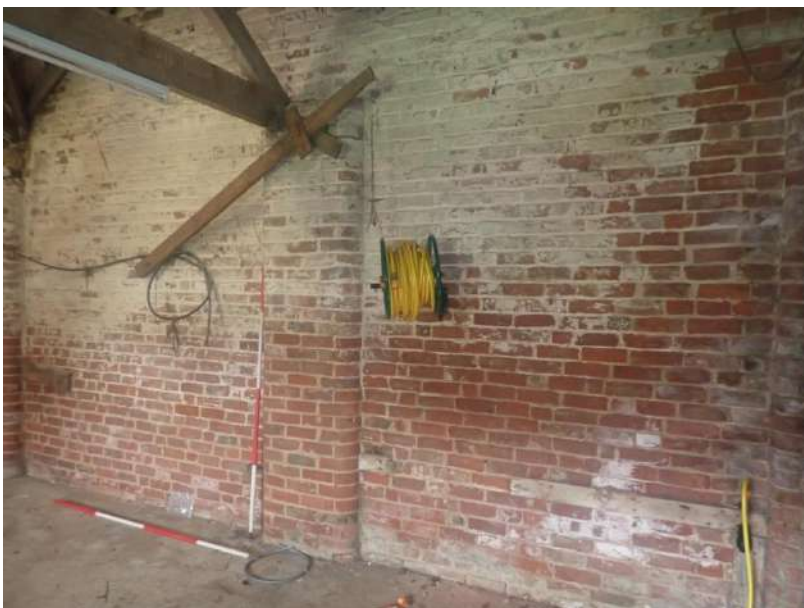
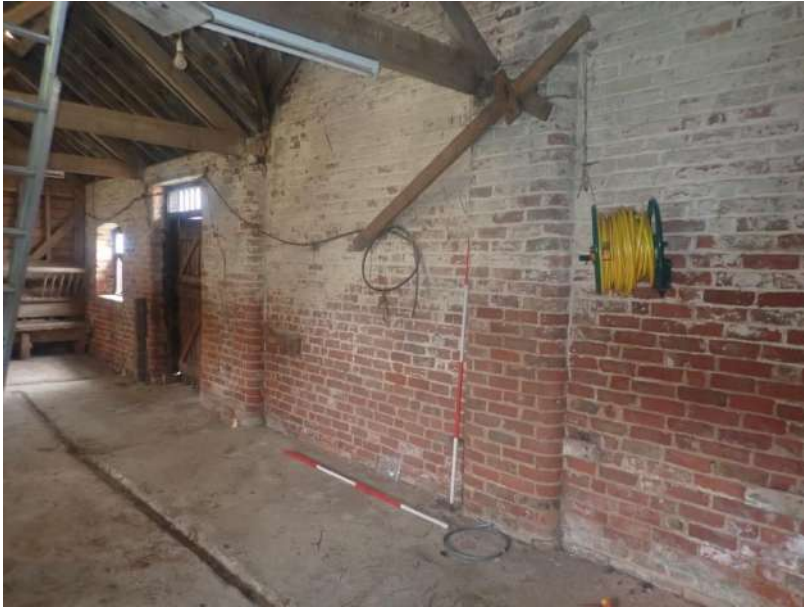
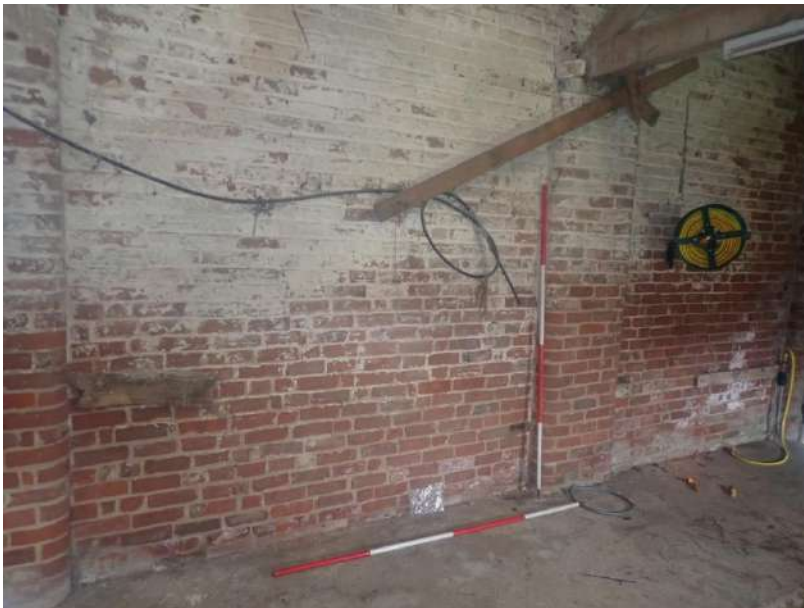
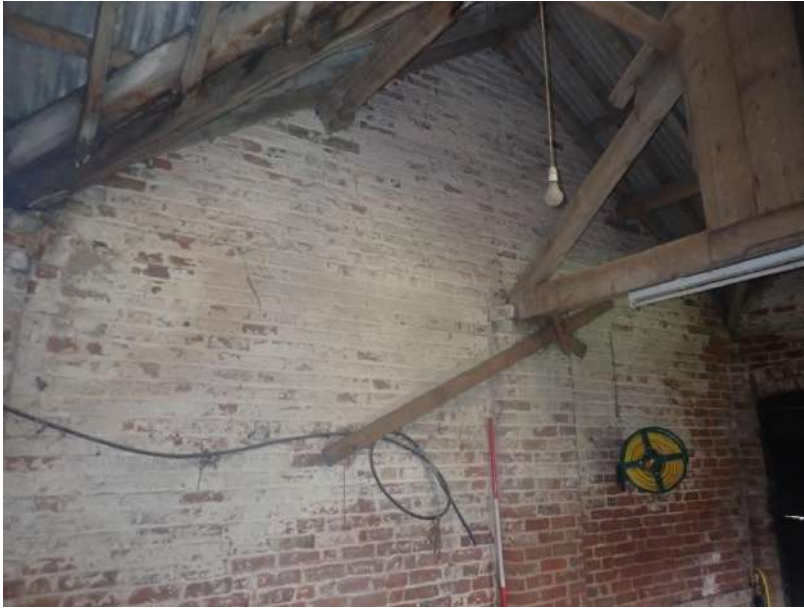
**Plate 192: View of the south wall of Cell 6, from the east**

**Plate 193: View of the south wall of Cell 6, from the east**

**Plates 192-198** present a number of views from different vantage points of the south wall of **Cell 6**. The brickwork of this south wall is composed of two different brickwork bonds. Though this difference in the brickwork bonding here is not apparent externally at the South Elevation. This Flemish bonding is considered to be a later alteration. To the left (east) of the south facing entrance opening, the brickwork here is in English Garden Wall Bond, composed of three courses of brick stretchers alternating with single courses of brick headers. By contrast, to the west (right) of the entrance opening, the brickwork here is in a variation of Flemish Bond, composed of courses of mixed brick headers and brick stretchers.

At the eastern end of this south wall is the slightly recessed inner face of a south facing window opening that was recorded externally at the South Elevation of this North Range. To the right (west) of this is one of the south facing entrance openings that was also recorded externally at

this South Elevation. This entrance is also slightly recessed. Featured are the inner faces of the two timber half doors, each of which are attached to internal frameworks of angled and horizontal timbers. Above the opening and incorporated into the brickwork wall fabric here is an horizontal timber lintel. To the immediate right (west) of this entrance opening and bonded to the brickwork is a wide vertical column in Flemish Bond. Further to the right (west) of this first column, is a second and narrower vertical column in brick, which is also bonded to this south wall, which is composed of courses of mixed brick stretchers and of bull nosed brick stretchers. A series of horizontal timber wallplates may be seen to extend along the top of the eastern portion of this south wall. It should also be noted that the western portion of this south wall is also an internal dividing wall with the bonded and adjoining northern portion of the West Range to the south with wallplates being absent here.

**Plate 194: View of the south wall of Cell 6, from the north-west**

**Plate 195: View of the south wall of Cell 6, from the north-west**

**Plate 196: View of the south wall of Cell 6, from the north-west**

**Plate 197: View of the south wall of Cell 6, from the north-east**

**Plate 198: View of the south wall of Cell 6, from the north-east**
