**NEVILLE HALL  
FREELANCE ARCHAEOLOGIST & CONSULTANT**

HISTORIC BUILDING RECORDING AT  
CROWN FARM, STOCKWELL GATE WEST,  
WHAPLODE, LINCOLNSHIRE.

**National Grid Reference: TF 3306 2504**  
**Planning Reference: H23-1116-21**  
**Site Code: CFWH23**  
**Accession Number: LCNCC: 2023.77**

July 2023

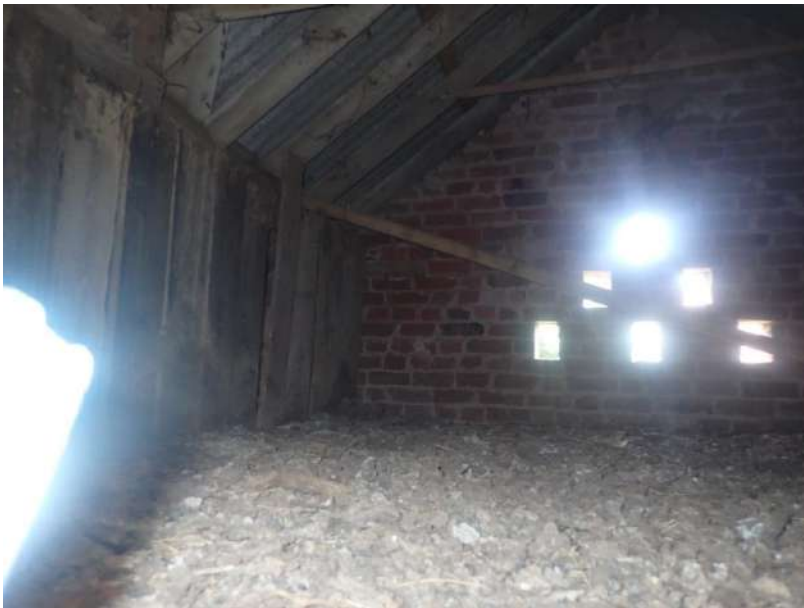
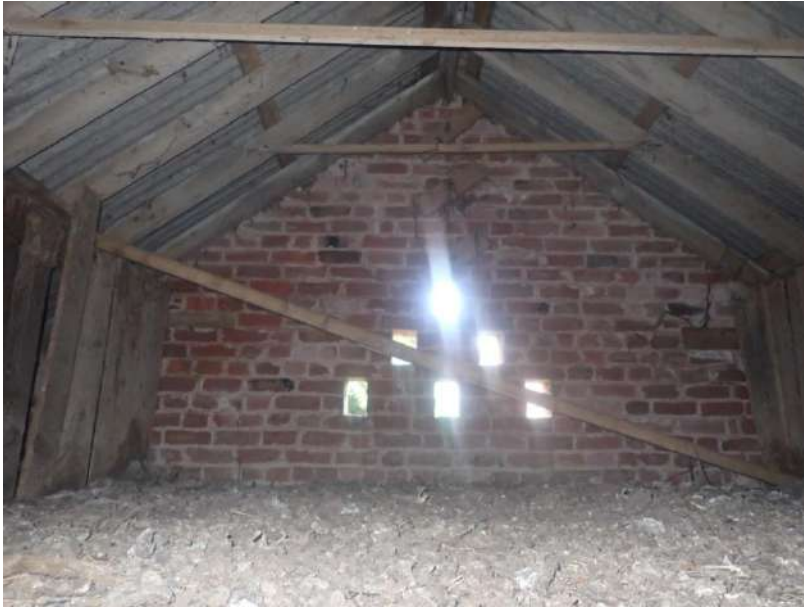
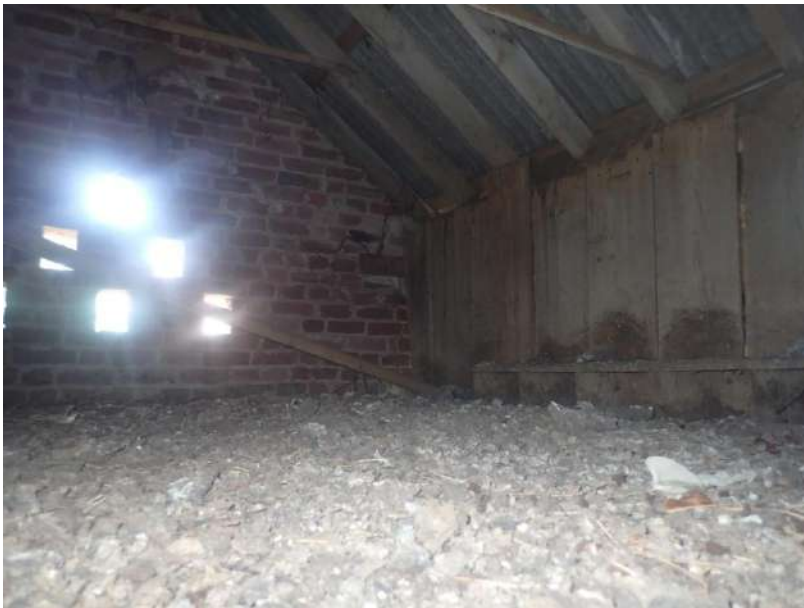
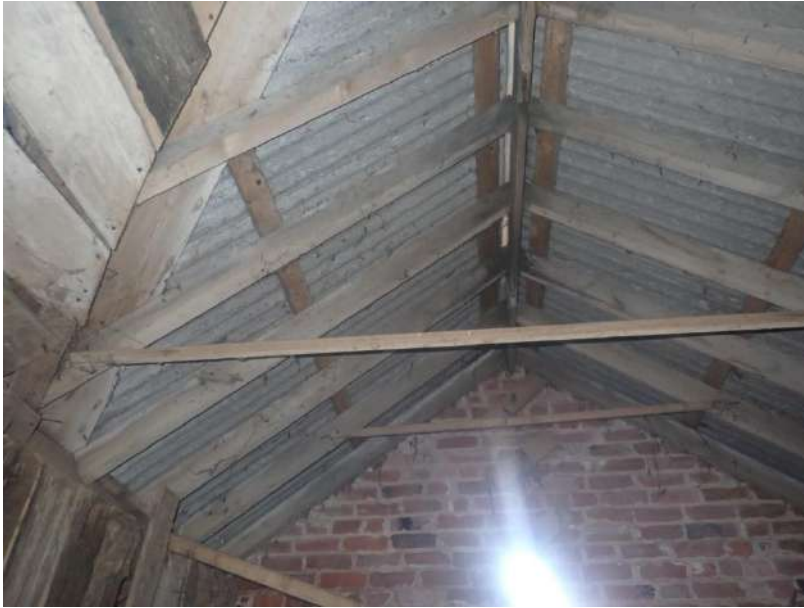
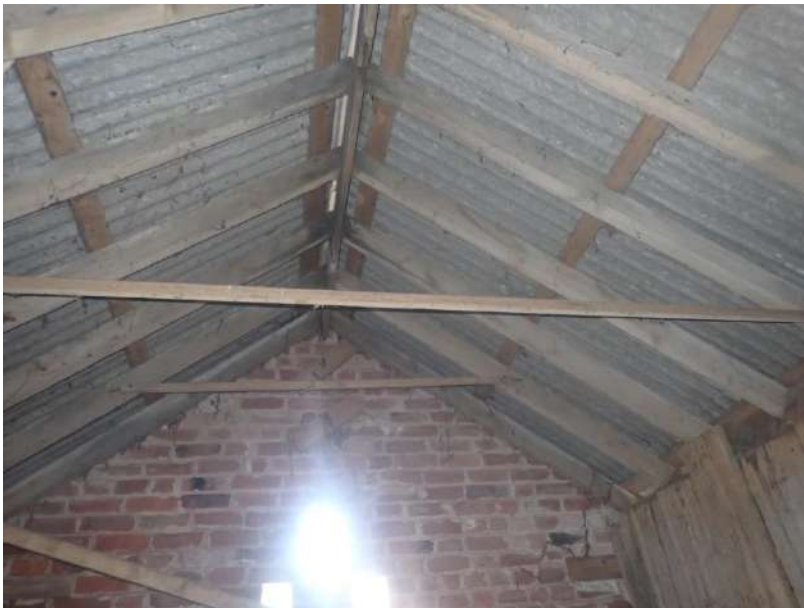
**Plate 199: View of the interior of the former dovecote, from the east**

**Plates 199-203** present a number of views of the interior of the dovecote, with its timber floor and sides. Also featured are the inner faces of the triangular shaped arrangement of small ventilation apertures that were recorded externally at the West Elevation of this North Range along with the brickwork, which also represents part of the upper levels of the west wall of **Cell 6**. The brickwork here is in English Bond. The roof of this dovecote is formed by the apex of the roof supporting structure at the western end of this North Range.

**Plate 200: View of the interior of the former dovecote, from the east**

**Plate 201: View of the interior of the former dovecote, from the east**

**Plate 202: View of the interior of the former dovecote, from the east**

**Plate 203: View of the interior of the former dovecote, from the east**

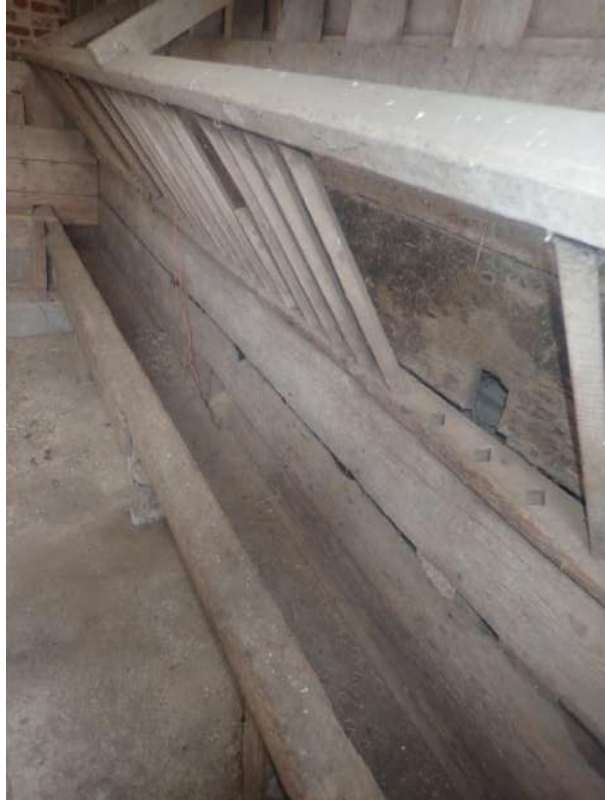
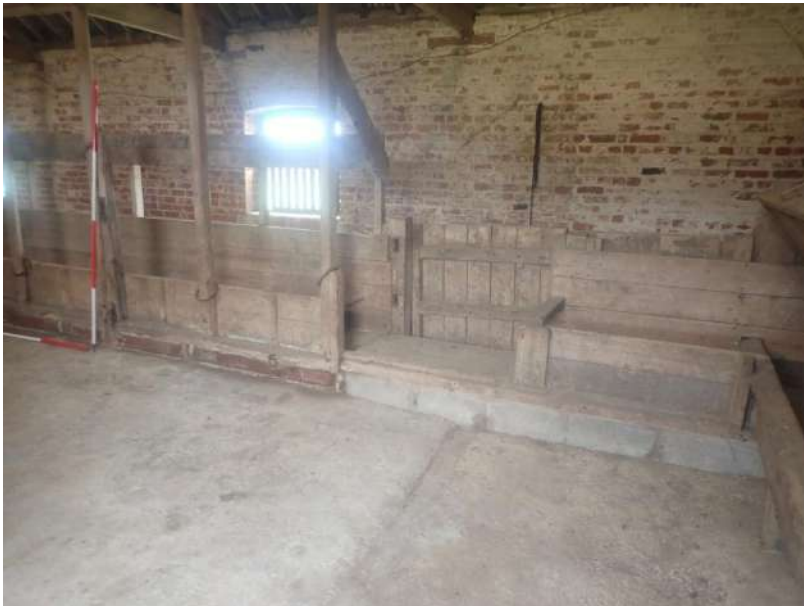
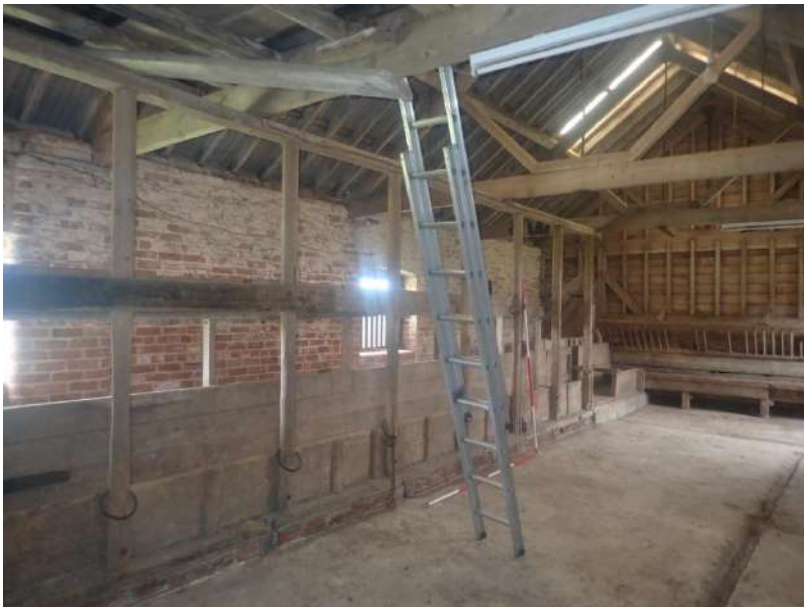
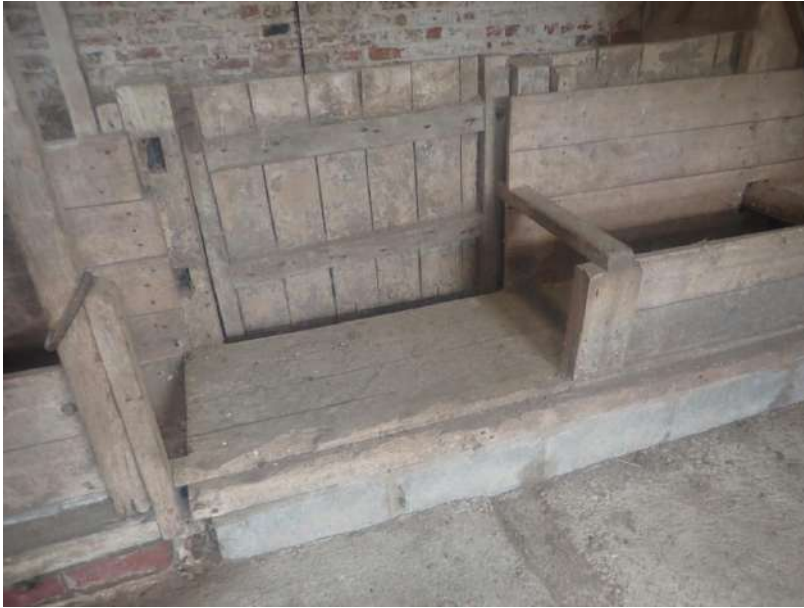
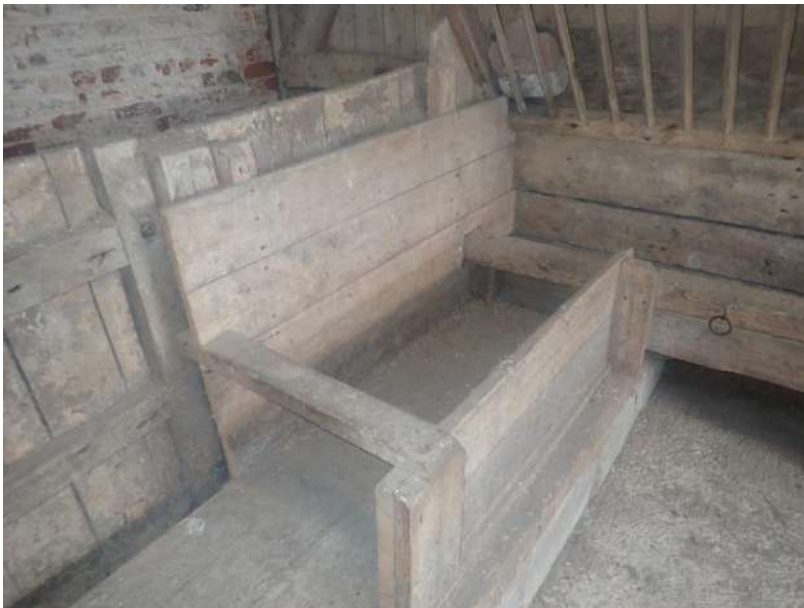
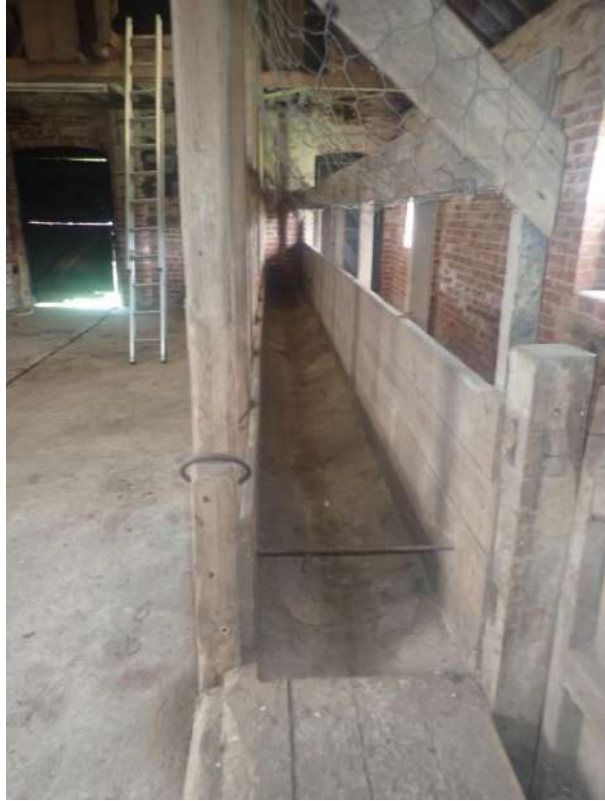
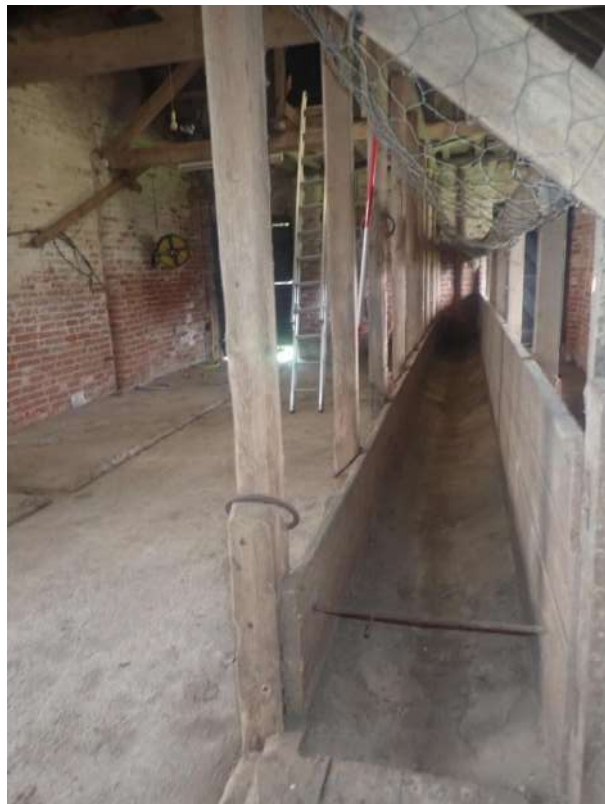
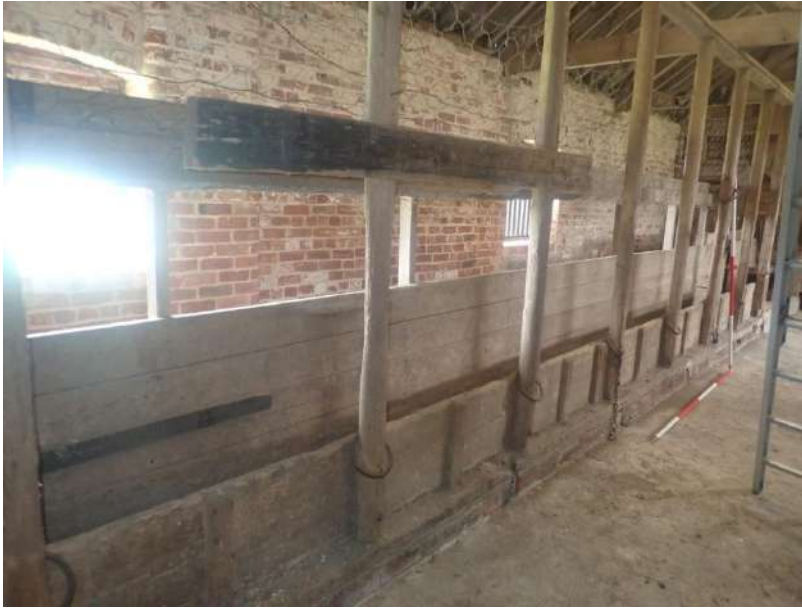
**Plate 204: View of the low animal feed trough at the east wall of Cell 6, from the south**

**Plate 205: View of the low animal feed trough, from the south-east**

**Plates 204-213** furnish a number of images from differing positions of the low animal timber feed trough, which was presumably used for the feeding of sheep, and which was noted extending along the base of the east wall of **Cell 6**. This trough turns at right angles and thence extends along the northern side of **Cell 6**, terminating at the west wall. This feed trough has a timber base and sides of horizontal timber planking. The northern side is attached to a lower level fence made up of a series of vertical timber posts, that are sunk into the concrete flooring and are topped with a horizontal timber hand rail. The southern side of the trough is also attached to a series of further vertical timber posts that are also sunk into the concrete flooring. The whole trough appears to be constructed in turn on a brick base of which one course of brick stretchers is visible above the concrete flooring. The upper ends of the vertical posts on the southern side are affixed to a higher horizontal timber rail that is affixed to the roof trusses of the overlying roof structure. At the eastern end of this trough is a low timber gate, that is composed of a series of vertical timber planks that are attached to an inner framework of several horizontal timbers. This low gate provides access into the interior of **Cell 6**, from the east-west orientated passageway that extends along the northern side of **Cell 6**. It may also be observed that there are a series of circular metal tethering rings attached to the vertical timber posts of the southern side of the feed trough.

**Plate 208: View of the low animal feed trough, from the south-west**

**Plate 209: View of the low animal feed trough, from the south**

**Plate 210: View of the low animal feed trough, from the west**

**Plate 211: View of the low animal feed trough, from the east**

**Plate 212: View of the low animal feed trough, from the east**

**Plate 213:** View of the low animal feed trough, from the west

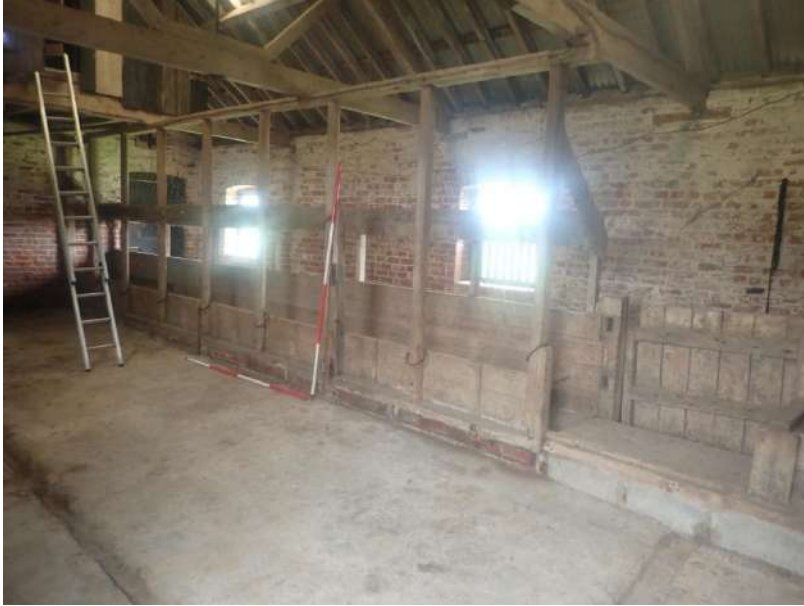
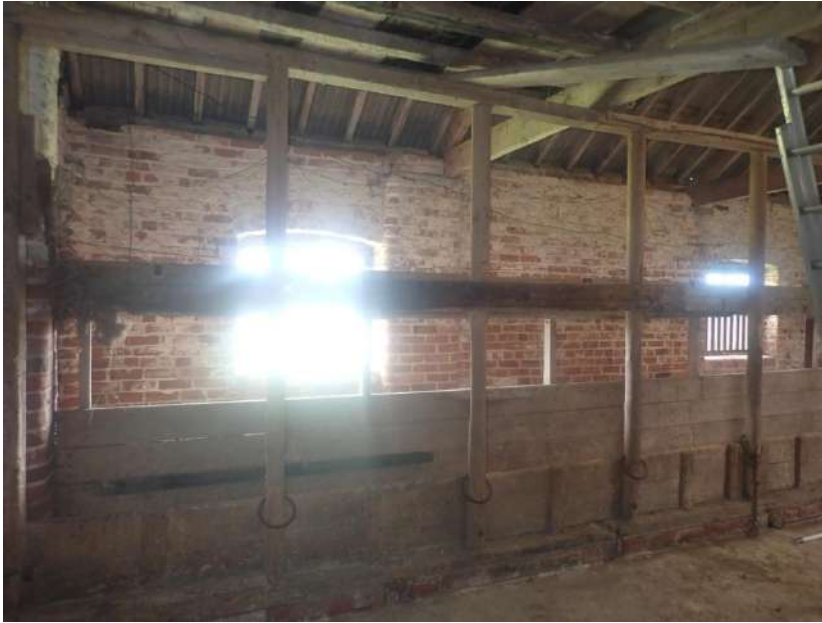
**Plate 206: View of the low animal feed trough, from the south-east**

**Plate 207: View of the low animal feed trough, from the south**

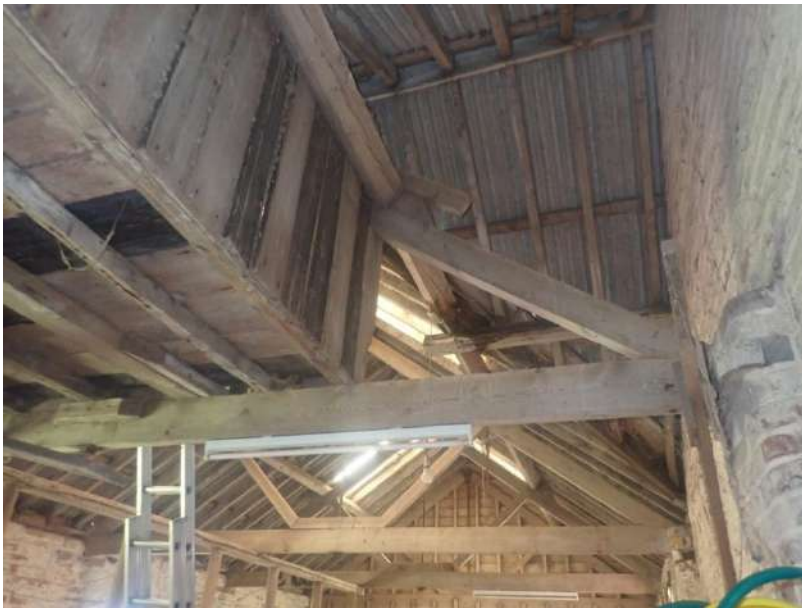
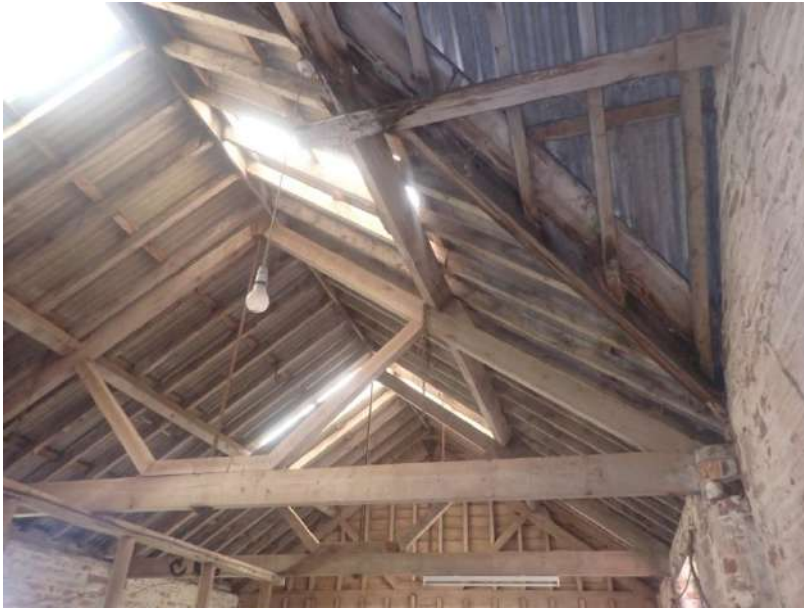
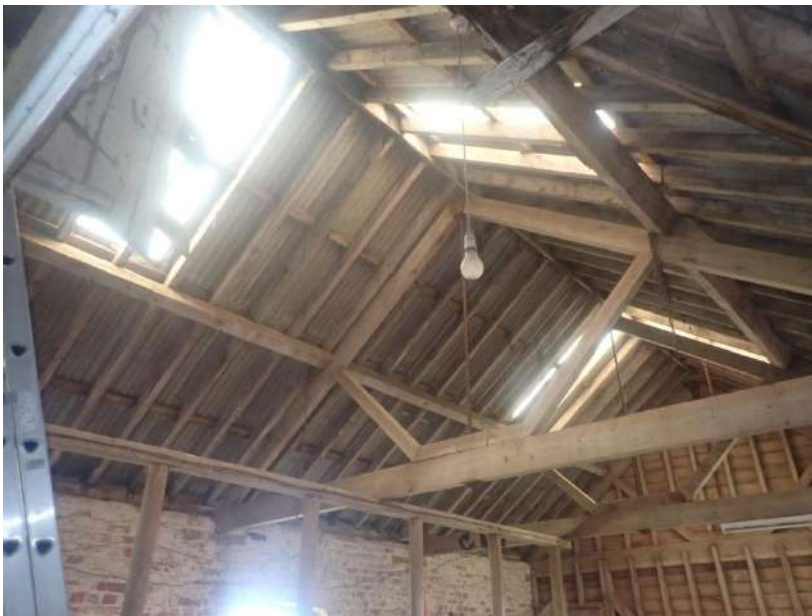
**Plate 214:** View of the roof supporting structure of Cell 6, from the west

**Plates 214-229** furnish a number of views from different vantage points of the nature of the roof supporting structure of **Cell 6**, and hence of the western end of the North Range. The main component parts of the roof supporting structure at this western end comprise a series of three king post timber roof trusses, from which the timber king posts appear to have been removed. The ends of the tie beams of the roof trusses are inserted into the upper levels of the north and south walls of **Cell 6**. The remainder of this roof structure is composed of a framework of timber rafters and horizontal timber purlins that extend along both sides of this structure along with further horizontal timber purlins that run along the roof apex. The roof trusses are also affixed to the timber purlins.

**Plates 214-215, 222-223, 226 and 228-229** also feature the intersection with or merging of the gabled roof structure of the bonded and adjoining West Range with that of the gabled roof

structure of this North Range. The detail of the northern end of the gabled roof structure of the West Range (which will be discussed in more detail later) is featured and terminates with the two principal and angled end rafters, which in turn form part of the gabled roof structure of this North Range.

**Plate 215: View of the roof supporting structure of Cell 6, from the west**

**Plate 216: View of the roof supporting structure of Cell 6, from the west**

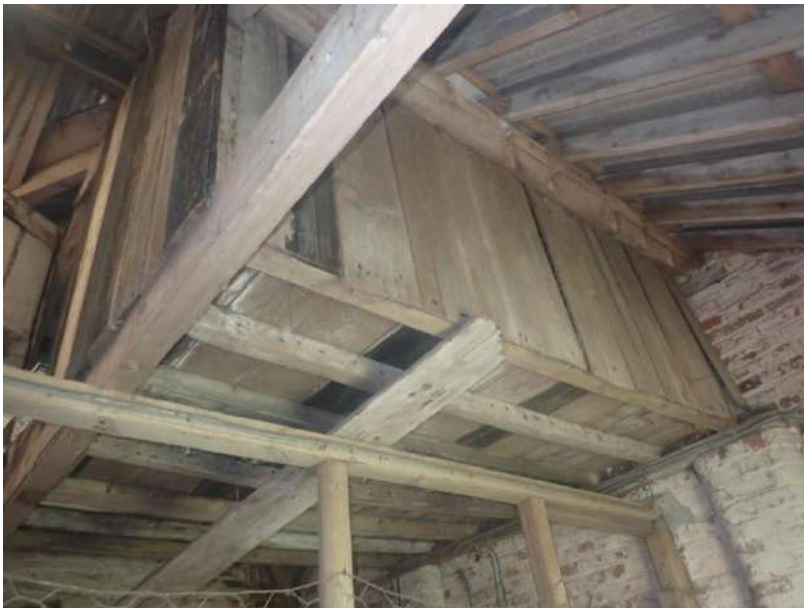
**Plate 229:** View of the roof supporting structure of Cell 6, from the north

**Plate 230:** View of the former dovescote attached to the west wall of Cell 6, from the north

**Plate 230** features a further image of the former dovescote that is attached to the west wall of **Cell 6**.

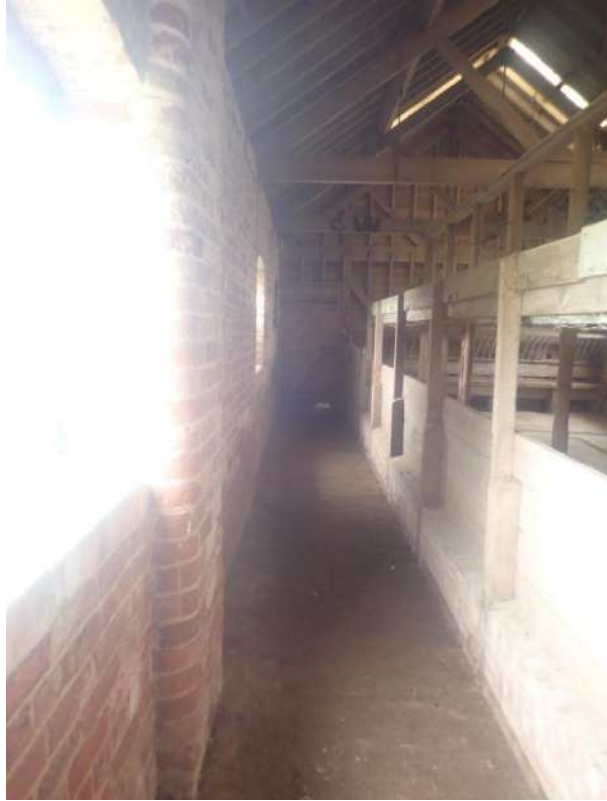
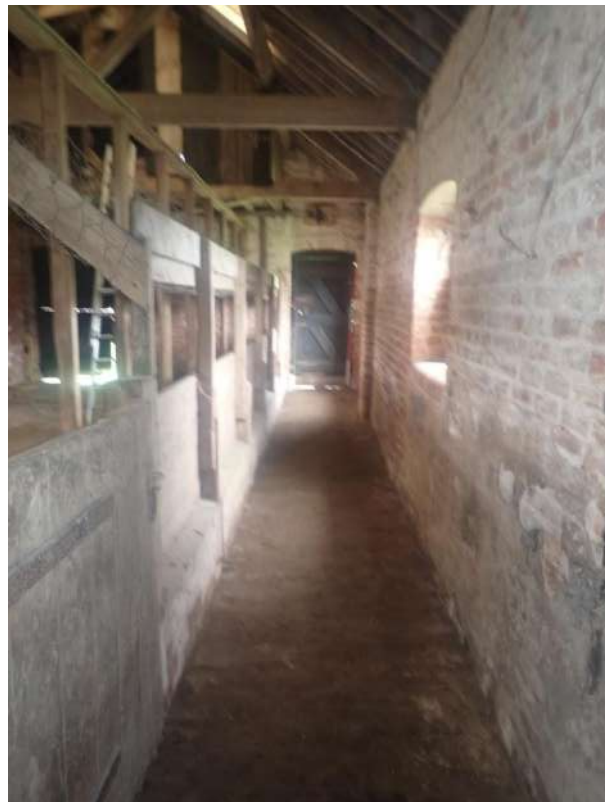
**Plates 231 and 234** present general views from either ends of the east-west orientated passageway that extends along the northern side of **Cell 6**. This passageway is created and defined by the timber fence (described earlier) that extends along the southern side of this passageway.

**Plate 231: General view of the northern passageway of Cell 6, from the west**

**Plate 234: General view of the northern passageway of Cell 6, from the east**

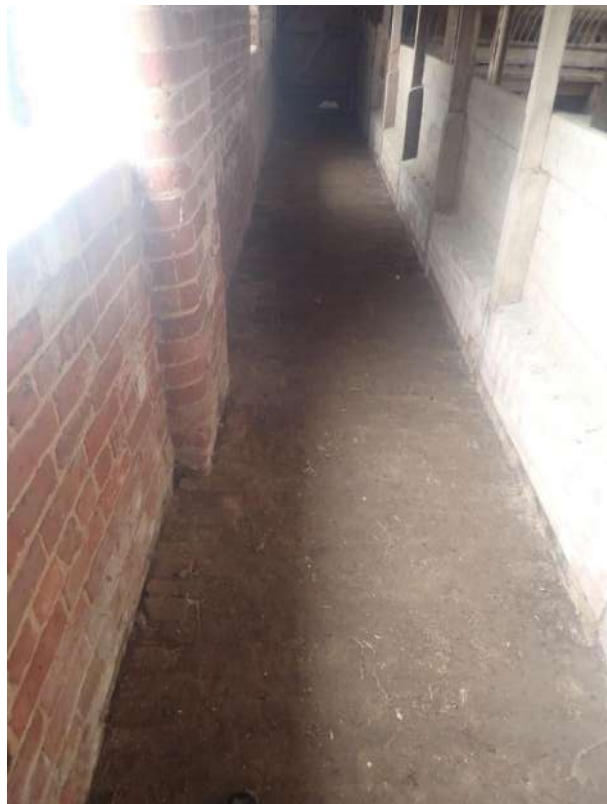
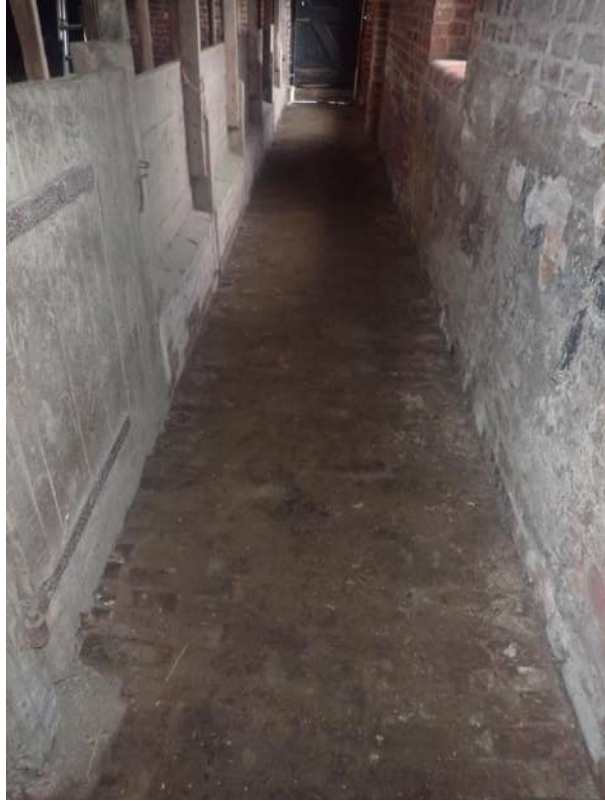
**Plates 232-233** feature the nature of the flooring of this northern passageway, which by contrast appears to be composed of brick stretchers laid on bed.

**Plate 232: View of the flooring of the northern passageway of Cell 6, from the west**

**Plate 233: View of the flooring of the northern passageway of Cell 6, from the east**

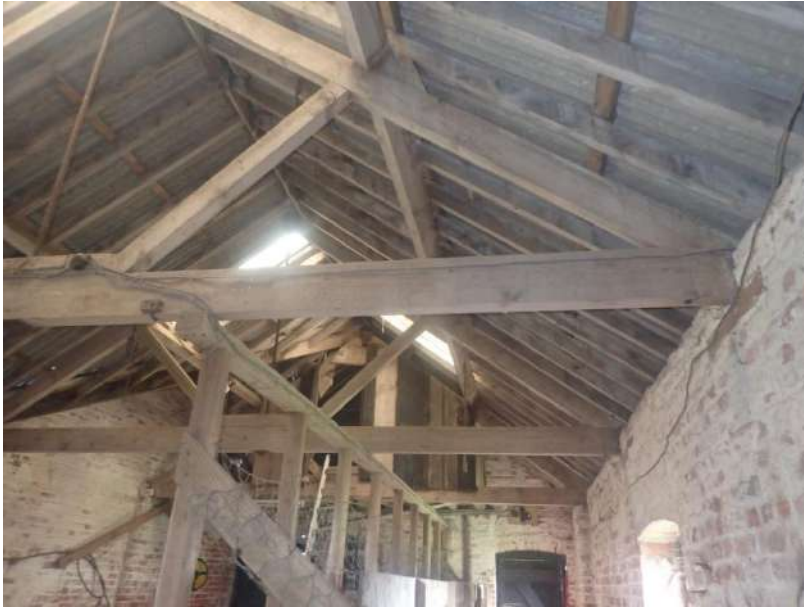
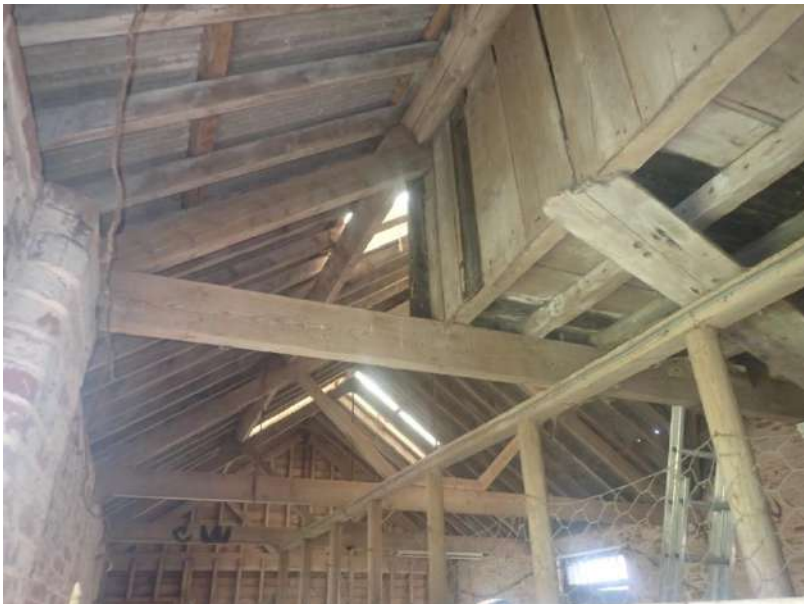
**Plate 235: View of the roof supporting structure of Cell 6, from the east**

**Plate 236: View of the roof supporting structure of Cell 6, from the west**

**Plates 235 and 236** furnish further views of the nature of the roof supporting structure above the northern passageway of **Cell 6**, which was described in detail earlier.

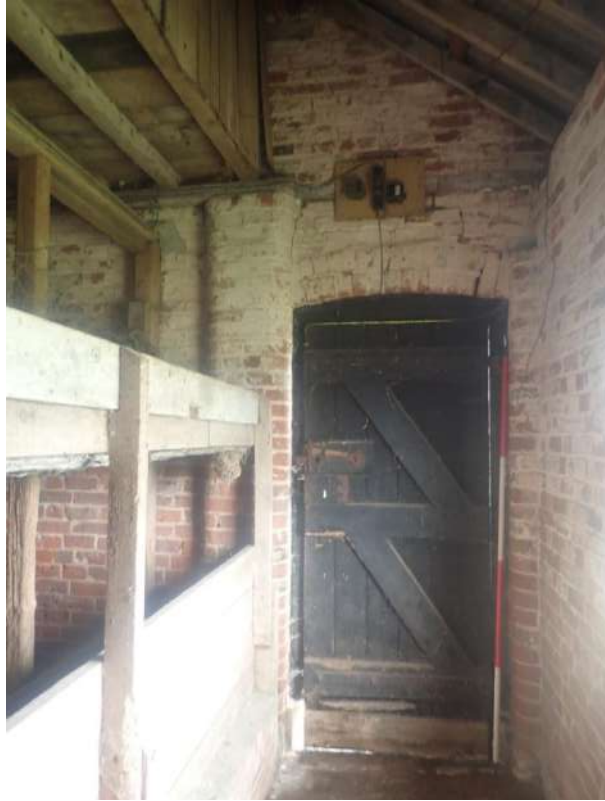
**Plate 237** provides a detailed view of the northern portion of the west wall of **Cell 6**. Featured is the inner face of a west facing entrance opening that was recorded externally at the West Elevation of this North Range. This shows the inner face of the timber door composed of a series of vertical tongued and grooved timber planks that are attached to an internal framework of angled and horizontal timbers. To the immediate left (south), is a vertical column in brick, which is bonded to this west wall. This column is composed of courses of mixed brick stretchers and of bull nosed brick stretchers.

**Plate 237: View of the west wall of Cell 6, from the east**

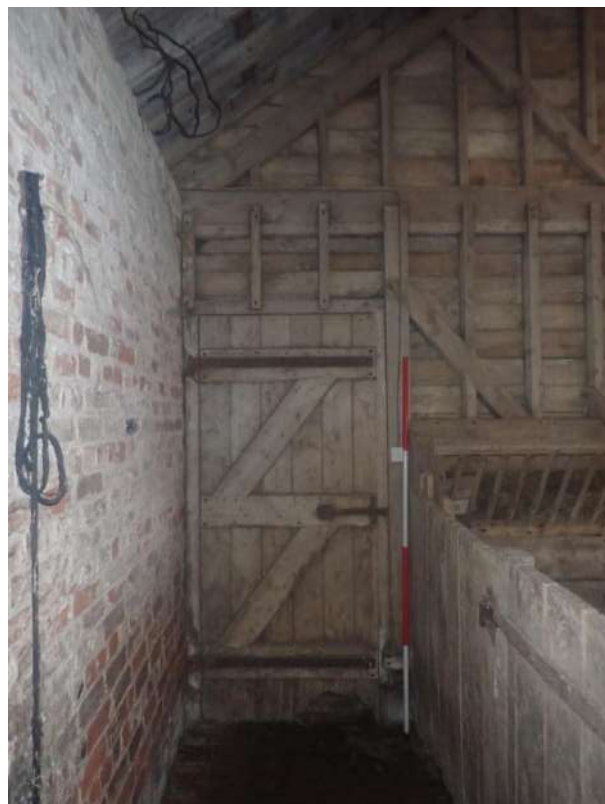
**Plate 238: View of the east wall of Cell 6, from the west**

**Plate 238** features the northern portion of the east wall of **Cell 6** and in particular the inner face of the east facing entrance opening that extends onto the adjoining **Cell 5** to the east. The door is composed of a series of vertical tongued and grooved timber planks that are attached to an internal framework of angled and horizontal timbers. The door is attached to a frame surround by two horizontal metal strap hinges.

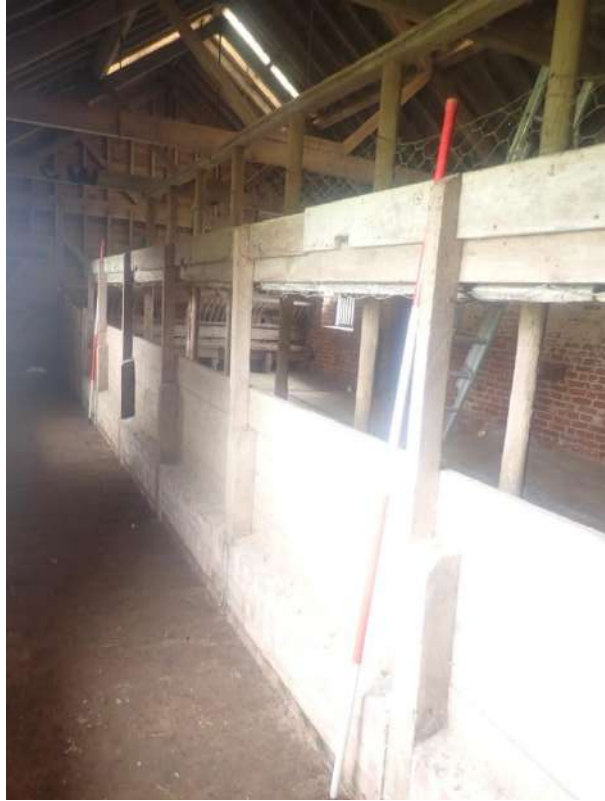
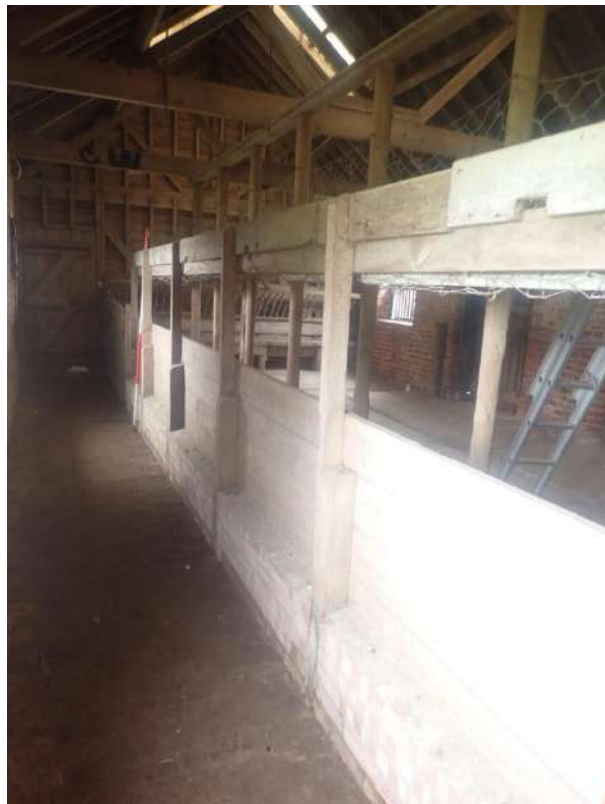
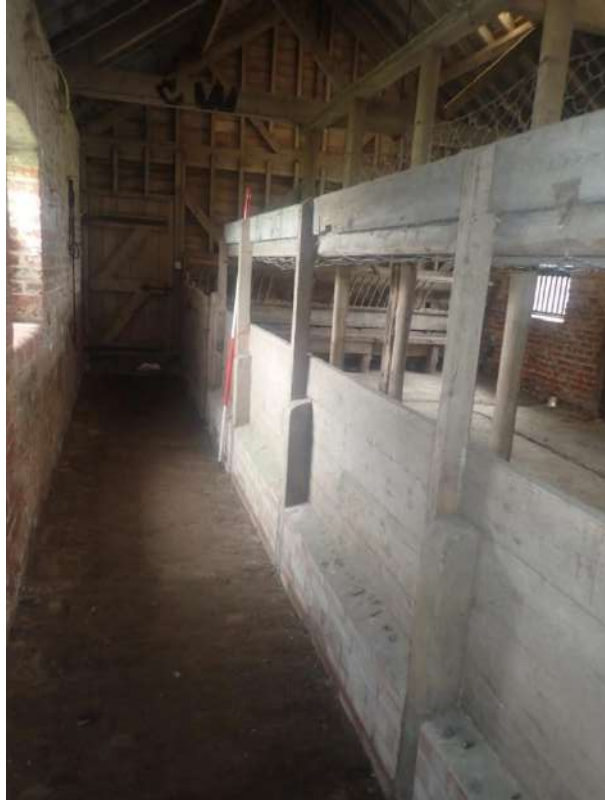
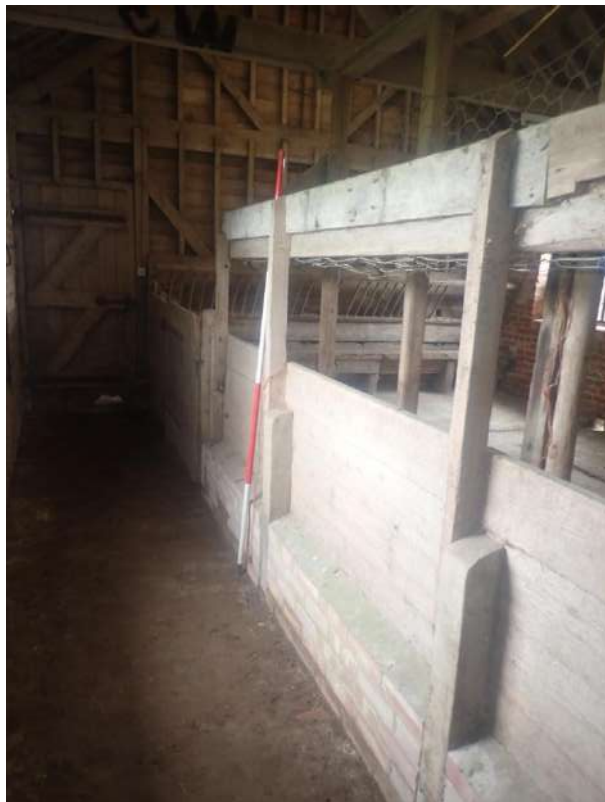
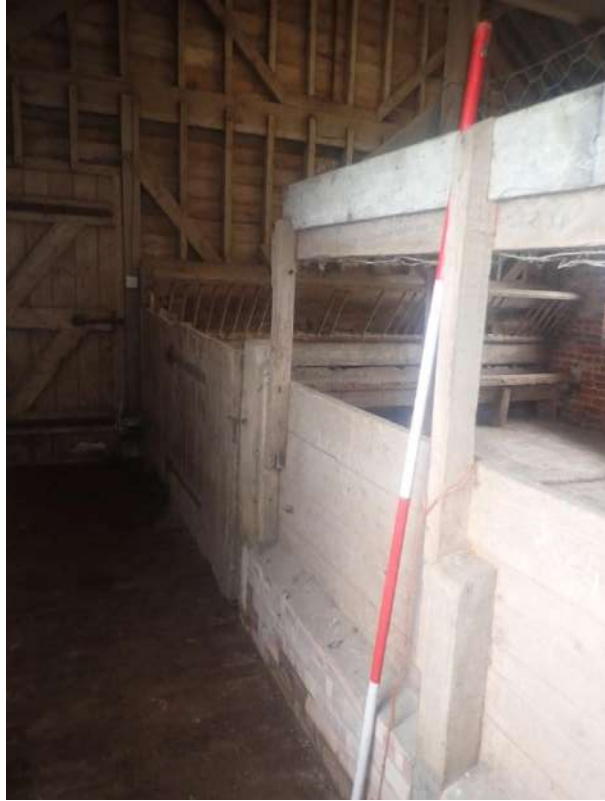
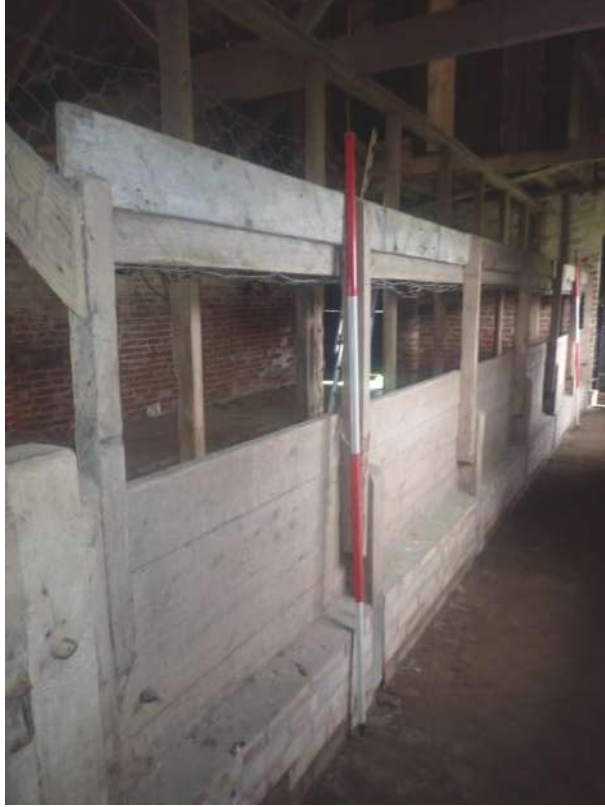
**Plate 239: View of the timber fence along the southern side of the northern passageway of Cell 6, from the west**

**Plates 239-243 and 245** present further views of the external northern face of the timber fence that extends along the southern side of the northern passageway of **Cell 6** and also forms the northern side of the low animal feed trough described in detail earlier. It may be observed that the vertical timber posts are sunk into the brick flooring of the passageway. The fence is also built upon a modern 20th century brick base that is of five courses in height of brick stretchers.

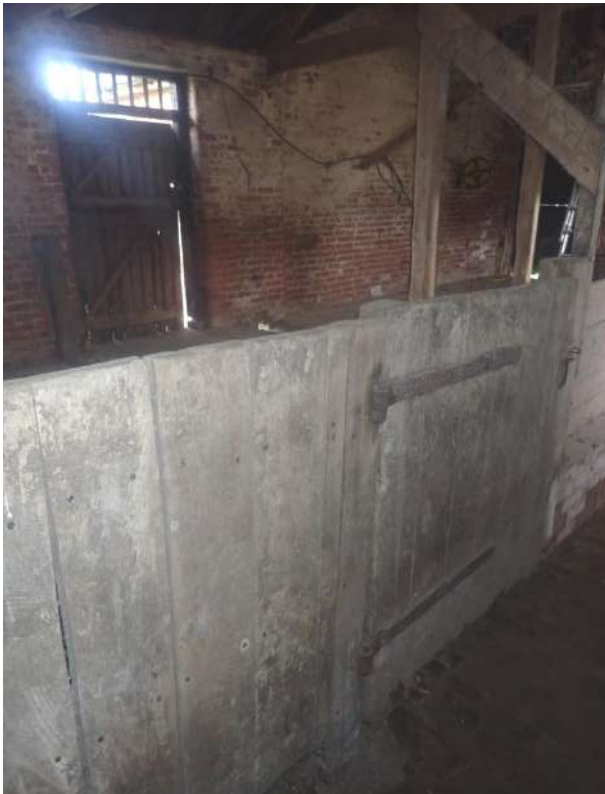
**Plate 244: View of the low timber gate at the southern side of the northern passageway of Cell 6, from the west**

**Plate 244** also features the outer northern face of the low timber gate and attached section of low timber fencing, both composed of a series of vertical timber planks at the eastern end of the passageway.
