**NEVILLE HALL  
FREELANCE ARCHAEOLOGIST & CONSULTANT**

HISTORIC BUILDING RECORDING AT  
CROWN FARM, STOCKWELL GATE WEST,  
WHAPLODE, LINCOLNSHIRE.

**National Grid Reference: TF 3306 2504**  
**Planning Reference: H23-1116-21**  
**Site Code: CFWH23**  
**Accession Number: LCNCC: 2023.77**

July 2023

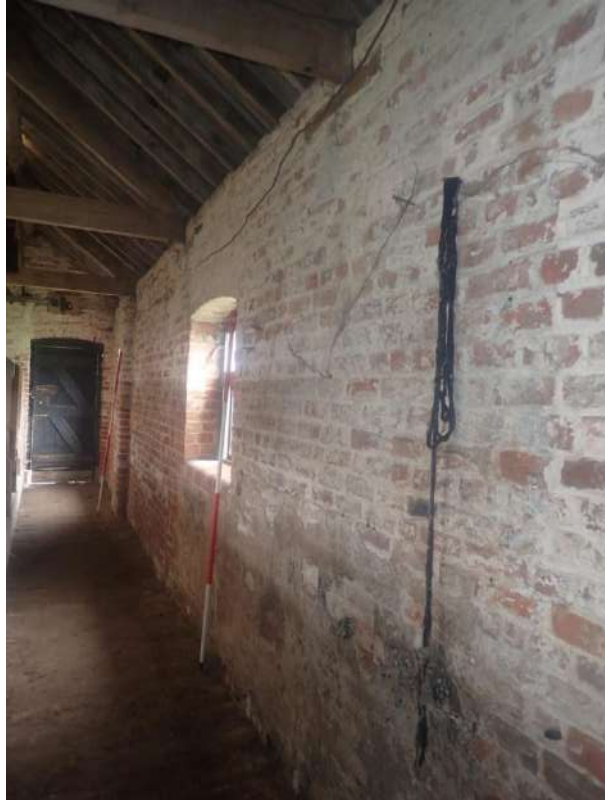
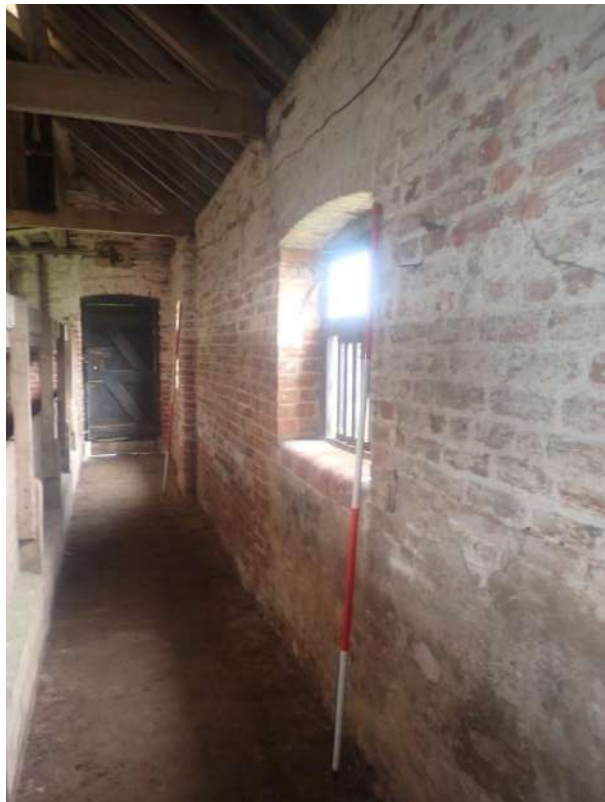
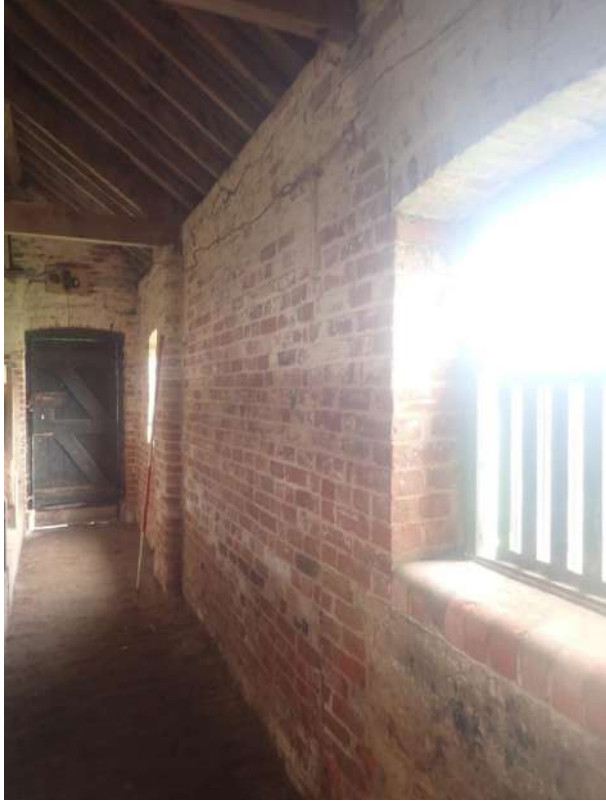
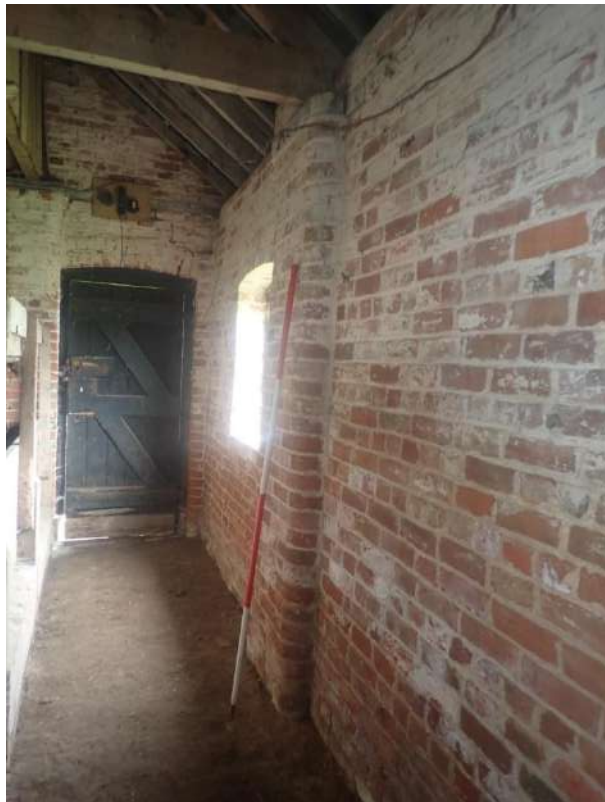
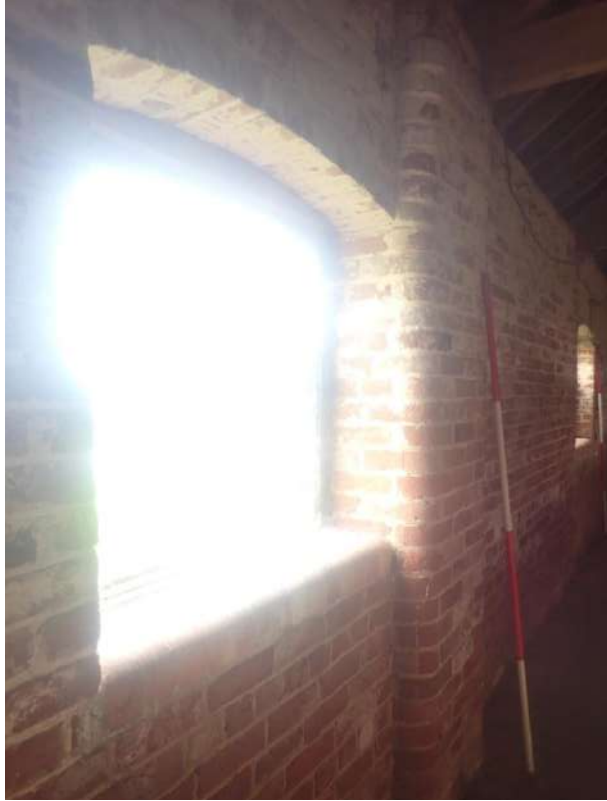
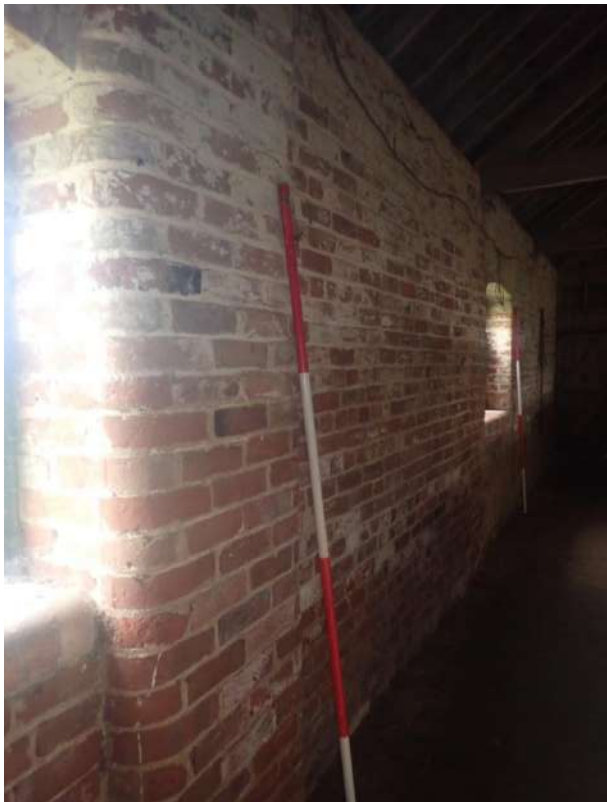
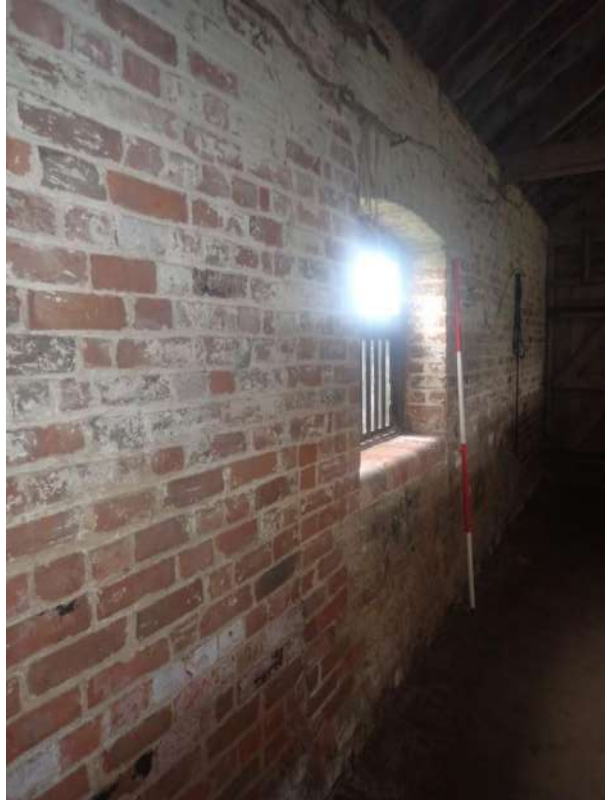
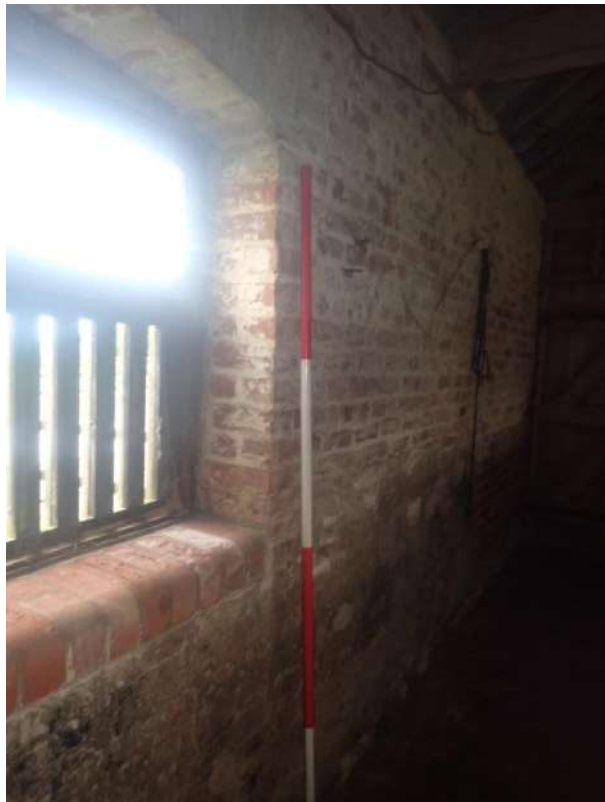
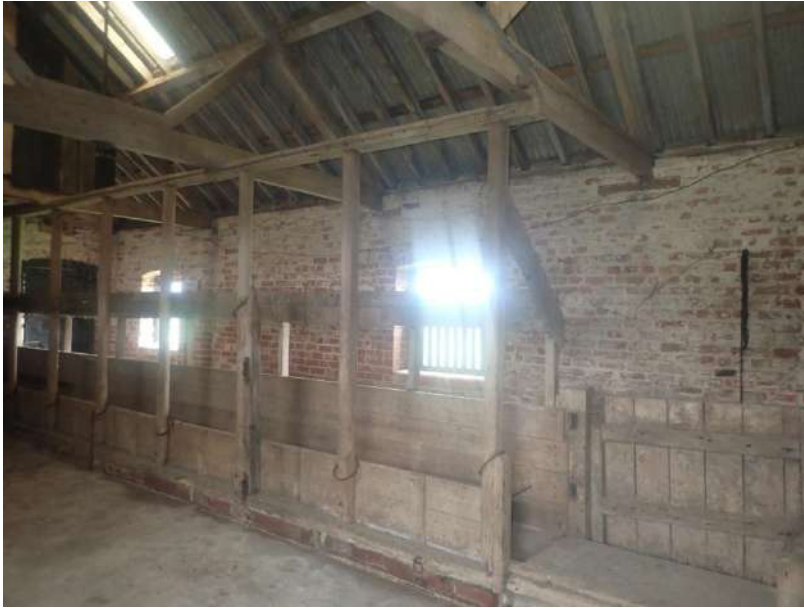
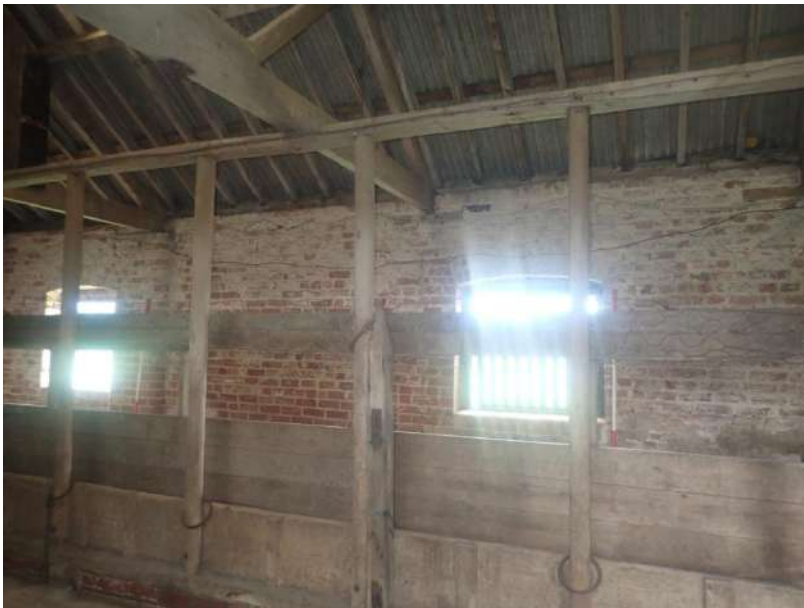
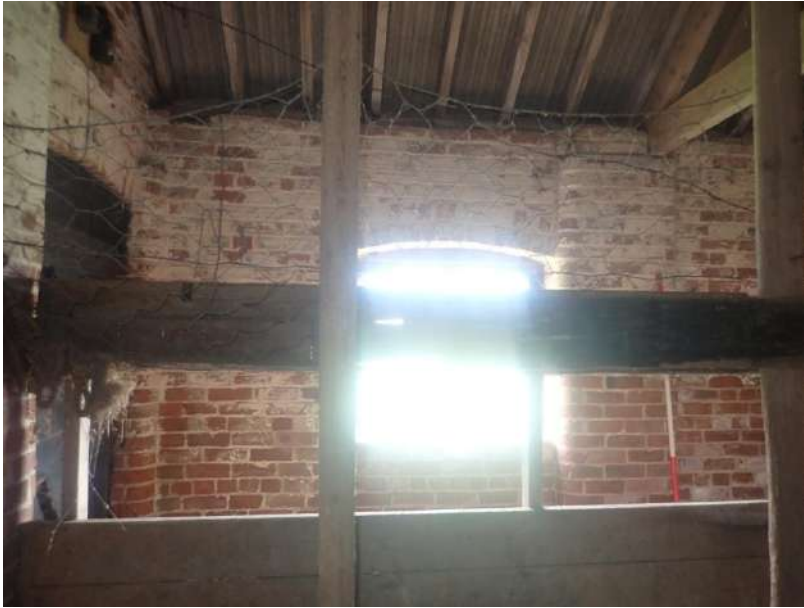
**Plates 246-258** present a number of views of the north wall of **Cell 6**. The brickwork wall fabric of this north wall, despite the detail being partially obscured by mortar or plaster rendering, is composed of three courses of brick stretchers that alternate with single courses of brick headers in English Garden Wall Bond. Horizontal timber wallplates may be seen to extend along the top of this north wall. Also featured are the slightly recessed inner faces of two north facing window openings that were recorded externally at the North Elevation of this North Range.

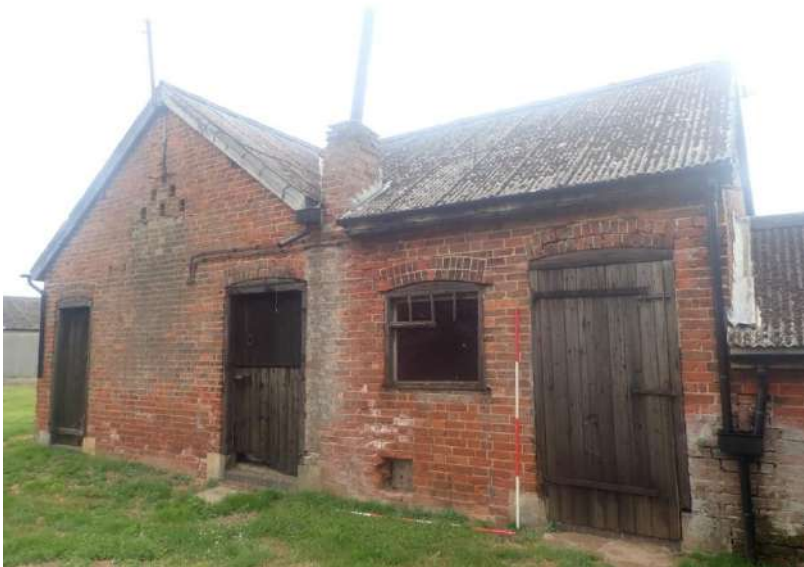
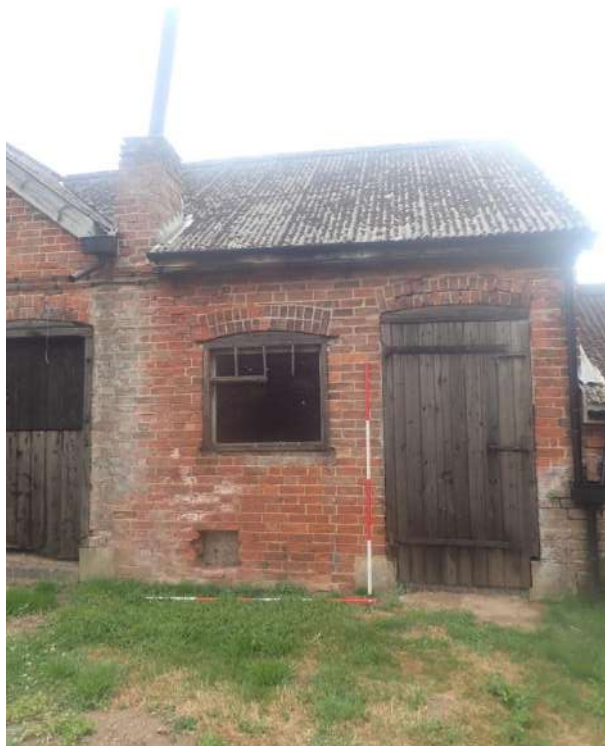
Plate 259: View of the West Elevation of Outbuilding 2, from the west

**Plate 260: View of the West Elevation of Outbuilding 2, from the west**

**Plates 259 and 260** provide detailed images of the West Elevation of **Outbuilding 2**, which clearly shows that it is bonded to the western end of the adjoining North Range of this complex. At just below roof levels are horizontal timber fascia boards, to which is attached modern horizontal Upvc guttering. This extends onto a modern vertical Upvc downpipe at the southern of this Elevation. The brickwork wall fabric of this West Elevation is composed of courses of mixed brick headers and brick stretchers in a variation of Flemish Bond.

Also featured is a west facing window opening, which is open to the elements. The opening has a timber frame of a head and surrounds with the opening itself being unglazed with the remnants of three vertical timber glazing bars and an horizontal timber transom being present. Above the opening is a curved head in brick that is composed of two courses of brick stretchers laid on edge along with two brick headers at each end of the head laid on end.

To the right (south), is a west facing entrance opening. This opening is occupied by a timber frame of a head and surrounds with a brick threshold at the base of the opening. The basal ends of the surrounds rest upon two worked, shaped and faced stone ashlar, that are incorporated into the brickwork here. The door itself is composed of a series of vertical tongued and grooved timber planks that are attached to a frame surround by two horizontal cast metal strap hinges. Above the opening is a curved head in brick composed of two courses of brick stretchers laid on edge along with two brick headers at each end of the head laid on end.

Extending through the gabled roof is a vertical chimney stack composed of course of brick stretchers and atopped with a mix of bricks and ceramic tiles and above these, a plastic pipe.

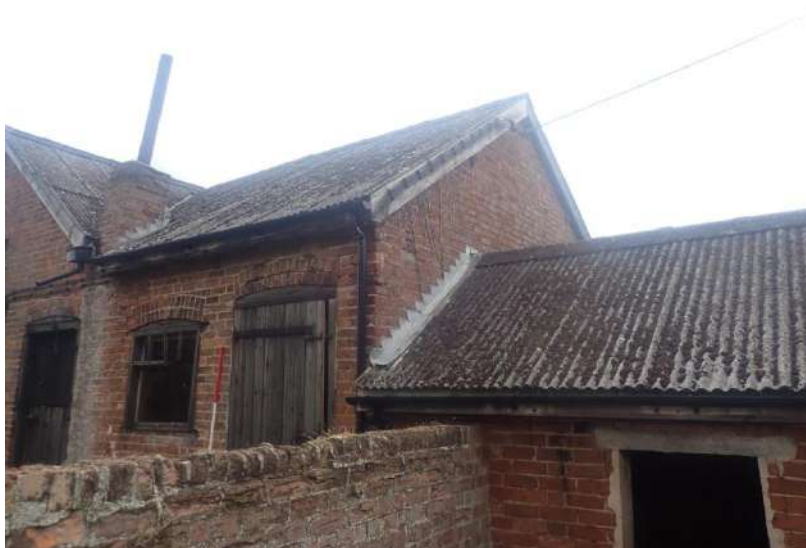
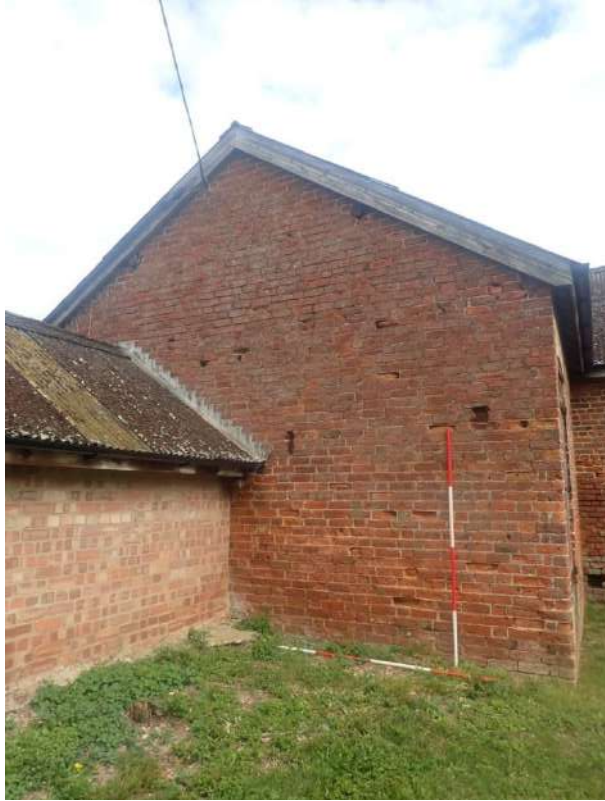
**Plate 261: View of the South Elevation of Outbuilding 2, from the south-west**

**Plate 262: View of the South Elevation of Outbuilding 2, from the south**

**Plates 261 and 262** show the South Elevation of **Outbuilding 2**. The brickwork wall fabric of this South Elevation is composed of courses of mixed brick headers and brick stretchers in a variation of Flemish Bond.

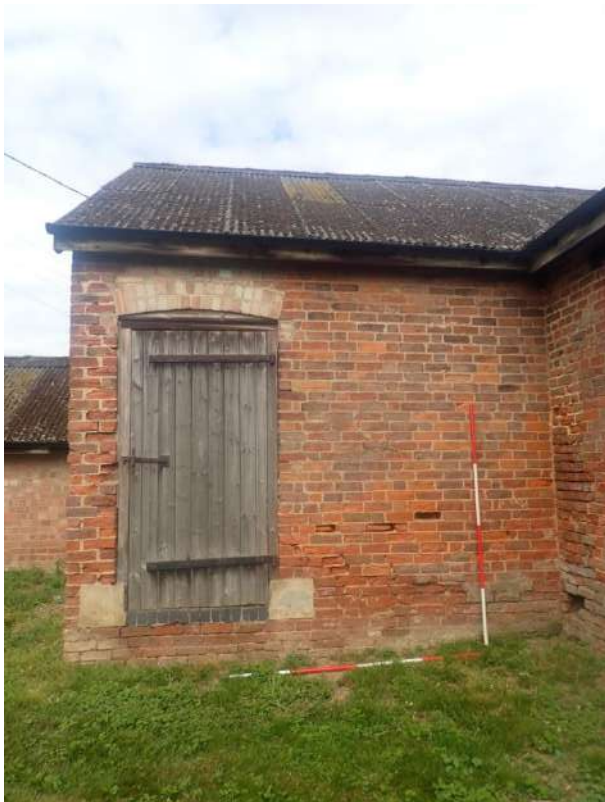
**Plate 263: View of the East Elevation of Outbuilding 2, from the east**

**Plate 263** furnishes a detailed view of the East Elevation of **Outbuilding 2** and shows its bonding to the western end of the adjoining North Range. At just below roof levels are horizontal timber fascia boards to which is attached modern horizontal Upvc guttering. The brickwork wall fabric of this East Elevation is of courses of mixed brick headers and brick stretchers in a variation of Flemish Bond. Also shown is an east facing entrance opening, which is slightly elevated above current ground levels indicating the absence of a possible former higher levelled yard surface here. This opening is occupied by a timber frame of a head and surrounds and a brick threshold at the base of the opening. The basal ends of the timber frame surrounds rest upon two, worked shaped and faced stone ashlar that are both incorporated into the brickwork wall fabric here. The door is composed of a series of vertical tongued and grooved timber planks and is attached to a frame surround by two cast metal horizontal strap hinges. Above this opening and extending up to the roof levels is a small area of modern brick repair that includes a curved head in brick. This is composed of both of two courses of brick stretchers laid on edge along with two brick headers at each and of the head laid on end.

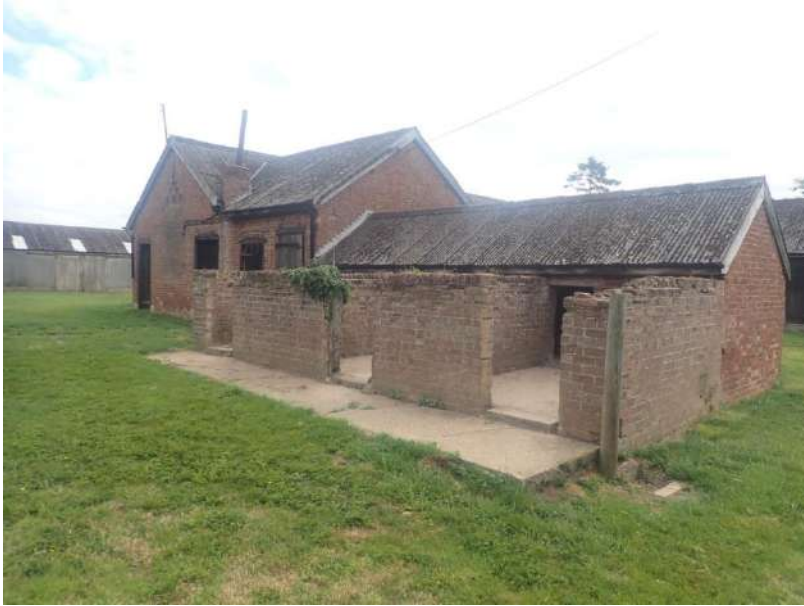
**Plate 264: General view of the former piggery, from the south-west**

**Plate 264** presents a general view of the former piggery, which is a single storey outbuilding, with a gabled roof and a roof covering of modern asbestos sheeting.

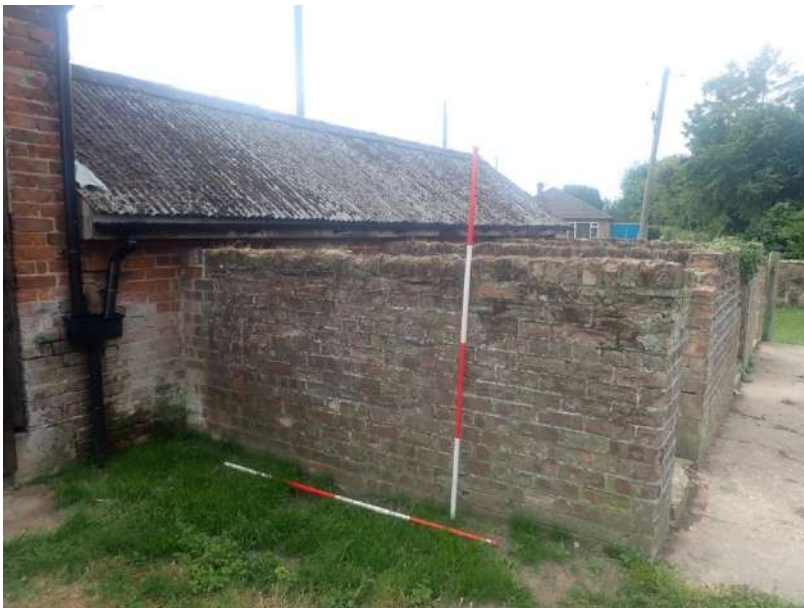
**Plate 265** features the northern boundary wall of the piggery. The brickwork here is composed of 3-5 courses of brick stretchers alternating with single courses of brick headers in a variation of English Garden Wall Bond. The wall is topped with a single course of brick stretchers laid on edge.

**Plate 265: View of the northern boundary wall of the piggery, from the north**

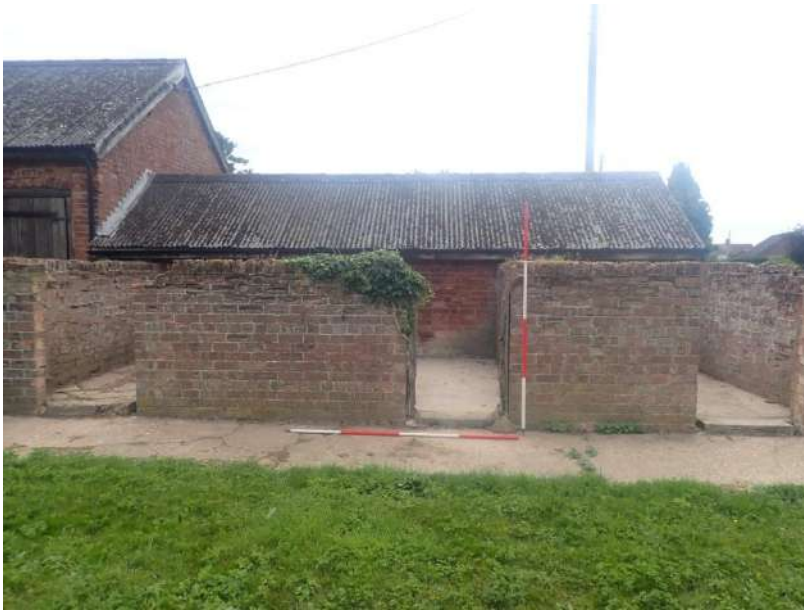
**Plate 266:** View of the western boundary wall of the piggery, from the west

**Plate 266** features the western boundary wall of the piggery with three intervening gaps or the sites of former gates. The brickwork here is composed of 3-5 courses of brick stretchers alternating with single courses of brick headers in a variation of English Garden Wall Bond. The wall is atopped within a single course of brick stretchers laid on edge.

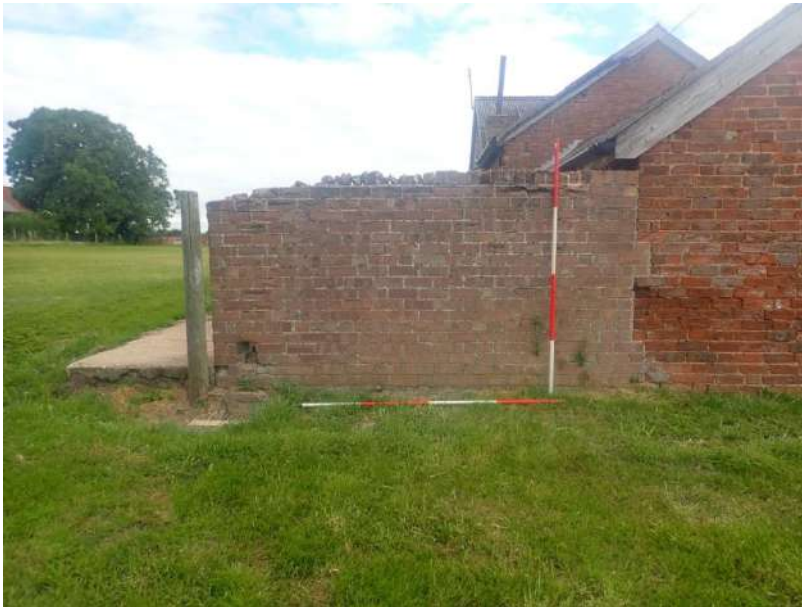
**Plate 267** presents a view of the southern boundary wall of the piggery. The brickwork here is composed of 5-6 courses of brick stretchers alternating with single courses of brick headers in a variation of English Garden Wall Bond. The wall is atopped within a single course of brick stretchers laid on edge.

**Plate 267:** View of the southern boundary wall of the piggery, from the south

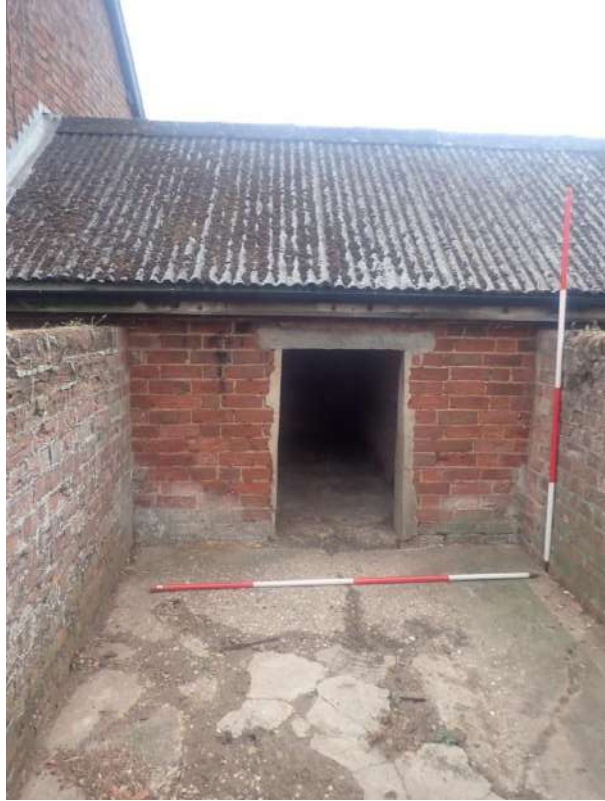
**Plate 268: View of the exterior of the first sty, from the west**

**Plate 268** features the western exterior of the first sty. At just below roof levels are horizontal timber fascia boards to which is attached modern Upvc horizontal guttering. The brickwork here is composed of courses of mixed brick headers and brick stretchers in a variation of Flemish Bond. Inserted into this brickwork is an open west facing entrance opening above which is an horizontal concrete lintel that is incorporated into the brickwork.

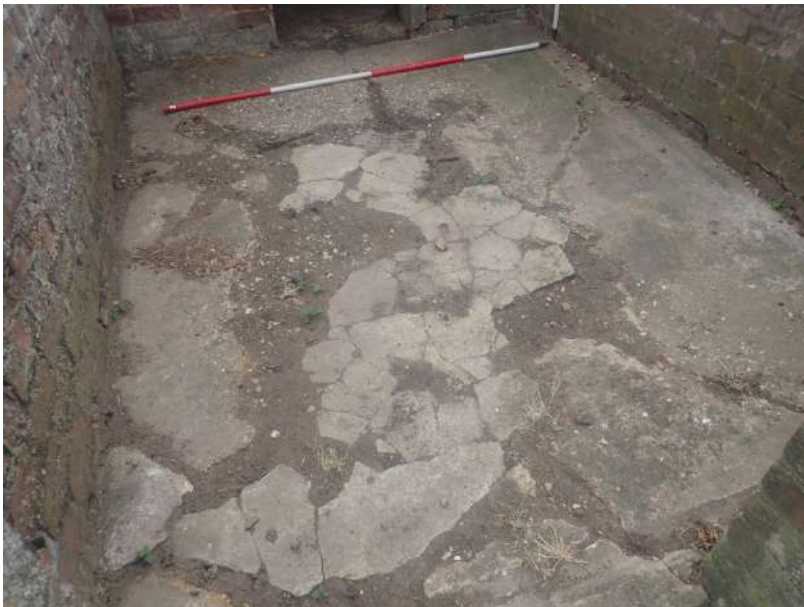
**Plate 269: View of the frontal yard of the first sty, from the west**

**Plate 269** features the frontal yard of the first sty, which is of modern concrete.

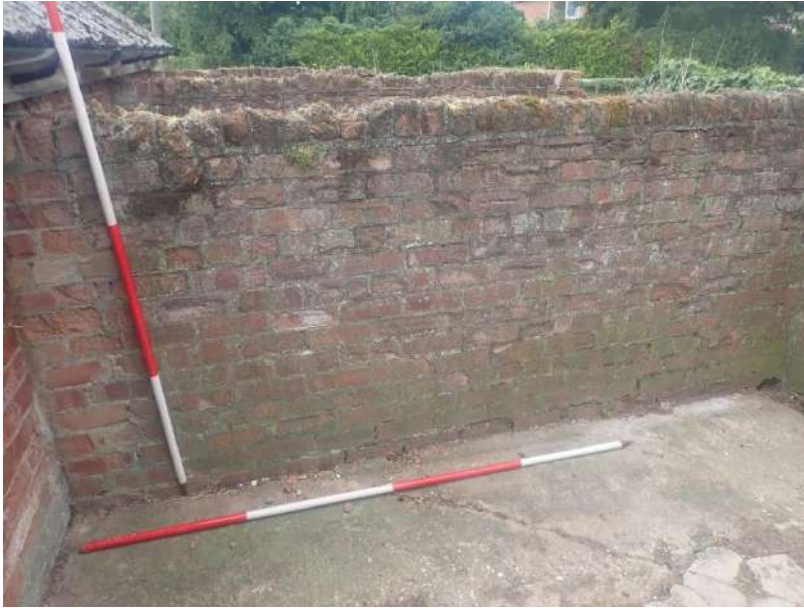
**Plate 270:** View of the southern yard wall of the first sty, from the north

**Plate 270** shows the southern yard wall of the first sty. The brickwork here is composed of 2-3 courses of brick stretchers alternating with single courses of brick headers in a variation of English Garden Wall Bond. The wall is atopped within a single course of brick stretchers laid on edge.

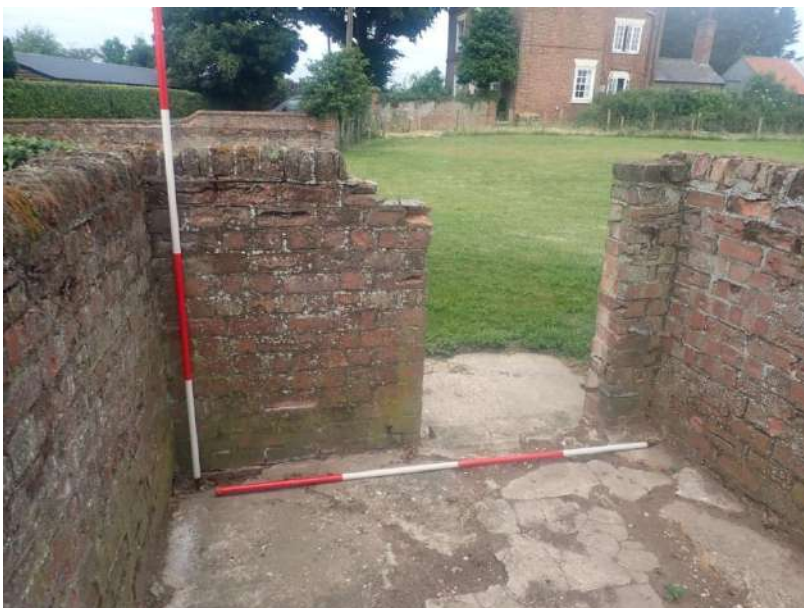
**Plate 271** presents a view of the western yard wall of the first sty with the former west facing gate opening. The brickwork here is composed of 2-4 courses of brick stretchers alternating with single courses of brick headers in a variation of English Garden Wall Bond. The wall is atopped within a single course of brick stretchers laid on edge.

**Plate 271:** View of the western yard wall of the first sty, from the east

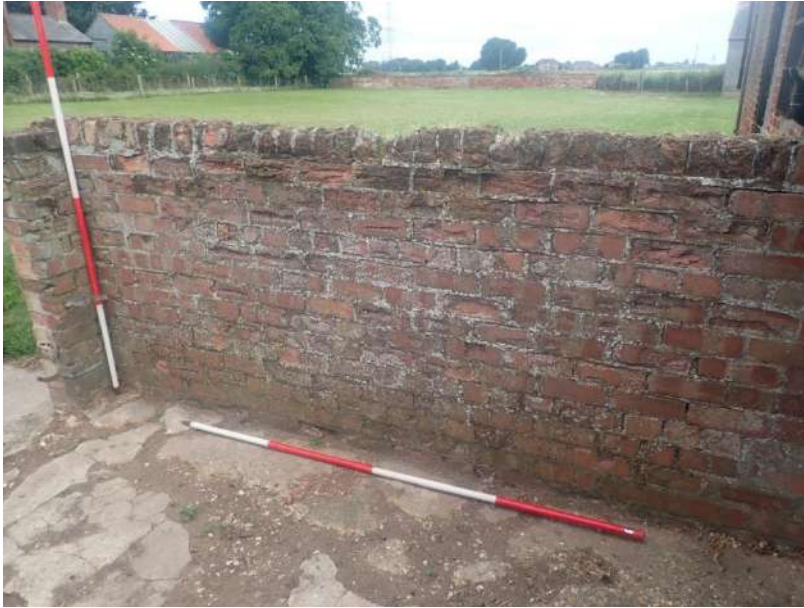
**Plate 272: View of the northern yard wall of the first sty, from the south**

**Plate 272** features the northern yard wall of the first sty. The brickwork here is composed of 2-6 courses of brick stretchers alternating with single courses of brick headers in a variation of English Garden Wall Bond. The wall is atopped within a single course of brick stretchers laid on edge.

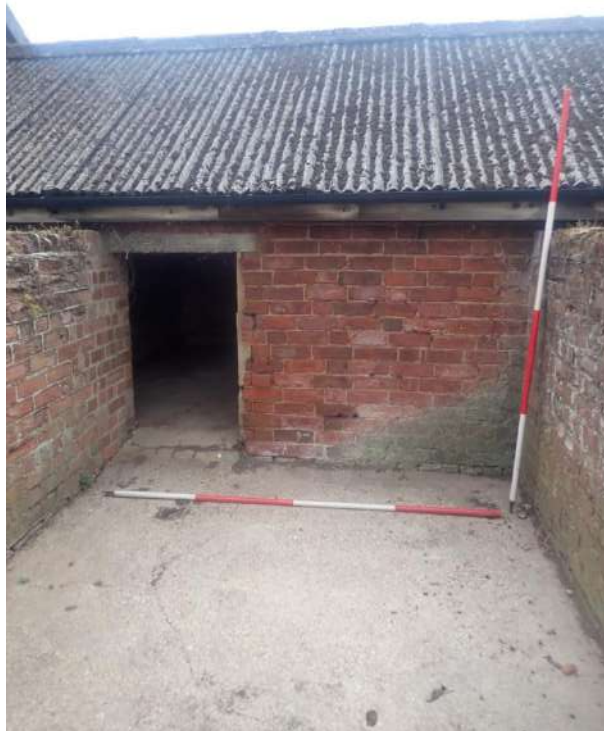
**Plate 273: View of the exterior of the second sty, from the west**

**Plate 273** features the western exterior of the second sty. At just below roof levels are horizontal timber fascia boards to which is attached modern Upvc horizontal guttering. The brickwork here is composed of courses of mixed brick headers and brick stretchers in a variation of Flemish Bond. Inserted into this brickwork is an open west facing entrance opening above which is an horizontal concrete lintel that is incorporated into the brickwork.

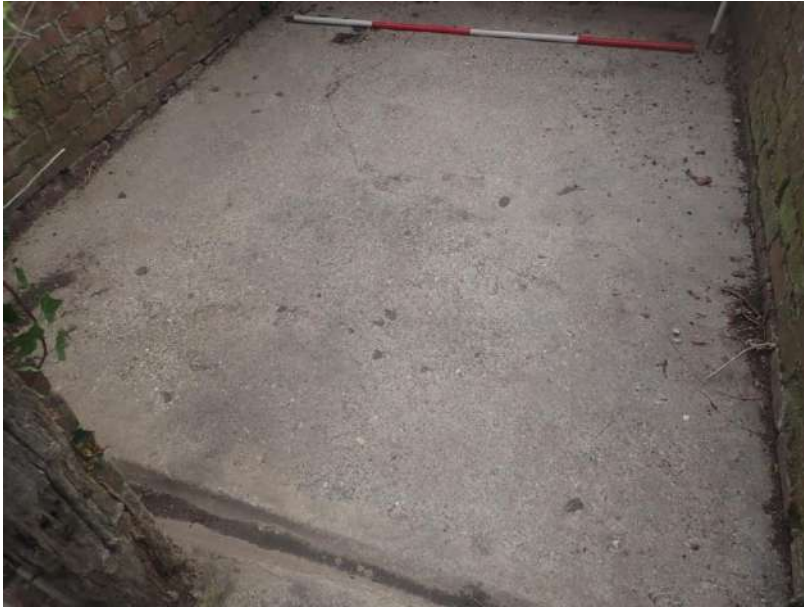
**Plate 274: View of the frontal yard of the second sty, from the west**

**Plate 274** features the frontal yard of the second sty, which is of modern concrete.

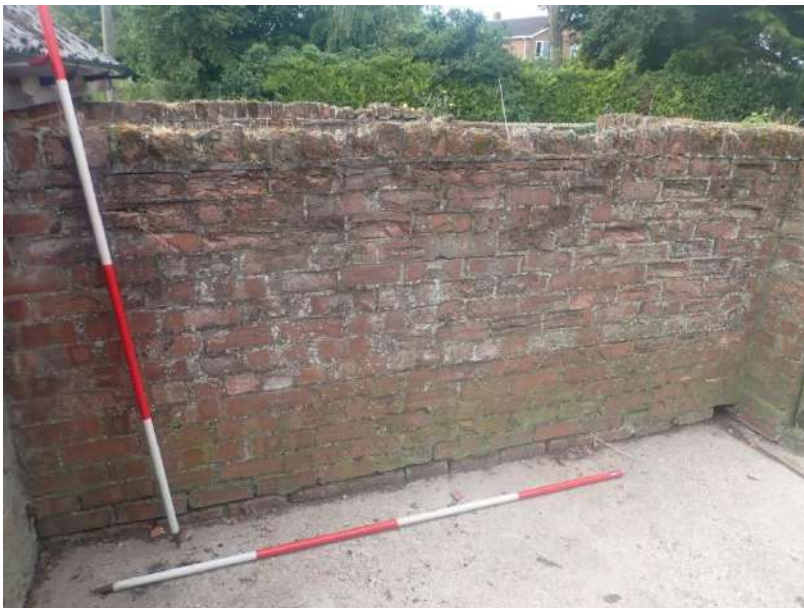
**Plate 275** shows the southern yard wall of the first sty. The brickwork here is mostly composed of courses of brick stretchers with a single course of brick headers. The wall is atopped with a single course of brick stretchers laid on edge.

**Plate 275: View of the southern yard wall of the second sty, from the north**

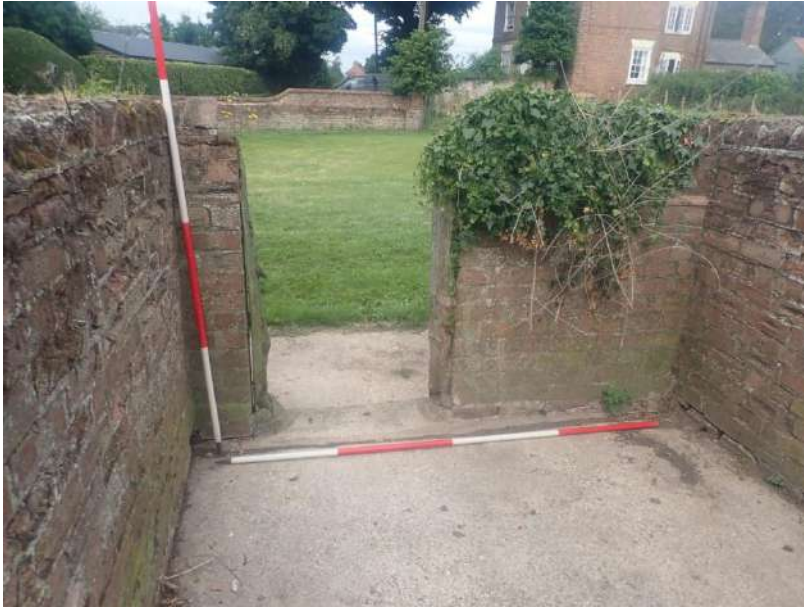
**Plate 276: View of the western yard wall of the second sty, from the east**

**Plate 276** presents a view of the western yard wall of the second sty with the former west facing gate opening. The brickwork here is mostly composed of courses of brick stretchers with a single course of brick headers. The wall is atopped within a single course of brick stretchers laid on edge.

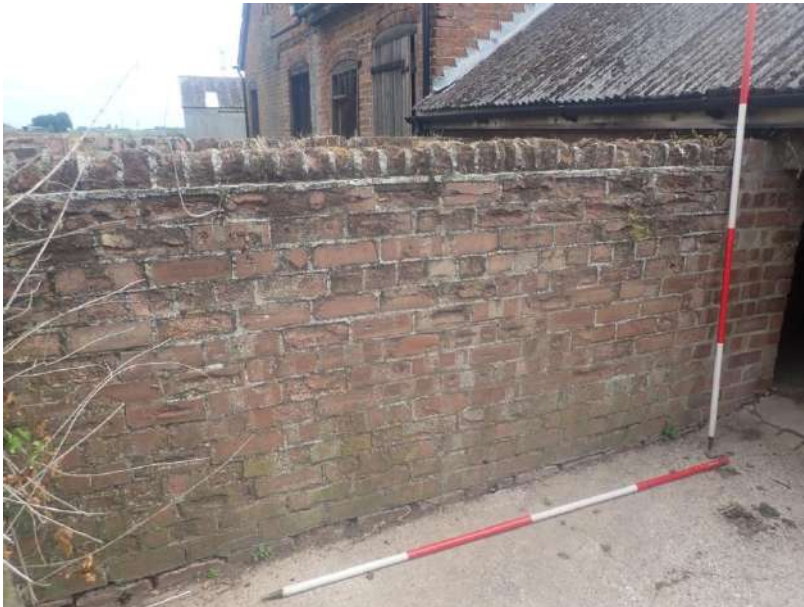
**Plate 277** features the northern yard wall of the second sty. The brickwork here is composed of 3-6 courses of brick stretchers alternating with single courses of brick headers in a variation of English Garden Wall Bond. The wall is atopped within a single course of brick stretchers laid on edge.

**Plate 277: View of the northern yard wall of the second sty, from the south**

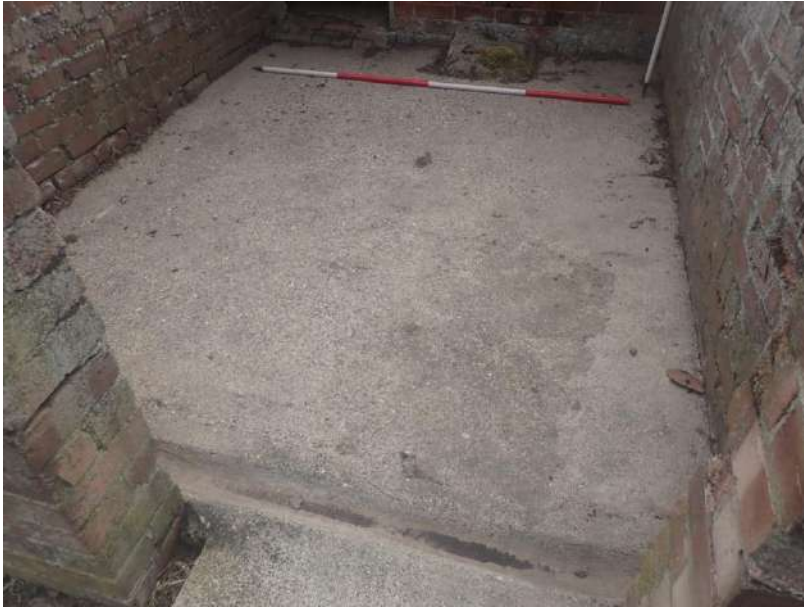
**Plate 278: View of the frontal yard of the third sty, from the west**

**Plate 278** features the frontal yard of the third sty, which is of modern concrete.

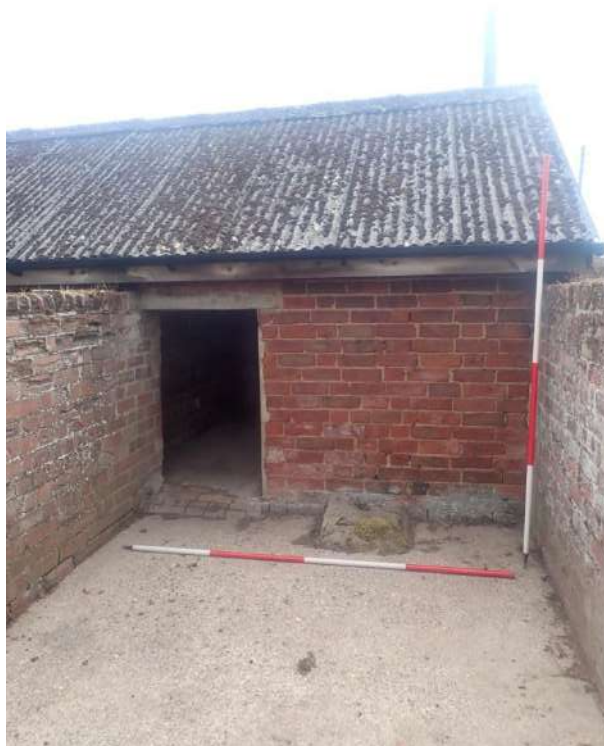
**Plate 279** features the western exterior of the third sty. At just below roof levels are horizontal timber fascia boards to which is attached modern Upvc horizontal guttering. The brickwork here is composed of courses of mixed brick headers and brick stretchers in a variation of Flemish Bond. Inserted into this brickwork is an open west facing entrance opening above which is an horizontal concrete lintel that is incorporated into the brickwork.

**Plate 279: View of the exterior of the third sty, from the west**

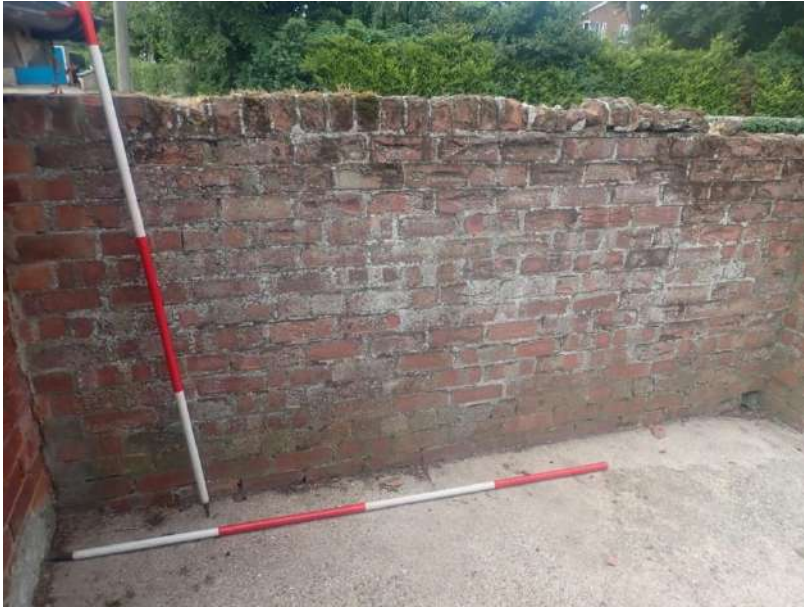
**Plate 280: View of the southern yard wall of the third sty, from the north**

**Plate 280** shows the southern yard wall of the third sty. The brickwork here is composed of 5-6 courses of brick stretchers alternating with single courses of brick headers in a variation of English Garden Wall Bond. The wall is atopped within a single course of brick stretchers laid on edge.

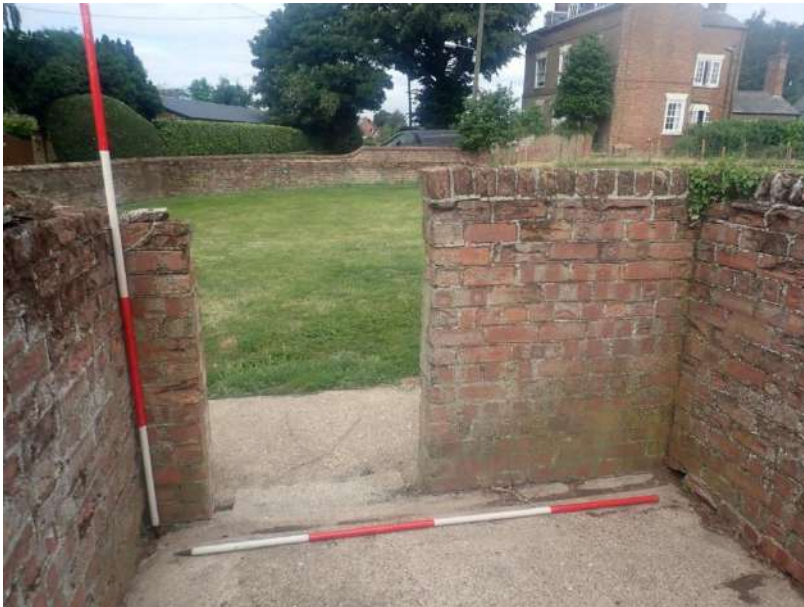
**Plate 281** presents a view of the western yard wall of the third sty with the former west facing gate opening. The brickwork here is composed of 4-5 courses of brick stretchers alternating with single courses of brick headers in a variation of English Garden Wall Bond. The wall is atopped within a single course of brick stretchers laid on edge.

**Plate 281: View of the western yard wall of the third sty, from the east**

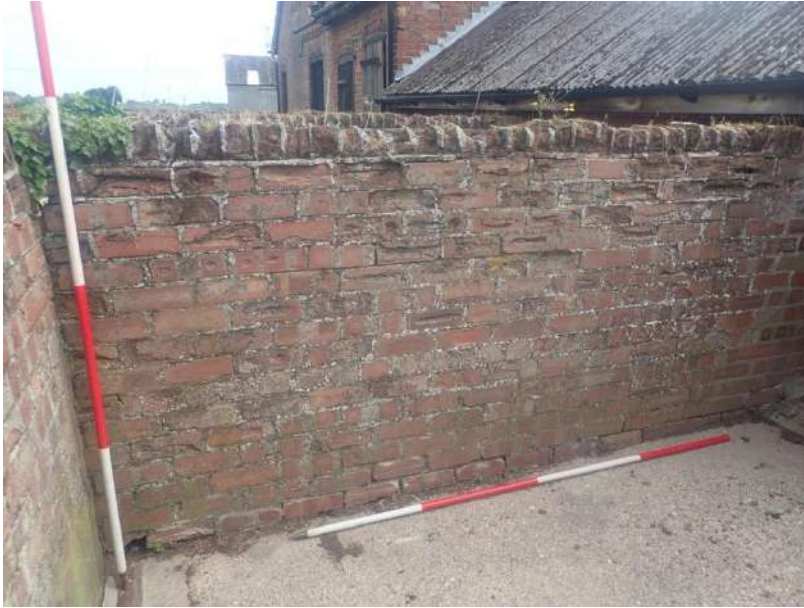
**Plate 282: View of the northern yard wall of the third sty, from the south**

**Plate 282** features the northern yard wall of the third sty. The brickwork here is mostly composed of courses of brick stretchers with one course of brick headers. The wall is atopped within a single course of brick stretchers laid on edge.

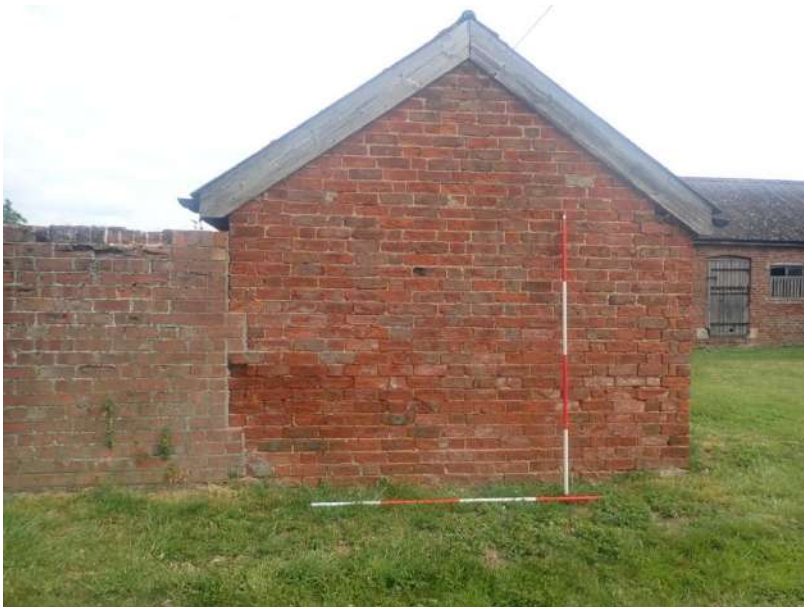
**Plate 283** presents a detailed view of the South Elevation of the piggery and also features the angled timber eaves of the southern gabled end of the outbuilding. The brickwork of this South Elevation is composed of courses of mixed brick headers and bricks stretchers in a variation of Flemish Bond.

**Plate 283: View of the South Elevation of the piggery, from the south**

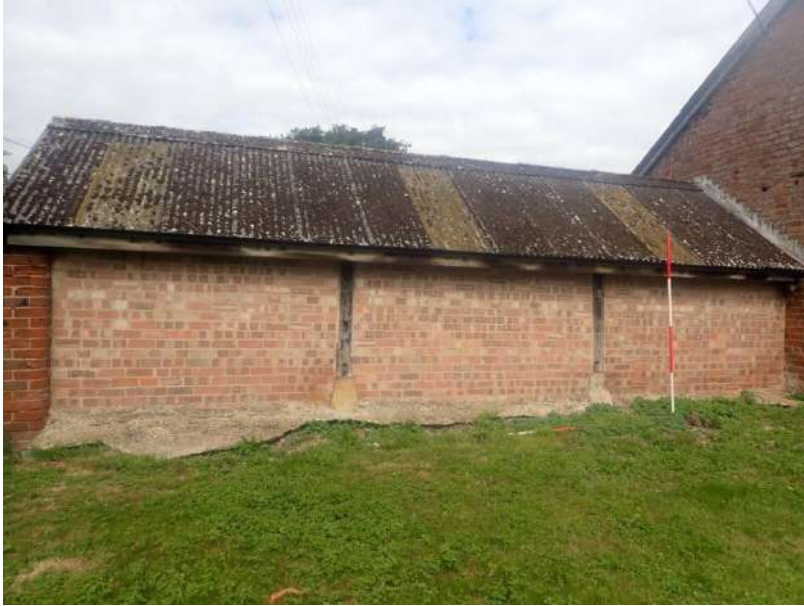
**Plate 284: View of the East Elevation of the former piggery, from the east**

**Plate 284** presents a detailed view of the East Elevation of the piggery. At just below roof levels are horizontal timber fascia boards to which is attached modern horizontal Upvc guttering. The original Elevation was open to the east and consisted of two vertical timber posts, the basal ends of which rest on two stone bases. This suggests that this outbuilding was probably once a low level storage shed for farm machinery prior to its conversion to a piggery. The modern infill brick panels are composed of 4-5 courses of brick stretchers alternating with single courses of brick headers in a variation of English Garden Wall Bond.

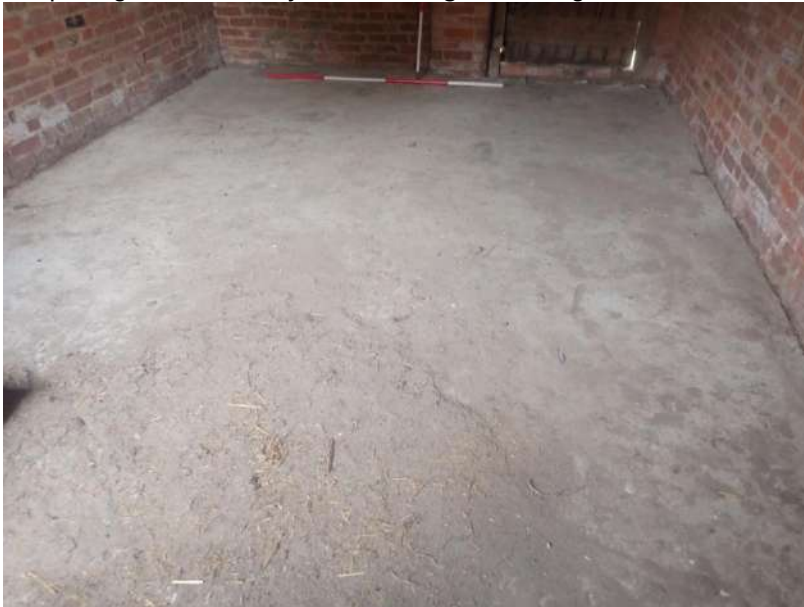
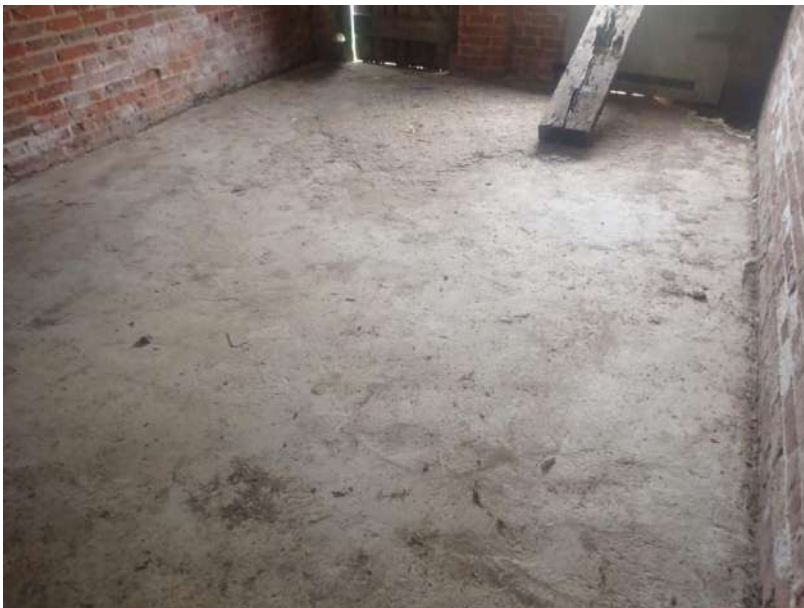
**Plate 285: View of the flooring of Cell 7, from the west**

**Plates 285 and 287** provide views of the nature of the flooring of **Cell 7**, which is of modern concrete.

**Plate 287: View of the flooring of Cell 7, from the east**
