**NEVILLE HALL  
FREELANCE ARCHAEOLOGIST & CONSULTANT**

HISTORIC BUILDING RECORDING AT  
CROWN FARM, STOCKWELL GATE WEST,  
WHAPLODE, LINCOLNSHIRE.

**National Grid Reference: TF 3306 2504**  
**Planning Reference: H23-1116-21**  
**Site Code: CFWH23**  
**Accession Number: LCNCC: 2023.77**

July 2023

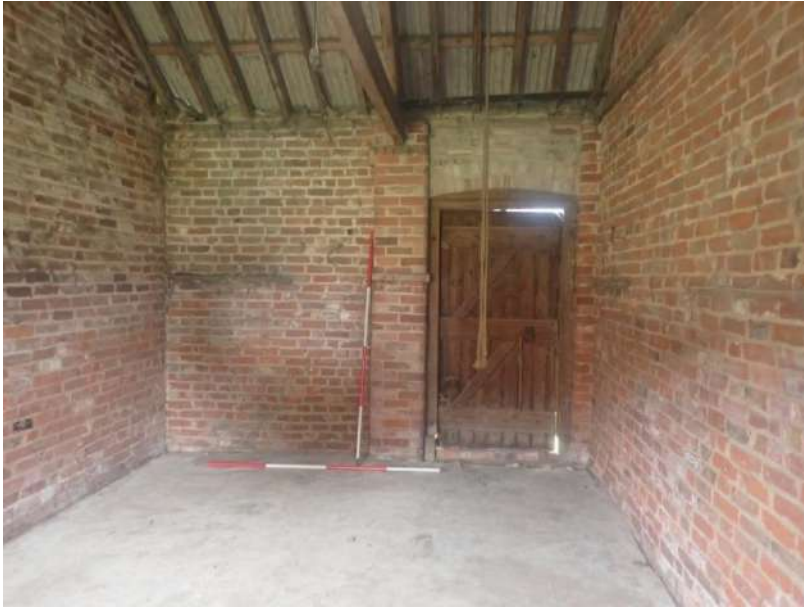
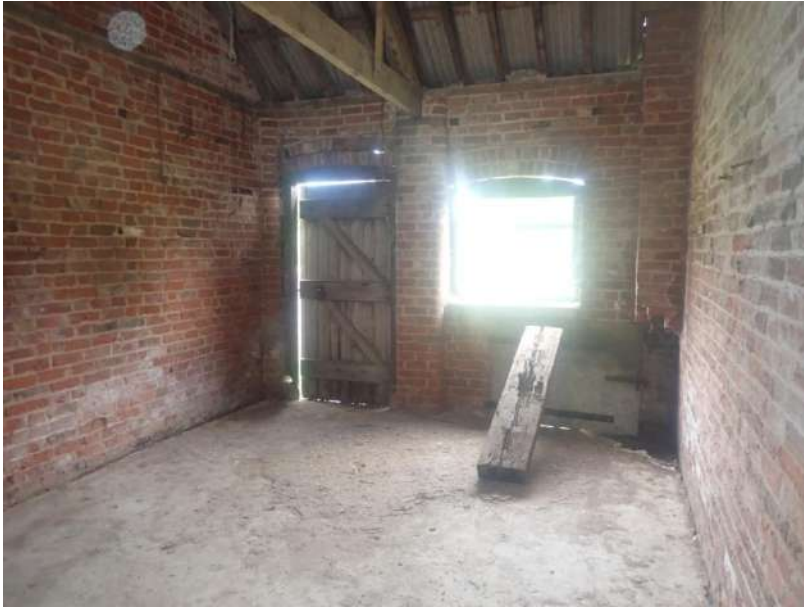
**Plate 286: General view of the interior of Cell 7, from the west**

**Plates 286 and 288** feature general views of the interior of **Cell 7**.

**Plate 288: General view of the interior of Cell 7, from the east**

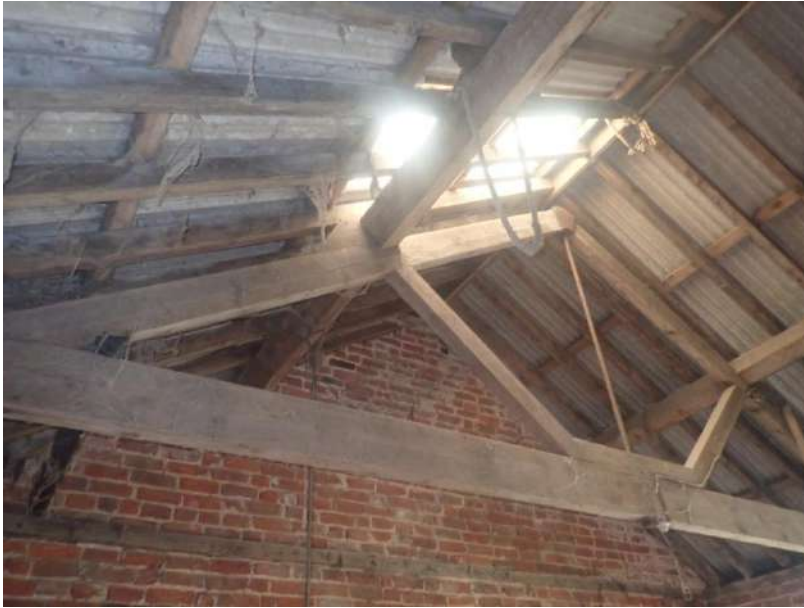
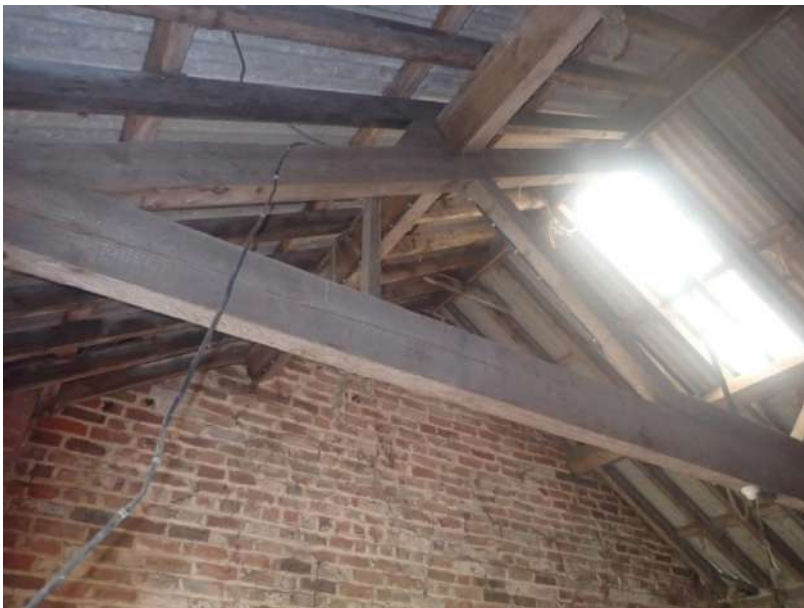
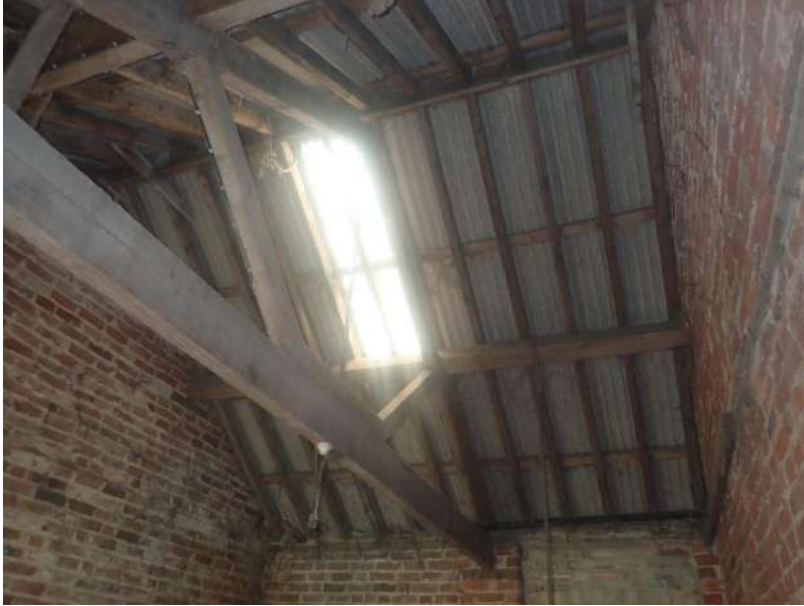
**Plate 290: View of the roof supporting structure of Cell 7, from the north**

**Plates 290-293** feature the nature of the roof supporting structure of **Cell 7**. The main component part of this structure comprises the single king post roof truss, from which the king post has been removed. The remainder of this structure consists of a framework of timber rafters and of horizontal timber purlins that extend along both sides of this structure along with further horizontal timber purlins at the roof apex. The ends of the tie beam of the roof truss are inserted into the upper levels of the brickwork of the east and west walls with the upper portion of the roof truss being affixed to the purlins.

**Plate 291: View of the roof supporting structure of Cell 7, from the south**

**Plate 292: View of the roof supporting structure of Cell 7, from the west**

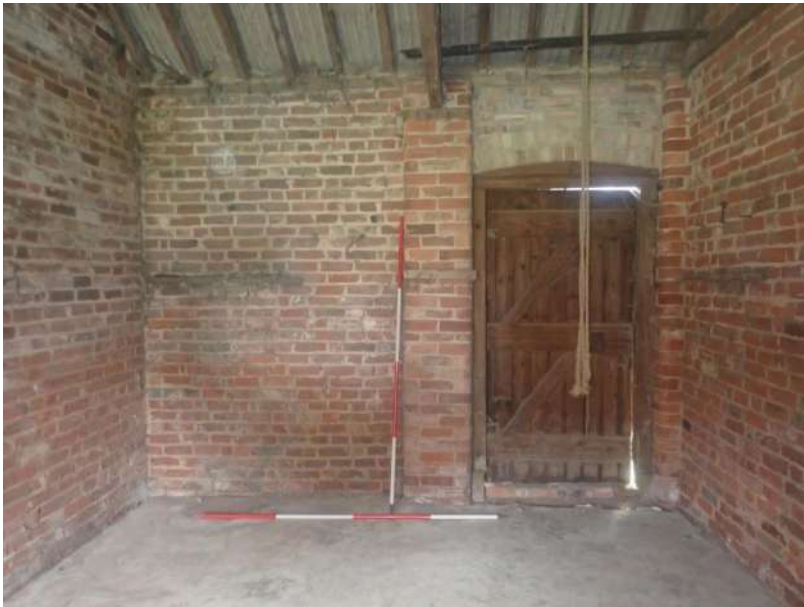
**Plate 293** presents a view of the east wall of **Cell 7**. The brickwork of this east wall is composed of courses of mixed brick headers and brick stretchers in a variation of Flemish Bond. The inner face of the east facing entrance opening that was recorded externally at the East Elevation of this outbuilding is also shown. The vertical tongued and grooved timber planks of the door are attached to an internal framework of angled and horizontal timbers. Above the opening is an area of modern brick repair that includes the brick head. Horizontal timber wallplates may also be seen to extend along the top of this east wall. The entrance opening is flanked to the immediate left (north) by a vertical brick column, which is bonded to the east wall. The column is composed of courses of mixed brick stretchers and of bull nosed brick stretchers.

**Plate 293: View of the east wall of Cell 7, from the west**

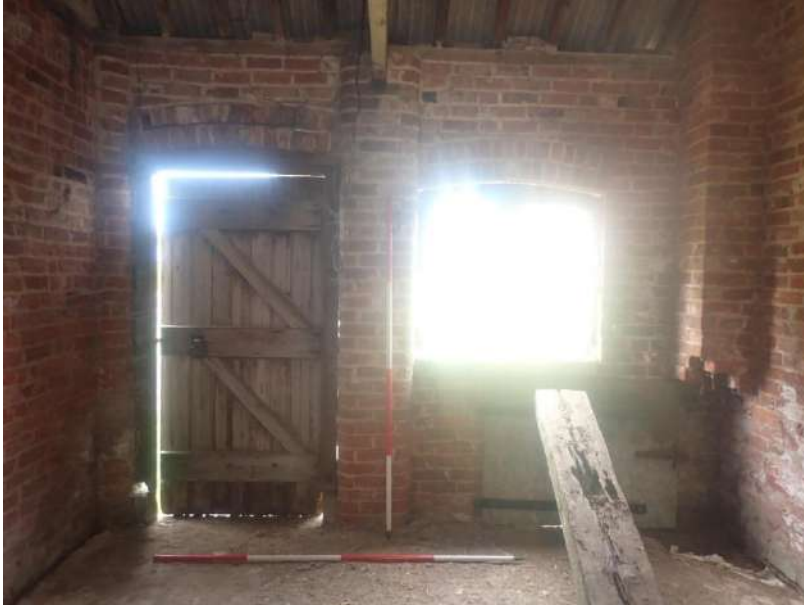
**Plate 294: View of the west wall of Cell 7, from the east**

**Plate 294** features the west wall of **Cell 7**. The brickwork wall fabric of this west wall is composed of courses of mixed brick headers and brick stretchers in a variation of Flemish Bond. To the right (north), is the inner face of the west facing window opening that was recorded externally at the West Elevation of this outbuilding. To the left (south), is the inner face of the west facing entrance opening which was also recorded externally at this West Elevation. The vertical tongued and grooved timber planking of the door is attached to an internal framework of angled and horizontal timbers. Both openings are bisected by a further vertical brick column, which is composed of courses of mixed brick stretchers and of bull nosed brick stretchers. Horizontal timber wallplates may also be seen to extend along the top of this west wall.

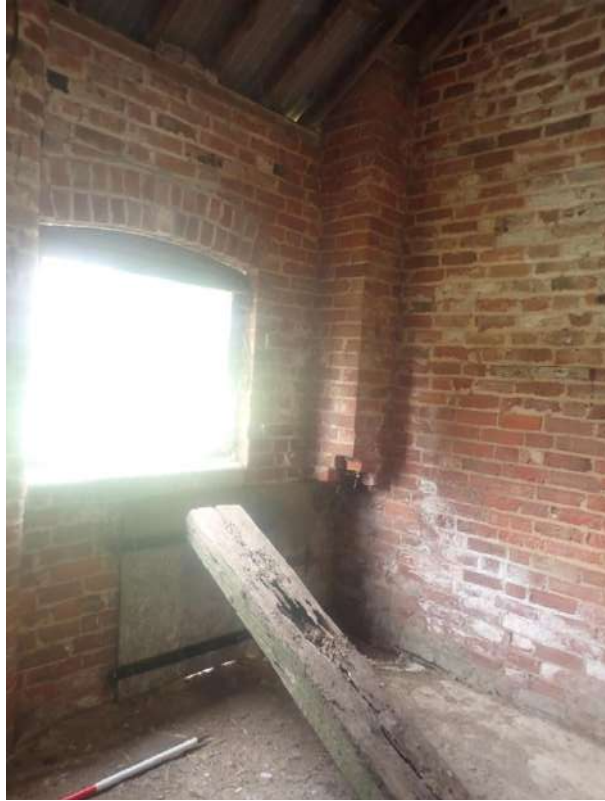
**Plate 295** shows the vertical brick chimney breast that is situated at the corner of the west and north walls of **Cell 7**. The base of the chimney breast is absent. The chimney breast is composed of courses of mixed brick headers and brick stretchers and extends through the gabled roof.

**Plate 295: View of the vertical chimney breast at the west wall of Cell 7, from the south-east**

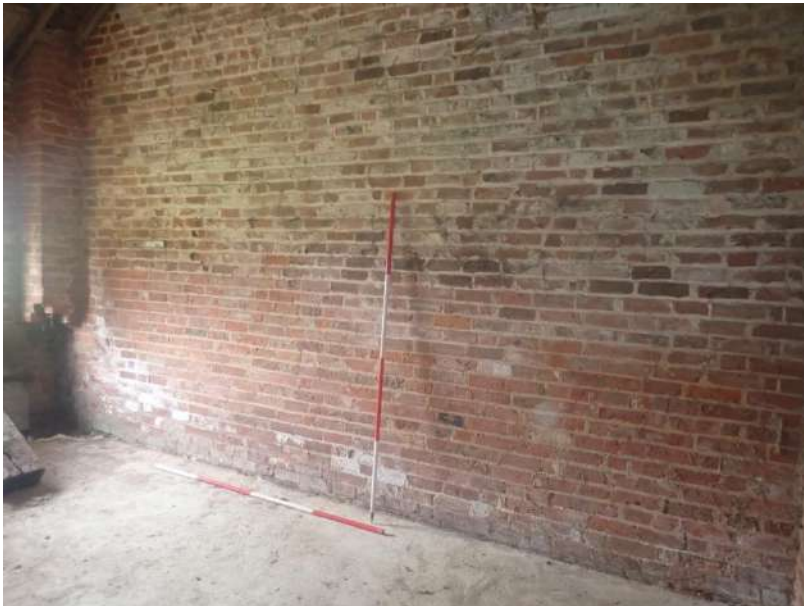
**Plate 296: View of the north wall of Cell 7, from the south-east**

**Plates 296 and 297** show the north wall of **Cell 7**, which is also the internal dividing wall with the adjacent **Cell 6** of the North Range to the north. The brickwork of this north wall is composed of courses of mixed brick headers and brick stretchers in a variation of Flemish Bond. The northern ends of the horizontal timber purlins of the overlying roof structure may be seen to be inserted into the uppermost levels of this wall fabric.

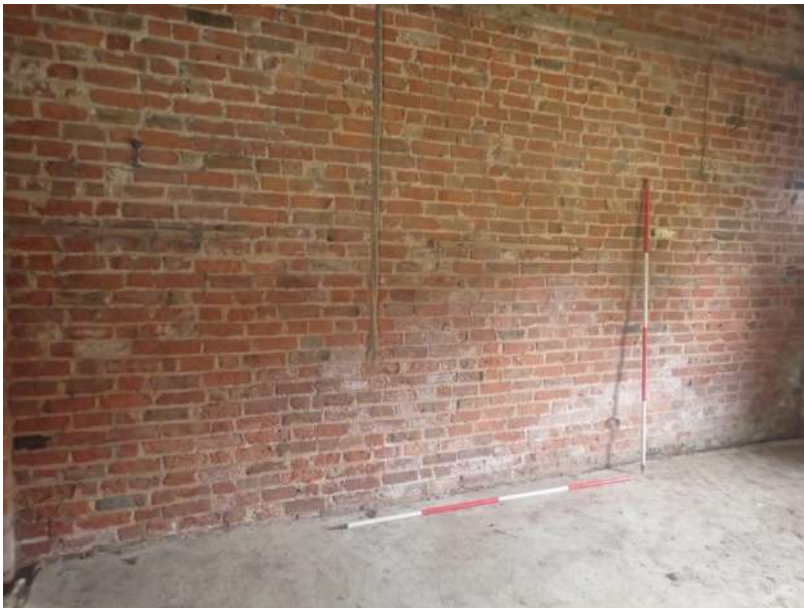
**Plate 298: View of the south wall of Cell 7, from the north-east**

**Plates 298 and 299** feature the south wall of **Cell 7**. The brickwork wall fabric of this south wall is composed of courses of mixed brick headers and brick stretchers in a variation of Flemish Bond. The southern ends of the horizontal timber purlins of the overlying roof structure may be seen to be inserted into the uppermost levels of this wall fabric.

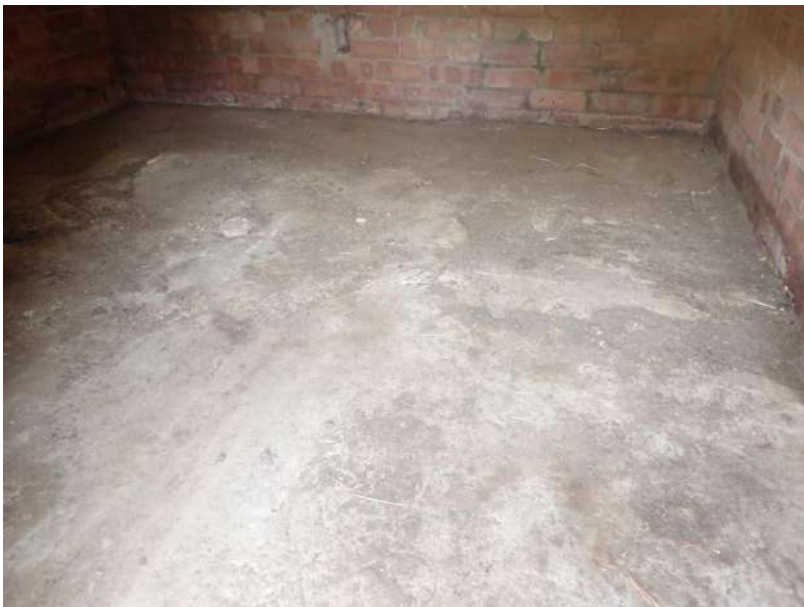
**Plate 300: View of the flooring of Stie 1, from the west**

**Plate 300** features the nature of the flooring of **Stie 1**, which is of modern concrete.

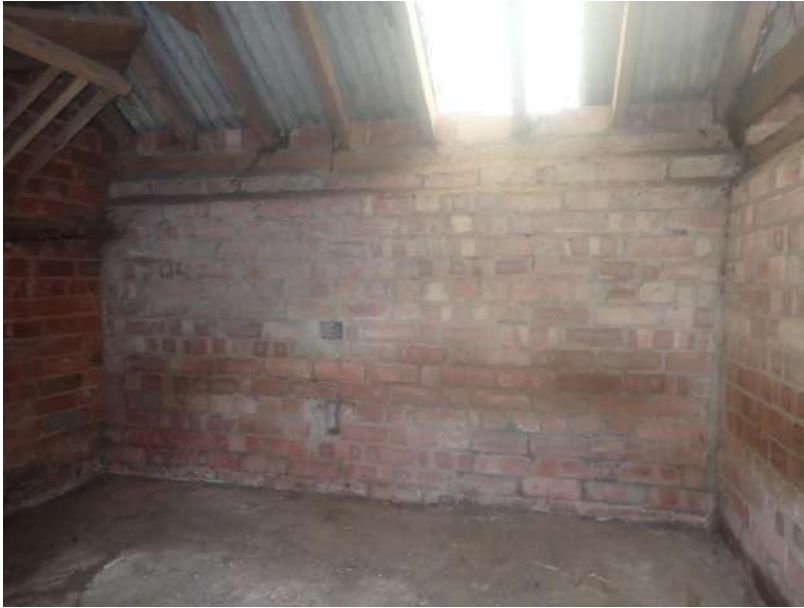
**Plate 301:** View of the back east wall of Stie 1, from the west

**Plate 301** provides a view of the back east wall of **Stie 1**, which is composed of 3-5 courses of brick stretchers alternating with single courses of brick headers in a variation of English Garden Wall Bond. An horizontal timber wallplate extends along the top of this wall.

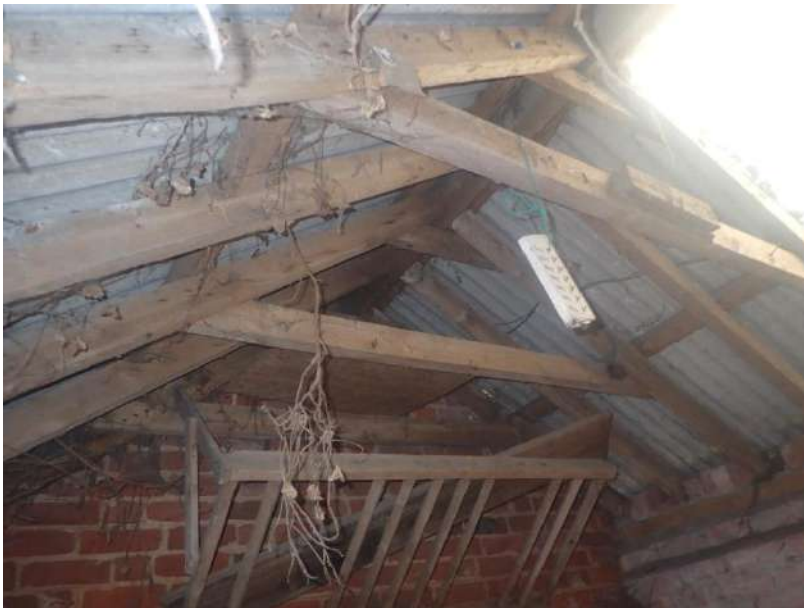
**Plate 302:** View of the roof supporting structure of Stie 1, from the south

**Plate 302** features the northern end of the roof supporting structure of **Sties 1-3**. This is a relatively simple structure that is composed of a framework of timber rafters and horizontal timber purlins that extend along both sides of this structure along with further horizontal timber purlins at the roof apex. Also featured in this image are several horizontal timber collars that are attached to the rafters.

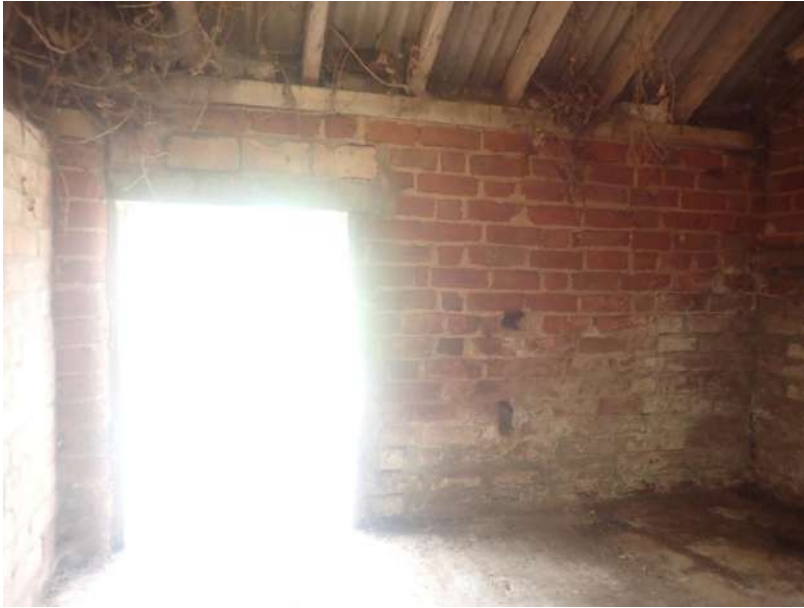
**Plate 303: View of the west wall of Stie 1, from the east**

**Plate 303** shows the west wall of **Stie 1** with its open west facing entrance opening. The brickwork of this west wall is composed of courses of mixed brick headers and brick stretchers. An horizontal timber wallplate extends along the top of this wall. Above the opening is a horizontal concrete lintel, which is also part of the wall fabric.

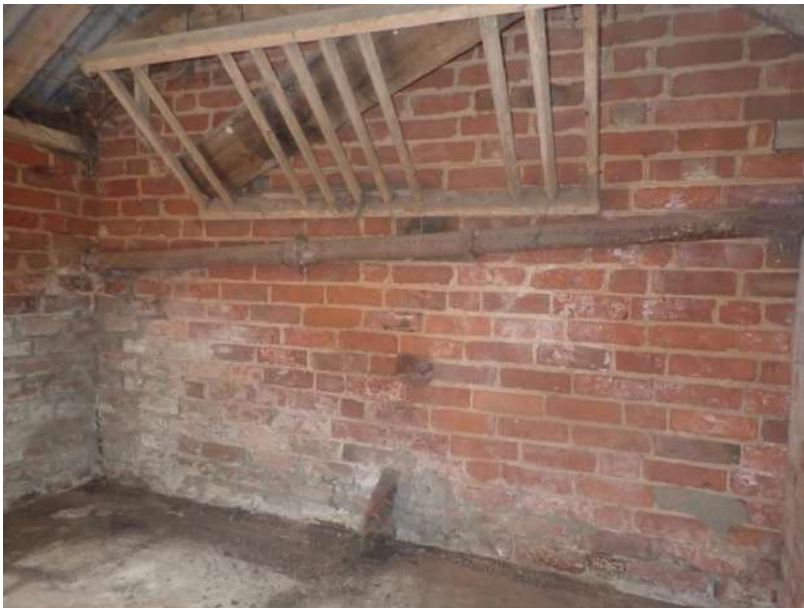
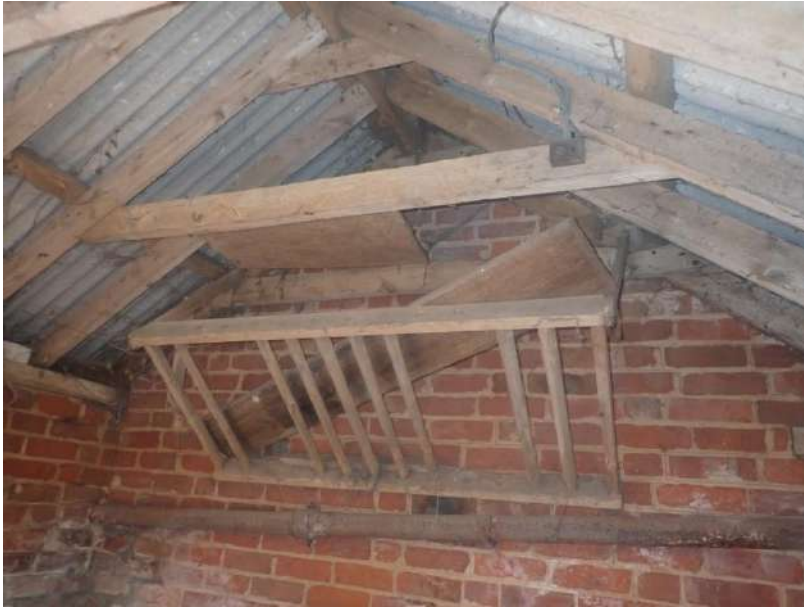
**Plates 304 and 305** feature the north wall of **Stie 1**, to which is attached a timber animal feed byre. The brickwork wall fabric here is composed of courses of mixed brick headers and brick stretchers.

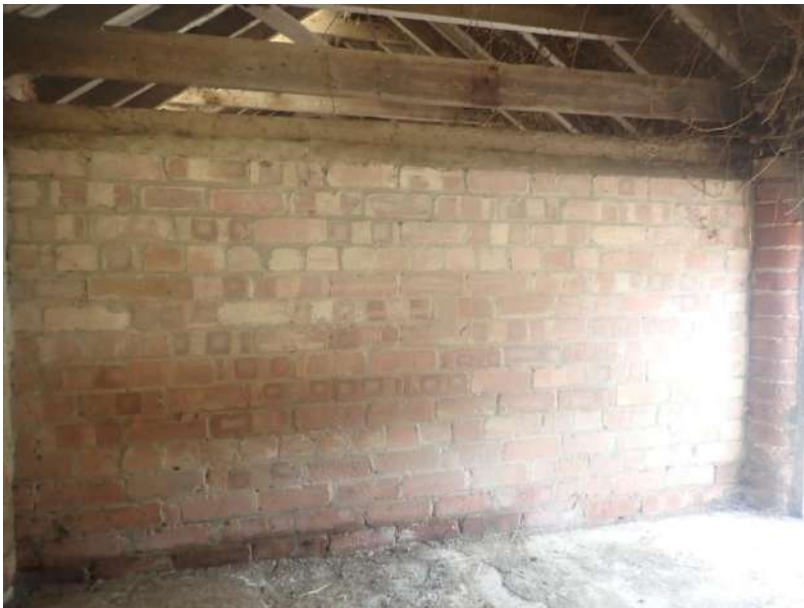
**Plate 306:** View of the south wall of Stie 1, from the north

**Plate 306** presents a view of the south wall of **Stie 1**, which is mostly composed of courses of brick stretchers with a single course of brick headers.

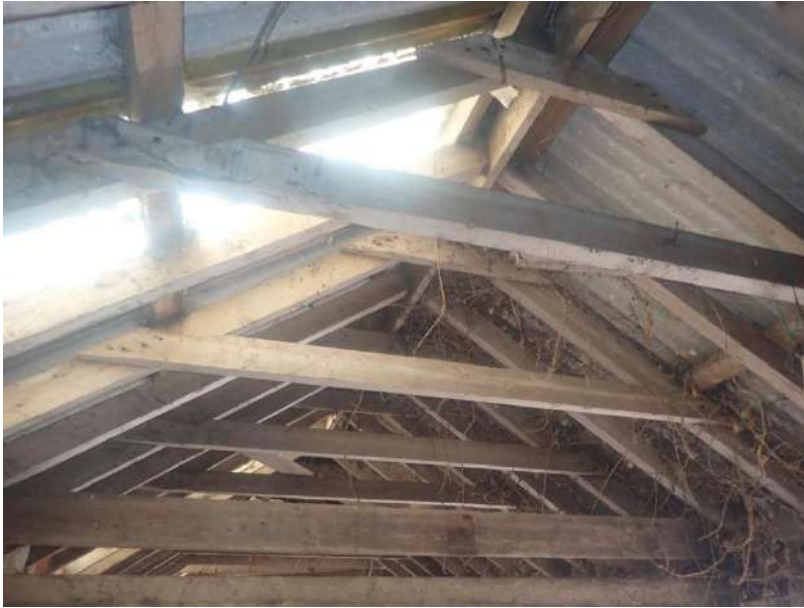
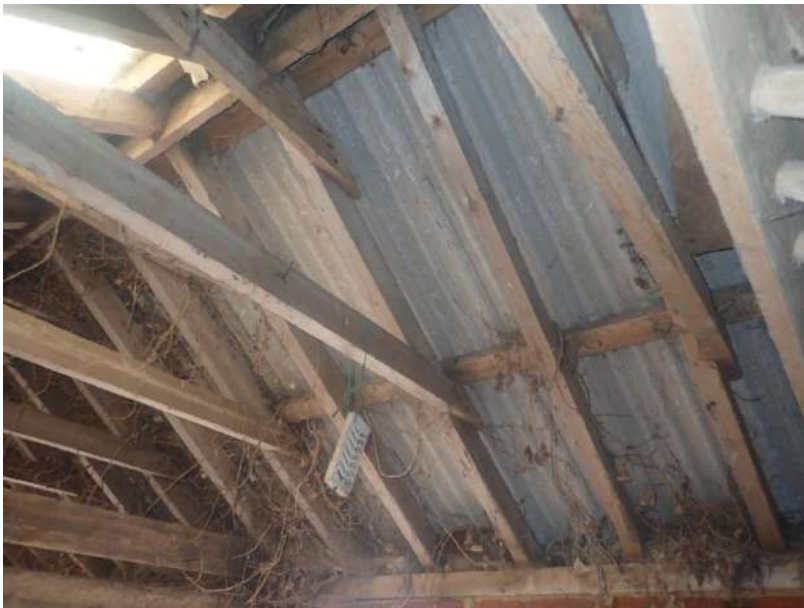
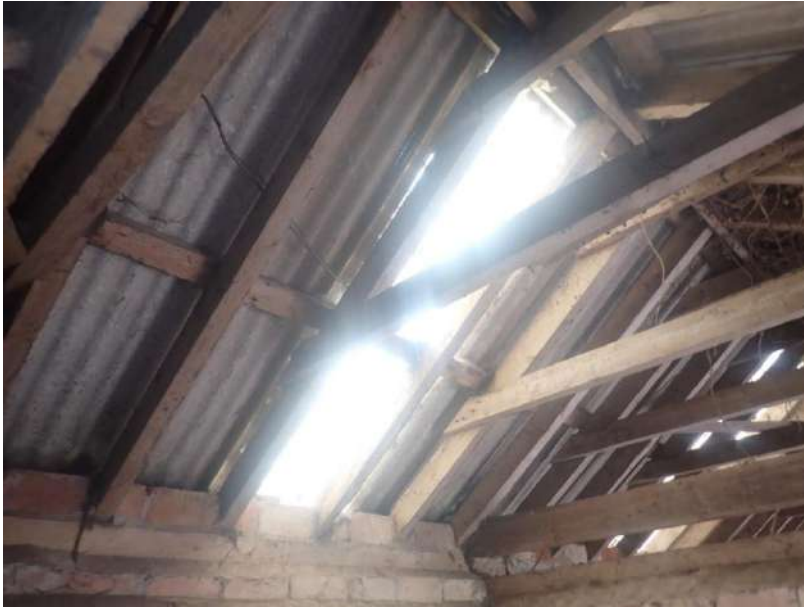
**Plates 307-309** provide several further images of the nature of the roof supporting structure above **Sites 1-3** from a northern position. In addition, to the timbers already described, there are a series of horizontal timber tie beams at the lower levels of this structure, which are below the series of horizontal timber collars.

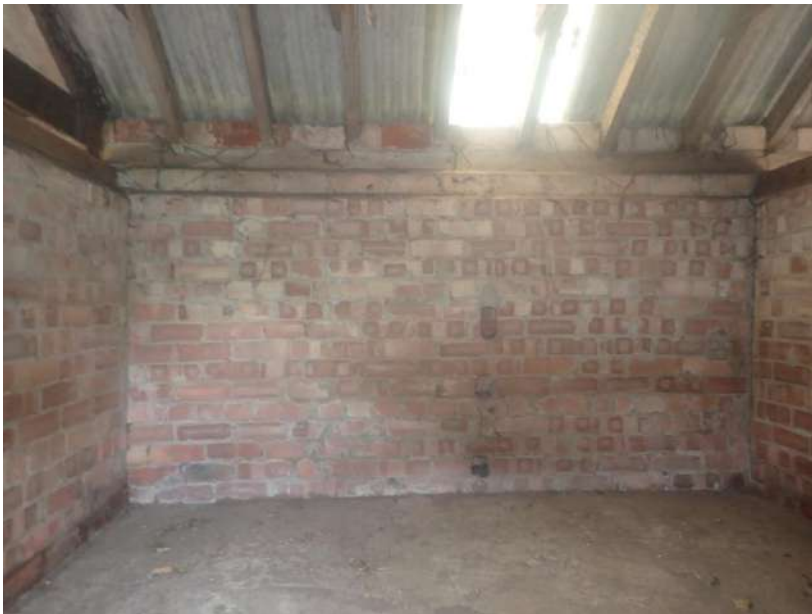
**Plate 310:** View of the east wall of Stie 2, from the west

**Plate 310** features the east wall of **Stie 2**, which is composed of 4-5 courses of brick stretchers that alternate with single courses of brick headers in a variation of English Garden Wall Bond. A horizontal timber wallplate extends along the top of this wall.

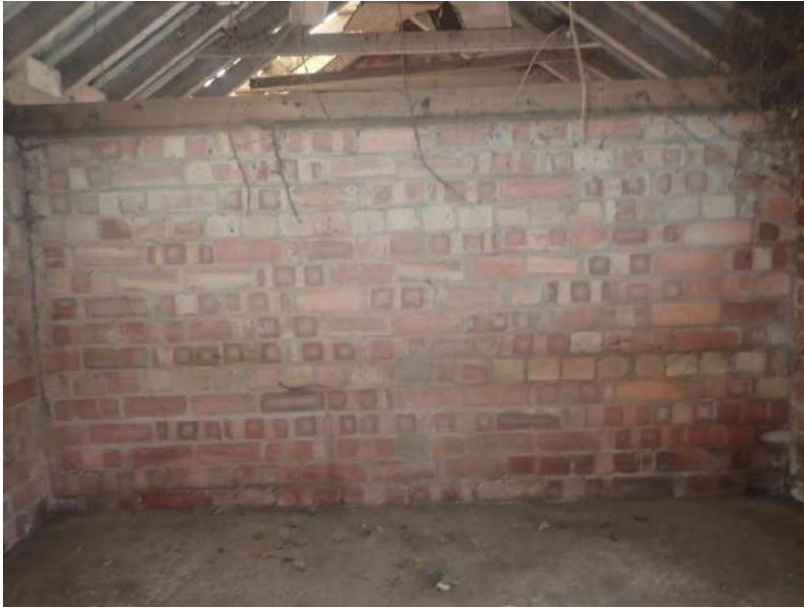
**Plate 311: View of the south wall of Stie 2, from the north**

**Plate 311** presents a view of the south wall of **Stie 2**, which is composed of 4-5 courses of brick stretchers that alternate with single courses of brick headers in a variation of English Garden Wall Bond.

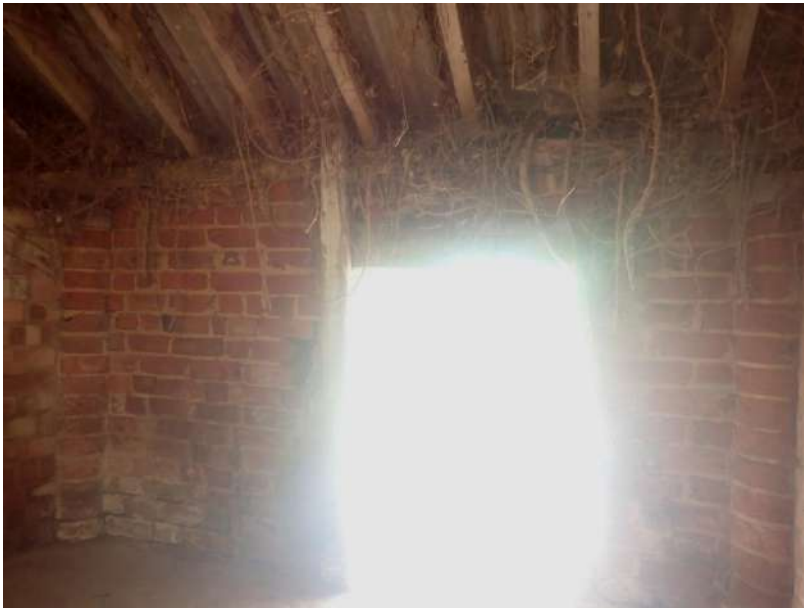
**Plate 314:** View of the west wall of Stie 2, from the east

**Plate 314** shows the west wall of **Stie 2**. The brickwork here is composed of courses of mixed birck headers and brick stretchers in a variation of Flemish Bond. Above the west facing entrance opening is an horizontal concrete lintel, which is also part of the wall fabric. An horizontal timber wallplate extends along the top of this wall.

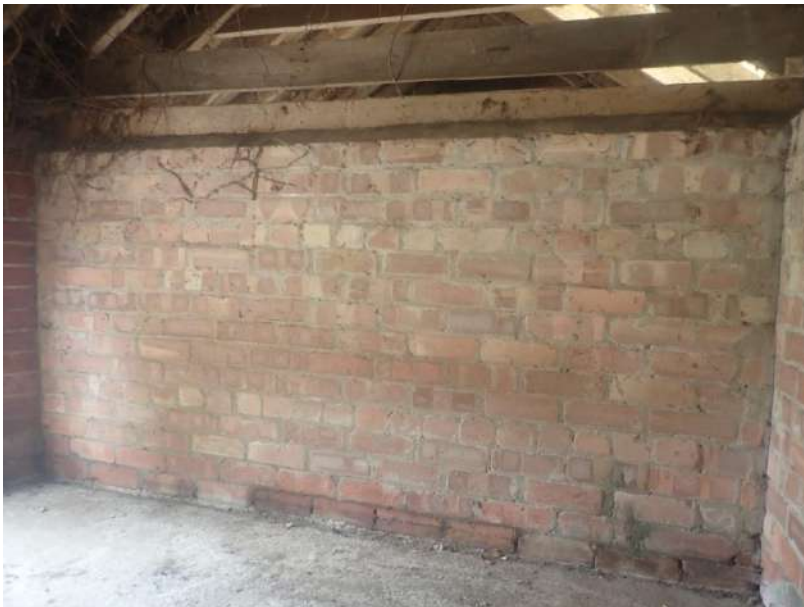
**Plate 316: View of the north wall of Stie 2, from the south**

**Plate 316** shows the north wall of **Stie 2**, which is constructed of 3-5 courses of brick stretchers that alternate with single courses of brick headers in a variation of English Garden Wall Bond.

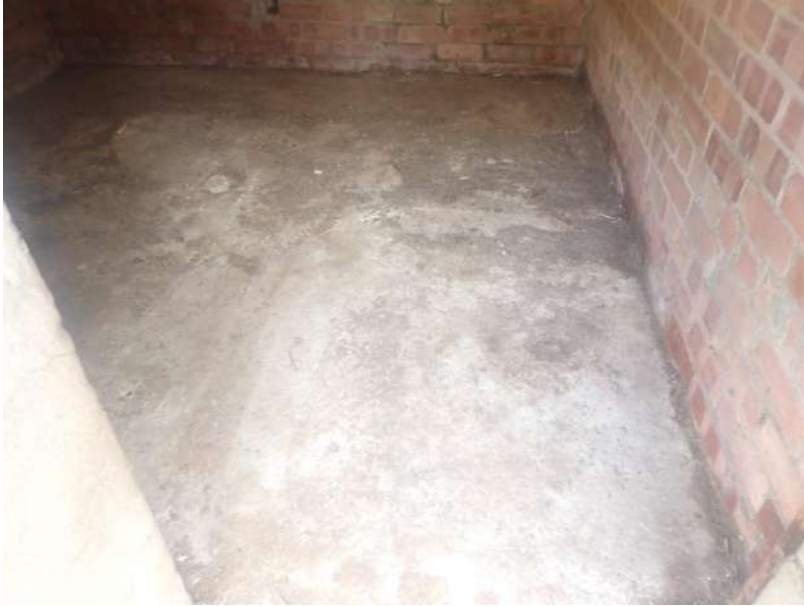
**Plate 317: View of the flooring of Stie 2, from the west**

**Plate 317** features the nature of the flooring of **Stie 2**, which is of modern concrete.

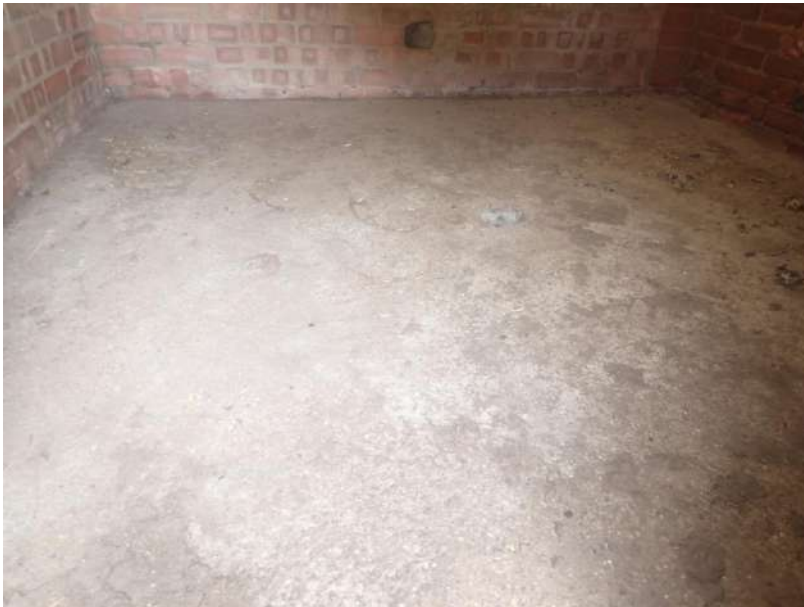
**Plate 318: View of the flooring of Stie 3, from the west**

**Plate 318** features the nature of the flooring of **Stie 3**, which is of modern concrete.

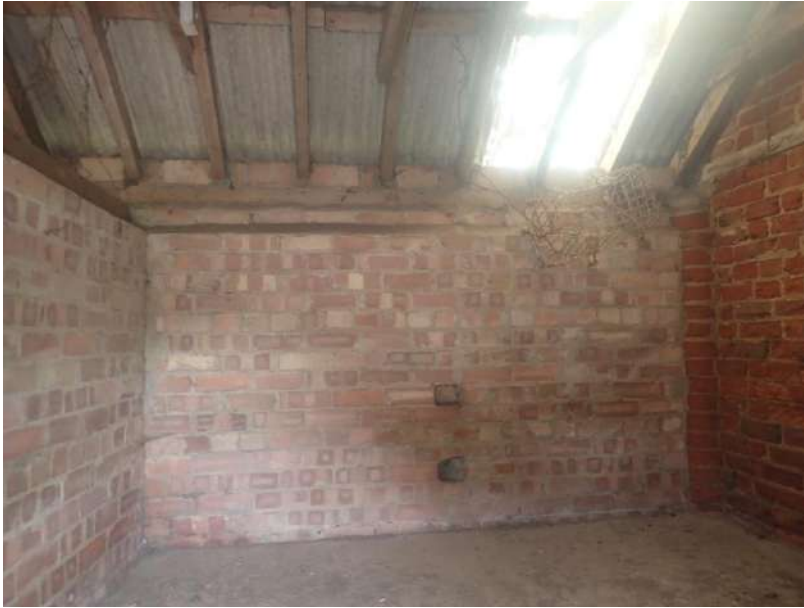
**Plate 319:** View of the east wall of Stie 3, from the west

**Plate 319** features the east wall of **Stie 3**, which is composed of 4-6 courses of brick stretchers alternating with single courses of brick headers in a variation of English Garden Wall Bond. A horizontal timber wallplate extends along the top of this wall.

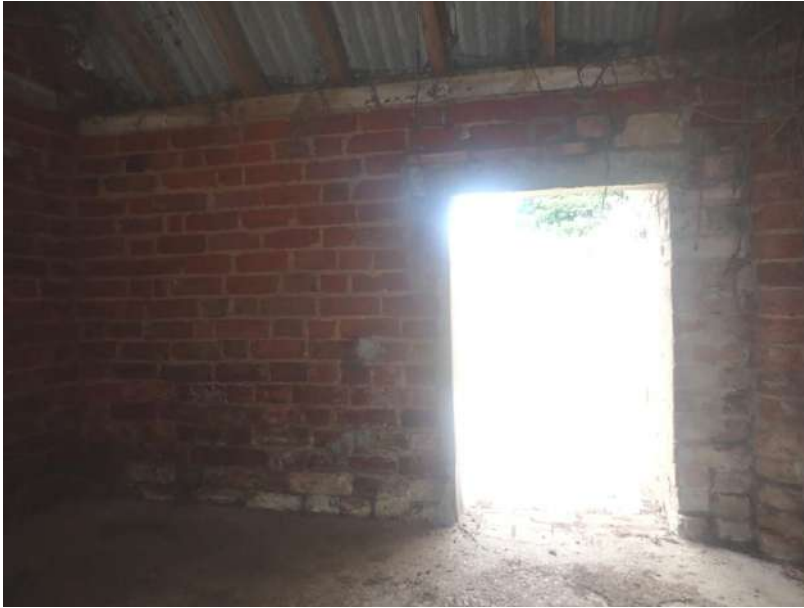
**Plate 321: View of the west wall of Stie 3, from the east**

**Plate 321** features the west wall of **Stie 3**. The brickwork wall fabric here is composed of courses of mixed brick headers and brick stretchers in a variation of Flemish Bond. Above the west facing opening is an horizontal concrete lintel that is incorporated into the wall fabric. An horizontal timber wallplate extends along the top of this wall.

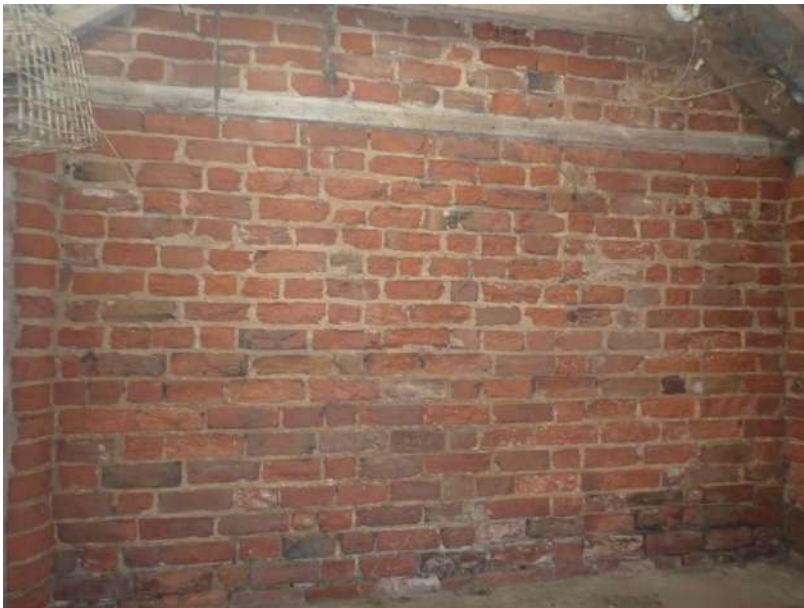
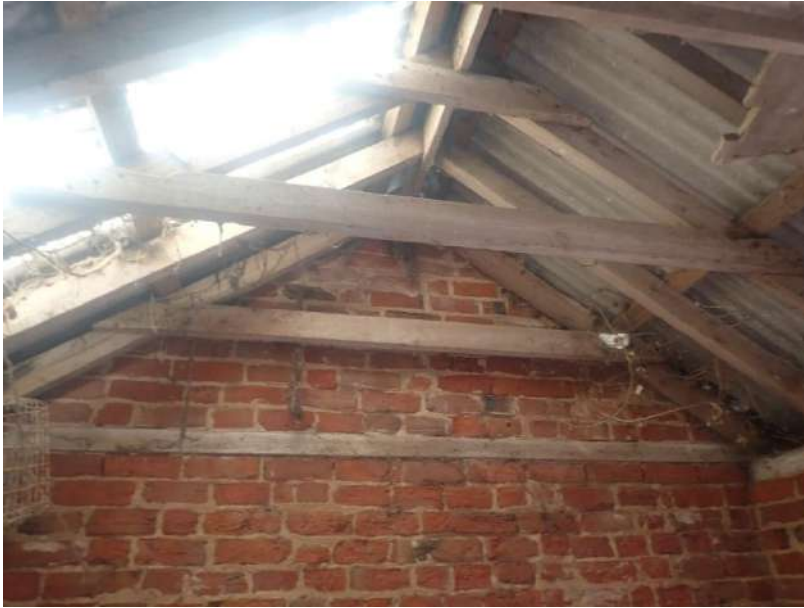
**Plates 324 and 325** show the south wall of **Site 3** with its earlier brickwork, composed of courses of mixed brick headers and brick stretchers in a variation of Flemish Bond. Incorporated into this brickwork is an horizontal timber wallplate.

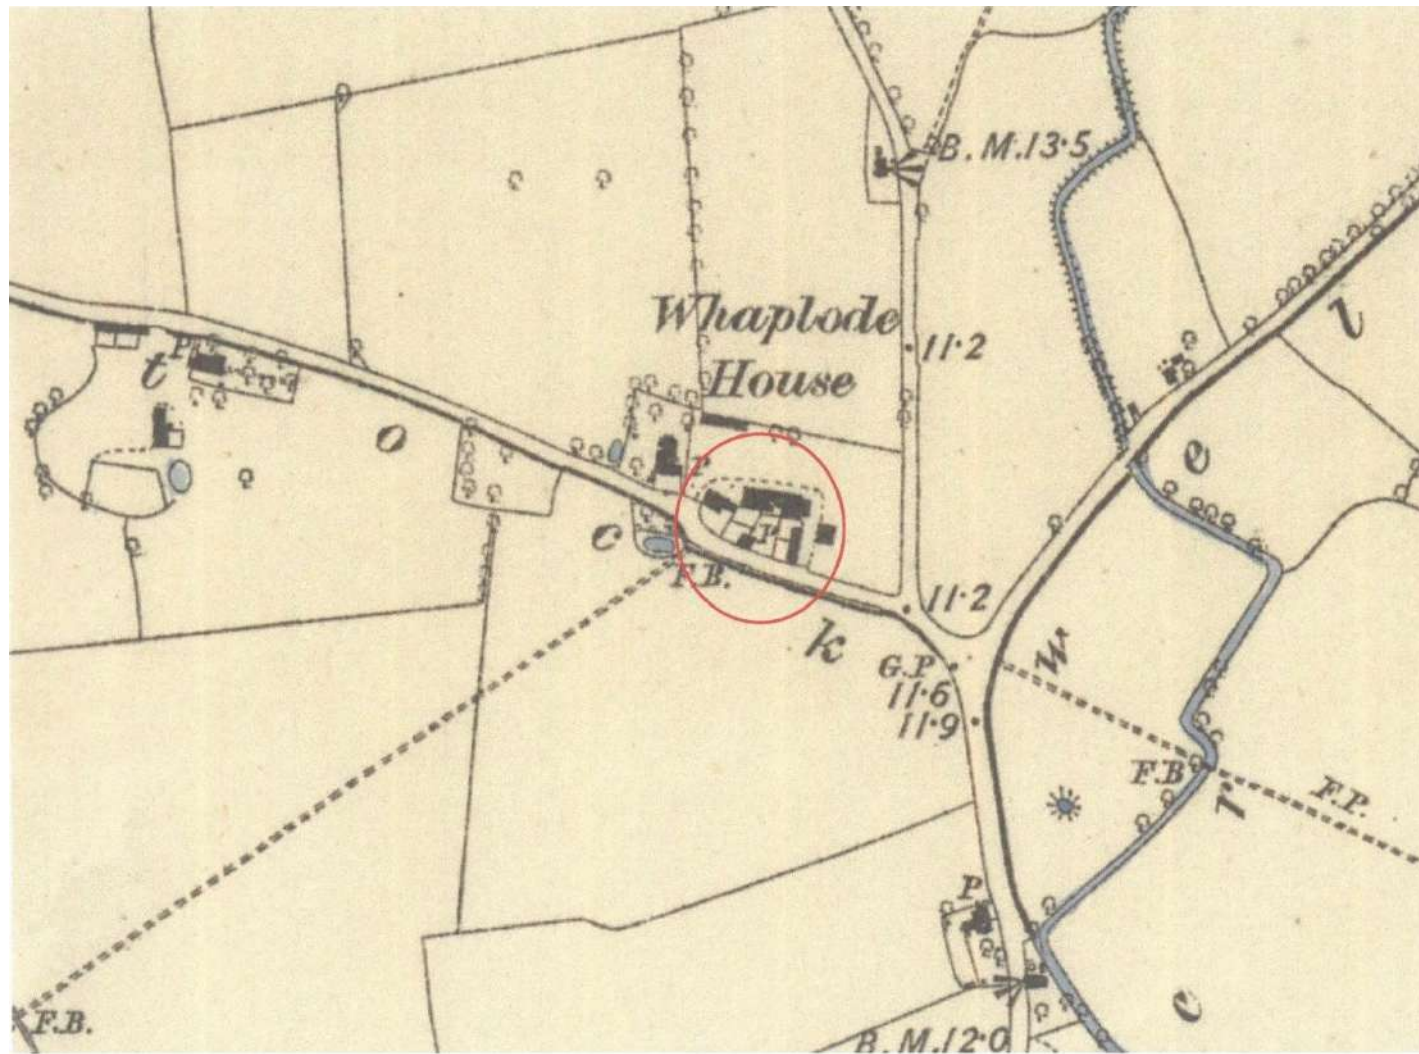
**Figure 8:** Extract from the First Edition six inch to one mile scale Ordnance Survey (O.S.) map of 1887, map sheet no. Lincolnshire 135SW. The site is shown encircled in red.

- 5.5 An extract from the First Edition six inch to one mile scale Ordnance Survey (O.S.) map of 1887 forms **Figure 8**. This map shows that radical alteration had taken place to the layout of this site between 1843 and 1887. The three small rectangular shaped outbuildings that were featured on the map of 1843, had by 1887, all been demolished. They were replaced by a large rectangular shaped outbuilding, along with four further and smaller detached outbuildings to the south-east, south and south-west of the first large outbuilding. A further detached linear shaped outbuilding is also shown to the north-west.
