## Phase 4 Verification Report

### **La Rose Homes Limited**

Land adjacent to Charnwood, 259 High Road, Whaplode, Spalding, PE12 6TG

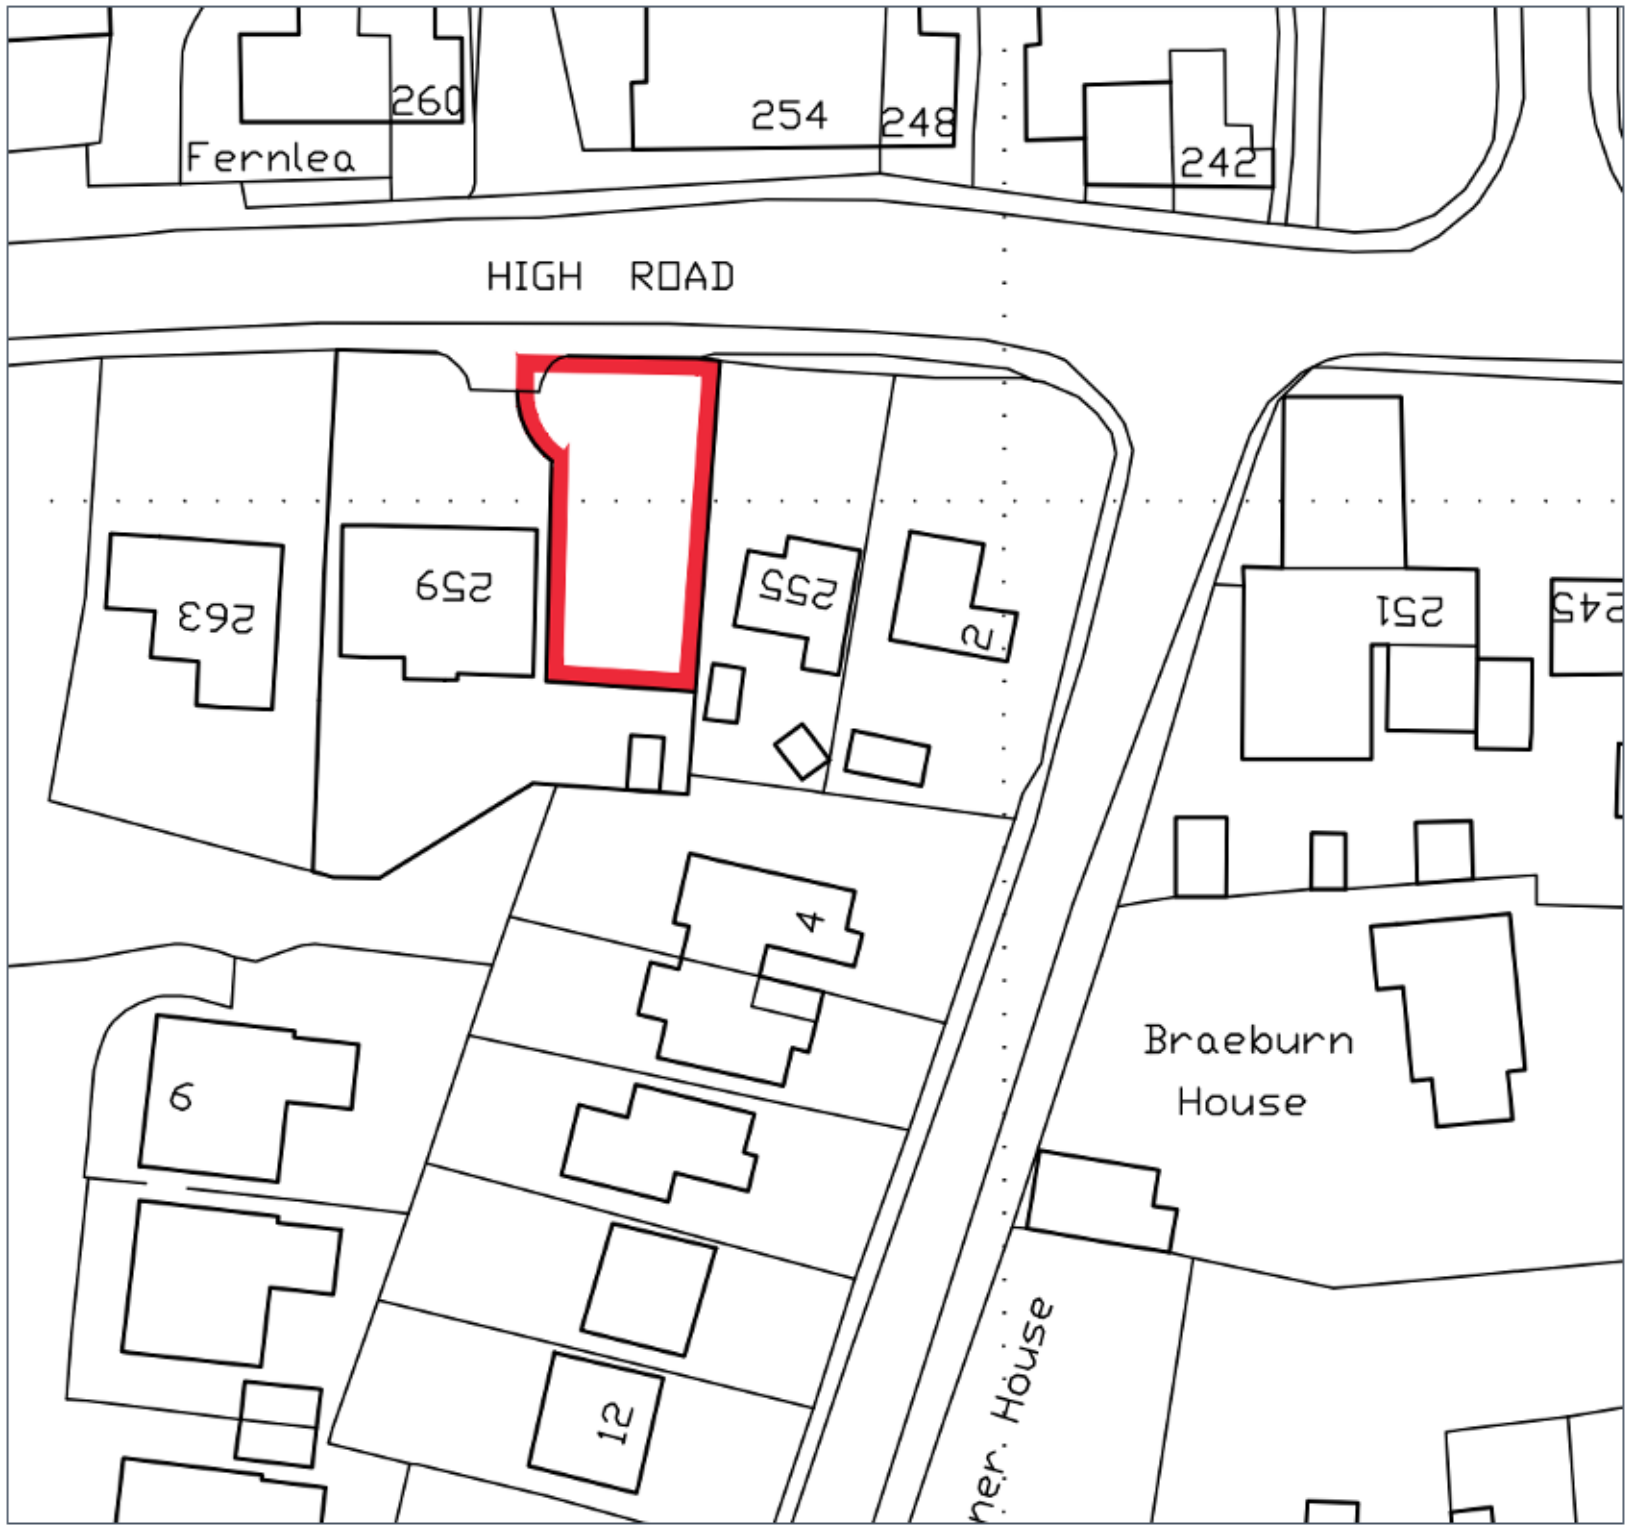
Appendix - Site Maps & Plans

| Appendix - Site Maps & Plans | |
|---|---|
| <div></div> | Extent of clean cover recommended |

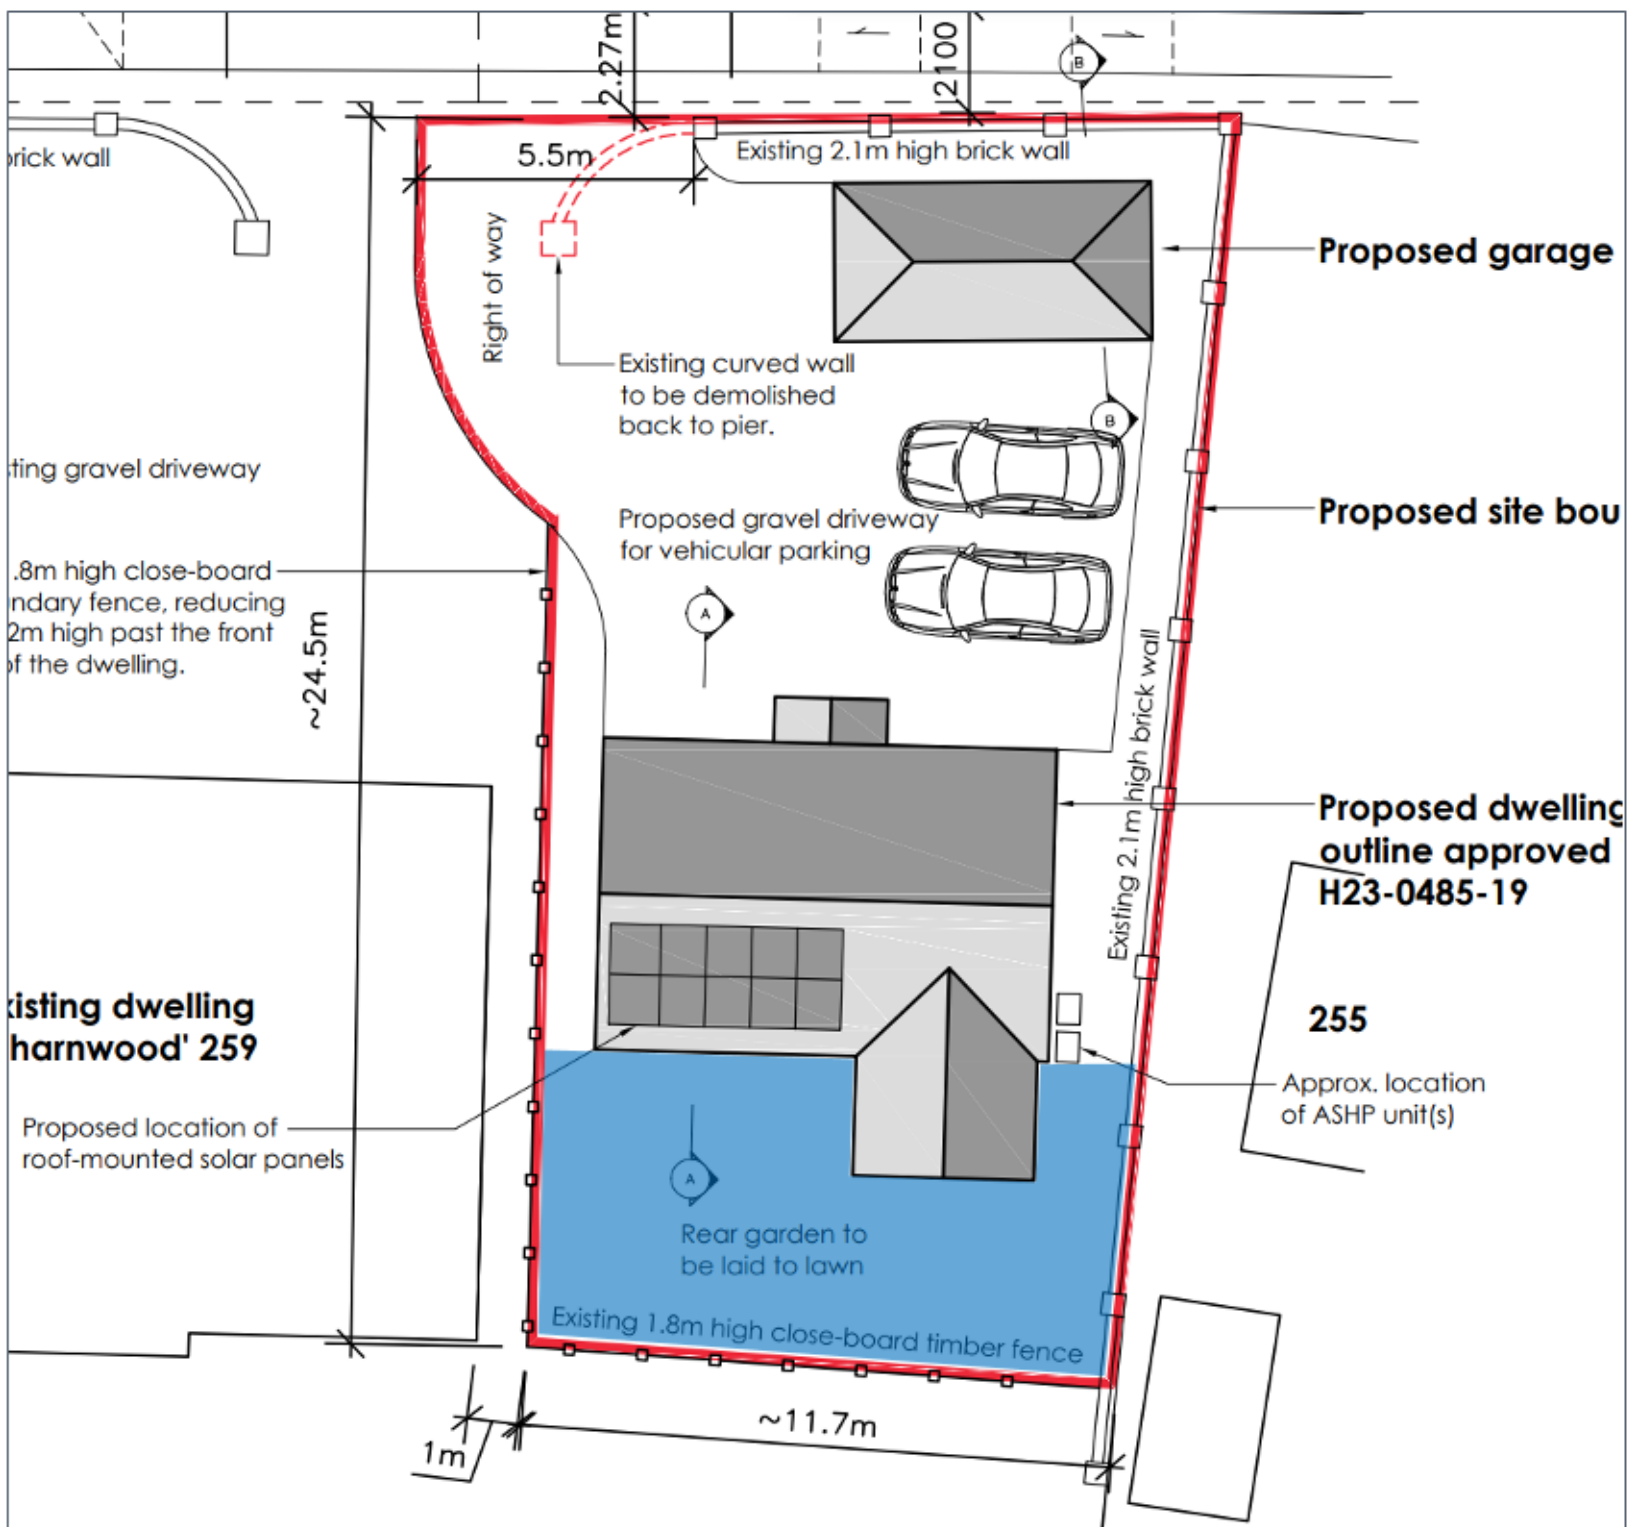
| Appendix - Site Maps & Plans | |
|---|---|
| Description | Proposed site plan showing the extent of clean cover required |

A cover layer of clean material should then be placed to a minimum depth of 0.6m at the south of the site in the proposed rear garden area. This material can be site-won material from the north of the site can be used, provided this can be shown to be free from made ground material.

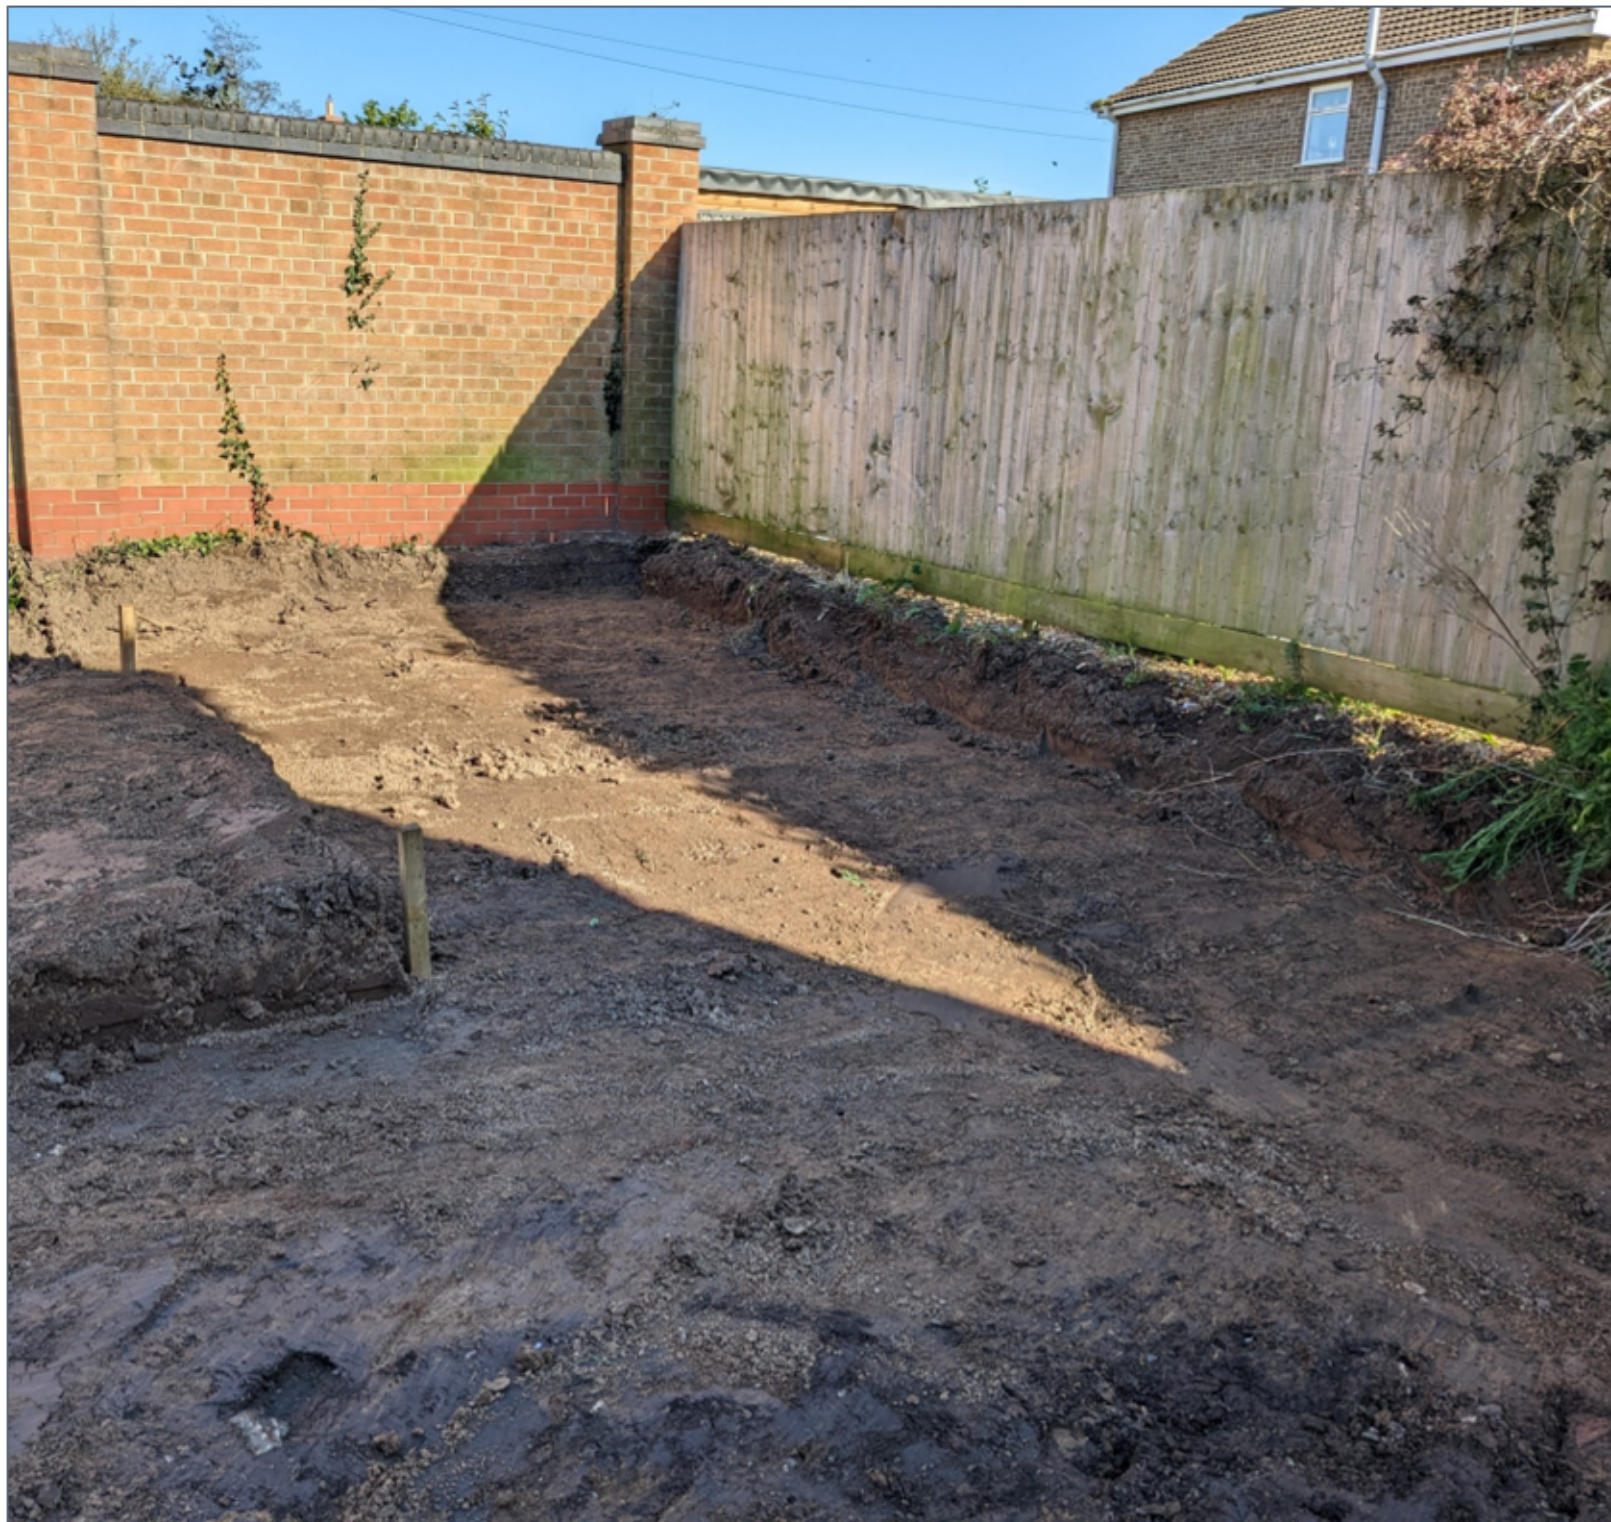
Photo showing the excavation of 600mm at the south of the site

Information and supporting evidence supplied by the client show that soil and made ground from the garden area at the south of the site was excavated down to 600mm, and removed from site, and replaced with clean site-won soil.

Photos showing the excavation of 600mm of soil and made ground from the south of the site are shown in Appendix.

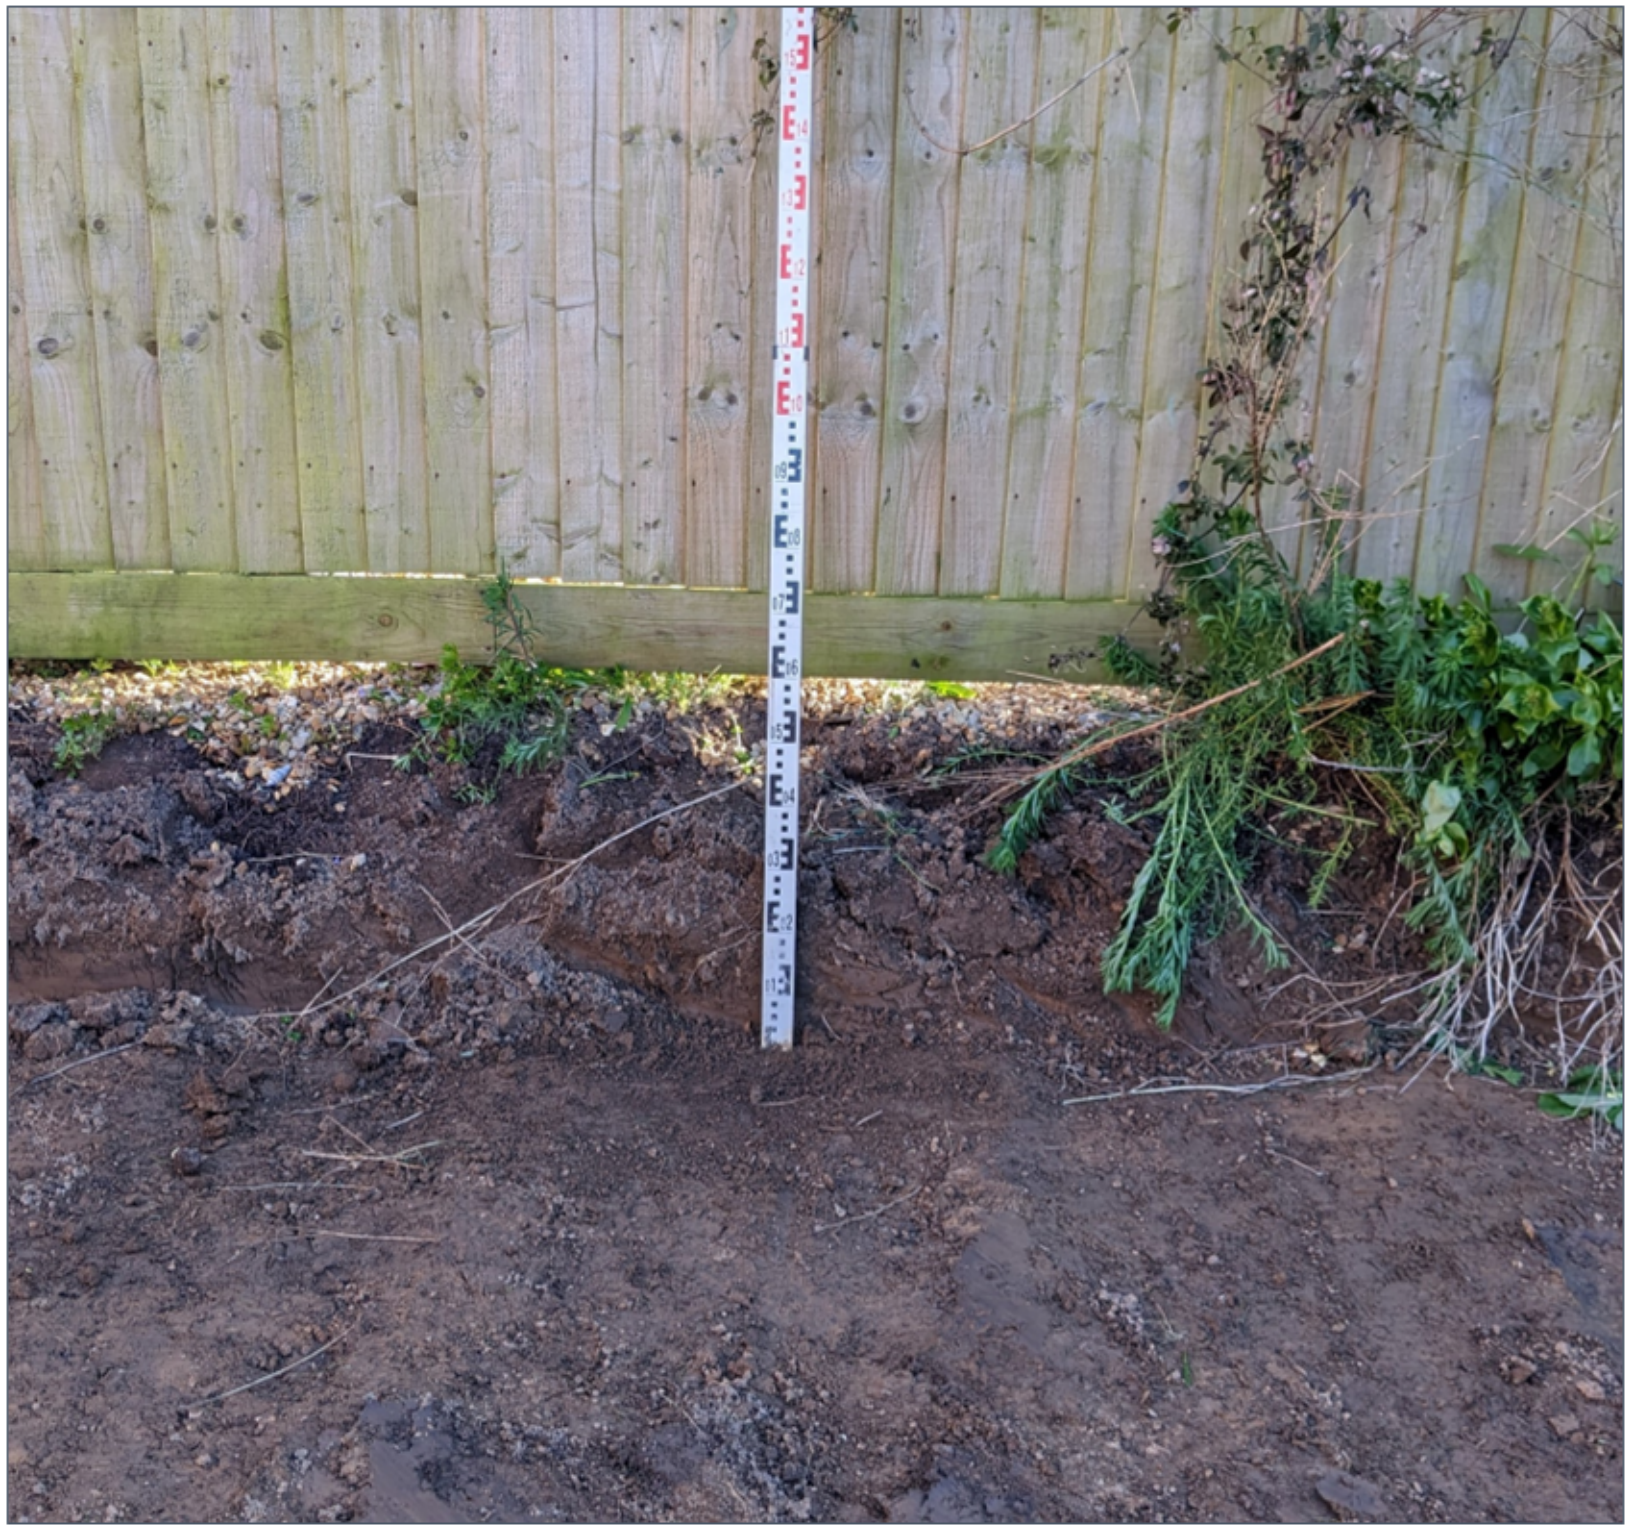
Photo showing the excavation of 600mm at the south of the site

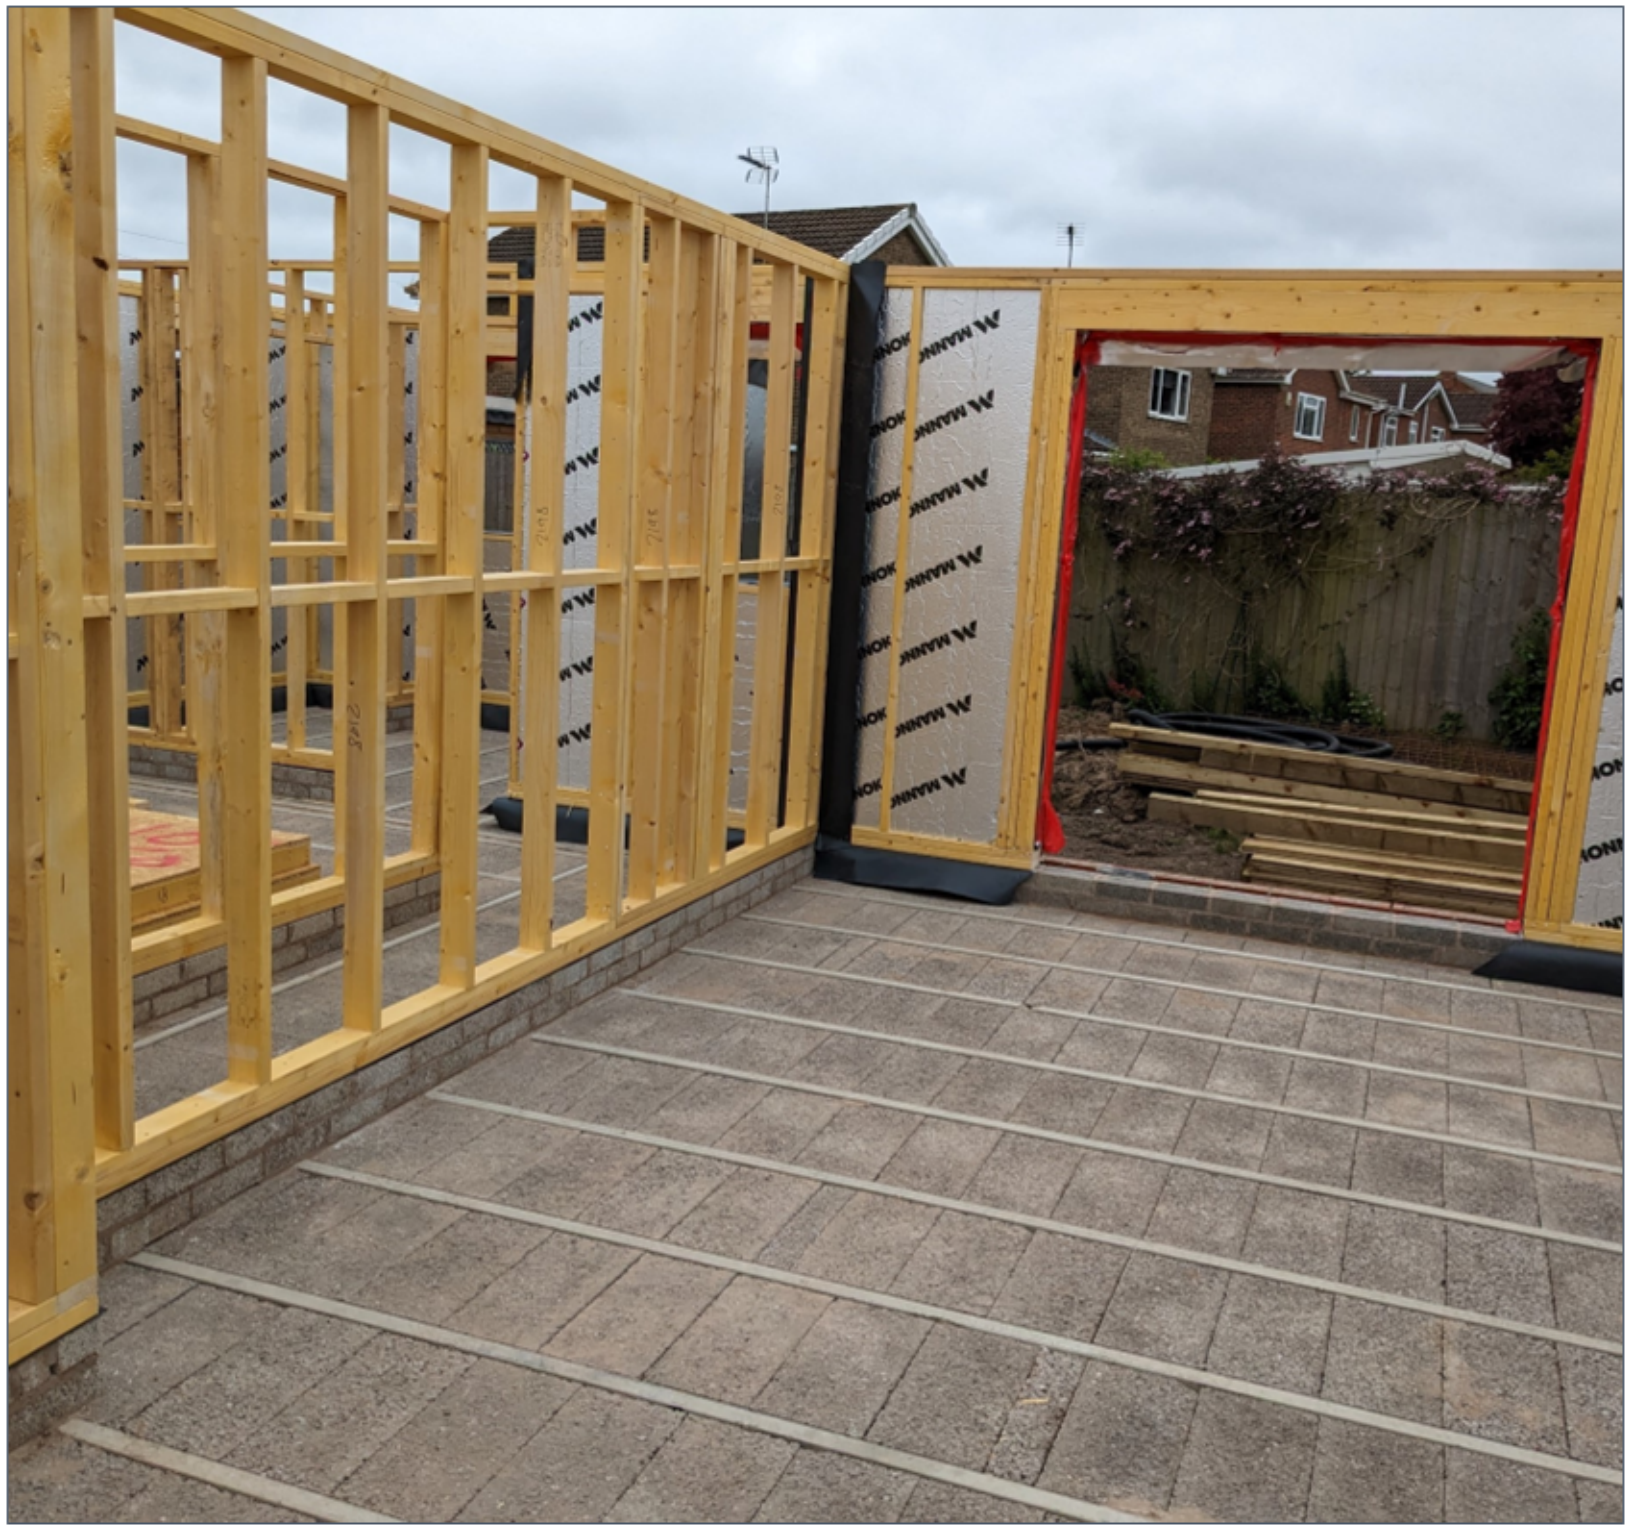
Photo showing the completed block and beam floor

In addition, the dwelling has been constructed with a block and beam floor design, incorporating a subfloor void with air bricks, and a 2000 gauge polythene membrane has been installed to mitigate the risk from ground gases.

Photos showing the installation process and completed building basework and floor were reviewed and confirm that a minimum 150mm underfloor void with telescopic vents and a 2000 gauge polythene membrane has been installed to mitigate the risk from ground gases, in addition, the installation and completion of this work was inspected and signed off by AIS Chartered Surveyors. AIS Site Inspection Reports were reviewed and are attached as supporting evidence to the report.

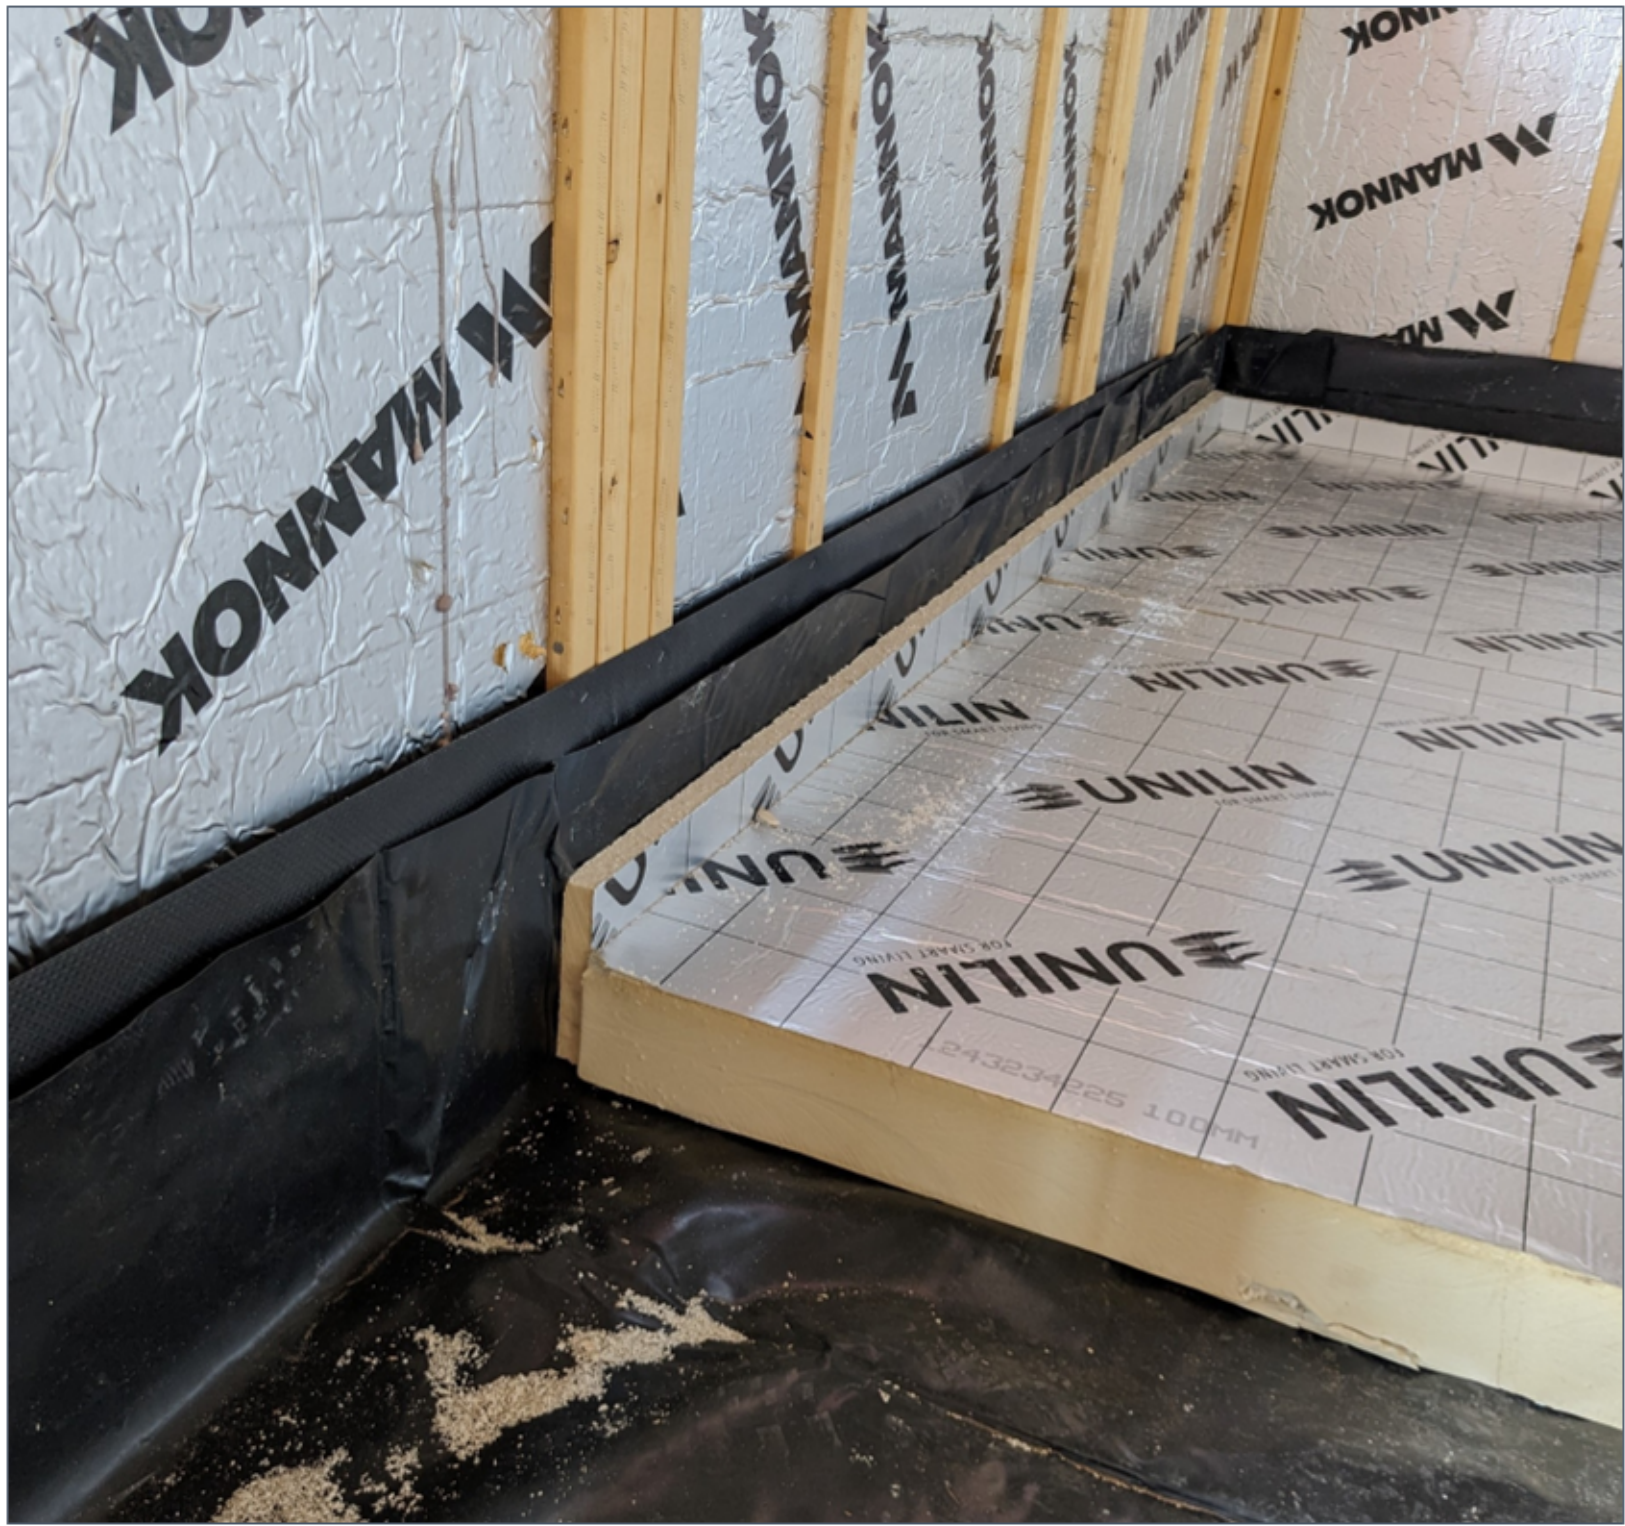
Photo showing the installation of a 2000 gauge polythene membrane

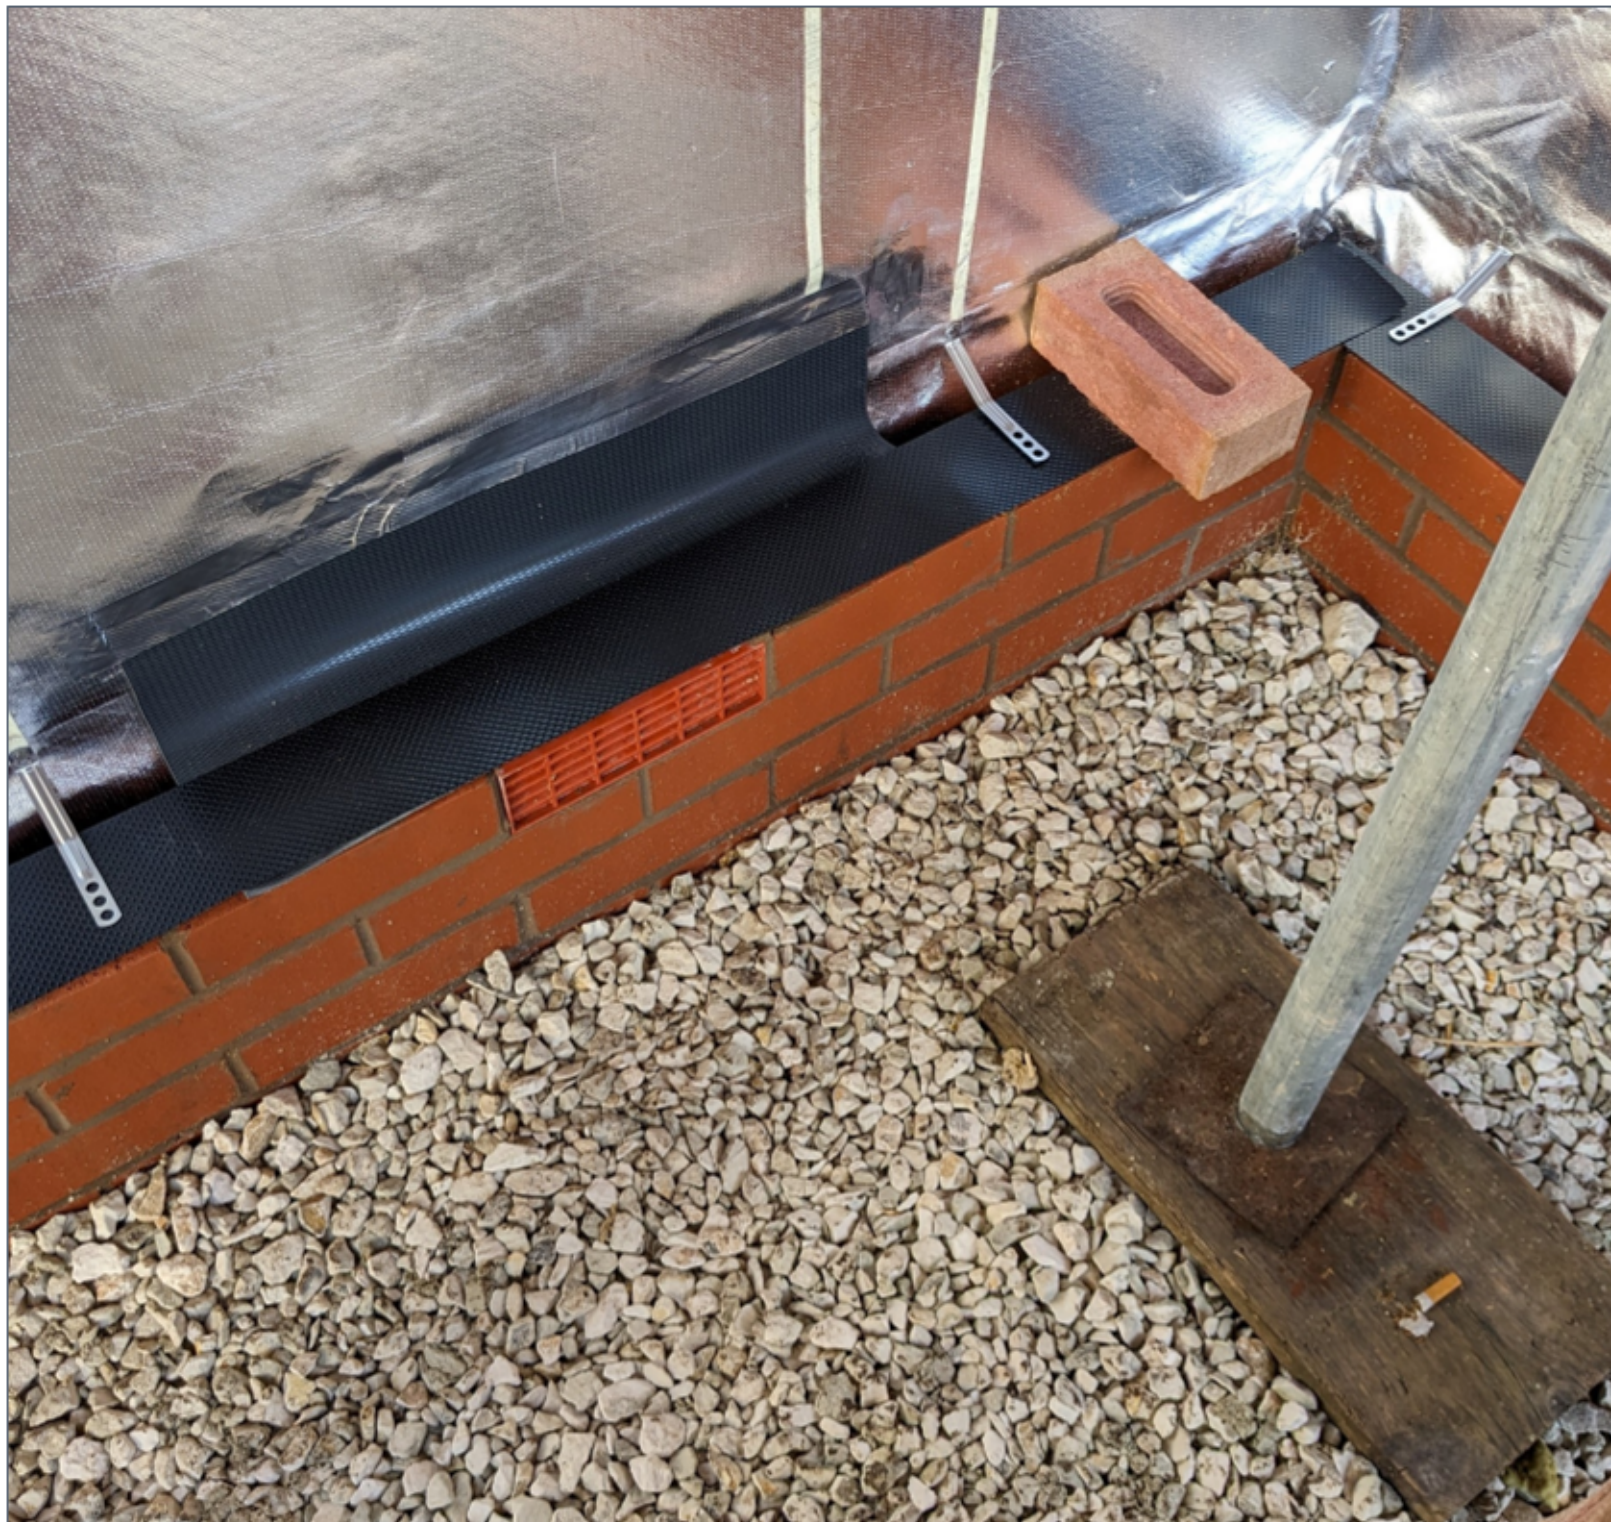
| Appendix - Site Photos |
|---|
| Photo showing the installation of DPM and air bricks |

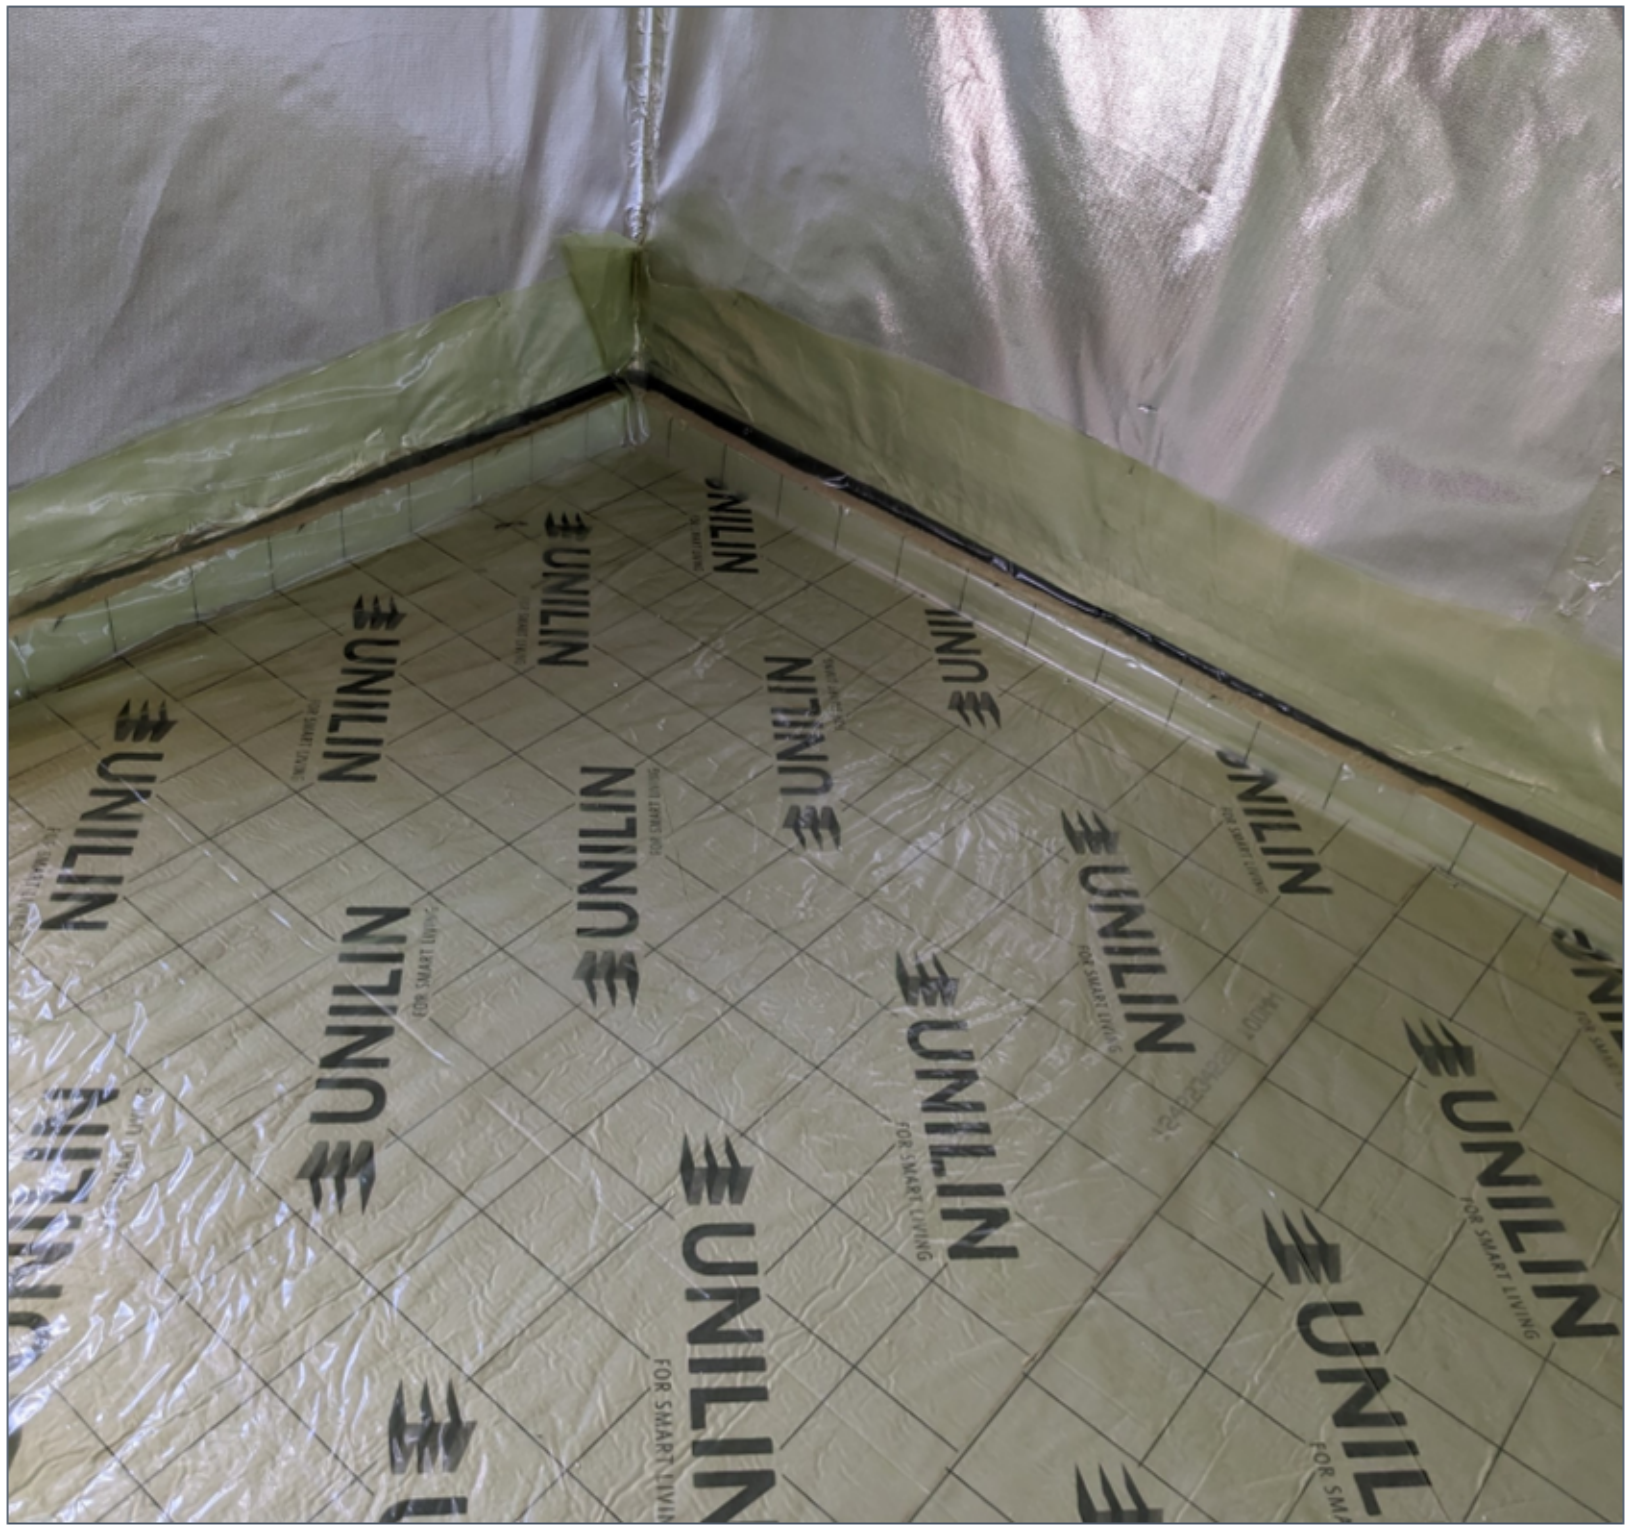
Photo showing the completion of the building sub floor

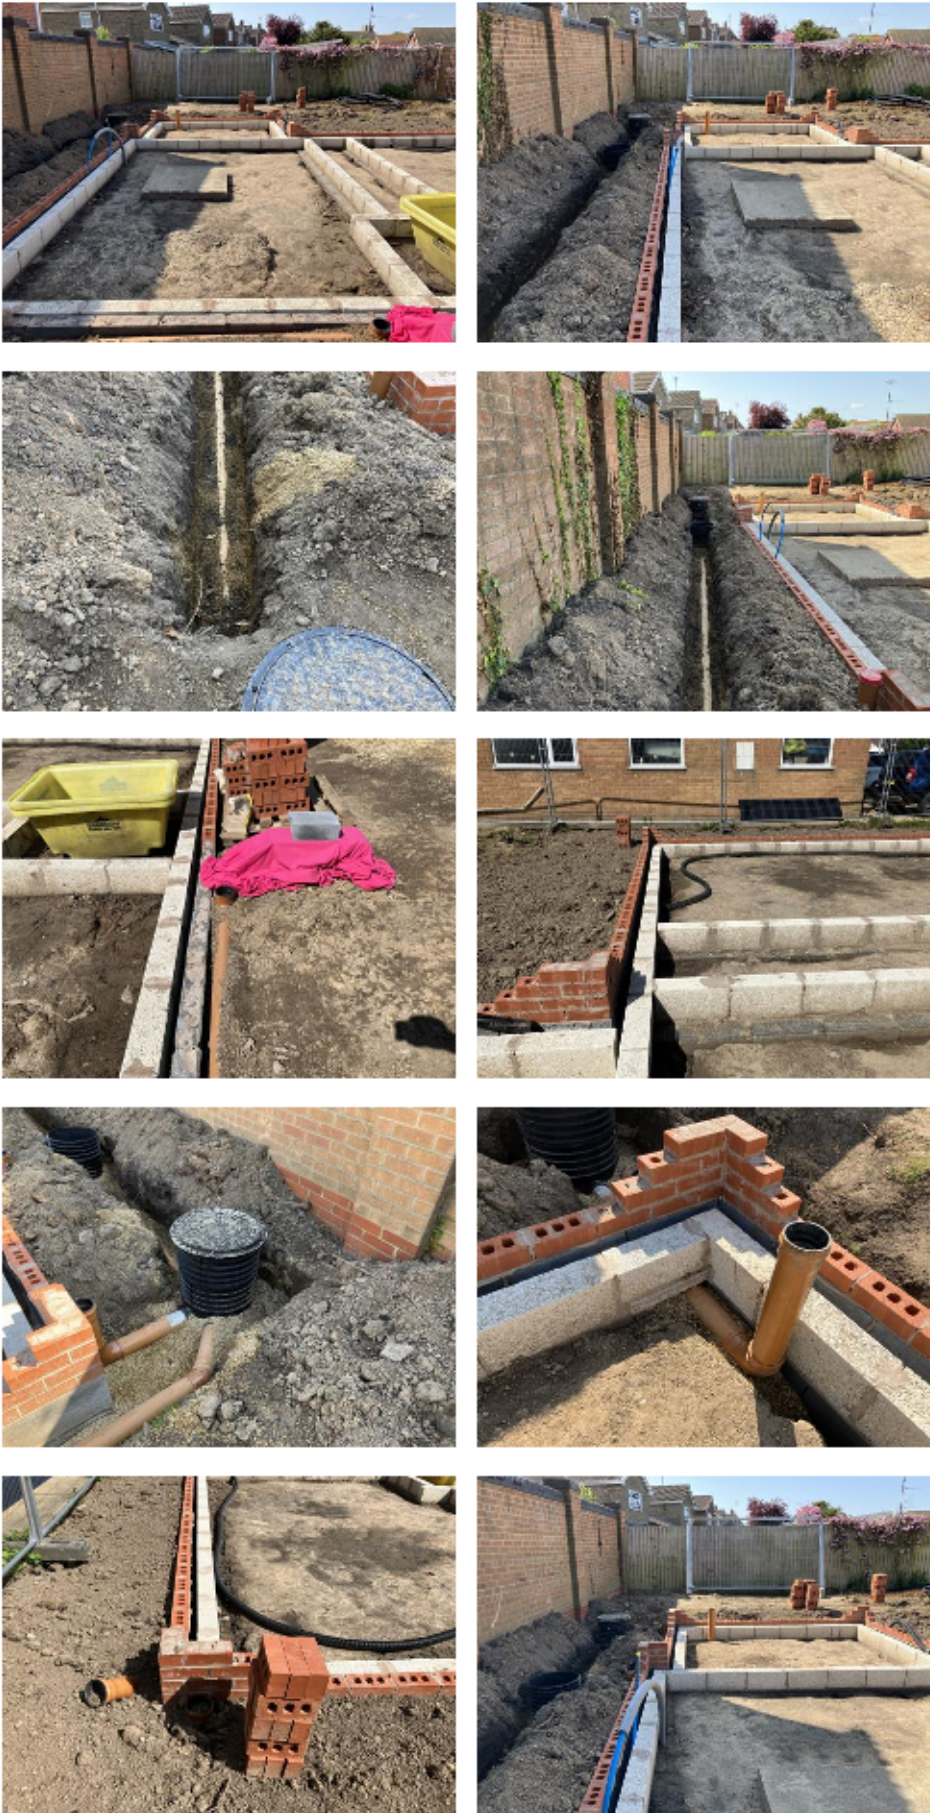
| <b>Summary of Visit:</b> | <b>Inspection Two – Substructure/Drainage</b><br><br>Inspection carried out with the developer.<br><br>Strip foundations are complete.<br><br>Sub structure masonry has been formed as 100mm block work inner skin and 100mm facing brick outer skin forming a minimum 100mm residual cavity.<br><br>Ground floor structure is to be installed as block and beam bearing down onto the inner skin, over DPC.<br><br>Foul drainage pipework has been installed, pipes have been laid to correct falls and bedded in pea shingle ready for back fill, ends are capped to prevent ingress.<br><br><b>Please note items 2.01, 2.05 and 2.06 on the remediation tracker to supply the required information, this is also listed below:</b> <ul style="list-style-type: none"><li>• Provide Site/Soil Investigation report.</li><li>• Client to provide Engineers Calculations and Drawings.</li><li>• Client provide Architects Drawings.</li></ul> | | |

| No. | Observations/Comments | Current Status |
|---|---|---|
| .02 | <p data-bbox="229 109 667 136">Notable photos from visit on 16/05/2023:</p> <p>The photographs document the foundation work. Top row: Overview of the rectangular foundation layout with concrete footings and brick walls. Second row: Close-up of a drainage trench with a blue pipe and a view of the trench along the brick wall. Third row: A yellow bin and a pink tarp near the foundation, and a corner detail of the brick and concrete. Fourth row: Close-up of a drainage pipe entering a trench, and another corner detail. Bottom row: A close-up of a pipe being installed through a brick wall, and a final overview of the foundation area.</p> | Observations |
