## Phase 4 Verification Report

### **La Rose Homes Limited**

Land adjacent to Charnwood, 259 High Road, Whaplode, Spalding, PE12 6TG

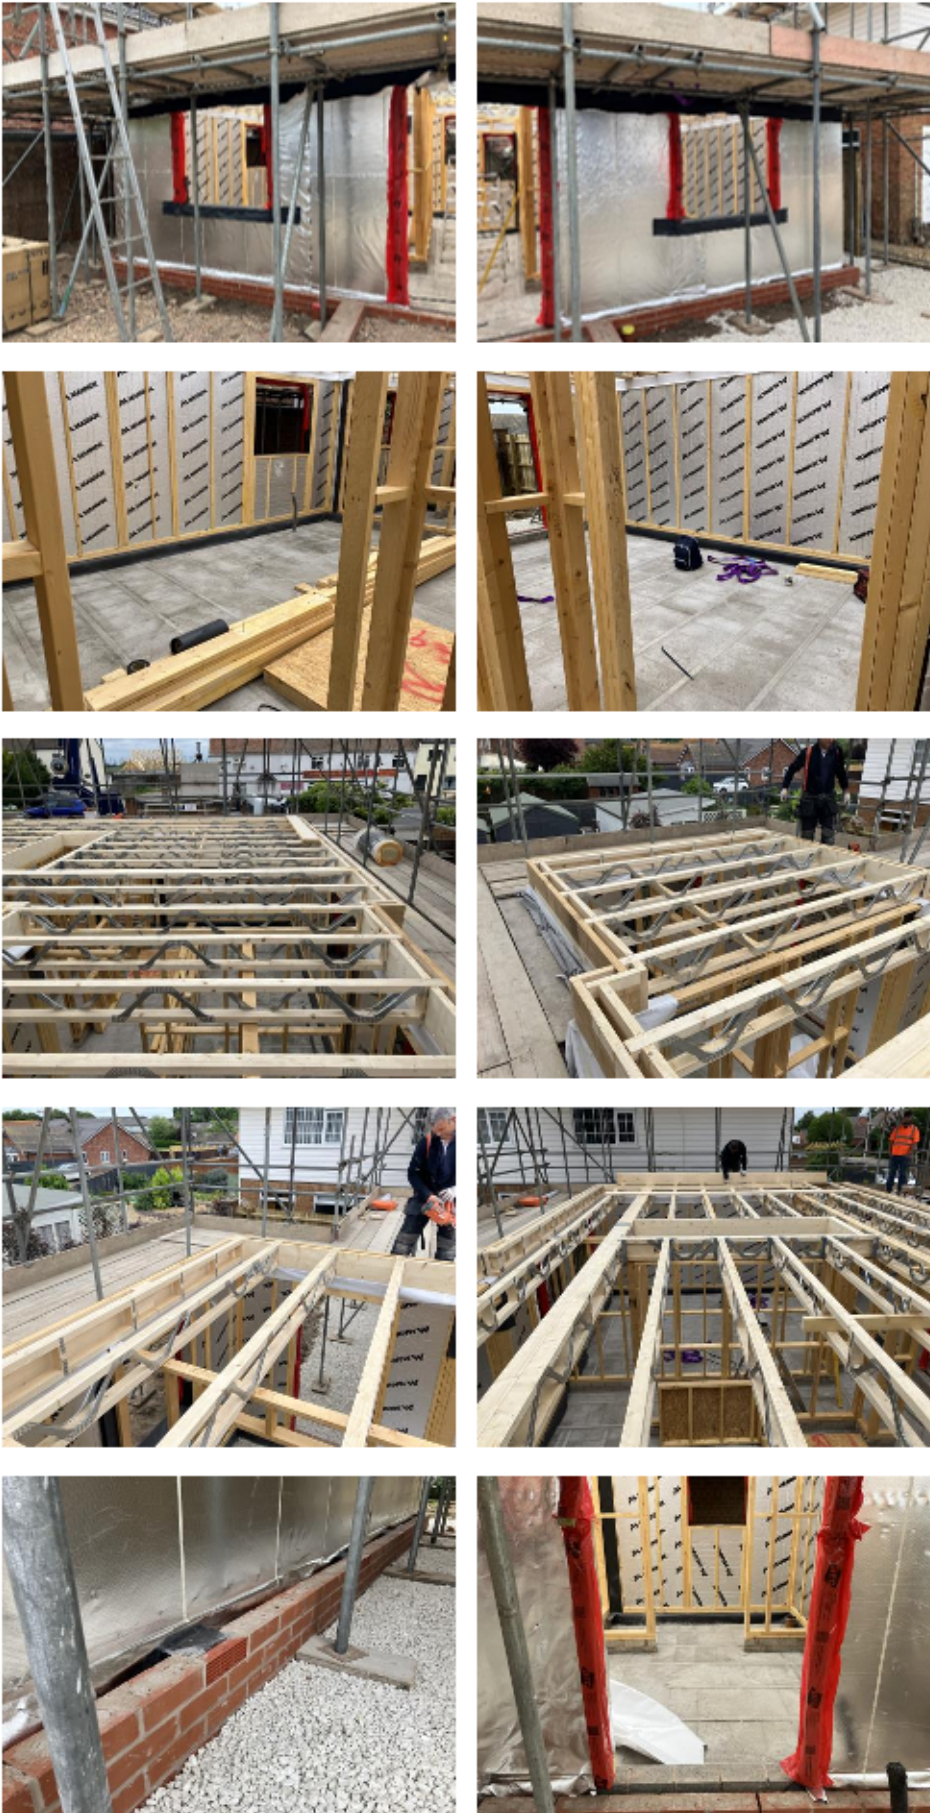
| <b>Summary of Visit:</b> | <b>Inspection Three – Timber Frame/DPC</b><br><br>Inspection carried out with the developer.<br><br>Strip foundations are complete.<br><br>Sub structure masonry has been formed as 100mm block work inner skin and 100mm facing brick outer skin forming a minimum 100mm residual cavity.<br><br>Telescopic vents are installed at regular centers on all elevations of the structure, with external vent grills installed.<br><br>Ground structure is installed as block and beam bearing down onto the inner skin, over DPC.<br><br>It is noted that a minimum of 150mm air flow clearance has been achieved between the underside of the block and beam floor and the concrete blinding.<br><br>Timber frame to ground floor has commenced with sole plate installed over DPC.<br><br>Joist installation was in progress, joists are 250mm x 100mm engineered web joists set at 600mm centres, with suitable bearing onto timber frame.<br><br>Partition walls to ground floor are installed as 100mm x 50mm C16 dry graded timber set at 600mm centers.<br><br>Cavity fire socks have been installed to all openings, with closers being fitted prior to commencement of external brickwork. | | |

| No. | Observations/Comments | Current Status |
|---|---|---|
| .03 | <p data-bbox="229 109 667 136">Notable photos from visit on 07/06/2023:</p> | <p data-bbox="1219 109 1369 136">Observations</p> |
