Phase 1 (desk study) report

Corner House, Church Gate, Whaplode

Produced for Mr & Mrs. Graves

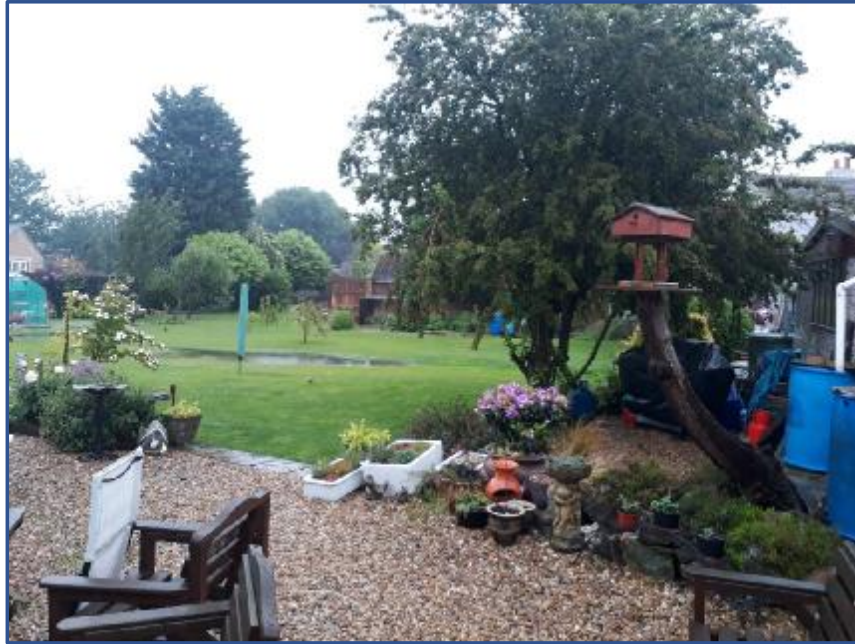
View of rear garden

There was no obvious evidence of any significant contamination at the site. No staining or sheen was noted that might indicate a spillage (e.g. of oil). No unusual odours were identified.

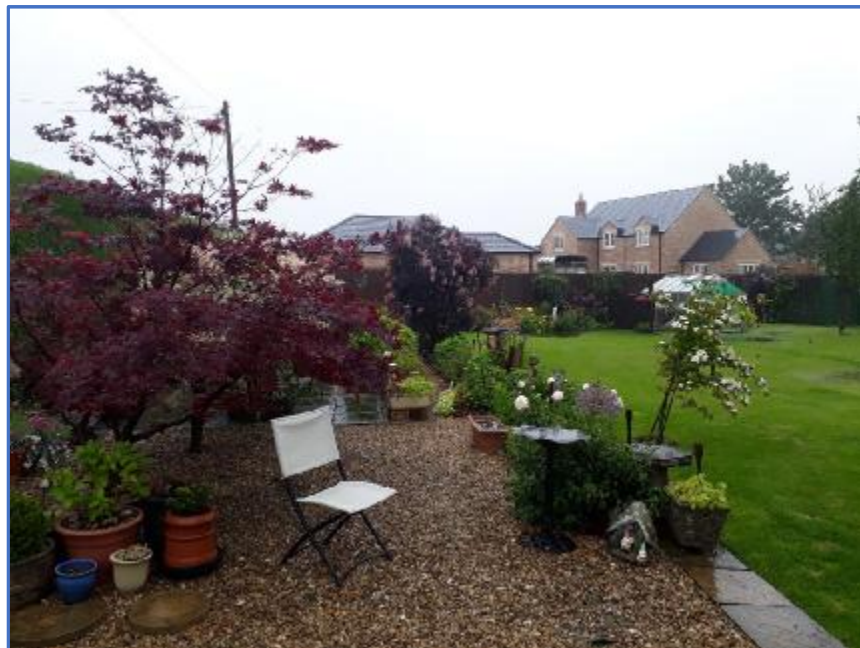
View of rear garden
