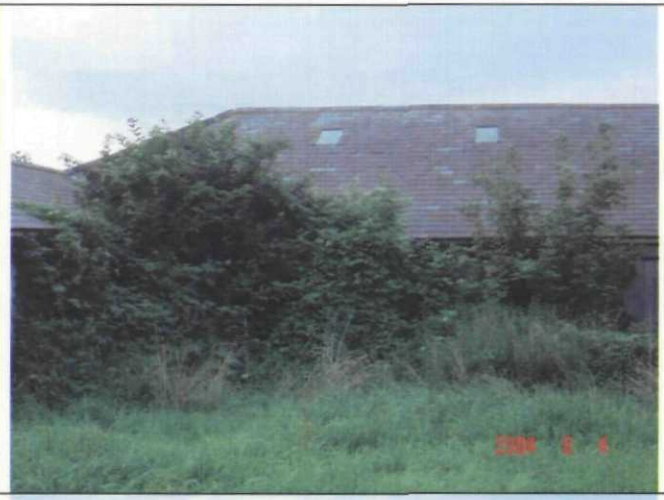
50	Open area	Trees/bushes	Remove and dig trial hole to asses damage to adjacent foundations.	
51	Gable detail Open Area	Heavy cracking and associated movement possibly caused by failed valley detail. Internal evidence of past roof failure i.e. brick/mortar damaged and propped roof rafters and joists.	Strip out damaged timber and replace with re – claimed timber or new seasoned timber of same type.
