Project:
Alterations and barn conversion
57 Days Lane, Donington
Spalding, Lincolnshire

Drawing Title:
ROOF SURVEY
(SHOWING NEW AND REPLACEMENT TIMBERS)

Project No: 05079
Drawn: PSK
Drawing No: 10
Rev: B

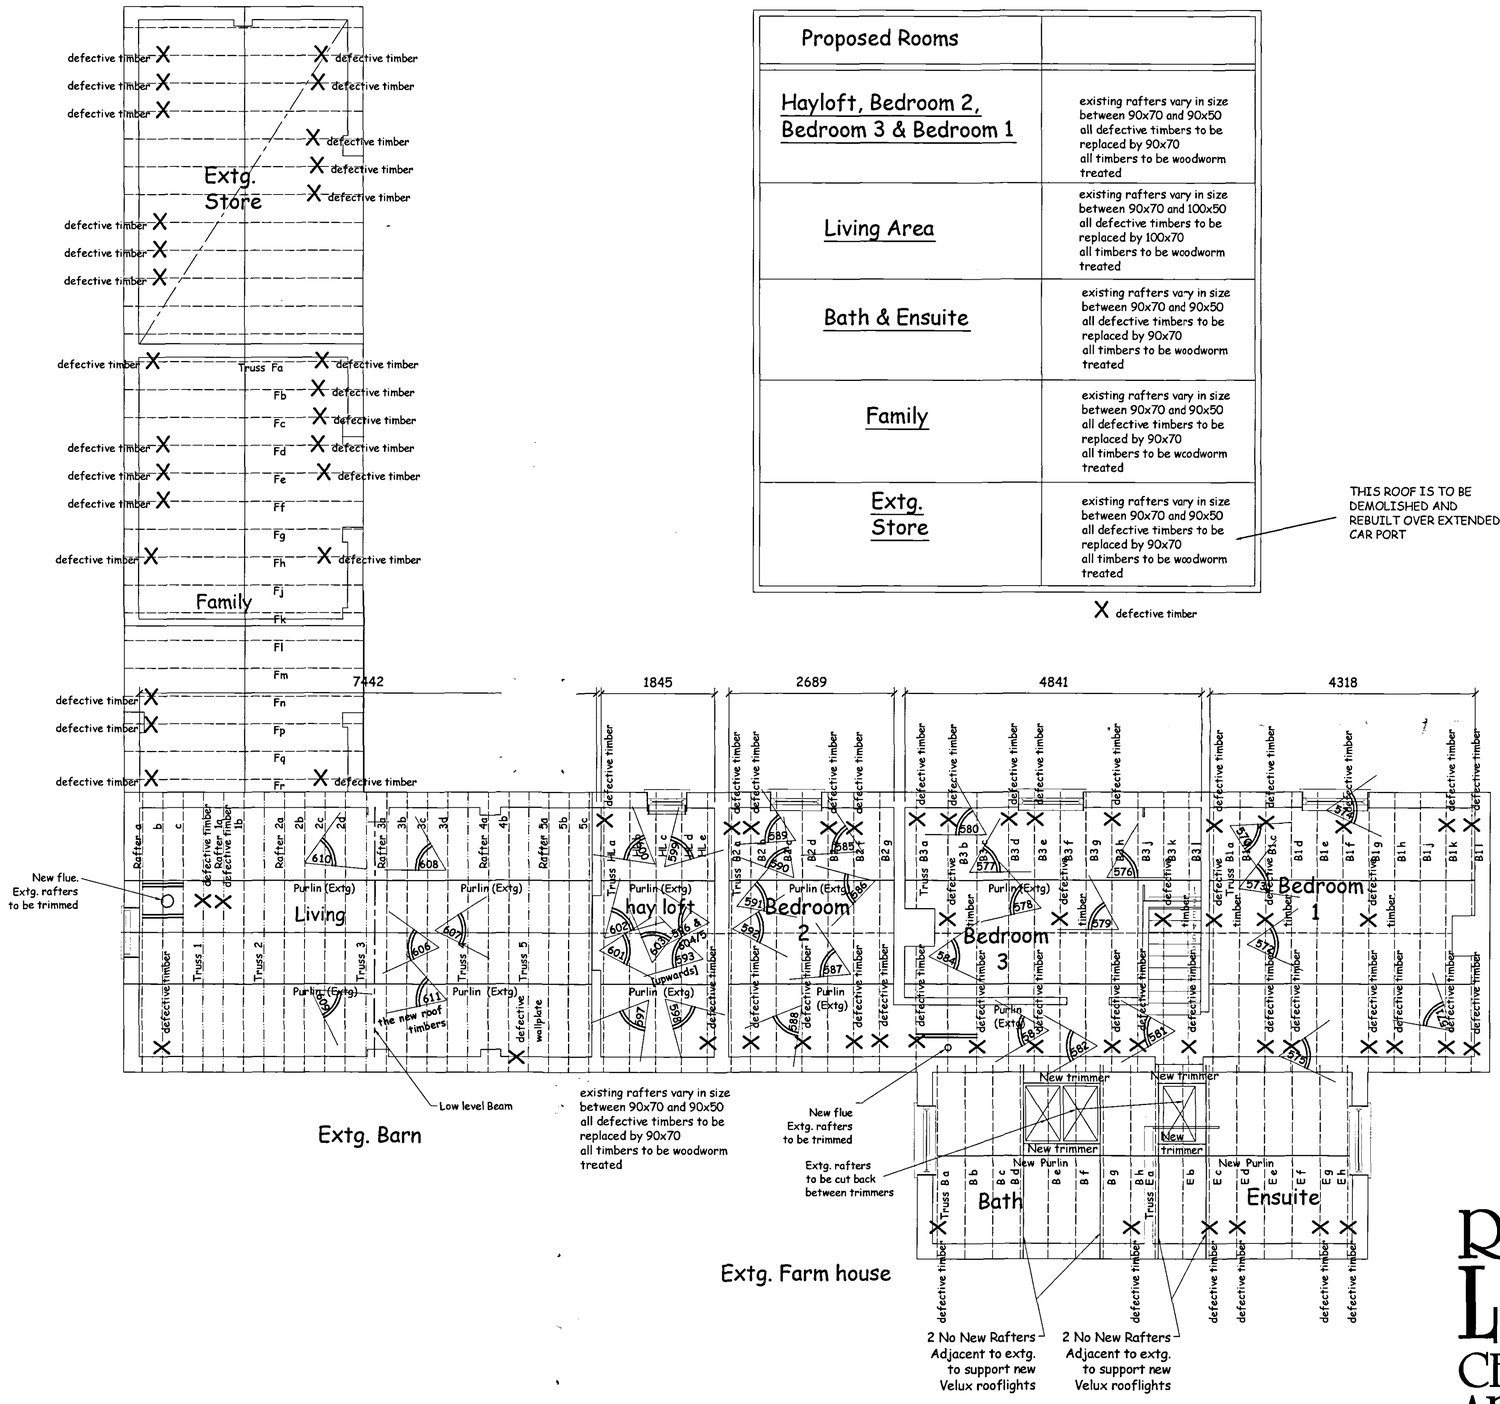
Proposed Rooms	
Hayloft, Bedroom 2, Bedroom 3 & Bedroom 1	existing rafters vary in size between 90x70 and 90x50 all defective timbers to be replaced by 90x70 all timbers to be woodworm treated
Living Area	existing rafters vary in size between 90x70 and 100x50 all defective timbers to be replaced by 100x70 all timbers to be woodworm treated
Bath & Ensuite	existing rafters vary in size between 90x70 and 90x50 all defective timbers to be replaced by 90x70 all timbers to be woodworm treated
Family	existing rafters vary in size between 90x70 and 90x50 all defective timbers to be replaced by 90x70 all timbers to be wcodworm treated
Extg. Store	existing rafters vary in size between 90x70 and 90x50 all defective timbers to be replaced by 90x70 all timbers to be woodworm treated

THIS ROOF IS TO BE DEMOLISHED AND REBUILT OVER EXTENDED CAR PORT

X defective timber
