Project:
Alterations and barn conversion
57 Days Lane, Donington
Spalding, Lincolnshire

Drawing Title:
ROOF SURVEY
(SHOWING NEW AND
REPLACEMENT TIMBERS)

Project No: 05079

Drawing No: 10

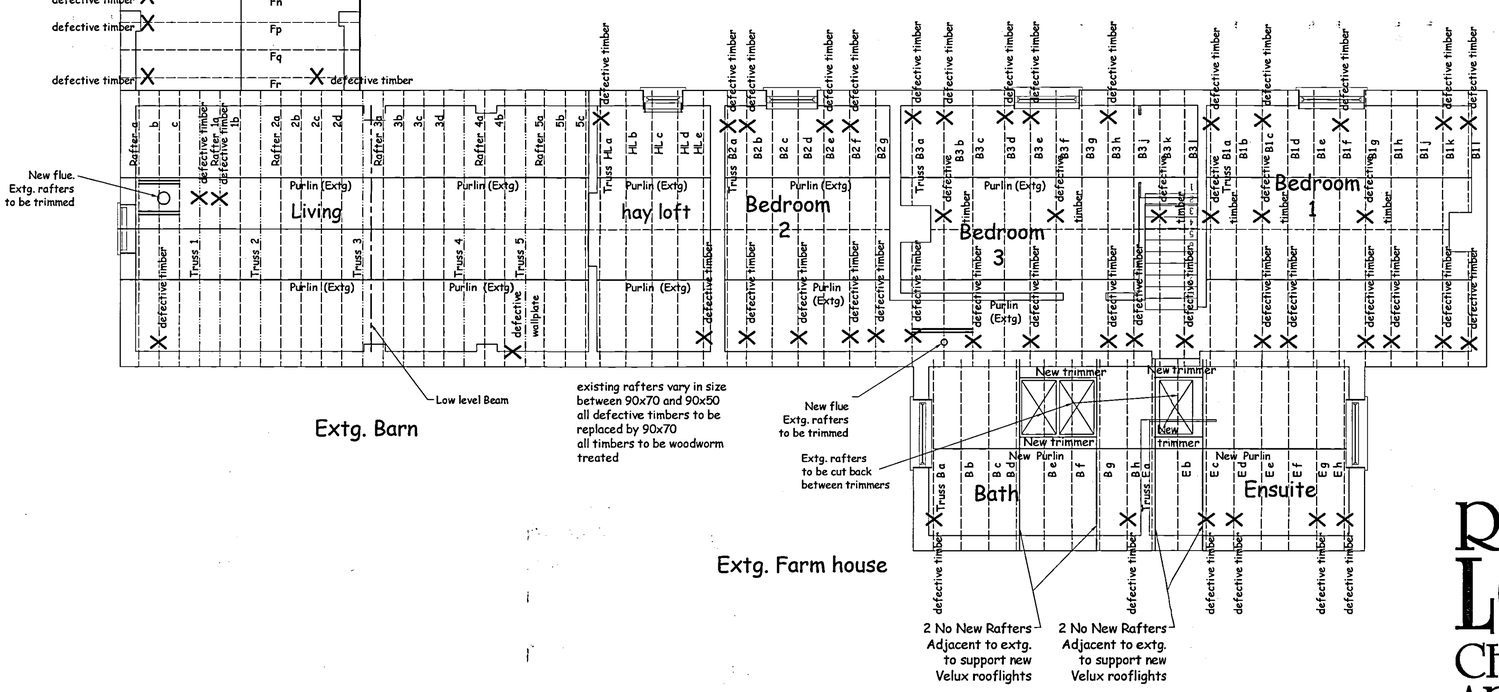
Proposed Rooms	
Hayloft, Bedroom 2, Bedroom 3 & Bedroom 1	existing rafters vary in size between 90x70 and 90x50 all defective timbers to be replaced by 90x70 all timbers to be woodworm treated
Living Area	existing rafters vary in size between 90x70 and 100x50 all defective timbers to be replaced by 100x70 all timbers to be woodworm treated
Bath & Ensuite	existing rafters vary in size between 90x70 and 90x50 all defective timbers to be replaced by 90x70 all timbers to be woodworm treated
Family	existing rafters vary in size between 90x70 and 90x50 all defective timbers to be replaced by 90x70 all timbers to be woodworm treated
Extg. Store	existing rafters vary in size between 90x70 and 90x50 all defective timbers to be replaced by 90x70 all timbers to be woodworm treated

THIS ROOF IS TO BE DEMOLISHED AND REBUILT OVER EXTENDED CAR PORT
