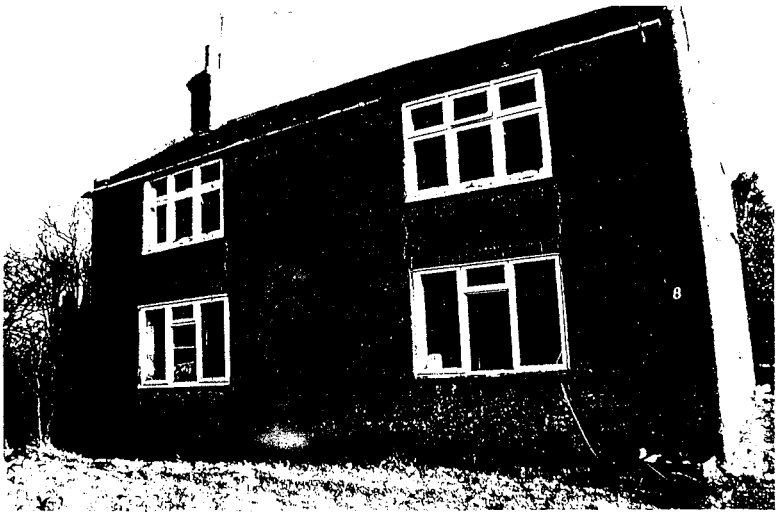
1. FRONTAGE ONTO FOXES LOWE RD.

2. VIEW FROM EAST TO REAR OF PLOT.

3. FRONT ELEVATION SHOWING WALL CRACKING BETWEEN GROUND & 1ST FLOOR WINDOWS – MATCHING CRACKS ON INSIDE.
