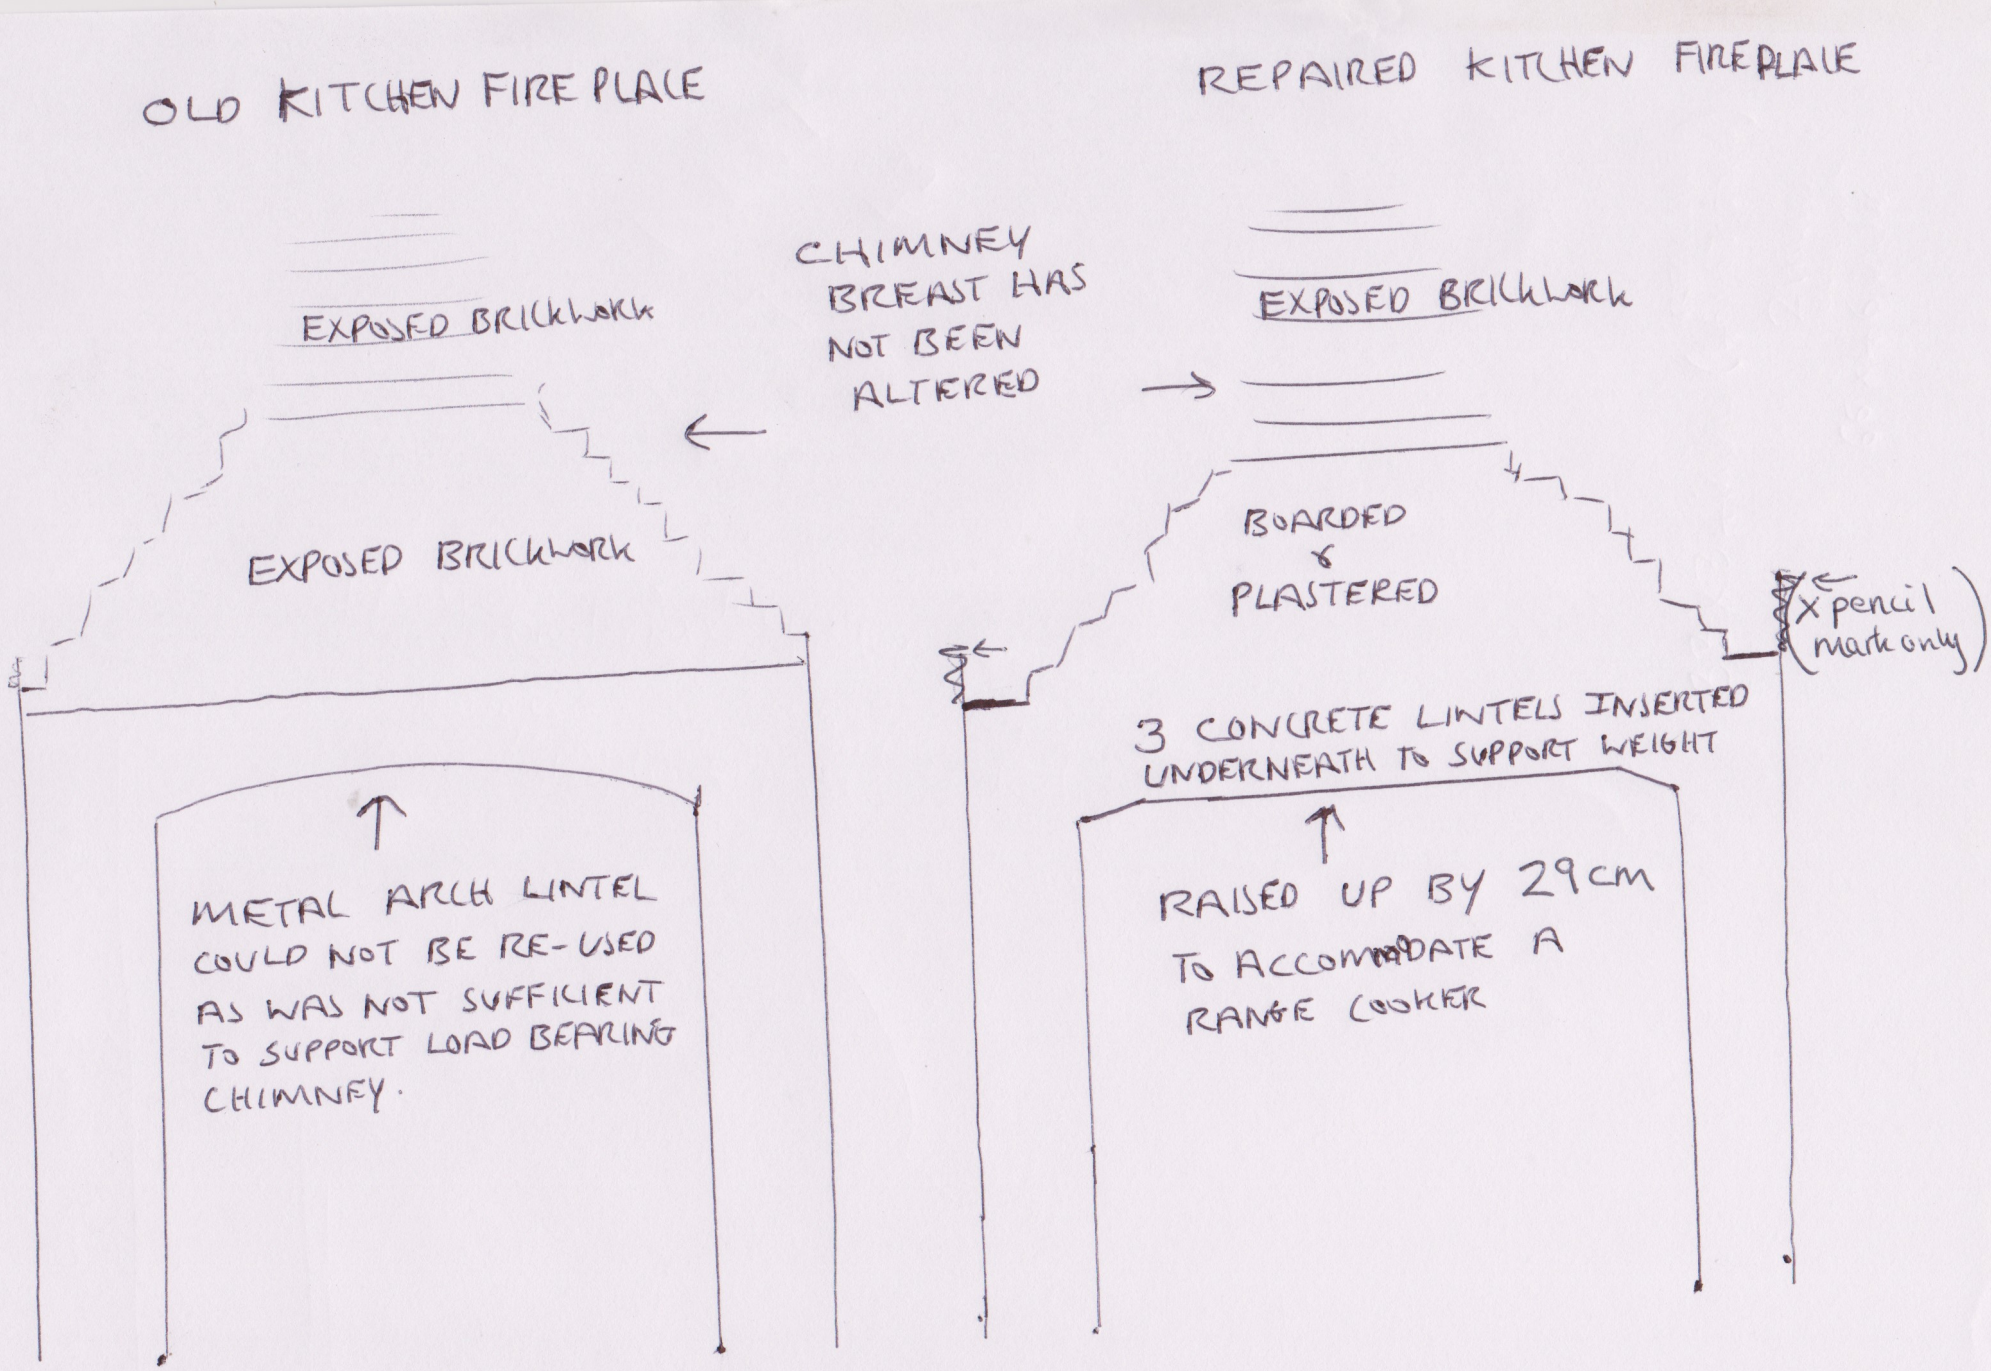
OLD KITCHEN FIRE PLACE
REPAIRED KITCHEN FIREPLACE
EXPOSED BRICKWORK
CHIMNEY BREAST HAS NOT BEEN ALTERED
EXPOSED BRICKWORK
EXPOSED BRICKWORK
BOARDED & PLASTERED
X pencil mark only
3 CONCRETE LINTELS INSERTED UNDERNEATH TO SUPPORT WEIGHT
METAL ARCH LINTEL COULD NOT BE RE-USED AS WAS NOT SUFFICIENT TO SUPPORT LOAD BEARING CHIMNEY.
RAISED UP BY 29cm TO ACCOMMODATE A RANGE COOKER
