HISTORIC BUILDING RECORDING

THE OLD RANCH
LOW ROAD
HOLBEACH HURN
LINCOLNSHIRE

August 2025
APS Report No: 34/25

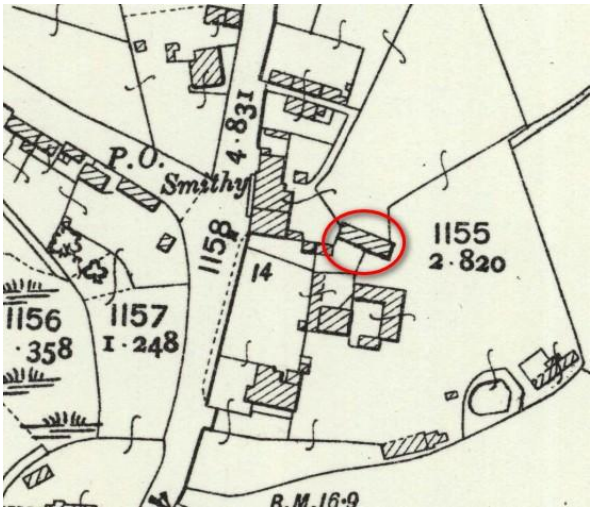
Fig. 1a. Extract from the 2nd edition 1903 Ordnance Survey 25" map

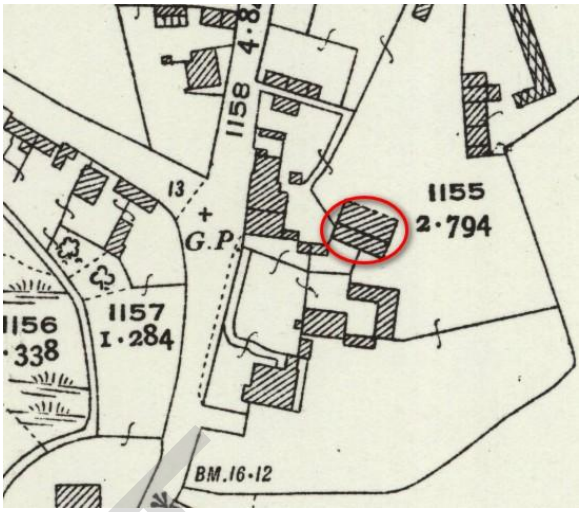
Fig. 1b. Extract from the 1931 Ordnance Survey 25" map

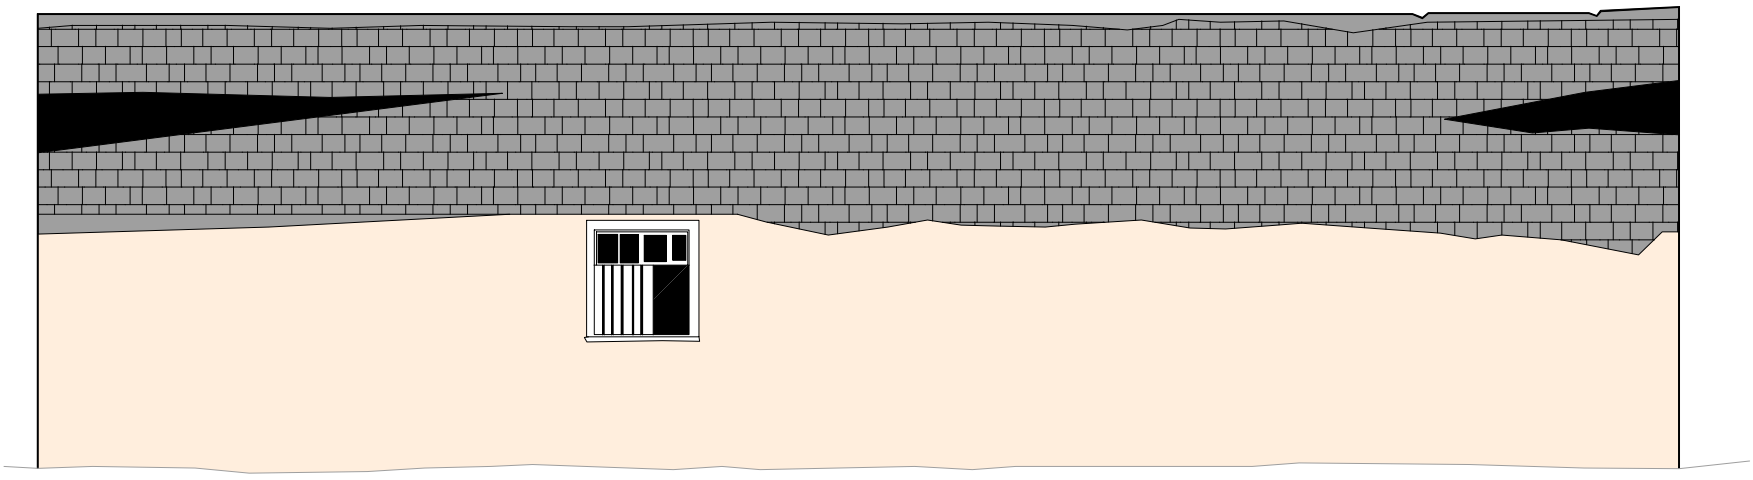
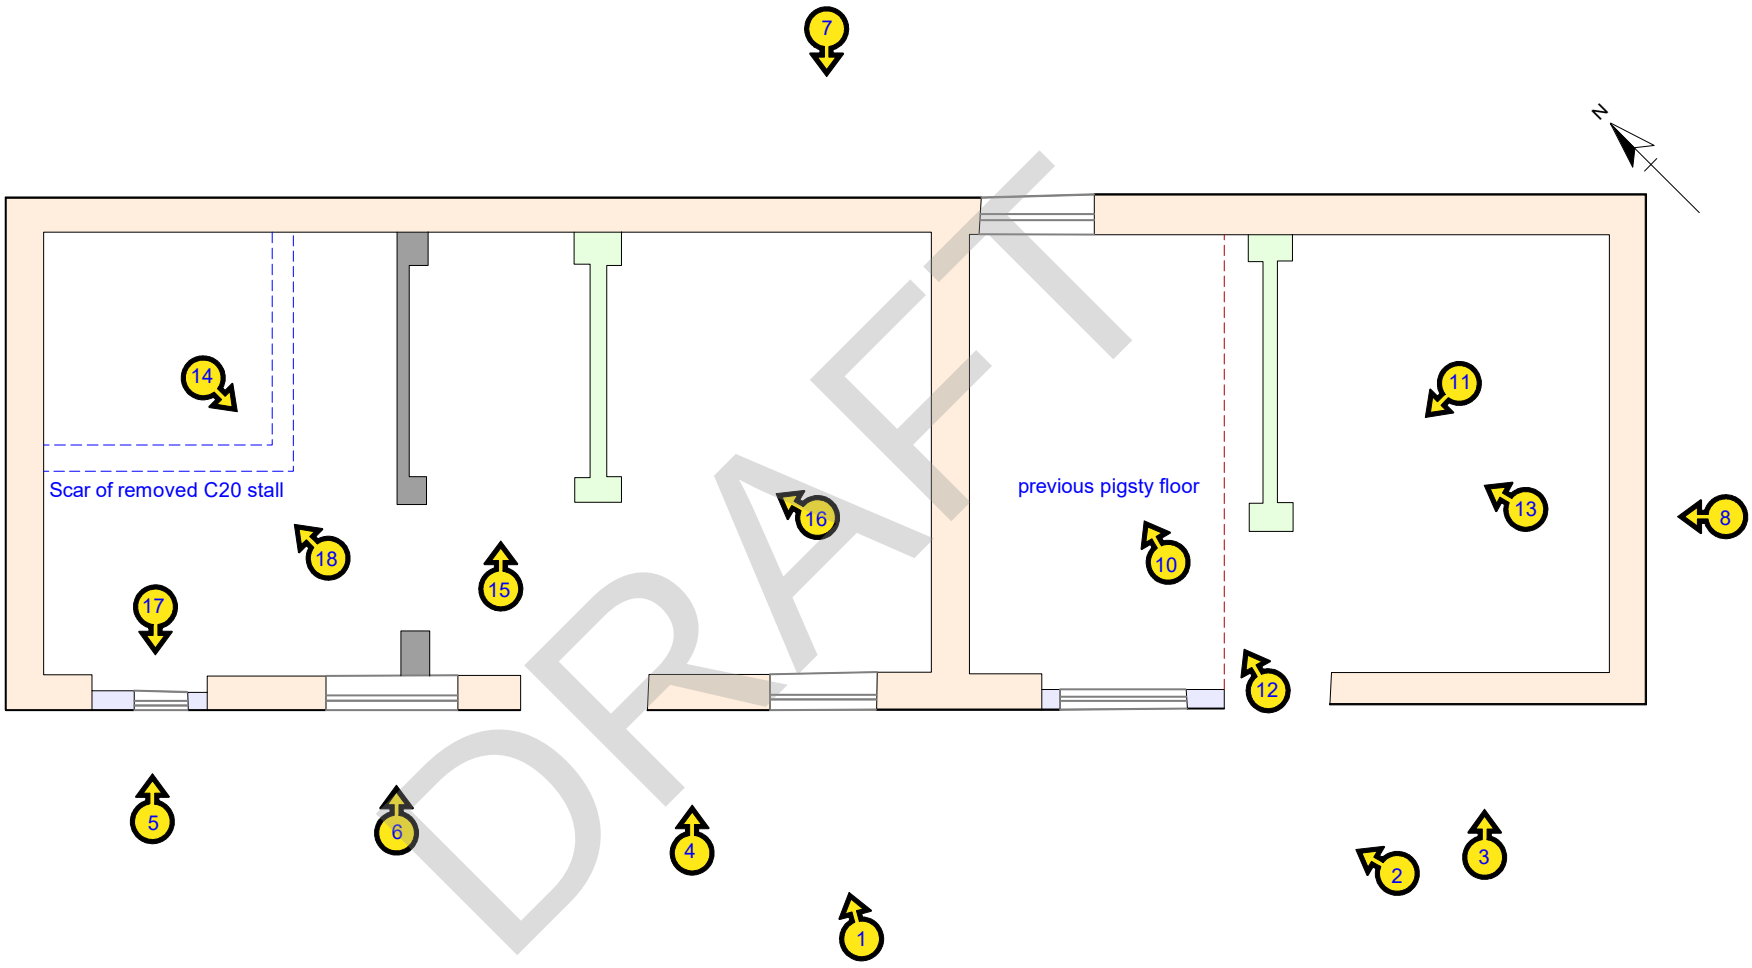
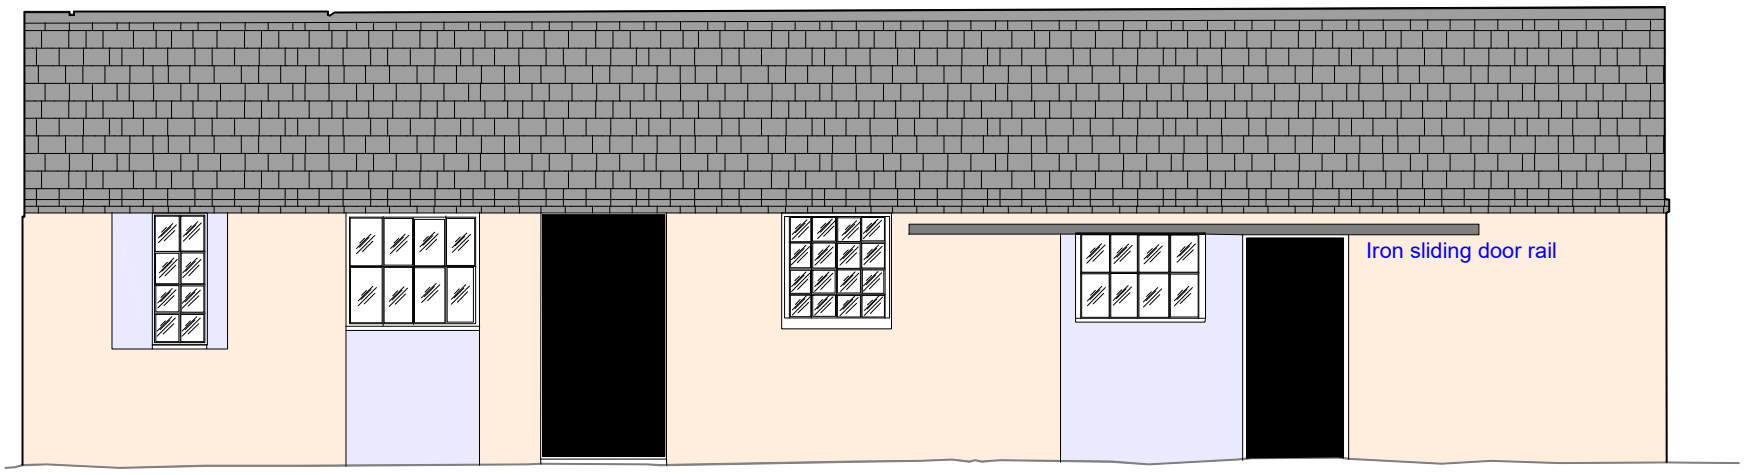
Figure 6. Plan and elevations with plate locations

The building was surveyed externally and internally and plans and elevations were checked and measured on site, alterations and additions to these are reproduced as Figure 4.
