DRAINS 'R' US

C.C.T.V. SURVEY

SITE: Marsh Road
Holbeach Hurn

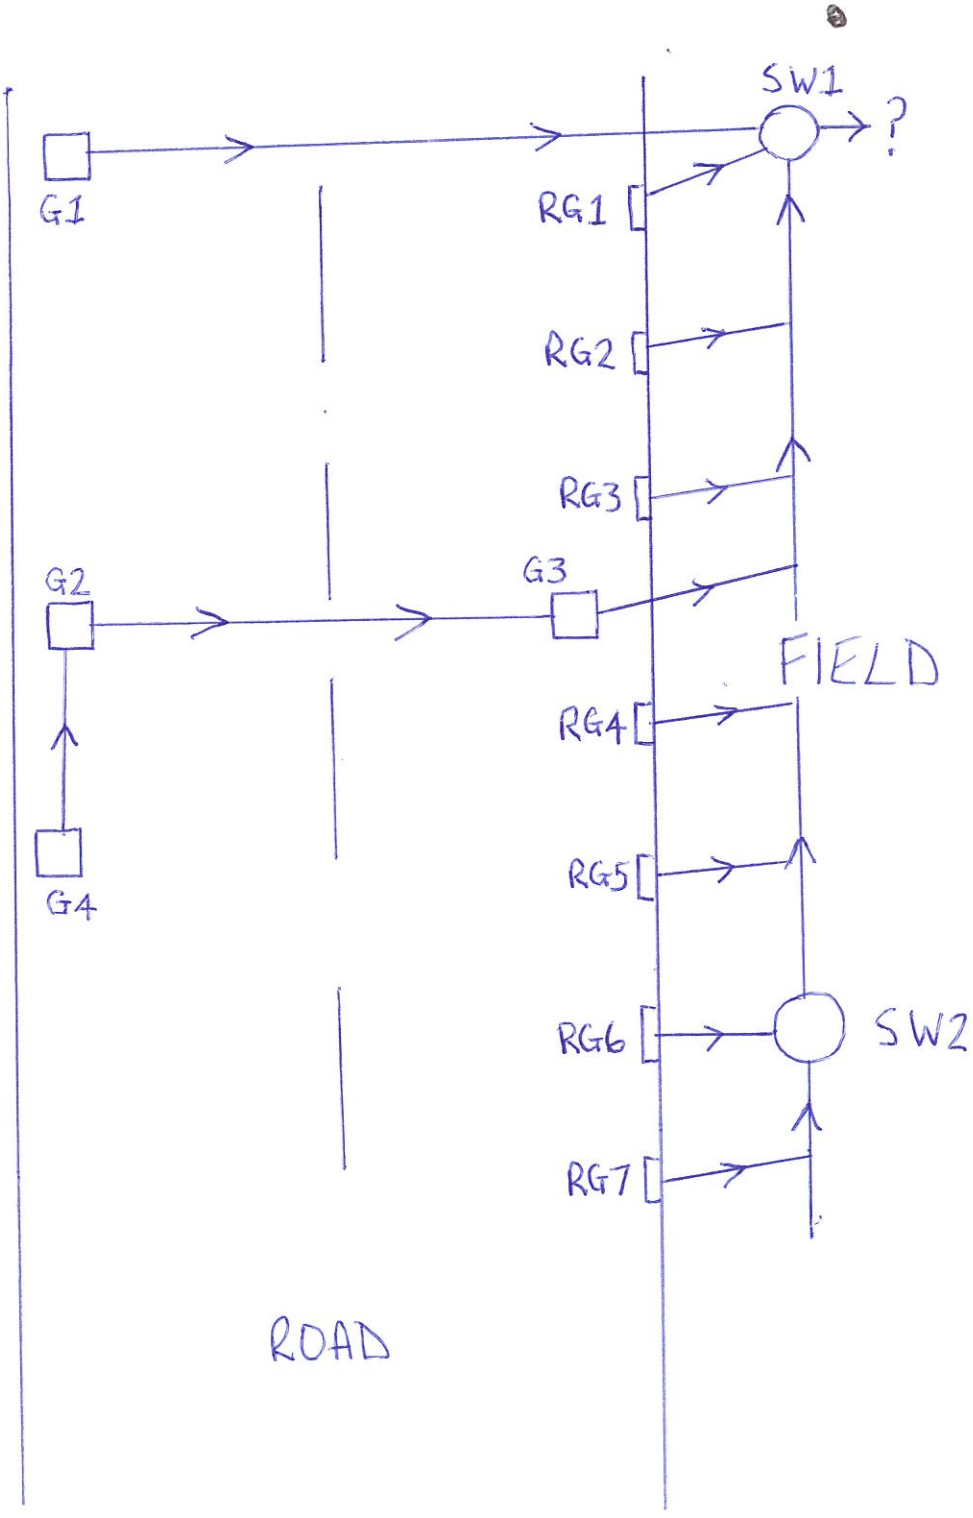
PLAN VIEW

NOTES:
Gully 2 & 4 are full of debris (silt etc.) & outlet is under water. Unable to survey.

Main run section SW1 U/S SW2 is 50%+ full of debris (silt etc.) & was unable to survey.

SW1 appears to be discharging towards field but again large amounts of debris in pipework. Unable to survey.

More investigation requiredto determine where outfall is.
