HISTORIC BUILDING RECORDING
FORMER WORKSHOPS AND STORES, MARKET STREET, LONG SUTTON, LINCOLNSHIRE
(MSLS 14)

Work Undertaken For
STP Properties Ltd.

August 2014

APS Report No: **78/14**

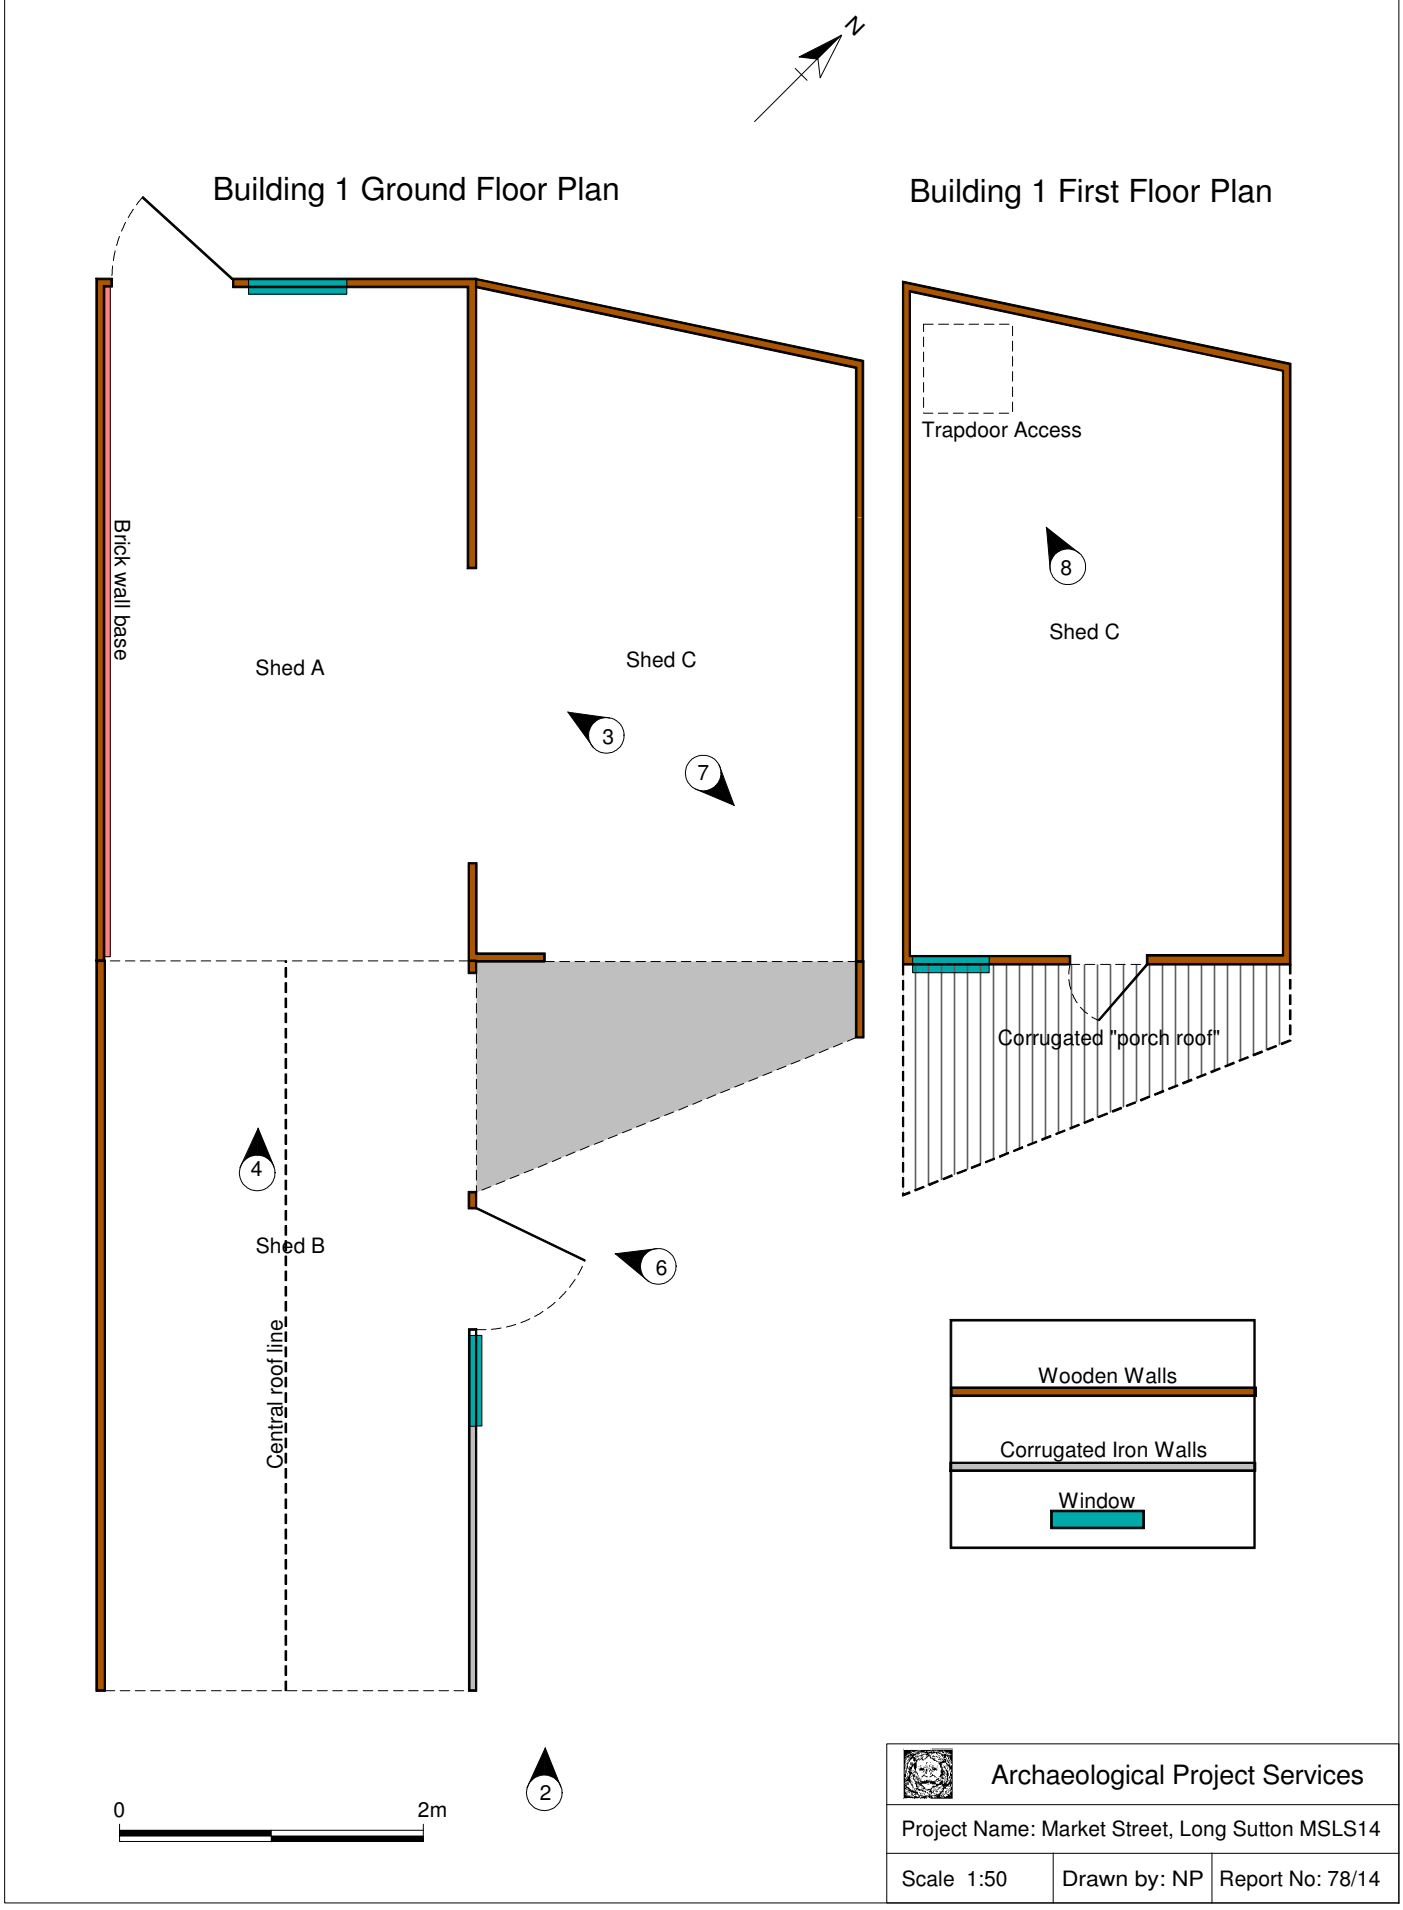
Figure 4. Building 1 Ground and 1st Floor Plan

Building one comprised three sheds: the original structure, (Shed A) and two additions (Sheds B and C).

The walls of Shed A have been considerably altered in that they have been cut away on their northeast and southeast sides to form a single open storage space in conjunction with Sheds B and C. The view in Plate 4 shows where the weatherboard timbers have been removed and at least one phase of repair has been necessary. The original access was through the door visible at the rear which is now locked and leads into the grounds of 2a Bull Lane.

Seen internally in Plate 3, the roof of Shed A is of pantiles with a central skylight. It is mono-pitched, sloping down to the southwest and aside from slight damage from the large Copper Beech tree above, is in reasonable waterproof repair.

Shed B, (along with Shed C) is a later addition to Shed A that has been roughly butted against the southeastern end wall. The southwestern wall of Shed B was weatherboard construction but the exterior (aside from a covering of ivy) was not visible as access lay outside of the property boundary. Unlike Shed A, there was no brick foundation course; the posts sat on concrete hardstanding. Due to the amount of debris present on the ground it was not possible to ascertain whether they were concreted in or simply sat atop the surface.

The northeastern wall differed in that it was of corrugated iron and did not reach all the way to Shed A. This was either a replacement wall, or the structure was constructed this way purposefully. Beyond the door and window, neither of which would open, there was a gap of 1.45m between these and Shed A that provided a wide opening to allow freer movement within the building.

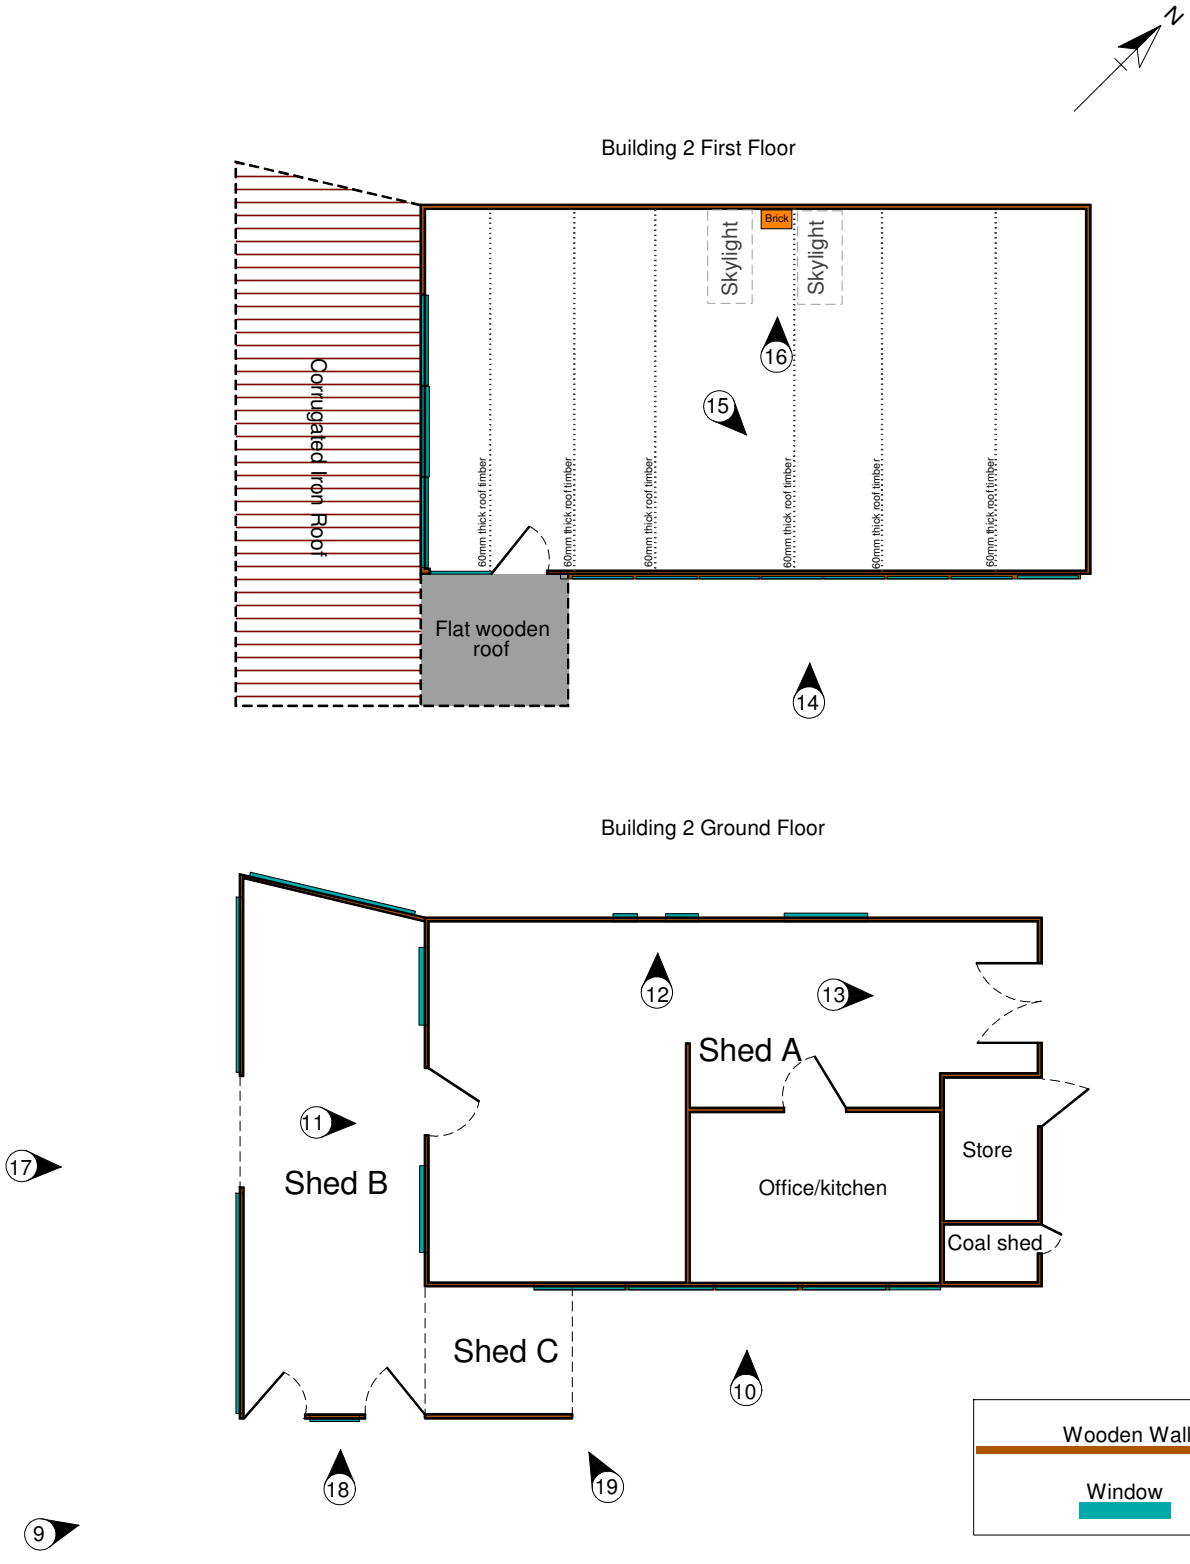
Figure 5. Building 2 Ground and 1st Floor Plan

In a similar fashion to Building 1, the overall structure of Building 2 comprised three parts. The ground floor of Shed A was smaller than the upper floor allowing access to the store rooms at the rear. The upper floor of the two storey structure of Shed A butted against the

The overall exterior of Shed A was constructed from weatherboard founded on three courses of brickwork. The main feature of the southeast (long) face of the building was the line of windows to allow as much natural light as possible to penetrate the building. This was in keeping with the intended use of this structure as workshops rather than stores. The ground floor windows were far from uniform; likewise the weatherboard timber of the southeastern wall.

The appearance of the windows, along with the cuts through the timbers, indicates that they were, on the ground floor at least, not original to the structure. It is likely that the windows on the northwest side (see Figure 5 & Plate 12) were repeated on this side as the originals, but did not let in sufficient light for the intended purpose of the building. Within the dimensions of the southeastern windows, the walls appear to have been rebuilt from the original wood of the structure that had been previously cut out. The hinged planks above the windows that serve no functional purpose are further evidence of this.

The internal space on the ground floor had been divided; firstly as part of the original structure to form a coal shed and store room, then latterly another portion had been plaster-boarded out to form a small office and kitchen area (See Figure 5). This appears to have been a fairly recent addition as the plasterboard was in excellent condition. The store and coal shed show timberwork that is contemporary with the original structure of the shed as a whole and there is secondary access to the ground floor at the northern corner.

The upper floor was accessed at the southern corner by a flat platform that previously had an attached outside wooden staircase that had since fallen away. The doorway and tops of the windows reached to the bottom edge of the pitched, corrugated iron roof.

The northwest wall of Shed B was angled to directly butt against the angled site boundary (see Figure 5) and each wall of the building had a long line of windows. The southwest facing wall had a large central doorway from which the actual door had since been removed. It was central to Shed B which made it slightly off centre from the entrance to Shed A.
