APPENDIX 1

TRIAL HOLE on WALL BASE.

Job No: 10242

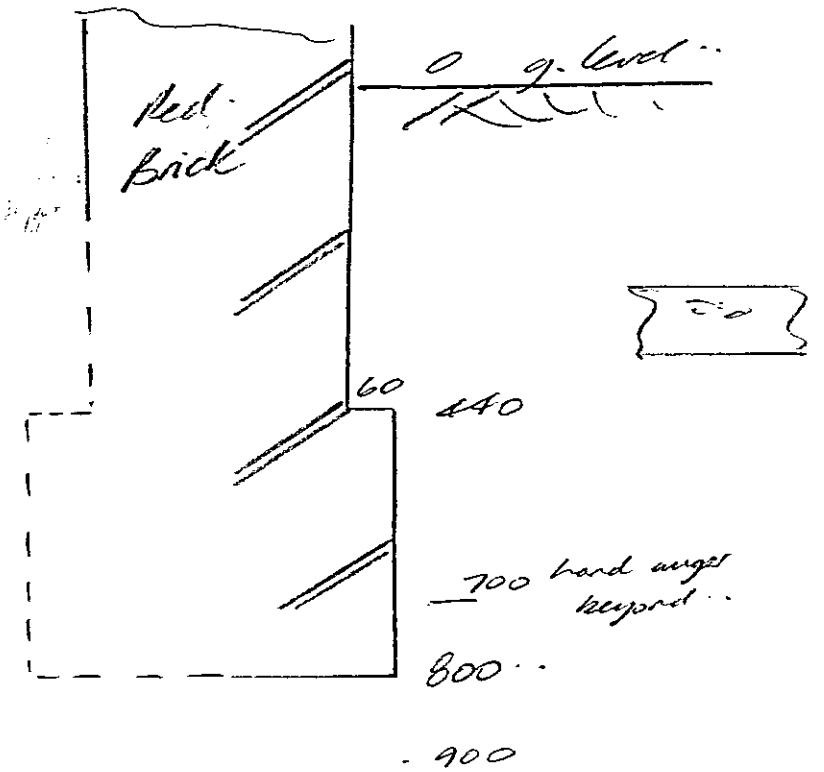
Gravel

Concrete slab. (broken thru)

Brown silt with brick fragment

Beyond wall base brown silts with stone content. Unable to retrieve core as fell through auger.

Gravel at high level over concrete slab. Tended to fall into hole as excavation proceeded. Augering tended to 'catch' side of brick footing and obviates infill at higher level. Entirely 'clean' virgin subsoil was not noted prior to core retrieval proving impossible. SLC borehole 3 just to north showed natural clayey silt beyond 550mm.
