plandescil
consulting engineers

APPENDIX 1

TRIAL HOLE on WALL BASE.

Job No: 10242

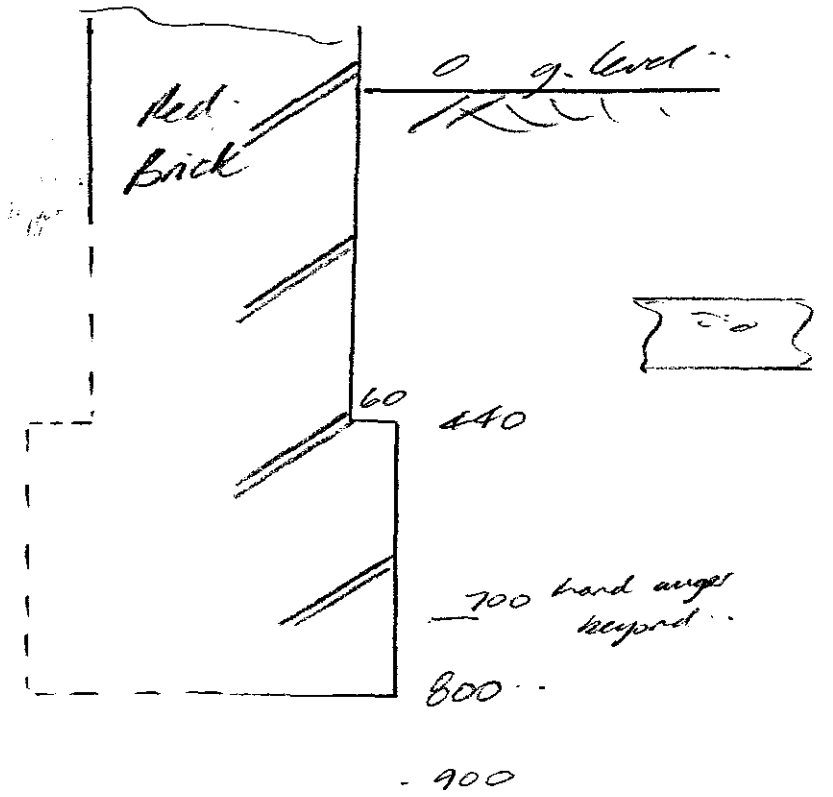
gravel

concrete slabs (broken down)

Brown silt with brick fragment

Beyond wall base brown silts with stone content. Unable to retrieve core as fell through auger

Gravel at high level over concrete slab tended to fall into hole as excavation proceeded. Augering tended to 'catch' side of brick footing and obviously infill at higher level. Entirely 'clean' virgin subsoil was not noted prior to core retrieval proving impossible. See borehole 3 just to north showed natural clayey silt beyond 550mm.
