CLIENT
Ashley King Developments

PROJECT
Bank House Farm,
Common Road,
Moulton Seas End,
Spalding, Lincs.

TITLE
Works Prior to Underpinning Elevations

DRAWN: MJG	DATE OF ISSUE
CHECKED	
DATE: Mar 2005	DRAWING NUMBER: M4262/08 A
SCALE: 1:100

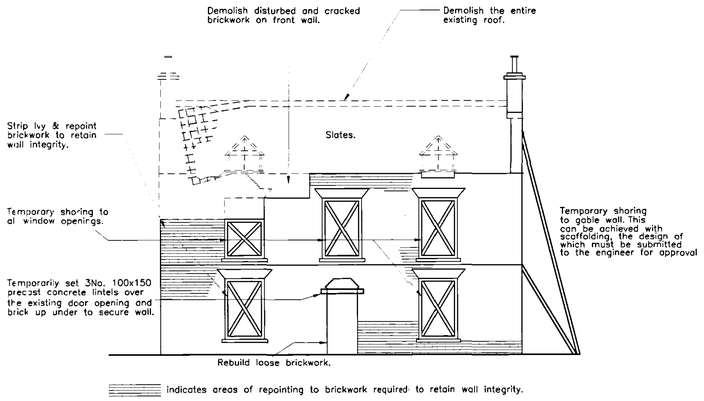
FRONT ELEVATION 1:100

indicates areas of repointing to brickwork required to retain wall integrity.

6. All repointing with lime mortar to the conservation officers agreed specified use.

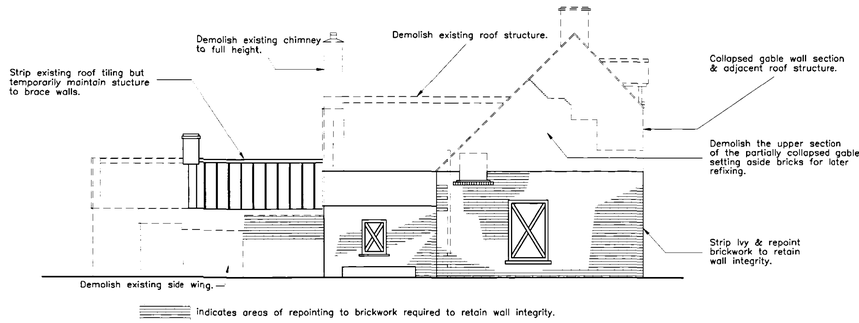
SIDE ELEVATION 1:100

indicates areas of repointing to brickwork required to retain wall integrity.

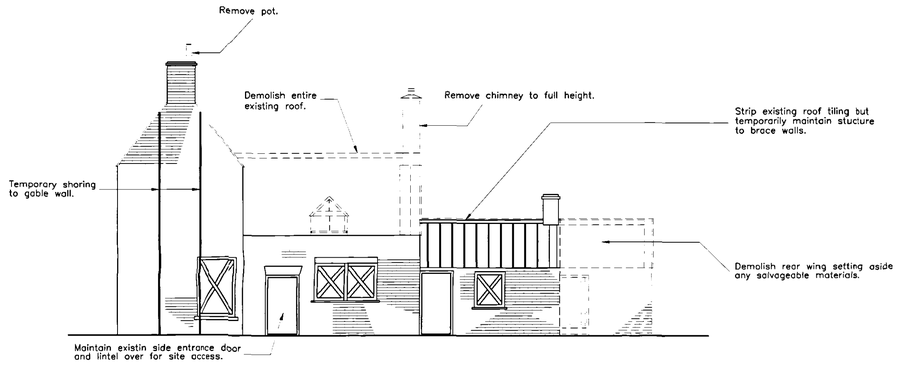
REAR ELEVATION 1:100

indicates areas of repointing to brickwork required to retain wall integrity.
