FARM BUILDINGS. BLACK HOLE DROVE.

14999 Appendix . 06

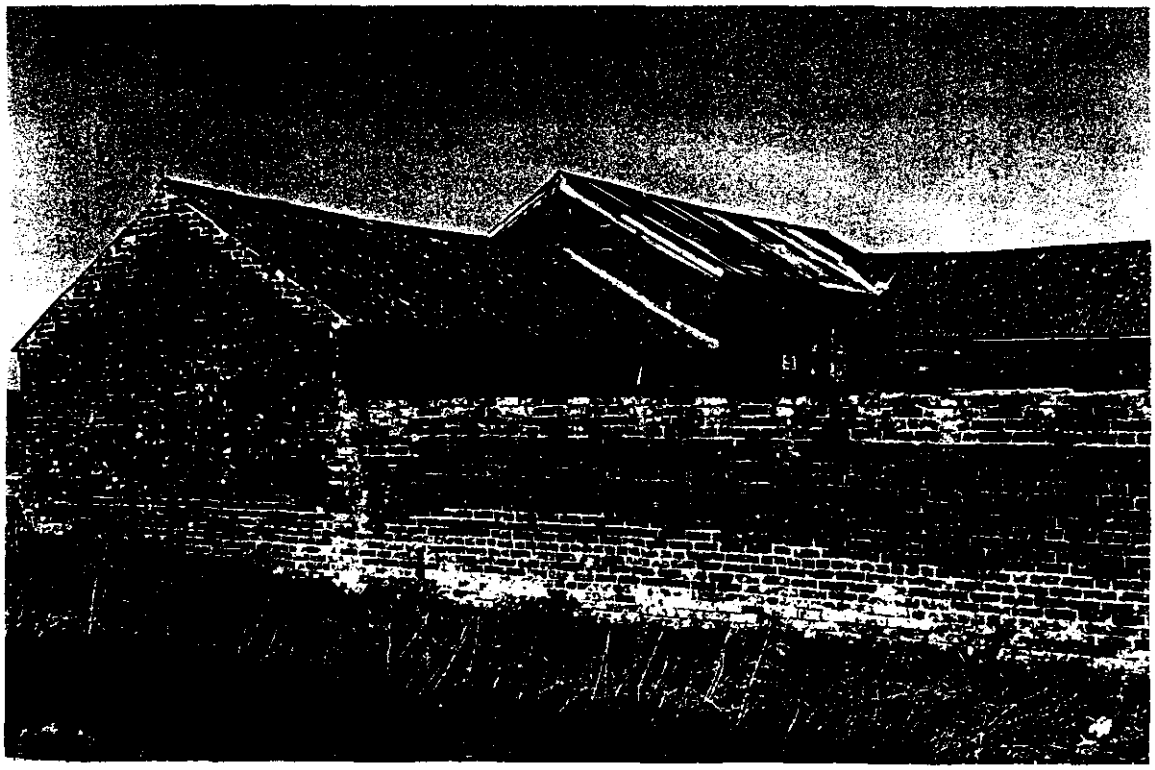
1. GENERAL VIEW FROM THE EAST SHOWING THE THREE SECTIONS OF THE PROPERTY

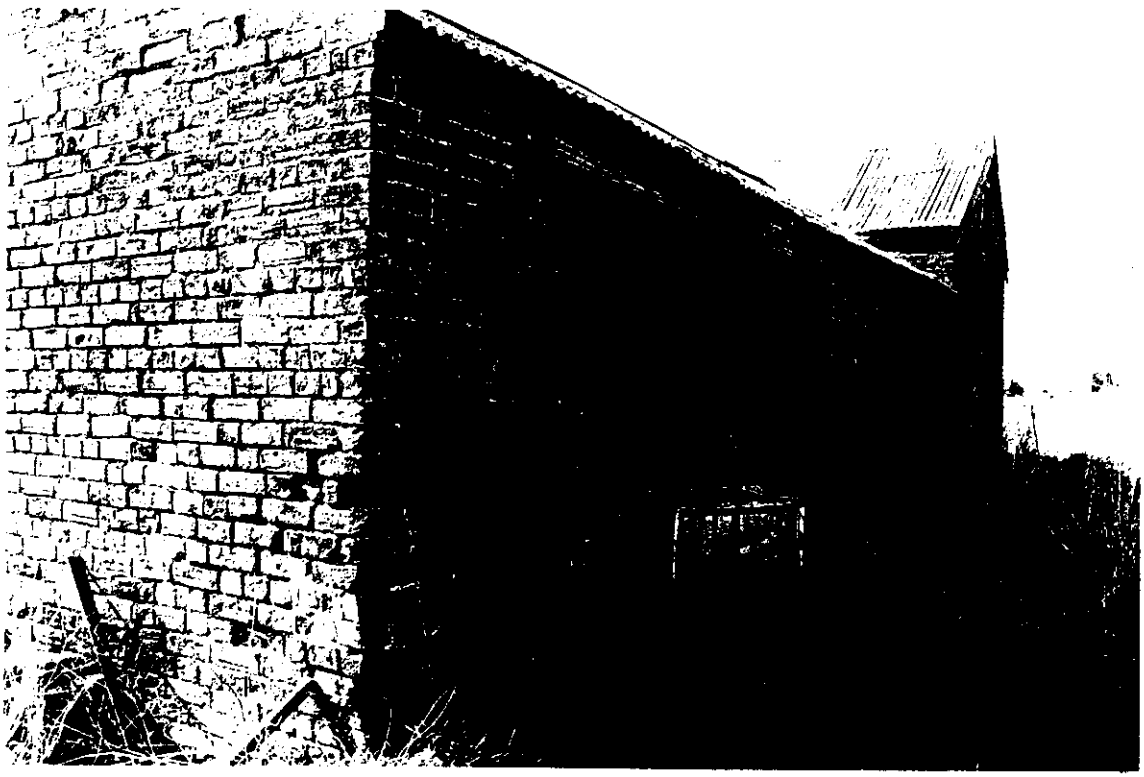
5. VIEW ON NORTH WEST CORNER OF "HIGH" SECTION. NB THIS CORNER AND GABLE PEAK ALSO LEAN OUTWARD.

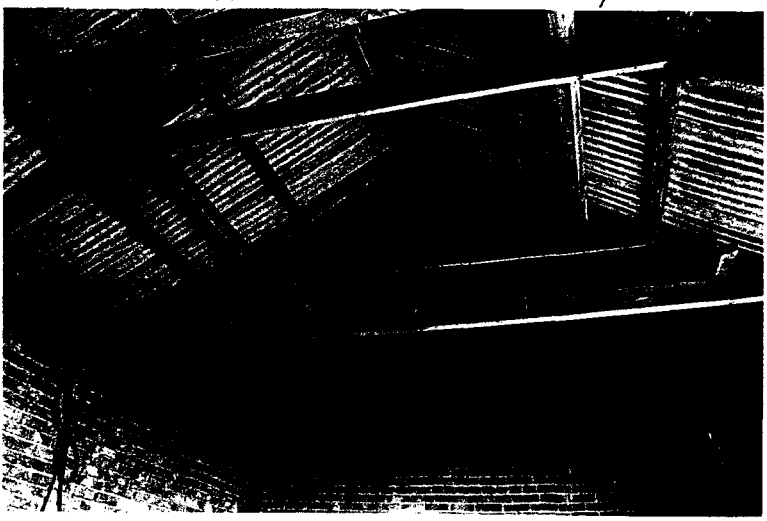
7. + 8. TYPICAL TIMBER ROOF FRAMING FOR AGRICULTURAL STORE IS A MIX OF PURLINS AND COLLAR FRAMES WITH EAVES LEVEL TIES/STRAPS ADDED IN

ALL WILL NEED TO BE REMOVED AND RE-FRAMED TO SUIT DOMESTIC HABITATION

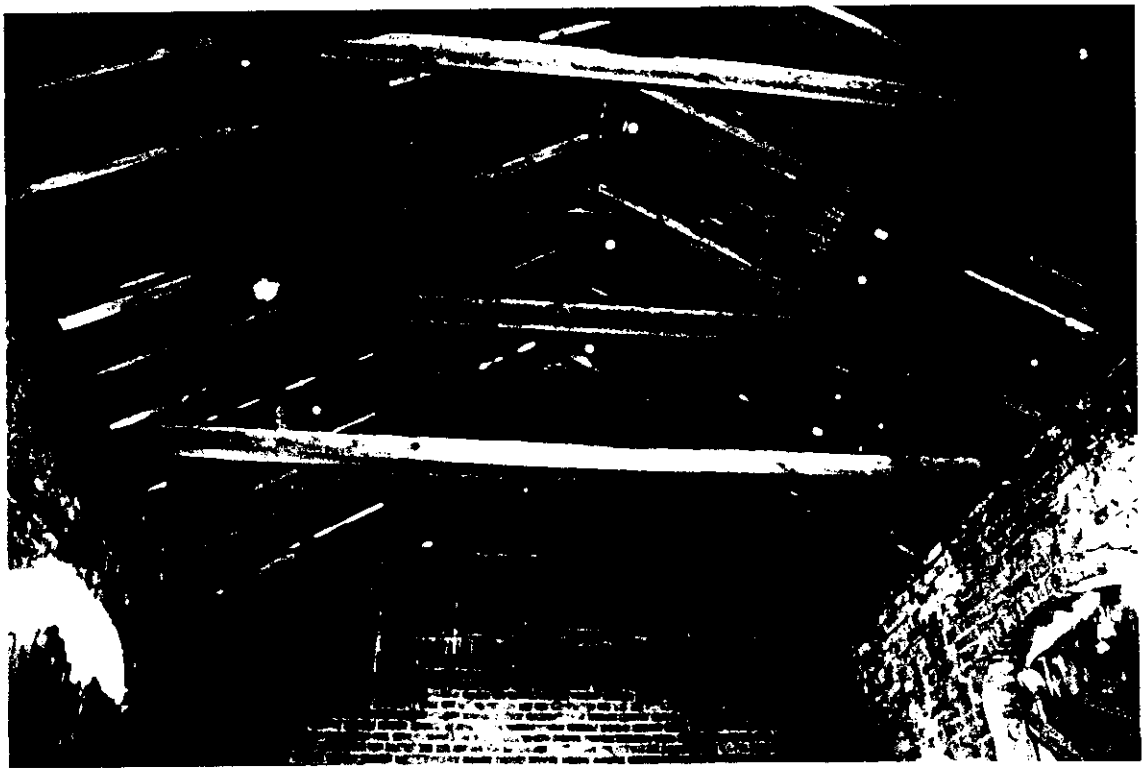
9. "HIGH LEVEL" ROOF FRAMING ALSO A MIX OF FRAMES AND TIES. WILL NEED TO BE REPLACED
