HISTORIC BUILDING RECORDING

NORTHGATE FARM

WEST PINCHBECK

APS Report No: 29/24

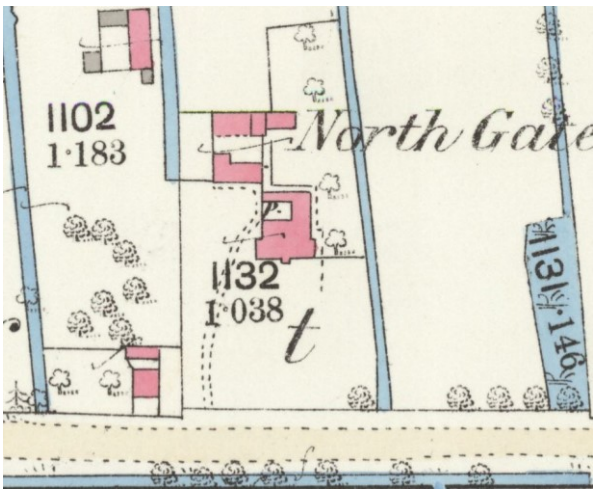
Fig. 1a. Extract from the 1st edition 25" Ordnance Survey Map of 1888

The 1st Edition Ordnance Survey 25" map of 1889 shows that the building was rectangular in form with an outshut at the west end of its north elevation. To the north was another range of buildings, partially open fronted on the south side. To the west of the coach/trap house was a drain which terminated level with the southern extent of the building forming part of the western boundary. A wider look at the mapping of the area suggests that the main farm complex might have been in the parcel of land on the south side of Northgate. Later mapping of 1904 indicates no changes, and the six inch map of 1952 indicates no significant changes apart from the addition of further buildings to the north.

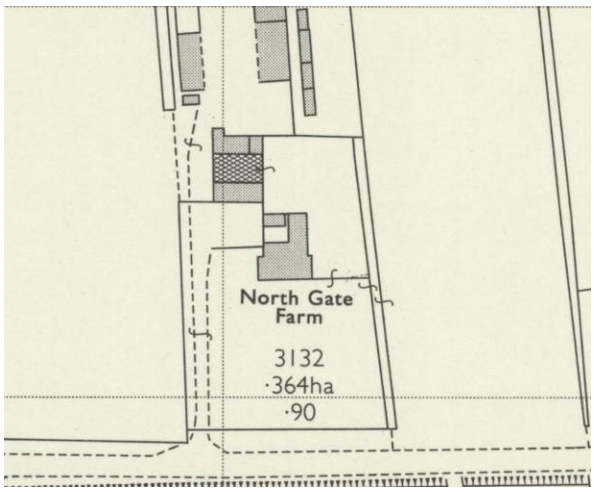
Fig. 1b. Extract from the 1:2500 Ordnance Survey Map of 1972

By the publication of the 1:25000 National Grid map in 1973, the land pattern has changed and the outbuilding has been enclosed into its most recent configuration joining the stables to the remains of the buildings that sat immediately to the north of the surveyed structure. The drain on the west boundary now terminates further to the north and the east boundary drain terminates level with the current configuration of the building of which this document is subject.

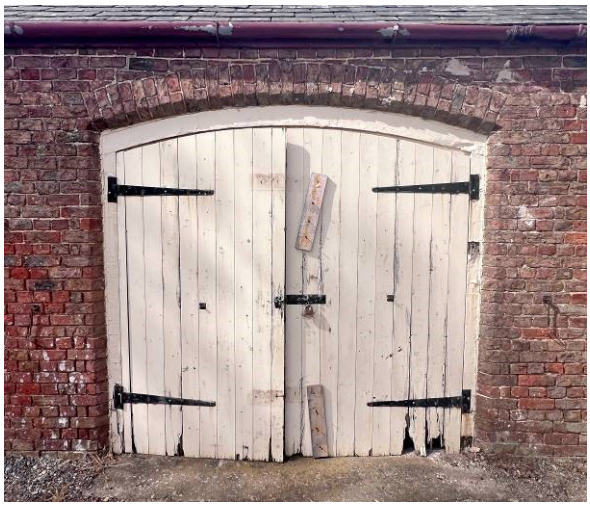
Plate 6. The double width door in the south elevation

The double door aperture in the south elevation was also edged with King Closers with Queen Closers for strength. The plank door was divided with a slight offset, the western side being lightly less wide than the eastern side. It was secured to the frame with iron strap hinges.

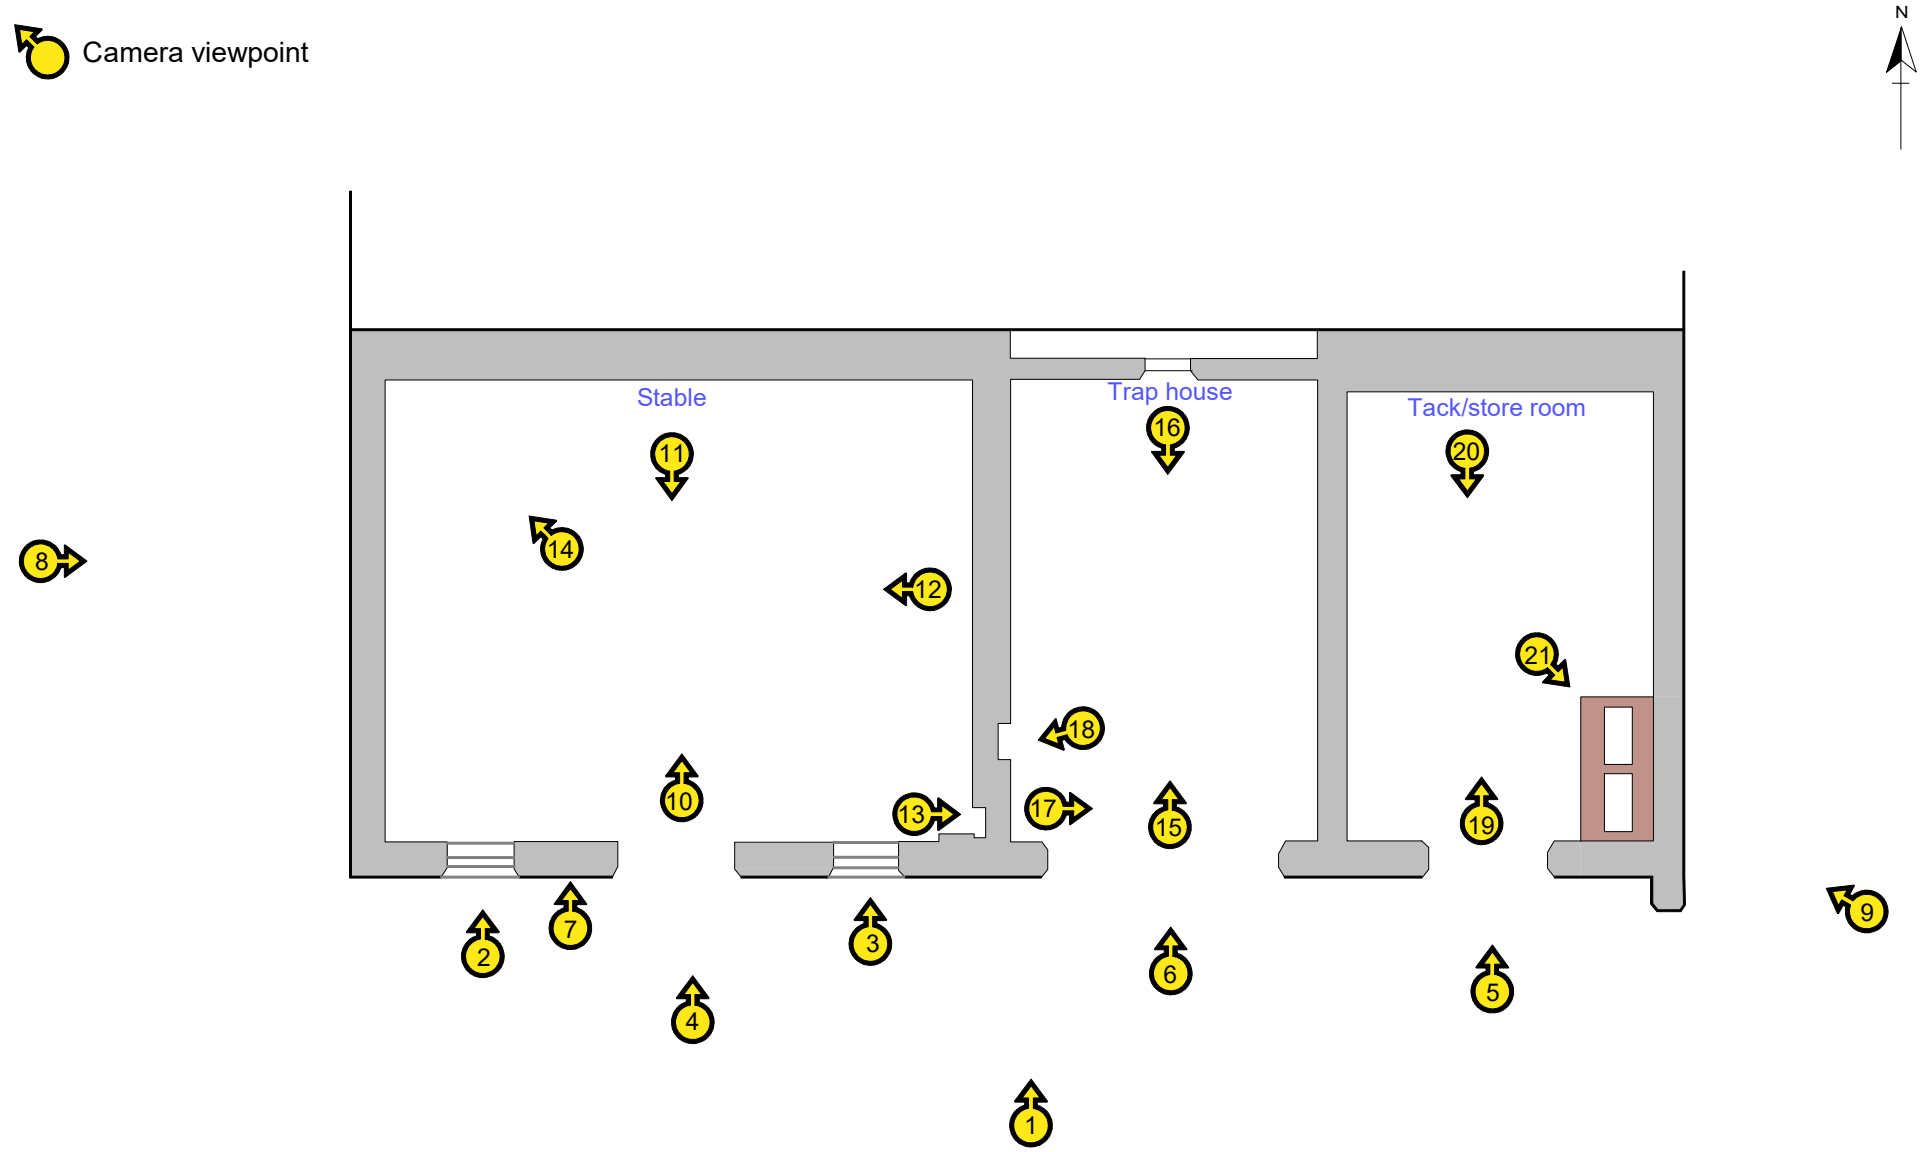
Figure 4. Plan and plate locations

Internally, the western room was the largest of the three divisions within the building and provided the stabling area.

Inside the double door aperture was the trap or coach house. Here the floor was brick pavers. In the north wall was a window aperture that had been blocked with 20th century bricks. Along the wall above these were the remains of holes, probably for the large timber pegs that would have supported the harnesses and other equipment. These were also present in the east wall.

Accessed through the single door at the east end of the building was a small room that would have served as a tack room coupled with a general purpose store room that would have served the stables and trap house. The floor of this room was constructed from brick pavers.

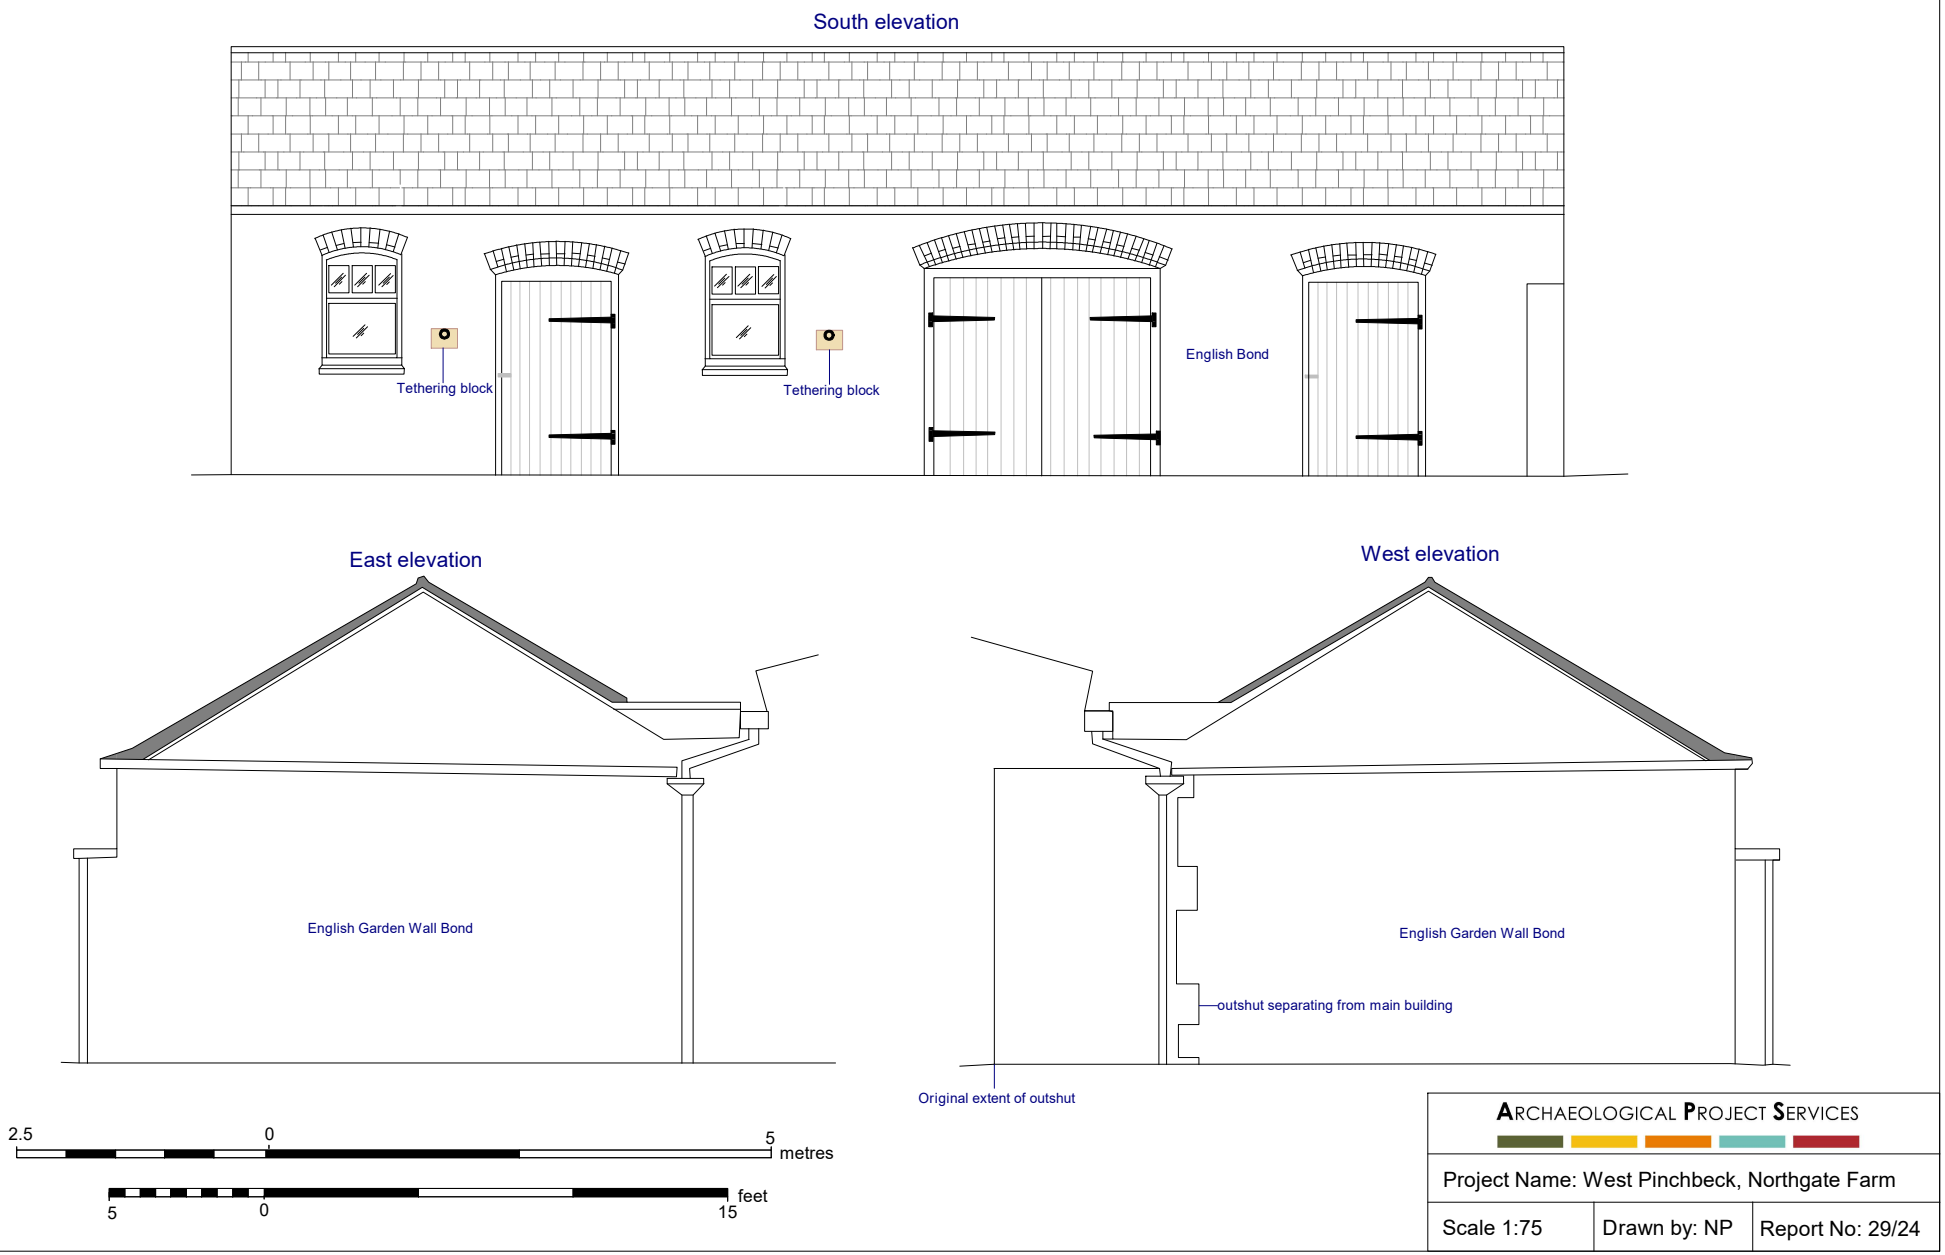
Figure 5. Elevations

The south elevation provided the main public façade of the building. The bricks were laid in English bond comprising alternating rows of bricks laid as stretcher (laid lengthways) and headers (laid end on). There were three door apertures each leading singly to its corresponding room and two window apertures at the west end providing light to the westernmost room. The roof was of slate.

The masonry of the west elevation comprised bricks laid in English Garden Wall bond where there are three courses of stretchers to one of headers. This continued north past the eaves line of the roof where the remains of the former northern outshut seen on historic mapping were present before being encapsulated in the modern barn.

The east elevation was also laid in English Garden Wall bond which extended slightly southwards in what appeared to be a gate pillar.
