Project
GOODS SHED CONVERSION
NORTH DROVE SOUTH
PODE HOLE
SPALDING, LINCS.

Drawing
EXISTING ELEVATIONS
REPAIR SCHEDULE

Job Ref.	Drawing No.
3029-16	20

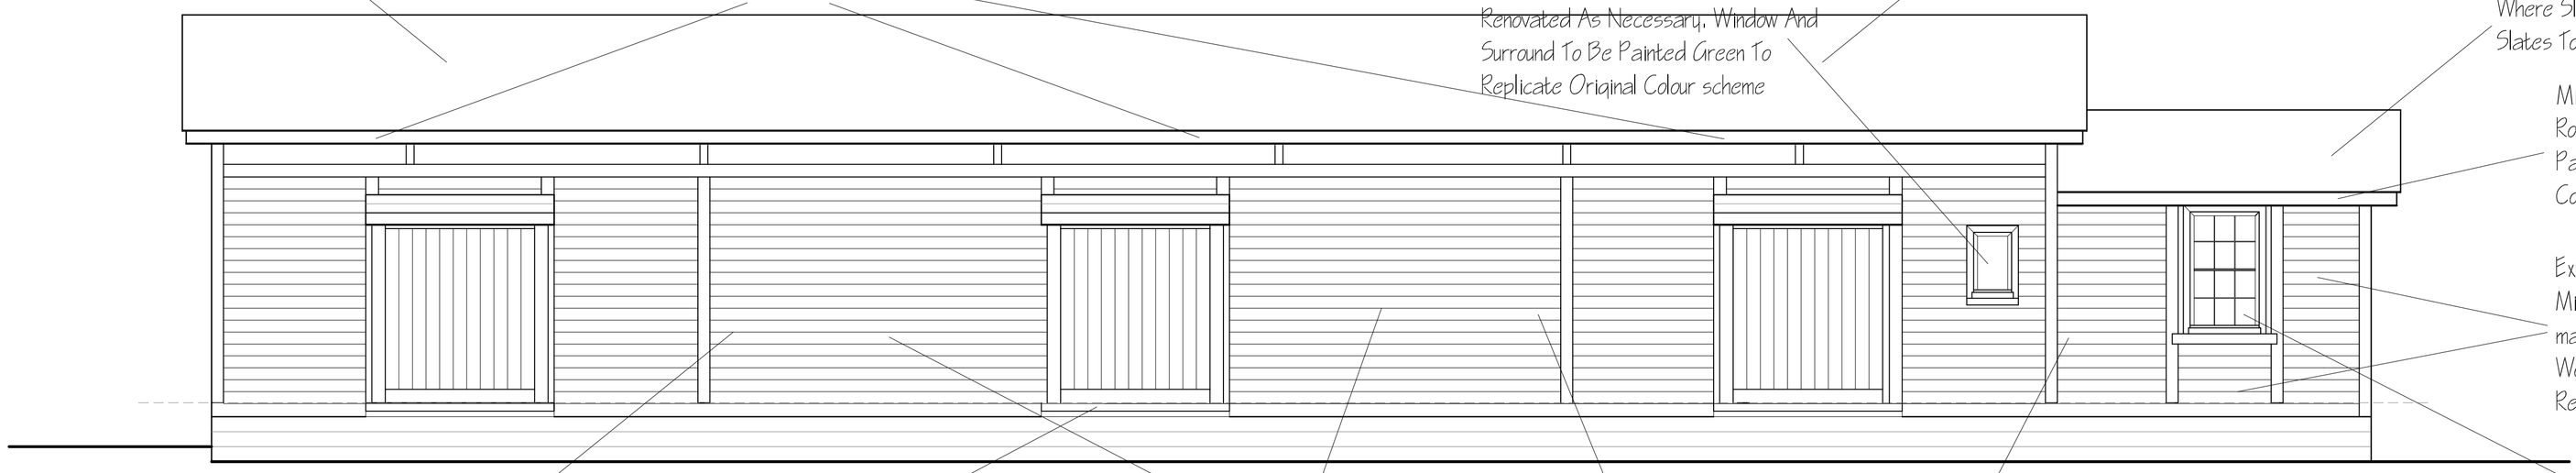
Existing Slate Roofing To Be Re-laid Where Slates Have Slipped And Missing Slates To Be Replaced.

Missing & Damaged Guttering To Be Replaced With ½ Round Metal Guttering. Guttering To Be Painted Green To Replicate Original Colour Scheme

Existing Wooden Fixed Window To Be Retained And Renovated Any Broken Panes Of Glass To Be Replaced. Existing Wooden Surround to be Repaired And Renovated As Necessary. Window And Surround To Be Painted Green To Replicate Original Colour scheme

Missing Guttering To Be Replaced With ½ Round Metal Guttering. Guttering To Be Painted Green To Replicate Original Colour Scheme

Existing Timber Walling To Be Repaired. Missing planks to be replaced with matching in size, profile and wood type. Wood Planking To Be Painted Cream To Replicate Original Colour Scheme

Missing & Damaged Downpipes To Be Replaced With Metal Guttering. Guttering To Be Painted Green To Replicate Original Colour Scheme

Missing Platform Edging To Be Replaced With Wood To Match Existing In Size, Profile And Wood Type. Wood Planking To Be Stained To Replicate Original Colour Scheme

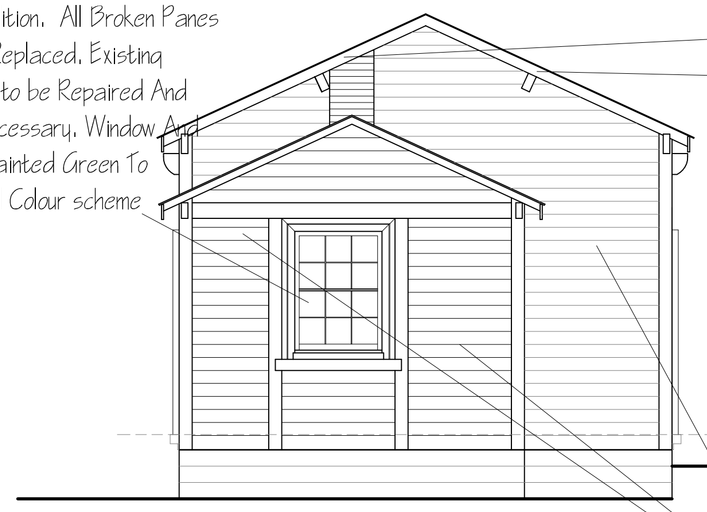
Existing Structural Timber Walling To Be Repaired or Replaced As Directed By Specialist Contractor. Missing and Damaged Woodwork To Be Replaced With Matching Woodwork In Size, Profile And Wood Type. Wood Planking To Be Stained To Replicate Original Colour Scheme

Missing & Damaged Downpipes To Be Replaced With Metal Guttering. Guttering To Be Painted Green To Replicate Original Colour Scheme

Existing Wooden Vertical Sliding Sash Window To Be Retained And Renovated Into Working Condition. All Broken Panes Of Glass To Be Replaced. Existing Wooden Surround to be Repaired And Renovated As Necessary. Window And Surround To Be Painted Green To Replicate Original Colour Scheme

Existing Timber Barge Boards To Be Repaired & Replaced. Missing woodwork to be replaced with matching woodwork in size, profile and wood type. Bargeboards To Be Painted Cream To Replicate Original Colour Scheme

Existing Timber Walling To Be Repaired. Missing Planks To Be Replaced With Matching Woodwork In Size, Profile And Wood Type. Wood Planking To Be Painted Cream To Replicate Original Colour Scheme

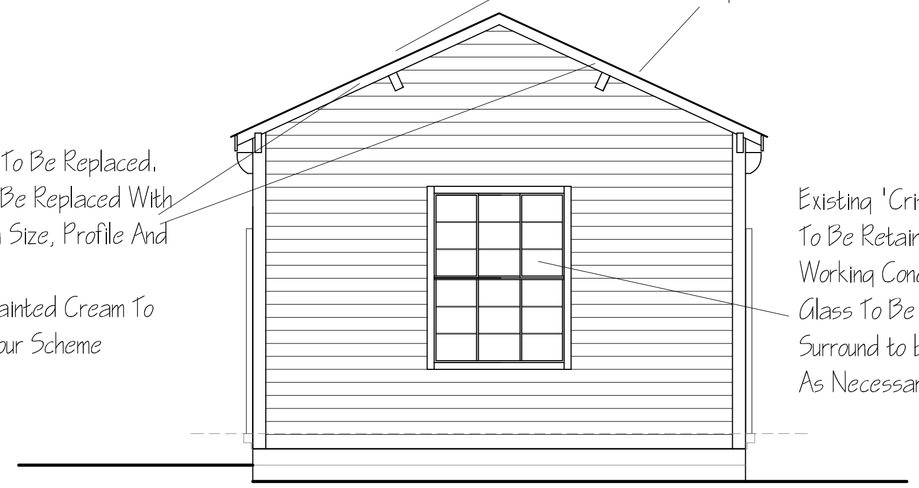
Existing Timber Door To Be Repaired. Missing And Damaged Wood To Be Replaced With Matching Woodwork In Size, Profile And Wood Type. Door And Frame To Be Painted Green To Replicate Original Colour Scheme

Existing Slate Roofing To Be Re-laid Where Slates Have Slipped And Missing Slates To Be Replaced.

Missing Guttering To Be Replaced With ½ Round Metal Guttering. Guttering To Be Painted Green To Replicate Original Colour Scheme

Timber Barge Boards To Be Replaced. Missing Woodwork To Be Replaced With Matching Woodwork In Size, Profile And Wood Type. Bargeboards To Be Painted Cream To Replicate Original Colour Scheme

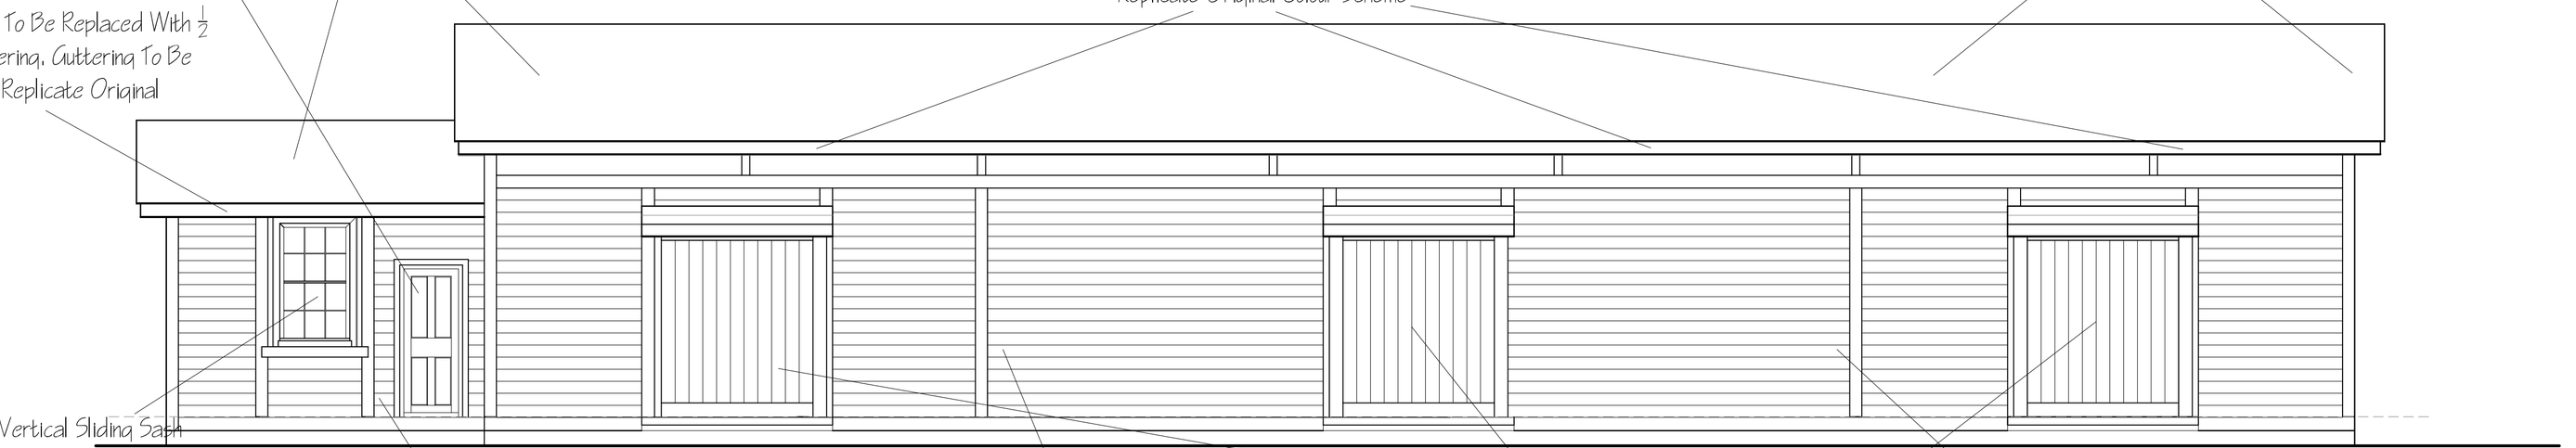
Existing 'Crittal' Metal Framed Window To Be Retained And Renovated Into Working Condition. All Broken Panes Of Glass To Be Replaced. Existing Wooden Surround to be Repaired And Renovated As Necessary.

Missing & Damaged Guttering To Be Replaced With ½ Round Metal Guttering. Guttering To Be Painted Green To Replicate Original Colour Scheme

Existing Slate Roofing To Be Re-laid Where Slates Have Slipped And Missing Slates To Be Replaced.

Missing Guttering To Be Replaced With ½ Round Metal Guttering. Guttering To Be Painted Green To Replicate Original Colour Scheme

Existing Wooden Vertical Sliding Sash Window To Be Retained And Renovated Into Working Condition. All Broken Panes Of Glass To Be Replaced. Existing Wooden Surround to be Repaired And Renovated As Necessary. Window And Surround To Be Painted Green To Replicate Original Colour Scheme

Existing Timber Walling To Be Repaired. Missing Planks To Be Replaced With Matching Woodwork In Size, Profile And Wood Type. Wood Planking To Be Painted Cream To Replicate Original Colour Scheme

Missing & Damaged Downpipes To Be Replaced With Metal Guttering. Guttering To Be Painted Green To Replicate Original Colour Scheme

Existing Timber Door And Canopy To Be Repaired And Reinstated. Missing And Damaged Planks To Be Replaced With Matching Woodwork In Size, Profile And Wood Type. Wood Planking To Be Stained To Replicate Original Colour Scheme
