Asbestos Refurbishment/Demolition Survey for

The Ferns
Beck Bank
Quadring Fen
Lincolnshire
PE11 4QY

Project Number: ECB/5510

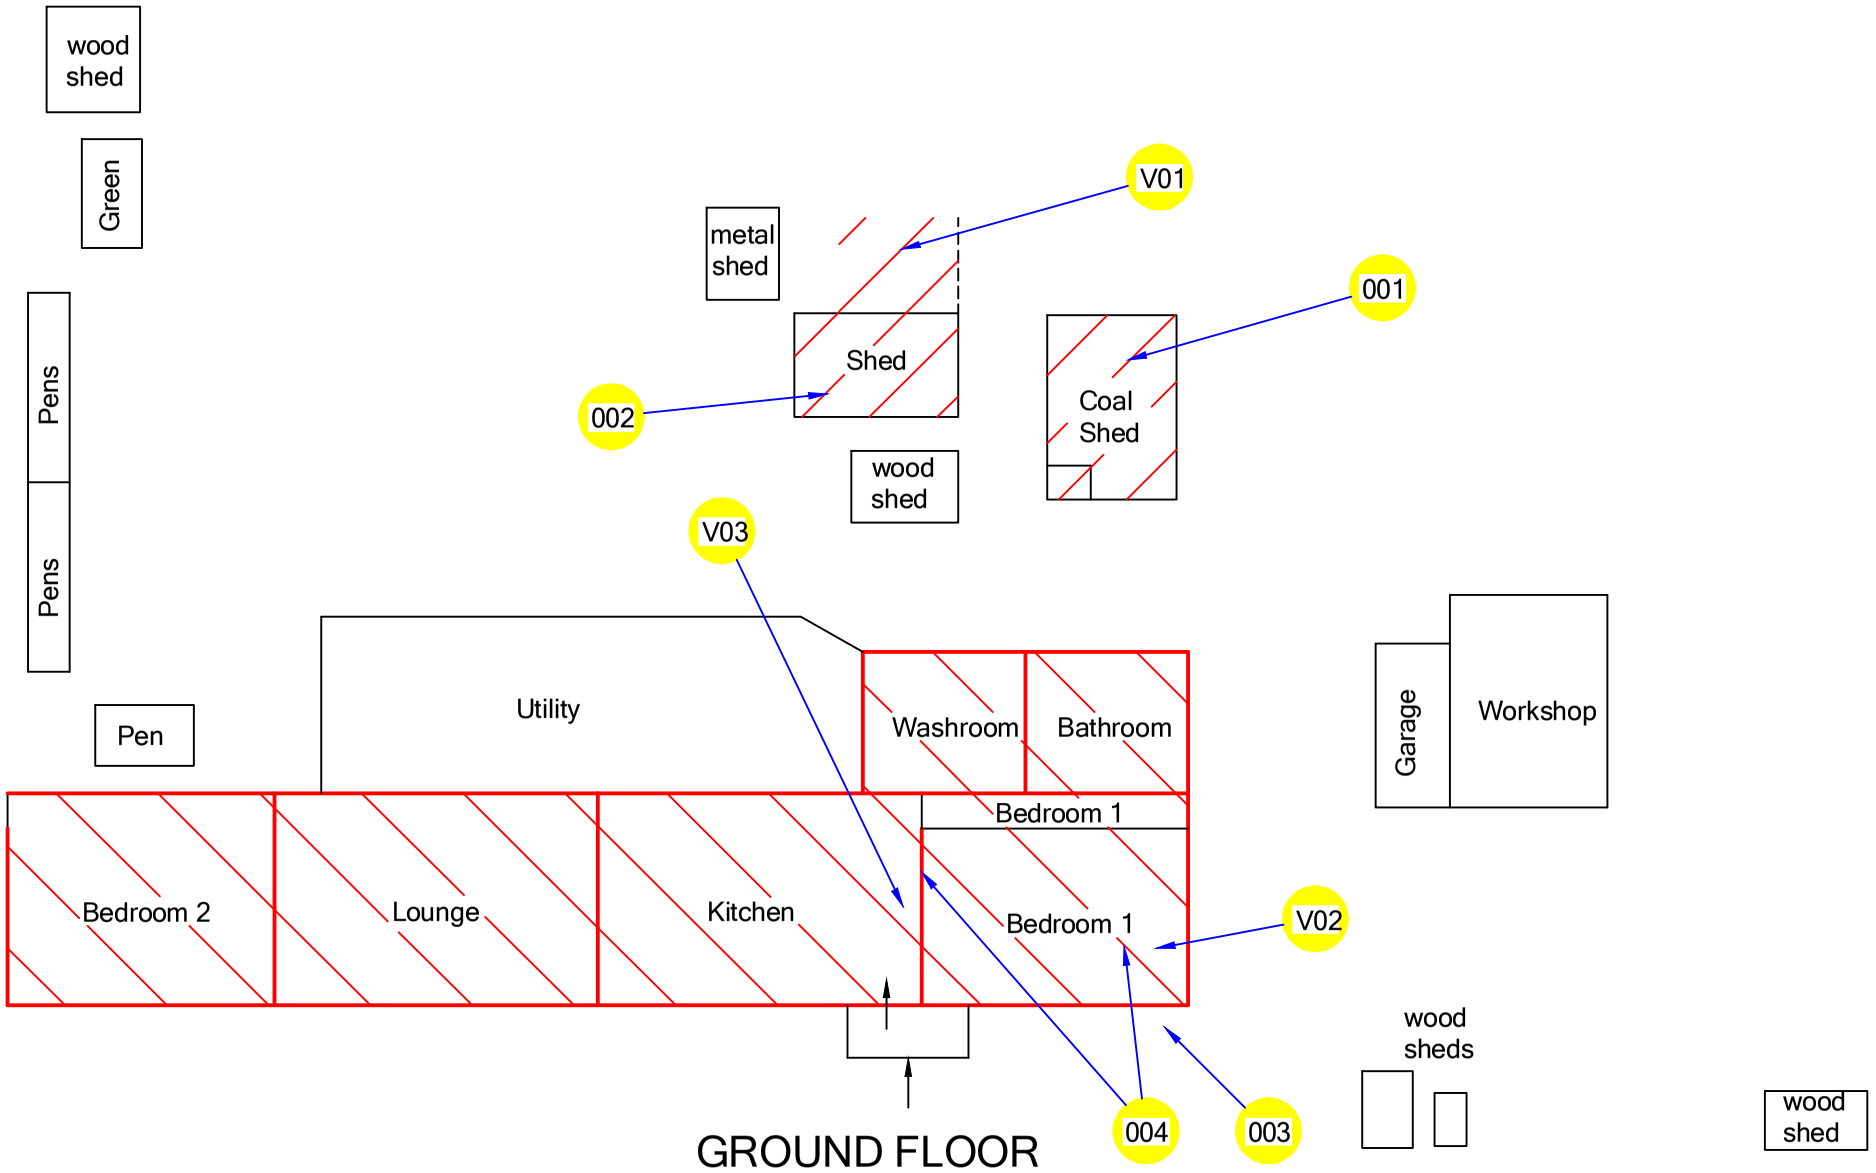
Site asbestos refurbishment & demolition survey consisted of a non standard construction residential bungalow with outbuildings.
Constructed of wood, steel, fibreglass roof, brick, concrete render, asbestos cement boarding, plastic rainwater goods, non asbestos fibreboards, wood claddings, plaster, ceramic cistern, ceramic wall 7 floor tiles, non asbestos vinyl floor coverings, plastic soil pipe, non asbestos bitumastic vertical damp proofing, polystyrene ceiling tiles, wooden sheds, metal corrugated roof & cladding sheets, asbestos cement corrugated roof sheets, and no asbestos detected to electrics.
