Project:
Proposed Conservation works to the Spalding War Memorial
Ayscoughfee Hall Gardens
Church Gate
Spalding
PE11 2RA

Drawing Title:
Proposed French Drain
Ground Floor Level Block Plan as existing

Drawing Number:	Rev:
A1606-03	P1

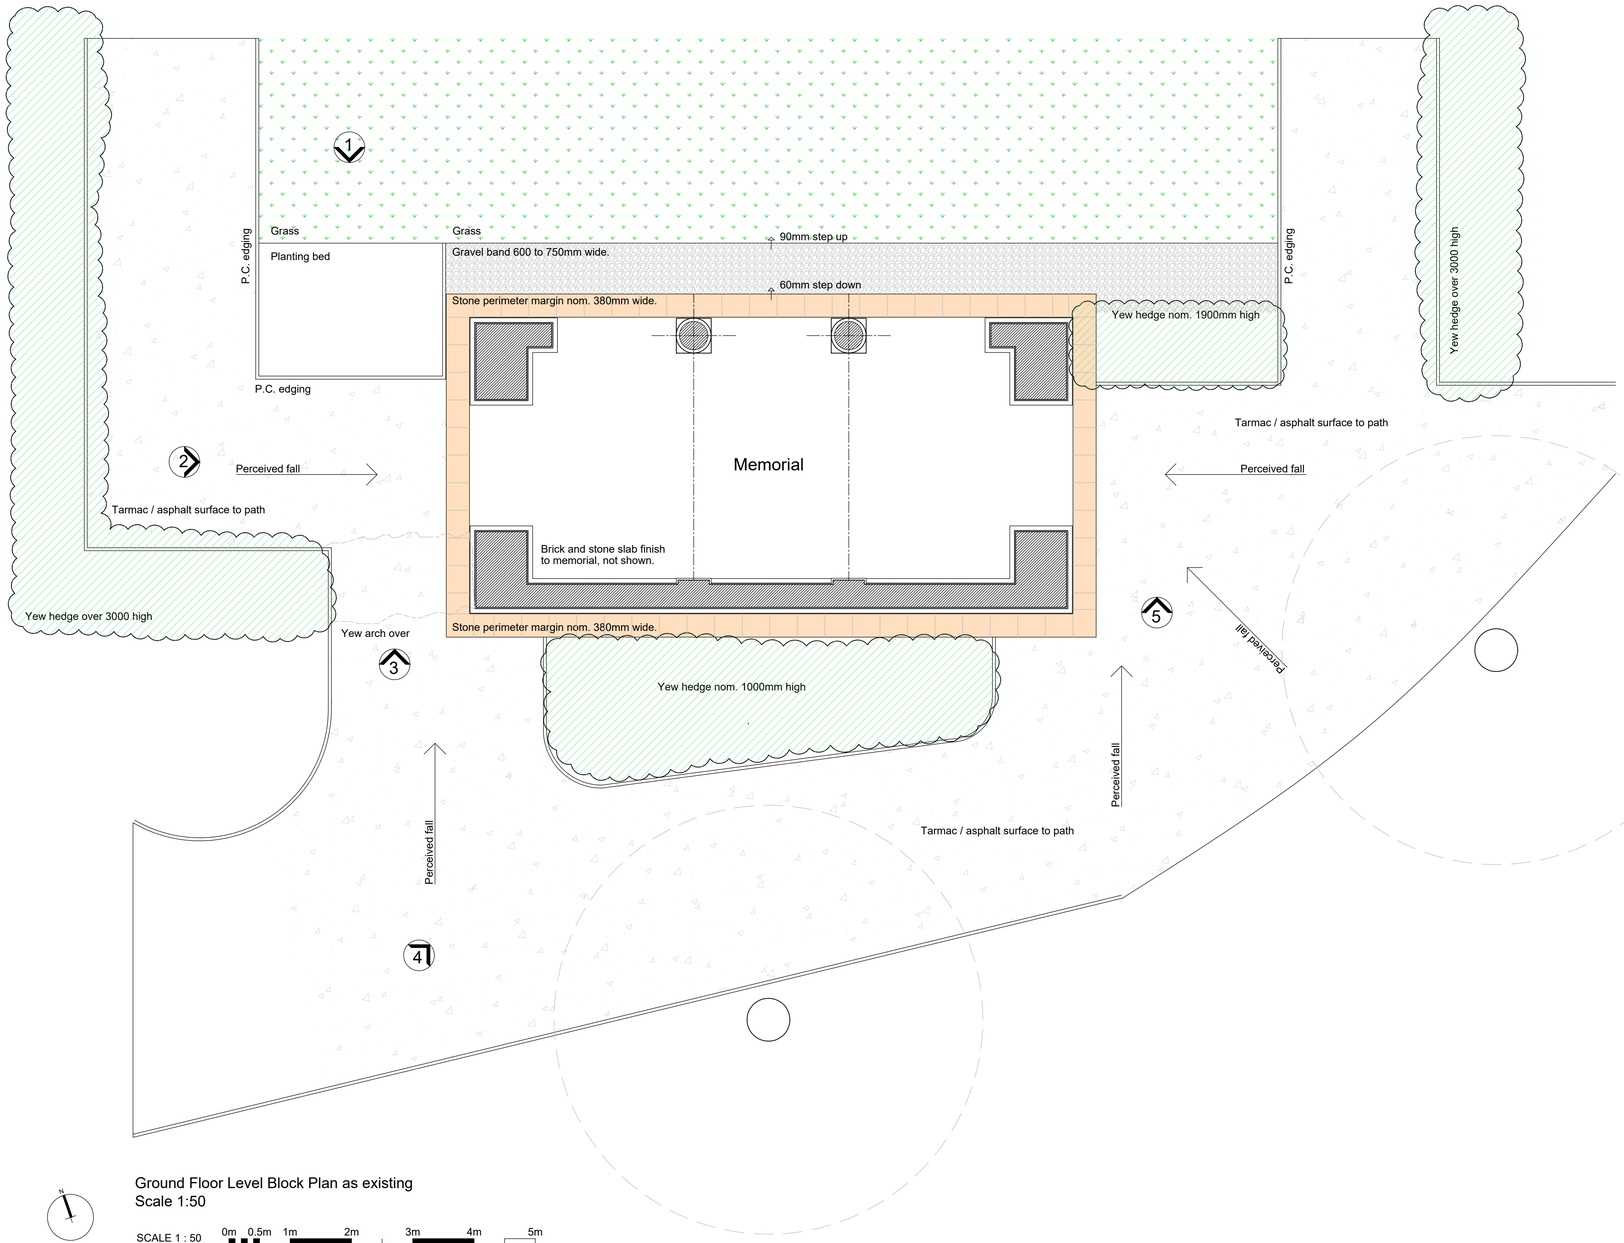
Photo 1 - perceived fall right to left towards memorial

Photo 2 - perceived near to far towards memorial

Photo 3 - algea growth evident to west of memorial

Photo 4 - rear (south) of memorial showing Yew hedge.

Photo 5 - algea growth evident to east of memorial
