SI-492292

Client: Sedgwick

Job Reference: 9581093

Address: Westbourne Lodge, Summerhouse & Coal House, 13 Cowbit Road, Spalding, PE11 2RD

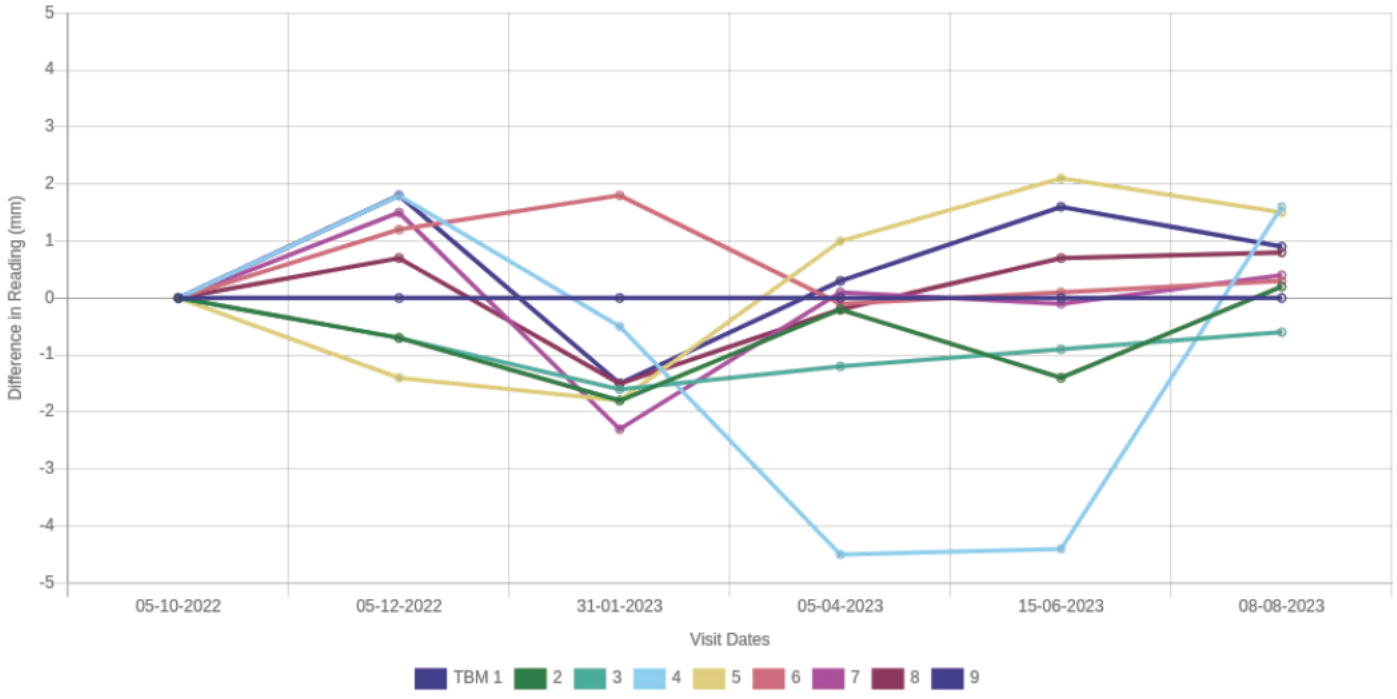
Level Readings Chart (Points TBM 1 - 9)

Visit 1	Visit 2	Visit 3	Visit 4	Visit 5	Visit 6	Visit 7	Visit 8	Visit 9	Visit 10
	05/10/22	05/12/22	31/01/23	05/04/23	15/06/23	08/08/23				
TBM 1	0	0	0	0	0	0				
2	0	-0.7	-1.8	-0.2	-1.4	+0.2				
3	0	-0.7	-1.6	-1.2	-0.9	-0.6				
4	0	+1.8	-0.5	-4.5	-4.4	+1.6				
5	0	-1.4	-1.8	+1	+2.1	+1.5				
6	0	+1.2	+1.8	-0.1	+0.1	+0.3				
7	0	+1.5	-2.3	+0.1	-0.1	+0.4				
8	0	+0.7	-1.5	-0.2	+0.7	+0.8				
9	0	+1.8	-1.5	+0.3	+1.6	+0.9

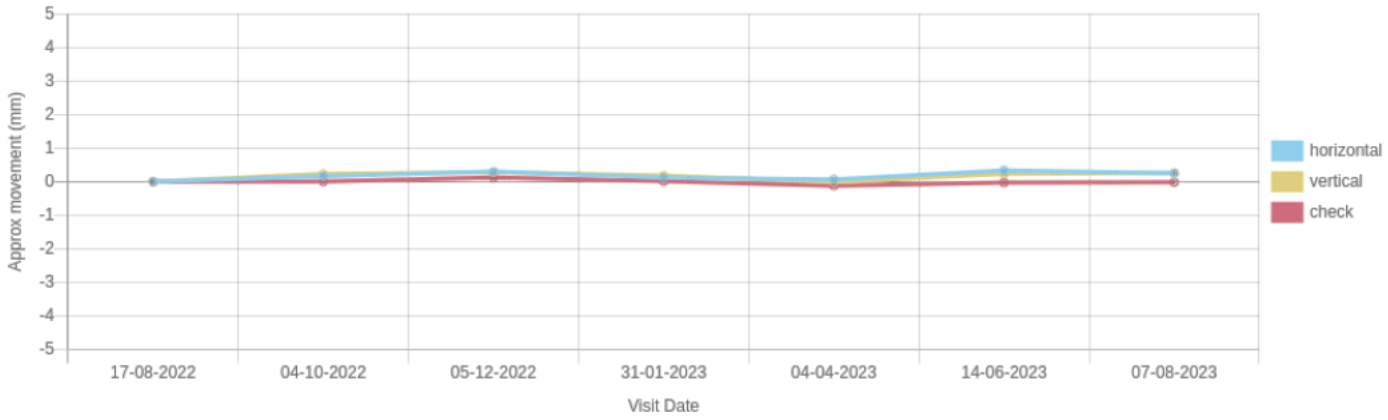
EXT RHS by RWP low level - Crack Readings Differences (Displayed in Millimetres)

Visit 1	Visit 2	Visit 3	Visit 4	Visit 5	Visit 6	Visit 7	Visit 8	Visit 9	Visit 10
	18/08/22	05/10/22	05/12/22	31/01/23	05/04/23	15/06/23	08/08/23			
H	-0.16	0	0.14	-0.04	-0.09	0.18	0.09			
V	-0.23	0	0.05	-0.05	-0.24	0	0.03			
C	0	0	0.13	0.01	-0.12	-0.03	-0.02

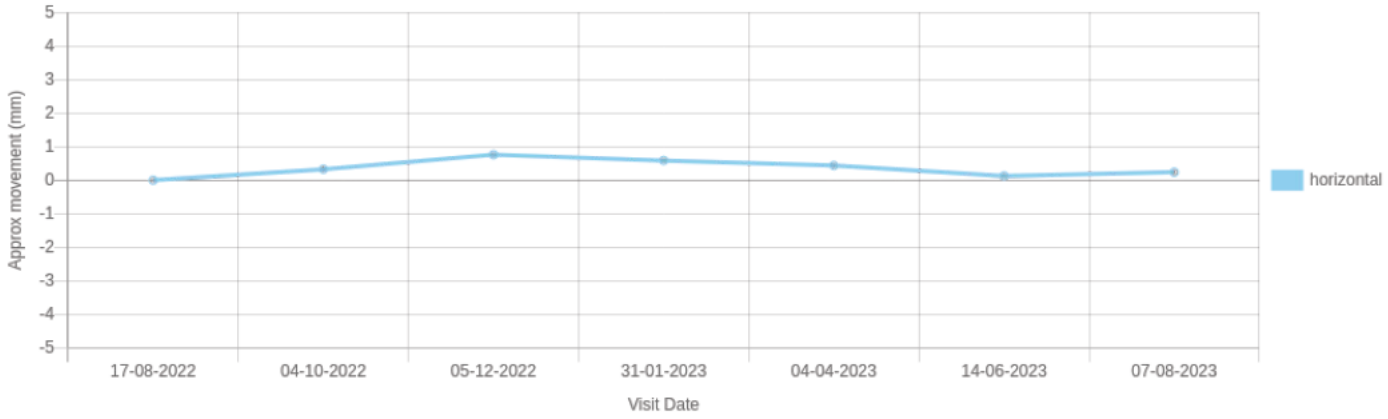
INT airing cupboard window - Crack Readings Differences (Displayed in Millimetres)

Visit 1	Visit 2	Visit 3	Visit 4	Visit 5	Visit 6	Visit 7	Visit 8	Visit 9	Visit 10
	18/08/22	05/10/22	05/12/22	31/01/23	05/04/23	15/06/23	08/08/23			
H	-0.33	0	0.43	0.26	0.11	-0.2	-0.09
