Heritage Impact Assessment

Proposed minor works to repair a flat roof and internal drainage to 16 High Street, Spalding PE11 1TW, which is adjacent to Holland House, a Grade II Listed Building.

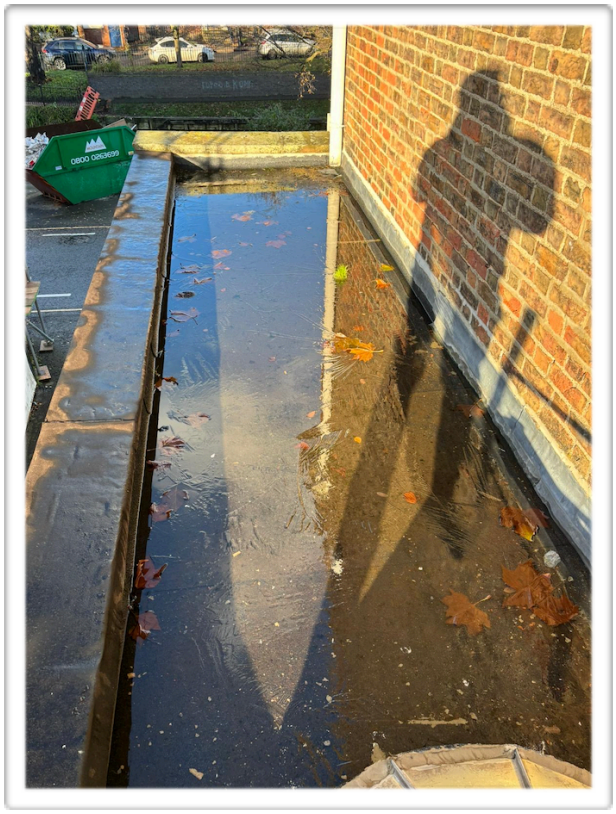
There is little fall on the roof and the lantern appears to be positioned too close to the building, preventing water to run off the roof and into the downpipes. Water is pooling on the roof and has caused damage to the interior of the building.
We would like to remove the lantern and replace with a solid roof, with enough fall to allow surface water to effectively drain away.

Pic 2.
The flat roof area of the building

Pic 3.
Water unable to drain away

Pic 4.
Water and debris build up near lantern

Pic 4.
Internal damage

To strip the existing roof back, and remove the failing lantern, remove the entire roof covering and replace with a warm deck, insulated roof with fibreglass covering to manufacturers specifications.
