| Job | SPALDING STATION<br>PLATFORM REFURBISHMENT |
| Title | EXISTING DEFECTS TO STAIR TOWER<br>TO FOOTBRIDGE ON PLATFORM 1 |

| Drawing No. | Rev. |
|---|---|
| NG6096/SPA-05 | |

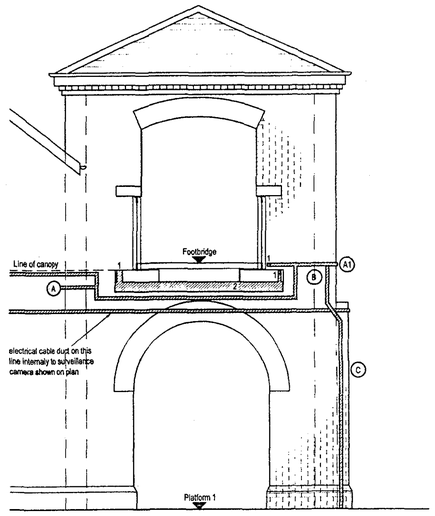
ELEVATION 1-1
LOCATION OF SERVICES

Position of services
A Surveillance camera
A1 Surveillance camera to side wall
B Station anouncement speaker
C Light to side wall
1 Point at which services run along walkway girders
2 Point at which services enter building

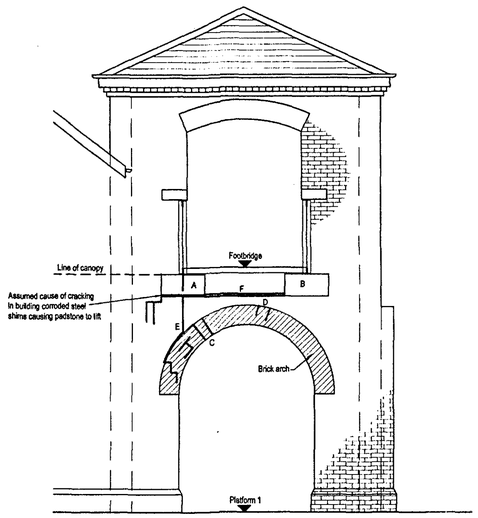
ELEVATION 1-1
DEFECTS AT PLATFORM LEVEL

Location of cracks in wall
A Padstone 700x370 deep 40mm gap under
B Padstone 700x360 deep
C Cracks in arch wider at bottom
D Radial cracks wider at top
E 3mm Crack through joints and bricks
F Brickwork between padstones lifted up

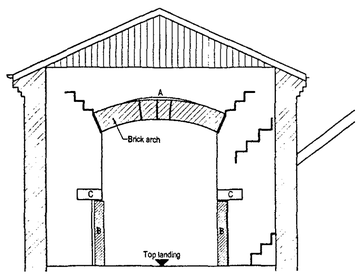
ELEVATION 2-1
DEFECTS AT FOOTBRIDGE LEVEL

Location of cracks in wall
A 3mm gap above arch
B Footbridge girders supported on padstones below
C Corbel stones being lifted by footbridge girders

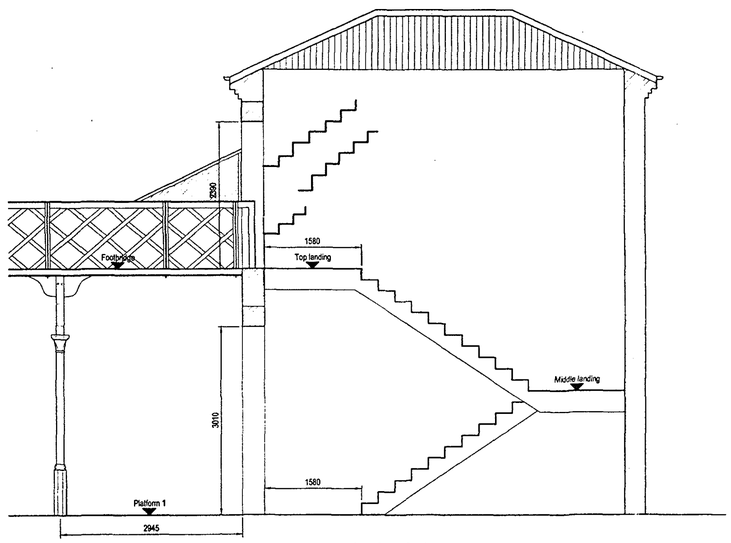
SECTION A-A
DEFECTS TO SIDE WALL AT FOOTBRIDGE LEVEL

Location of cracks in wall
